PROPERTY INSPECTION REPORT

Concerning: 6646 Miller Shadow Ln, Missouri City, TX 77459
(Address or Other Identification of Inspected Property)

By: Michael Holguin, Lic #3752 ICC #5116880 09/04/2019
(Name and License Number of Inspector) (Date)

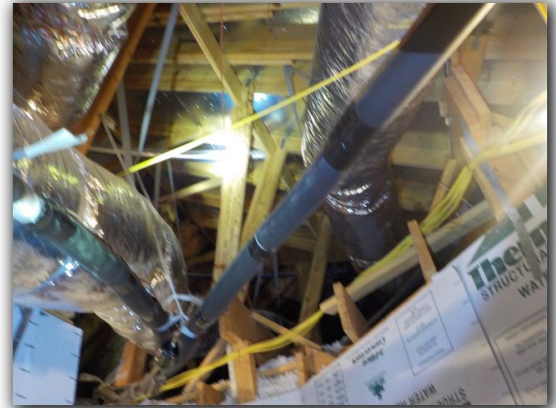
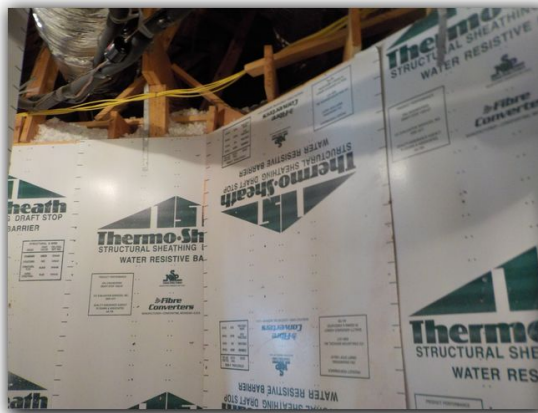
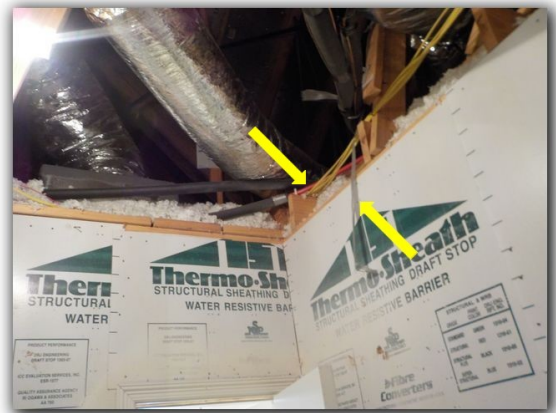
Comments: The upper attic should be readily accessible. A fixed ladder should be installed at the side HVAC attic or the garage attic.

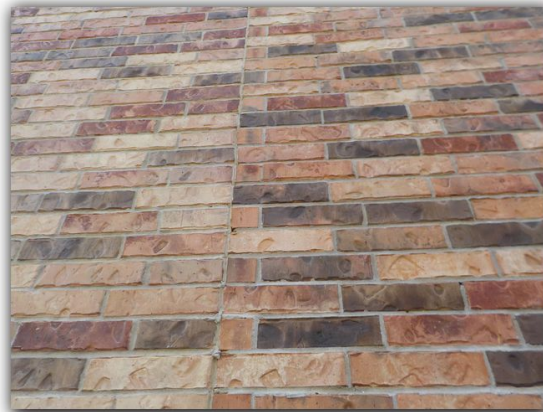
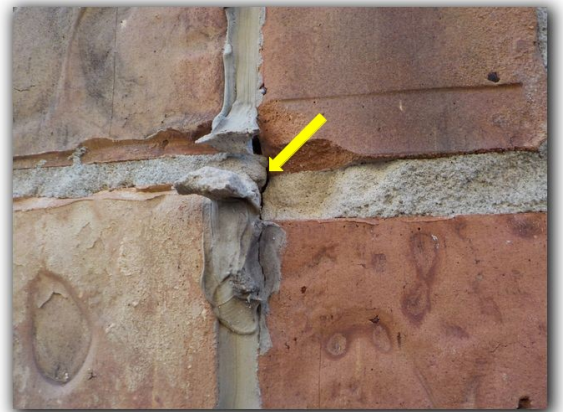
Comments: The brick veneer expansion joints need maintenance.

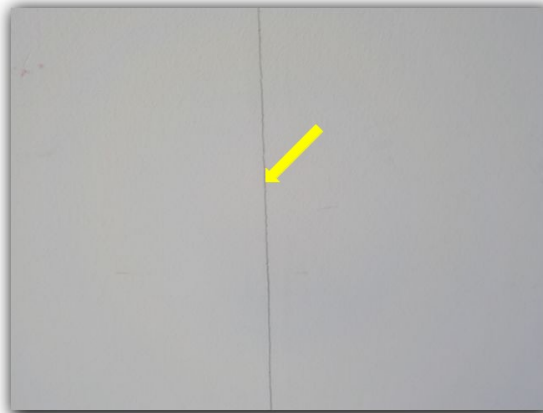
The garage has a hairline taping crack.

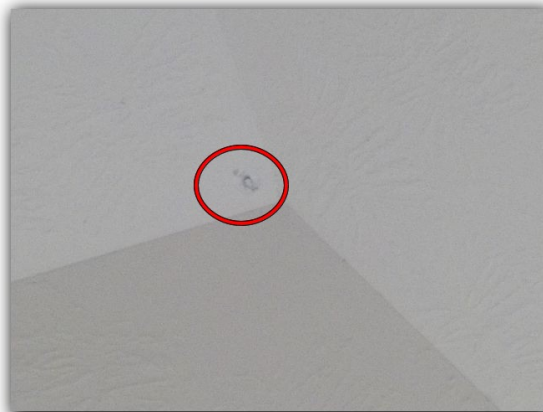
Comments: The den ceiling has a small taping crack.

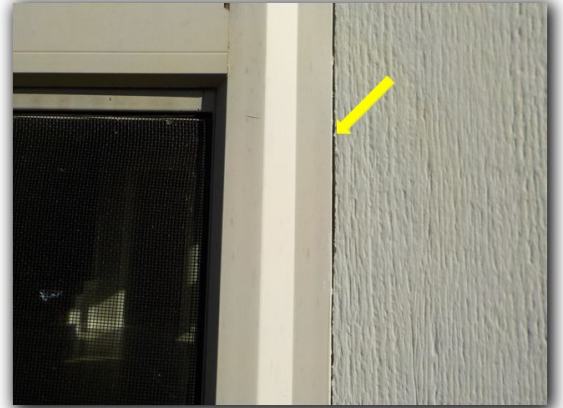
The exterior window frames caulk needs maintenance.

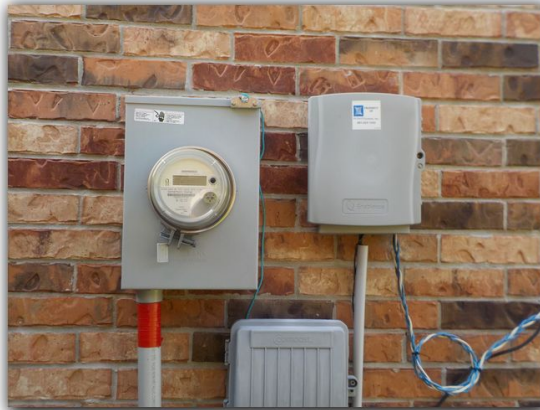
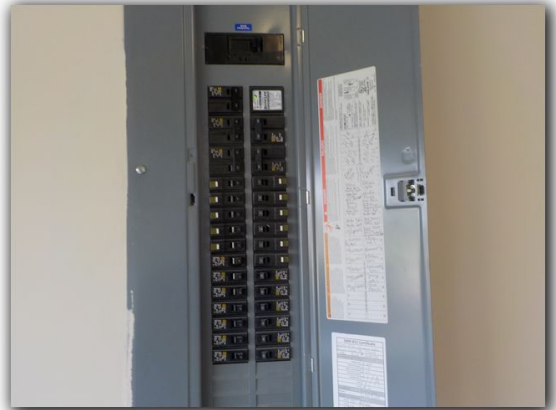
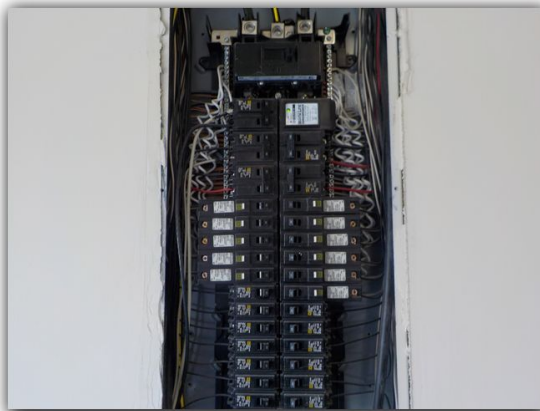
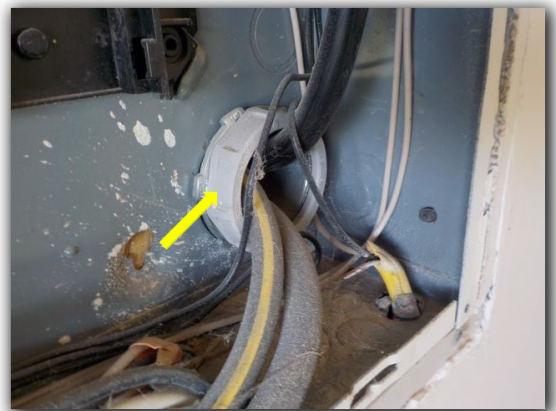
Comments: The plastic bushing should be a metal bonding bushing. Consult a licensed electrician.

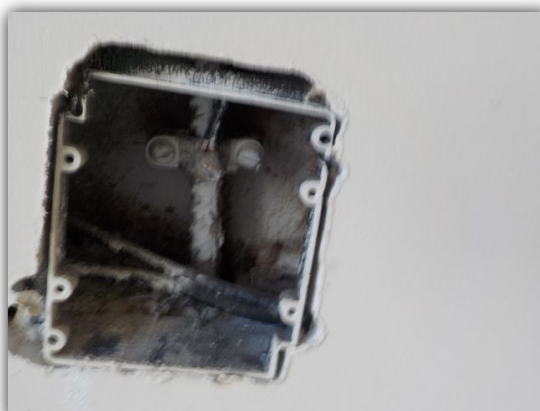
The foundation steel bonding junction box should have a cover in place.

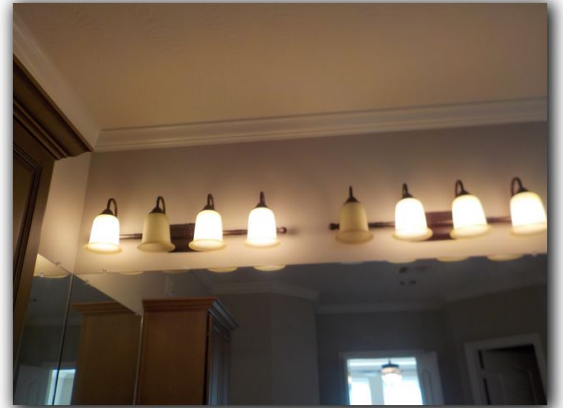
Comments: The upstairs right middle room closet light is inoperative. The master bath has burned out bulbs.

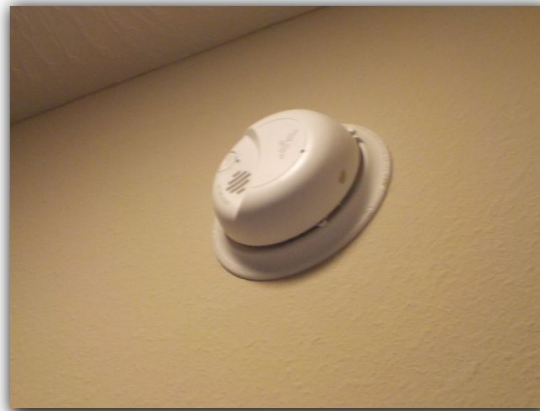
The master bedroom should have a carbon monoxide alarm near the bedroom exterior. The other bedrooms should have carbon monoxide alarms besides a smoke alarm in the vicinity of the bedrooms.

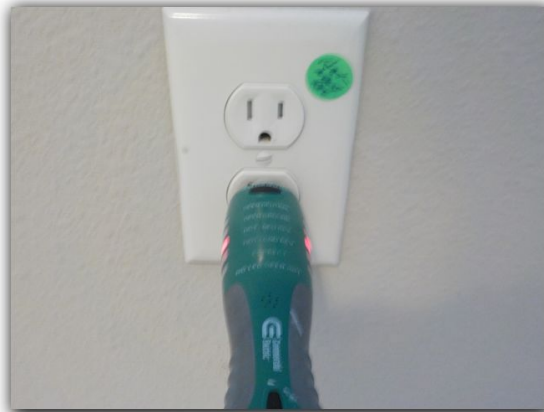
The upstairs right middle room has a hot-neutral reverse hook up receptacle. Correct improper hookup. Potential shock hazard.

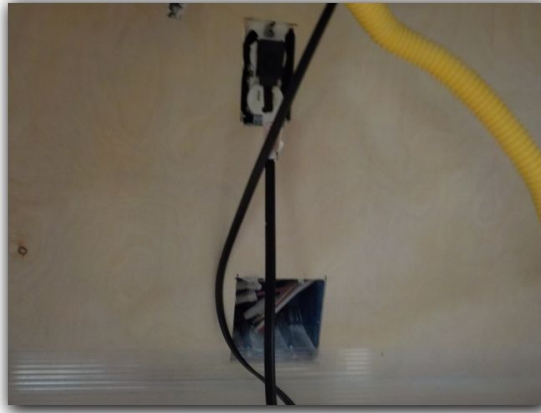
The receptacle and junction box under the stove should have covers in place.

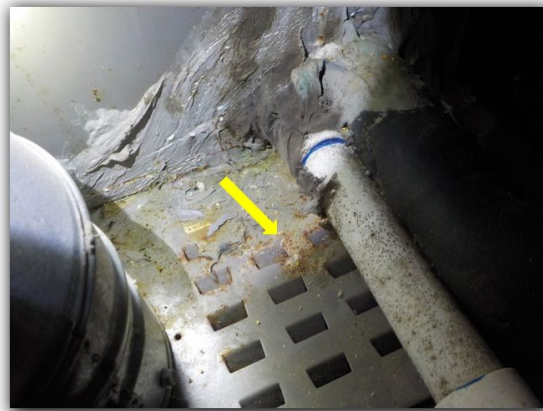
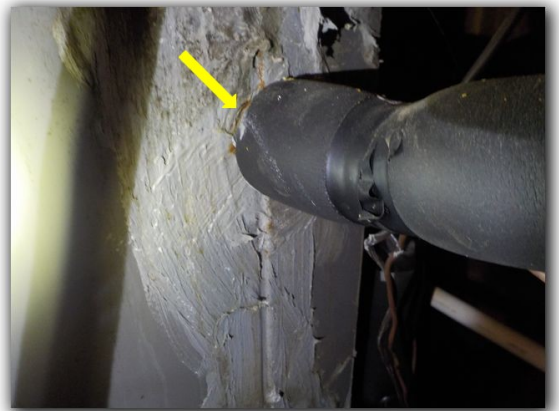
Comments: The right evaporator suction line insulation should be butted up to the cabinet to prevent condensation from dripping and causing a rusting condition.

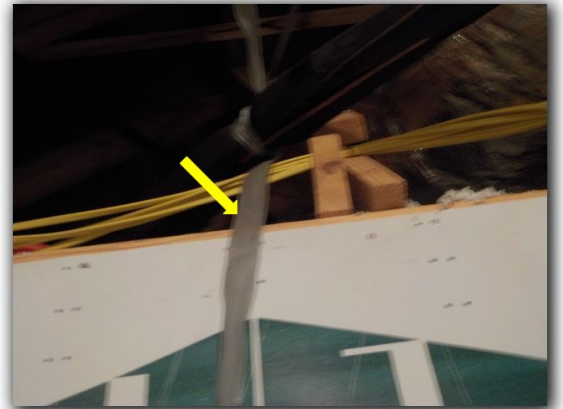
One evaporator suction line support strap is broken at the HVAC side attic.

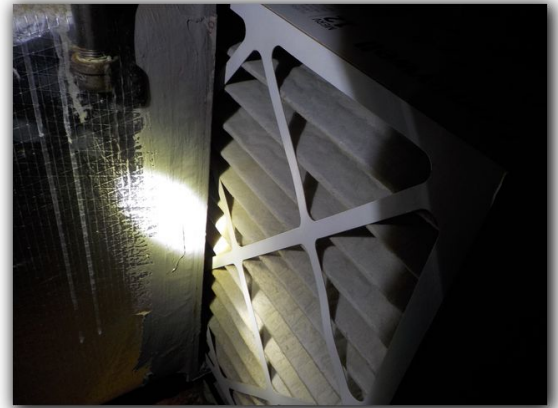
Comments: The dirty media filters should be replaced which should improve the cooling temperature differential.

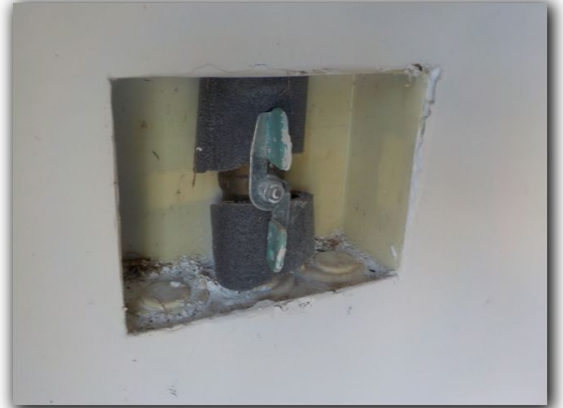
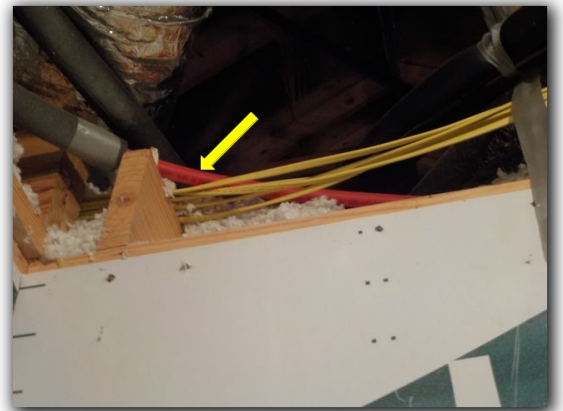
Comments: The exposed water line at the HVAC side attic should be insulated. There is a water pressure drop when all the fixtures are operating even though the water pressure drop is not visible to the eye from 64# to 35#. Consult a licensed plumber.

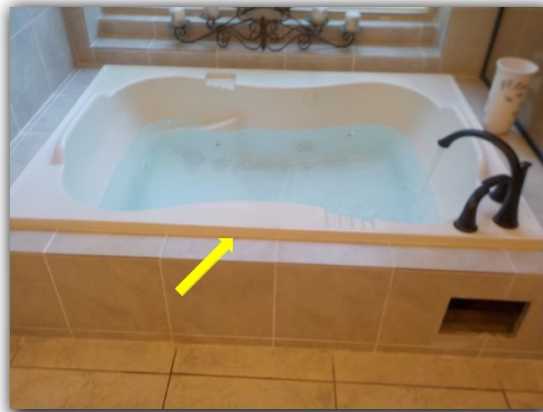
The bathtubs perimeters should be caulked.

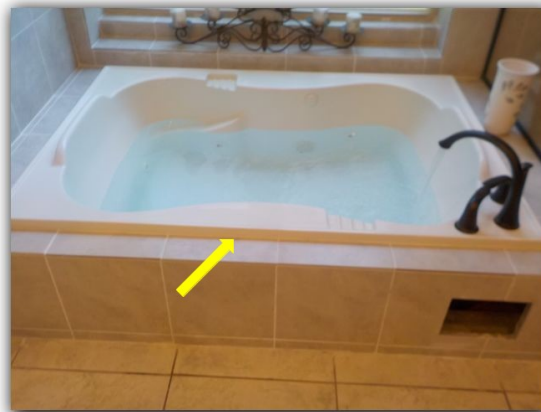
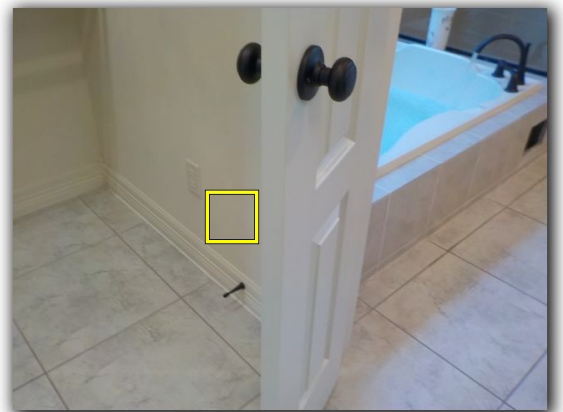
Comments: The pump-motor is not accessible. Recommend and access at the closet side wall.

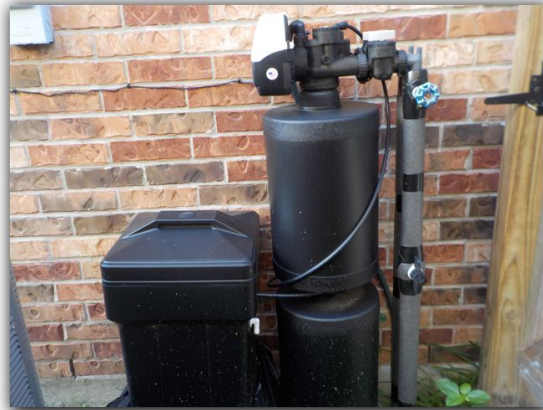
Comments: Recommend maintenance be performed on the water softener.
