Property Inspection Report

PROPERTY INSPECTION REPORT

Concerning: 7911 Deaton Dr., Humble, TX 77346
(Address or Other Identification of Inspected Property)

By: Larry Fleming, Lic #4860 08/09/2019
(Name and License Number of Inspector) (Date)

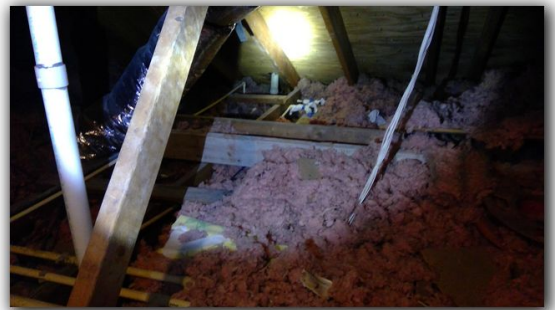
Evidence of previous moisture penetration observed in roof decking from attic side

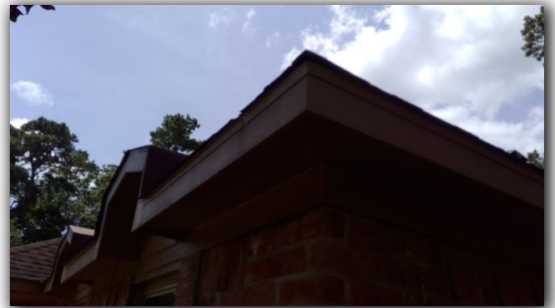
Edges of shingles around the perimeter are damaged at one or more locations.

Roof covering shows evidence of deterioration / fiberglass threading showing in some locations.

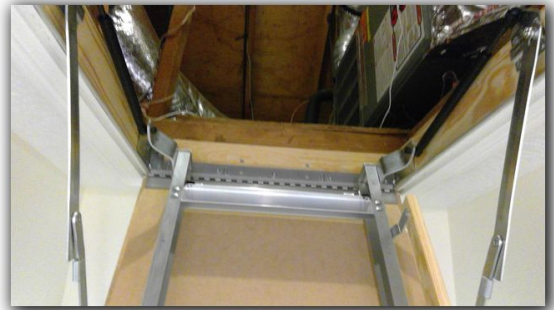
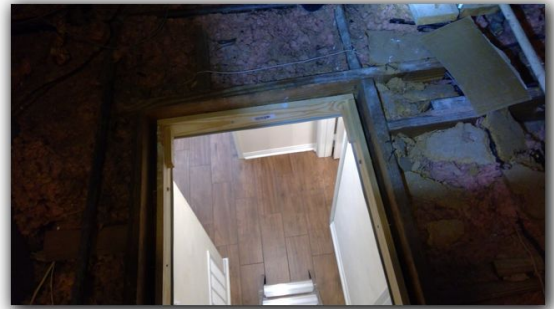
- Attic access fold down ladder not installed per manufacturer's specifications / proper fasteners

- Framing at the attic access does not conform to current standards requiring double framing for the access door.

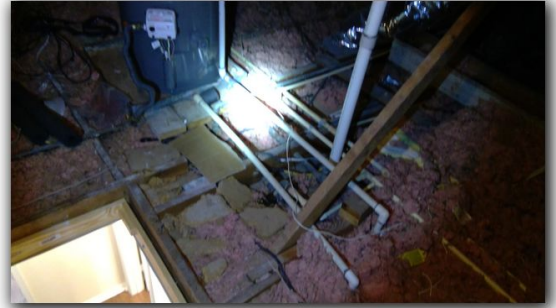
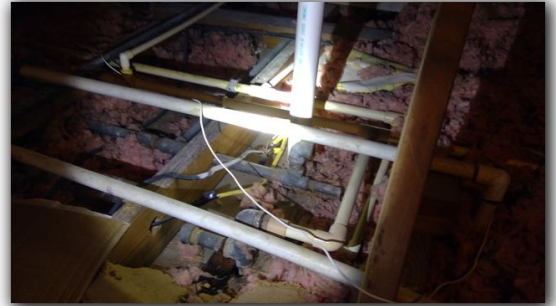
Insulation piled up in some areas of the attic space that appear to need to be redistributed.

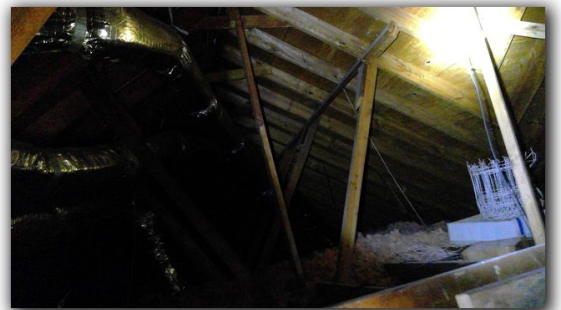
House was not constructed per current standards requiring the purlin brace to be the same size or larger than the rafter being supported. 2 x 4 purlins supporting 2 x 6 rafters observed.

Purlin braces needed every 4' per current code to properly support purlins in attic space. It

appears that some purlin braces are missing at some locations.

Would recommend that a licensed and / or qualified contractor be consulted to make any further recommendations and / or repairs

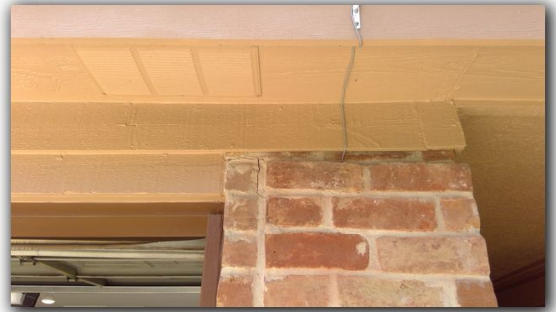
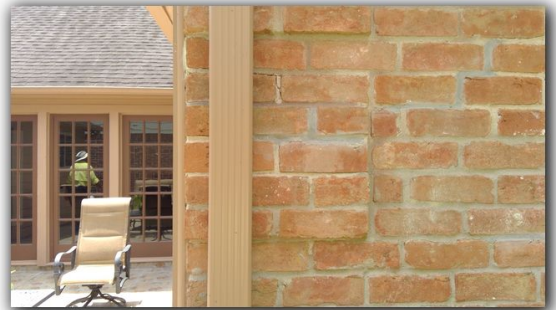
Mortar is separated, cracked or missing in some areas

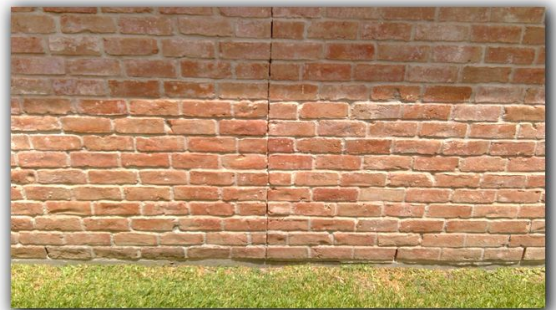
Caulking / sealant is separated or missing in some areas

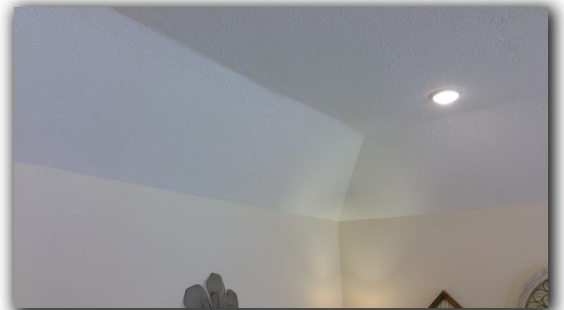
Evidence of previous repair observed in multiple sheetrock ceiling locations

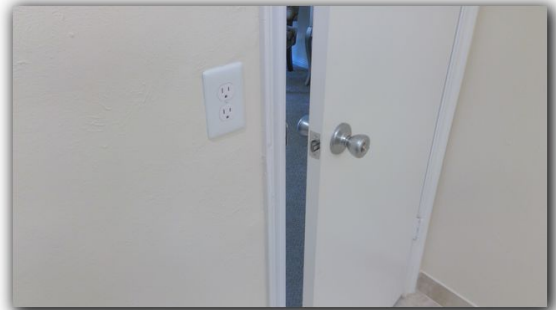
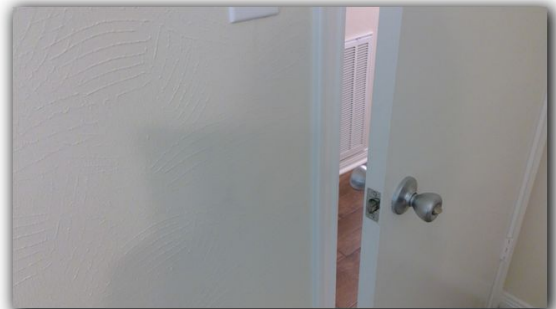
Interior doors do not latch properly at one or more locations.

Ball latches appear to be damaged / missing at one or more door locations which keeps the door from latching properly. See study closet area. Doors do not appear to be supplied with appropriate ball latches.

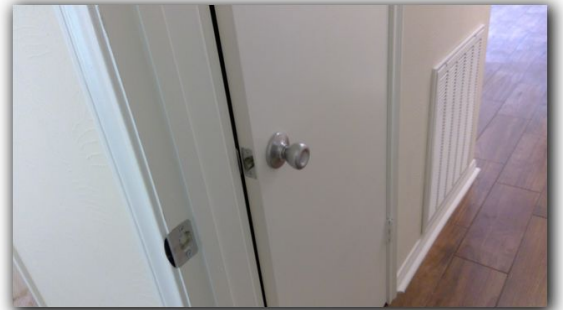
- Double door units do not fit square to each other at one or more bedroom closet locations

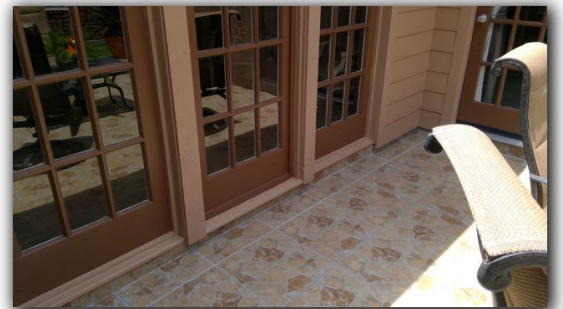
- Wood rot observed in the lower door area of one or more exterior doors where it appears that the middle window present was once a door that has been permanently fixed into a window.

- Exterior door has been altered and turned into a window location at the middle patio area.

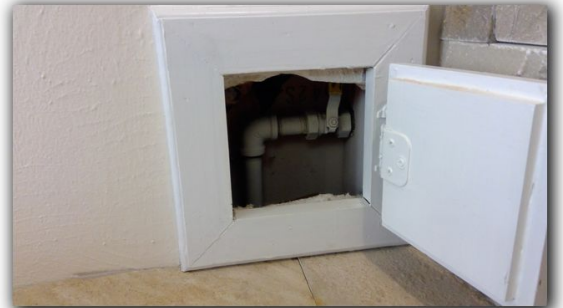
Gas valve does not require the use of a separate key. This can present a potential safety hazard if valve is turned without the use of the key and gas is inadvertently turned on.

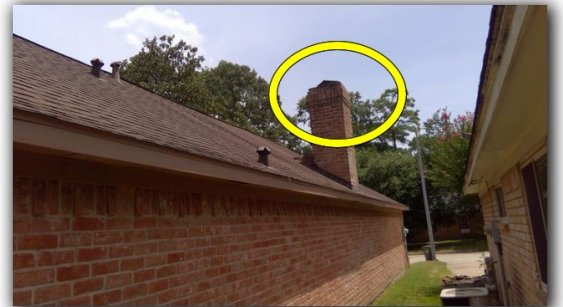
Inspector did not have access to the chimney cap location. Due to the age of the structure and the type of construction, this inspector would recommend that a qualified fireplace specialist make any further recommendations and potential repairs to the mortar chimney cap as needed.

Would recommend that a licensed and / or qualified contractor be consulted to make any further recommendations and / or repair

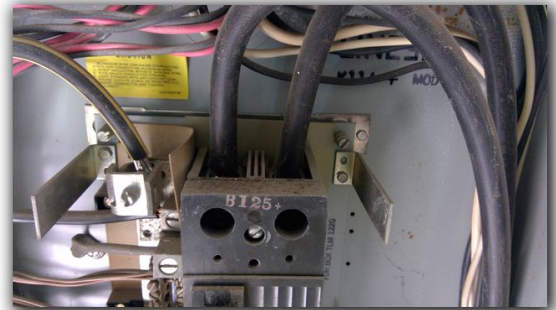
Wiring entering the panel box without appropriate clamps / bushings at knock out holes

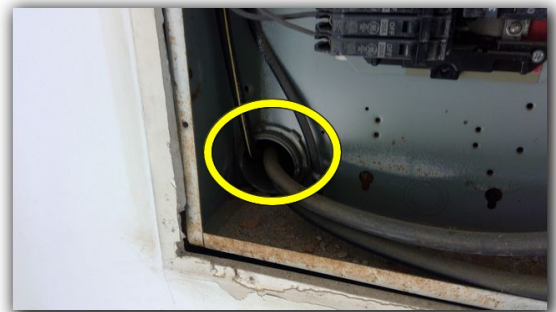
Electrical panel box is not properly labeled

Conduit appears damaged (not installed in a usual and customary building practice manner) at the electrical meter can.

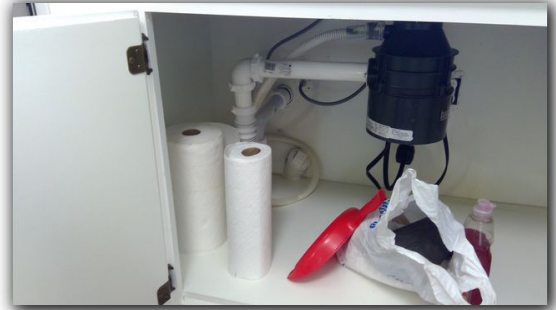
Outlet/Switches loose at multiple locations.

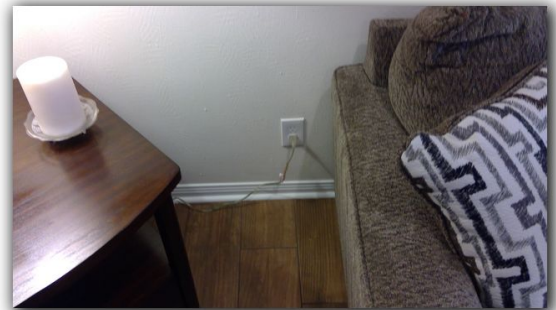
Switch(s) could not be determined for proper operation at one or more locations.

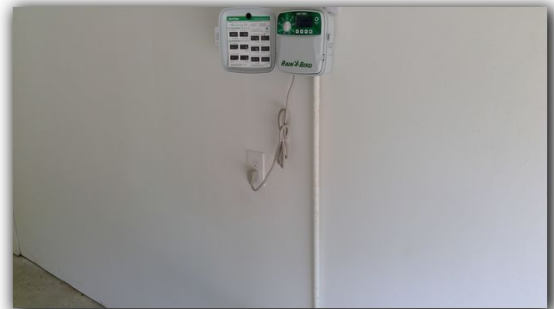
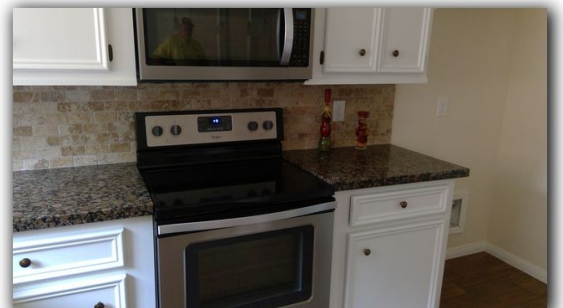
No GFCI protection at one or more location. This is considered a recognized safety hazard: All kitchen, bathroom, garage, exterior, washing machine, dishwasher, disposer and wet bar locations are required by current code to be GFCI protected.

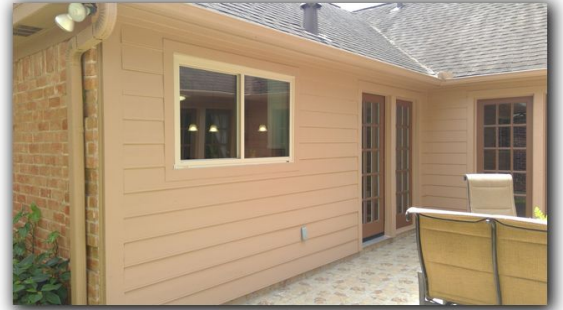
GFCI are not properly installed or operate properly at one or more locations.

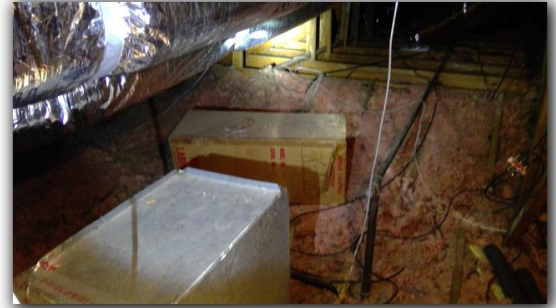
- Electrical wiring observed that was not properly terminated in a junction box.

- Improper use of extension cords as permanent wiring observed in one or more locations. Permanent use of extension cords for permanent wiring is considered a safety hazard by current standards. See above microwave area.

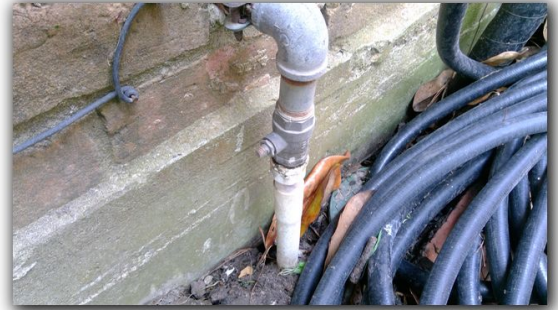
Proper insulation needed on exterior exposed water lines / plumbing

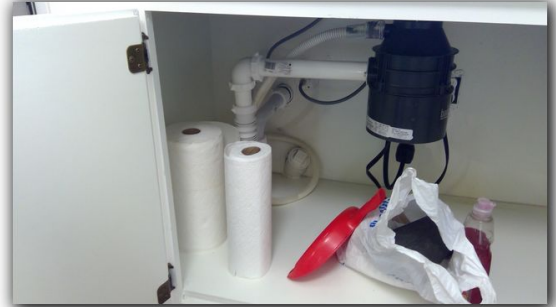
Dishwasher unit appears to be hardwired. No means of electrical disconnect observed per current code.

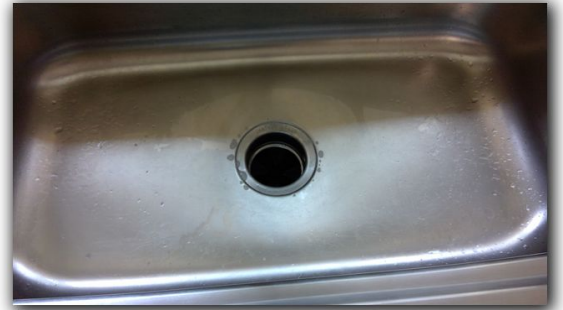
Excessive vibration / noise observed in food waste disposer unit. Appears to have something loose inside the disposer

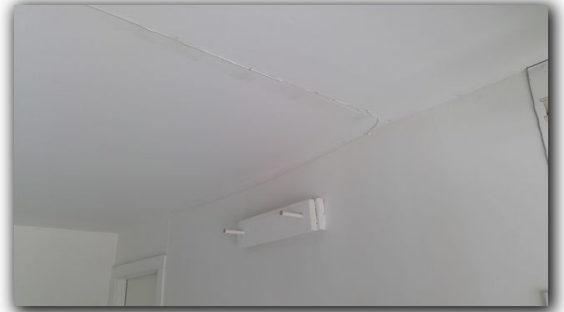
- Wiring for the garage door operator controller is not installed in a usual and customary building practice. Wiring was installed on the outside of the sheetrock at wall and ceiling and is visible

from the controller to the garage door operator unit.

Would recommend that a licensed and / or qualified contractor be consulted to make any further recommendations and / or repair

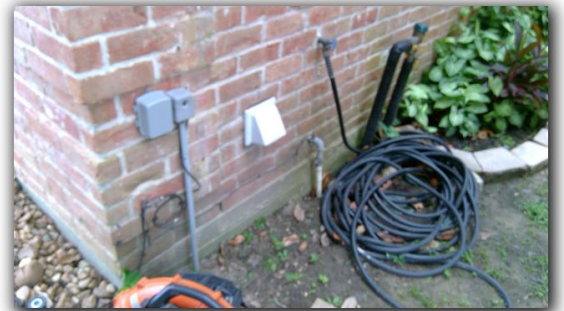
Dryer vent cover does not conform to current code and TREC standards. The cover should not have a screen at the termination point.

It is recommended that the dryer vent be properly cleaned by a professional prior to using vent. There are components of the dryer exhaust vent system that are not accessible and cannot be inspected.
