TEXAS OFFICIAL WOOD DESTROYING INSECT REPORT

1A. Accurate Insect and Pest Control	1	в. ТРСL # 0616331						
Name of Inspection Company	SPCS Business License Number							
1C. 24420 FM 1314, Suite #15	Porter	Texas 77365	28 1	1-745-0234				
Address of Inspection Company	City	State Zip	Tele	ephone No.				
1D. Larry Fleming		1E. Certified Applicator	\checkmark	(check one)				
Name of Inspector (Please Print)		Technician

7911 Deaton Dr.

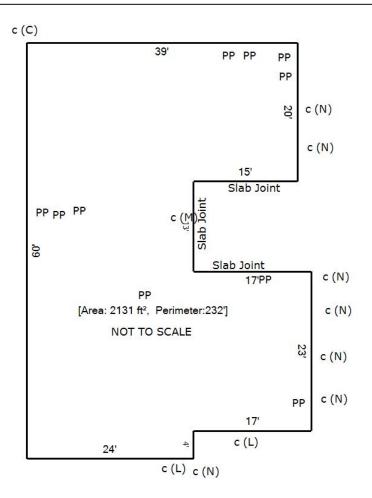
Planter box abutting structure (0)			Wood to Ground Co	ntact (G)	[Formb	oards left ir	n place (I)	Exce	ssive Moisture (J)	
Insufficient ventilation (1) Other (C) Specify: Crack observed in side of foundation that extends into the soil. B. Inspection Reveals Visible Evidence in or on the structure: Active Infestation Previous Infestation Previous Infestation Previous Treatment B. Subtranean Termites Yes No Yes	Debris under or around str	ucture (K)	Footing too low or so	oil line too	o high (L) 🛛	₫	Wood I	Rot (M)	\checkmark	Heav	vy Foliage (N)	\checkmark

Specify reason: Heavy vegetation present that needs to be trimmed from touching the house; Wood rot observed in middle patio window that needs to be repaired; Crack in side of foundation that extends into the soil at the left rear corner; High soil level around the front porch post area. Provide proper slab exposure between the finish grade and the first course of brick /siding. Refer to Scope of Inspection Part J 10A. This company has treated or is treating the structure for the following wood destroying insects: N/A If treating for subterranean termites, the treatment was: Partial Spot Bait Other Image: Common Name of Insect 10B. N/A N/A N/A Name of Pesticide, Bait or Other Method 10B. N/A List Insects: List Insects: Mit for control of the following wood destroying insects: Name of Pesticide, Bait or Other Method	as identified in Section	on 8. (Refer to I	Part G, H and I, Scope of Ins	spection)							_
