PROPERTY INSPECTION REPORT

Prepared For: Karan Bathija
(Name of Client)

Concerning: 11210 St. Laurent Ln. Houston, TX 77082
(Address or Other Identification of Inspected Property)

By: Stephen LaCombe, T.R.E.C. License #2709 12-10-2020
(Name and License Number of Inspector) (Date)

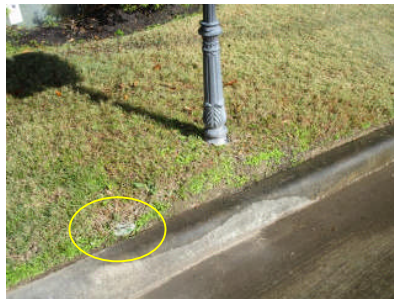
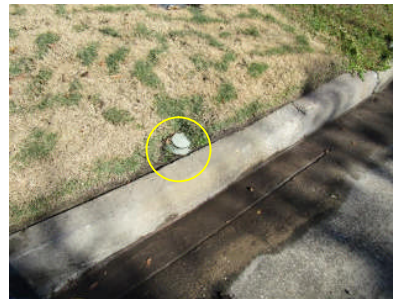
- There are at least two “pop-up” drains at the street/curb that appeared to be clogged or overgrown by grass/turf that should be cleaned out and checked for adequate flow.

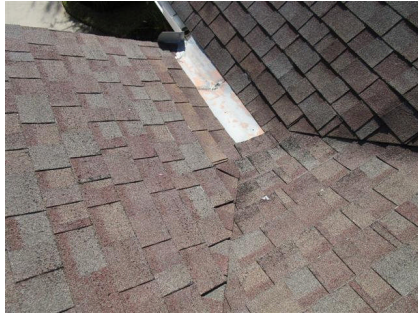
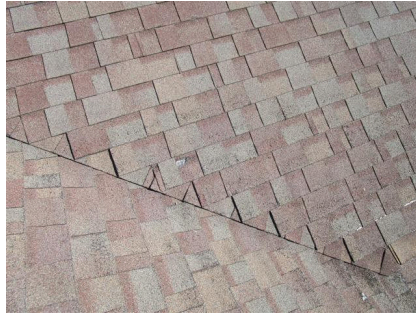
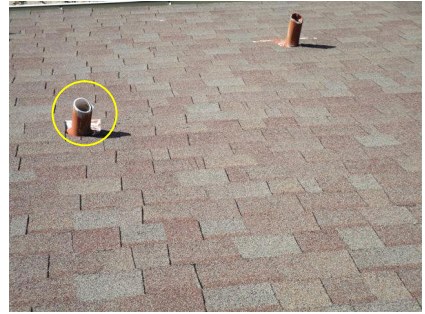
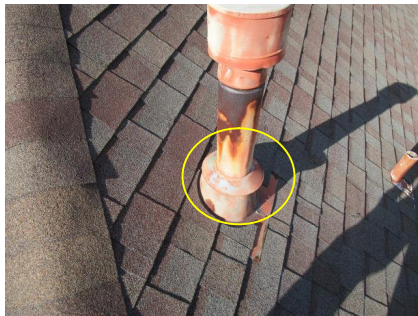
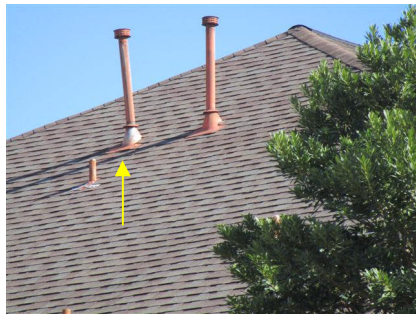
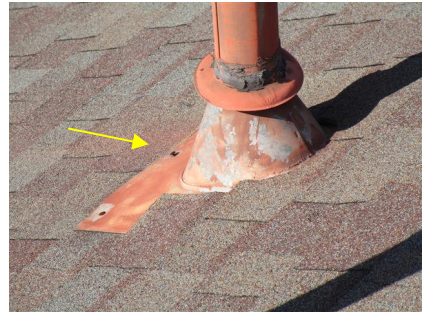
- This roof is well-worn, and shingles have lost much of their granular covering, particularly at the front of the house and on the west side. The remainder of the roof shows fairly typical “wear-and-tear” for a roof of this age and type. Shingle pitting and damaged shingle strips on the south and west sides are suggestive of previous hail or other storm-damage, reducing the overall life span of the roof. The fiberglass mat is starting to show through at the edges of shingles, which can also be an indication of excessive wear for a composition shingle roof of this age.
- From the attic, daylight was visible at the furnace roof jack, which could result in leakage. The storm collar flashing needs to be caulked.

- Uplifted flashing and loose nail(s) at the water heater flashing should be re-nailed and sealed.
- The lead flashing at the plumbing vent stack on the west side of the house is damaged or not completely sealed, which could result in leakage. (The lead flashing should be folded-down inside the pipe.)
- Exposed nail heads at ridge rows, vent caps, plumbing flashing, chimney flashing, furnace and water heater roof jacks, etc. should be sealed with caulking or roofing cement.
- Flashing at the chimney is slightly rusty.
- Shrub or tree limbs touching the roof or rain gutters should be cut back.

Recommend that a roofing contractor be employed to make the necessary repairs. At the time the roof repairs are performed, the roofer should make repairs or recommendations he considers necessary to place the roof covering in a serviceable condition.

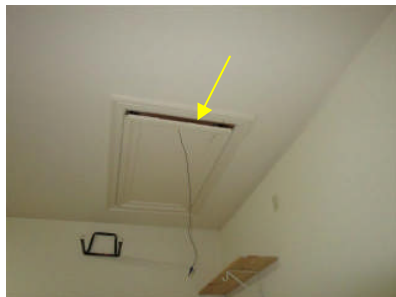
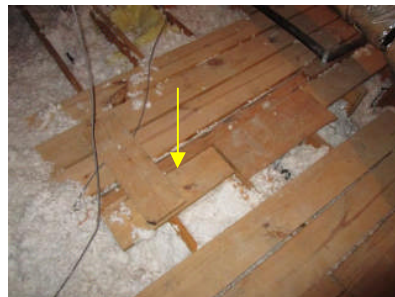
- The attic stair doesn't close properly. (Missing a piece of wood.)
- Loose walkway boards in the attic could be a hazard (near the water heaters).

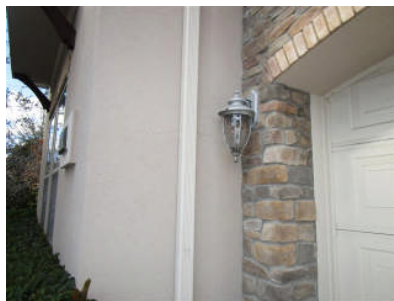
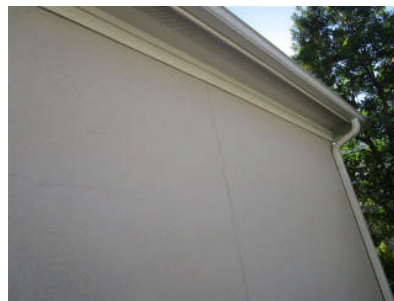
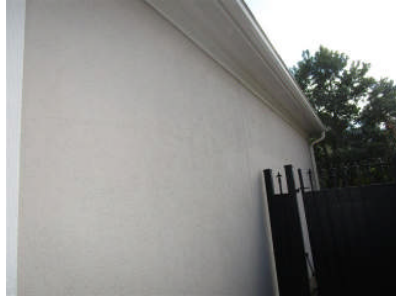
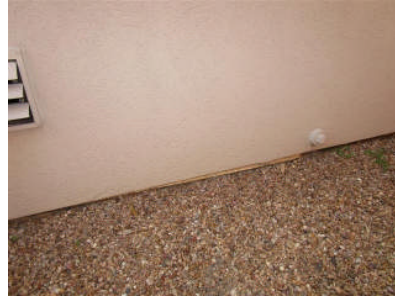
- Hairline stucco cracks were observed, the most obvious of which were on the west side near the gate (master bath/front bedroom area), at the front porch, and at the front bedroom area adjacent to the garage. These cracks are relatively minor and should be monitored for any future changes. When stucco is painted or re-coated (typically every 10 - 15 years) these smaller cracks will normally be “bridged” or sealed.

- Sprinkler heads should be adjusted or directed away from the house, especially around doors and windows to prevent possible water intrusion and rusting of metal weep screed, casing bead, corner and control joints (etc.).

- Also see the Stucco Maintenance Attachment at the end of this report.
- Vapor barrier material that extends beyond the bottom of the stucco on the east side of the house (kitchen area) should be cut/trimmed to be even with the bottom of the stucco.

- Shrub and/or tree limbs touching the house should be cut back.

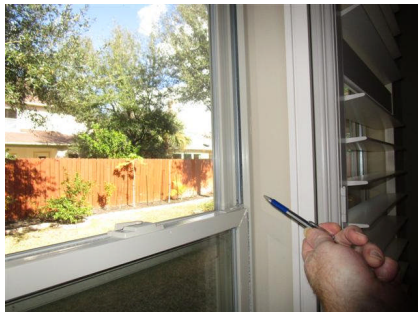
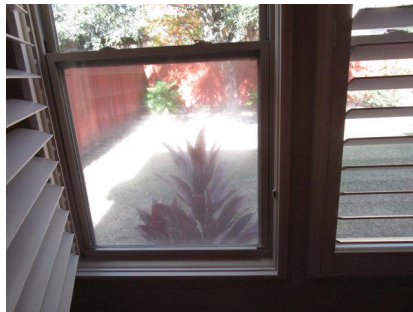
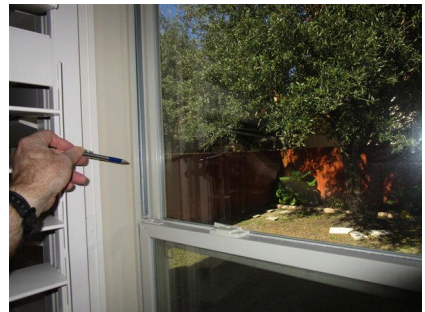
- One of the master bedroom windows appears to be fogged, indicating seal failure. (All windows should be checked since seal failure of double-pane glazing is not always obvious.)
- The front, southeast corner bedroom window is stuck and could not be opened.
- Several windows have broken or damage sash lift springs in need of repair (master bedroom, den, breakfast area and front bedroom windows).
- Note: We do not evaluate any window coatings.

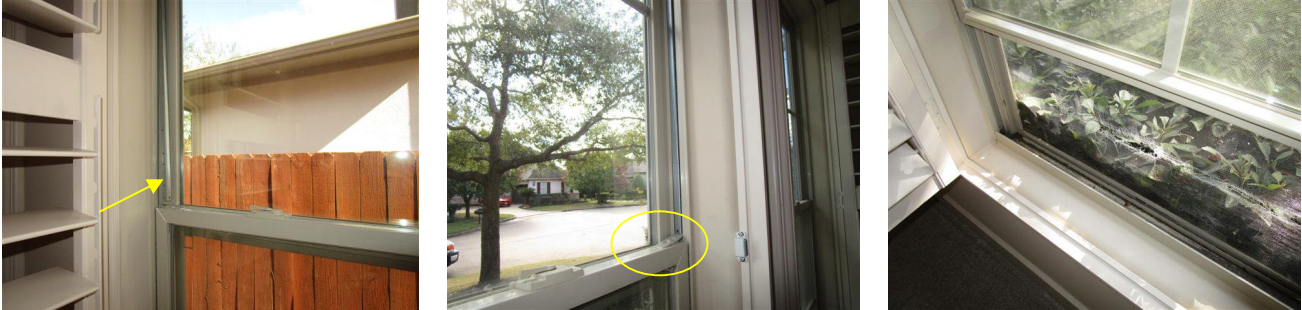
- The front bedroom window screens are damaged.

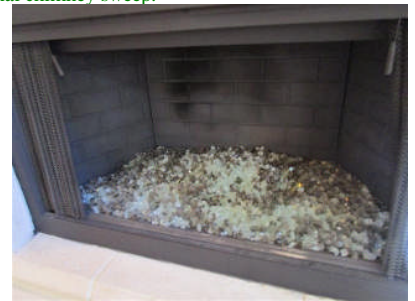
- The damper opens and closes freely.
- Since the fireplace is filled with crushed glass, the inspector did not attempt to light the fireplace. (A log rack and burner for the fireplace were observed in the attic above the garage.)
- The fireplace damper does not have a clip or spacer to prevent it from completely closing if you intend to use the fireplace with gas logs.

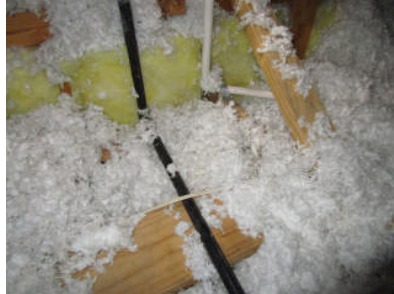
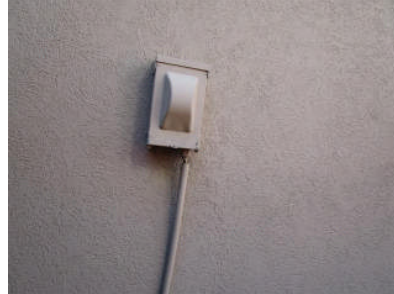
WIRING BOXES & CONDUIT: **(D)** One or more conductors (wires) are too close or touching gas piping in the attic. Minimum six inch clearance is needed for wiring not in conduit. Conduit is pulled-apart at the A/C disconnect switch.

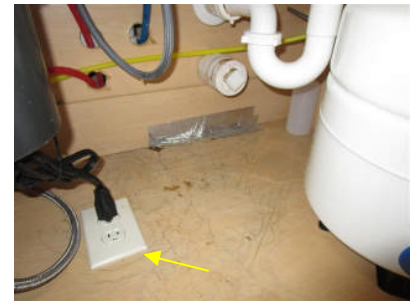
G.F.C.I. CIRCUITS: **(D)** G.F.C.I. protection is recommended for the garbage disposer outlet (underneath the kitchen sink), since it is mounted horizontally and could easily get water inside in the event that the kitchen plumbing develops a leak. G.F.C.I. protection is now recommended for all garage outlets (for the garage door operator and the outlet for the sprinkler controller/water softener). **(C)** G.F.C.I.'s for the kitchen are inside the pantry (FYI).

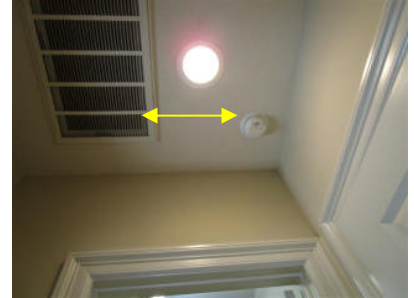
SMOKE DETECTORS: **(D)** The hallway smoke detector is too close to the air return. **(C)** When there are gas appliances in the home, it is recommended that carbon monoxide detectors also be installed at sleeping areas. Smoke detectors that are more than 10 years old should be replaced.

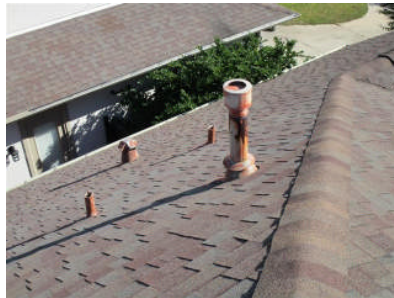
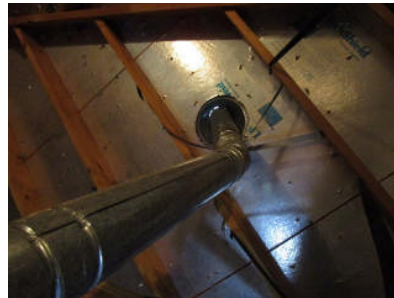
FURNACE: **(D)** The furnace appeared to be working, however, rusting on the flue pipe could be a possible indication of a problem with the furnace or the flue pipe. Further inspection is recommended.

FLUE PIPE: **(D)** The flue pipe is rusty. Further inspection is recommended.

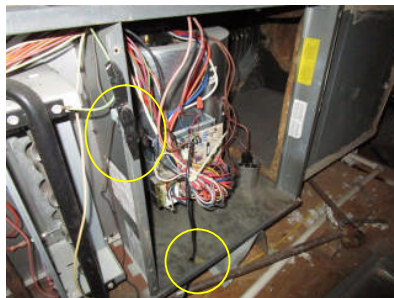
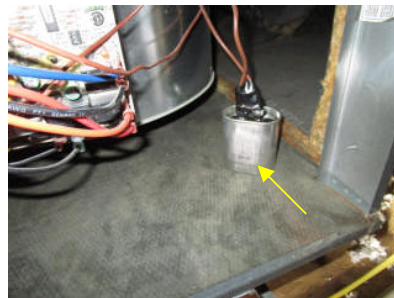
BLOWER AND MOTOR: **(D)** The blower door safety switch is taped-over. The capacitor for the fan motor should be mounted to the blower housing. Seal around thermostat wires that go into the blower compartment.

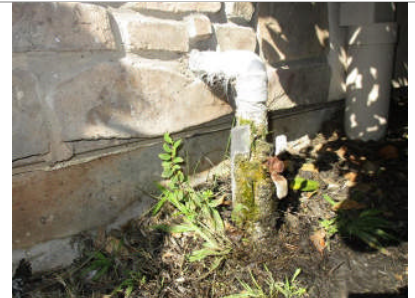
MAIN CUT-OFF: **(D)** Leaking – needs repair.

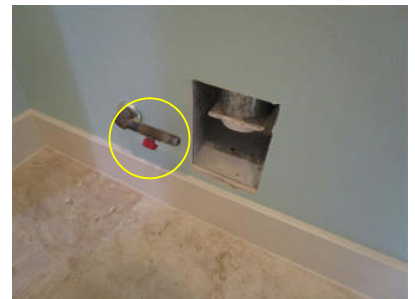
KITCHEN: **(D)** The sprayer hose is leaking (has been leaking underneath the sink, with some visible water-damage). Recommend re-caulking between the counter top and the backsplash. (C) The water filter system appears to be working but water quality was not tested (filters may need to be replaced).

LAUNDRY / UTILITY: **(D)** Cap the gas valve if you will not be using it.

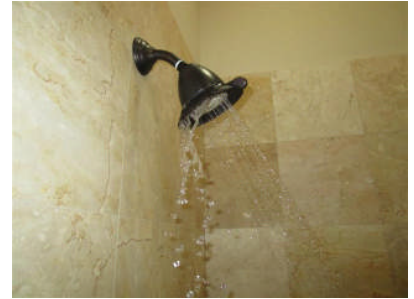
- a) Lavatory (I)
- b) Shower (D) The shower head leaks.
- c) Toilet (I)

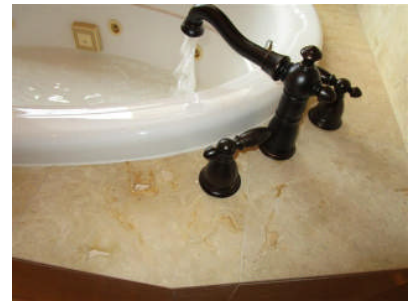
- a) Lavatory (I)
- b) Shower (C) The inspector has no way of knowing if the shower pan (or liner) extends underneath the seat (as it should). It is recommended that you keep this area well caulked to prevent possible leakage/water-penetration.
- c) Tub (D) The spout is loose and the cold stem is leaking. (C) No access to inspect drain and plumbing. (Could not be checked for leaks.)
- d) Toilet (I)

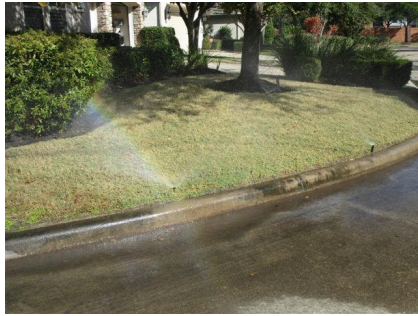
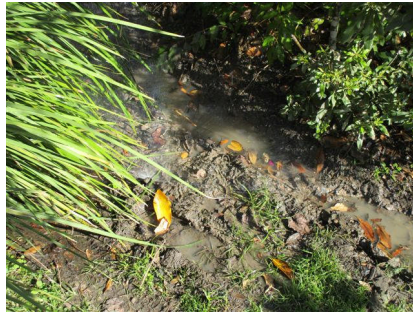
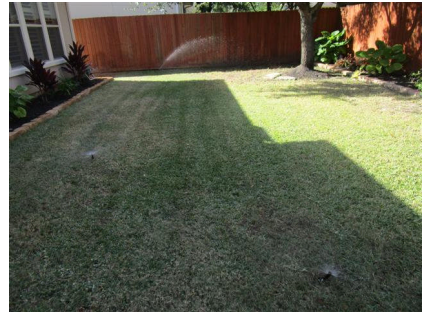
(D) The irrigation system did not appear to have a rain sensor switch. The isolation valve was not observed or could not be located. Adjust spray patterns and over-spray onto the house, into the street, onto the patio, etc. as needed. There is a muddy area in the front yard on the west side that could be an indication of leakage or sprinkler head spraying downward onto the ground. There are mixed heads on station #5 (in the back yard). Normally, all spray heads on the same station should be of the same type and with similar precipitation rates. (C) *Backflow prevention devices should be checked annually by a BPA tester licensed by the Texas Commission of Environmental Quality.*
