**5826 Augusta Ct.
Houston 77057**

PROPERTY INSPECTION REPORT

By: Ruben Santillan, Lic #5570 07/27/2021
(Name and License Number of Inspector) (Date)

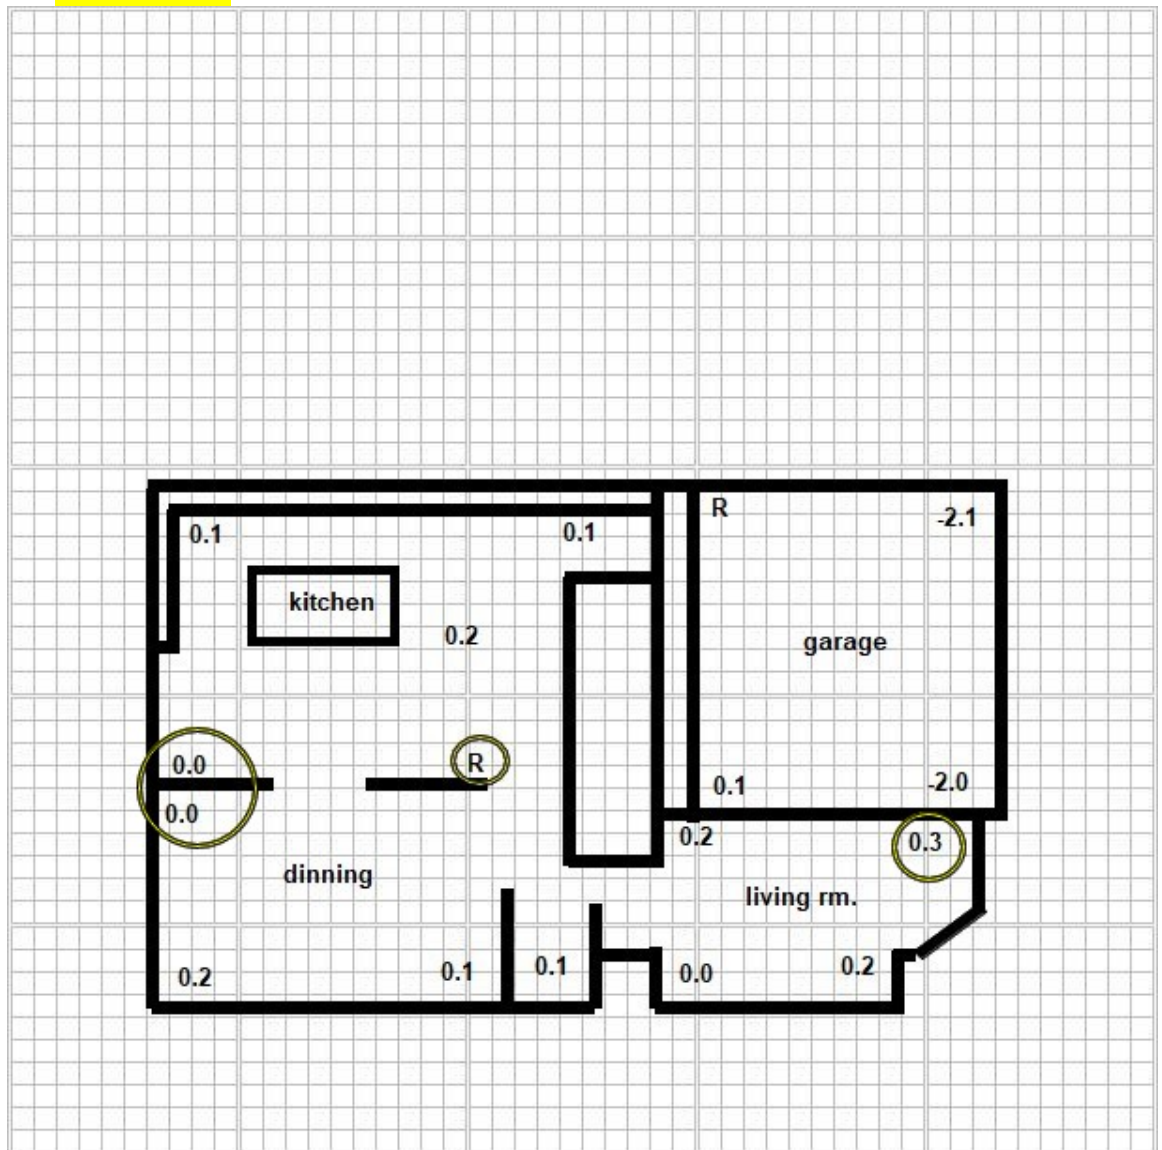
A foundation elevation survey was conducted during the inspection. The table below represents data gathered using a Zip Level or similar instrument and adjusting for floor covering height differences. i.e. differences between tile, carpet and wood flooring. Measurements are listed to the nearest .1". Measurements were taken along the respective walls listed below-North, East South, West, etc. Greatest variance was 0.3 of an inch

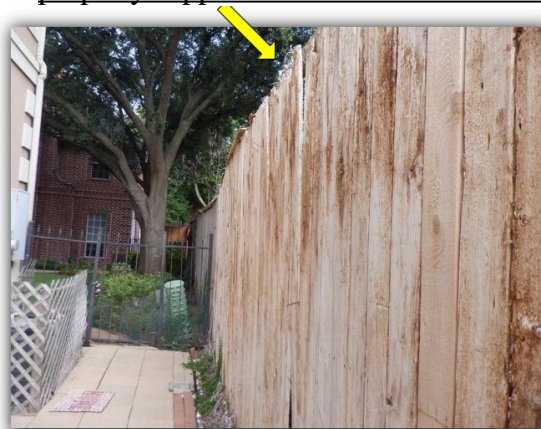
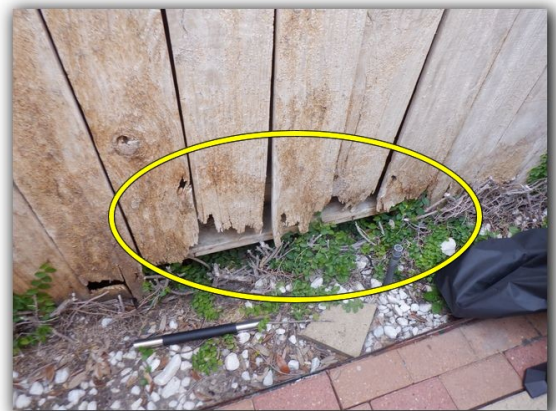
Wood fence observed to be leaning at one or more locations, indication that it is not properly supported. Wood deterioration also observed.

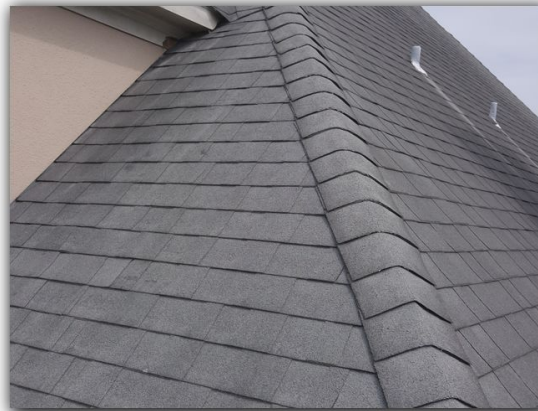
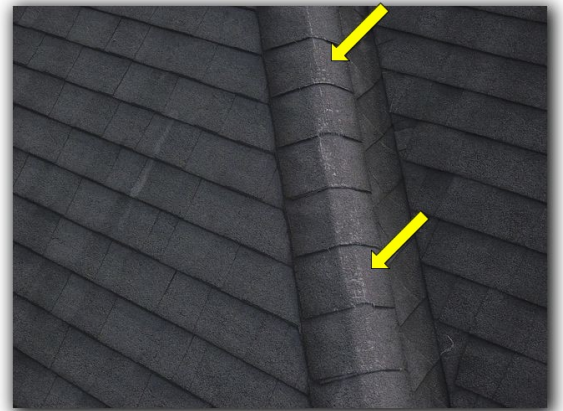
Older roof, nearing end (last 1/3 to 1/4) of serviceable life. Observed Brittle, cracked, curled ends, and/or excessive granular loss of shingles.

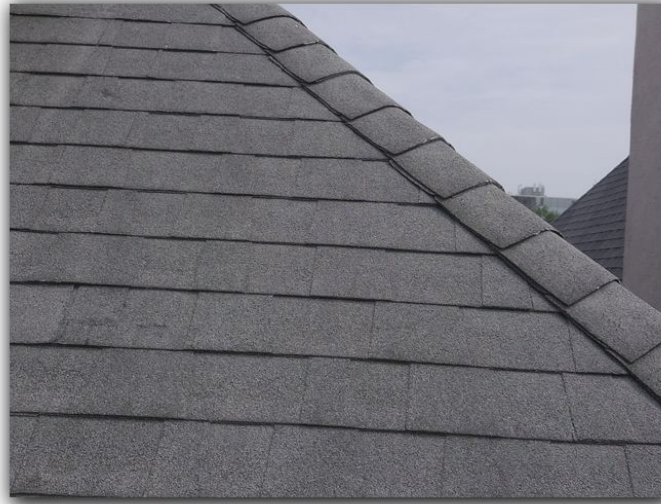
Observed spot repairs to roof surface.(Around the chimney)

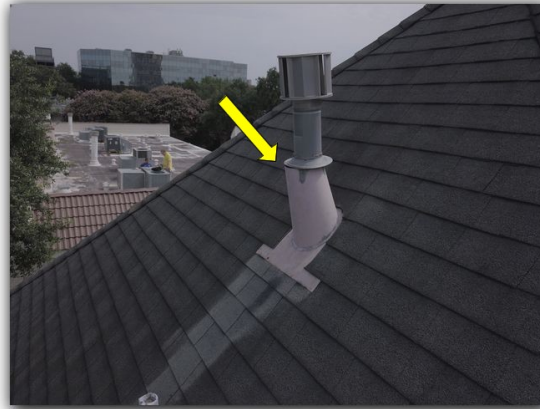
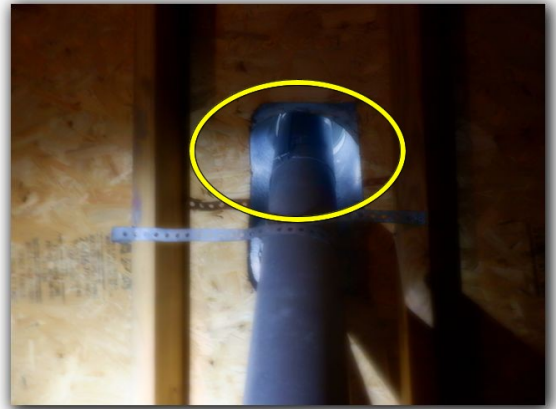
The water heater storm collar or class B vent is not set/sealed properly. This condition does allow water penetration into the attic and should be repaired.

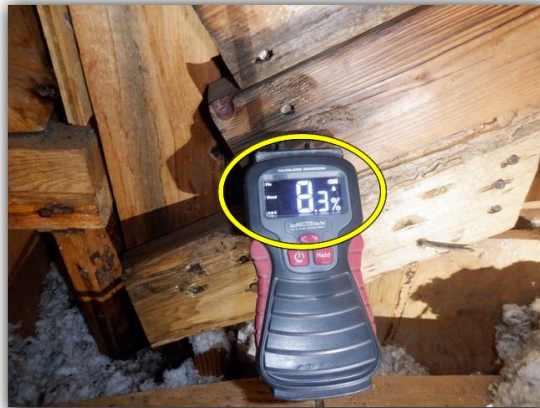
Roof water penetration observed at the following location(s):see pictures above and water heater section for additional pictures. Additional evidence of previous water penetration observed adjacent to the chimney. Low moisture meter readings were taken at the time of this inspection.

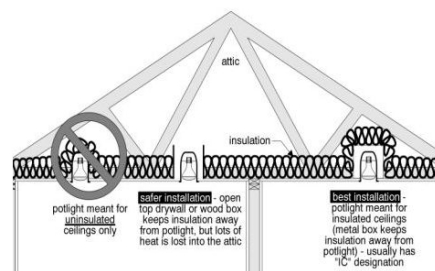
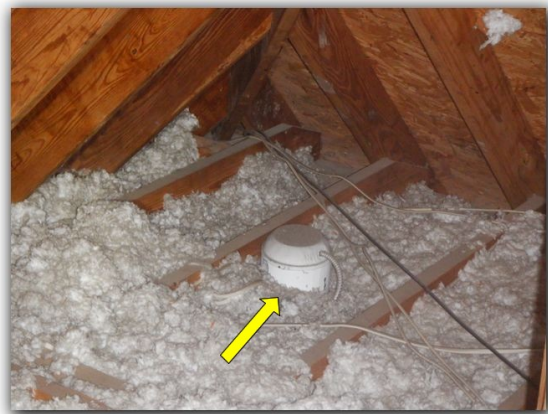
Potlights in insulated ceilings

Ensure insulation is maintained a minimum of 3 inches and wood a minimum of 1 inch from around all recessed lights to reduce possible fire hazard.

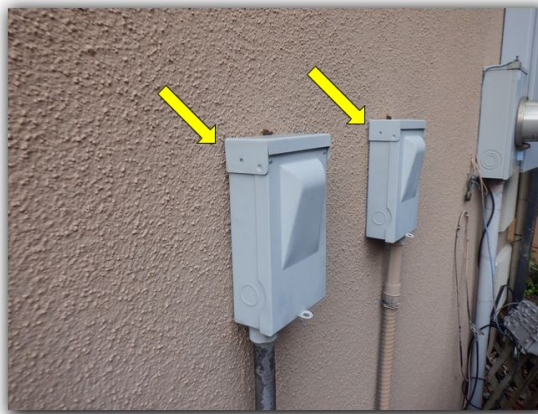
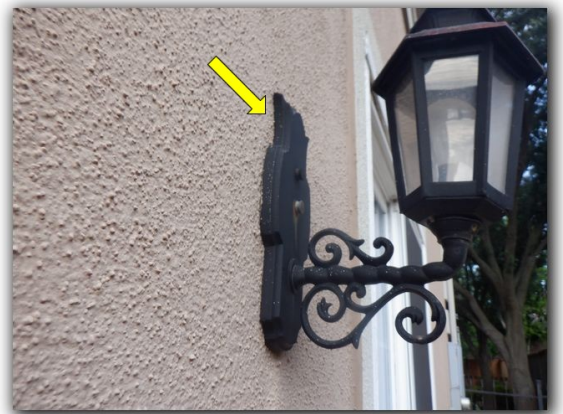
Need sealing / caulking around all holes and exterior siding penetrations on top and both sides, (leave bottom open) to prevent water entry. Including but not limited to dryer, bath and range top vents, light fixtures, etc.

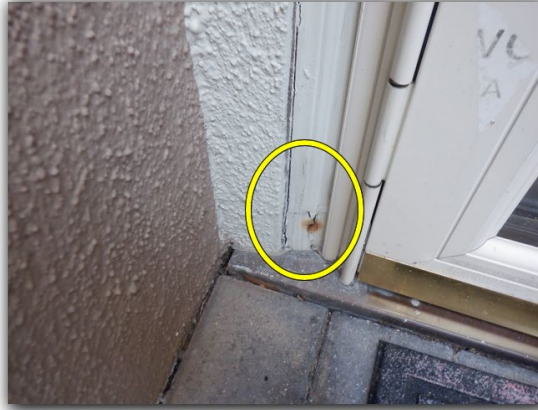
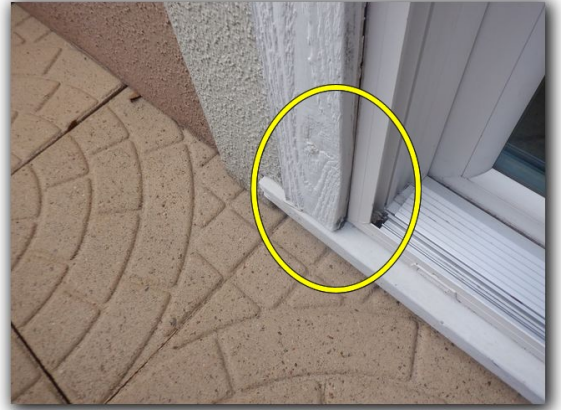
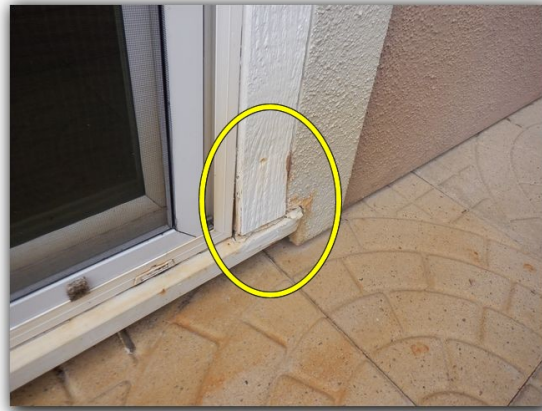
Wood rot observed on areas of house / garage.

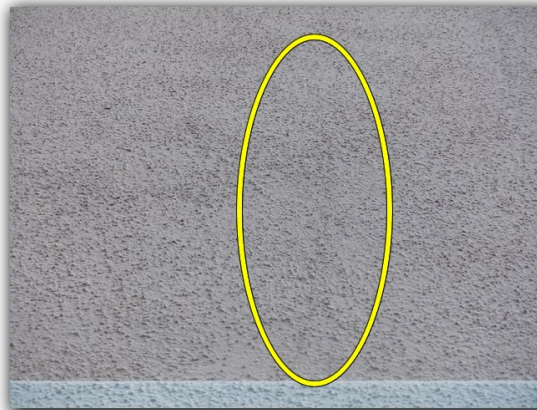
A hair line crack of the stucco observed over the garage area, recommend sealing.

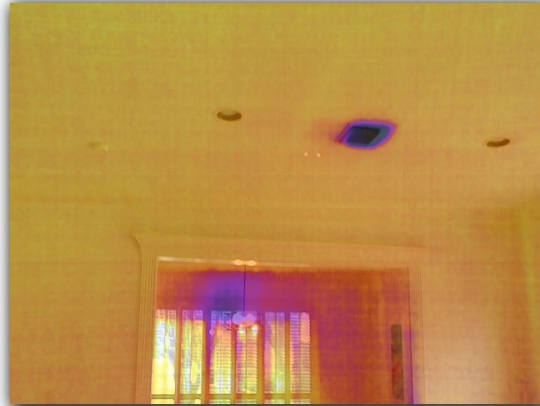
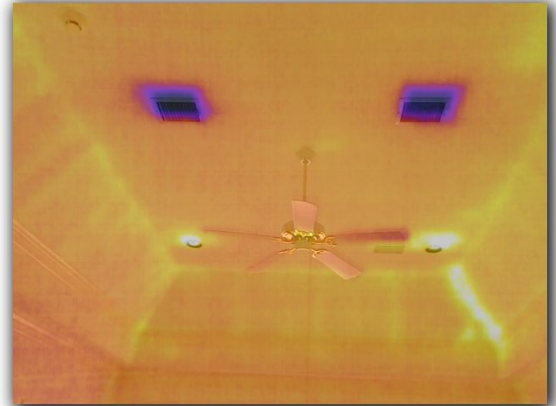
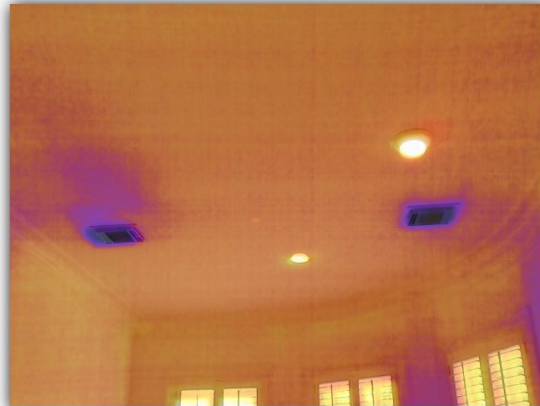
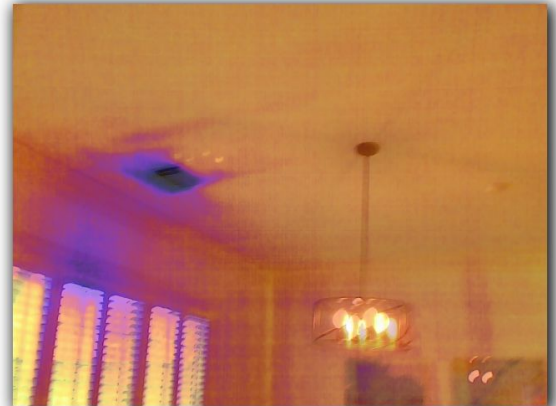
Joint sheetrock crack observed in the master bedroom area.(cosmetic in nature)

Thermal imaging of the interior was taken and no anomalies were observed.

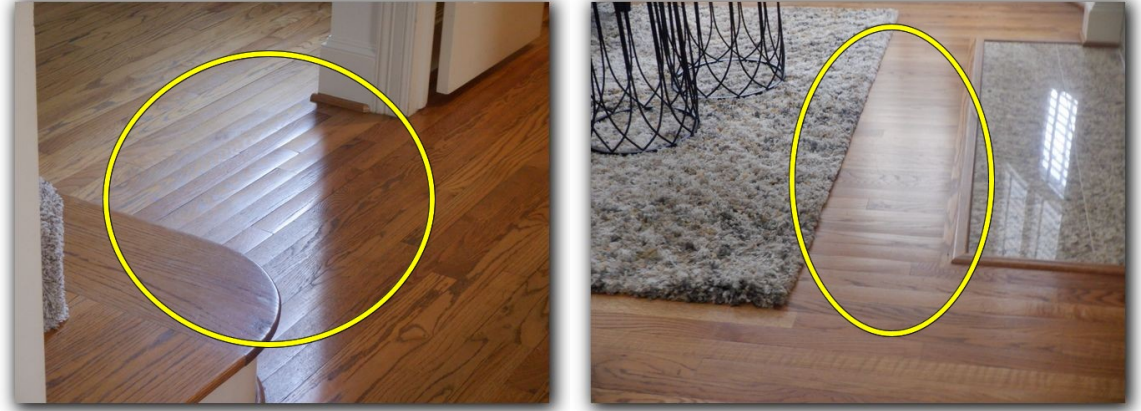
Water damaged wood flooring. Observed cupping / unevenness of wood flooring, indication of high moisture conditions below wood flooring.

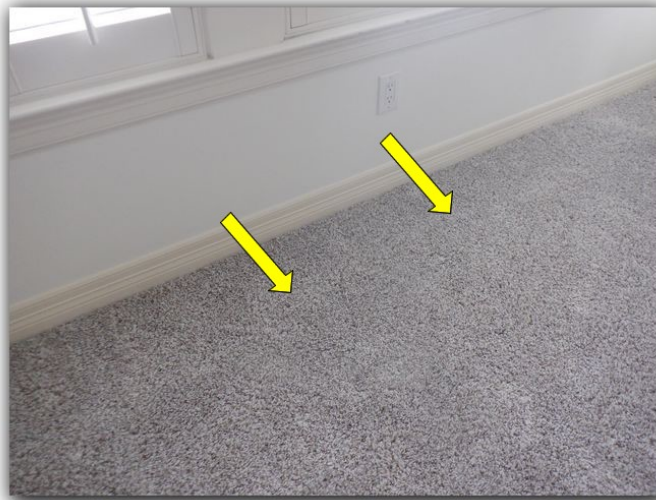
Note: a sub floor anomaly could be felt at the 2nd floor southeast bedroom adjacent to the windows, possibly deterioration. Low spots could be felt when walking over the area.

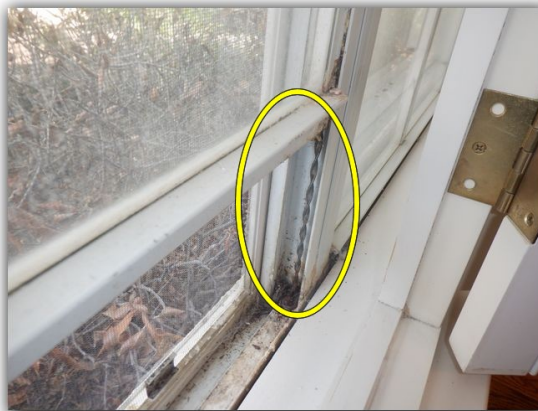
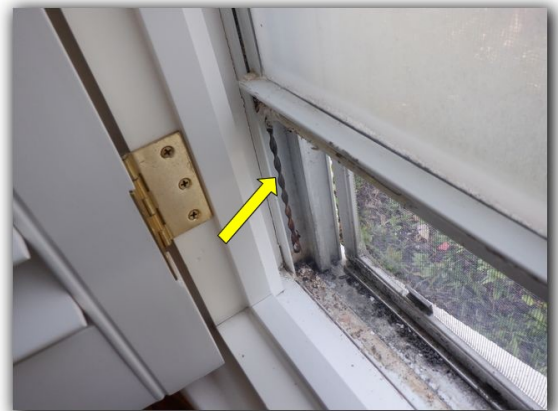
One or more window spring(s) were observed to be sprung/broken/detached. (dinning, formal living room, master bedroom, upstairs southeast bedroom, southwest bedroom)
Due to the damage spring the window in the dinning area is not latching.

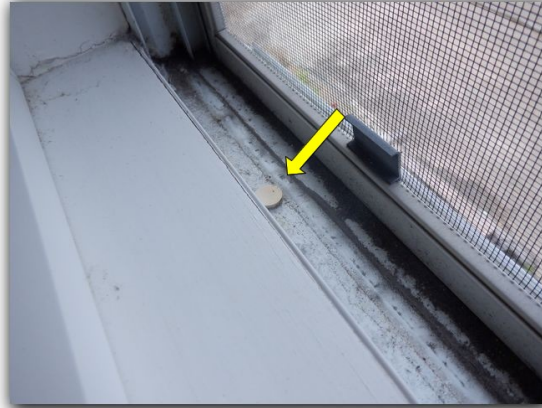
One or more screens are missing and/or damaged.

Window jamb alarm sensors need to be sealed with silicone seal to prevent water entry.

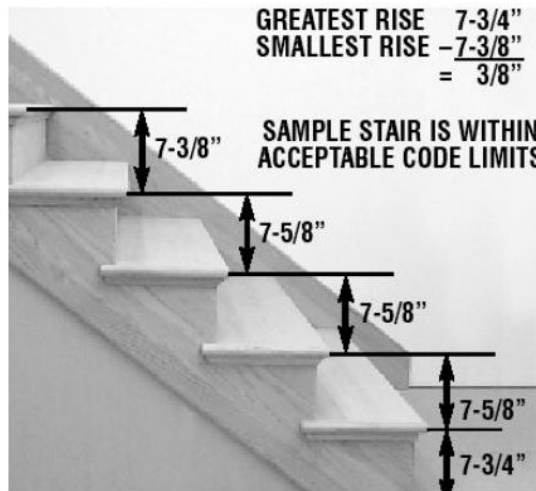
Stairway has tripping hazard, Risers are not same height along the entire height of steps.

Stairway does not comply with current industry standard, (code). CABO 314.2 & UBC 1006.3 requires "The greatest riser height within any flight of stairs shall not exceed the smallest by more than 3/8 inch."

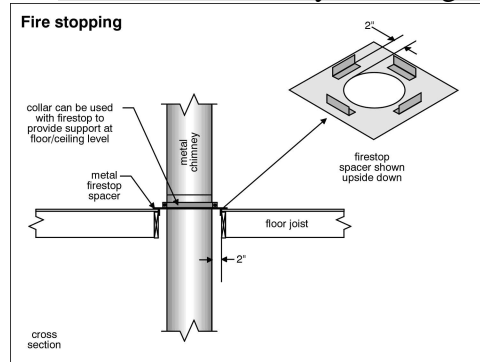
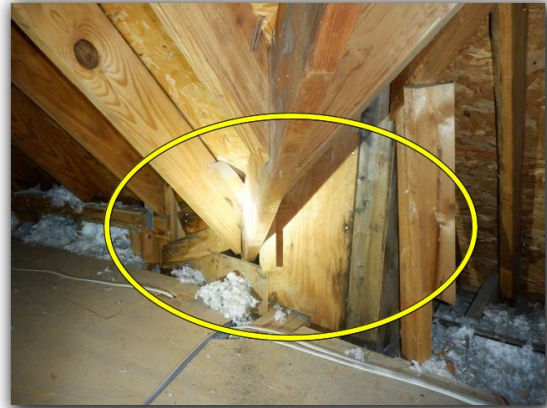
Chimney is not properly fire stopped in attic ; Does not comply with the 1992 CABO One and Two Family Dwelling Code section R-402.7 IRC R1001.16.

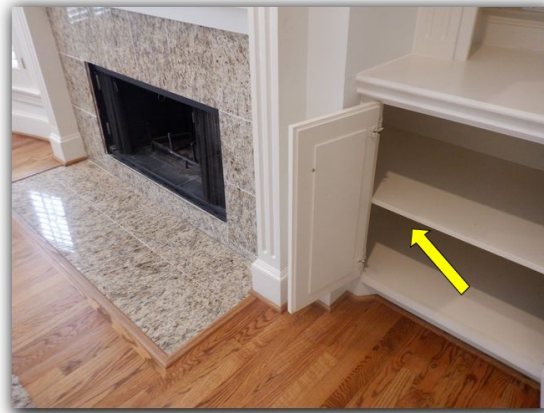
Note: the gas valve is located within the allowable 4 foot span of the opening of the fireplace, however due to cabinet one must reach deep into the cabinet to turn the valve on then quickly rotate back to the burner to lit the gas. Typically the valve should be able to rotate with one hand while lighting the starter bar with the other.

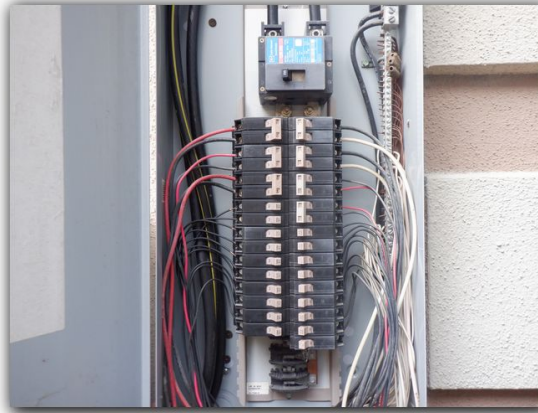
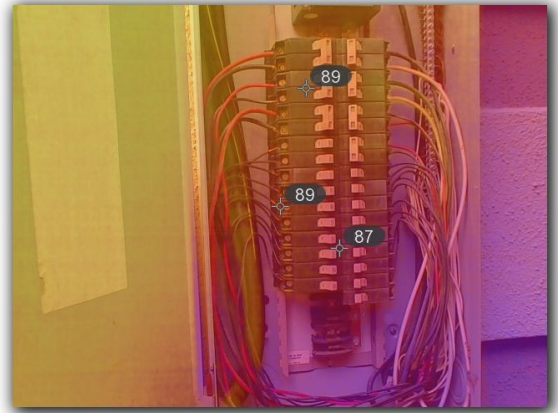
150 AMP ELECTRICAL SERVICE PANEL LOCATED AT NORTH EXTERIOR

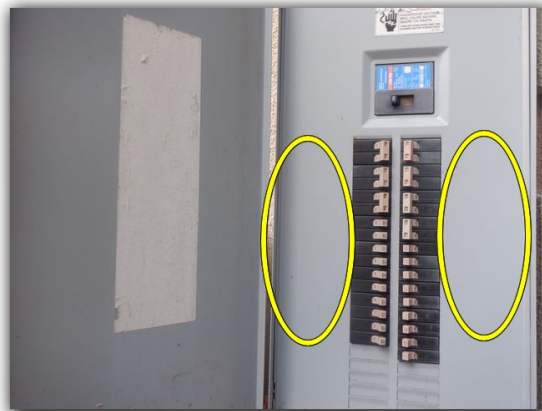
Dead front missing one or more securing screws. Need to ensure screws used do not have sharp / pointed ends that can penetrate live electrical wiring behind dead front and cause shock, fire, serious injury.

Not all breakers are properly identified.

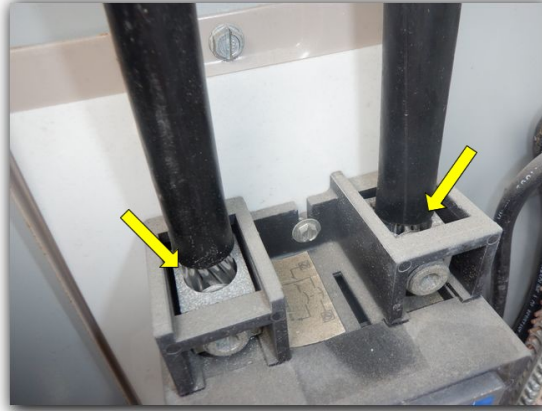
Observed type of feeder wiring is aluminum.

Did not observe anti-oxidant compound (grease) on the exposed aluminum feeder wiring.

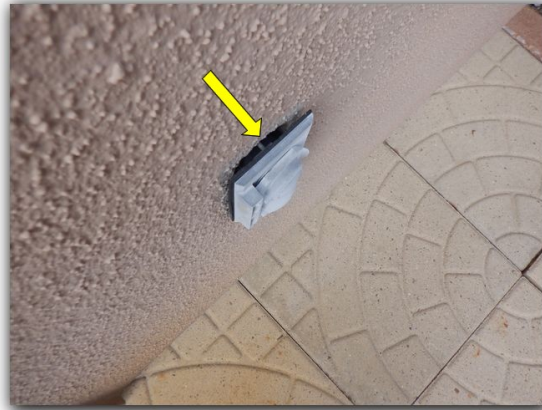
GFCI reset locations; kitchen 2, garage 1, master bathroom 3, Jack and Jill bathroom 1.
One or more outlets are not secured well in wall.(North exterior, master bedroom)

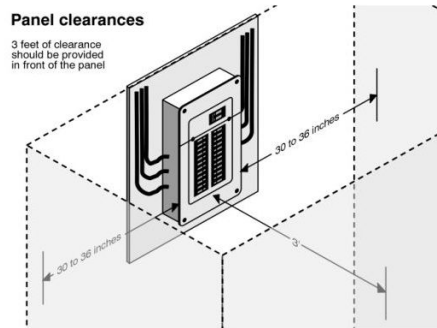
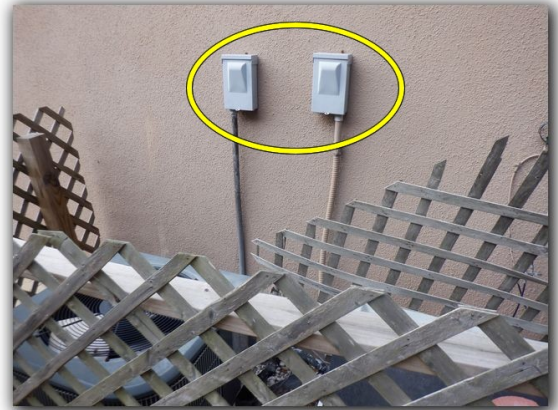
Code requires minimum clearance to electrical service panels (including A/C disconnects) to be 36" in front of and 30" from side to side.

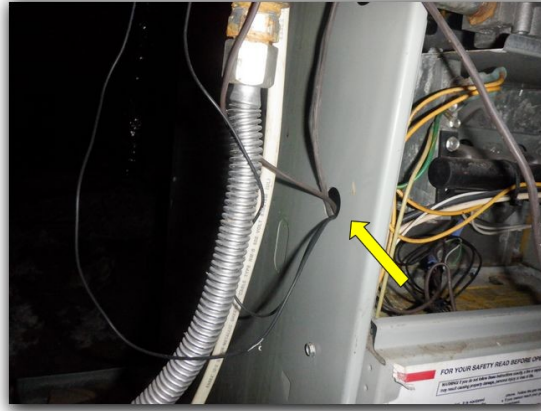
The thermostat wiring for the upstairs unit were crimped/damaged and very sensitive to movement. The HVAC system stopped working when the wiring was marginally moved to removed the burner cover. **The cause and remedy should be investigated and corrected as necessary.**

Thermostat wiring not secured to attic unit(s), missing small fitting that secures wiring to cabinet to prevent pulling loose by service personnel or homeowner.

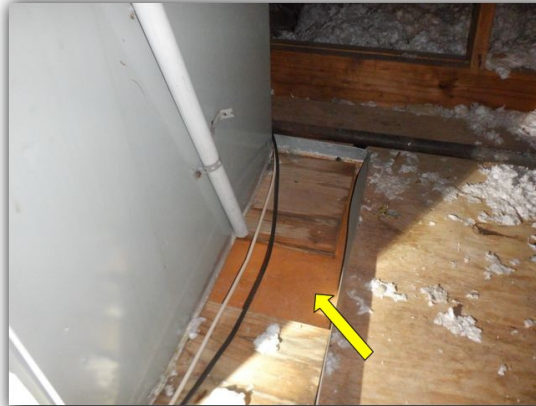
Secondary drain pan is rusted; indication coil (or previous coil) has history of leaking/dripping condensation into pan. (1st floor)

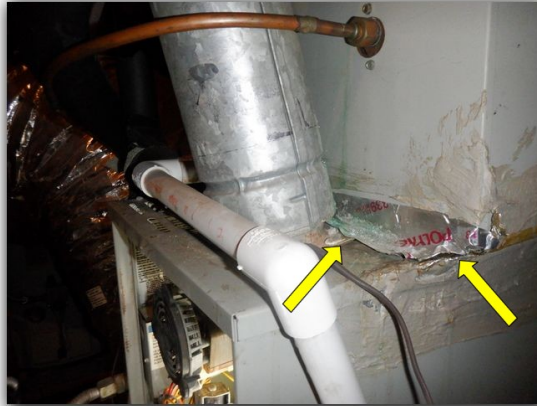
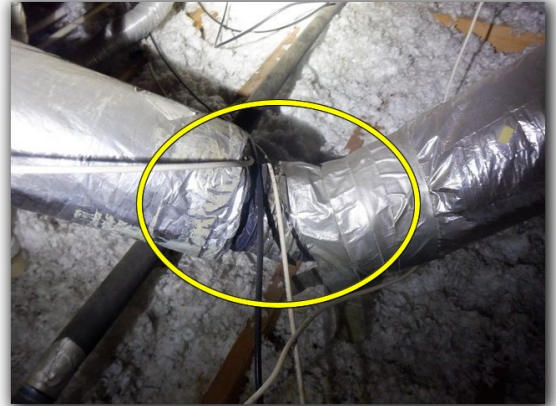
One of the registers in the dinning area is marginally loose at the ceiling mount.

Excessive air loss at defective manufacture construction joint / seam of heater.(downstairs unit)

Insulation observed to have pulled loose off of a duct between the downstairs furnace and the water heater, this section of duct will loose some efficiency.

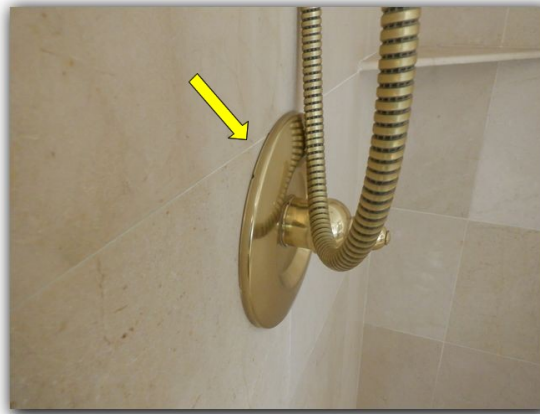
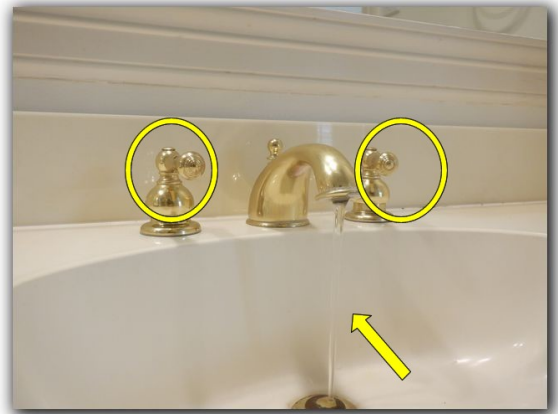
Low water pressure observed at one or more faucets; right Jack and Jill bathroom sink. Drips water, hard to turn off completely.(right Jack and Jill sink)

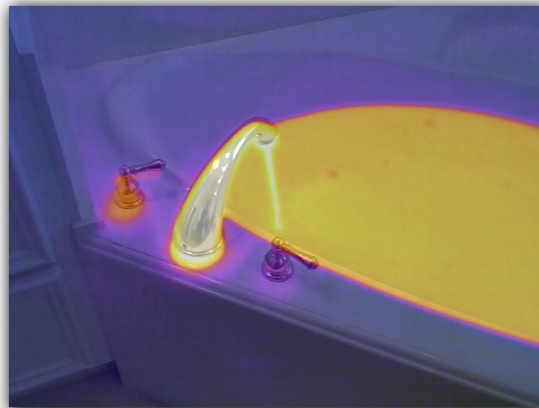
Low water pressure observed at one or more faucets; Jack and Jill bath.(both sinks)

Hot/cold reversed, Hot water supply to any fixture shall be installed on the left side, Standard Plumbing Code; master bathtub.

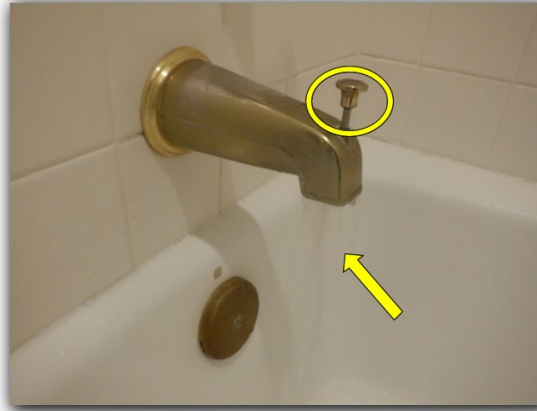
Shower diverter valve is not fully functional, does not direct all water to shower head during operation, (on or more bathrooms)

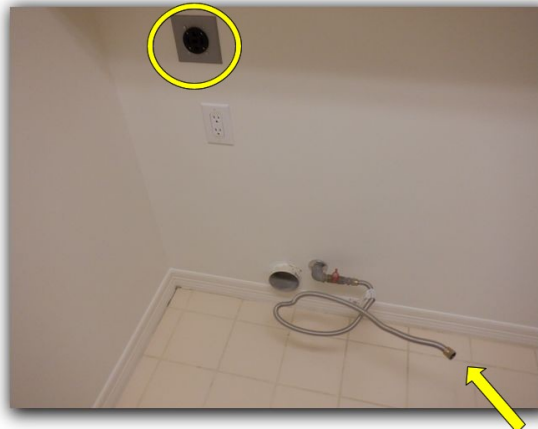
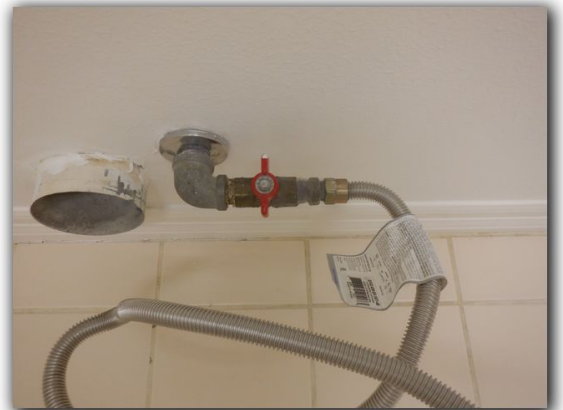
Uncapped gas valve at laundry room. Gas line needs to capped if not used.

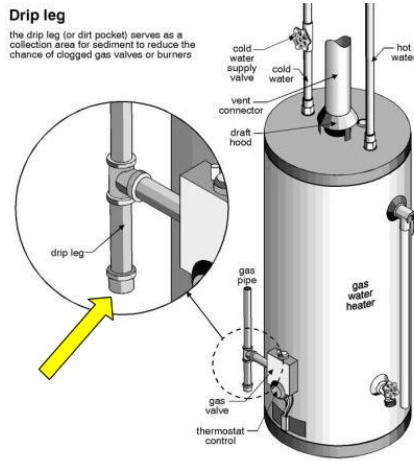
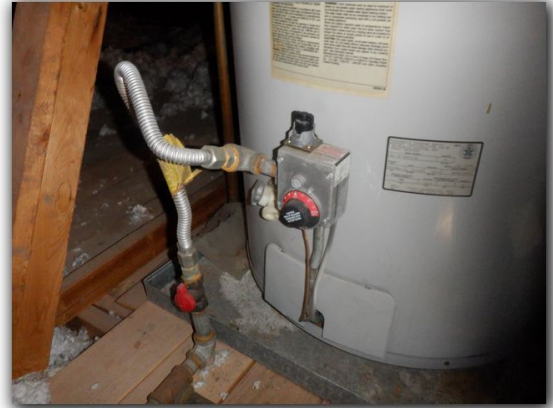
Did not observe gas line drip leg(s) on gas house heater and/or gas water heaters which is called for in the manufactures installation instructions.

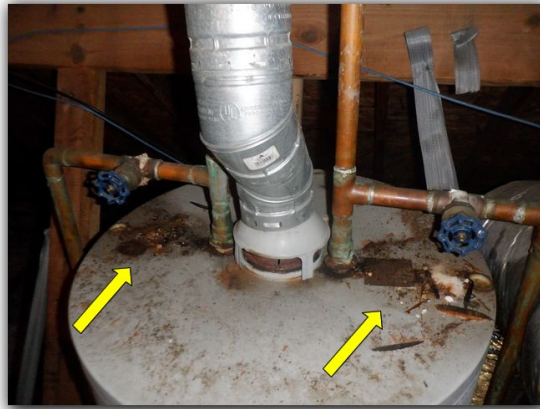
Unit has exceeded its normal serviceable life; budget for repair or replacement. Corrosion at the top of the water heater can be observed, the storm collar is not sealed allow water penetration.

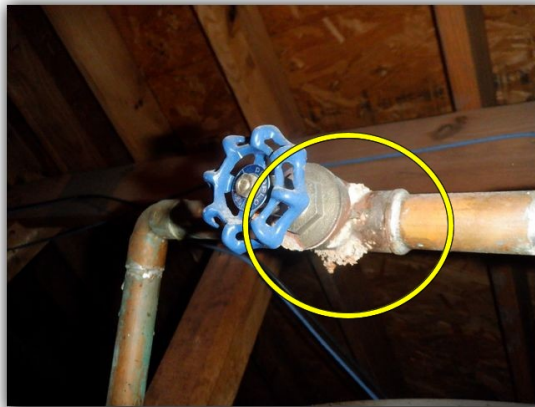
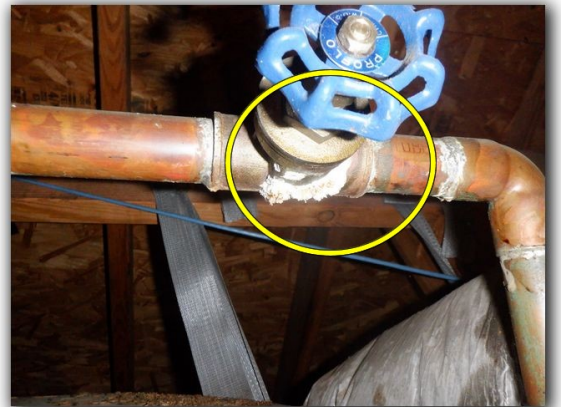
Corrosion observed at shut off valve and/or connections on top of water heater.

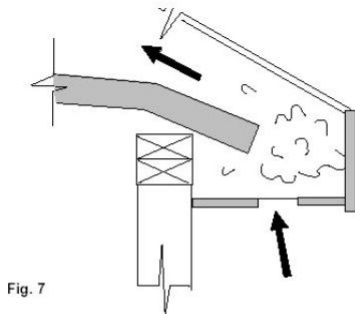
Fig. 7

Improperly vents to soffit. Should vent to exterior.

Terminating exhaust fans to soffits/eaves builds up condensation moisture within the soffit that can deteriorate the fascia board, soffit and/or plywood roof decking and cause paint peeling. A soffit/eave is part of attic air space where exterior air is drafted in to the attic space with the exhaust duct fumes and moisture.

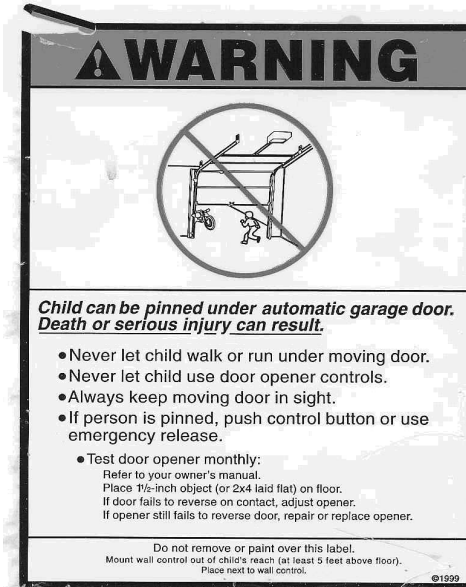
Electronic sensing eyes are improperly installed; should be no more than 6 inches above floor.

Garage door operator control button is improperly located. Federal safety standard for automatic residential garage door openers states "Locate control button: (a) within sight of door, (b) at a minimum height of 5 feet so small children cannot reach it, and (c) away from all moving parts of the door."

Missing required safety sticker / decal next to operator button.

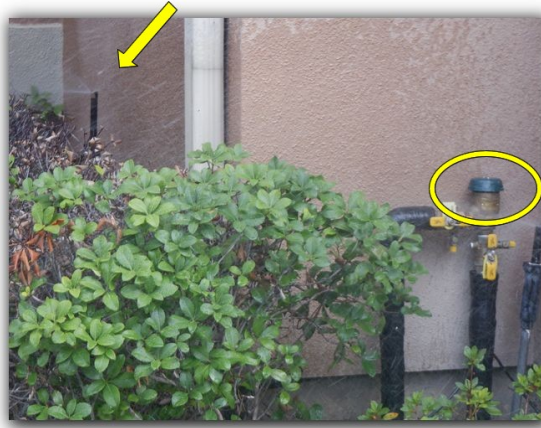
Code required back flow prevention device on sprinkler system is not installed at proper height; a minimum of 6" above highest head IRC 2902.2.2.

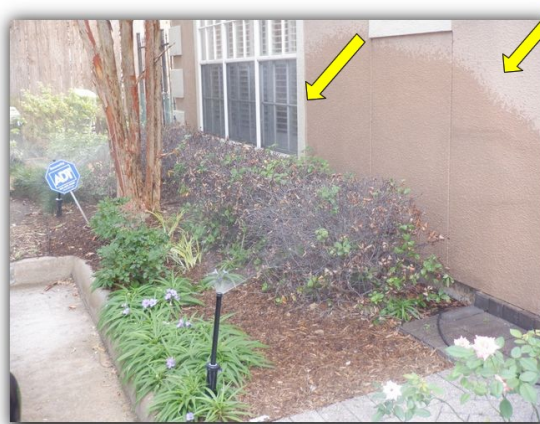
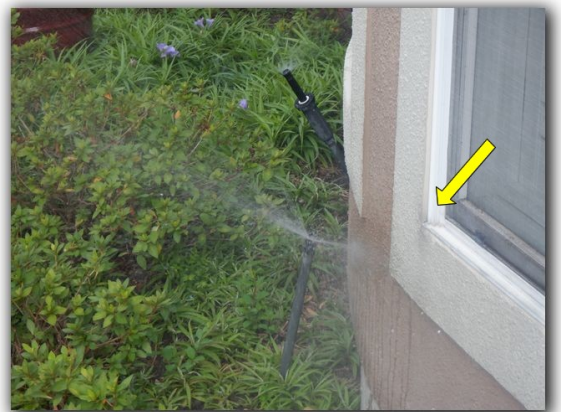
One or more spray heads need adjustment for proper yard cover and reduced over spray on house.

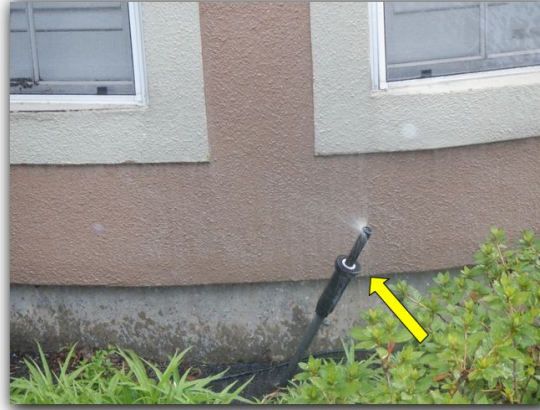
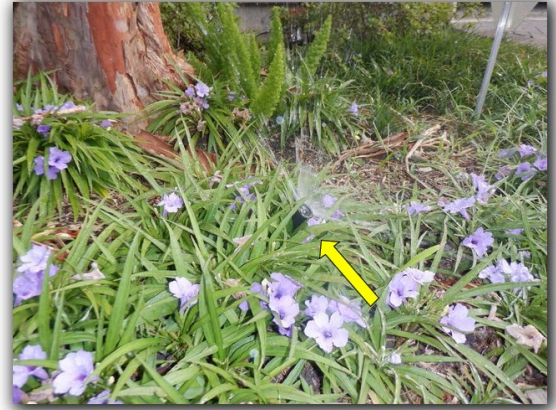
The trajectory of 1 or more of the sprinkler heads need to be adjusted for a more efficient coverage of the area.
