Baker Real Estate Inspections

Property Inspection Report
Exclusively Prepared For
Randyl Murrell
Kendra Murrell

31023 Raleigh Creek Tomball, TX 77375

PROPERTY INSPECTION REPORT

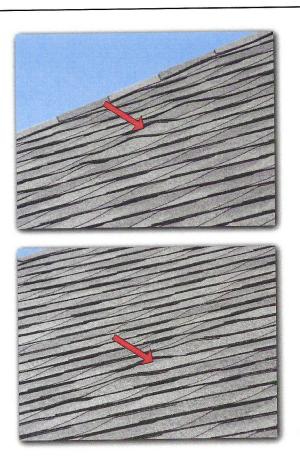
Report Identification: Murrell20180404-, 31023 Raleigh Creek, Tomball, TX **D=Deficient** NP=Not Present NI=Not Inspected I=Inspected I NI NP D B. Grading and Drainage Comments: Grading appears to be adequate on the day of the inspection. C. Roof Covering Materials Types of Roof Covering: Composition Shingles Viewed From: The roof was inspected from the roof level at the eaves where reachable with a twelve foot ladder and from the ground with binoculars. **Buckled Shingles** Buckled shingles were noted on the south and east slope of the roof. According to manufacture installation instructions shingles are to be installed fully flat.

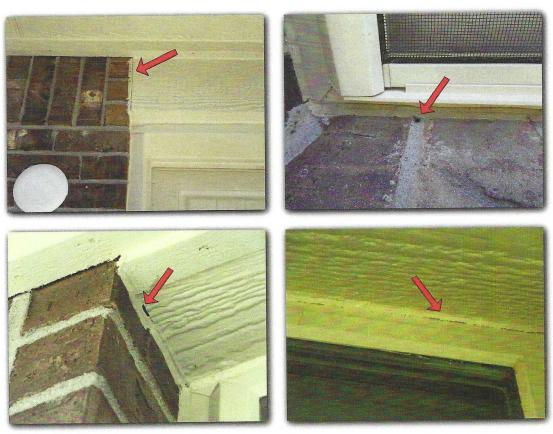
Deteriorated Sealant/Caulk: Various Locations

All deteriorated sealant/caulk should be replaced around windows, doors, vents, wall penetrations, exterior lights, ect.
