Date: 07/24/2018

Inspector: David Rogers T.R.E.C.: #5048

18322 Spruce Tree Line Trail
Houston, TX 77084

A+ HOME INSPECTIONS
Structural & Mechanical

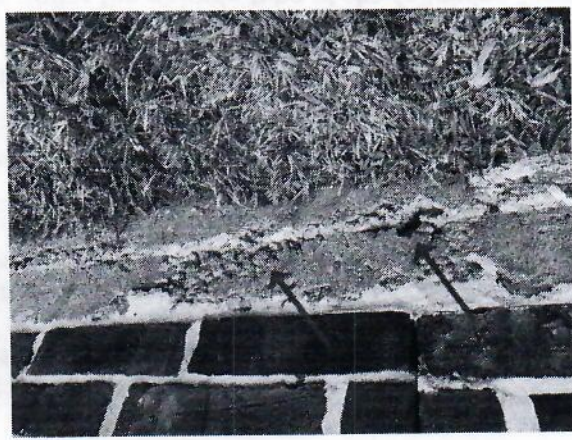
Honeycomb left perimeter slab

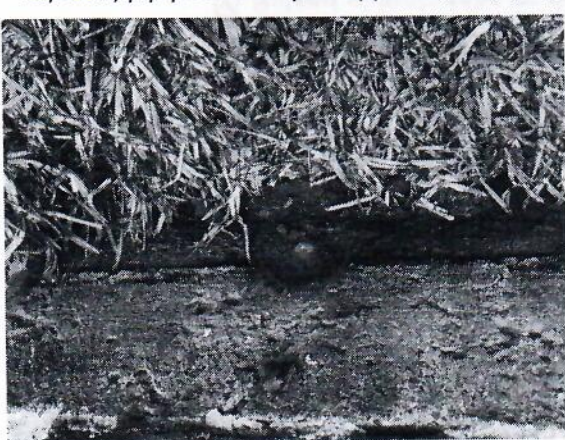
Post tension cable ends exposed right master

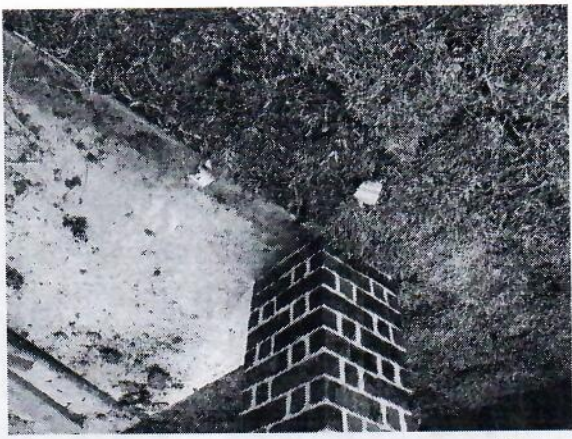
High soil levels observed at the following locations: rear patio column, front porch column.

High soil levels rear patio column

Suggested Grading and Drainage Maintenance: Grading around the dwelling should slope away from the structure, 6 inches per 10 feet. Excess runoff should drain to adjacent right-of-ways, swales or culverts. Allowing excess runoff to collect and stand around the dwelling will effect the soil conditions around the structure which may result in differential movement. Most of the greater Houston area soils contain expansive clays. Therefore, proper care of the soil under and around your home's foundation is very important in preserving the integrity of the structure. Implementing drainage provisions and a watering program around the perimeter of the dwelling will help to stabilize soil conditions and reduce the risk of abnormal differential movement.

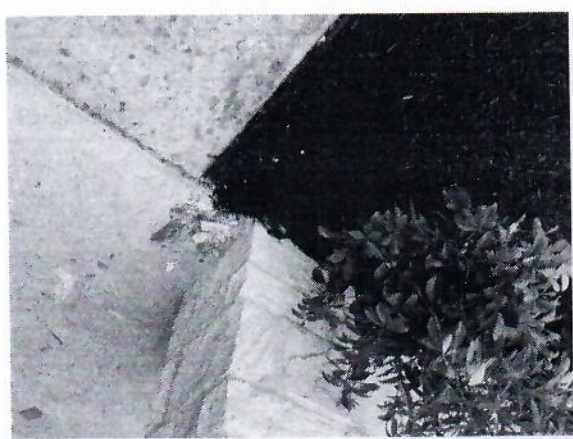
High soil levels front porch column

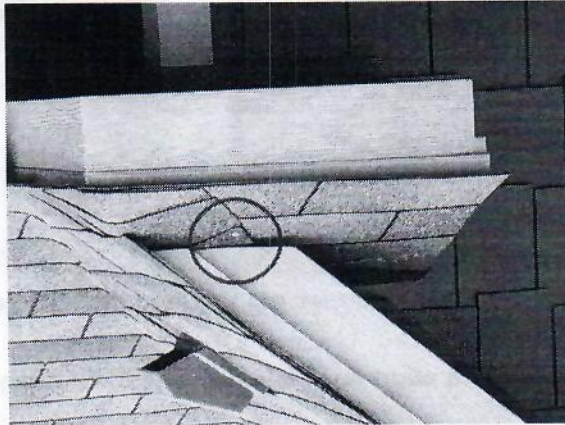
Flashing missing at front bedroom eyebrow

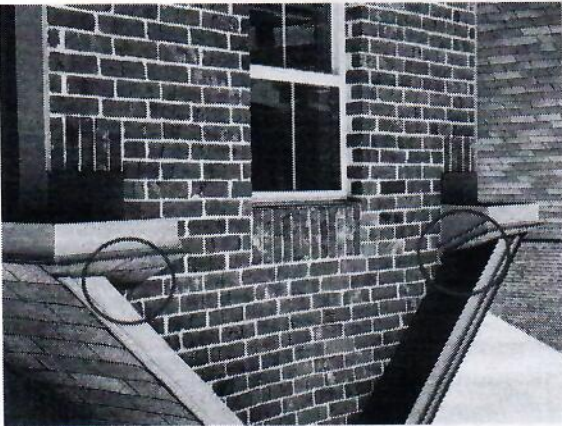
Loose nails at roof covering

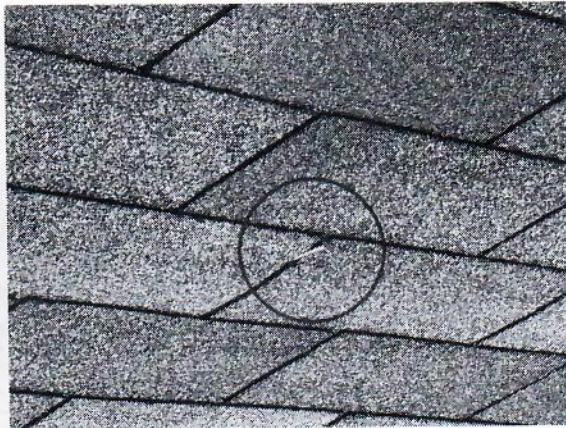
Caulk face nails at ridge caps

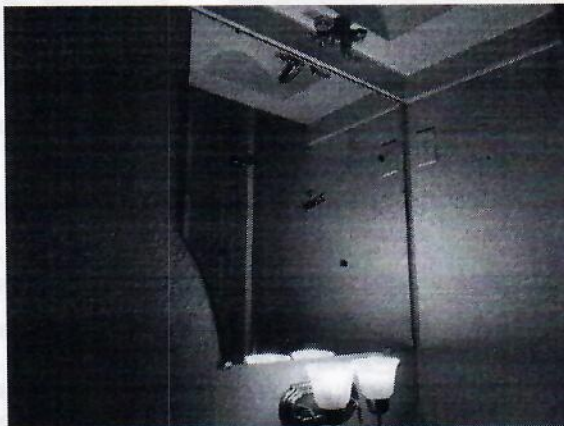
Mirror broken upstairs bathroom

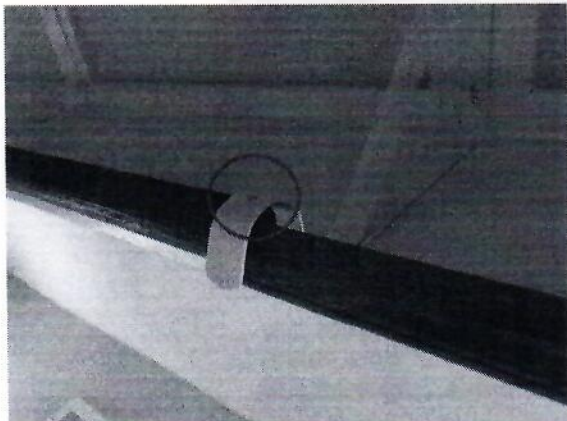
Clothes rods not secured at bedroom closets

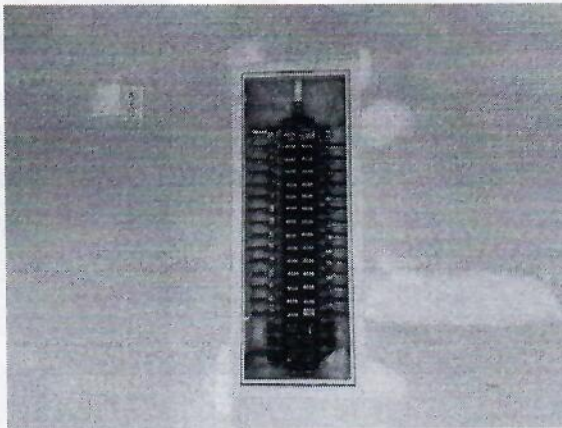
Manifold recessed at garage common wall

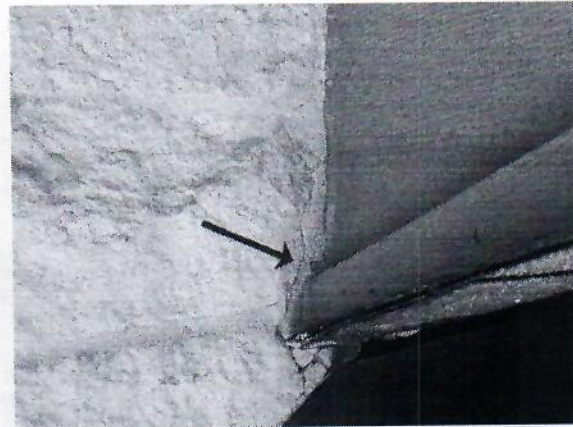
Mortar crack at garage roof left eyebrow eave

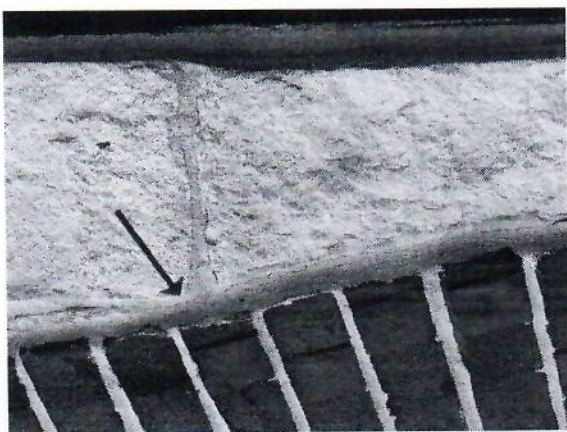
Mortar crack above garage door

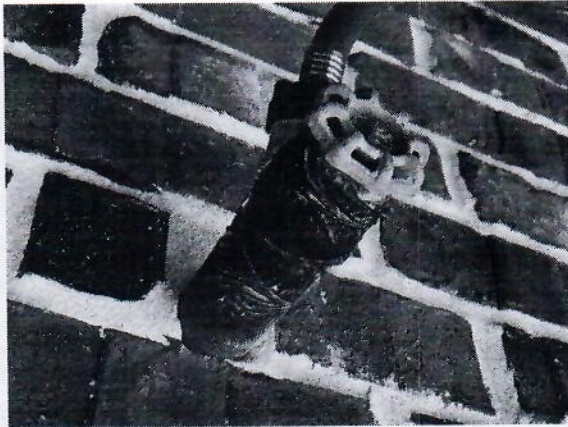
Hose bibs not sealed at exterior walls

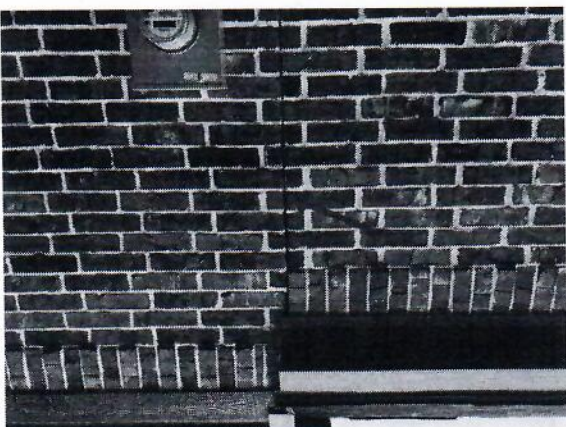
Expansion joint caulking missing exterior walls

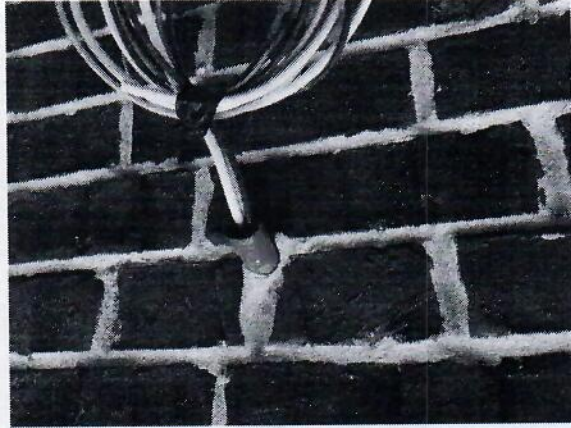
Exterior conduit not sealed at wall

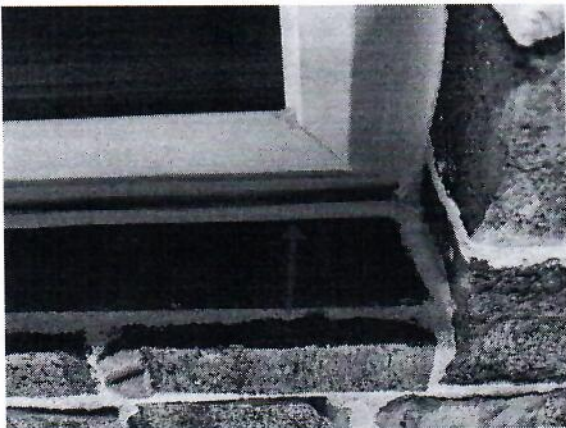
Z-flash drainage plane covered with caulk

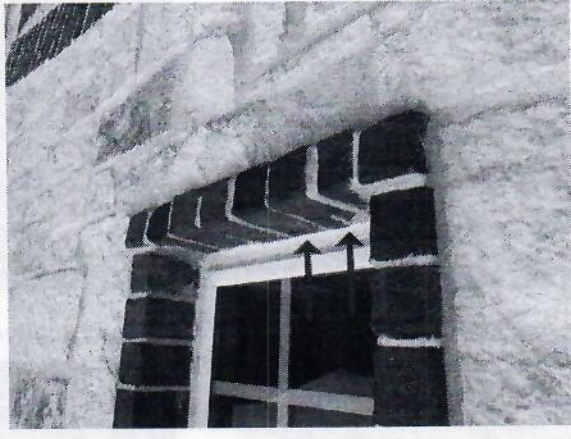
Window ledges not properly sloped

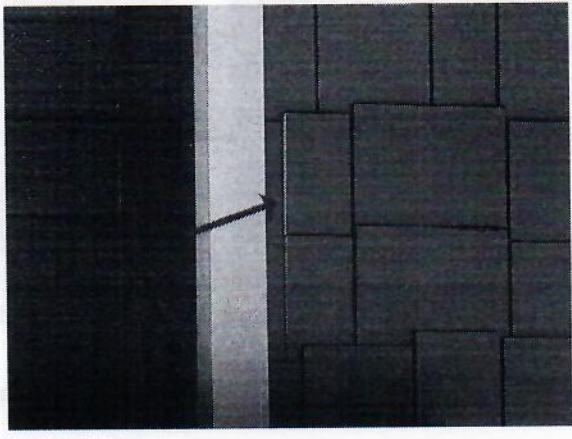
Seal soffit penetration A/C drain line

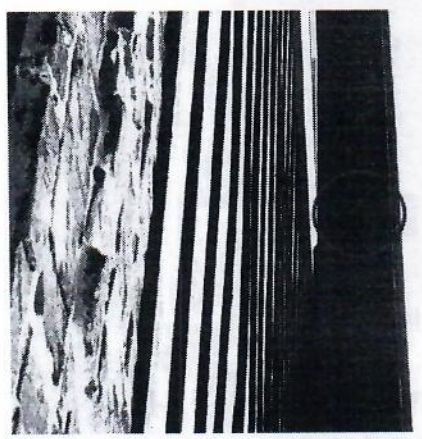
Utility room floor drain not sealed at wall

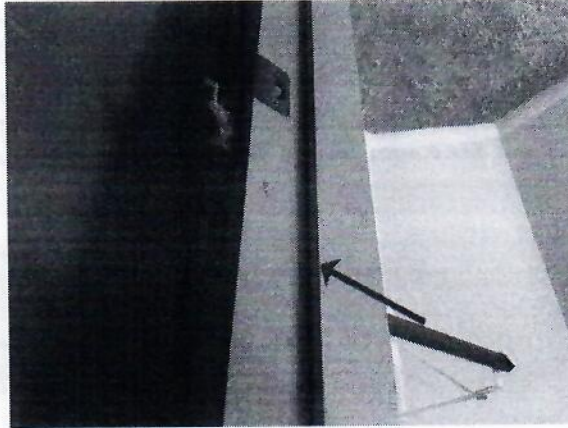
Jamb not caulked at base front entry door

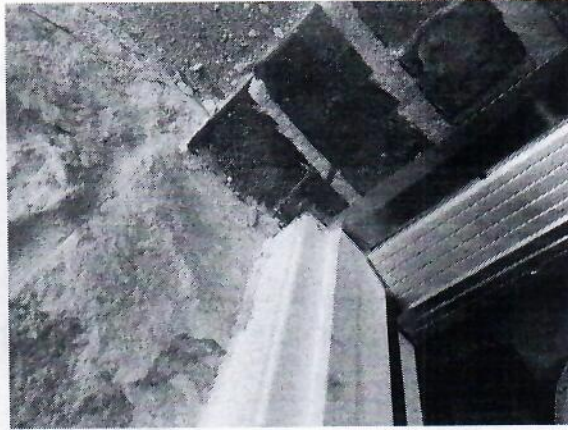
Paint missing front entry door jamb

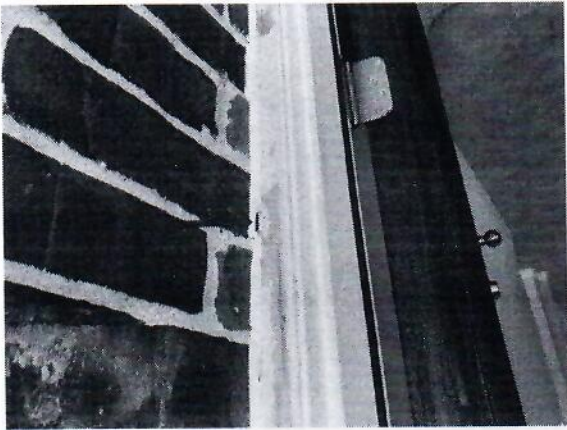
Paint missing at rear patio door jamb

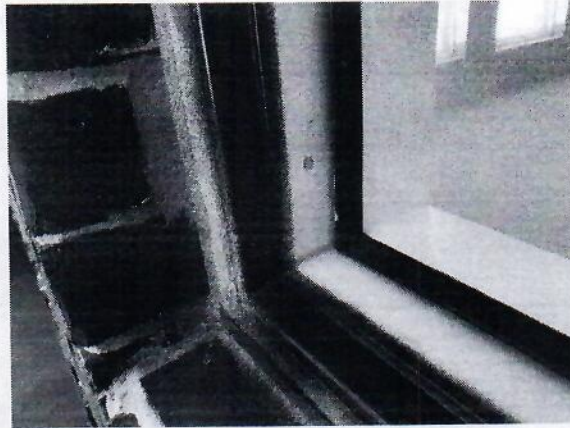
Caulk missing at rear patio door jamb at base

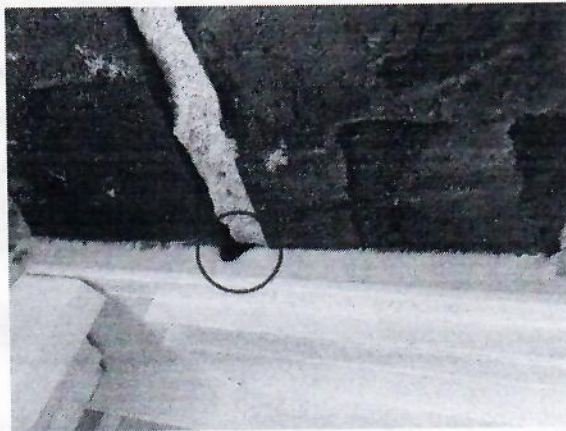
Gaps observed at exterior window caulking

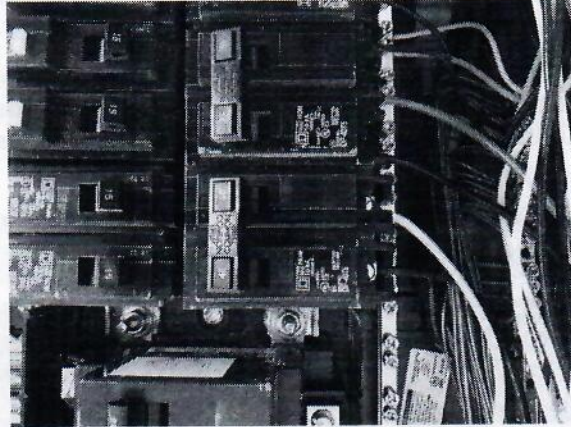
Black sheathed grounds not marked green

- Debris observed at the interior of the service equipment disconnecting means panelboard enclosure.
- The white wire connected to the 240 volt circuit breakers should be marked with a color (red or black).
- The black insulated conductor used for grounding and or bonding should be marked green.
- The dual GFCI and combination arc fault circuit breakers at the microwave #21 and kitchen counter receptacles #23 are simultaneously tripping when a load is plugged into either one of the circuits. Further evaluation by a master electrician is recommended.

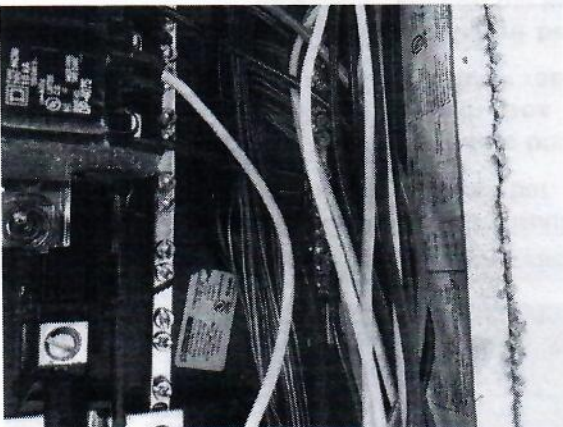
Microwave and kitchen breakers tripping

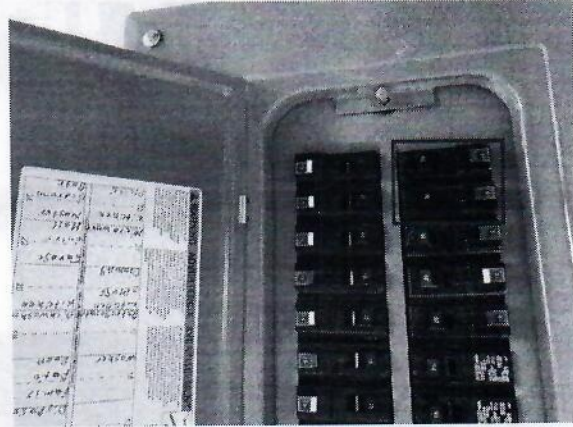
Debris bottom panelboard

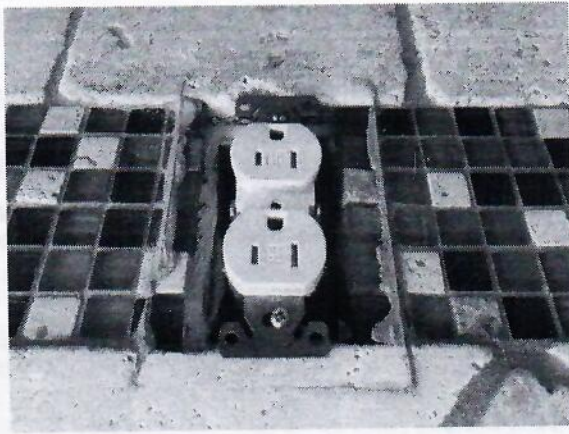
Spark rings missing kitchen backsplash outlets

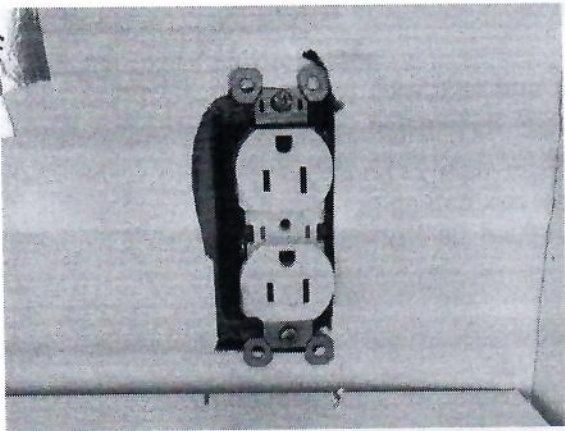
Spark rings missing kitchen cabinet receptacles

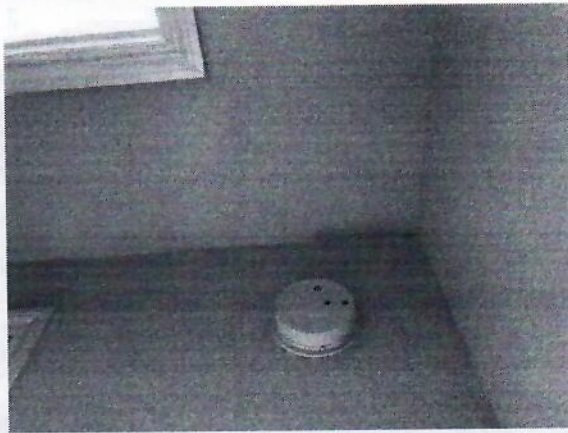
Carbon monoxide alarm not installed at the exterior of the upstairs left guest bedrooms. An approved carbon monoxide alarm shall be installed outside of the each separate sleeping area in the immediate vicinity of the bedrooms in dwelling units within which fuel fired appliances are installed and in dwelling units that have attached garages.

Upstairs hallway smoke detector not CO too

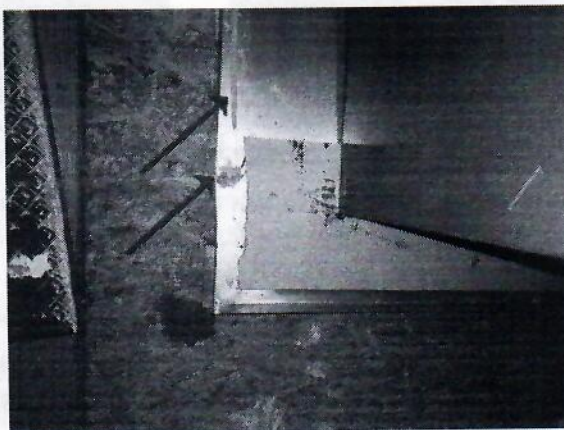
A/C thermostat missing at upstairs wall

The A/C thermostat was not installed at the time of inspection. The A/C system installation was not complete and was not inspected for performance. The system was only visually inspected

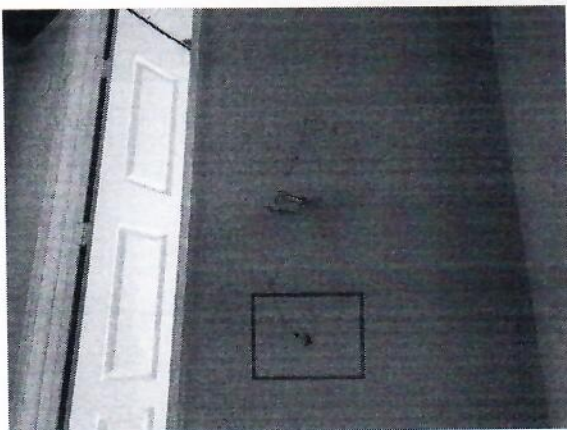
Insulation/debris observed at the A/C auxiliary condensate drain pan.

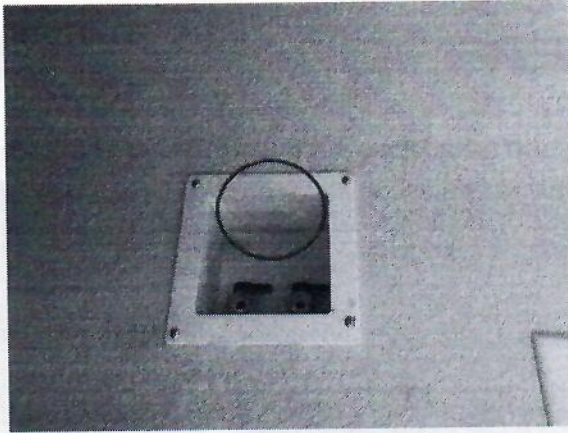
The utility room drain line is not present at the washing machine hook-ups.

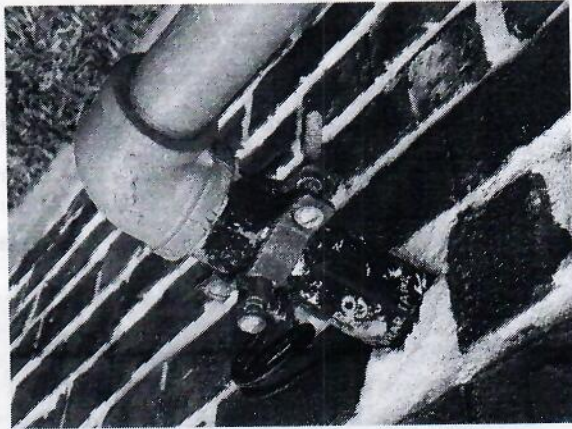
Gas pipe rusted right exterior wall

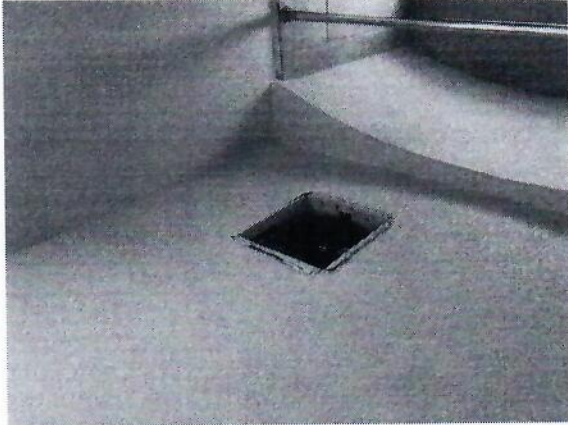
The bathroom exhaust fan vent cover not attached at the upstairs front bathroom ceiling.

Exhaust fan vent cover missing upstairs bath
