222 Garfield Ave. Pasadena Texas

PROPERTY INSPECTION REPORT

(Name of Client)		
222 Garfield Ave., Pasadena, Texas		
(Address or Other Identification of Inspected Prope	rty)	
Richard Chandler #6803 / Insight Property Inspections	10/13/2021	
(Name and License Number of Inspector)	(Date)	
(Name, License Number of Sponsoring Inspector)		
	222 Garfield Ave., Pasadena, Texas (Address or Other Identification of Inspected Prope Richard Chandler #6803 / Insight Property Inspections (Name and License Number of Inspector)	222 Garfield Ave., Pasadena, Texas (Address or Other Identification of Inspected Property) Richard Chandler #6803 / Insight Property Inspections 10/13/2021 (Name and License Number of Inspector) (Date)

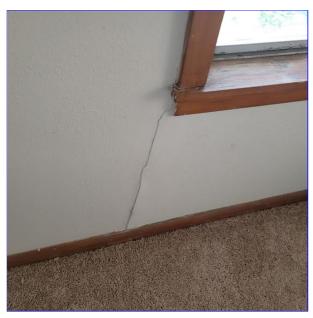
A. Item 1(Picture)

(1) Differential movement / settlement observed; indicated by one or more of the following observed conditions; Cracks in brick veneer and/or foundation, Cracks in sheetrock over doors and windows, door that are not square in jamb, etc. In my opinion the distress patterns observed at the time of inspection are/were severe enough to recommend repair.

Recommendation: visit the following website: www.houston-slab-foundations.info. This website will provide you with general information about slab on ground foundations in the Greater Houston Area that is not readily available elsewhere. The website was published specifically to help buyers and others understand the foundation inspections with reference to real estate transactions.

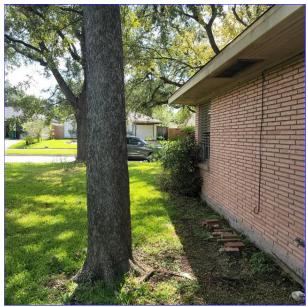
B. Item 2(Picture)

There are trees in close proximity to the foundation. Trees less than 10 feet from the foundation's perimeter grade beam may cause root encroachment under the slab. Such encroachment can deplete soil moisture in the area creating uneven soil moisture content around the perimeter grade beam.

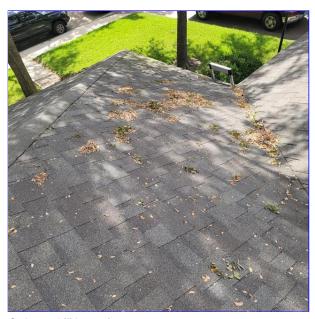
C. Item 1(Picture)

Accumulations of tree debris (leaves, needles, twigs, etc.) are present on the roof. These accumulations slow water runoff and can cause water to back up under the shingles causing leaks, fungus growth and staining. The existing accumulation should be cleared. You should plan for periodic roof maintenance to remove these accumulations

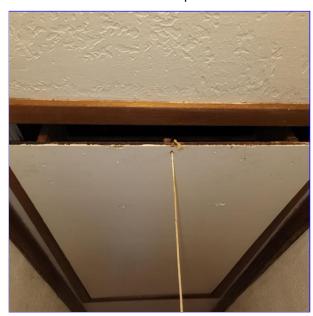
D. Item 1(Picture)

(1) The attic door does not shut properly. This can cause some heat loss in winter and loss of cool air in summer if not corrected. A qualified contractor should inspect and repair as needed.

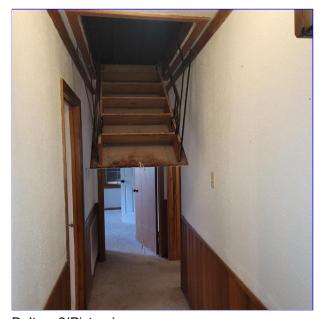
D. Item 2(Picture)

(2) The bottom section is missing at the attic pull-down stairs. Repair is needed.

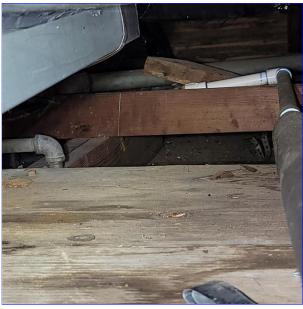
D. Item 3(Picture)

(3) The attic was missing insulation over areas of significant size. This condition can result in increased heating and cooling costs, reduced comfort levels and may contribute to ice damming of the roof during the winter. The Inspector recommends that insulation be properly distributed to cover all portions of the attic located above the home living space.

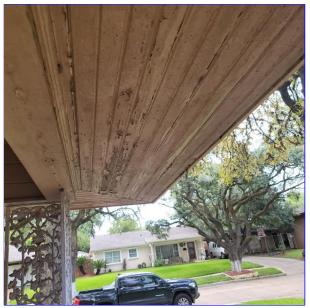
E. Item 1(Picture)

(1) Peeling paint was observed at the exterior of the house and garage. Homes built prior to 1978 may have lead-based paint. This should be evaluated by a qualified contractor.

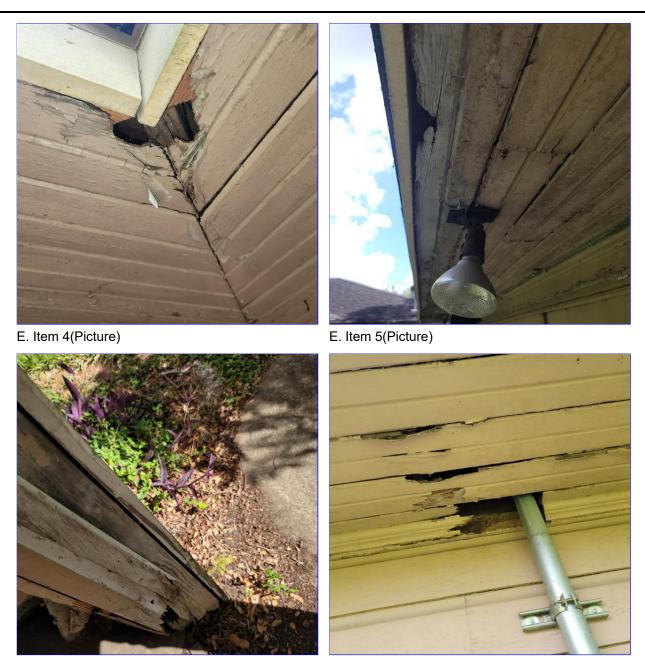
(2) Wood rot was observed at the exterior of the house and garage.

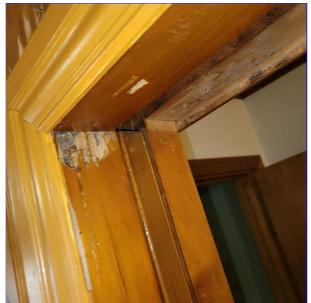
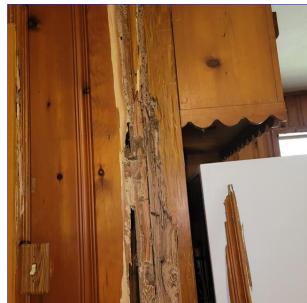
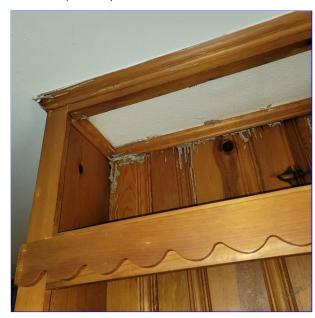
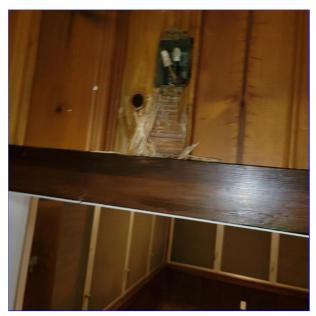
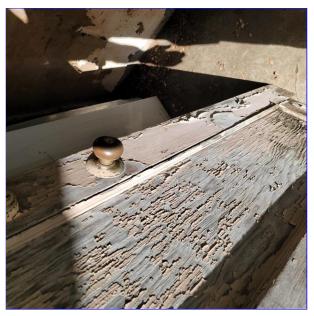
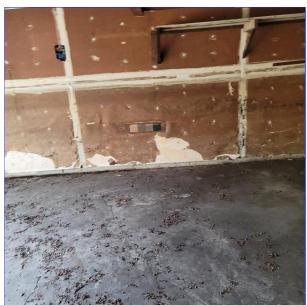
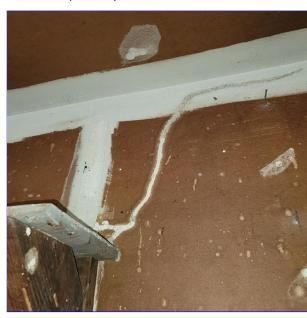
(3) Termite damage was observed in several rooms and in the garage. Frame damaged was observed.

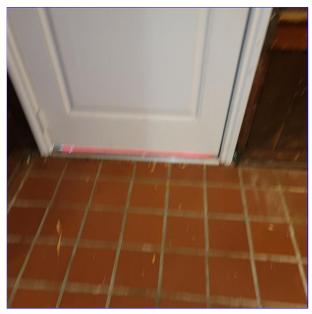
G. Item 1(Picture)

The rear exterior door reveals daylight when latched at areas missing weather-stripping and at the threshold.

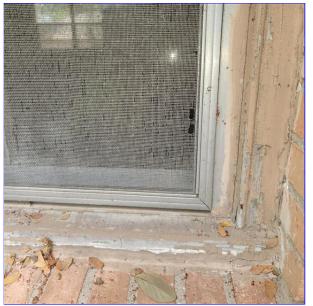
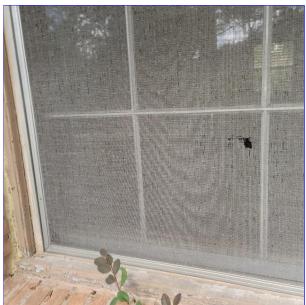
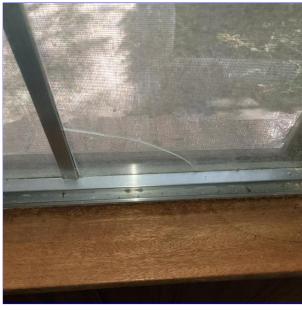
(1) Damaged and missing screens were observed at several windows. Screens that are torn enough to allow insect infestation should be repaired or replaced

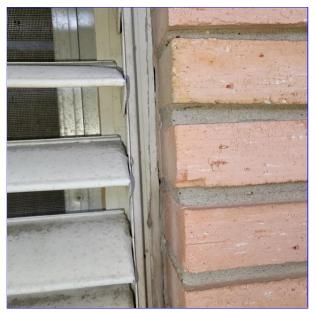
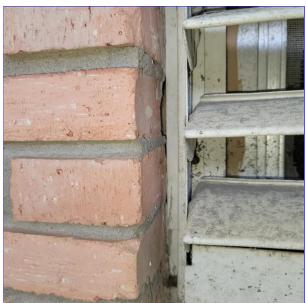
(2) Caulking is missing and/or deficient around some windows. Maintaining window caulking makes a house more energy efficient, ensures that bugs cannot enter the home and keeps outside elements from entering through the installation gaps that occur between the window and the house's framing

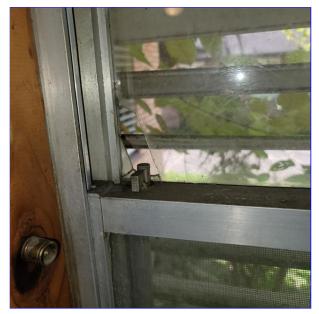
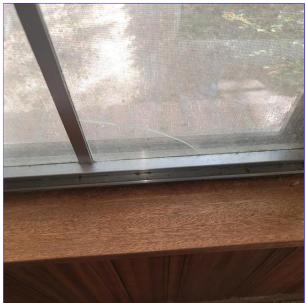
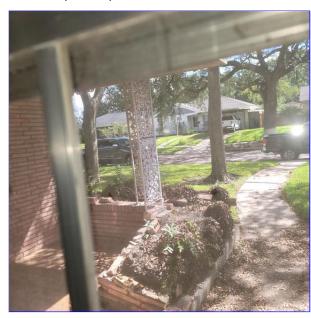
(3) Several damaged windows were observed

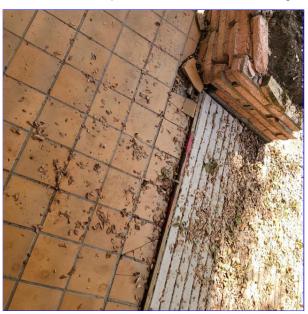
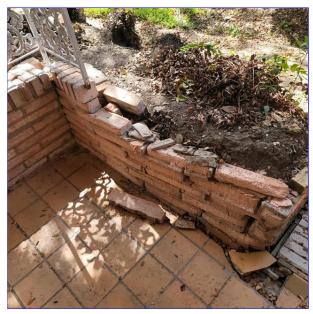
Floor tiles and planter box bricks were damaged at the porch.

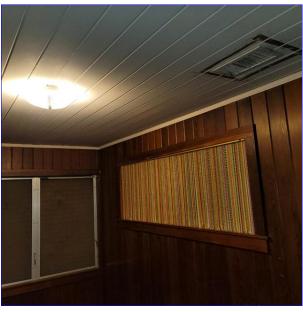
C. Item 1(Picture)

The bonus room at the rear of the house does not appear to be supplied with central air conditioning.

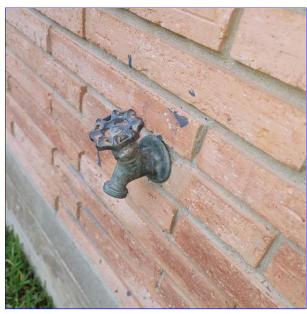
A. Item 2(Picture)

(1) Install anti siphon devices on all exterior faucets. The lack of anti siphon devices can allow non-potable water or other contaminants to be drawn into the water supply in the event of a drop in water pressure. This is considered a health hazard

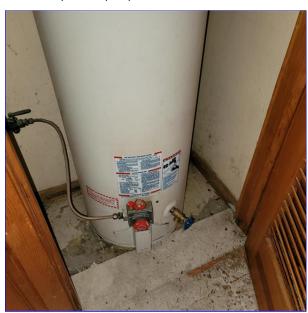
C. Item 2(Picture)

which is installed in such a way that any debris or moisture in the gas line will be caught in the trap where it can be cleaned out easily. The reason for this is to ensure safe operation of an appliance by keeping debris out of the tiny orifices of the gas valves

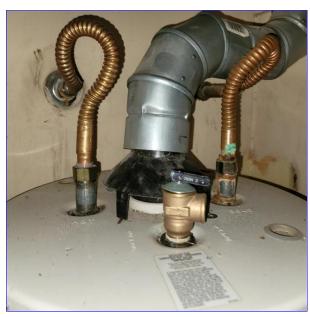
C. Item 3(Picture)

(2) The T&P (Test and Pressure) valve on water heater needs a 3/4 threaded pipe to extend within 6 inches of floor for safety. (PVC is not approved for hot water use). I recommend repair by a qualified person.
