**HOME
INSPECTION**

**Dave Hilgartner
335 Harbor Addition
Livingston , TX 77351
January 27, 2022**

Inspected By: Erik Placker TREC # 21184

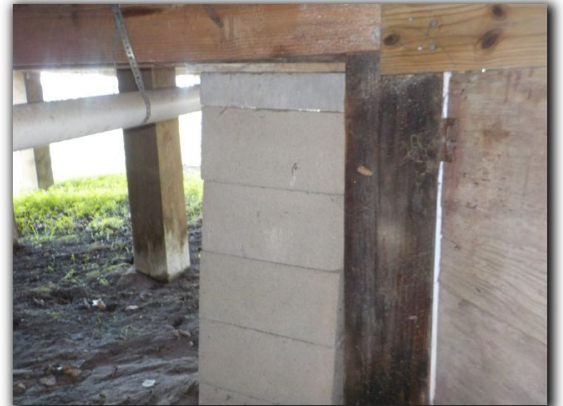
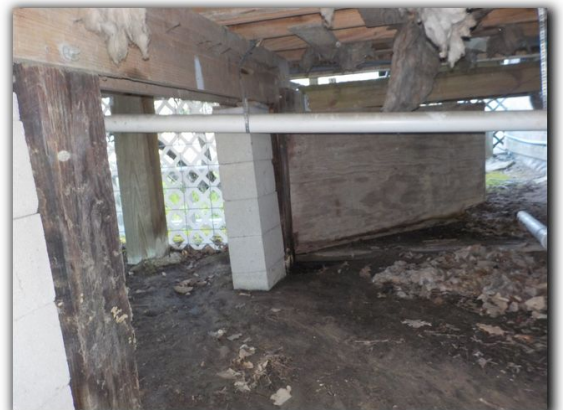
It appears that concrete masonry block piers were installed adjacent to the original wooden piers. This appears to be from deterioration and/or wood rot at the bottom of the wooden piers. Some of the masonry blocks have shifted and are either leaning and/or not in contact with the beam. Some of the block piers were not properly shimmed to support both beams/girders running parallel with each other. Repairs may be needed in order to ensure proper supporting and levelness of the foundation components.

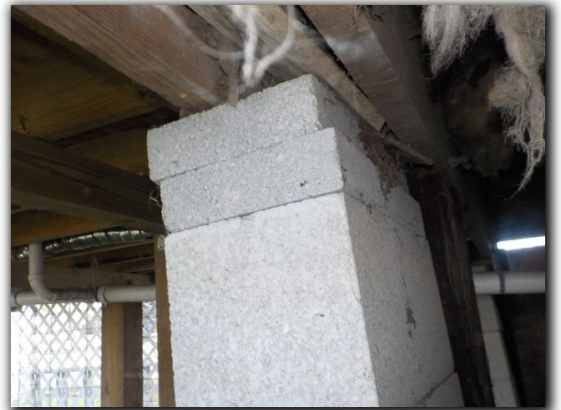
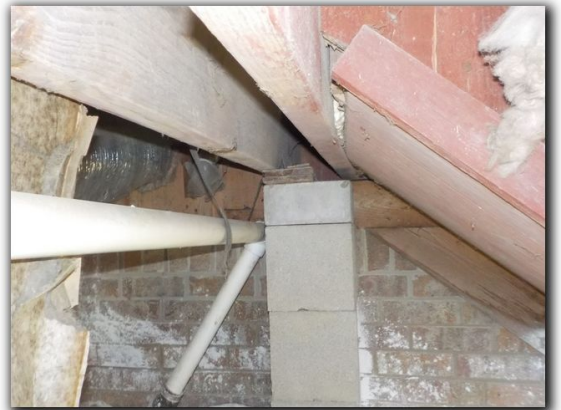
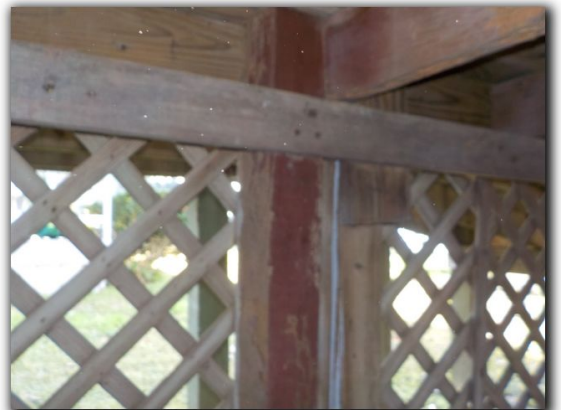
Evidence of previous and/or active wood destroying insects was detected under the screened in porch area of the crawlspace and upward around the door to the porch. A full evaluation of the amount of damage caused by the insects cannot be detected within the walls, voids, or other hidden areas without defacing the property and cannot be address in this report. With the detection of active and/or previous activity of a wood destroying insect, it should be assumed that some degree of damage is present.

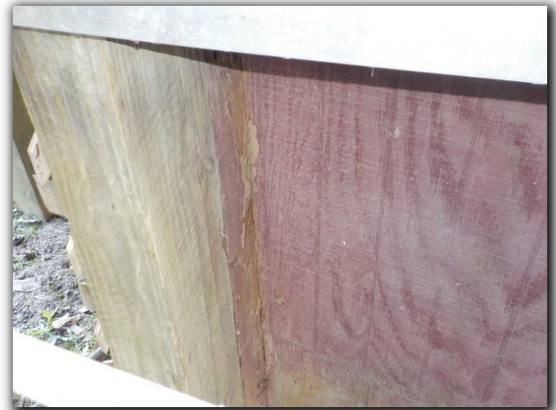
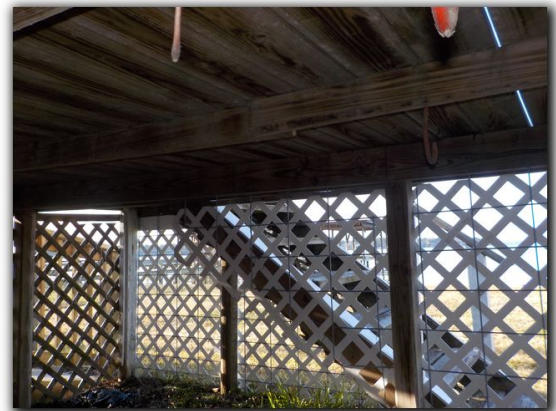
Inadequate amount of piers and/or supports was observed at the foundation for both porches. Piers with proper footers should be installed directly below the intersection of two girders and piers should be placed at over spanning of girders and floor joist to prevent sagging.

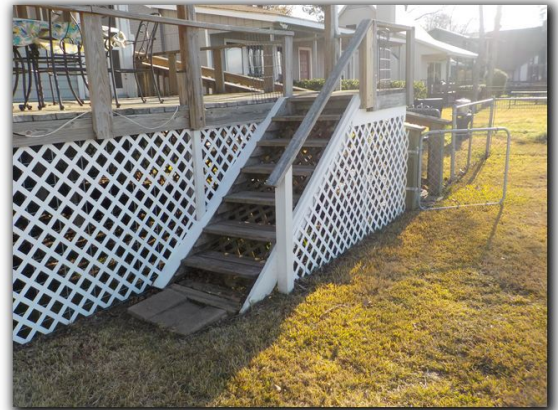
There is evidence of past water in the crawl space. This condition may vary seasonally and/or with precipitation intensity. Lot drainage improvements should be addressed as a first step to controlling water in the crawl space. Moisture will also cause foundations to shift or move over time.

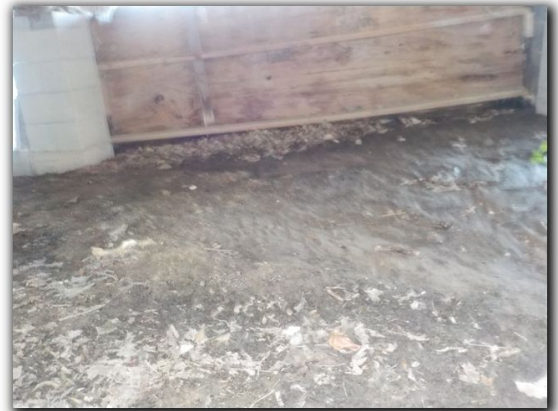
Crawl space has wood to ground contact. Wood to ground contact is a conducive condition for wood rot and can allow wood destroying insects to enter the home. Homeowner needs to remove wood to ground contact and/or have a preventive type treatment done by a licensed pest company.

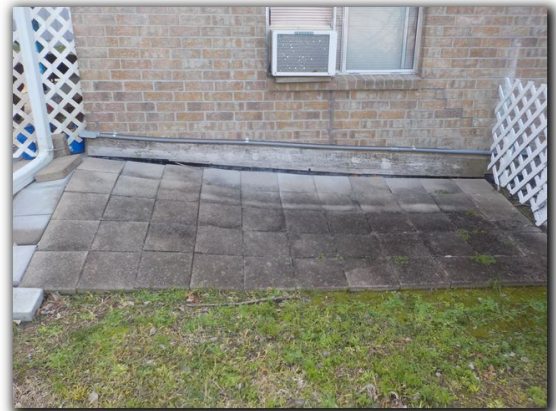
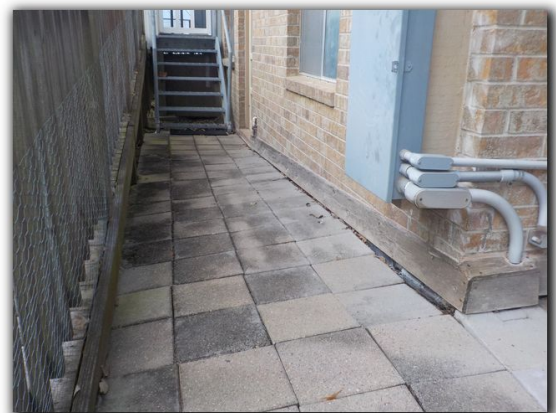
The face of the foundation is obstructed by plastic, wood and/or pavers. These conditions can allow wood destroying insects to enter the structure unseen. Other defects and/or deficiencies could be present.

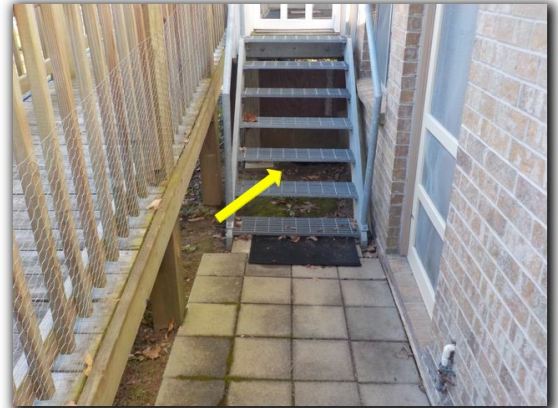
Negative site drainage was observed on the east and west sides of the structure. Proper drainage is needed to help prevent water from entering the crawlspace area.

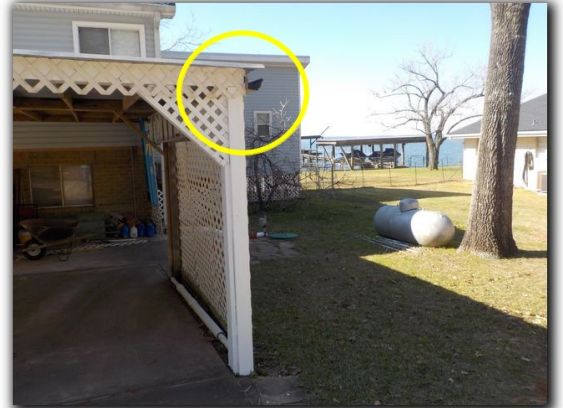
The guttering system downspout is missing on the carport.

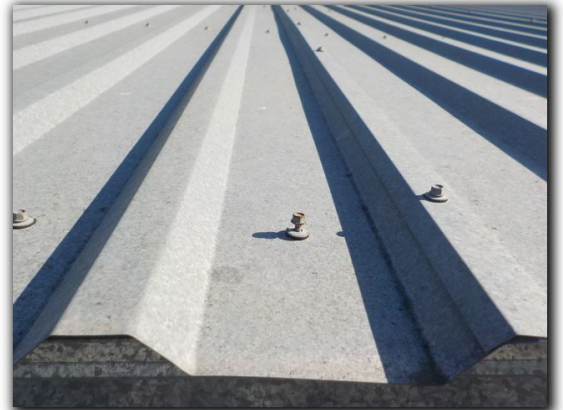
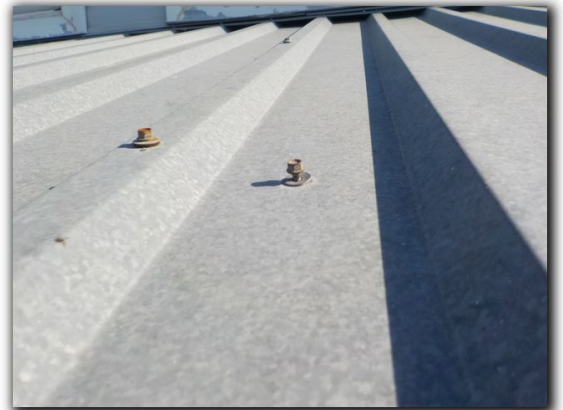
There are fasteners on the metal roof that are raised . These usually can be screwed down to secure the fastener. It is a good idea to inspect the roof annually for fasteners that are getting loose

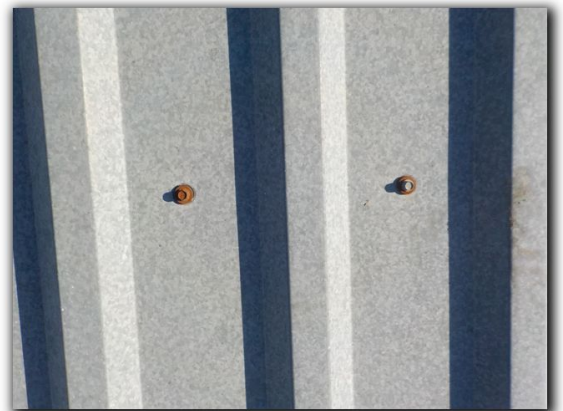
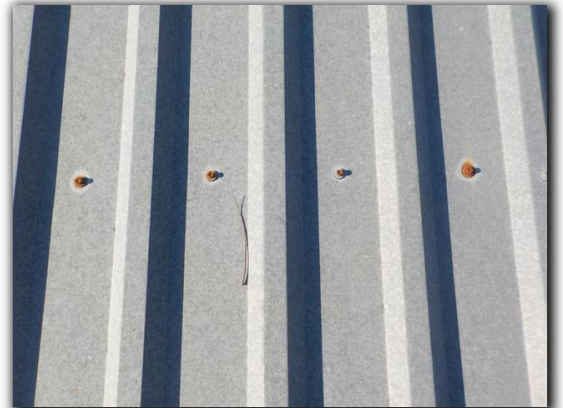
The roof fasteners are starting to rust and/or showing signs of aging. In general metal roof fasteners have a life expectancy of 12-15 years. It appears that the ones present may be nearing replacement.

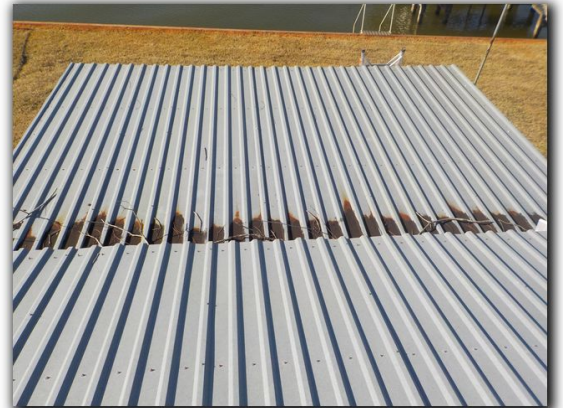
There are areas of the metal roof that have surface rust. I recommend painting or repairing the rusted areas to prevent further deterioration.

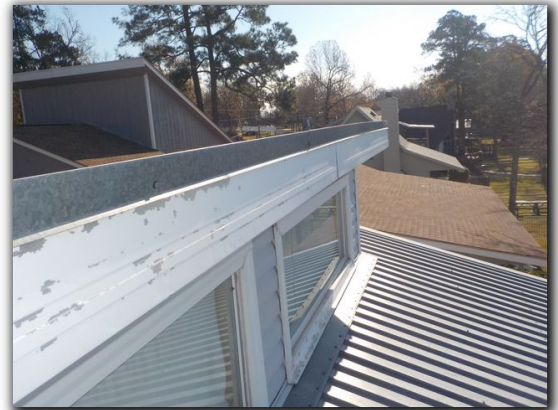
Paint was observed to be peeling at the fascia covering above the lower roof level.

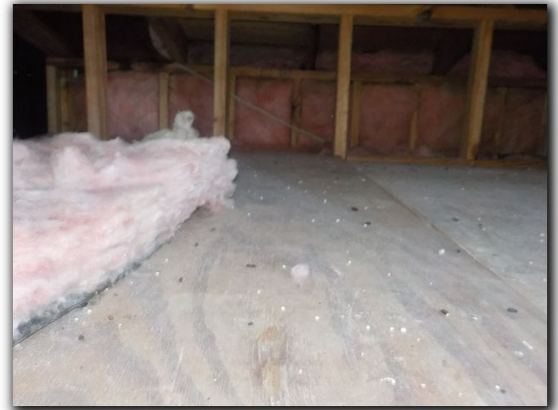
Visible evidence of rodent activity was observed in the attic area. It is recommended to have a Certified Pest Control Operator further evaluate this condition and make corrections as necessary.

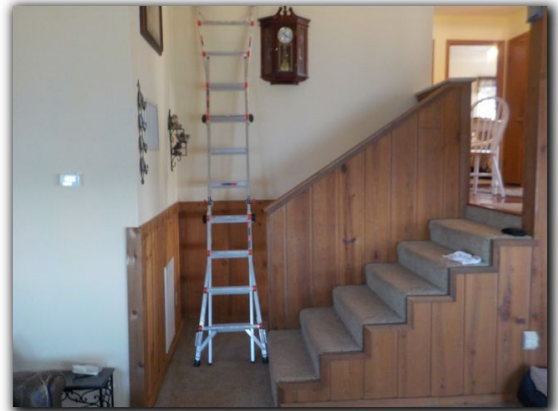
The only attic space available was observed over the upstairs bathroom area. It is difficult to access the attic space due to the stairs creating an unlevel platform directly below the access.

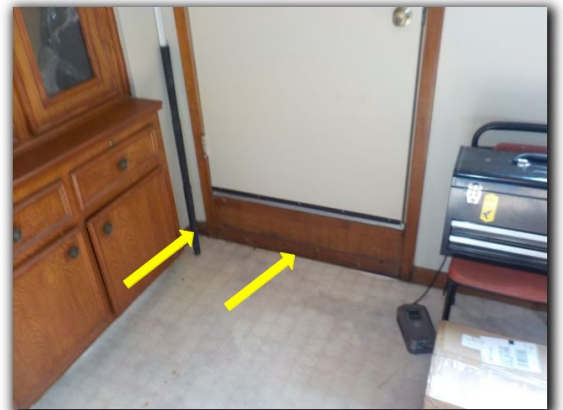
There was an unknown dark like substance observed around the downstairs exterior door. Evaluation of this substance is beyond the scope of this inspection. If any concerns exist on the type and/or nature of this substance, we recommend further evaluation by a professional in the Air Quality sampling field.

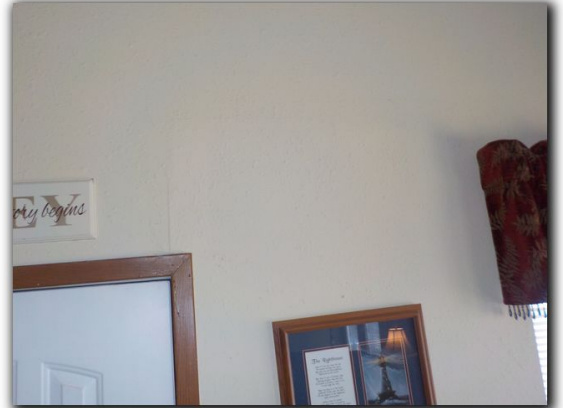
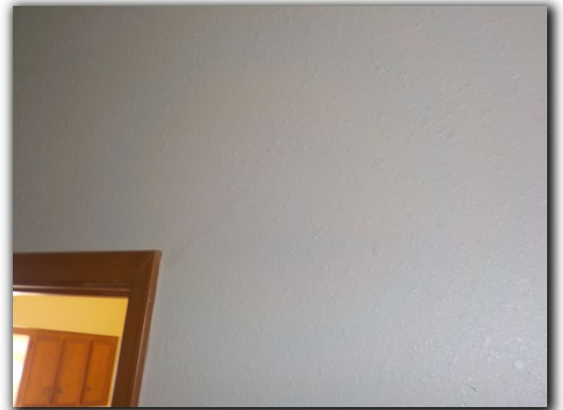
Common hairline wall cracks were noted in the interior gypsum wallboard. Cracks near the interior windows and doors are usually indications that there is some degree of movement occurring in the structure. (In any structure some degree of movement is normal and should not be of concern) the severity of the cracks can be an indication of the amount of movement in a structure.

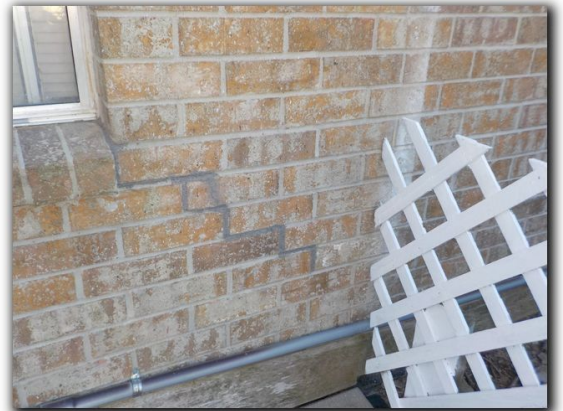
Stress cracks were noted to have been repaired on the exterior walls in various areas. This implies that some structural movement of the building has occurred, as is typical of most houses.

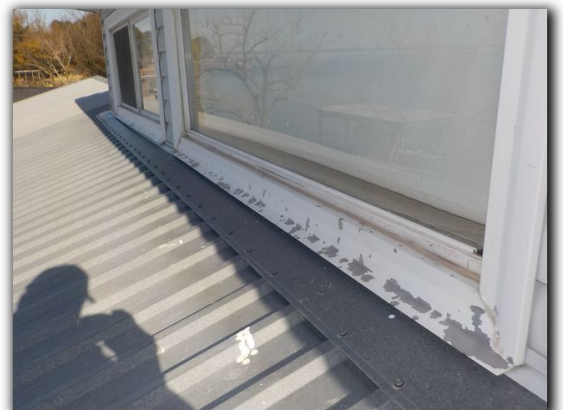
Paint was observed to be peeling at the metal type window trim above the roof structure.

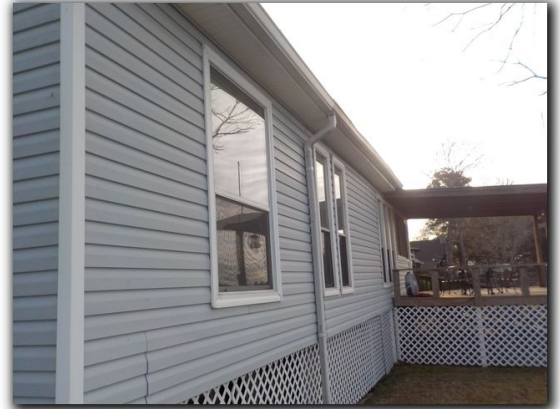
The exterior walls on this structure have a man made covering such as aluminum, vinyl or some other type of siding. Such siding sometimes creates or holds moisture against wood studs or other framing material. Those areas have not been inspected. Inspection of these areas would require the removal of the siding.

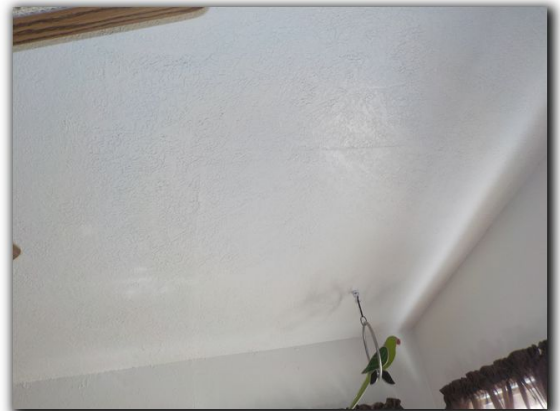
Common ceiling joint cracks were observed in various locations throughout the house.

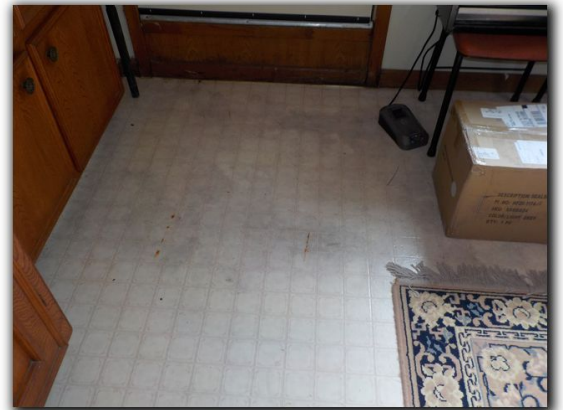
The vinyl floor covering was observed to have moisture damage and/or stains in the downstairs laundry and bathroom. This may be from previous water intrusion that was explained in the sellers disclosure.

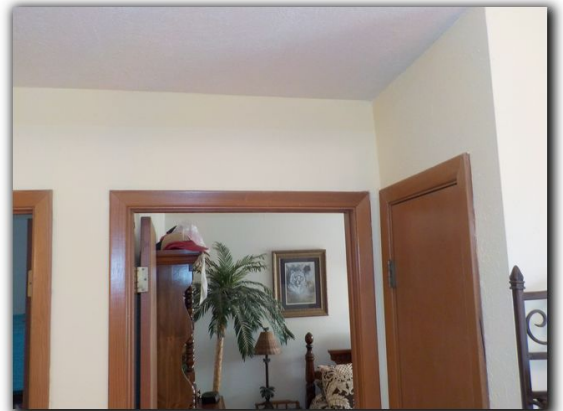
Some of the interior doors frames are out of square and the door has been adjusted to fit the opening. This usually is an indicator of movement within the structure.

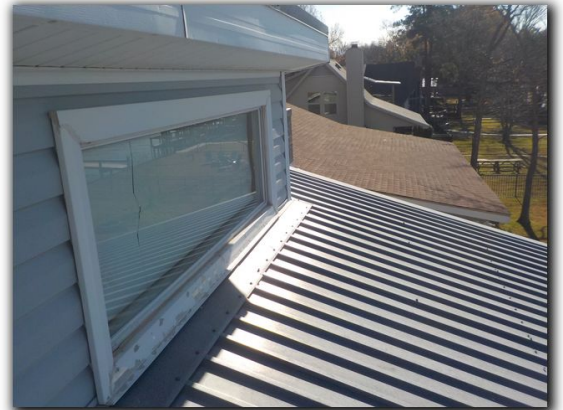
Broken glass panes were noted at one of the high wall windows in the kitchen. Broken glass is considered a recognized safety hazard and limits the energy efficiency of the glass.

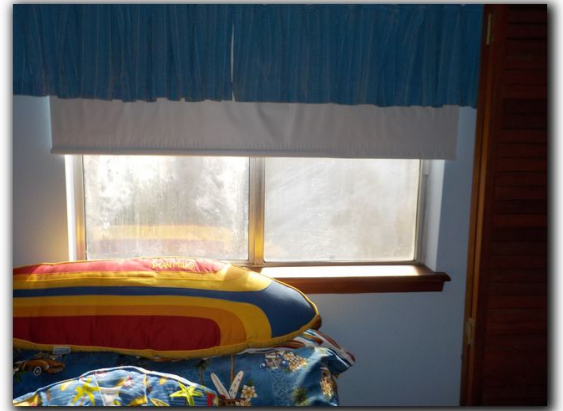
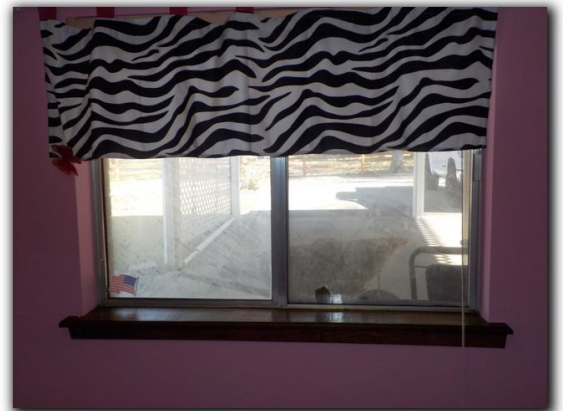
Windows with broken seals were noted at all of the downstairs double pane windows . This allows moisture inside between the panes of glass. This causes fogging to take place, which will eventually cause staining to the point of zero visibility.

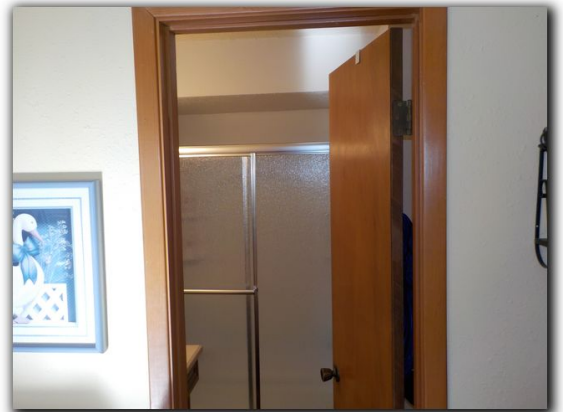
In bathrooms with no windows, an exhaust fan should be installed to remove moisture from the air.

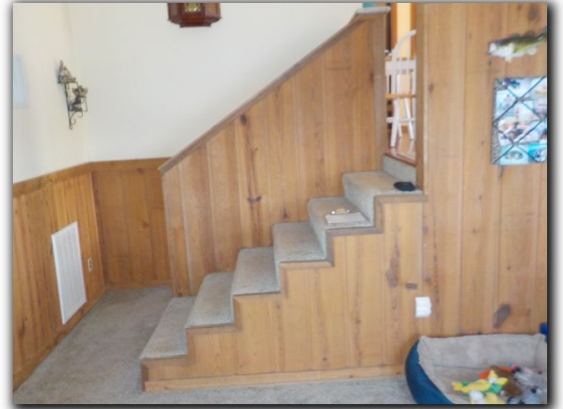
balusters with openings no larger than 4-inches should be installed. This may be an “as-built” condition but Per TREC standards of practice we are required to report this condition as a deficiency. You may consider corrective measures for improved safety.

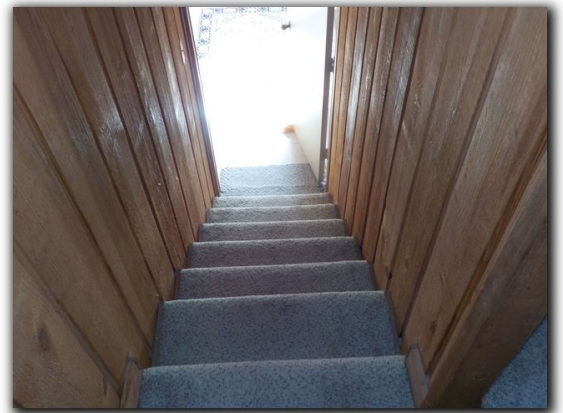
There is no handrail in place for the stairwell. For improved safety, a handrail should be installed.

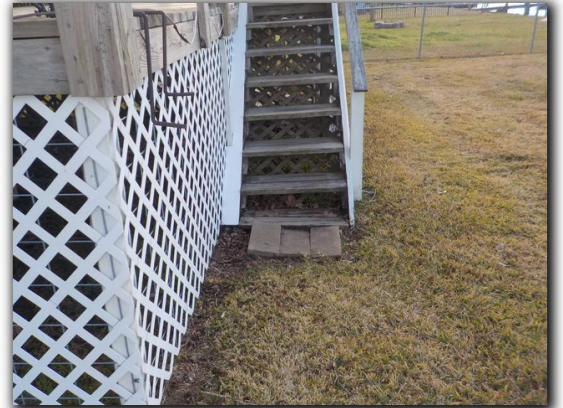
The exterior steps are resting on the ground. Wood to Ground contact is a conducive condition to wood destroying insects and wood rot. This configuration should be avoided.

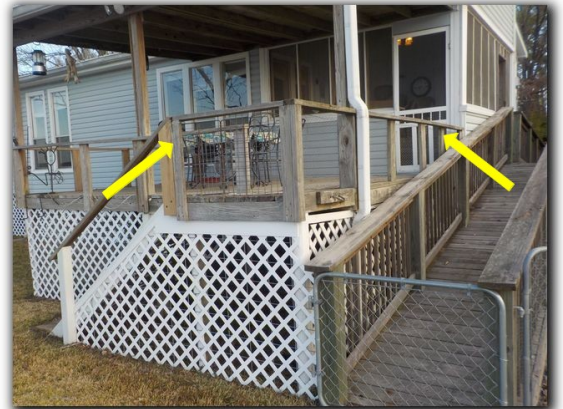
Porches, decks, ramps or balconies that are located 30-inches or more off the adjacent ground (floor or grade) should have guard rails in place for reasons of safety. The guard railing should be installed at a minimum height of 36-inches and guard openings should be no larger than 4 inches. The railing at the covered deck is too short and openings too large.

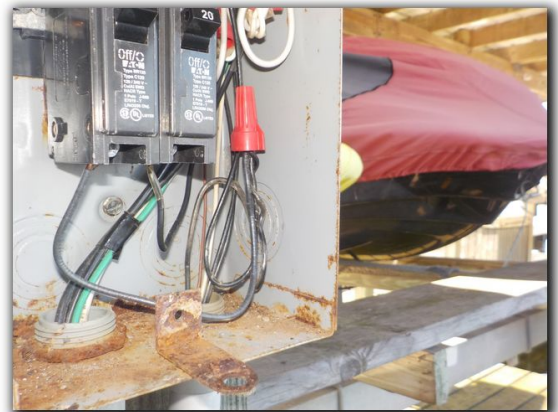
It appears that multiple circuits are wired to one breaker inside the panel box. A load calculation test would have to be performed by a licensed electrician and is recommended.

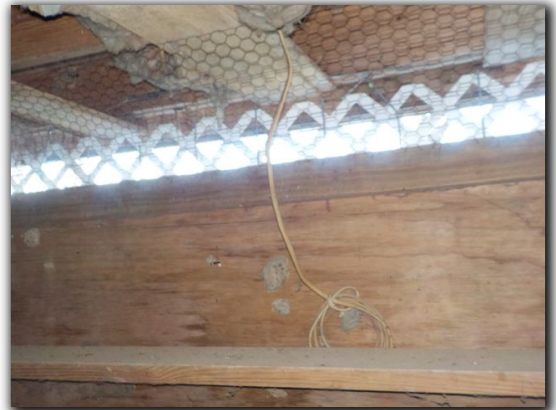
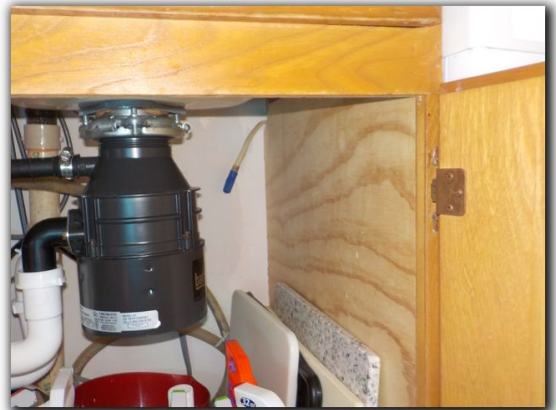
Wires that were improperly spliced or terminated were noted in the crawlspace and under the kitchen sink. Wire ends or splices are recommended to be in junction boxes that are properly mounted and covered. This condition is considered an electrocution/fire hazard and should be serviced by a licensed electrician.

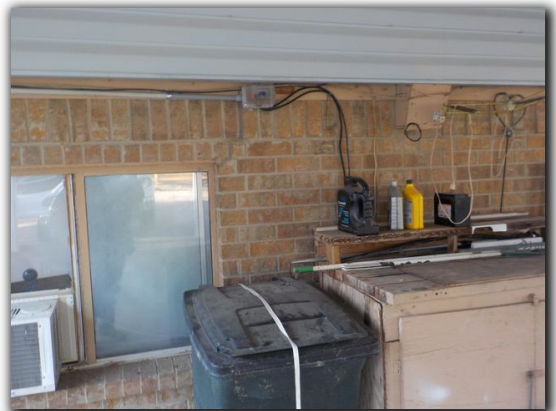
Extension cords were found being used as permanent wiring to both sump pumps. Extension cords are not designed for this application and should not be used as permanent wiring.

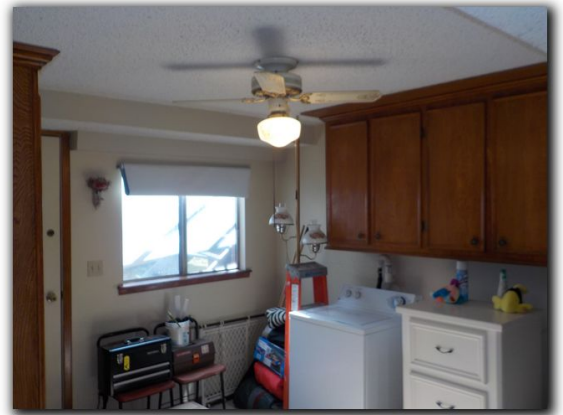
The ceiling fan is not balanced properly and wobbles when operated in the laundry room.

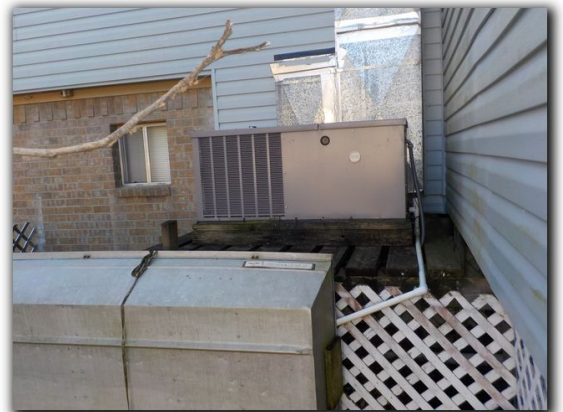
I was unable to locate or observe a service disconnect at or around the heating unit.

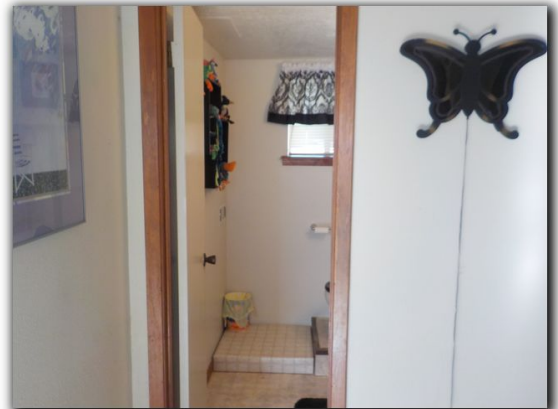
The only return register is located on the middle floor at the stairwell. The door from the downstairs to the stairwell and the downstairs bathroom door will need to be left in the open position to help prevent a negative pressure result and to help control the temperature throughout both levels.

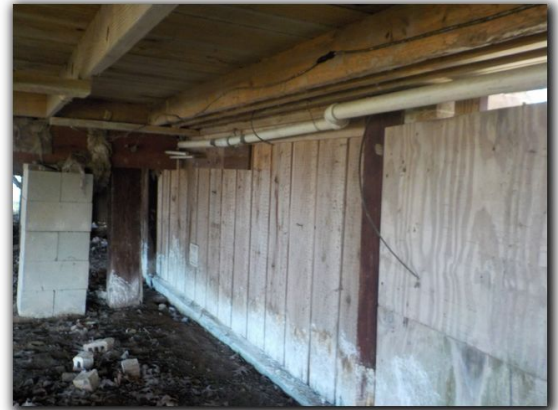
There was no P-trap observed for the washing machine drain line. This does not meet current plumbing standards and should be repaired as needed.

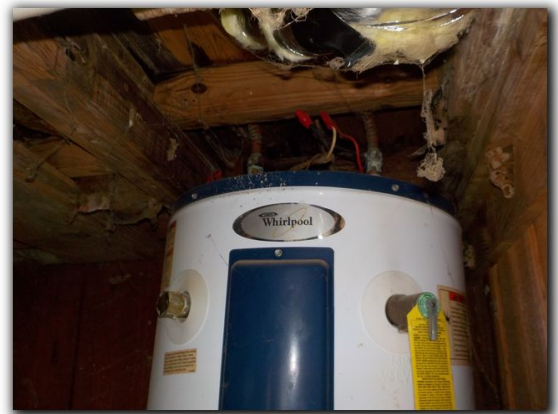
The spliced wires at the top of the water heater should be properly enclosed for reasons of safety.

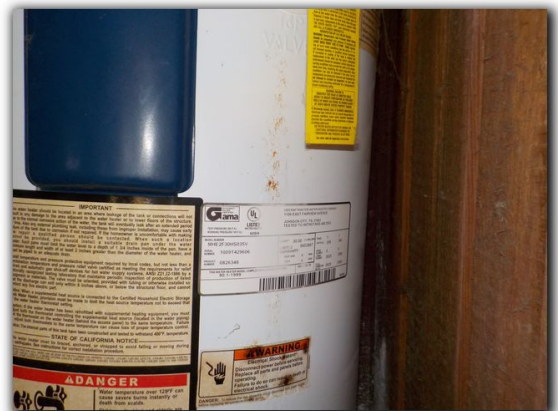
Water tank is showing signs of rusting. Recommend a periodic check on the tanks condition.

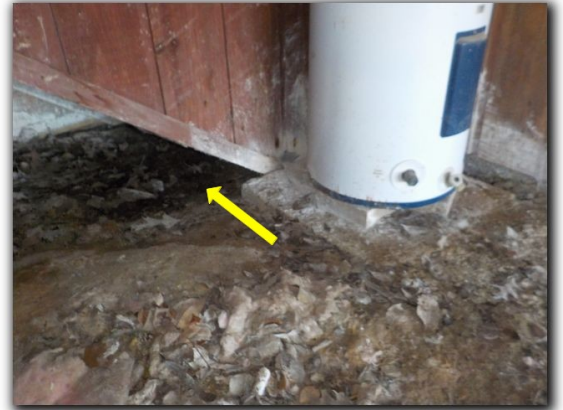
Although the water heater is in the crawlspace, a pan and drain line is recommended. The ground is lower directly behind the unit and against the foundation. In the event of a leak it appears that the water could drain to the low area and possibly penetrate into the structure.

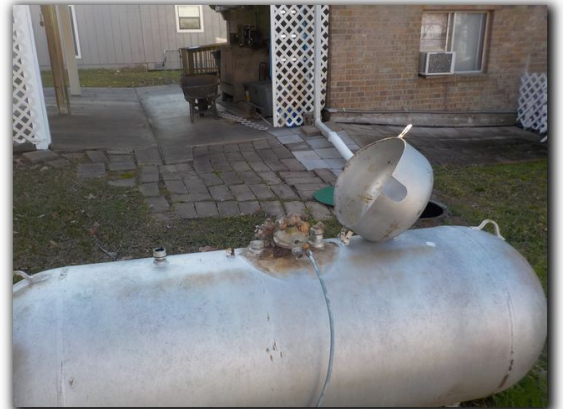
The gas line to the structure has been disconnected from the tank. Note: There was no gas appliances observed for the structure.

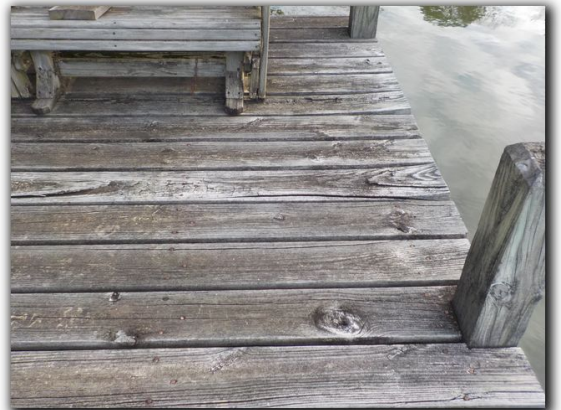
Common weathering of the deck material was observed. Routine maintenance as in cleaning and sealing the wood should be considered to help prolong the life expectancy.
