# PROPERTY INSPECTION REPORT

Concerning: **7927 Chatham Springs, Cypress, TX 77433**

By: **Ning Xue** **09/27/2021**

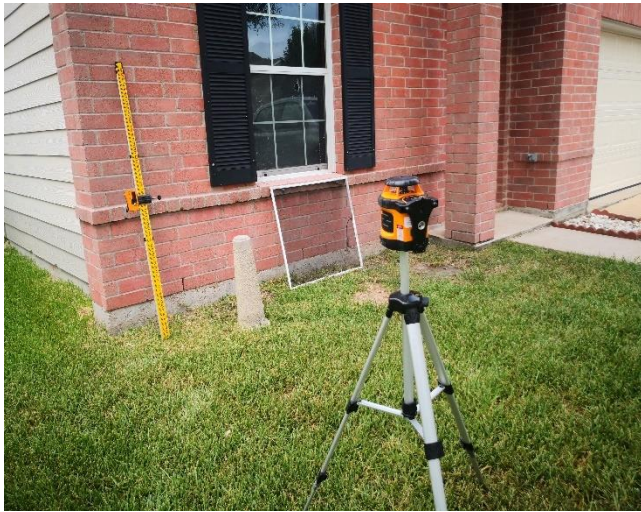
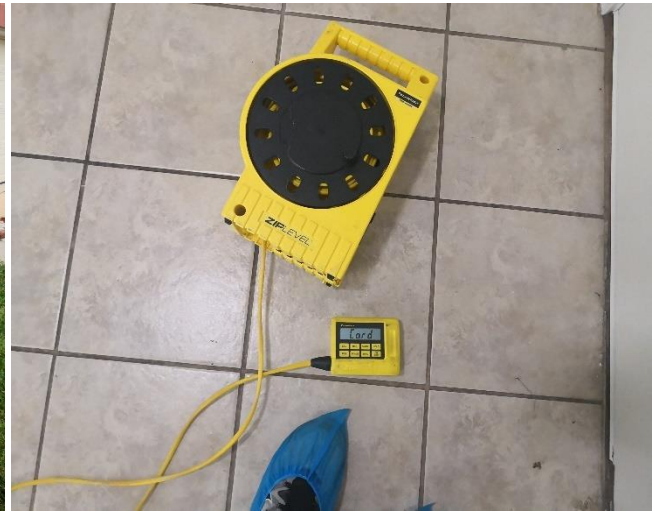
a. In my opinion, current foundation integrity appears to be performing the function intended; no significant differential movement was noted at the exterior and interior by using laser level and Ziplevel;

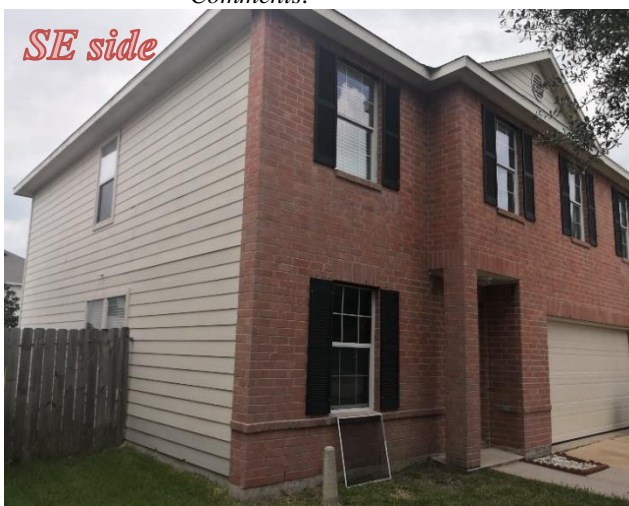
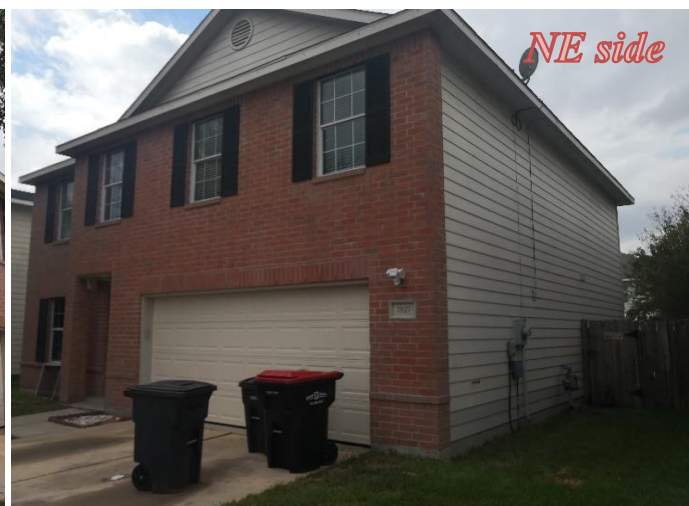
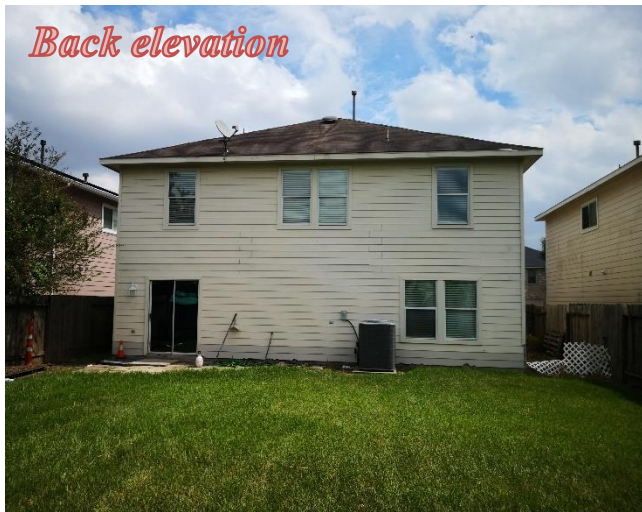
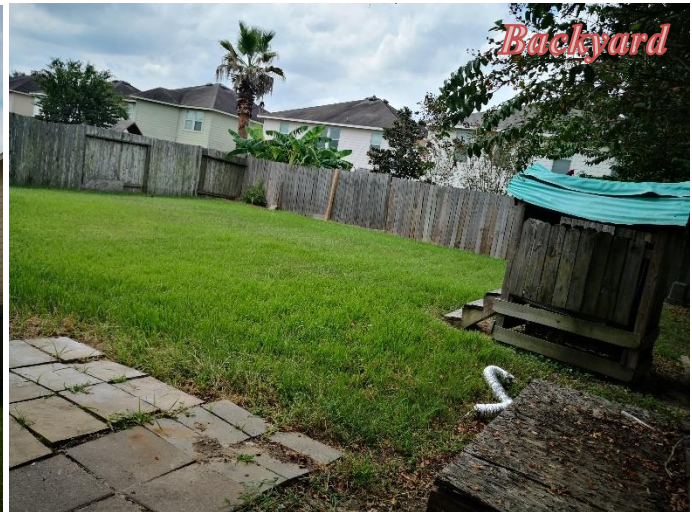
- a. The finish grade slopes away from the house to provide positive drainage along all three sides of the property where the finish grade of the backyard seems to be fairly flat and no defined drainage pattern can be identified at time of the inspection;

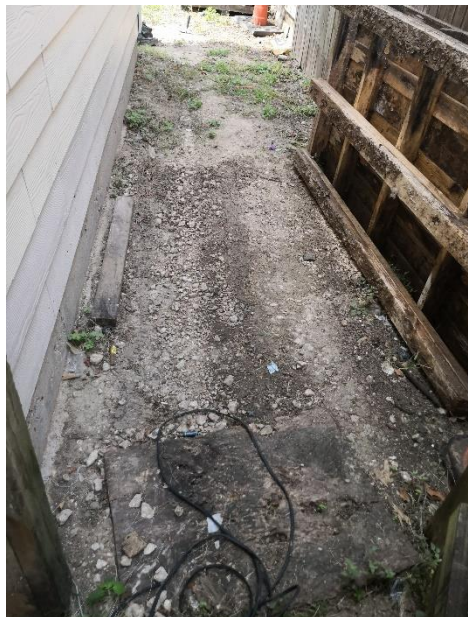
- b. The side alleyway has large bold patches due to soil erosion and improper lawn care, recommend having these areas re-graded and sodded;

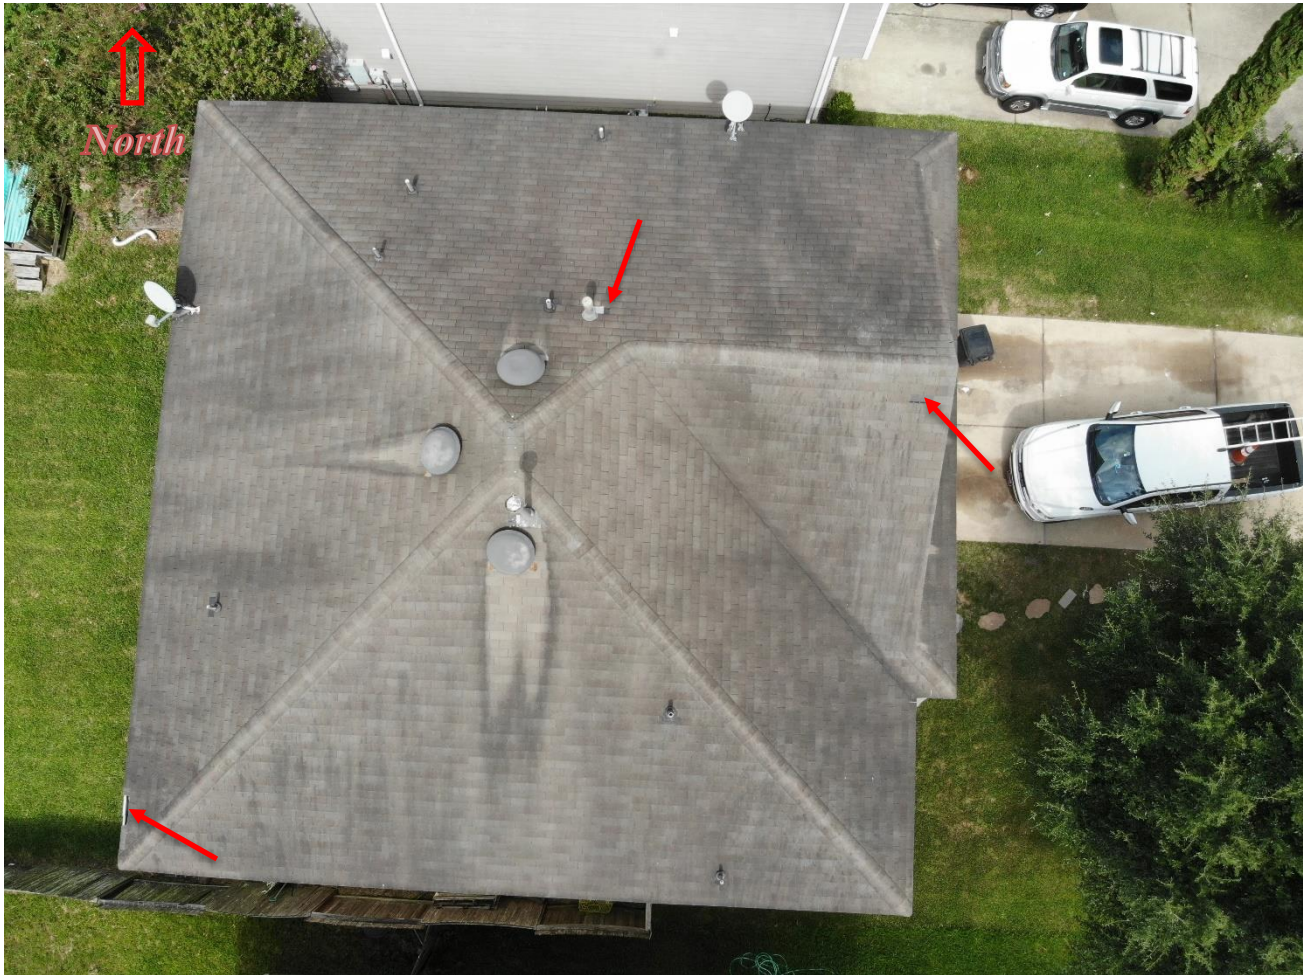
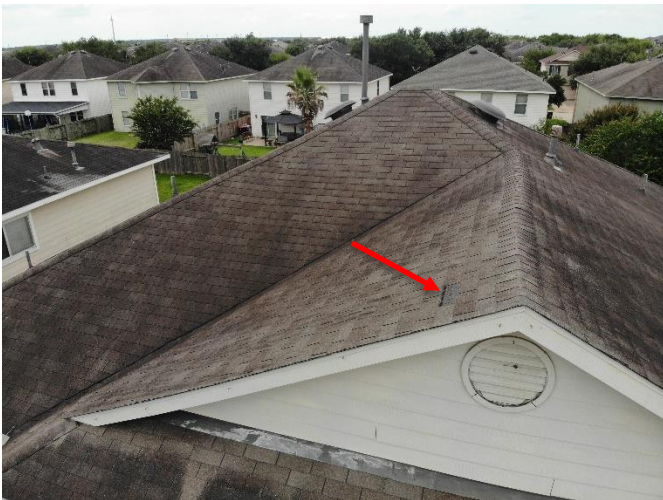
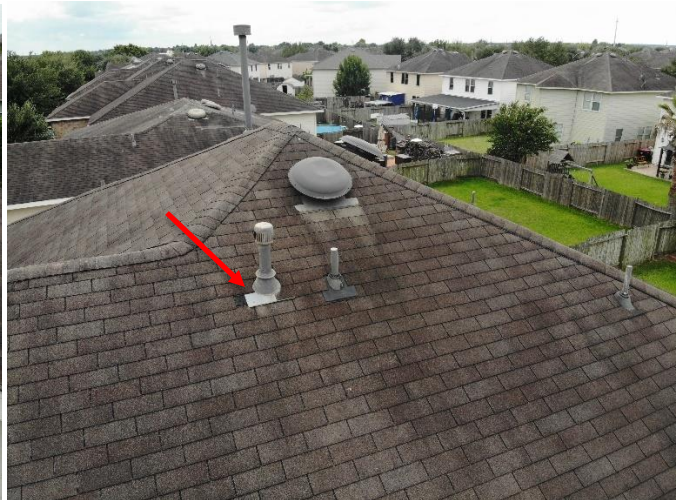
- a. *Missing shingles observed at marked locations on the roof; It is recommended that a qualified roofer be contacted to further evaluate and repair as needed; Photos are representative of the issue and may not include all locations;*

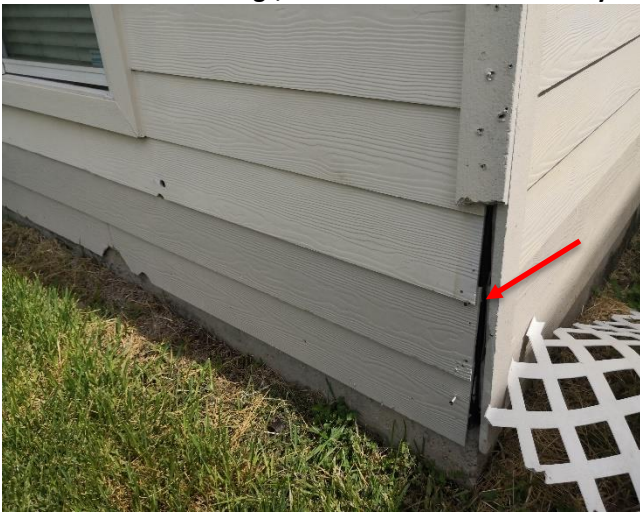
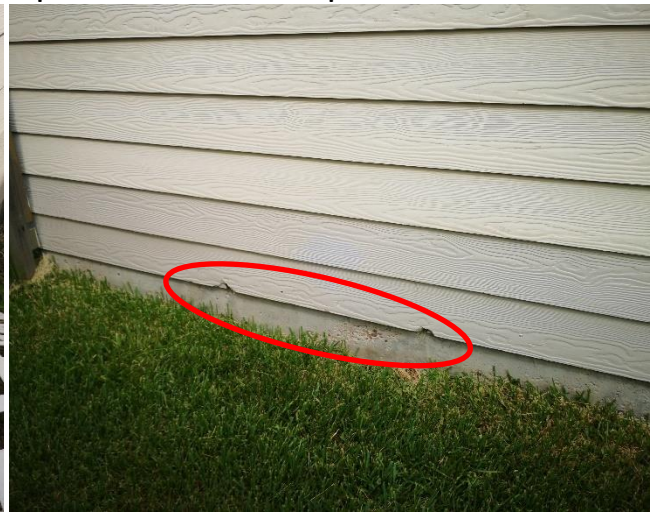
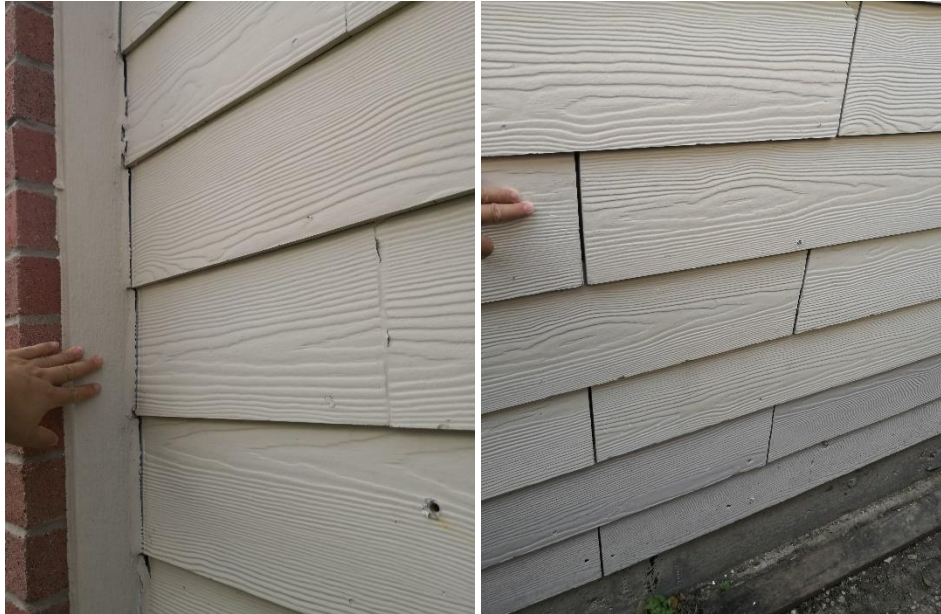
- a. *Observed damaged/cracked sidings (Hardie plank) and cracked caulking at various locations; recommend repair to prevent further deterioration;  
Photos are representative of the issue and may not include all locations;*

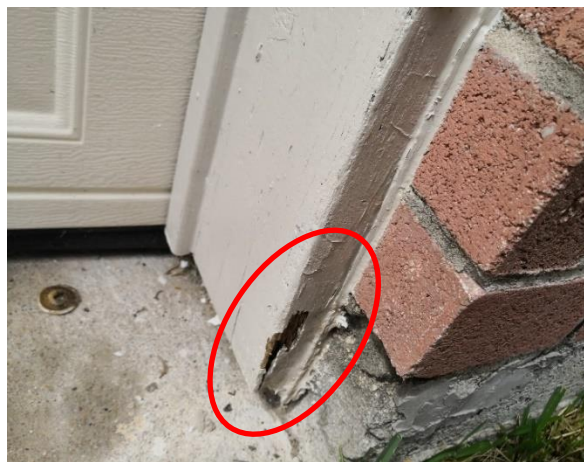
- b. *The inspector noted signs of past moisture damage, such as peeled paint and rotted wood, on garage door trims (marked) ; recommend repair to prevent further deterioration;*

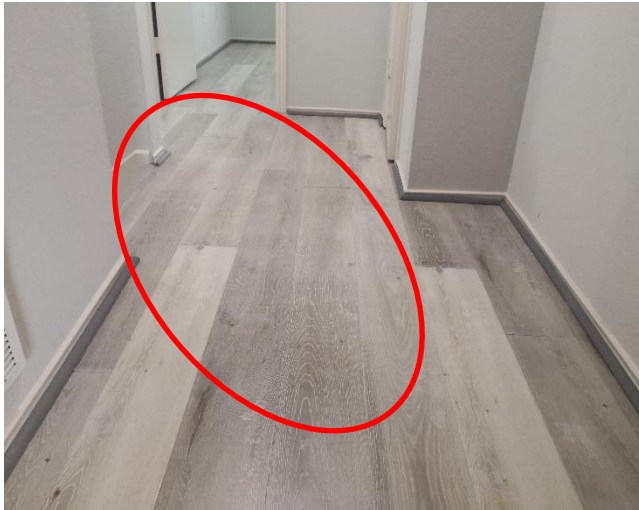
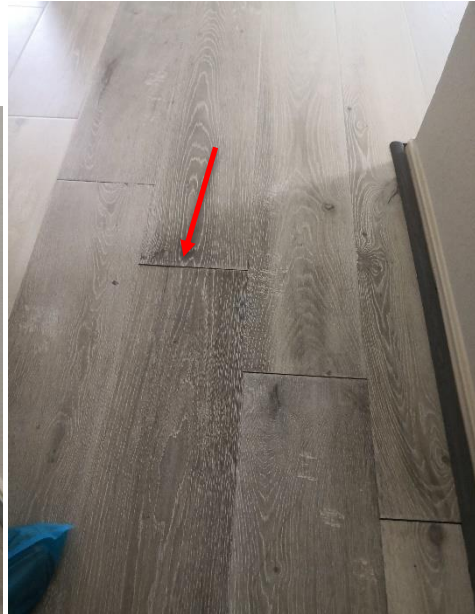
- a. Observed uneven floor at circled location (upstairs hallway); gaps noted between vinyl planks at various locations due to even floor and/or substandard installation practice; upstairs NE bedroom floor squeaks when walked upon in a normal manner; recommend further evaluation by a qualified specialist and repair if needed; Photos are representative of the issue and may not include all locations;

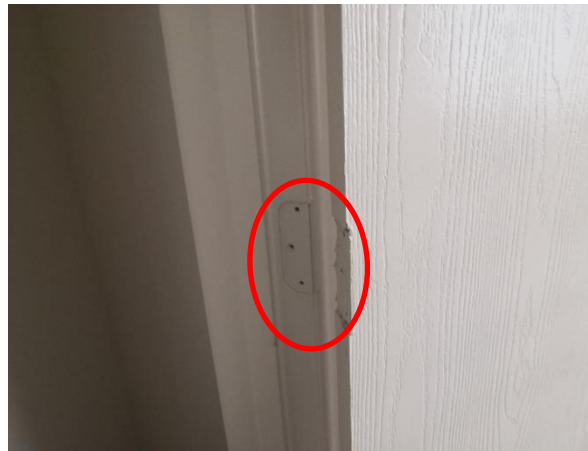
- a. The closet door (@downstairs hallway) missing a hinge; recommend repair;

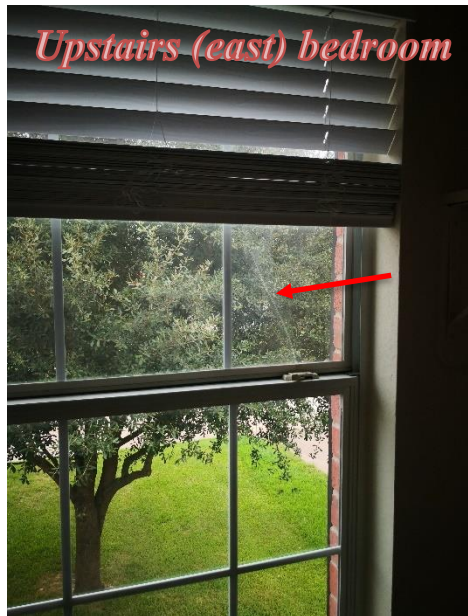
a. The inspector noted a cracked window pane (upstairs SE bedroom); recommend window replacement;

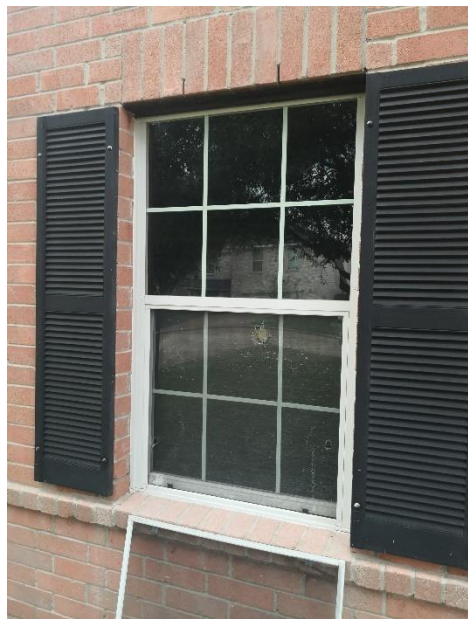
b. Certain windows (mostly in downstairs) closed by themselves when tested, this is possibly caused by loose/damaged window sash springs ; it is suggested that the client consult with a specialist for further evaluation; Also recommend installation of missing screens at all windows; Photo is representative of the issue and may not include all locations;

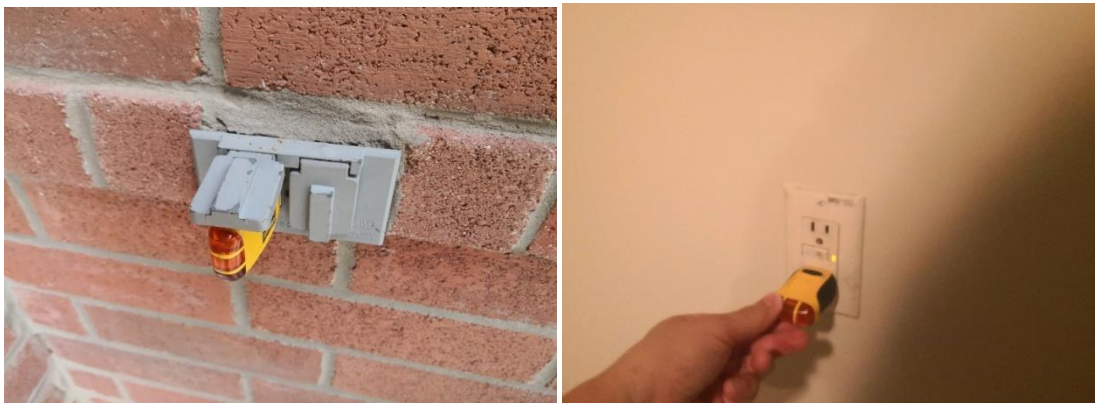
- a. *All exterior receptacles and garage wall receptacles did not have power, even after both the circuit breaker and GFCI test button were reset by the inspector; recommend further evaluation by a licensed electrician and repair as needed;*

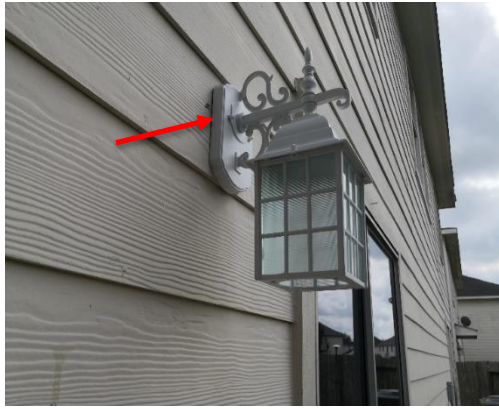
- b. *The light at the back patio was faulty at time of the inspection; suggest replacing light bulbs and verifying fixture for proper operation prior to closing;  
In addition, need sealing / caulking around all holes, openings (expansion joints, windows, door thresholds, etc.) and exterior wall penetrations to prevent water/critter entry; including but not limited to the above location ( light fixtures), electrical panel, dryer vent, bath and range top vents, wall penetration for AC suction/refrigerant lines, etc.; Photo is are representative of the issue and may not include all locations;*

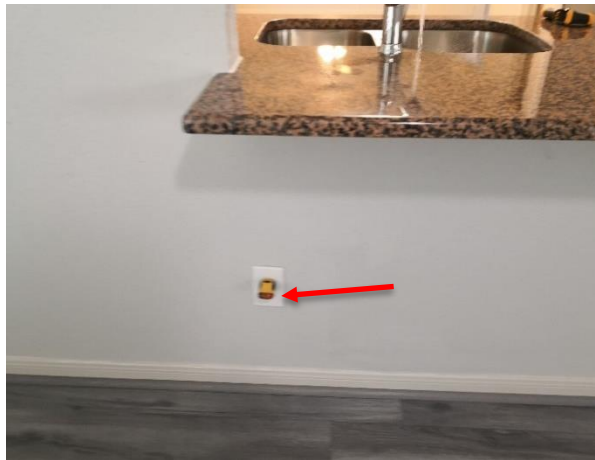
- c. *The wall receptacle behind the kitchen counter did not have power when tested; recommend further evaluation by a licensed electrician and repair as needed;*

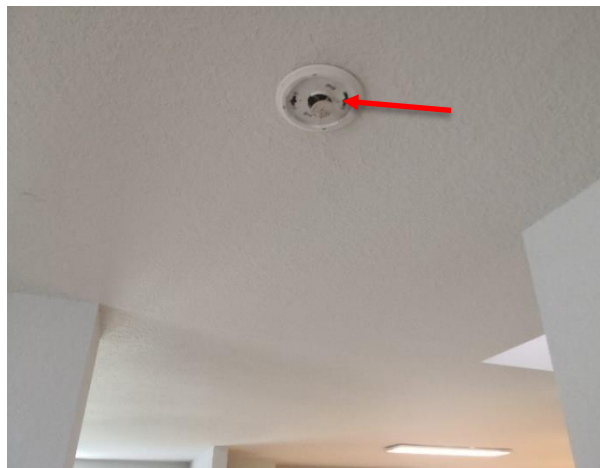
- d. *Smoke detectors were removed at various locations for unknown reason; recommend proper installation by a qualified contractor and having it tested on a regular basis based on manufacturer's recommendations;*

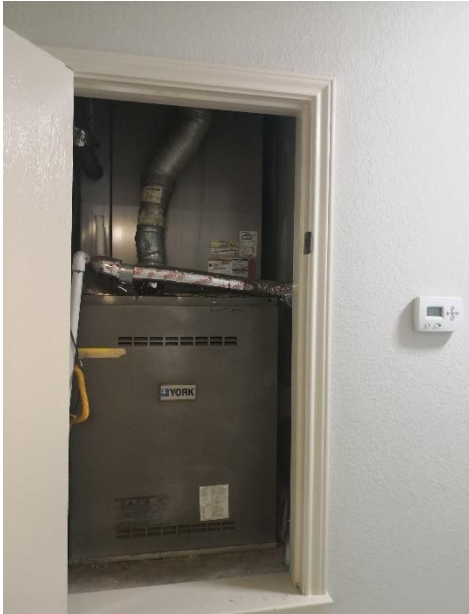
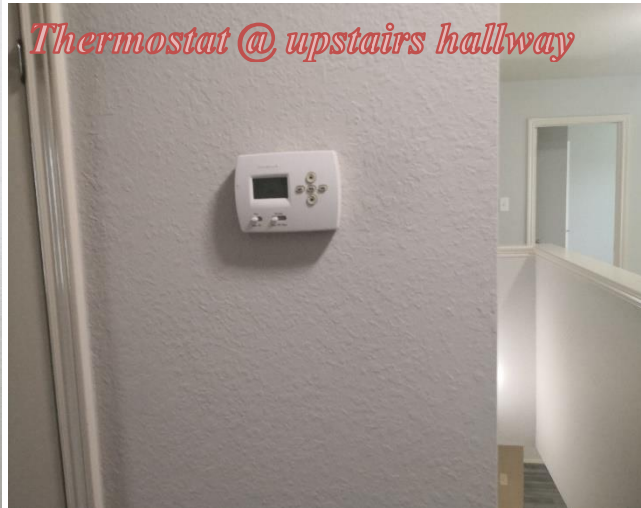
- a. The furnace and AC evaporator is improperly housed in a closet that may not allow for normal intake of combustion air and could cause carbon monoxide to enter into the home's air distribution system; the client is advised to consult with a licensed professional for further evaluation and correction options; Installation of CO monitor in this area is highly recommended for safety reason;

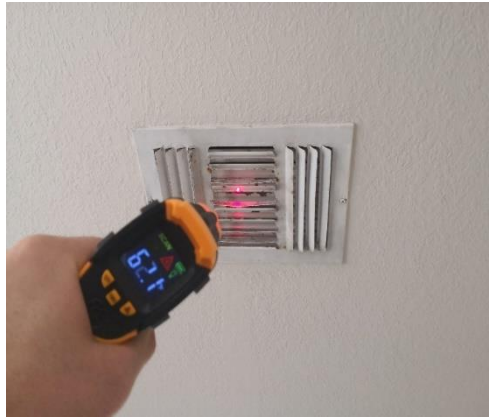
- a. *Debris built-up and sign of rust noted on almost all HVAC registers/vents; it is recommended that a licensed HVAC professional be contacted to determine if the entire duct system needs to be professionally cleaned prior to closing; Photo is representative of the issue and may not include all locations;*

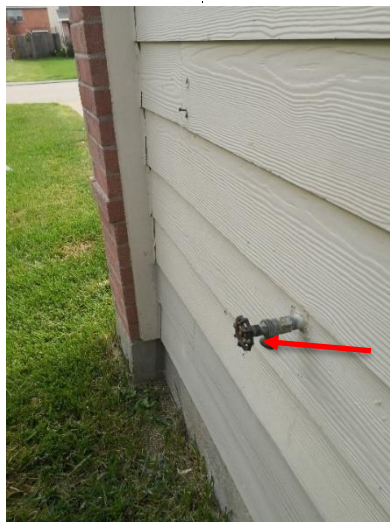
- a. *Recommend adding insulations on all exposed water pipes and adding vacuum breakers to exterior hose spigots/faucets;*

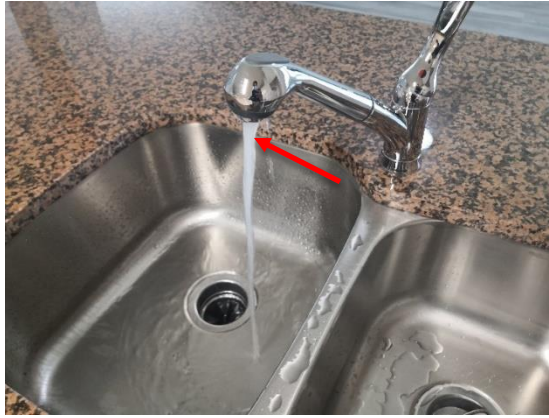
- b. The kitchen faucet did not seem to have a complete stream mode when tested; it still sprays water possibly due to a faulty diverter; it is recommended that a qualified plumber be contacted to further evaluate both spray and stream mode and repair/adjust as needed;

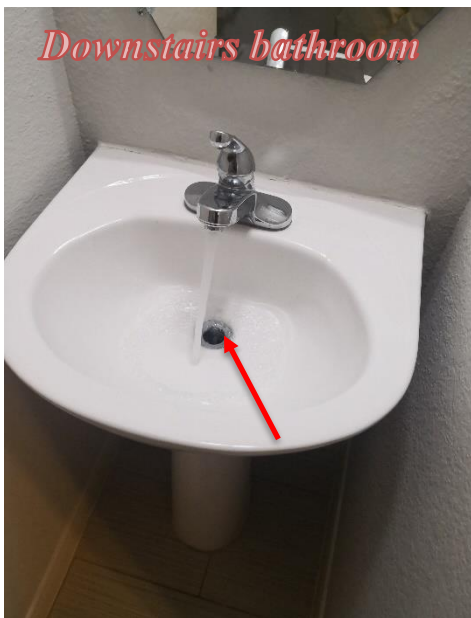
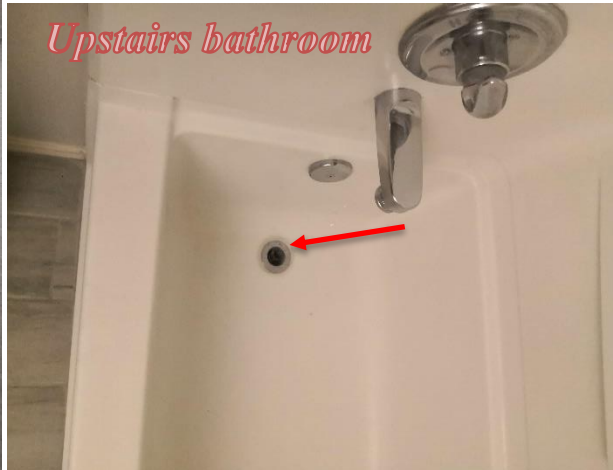
- c. The cold water line feeding the downstairs bathroom sink appears to be shut-off due to unknown reason; recommend following up with the seller prior to closing; also suggest adding missing drain stoppers at all sinks/tubs;;

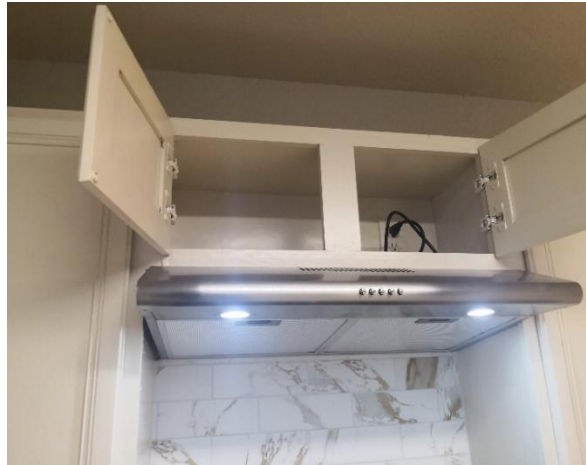
a. No external ventilation range hood present; recirculating fans that draw air through a filter and discharge it back into the room are not a good practice; recommend installation of duct system to exhaust moisture and odors associated with cooking to the outside;

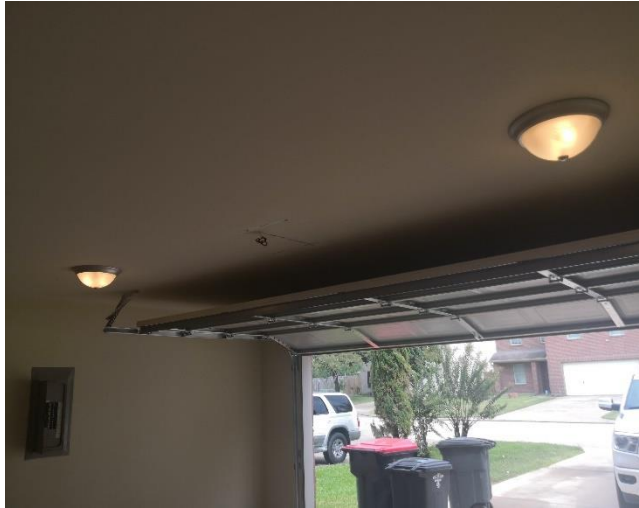
a. No automatic garage door opener present at time of the inspection;

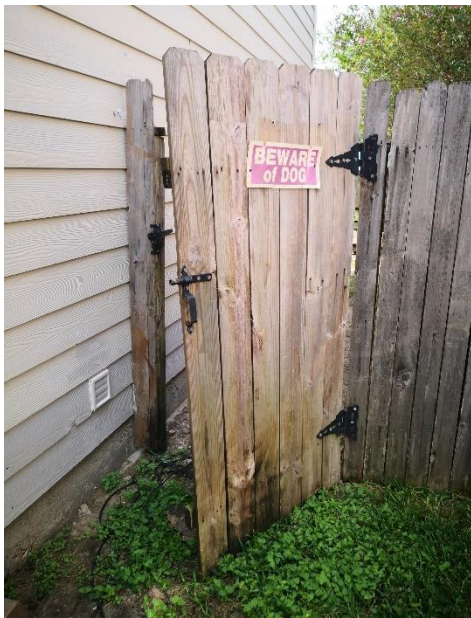
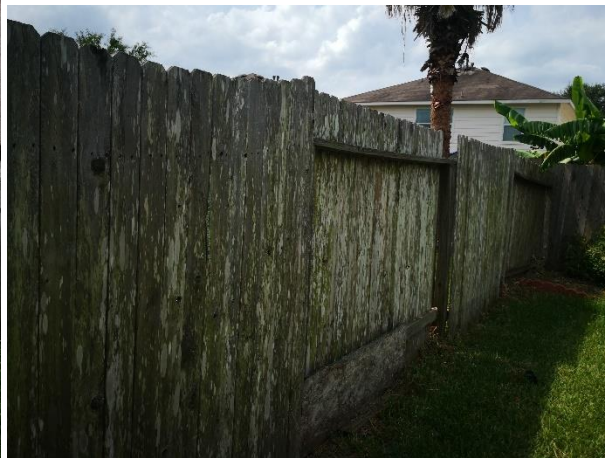
- a. Backyard fence show signs of deterioration and have leaning panels at various locations; the sagging fence gate did not swing open freely and closed when tested; recommend repair; repair/replacement is discretionary;

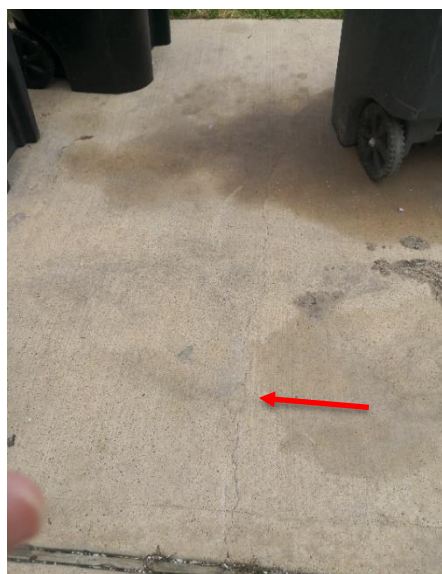
- b. Observed minor concrete cracks and uneven surface on driveway; recommend repair to prevent further deterioration;
