Texan Inspection Services

Property Inspection Report

10039 Bordley Drive, Houston, TX 77042
Inspection prepared for: Barry Oakes
Real Estate Agent: Jennifer Cramer - Dunninghill Properties

Date of Inspection: 1/23/2018 Time: 1:00 PM
Age of Home: 1963 Size: 2517
Weather: 64 Degrees and Clear
Interested Parties:

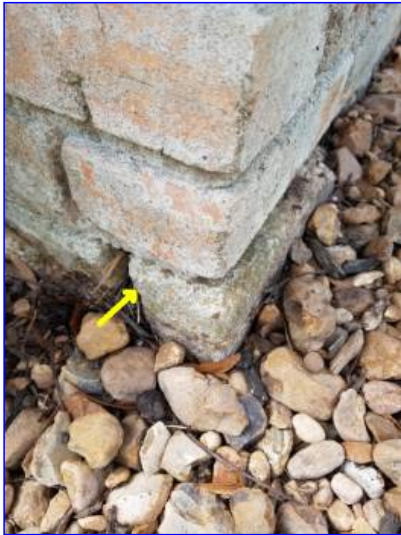
- "Corner pops" were observed on some corners of the foundation. This condition is typically cosmetic issue only as it does not affect the structural integrity of the foundation, however due to the severity, repairs are recommended. The corner pops at the rear left and front left corners of the home has actually caused a piece of the foundation to separate. The foundation also acts as a brick ledge supporting the weight of the brick veneer. Due to the damage to the foundation at the rear right corner this may effect the long term support of the brick veneer above the damaged area.

"Corner pops" were observed on some corners of the foundation. This condition is typically cosmetic issue only as it does not affect the structural integrity of the foundation, however due to the severity, repairs are recommended. The corner pops at the rear left and front left corners of the home has actually caused a piece of the foundation to separate. The foundation also acts as a brick ledge supporting the weight of the brick veneer. Due to the damage to the foundation at the rear right corner this may effect the long term support of the brick veneer above the damaged area.

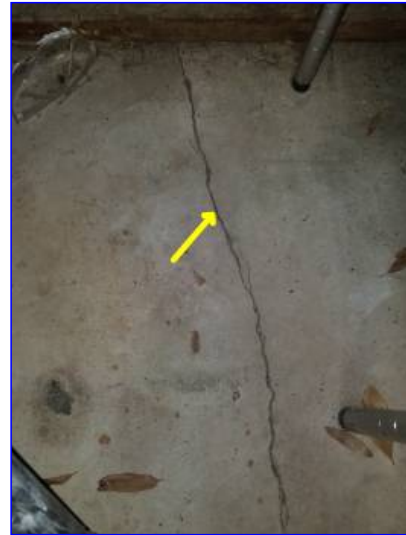
- Observed significant foundation cracks running through the garage foundation. Further investigation from a foundation specialists is recommended.

Observed significant foundation cracks running through the garage foundation. Further investigation from a foundation specialists is recommended.

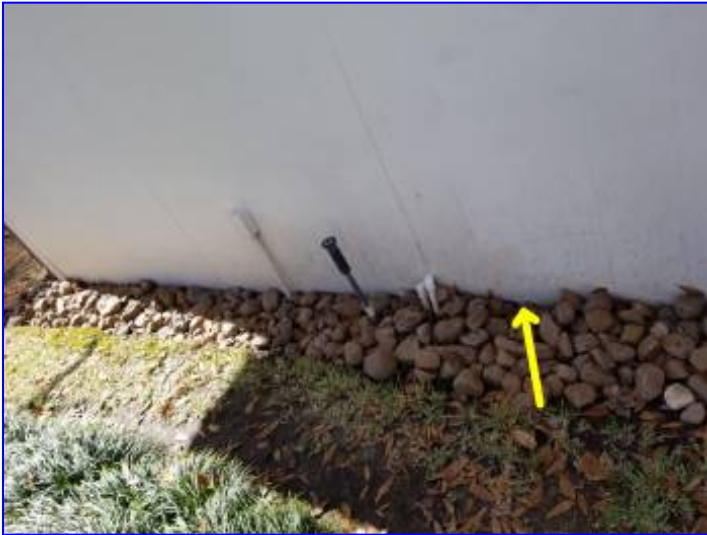
The soil around the garage is too high. Ideally, the soil should be at least 4 inches from the bottom brick and 6 inches from any wood. Inadequate clearance may result in moisture intrusion of the structure. Excessively high moisture levels can result in damage to the home structure or materials from decay or deterioration and may result in conditions which encourage the growth of microbes such as mold fungi. Excessive growth of mold fungi can produce high concentrations of mold spores in indoor air which can cause serious health problems in some people.

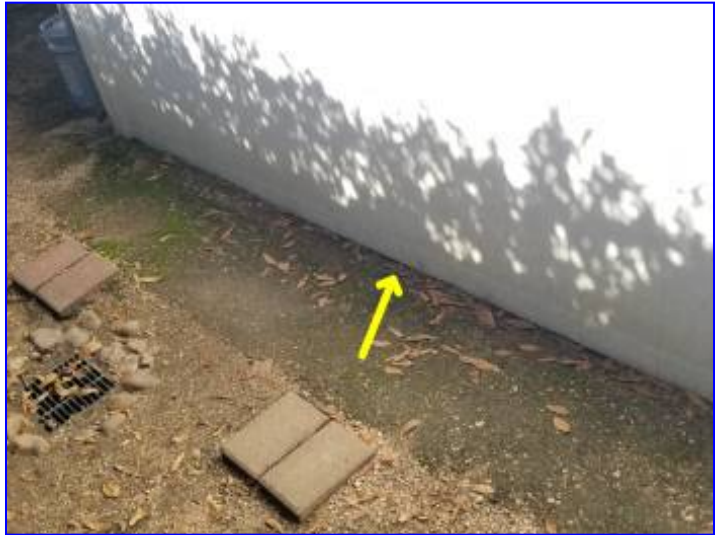
The soil around the garage is too high. Ideally, the soil should be at least 4 inches from the bottom brick and 6 inches from any wood. Inadequate clearance may result in moisture intrusion of the structure. Excessively high moisture levels can result in damage to the home structure or materials from decay or deterioration and may result in conditions which encourage the growth of microbes such as mold fungi. Excessive growth of mold fungi can produce high concentrations of mold spores in indoor air which can cause serious health problems in some people.

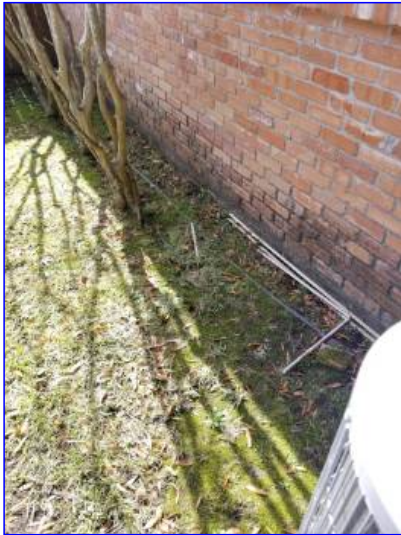
- The grading on the left side of the home should be improved to promote the flow of storm water away from the house. This can usually be accomplished by the addition or subtraction of top soil. The ground should slope away from the house at a rate of six inches of fall within the first ten feet. Ideally, at least six (6) inches of clearance should be maintained between soil level and the top of the foundation walls.

The grading on the left side of the home should be improved to promote the flow of storm water away from the house. This can usually be accomplished by the addition or subtraction of top soil. The ground should slope away from the house at a rate of six inches of fall within the first ten feet. Ideally, at least six (6) inches of clearance should be maintained between soil level and the top of the foundation walls.

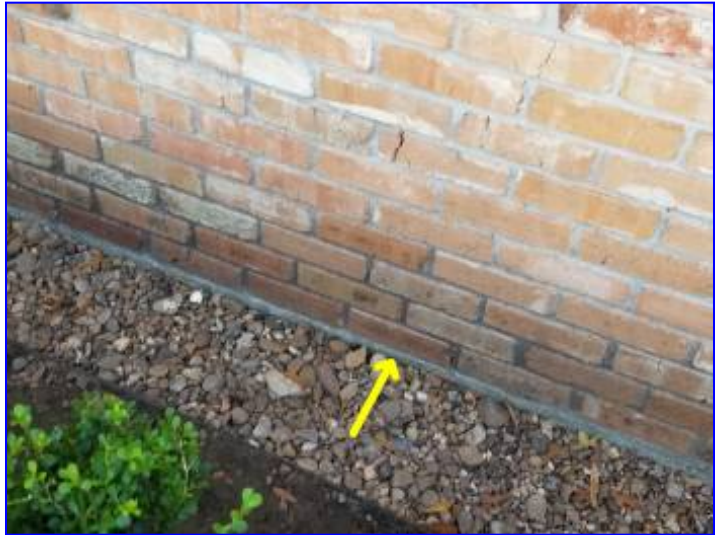
- The soil around the garage and front side of the home is too high. Ideally, the soil should be at least 4 inches from the bottom brick and 6 inches from any wood. Inadequate clearance may result in moisture intrusion of the structure. Excessively high moisture levels can result in damage to the home structure or materials from decay or deterioration and may result in conditions which encourage the growth of microbes such as mold fungi. Excessive growth of mold fungi can produce high concentrations of mold spores in indoor air which can cause serious health problems in some people.

The soil around the garage and front side of the home is too high. Ideally, the soil should be at least 4 inches from the bottom brick and 6 inches from any wood. Inadequate clearance may result in moisture intrusion of the structure. Excessively high moisture levels can result in damage to the home structure or materials from decay or deterioration and may result in conditions which encourage the growth of microbes such as mold fungi. Excessive growth of mold fungi can produce high concentrations of mold spores in indoor air which can cause serious health problems in some people.

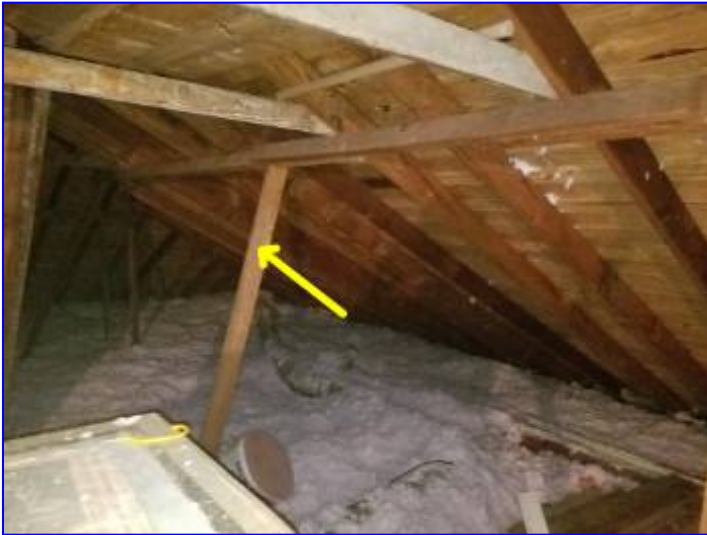
Today's building standards require purlin struts to be spaced no further than 4 feet on center. Additional supports are recommended if the roof begins to show sign of sagging.

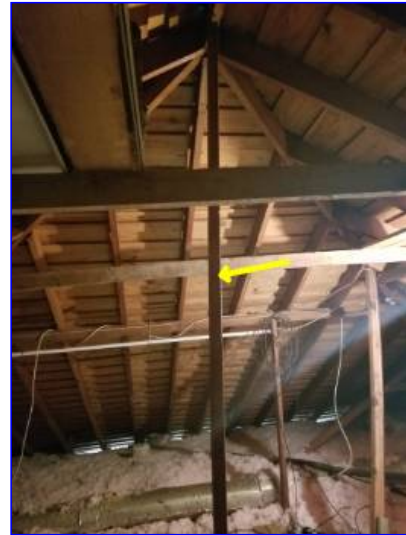
Braces that support the ridge that are longer than 8 feet long should be doubled in a Tee formation. Improvements are recommended to better support the ridge of the roof.

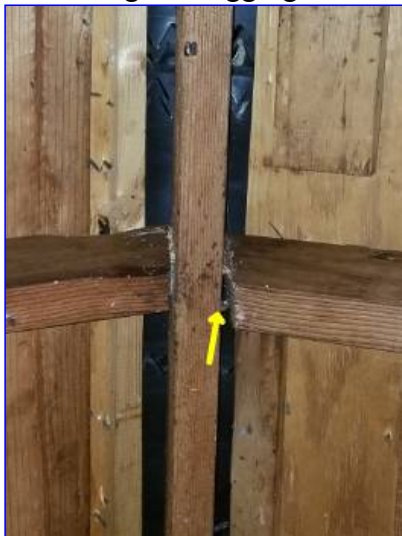
The rafters do not have adequate support at the ridge. Rafters that are cut improperly or do not fully bear should be repaired. This condition appears to be related to improper cuts during construction rather than to roof structure movement, as evident by the fact that they are scattered and not consistent.

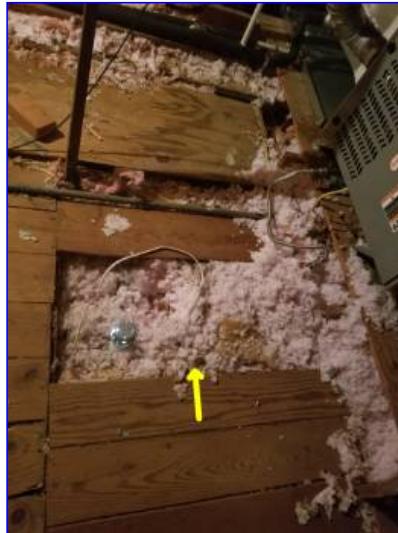
A proper workspace is not present for the furnace. Current standards require 30" minimum from face of unit. Recommend adding decking for improved safety.

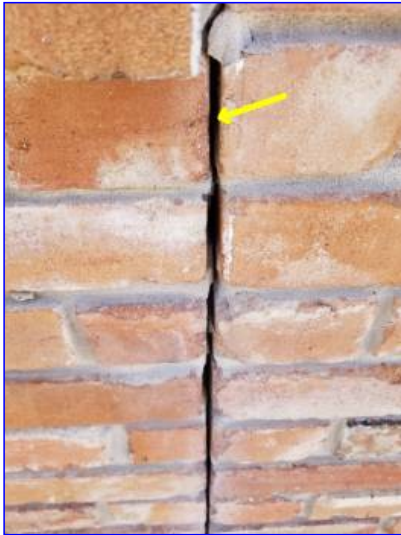
Recommend sealing the expansion joints. Expansion joints are designed to allow movement in the house without the brick veneer cracking. The joints should be sealed with a flexible caulk and continued movement along this joint is normal.

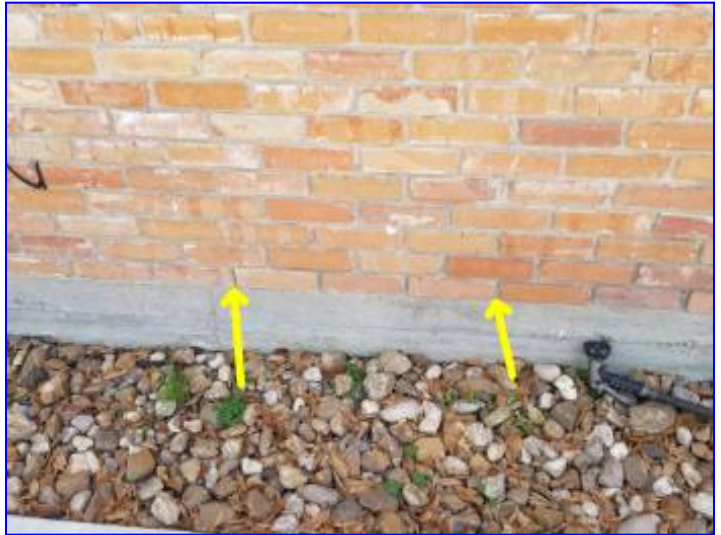
Weep holes (openings in the mortar joints) are recommended above the foundation wall of the brick veneer. Weep holes allow moisture that penetrates the brick a place to drain and allows the wall to breath. Weep holes should be installed a minimum of 33 inches on center.

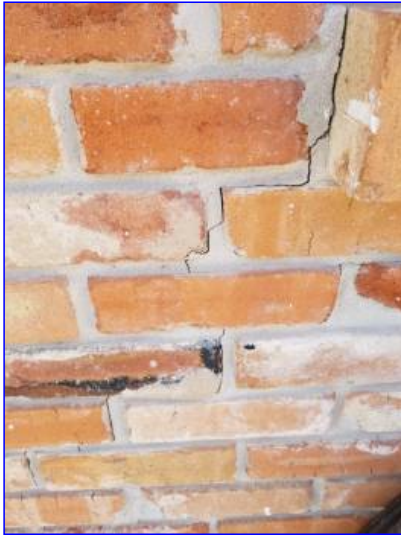
Typical minor cracking was observed on the exterior walls of the house. This implies that some structural movement of the building has occurred, as is typical of most houses.

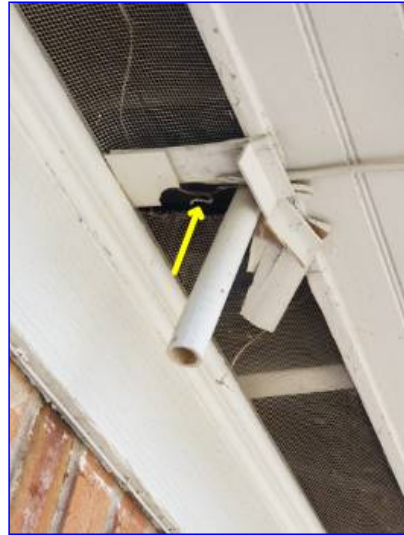
Observed a hole in the soffit screen on the left side of the home. Repairs are recommended.

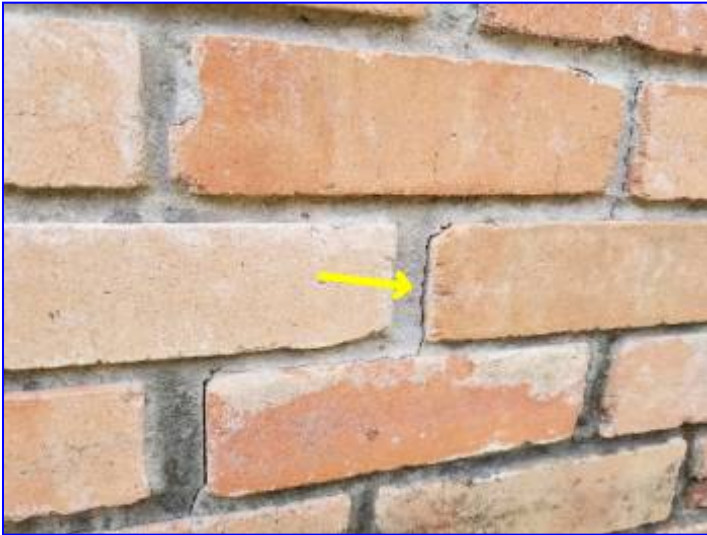
Typical minor cracking was observed on the exterior walls of the house. This implies that some structural movement of the building has occurred, as is typical of most houses.

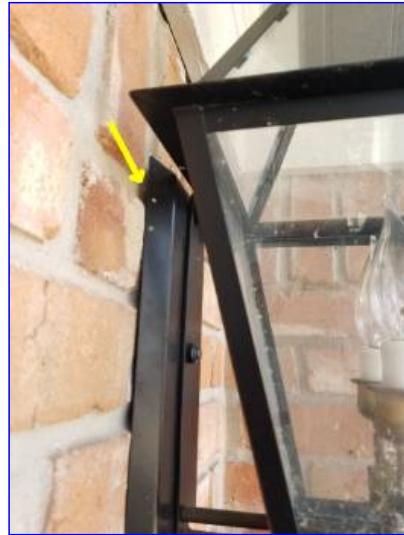
All exterior wall penetrations should be sealed. Failure to keep all penetrations properly sealed may lead to water intrusion to interior walls. This is a common maintenance item and all penetrations should be checked periodically.

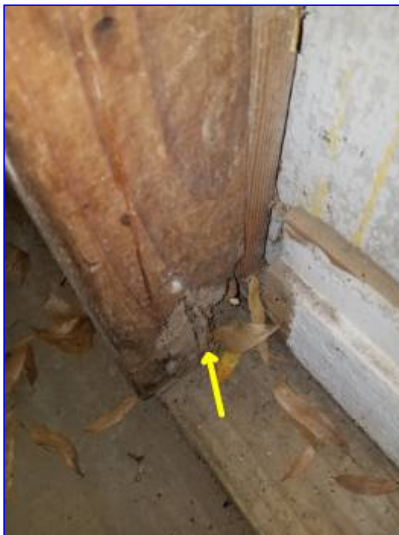
Observed evidence of wood destroying insects in the garage. Several wall studs are severely damaged. Further investigation by a wood destroying specialist is recommended. Repairs to the damaged wall studs are recommended.

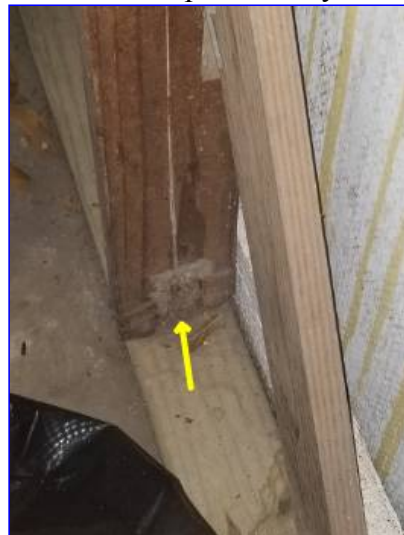
Observed evidence of wood destroying insects in the garage. Several wall studs are severely damaged. Further investigation by a wood destroying specialist is recommended. Repairs to the damaged wall studs are recommended.

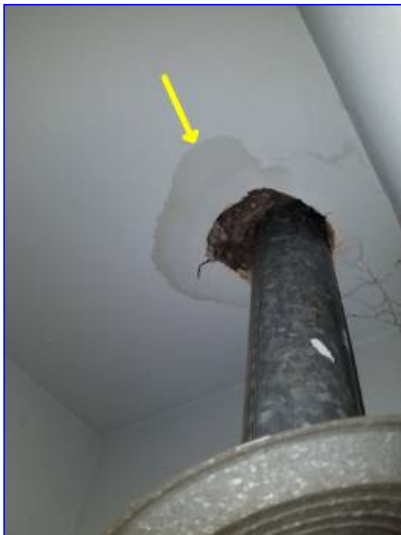
Water staining was observed in the laundry room ceiling, around the water heater flue. The stained area was dry at the time of inspection. The cause for the staining should be determined and repairs undertaken, if necessary, to prevent damage

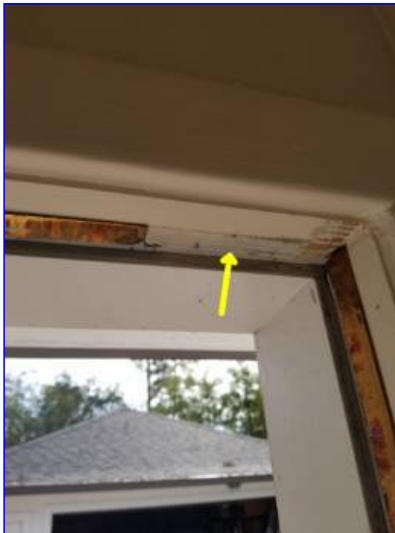
Weather stripping improvements are recommended on the rear egress door.

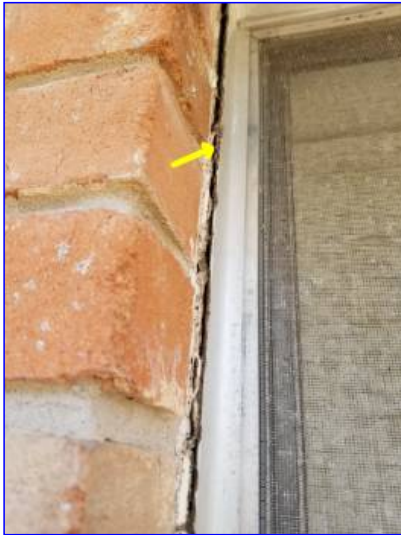
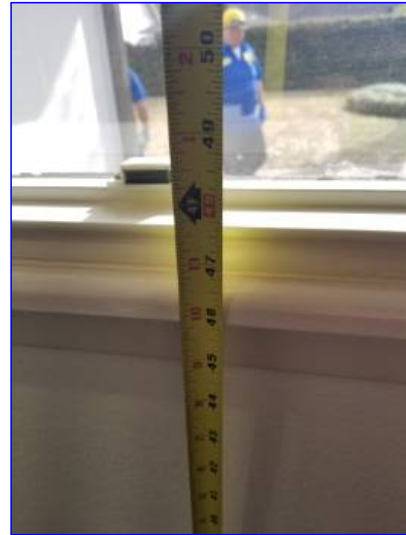
At the time of the inspection, the window exteriors were dependant upon sealant to help prevent moisture intrusion of the wall assembly. Some separation and/or cracking of the installed sealant was visible at the time of the inspection. Areas around exterior window openings should be examined annually and an appropriate sealant reapplied as necessary.

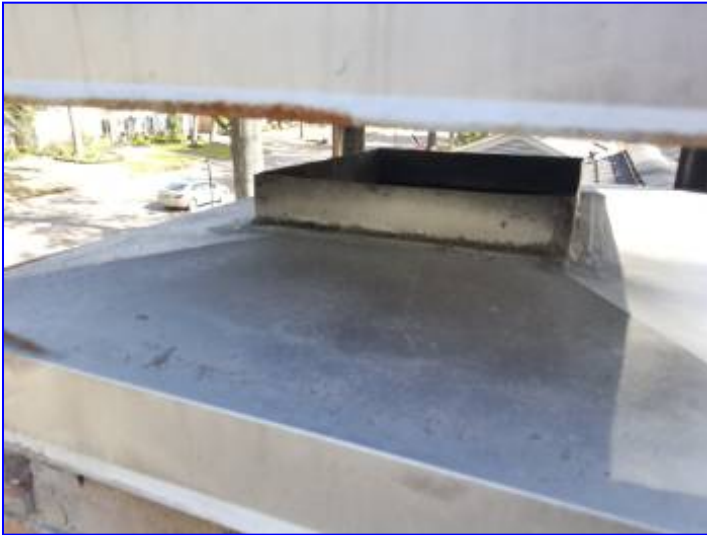
It is recommended that the chimney cap be screened to keep critters out.

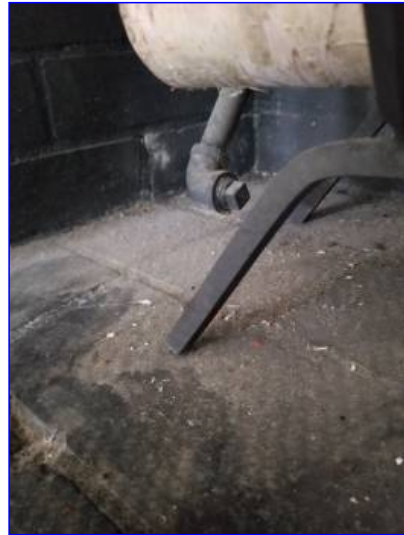
The gas log lighter has been capped off.

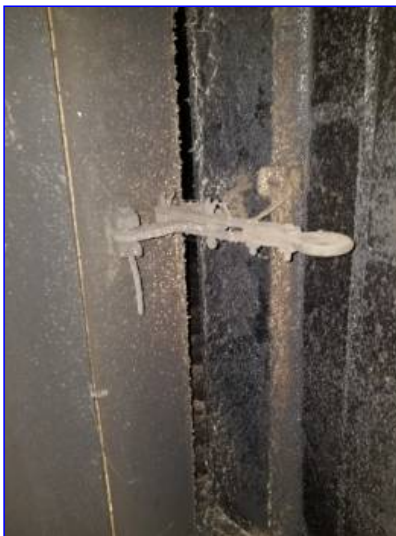
Creosote build-up was noted in the fireplace flue and/or firebox. Cleaning of these areas should be undertaken for improved safety.

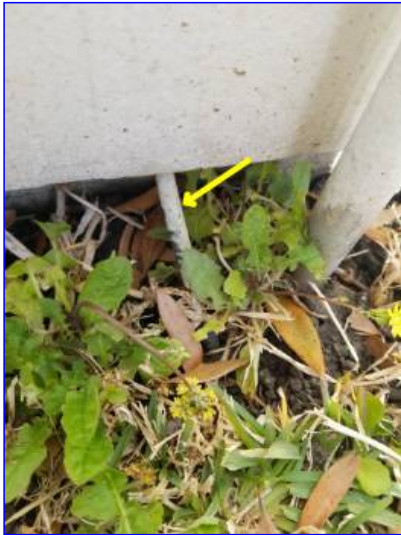
The main electrical service grounding electrode was not visible at the time of the inspection. A grounding electrode conductor was visible exiting the main panel and entering soil, but the inspector was unable to confirm its proper termination or proper grounding of the electrical service. Although this is a common condition, you may wish to have proper grounding conditions confirmed by a qualified electrical contractor for safety reasons.

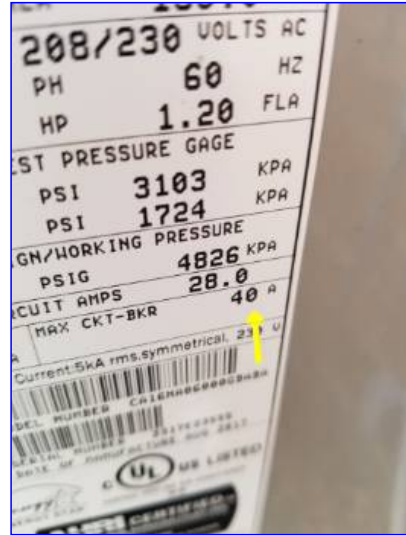
The breaker serving the A/C is over sized (50 Amp) the manufacture rates a maximum breaker size of 40 Amps, this breaker should be replaced for increased safety.

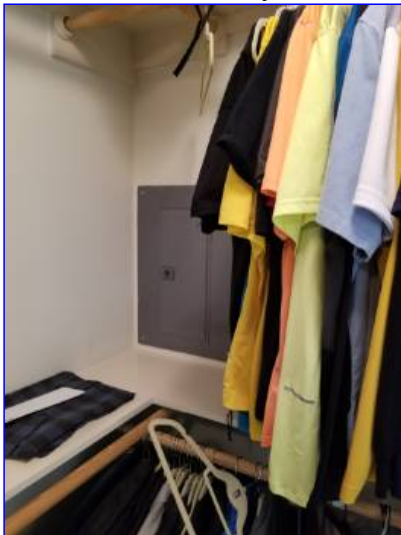
Electrical panels should not be located in clothes closet to today's standards, it is important to note that the electrical panel should not be covered or obstructed and should not have clothes or any other material contacting it. Ideally the panel should be relocated, but it is usually not practical.

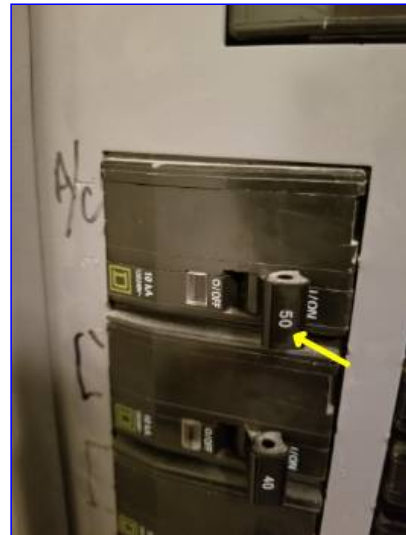
The breaker serving the A/C is over sized (50 Amp) the manufacture rates a maximum breaker size of 40 Amps, this breaker should be replaced for increased safety.

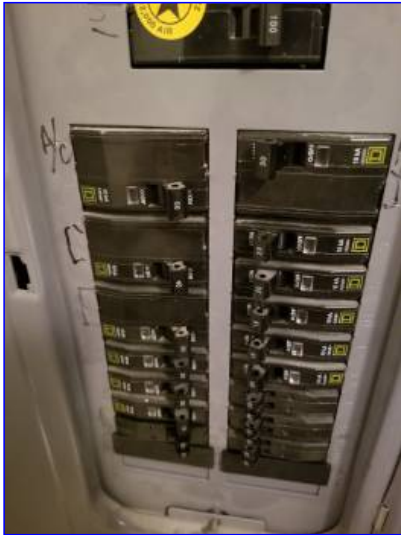
Current standards call for arc fault protection on outlets in living areas. No arc fault protection is supplied. Recommend updating to these standards.

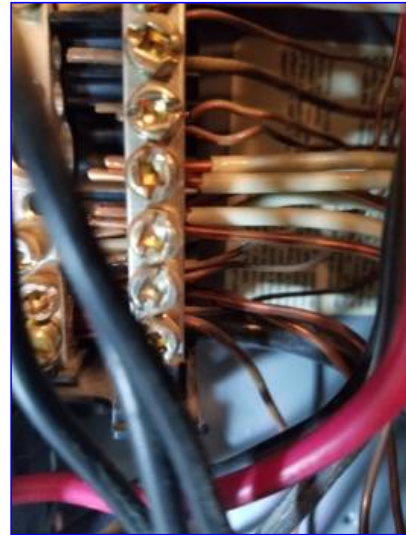
Observed multiple grounded (white) conductors terminated beneath a single lug on the neutral busbar. The conductor terminations were only rated for the termination of one conductor per lug. This causes an issue with the continuity of the homes electrical system when an attempt to isolate a single circuit is desired.

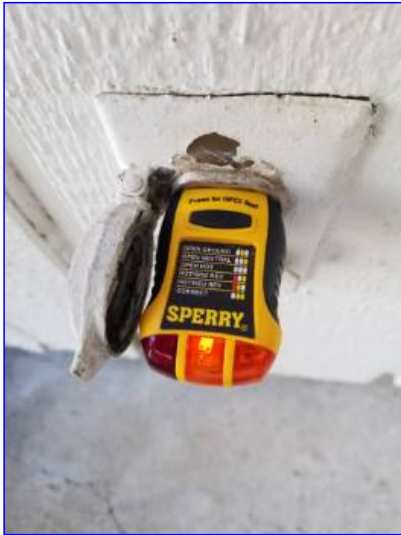
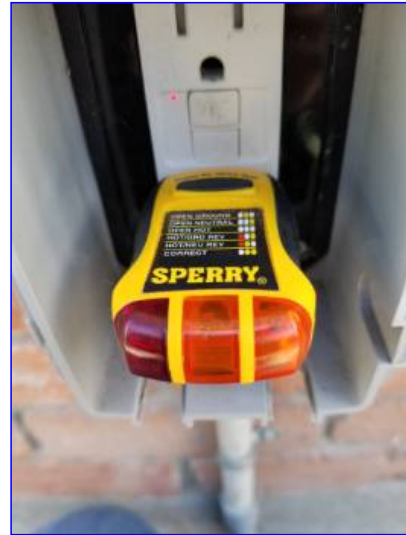
Although the 3-prong outlets installed in this home typically indicate a home with grounded branch wiring, many outlets in this home and several exterior outlets had no grounding system installed to protect devices such as switches, light fixtures and electrical outlets.

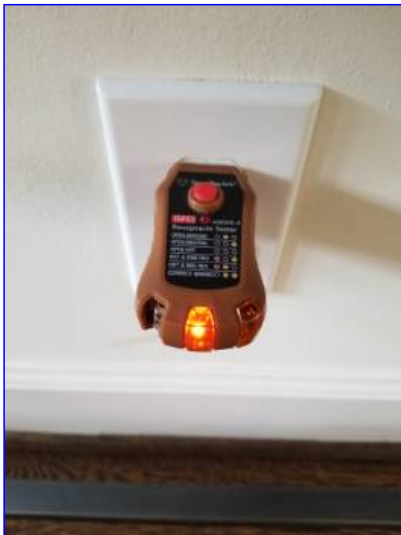
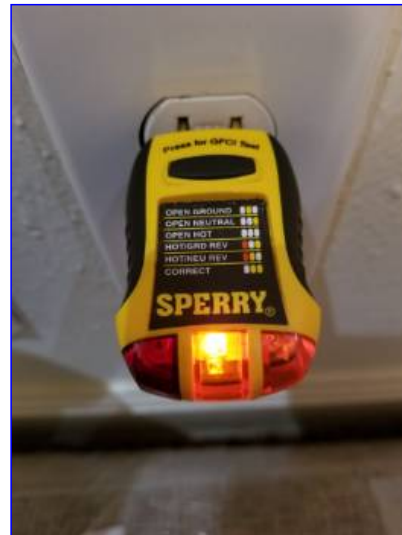
Although the 3-prong outlets installed in this home typically indicate a home with grounded branch wiring, many outlets in this home and several exterior outlets had no grounding system installed to protect devices such as switches, light fixtures and electrical outlets.

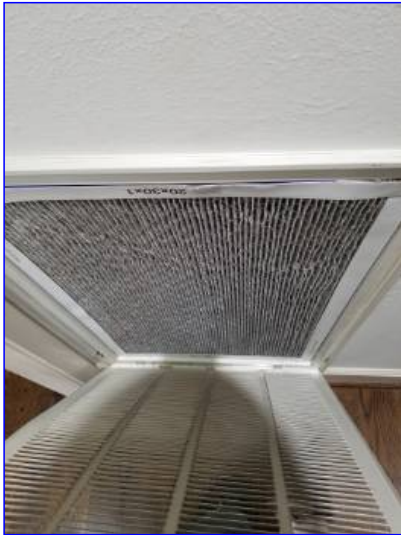
Recommend replacing all HVAC filters. When air filters are not changed frequently enough, they get clogged with any number of airborne pollutants and allergens. This makes the HVAC system's job much more difficult, so it works harder and longer to do the job it's been tasked to do.

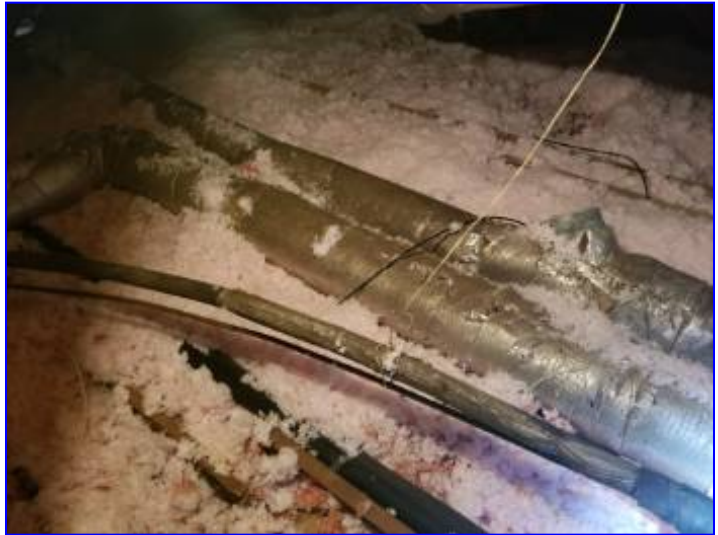
Today's building standards call for the ductwork to be suspended from attic ceiling.

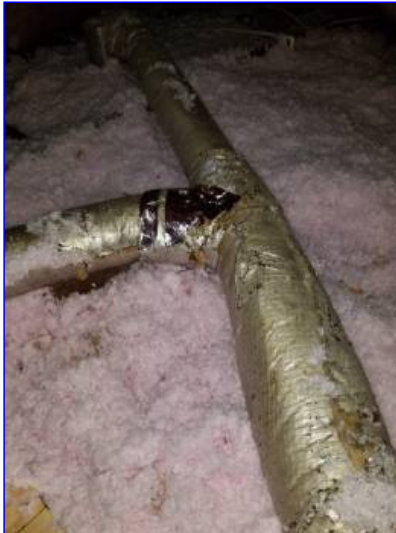
Observed damaged/deteriorated duct insulation. Repairs are recommended.

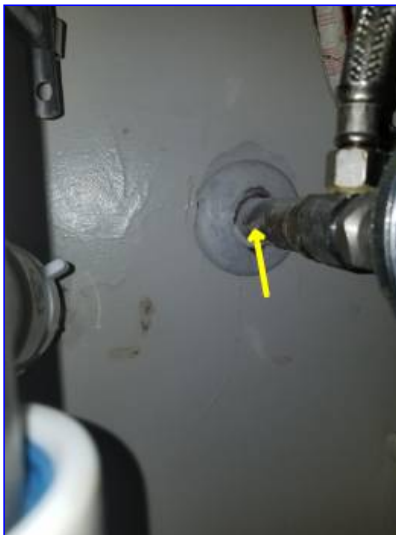
The older steel piping found in some locations of the home is subject to corrosion on the interior of the pipe. As corrosion builds up, the inside diameter of the pipe becomes constricted, resulting in a loss of water pressure.

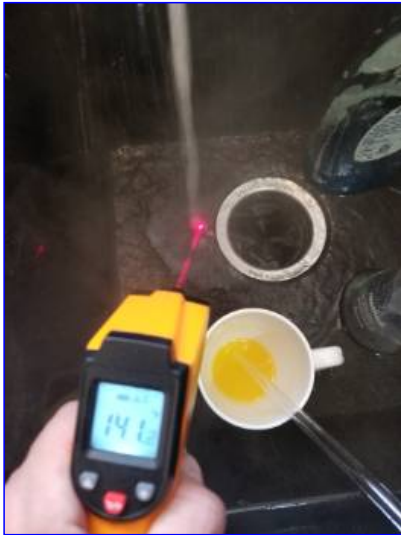
The water temperature was measured at 141 degrees which is not within acceptable limits to prevent the potential for scalding of 120 degrees. Adjustments to the setting is recommended.

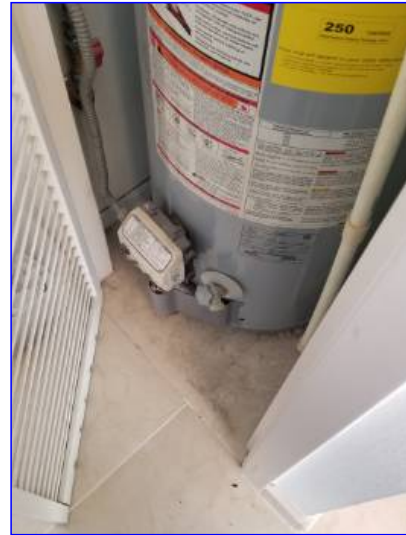
No safety pan and drain was found for the water heater. This should be repaired by the installation of a pan with a drain by a qualified professional

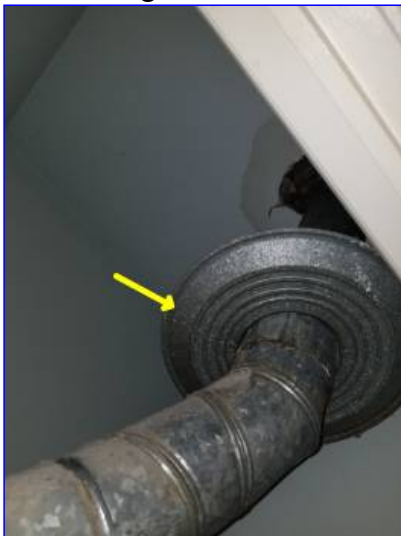
The fire stop at the ceiling should be re-secured to the ceiling.

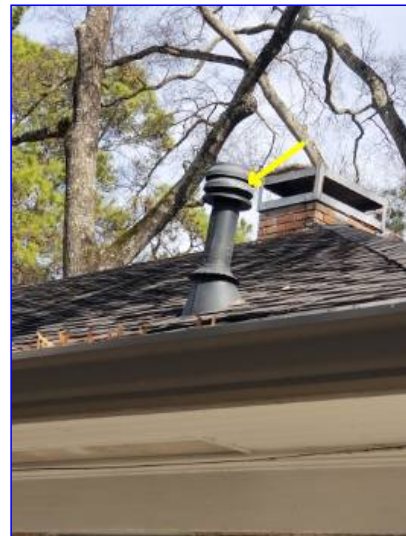
Today's standards call for the water heater flue to penetrate the roof 2 feet higher than any portion of the roof within 10 feet or a minimum of 3 feet. Recommend updating for improved safety.

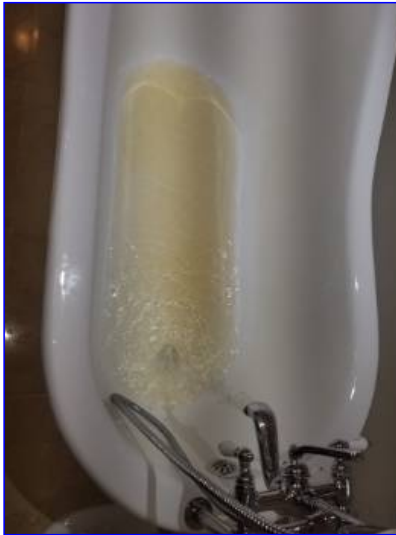
Rust colored water was observed. This is typically caused from sediment in the tank. The tank may need to be flushed, or the sacrificial anode rod in the tank may be bad. Further investigation and repairs are recommended as necessary.

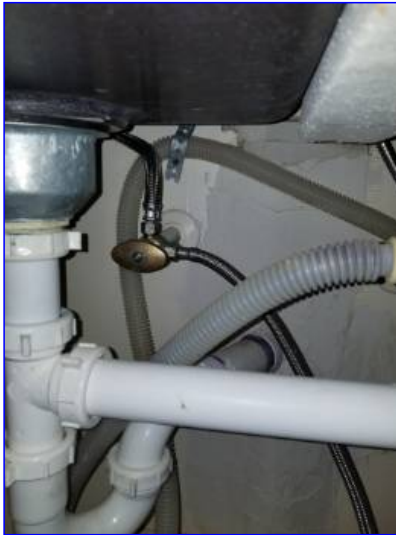
The hose leading from the dishwasher to the food disposer should be attached to the underside of the counter top to create a "trap" called a "High-loop". This helps prevent dirty water from the disposer from flowing back into the dishwasher. Recommend adding an air gap.

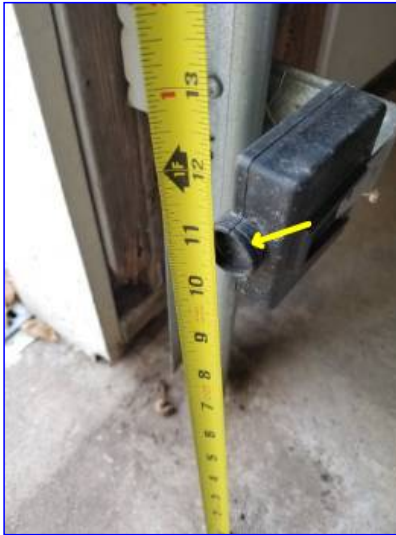
The garage door photoelectric sensors at the bottom of the garage door should not be higher than 6 inches from the ground, the sensors are currently installed 11 inches off of the ground. The photo eye of an automatic-opening garage door is a safety feature. If the photo eye senses an obstruction, it stops the door from closing and potentially prevents damage or injury to a vehicle, person or pet in the path of the door. Repairs are recommended.
