HEDDERMAN ENGINEERING, INC.

April 10, 2019

REF: CONDITION OF PROPERTY SURVEY

At your request, a visual survey of the house located at 12710 Old Oaks Drive, Houston, Texas, was made by Mr. Pedro Salazar and Mr. David Koteles.

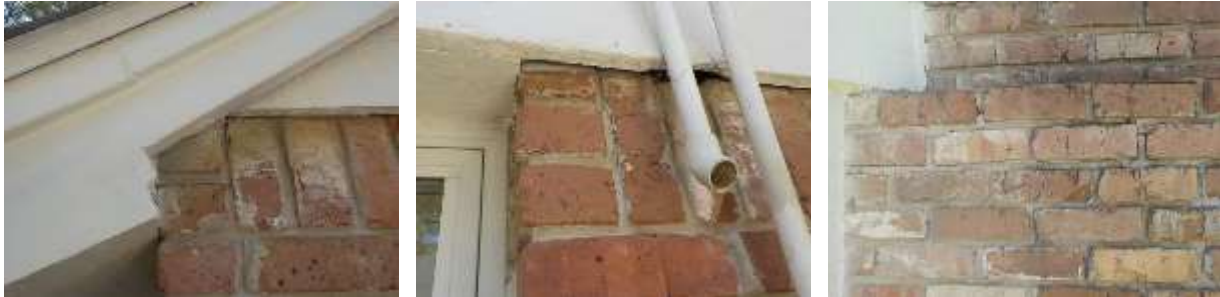
Cracks in the exterior veneer were minimal in number and degree.

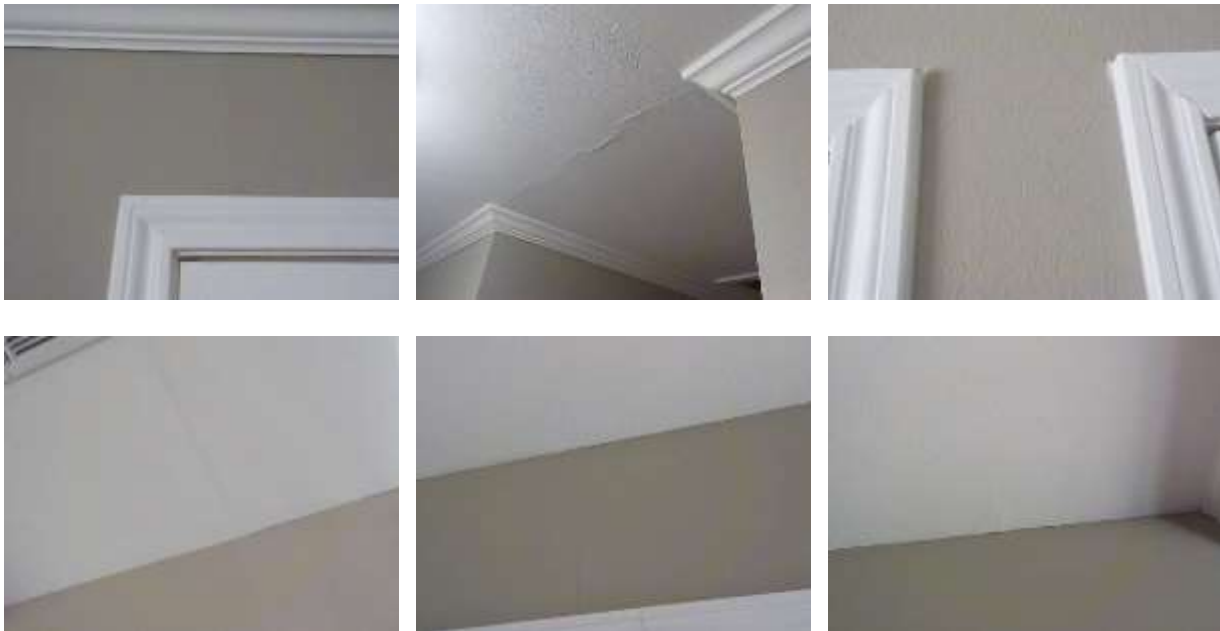
Sheetrock cracks, patches, and/or compression ridges were observed, including at the master bedroom, hallway, southeast bedroom, and family room.

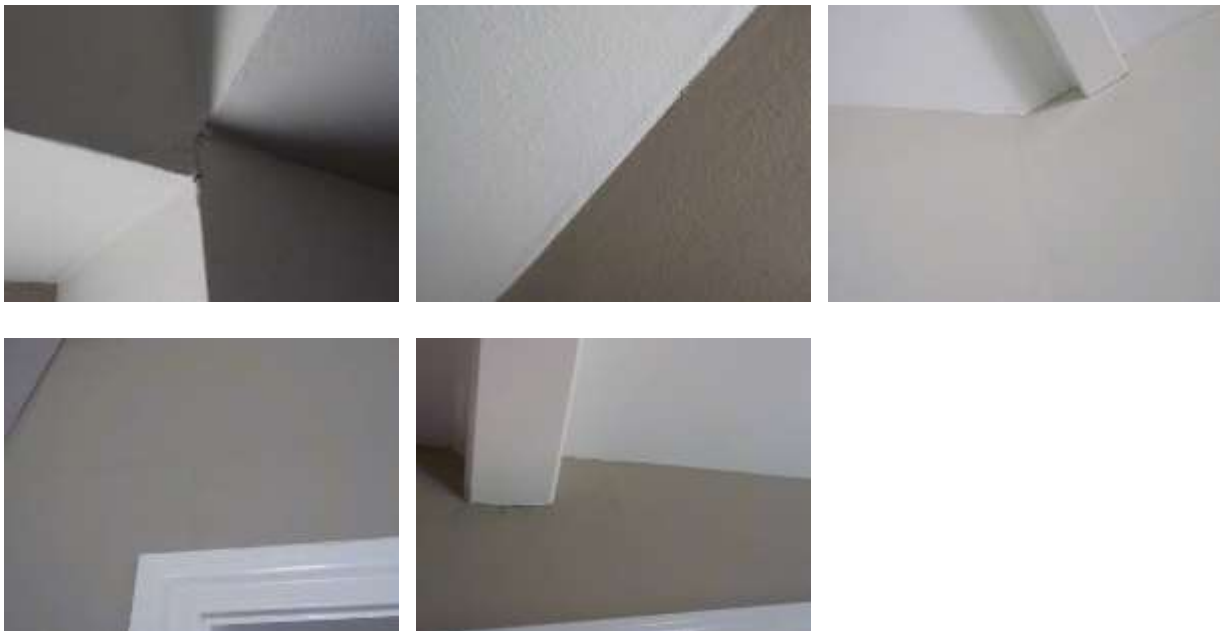
Wrinkled sheetrock tape was observed, including at the southeast bedroom, and family room.

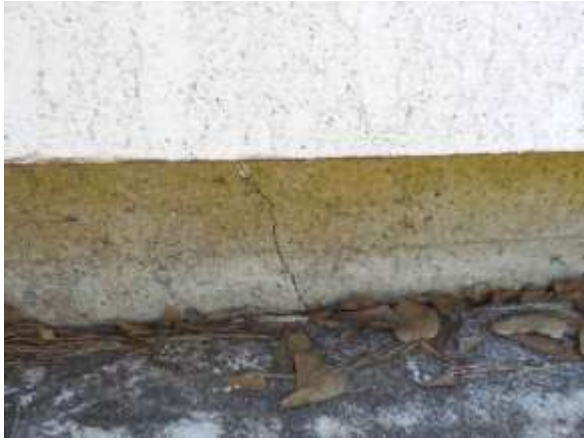
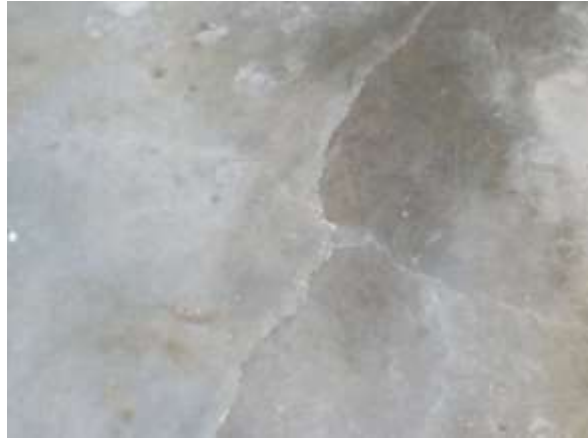
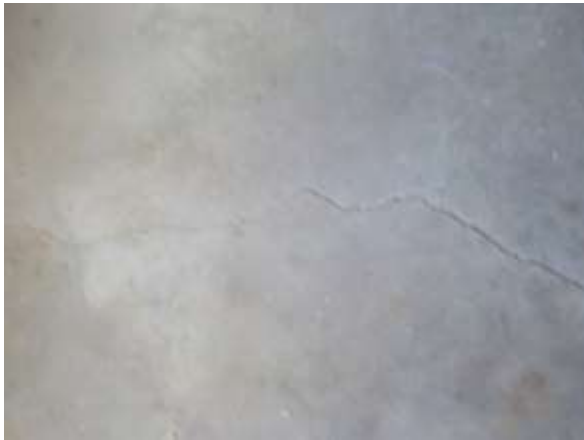
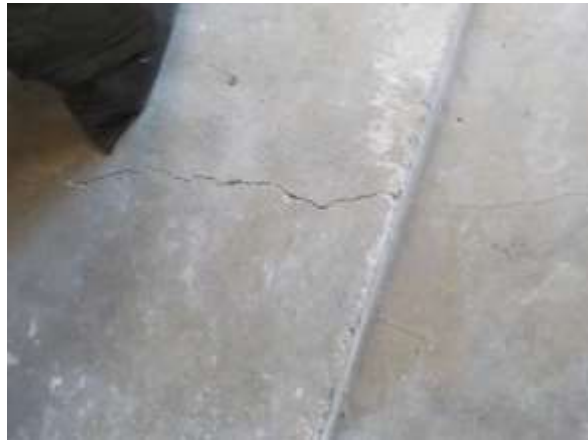
Cracking of the foundation concrete exists in virtually all foundations. It is pointed out that cracking is a normal property of concrete and other brittle materials, and Hedderman Engineering, Inc. assumes no responsibility should cracks be found that are not mentioned in this report. Some cracking was observed in this concrete foundation, including at the east side of the garage, and garage floor.

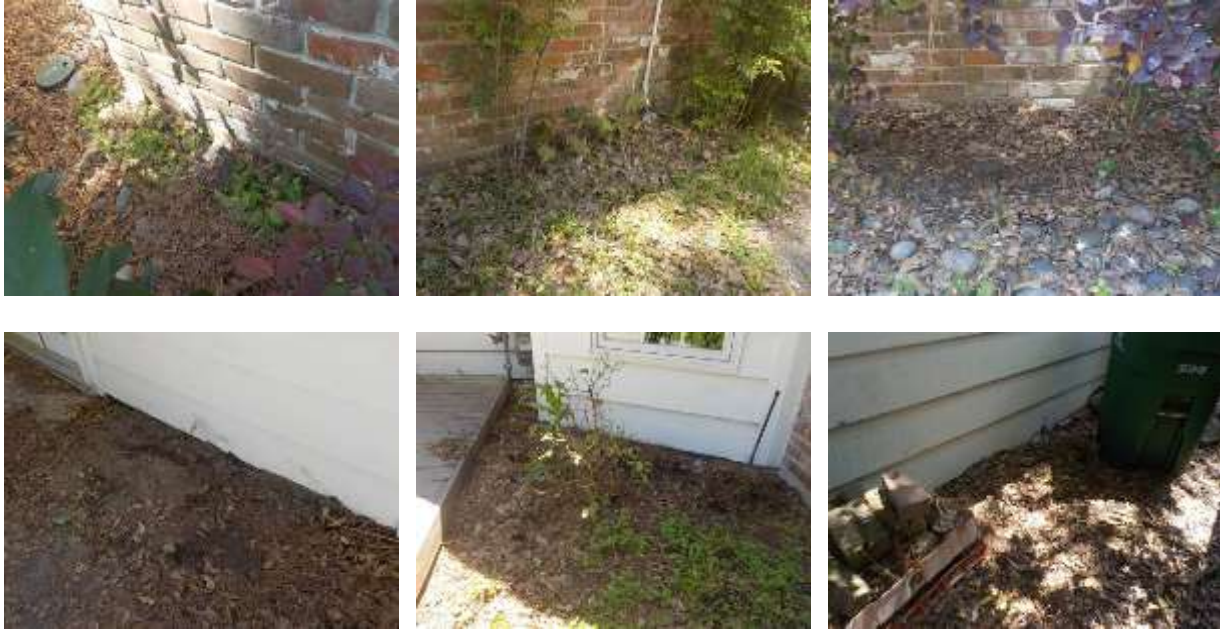
It is pointed out that a portion of the foundation concrete could not be viewed due to soil that was graded near or above the top of the foundation and/or heavy foliage growing against the house. The soil and/or foliage should be removed, and 3-4 inches of foundation concrete exposed.

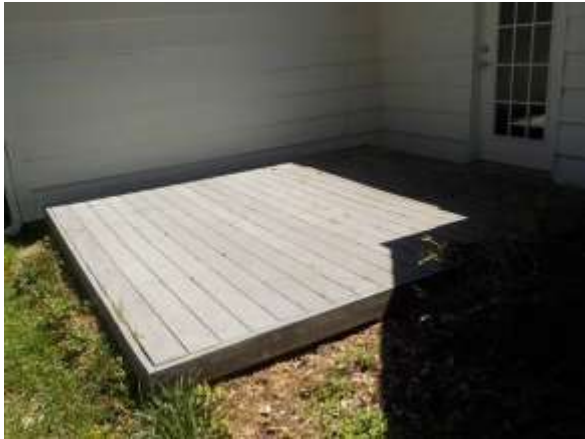
It is pointed out that a portion of the foundation concrete could not be viewed at the rear of the house due to the wood deck that adjoined the foundation.

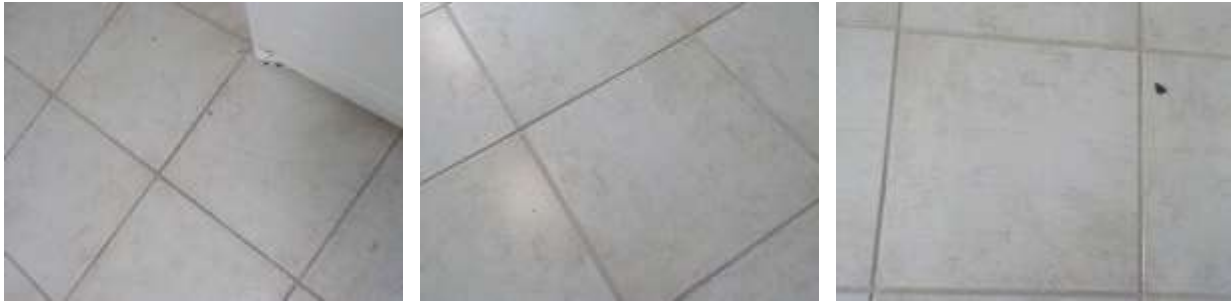
- * Some separations and differential movement of materials due to differential foundation movement were observed, including the following:
 - Doors that were sticking were observed at the hallway bathroom, southwest bedroom closet, and entry door.
 - Doors that would not latch due to misalignment of the striker plate and the locking mechanism were observed at the master bedroom.

- The floor tile was cracked at the kitchen and breakfast room.

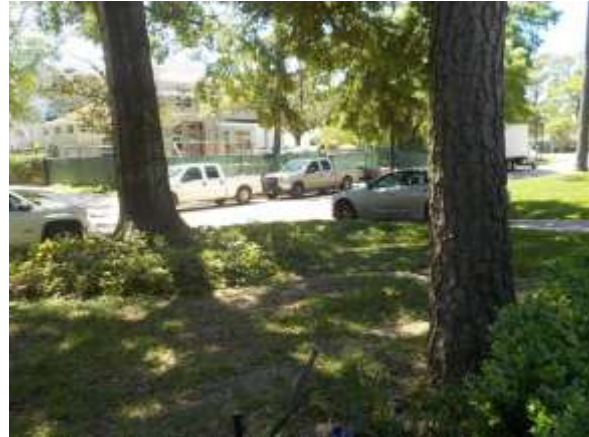
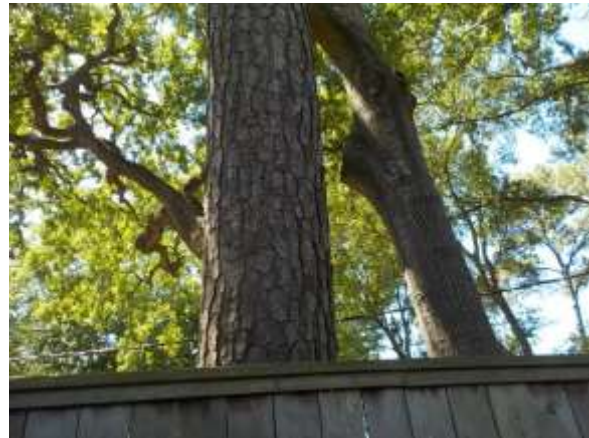
Trees and/or foliage were observed in the vicinity of the house, which can contribute significantly to differential movement of the house foundation. Care should be taken to prevent the trees and foliage from removing an excessive amount of water from near the foundation of the house. Consideration should also be given to cutting the tree roots that extend under the foundation, and installing a root barrier to prevent any further moisture from being removed from under the interior of the house.

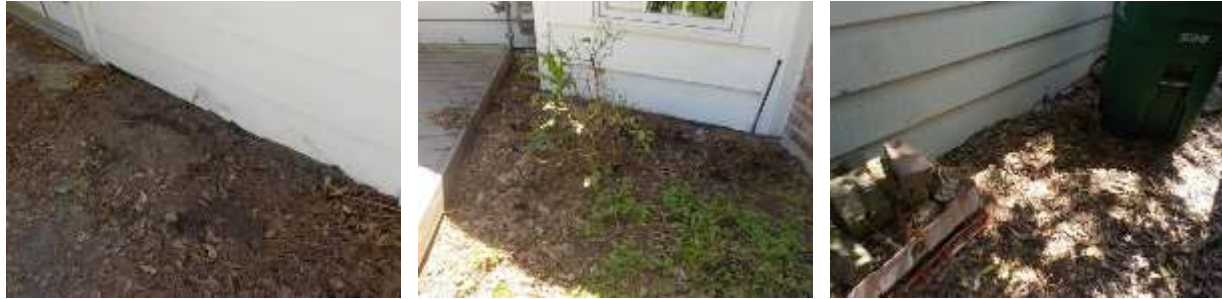
The soil was graded near or above the top of the foundation and/or heavy foliage growing against the house. This condition can cause settlement of the foundation. It is recommended that the soil and/or foliage should be removed, and 3-4 inches of foundation concrete exposed to keep water away from the house.

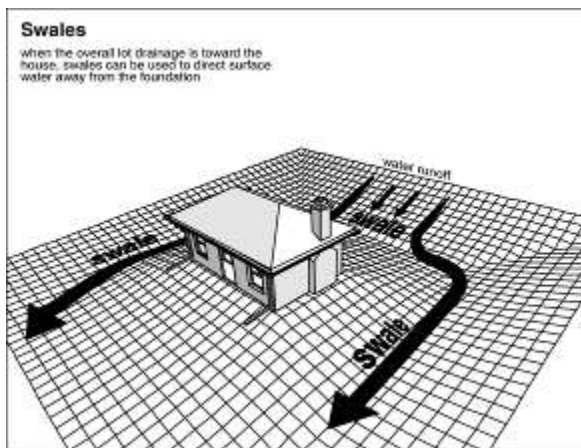
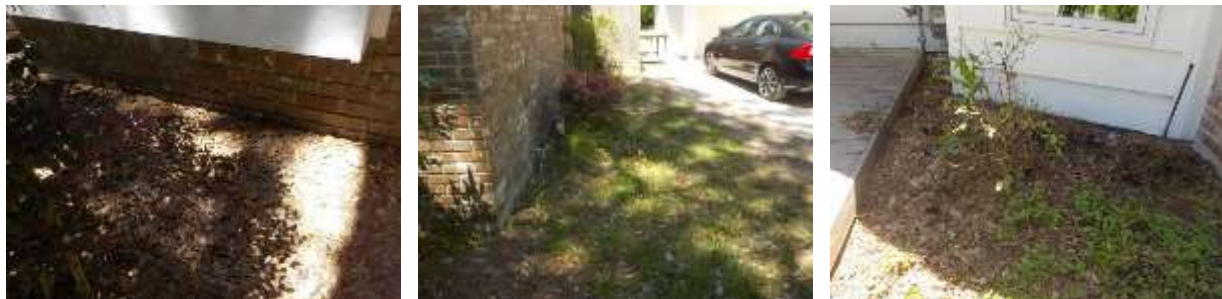
The grade was essentially flat, and it appears that water may pool at some areas after a rain. Further investigation with the homeowner is recommended to determine if water pools for a significant time after a rain. If so, an underground drainage system may need to be installed, and you should contact a company specializing in underground drainage system for a cost estimate.

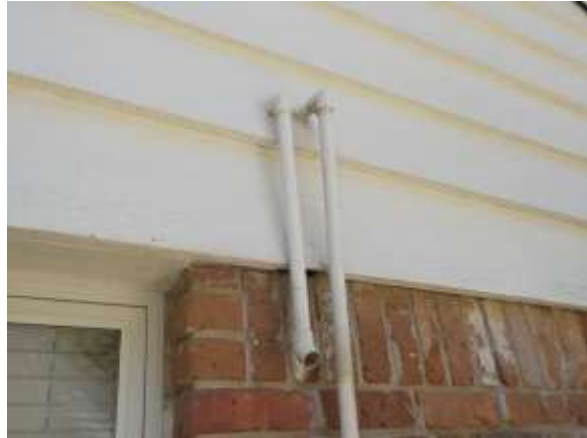
The primary condensate drain line from the air conditioning unit was emptying its water next to the foundation. This can cause the soil in that area to stay saturated, and contribute to differential foundation movement. It is recommended that the drain line be routed to a bathroom sink drain line.

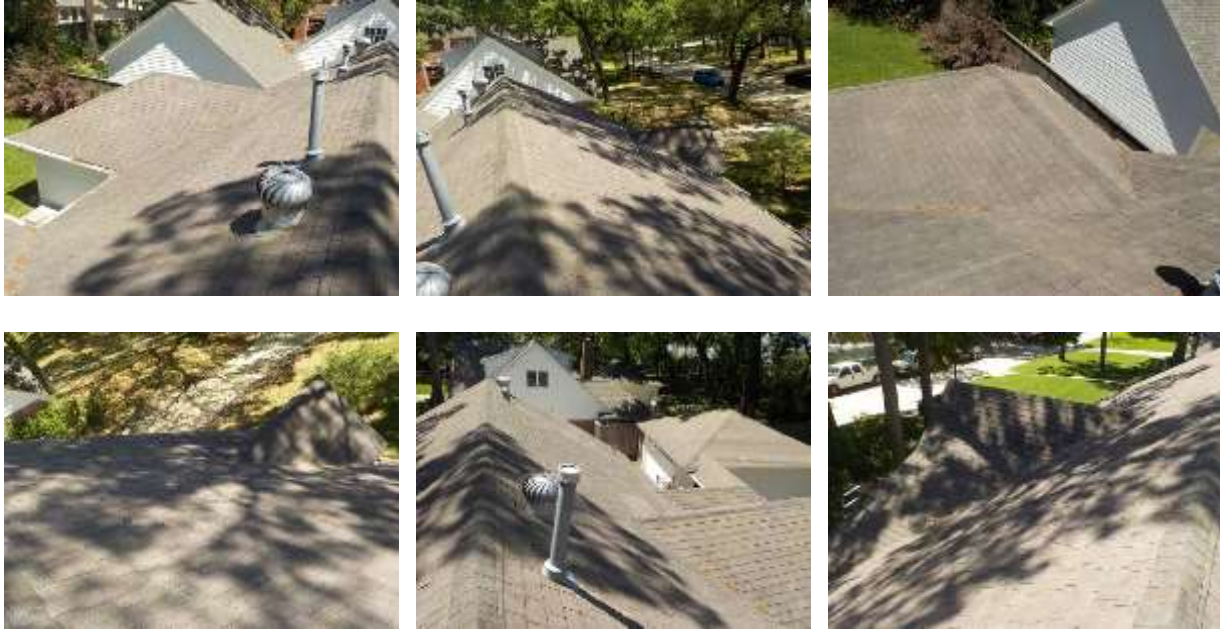
The roof surface was constructed of composition shingles. The life expectancy of a composition shingle roof has been observed to vary from 15 to 20 years, with most requiring replacement at about 17-20 years. We estimate that the age of the roof is approximately 20-22 years.

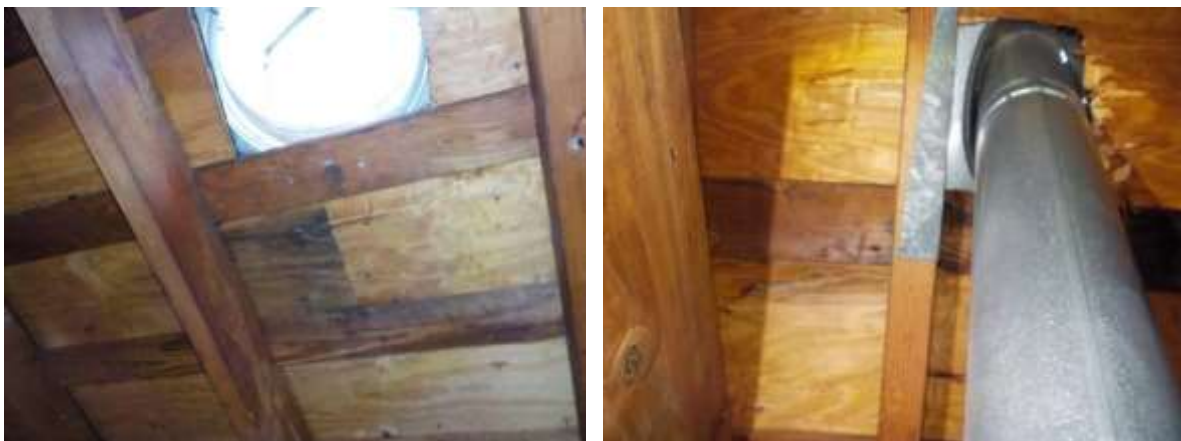
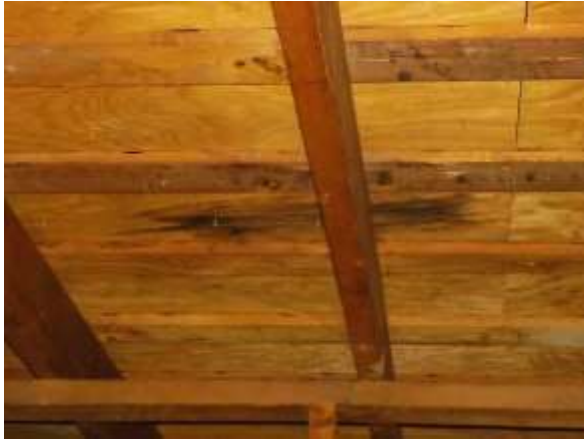
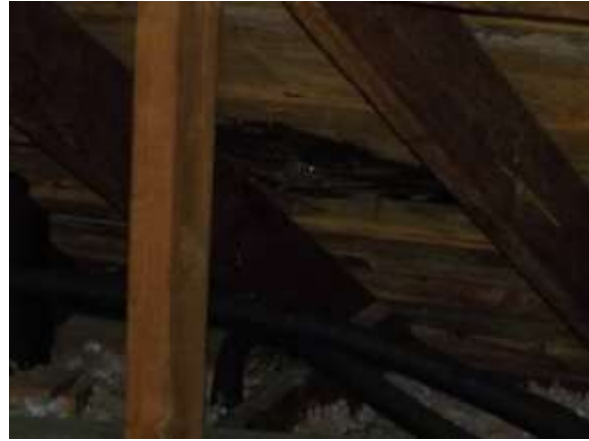
After observing the interior of the structure, evidences of roof leaks were visible in the attic, where the roof decking and/or roof framing members were water stained. It is recommended that a roofing contractor be contacted to find the source of the leaks, and to make any needed repairs.

Locations included: middle whirlybird area, water heater vent pipe area, and northwest roof decking.

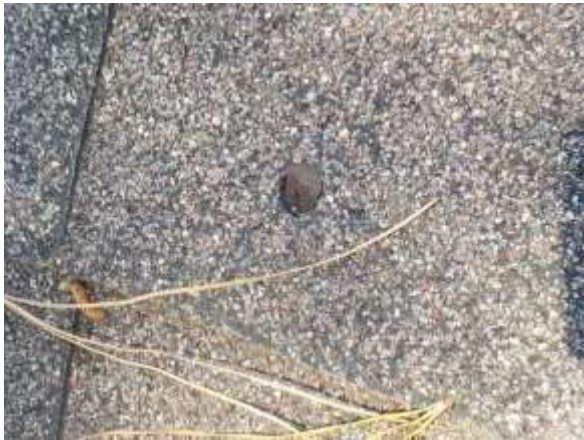
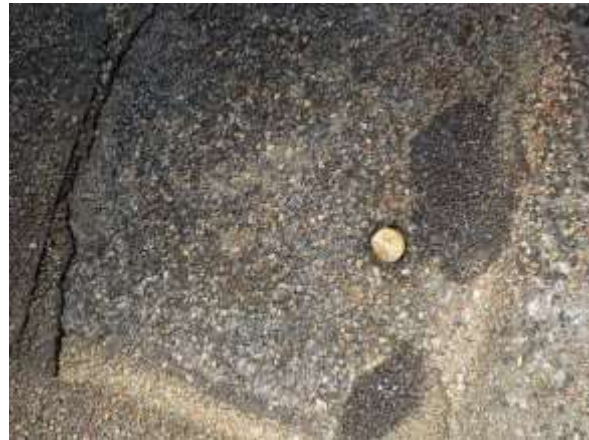
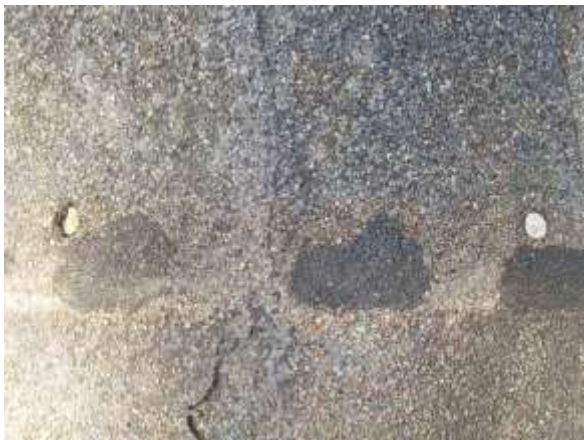
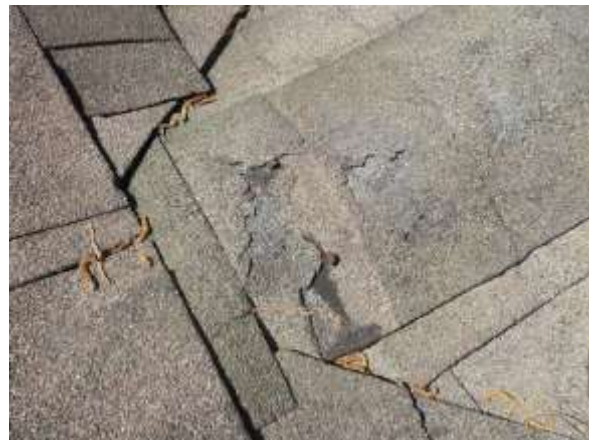
The composition roof surface was showing evidences of advanced deterioration, including the majority of shingles that were brittle, discolored, curling on the edges, cracked, and losing their aggregate.

Some nails were observed to be penetrating through the shingles at different locations on the roof, and the nails need to be sealed to prevent water penetration.

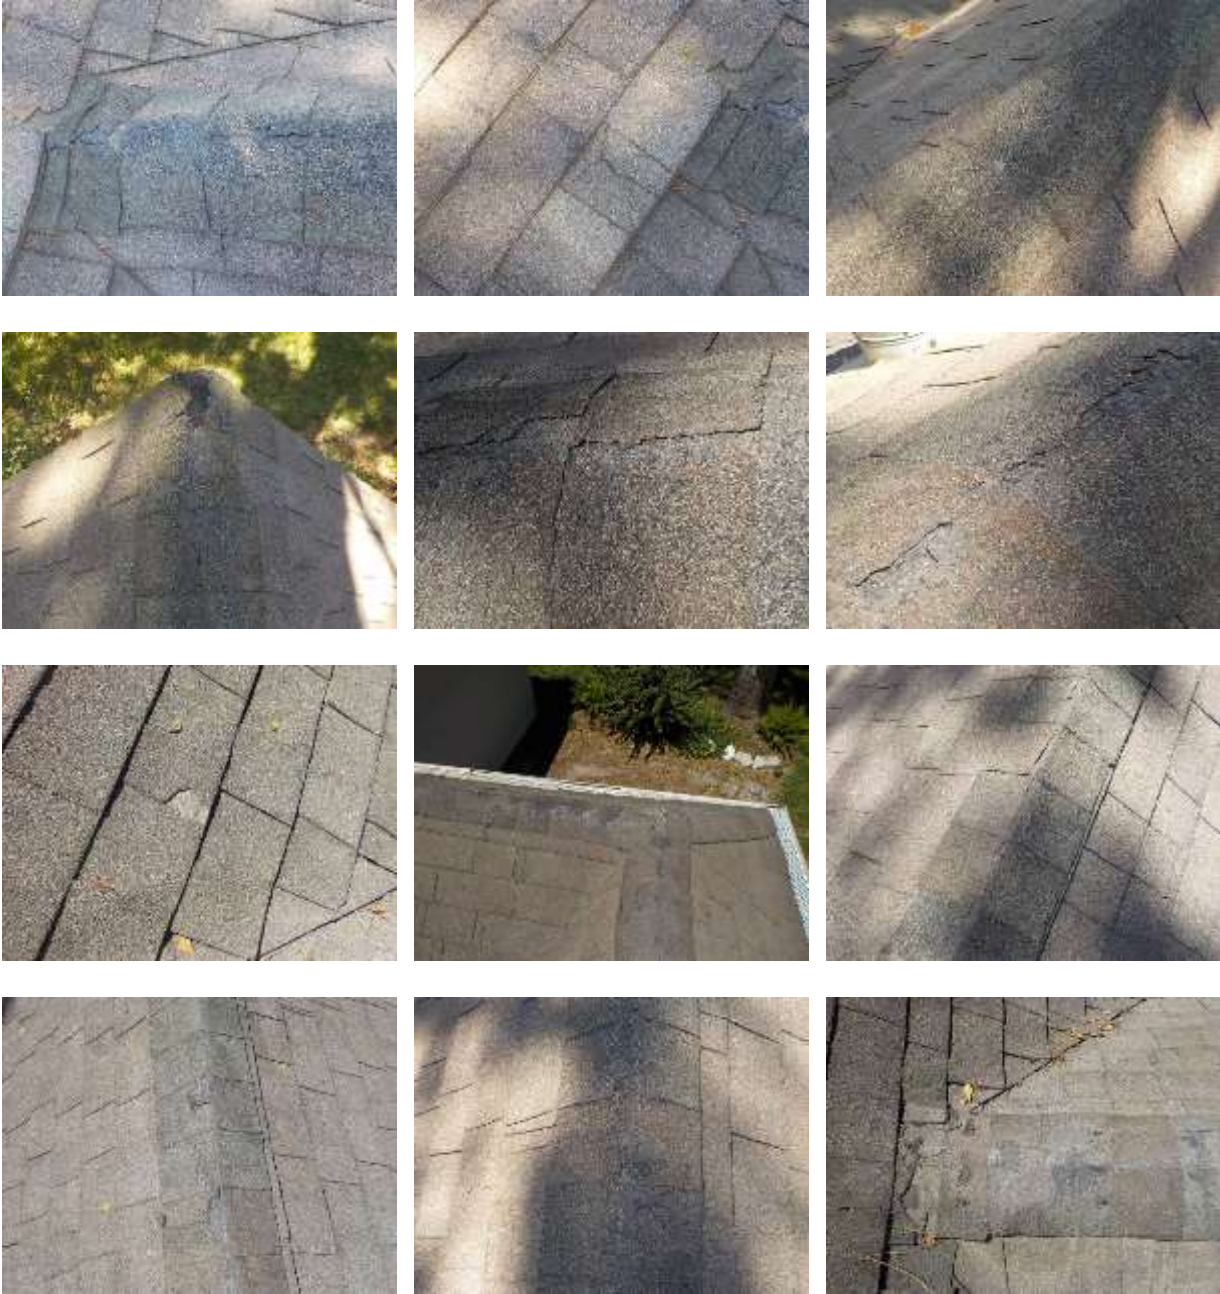
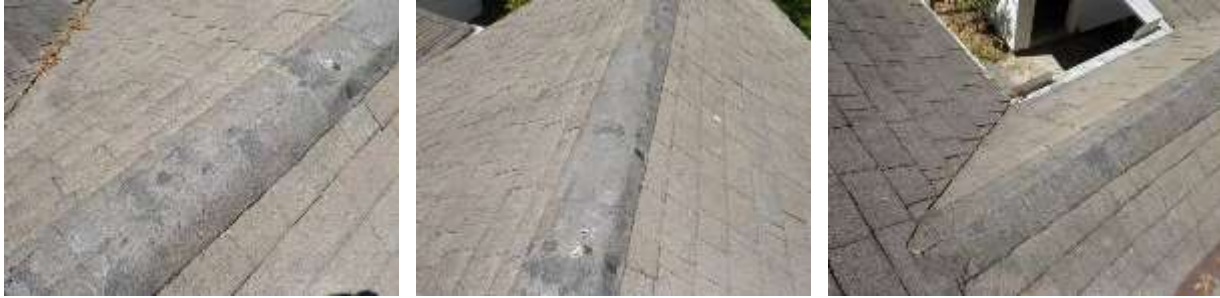
We observed shingles with broken corners or broken tabs.

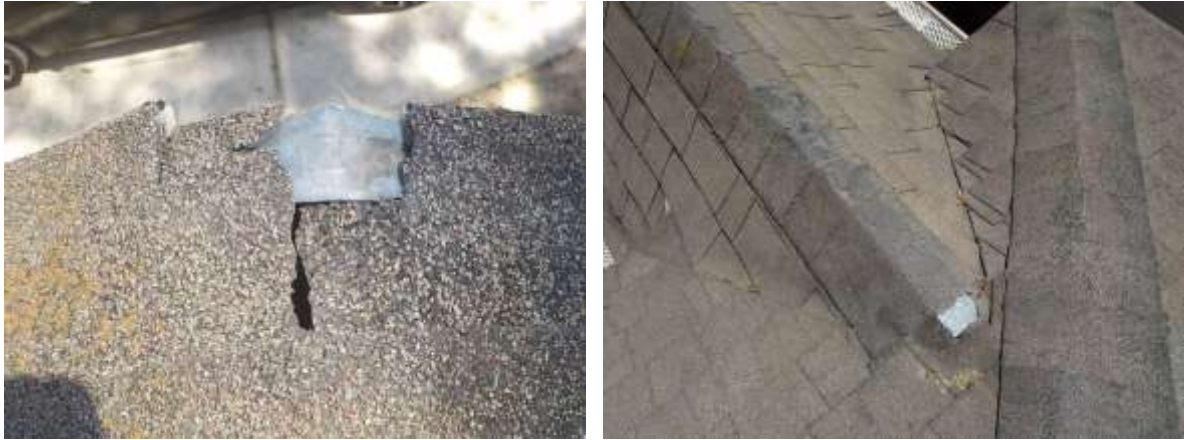
We observed shingles that were loose or missing, and need to be replaced.

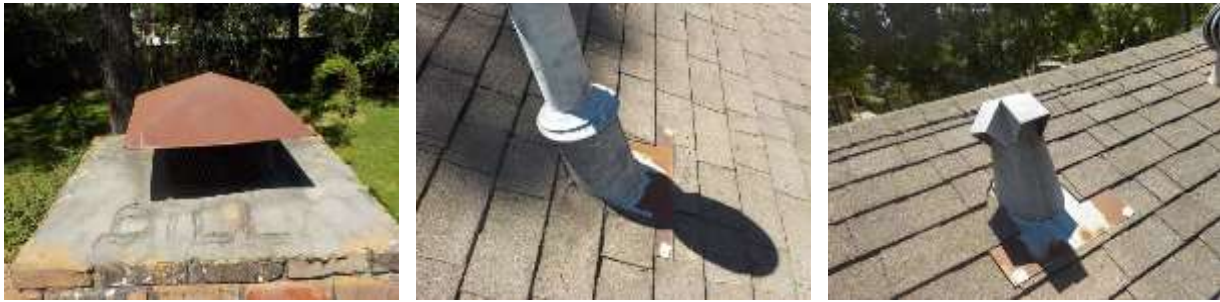
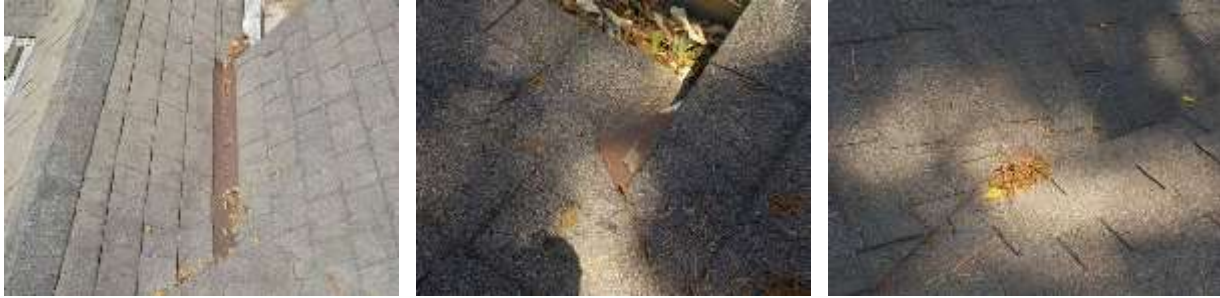
We observed rust on some of the metal roof accessories, and although the accessories are still performing their intended function, it is recommended that the rust be removed. Locations included: chimney weather cap, water heater vent pipe flashing, kitchen range vent pipe flashing, and valley flashing.

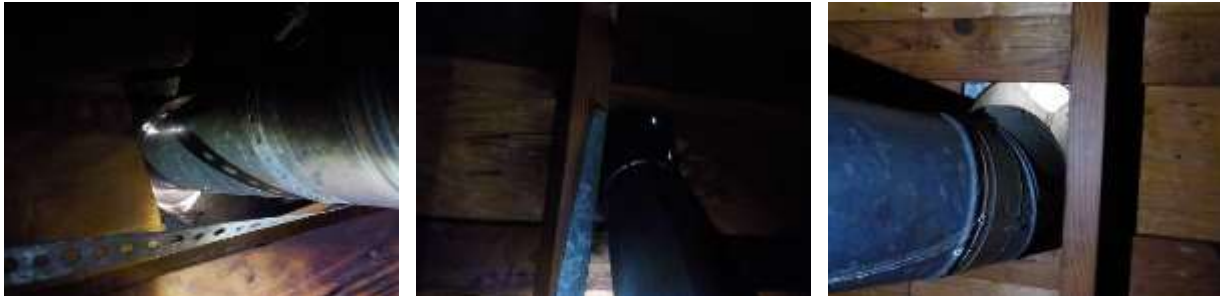
- * Sunlight was observed around the vent pipe(s) in the attic, and allows water to enter the living space around the vent pipe(s) where the sealant is missing. Locations included: furnace vent pipe, water heater vent pipe, and kitchen range vent pipe.

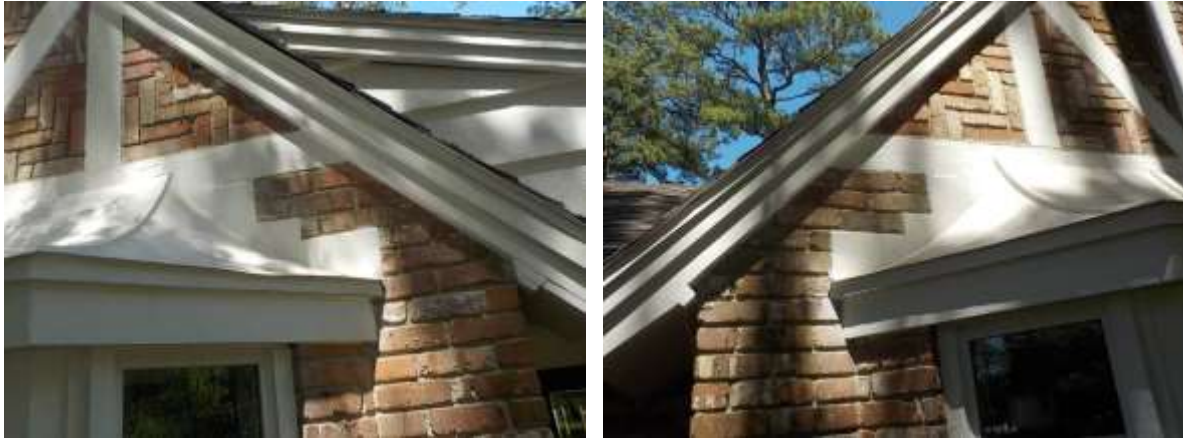
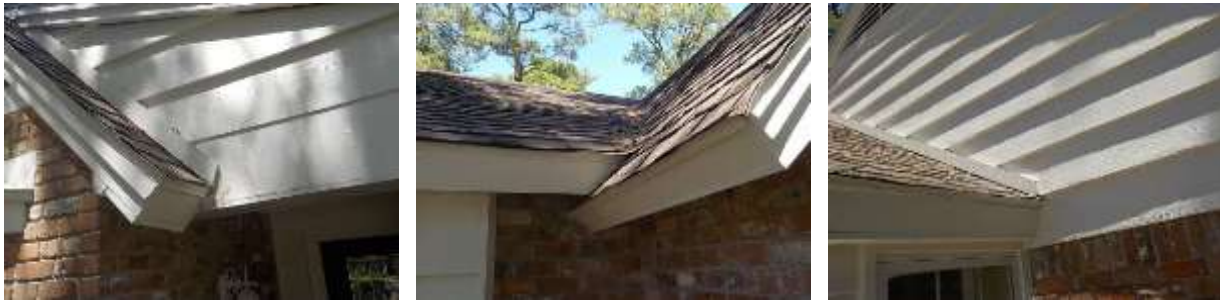
* No kickout flashing has been installed at some of the roof/wall intersections. This can allow water to be routed off the roof into the wall cavities, causing wood rot, damage from wood destroying insects, mold, etc. It is recommended that a contractor install the flashing at all needed locations.

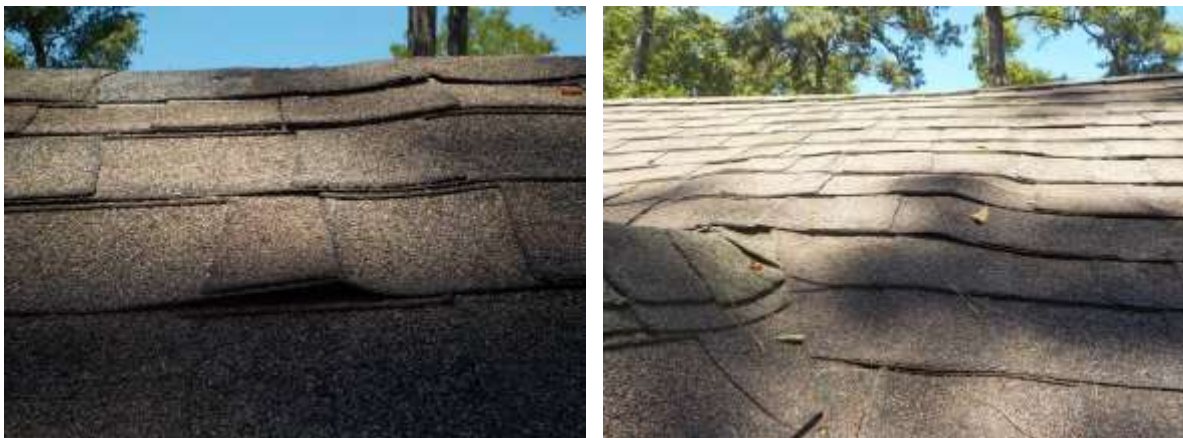
Several of the shingles at the rear elevation of the roof had “fish mouths”, where small humps were visible in the shingles. This problem is typically caused by the felt paper underlayment under the shingles, which was not installed flat. It has been our experience that the felt paper does not lay down flat over time, even in the summer heat, and needs to be repaired.

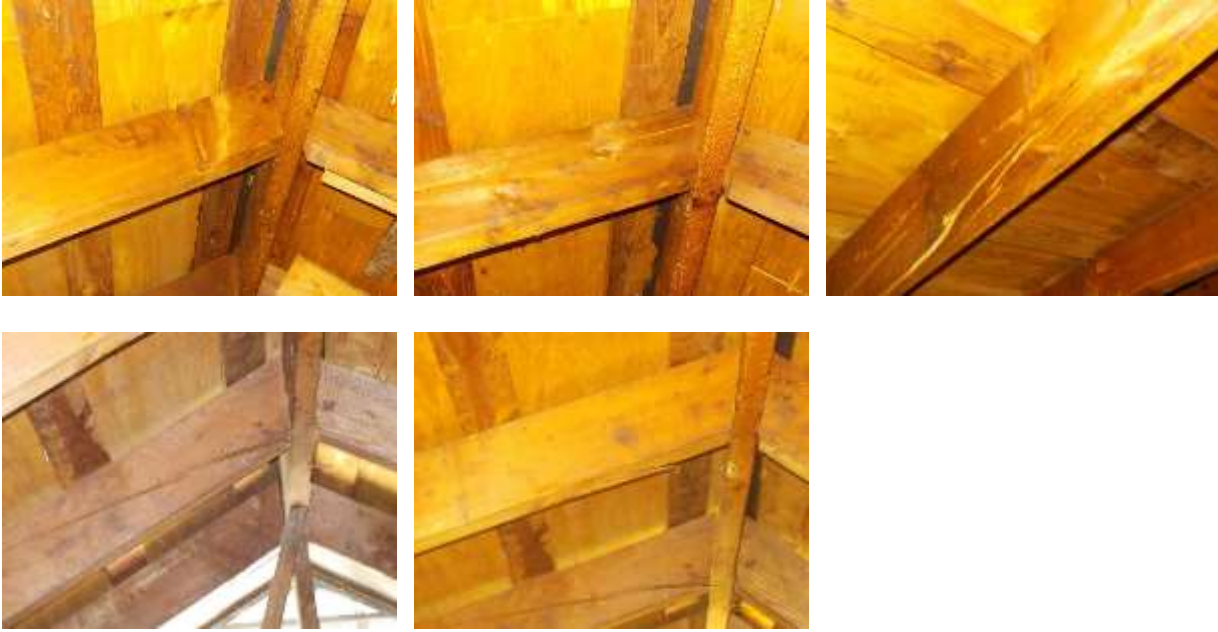
- * Several of the rafters in the attic were observed to be split, and need to be repaired.

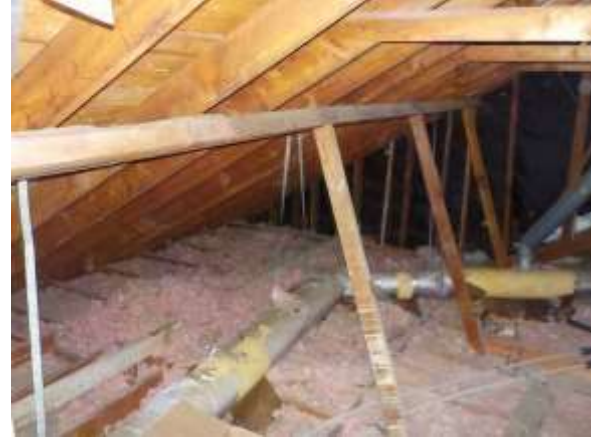
* The vertical braces were spaced farther apart than the currently recommended four feet. However, no significant deflections were visible in the roof framing, and no repairs are recommended.

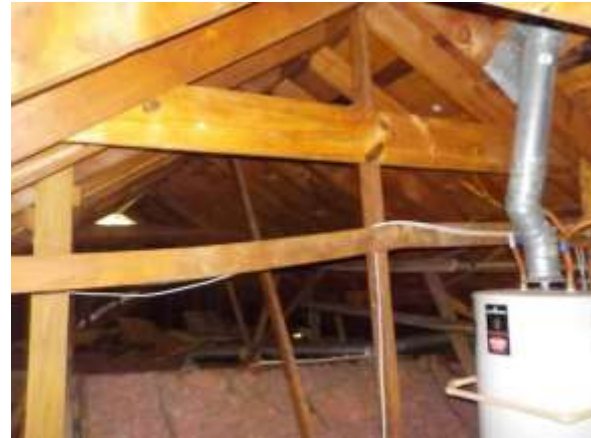
* There were several vertical braces in the upper attic at the purlins that were longer than eight feet, but were not reinforced with another member to make a "T" section of the braces. It is recommended that the braces be reinforced.

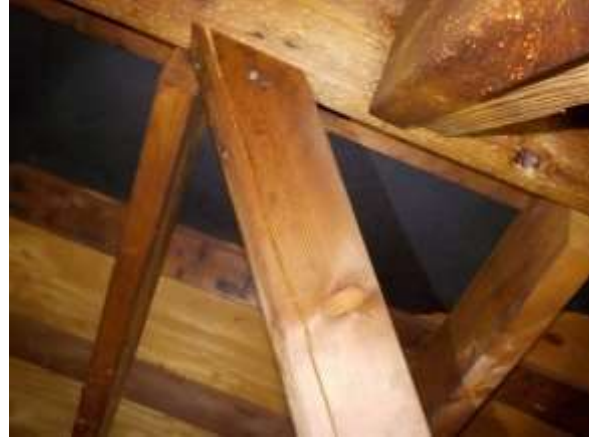
* One of the vertical braces was split and is in need of repair.

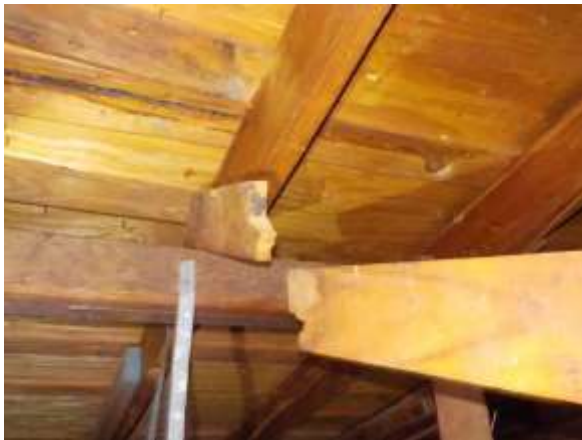
- * One of the collar beams between the roof rafters was cracked and is in need of repair.

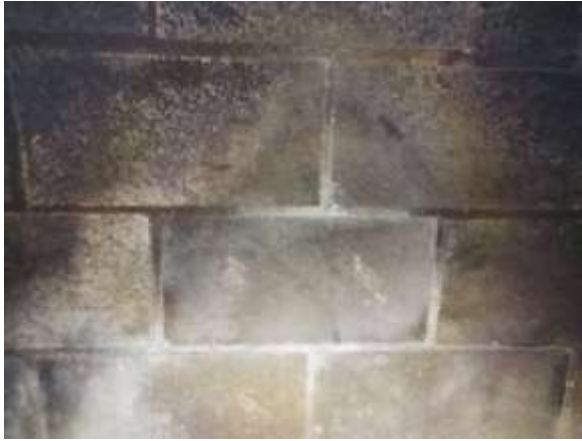
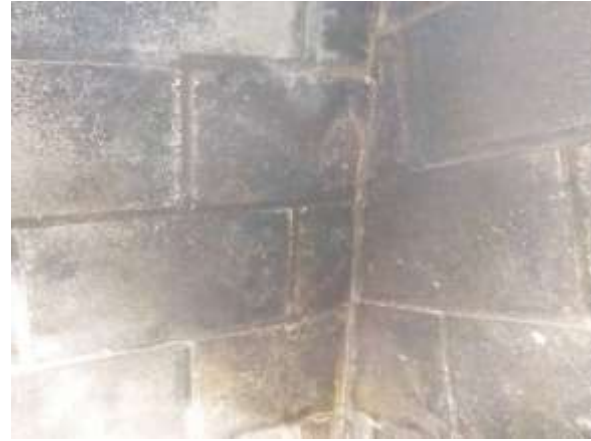
The mortar between the firebricks in the fireplace was cracked and missing in areas, and needs to be tuckpointed with a high temperature (refractory) mortar.

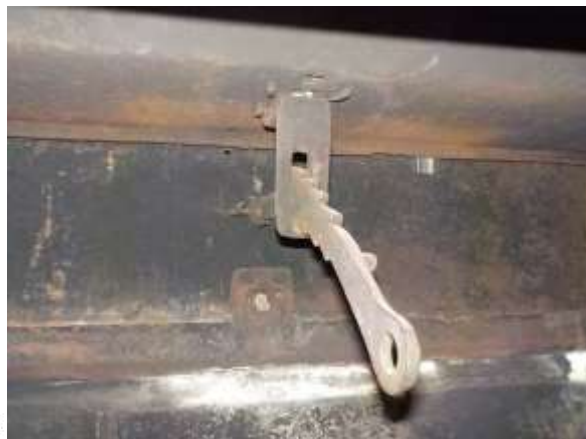
HEI file photo showing c-clamp in masonry fireplace

The fireplace was equipped with a ceramic gas log that was functional at the time of the inspection. The smoke chamber and flue pipe were free from built-up soot, the damper was operational, and the firebox was properly sealed. While the draw of the chimney was not able to be checked, no evidences of poor draw were visible, and no repairs were needed to the fireplace. It is pointed out that the damper was not equipped with a spacer device to prevent the damper from closing completely. This device keeps the damper open slightly, even when it is in the closed position, to prevent combustion gases from building up in the living space should the gas log be operated when the damper is closed. It is recommended that the clamp be installed for safety purposes.

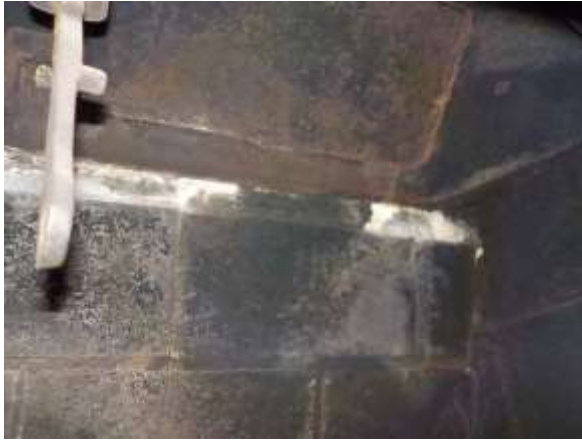
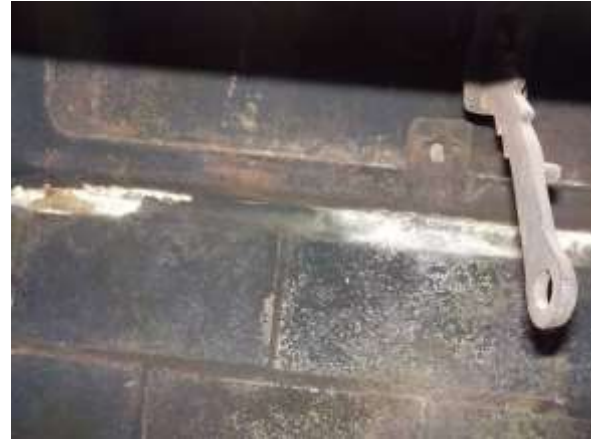
White powder was observed in the firebox, this is efflorescence. Efflorescence is composed of salts and other mineral-like materials that remain in almost all masonry products after manufacture. The fact that this was observed is an indication that moisture is moving from the inside of the firebox, and taking these mineral salts with it. The lack of an adequate barrier, could be the cause of this condition through exterior moisture penetration from water, particularly rain fall.

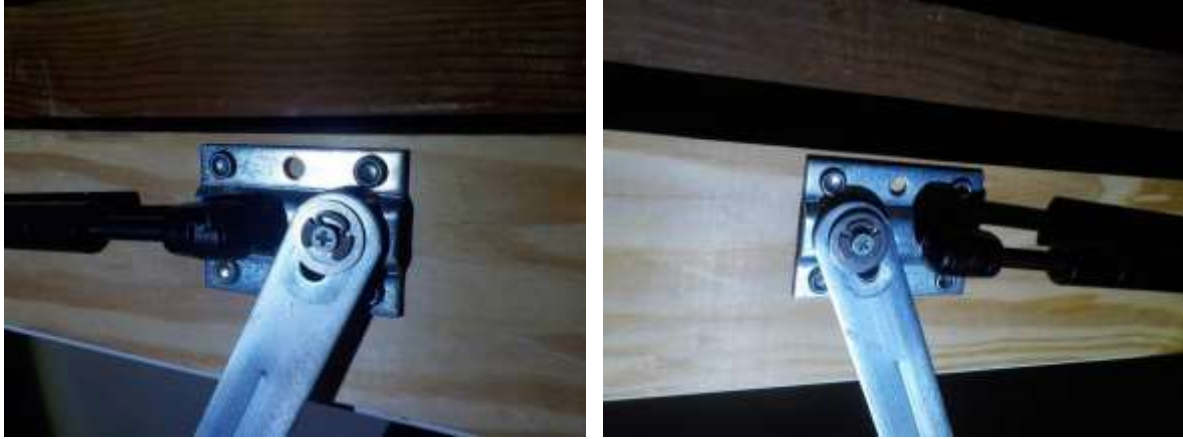
The stair assembly was not properly installed or secured to the framing members, and repair is needed for safety purposes. The condition(s) can be a safety hazard, and repair is needed, as an improperly installed stair assembly can possibly collapse. Defective conditions we observed included the following:

- The nails used to secure the ladder assembly to the attic framing were not installed through the holes in the spring arm pivot plates on the sides of the access ladder.

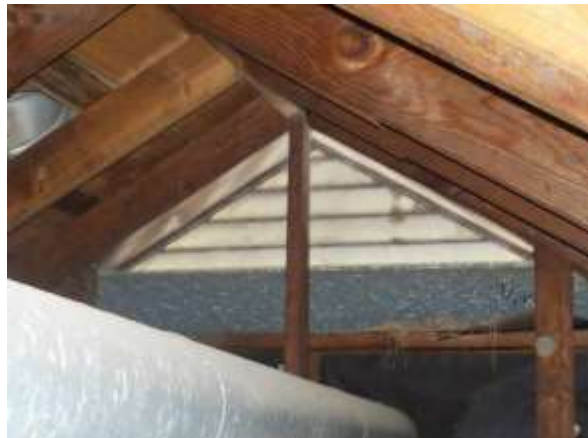
The gable vent screens were torn at both ends of the house and need to be replaced.
Obtain Cost Estimate

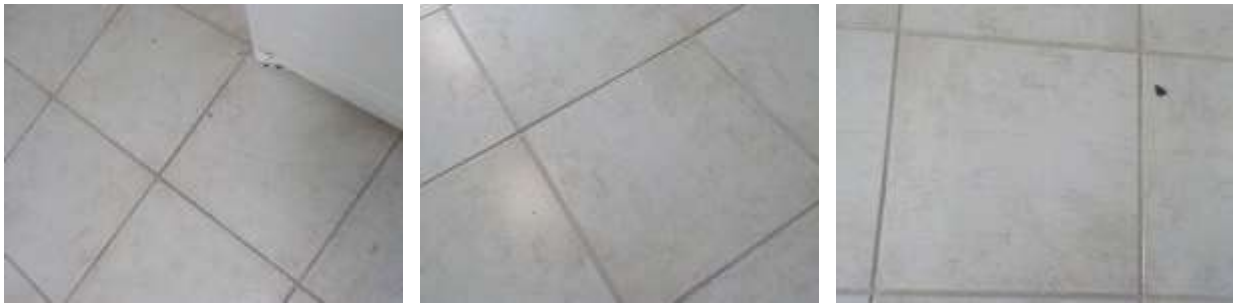
Floor tiles were cracked at the kitchen and breakfast room.

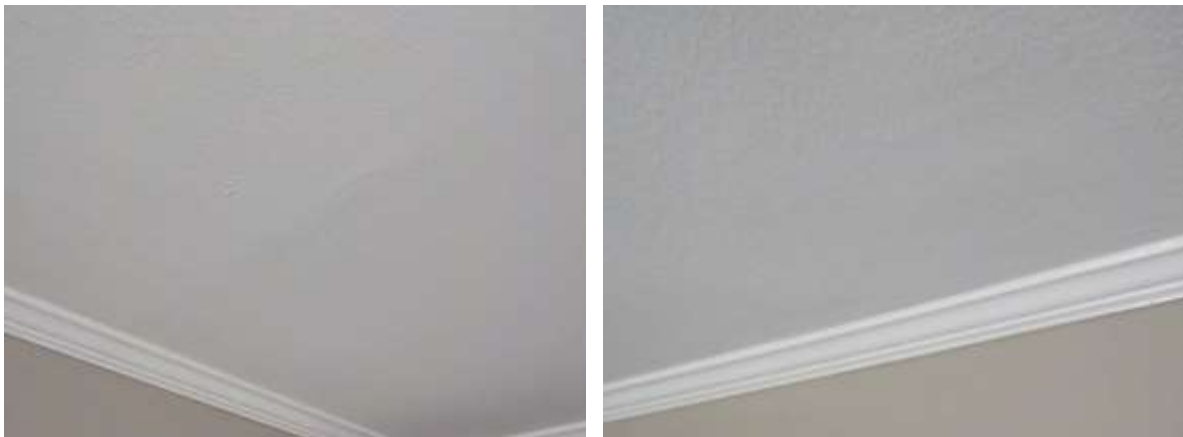
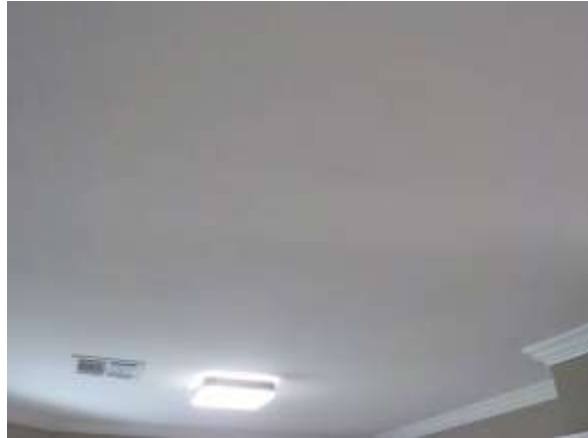
Patches in the sheetrock were seen at the master bedroom ceiling, southeast bedroom ceiling, breakfast room ceiling, and kitchen ceiling. The cause of the patching could not be determined at the time of the inspection, and further investigation into the cause of the patch with the homeowner is recommended.

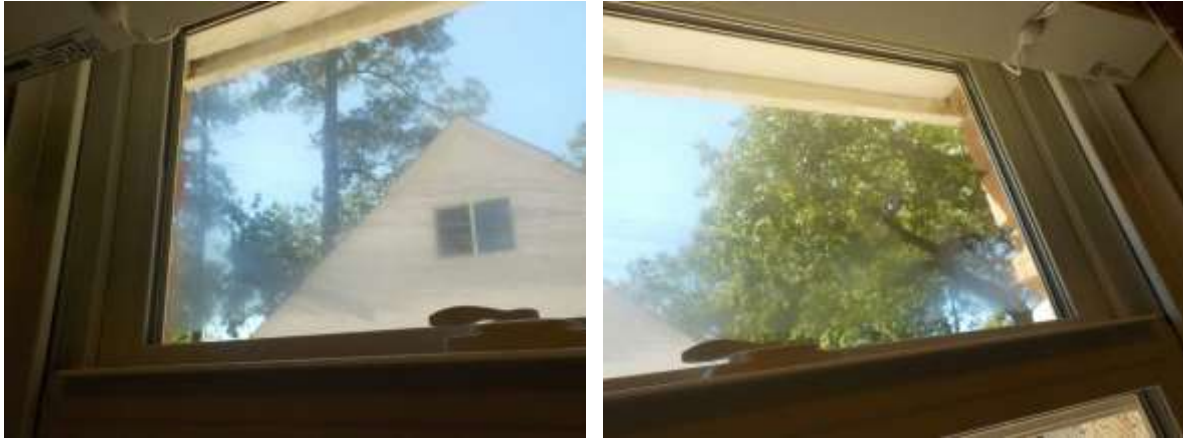
Some double pane windows were observed where the seal has been compromised and allowed moisture between the two panes. It is pointed out that we were not able to view every window under differing lighting conditions at different times of the day, and we may not be able to see discoloration that may become visible under different lighting and/or weather conditions, other than at the locations listed below. Further investigation with a window specialist is recommended concerning the windows to determine the extent of the condition throughout the house, and to make all needed repairs. Locations included: half bathroom.

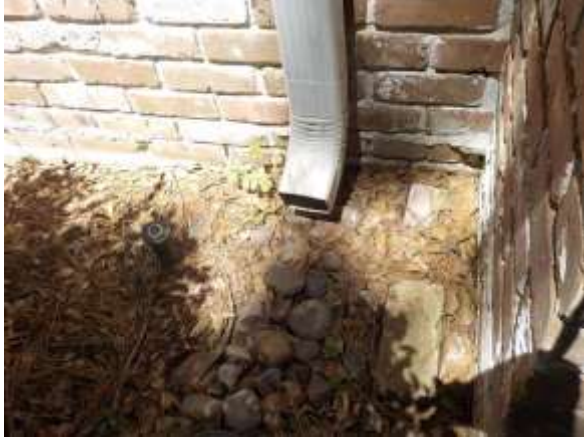
The downspout was missing a splash block at the front of the house.

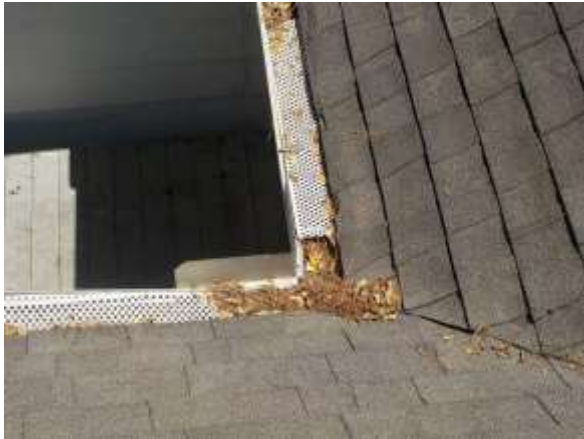
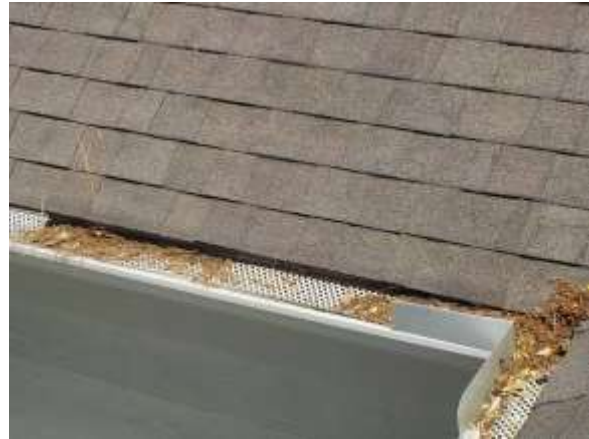
The screens were loose and/or missing at the gutters, and need to be repaired.
