HEDDERMAN ENGINEERING, INC.

April 10, 2019

REF: CONDITION OF PROPERTY SURVEY

At your request, a visual survey of the house located at 12710 Old Oaks Drive, Houston, Texas, was made by Mr. Pedro Salazar and Mr. David Koteles.

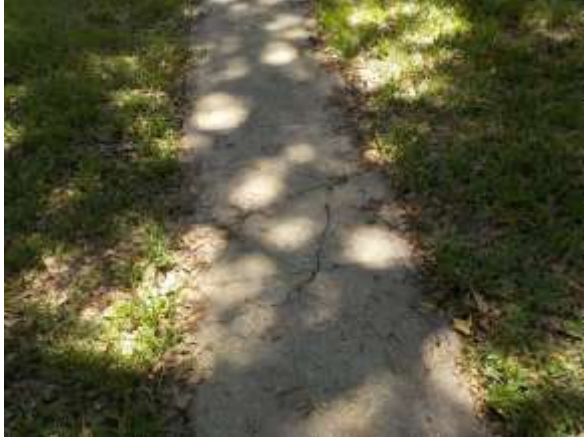
The sidewalk was cracked and uneven at the front of the house, and presents a tripping hazard.

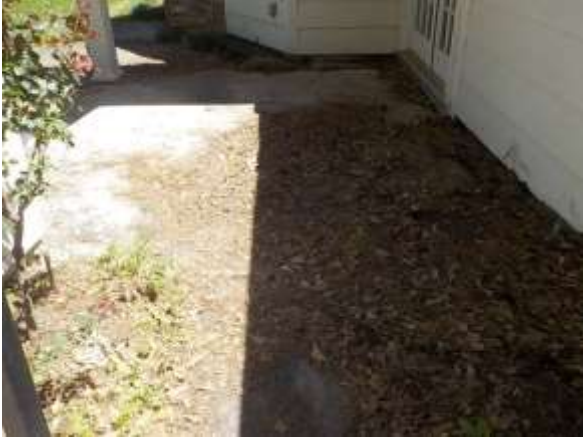
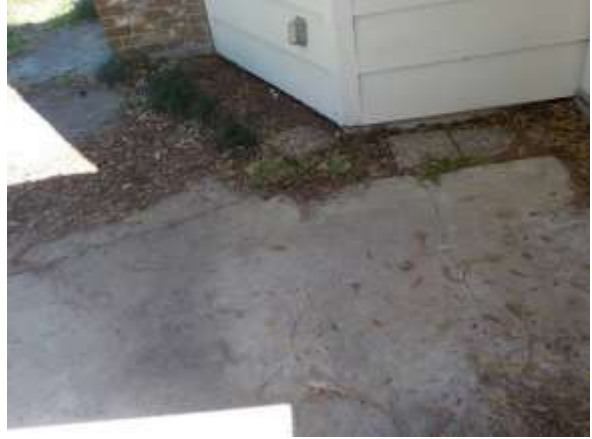
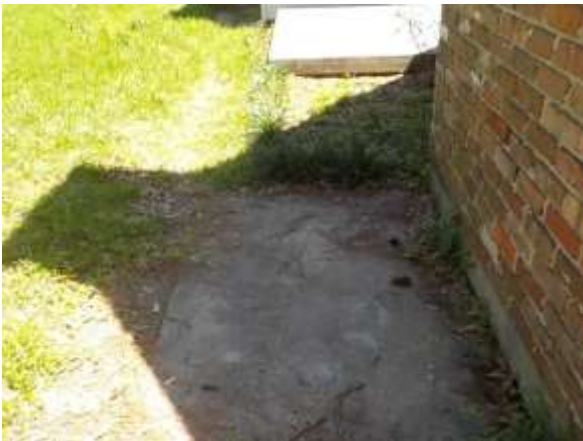
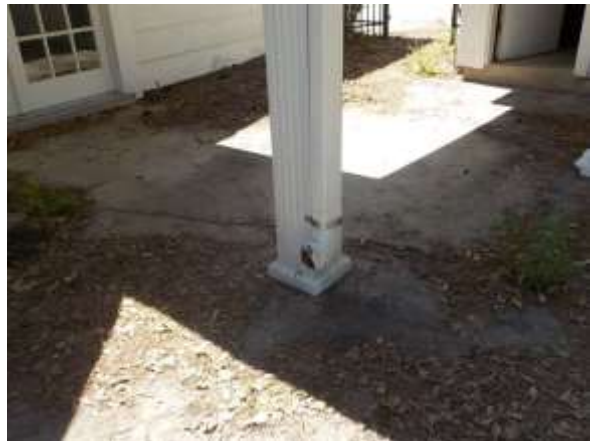
The rear patio had cracks in the patio and has experienced significant settlement.
