PROPERTY INSPECTION REPORT

Concerning: **12710 Old Oaks Drive, Houston, TX 77024**

By: **David J. Koteles #22594**

4.10.19

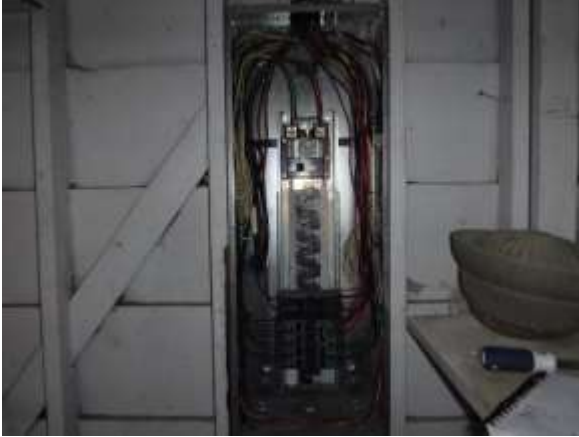
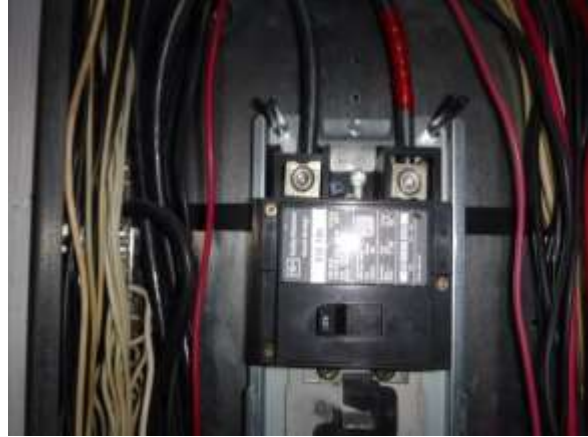
Electrical Bonding

The hot and cold-water piping and gas piping were not properly bonded to the grounding electrode to prevent the metal piping from becoming energized, and repair is needed. Usually the gas piping will be bonded with a grounding electrode at the exterior and then the gas piping, cold water and hot water piping will be bonded together at the water heater. Contact an electrician to make the needed repairs.

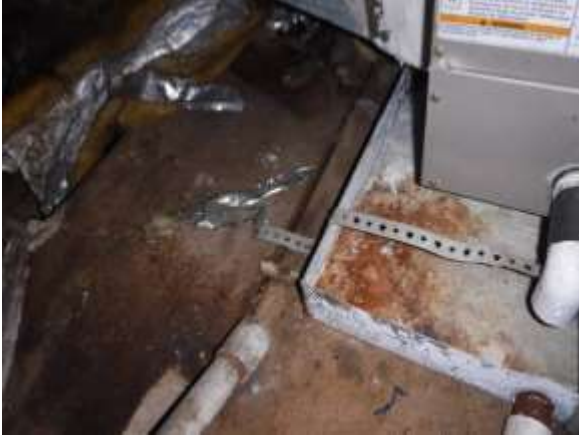
Overflow Pans – Rust

The overflow pan under the evaporator coil had rust in the pan, apparently from water overflowing the condensate drain line into the overflow pan. No water was in the pan at

the time of the inspection, but, since we only ran the unit for a few minutes, it is recommended that the drain line be checked by an air conditioning service company.

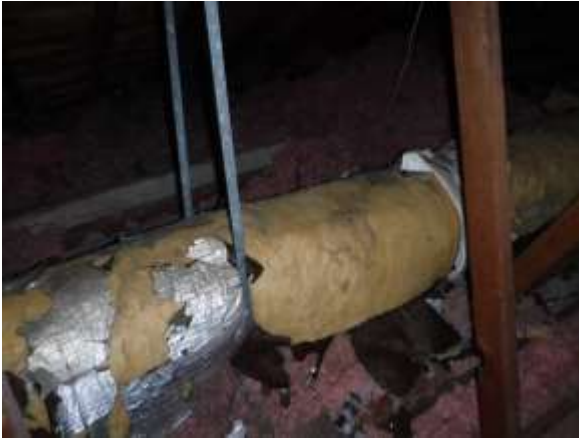
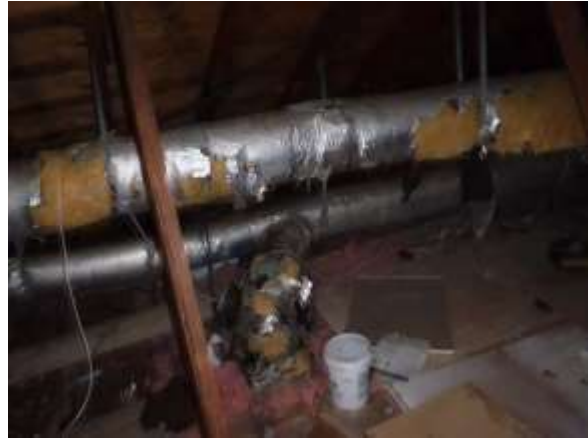
The insulation on the ductwork was in disrepair. Have an HVAC service company give a quote to make any necessary repairs.

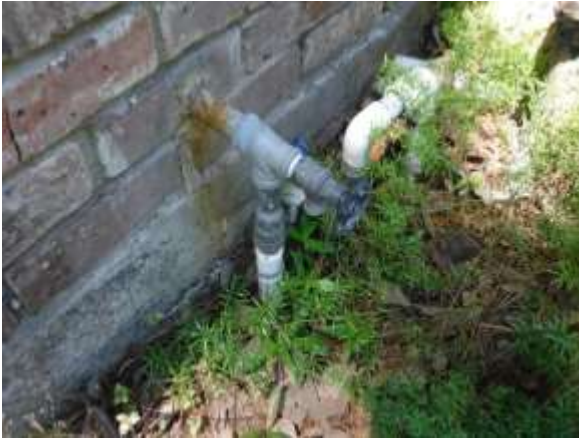
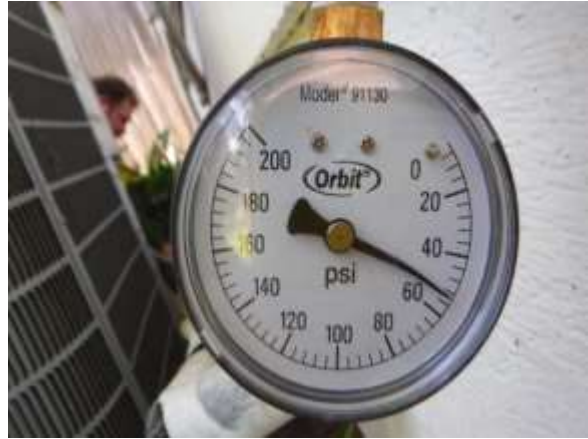
The main inlet water line needs to be insulated at the house.

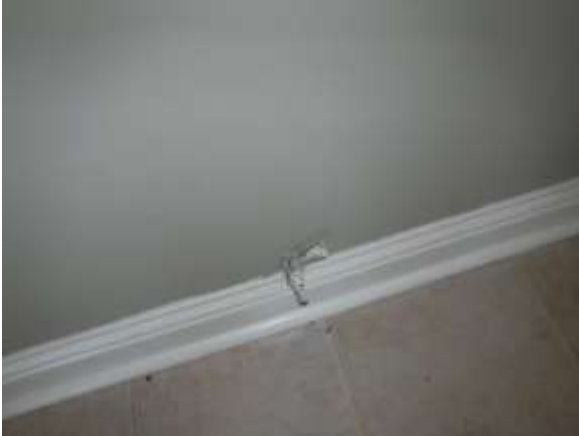
An unused gas valve was observed in the utility room that was not capped. This needs to be properly capped to prevent gas leaks.

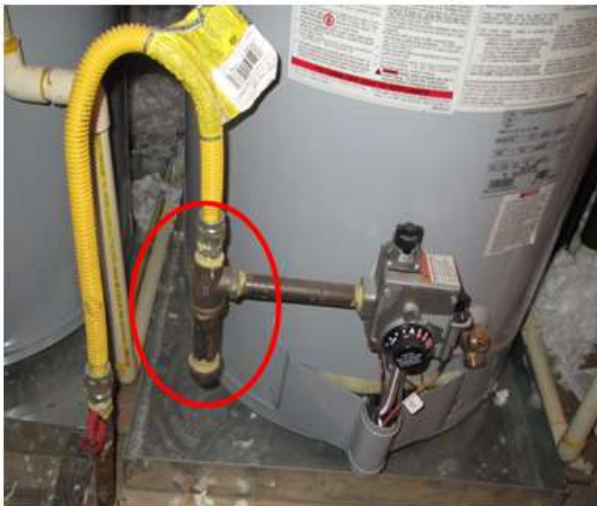
Moisture/Sediment traps were not installed at the gas supply lines for the gas fired equipment as currently required. A moisture/sediment trap is intended to catch moisture and debris in the gas supply lines before they can enter into the equipment. Obtain cost estimate for any needed repairs.

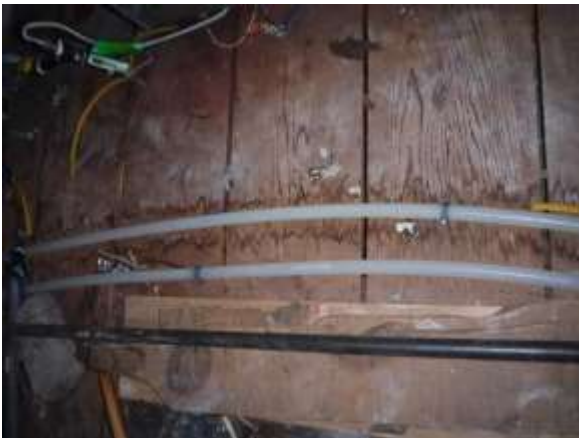
Stains

Water stains were observed on the ceiling at the southeast bedroom. This is located under the plumbing in the attic, and HVAC systems in the attic. We observed stains on the decking of the attic which indicate either a condensation problem or a leak in the piping. Have a plumber find the source of excessive moisture and make any necessary repairs.

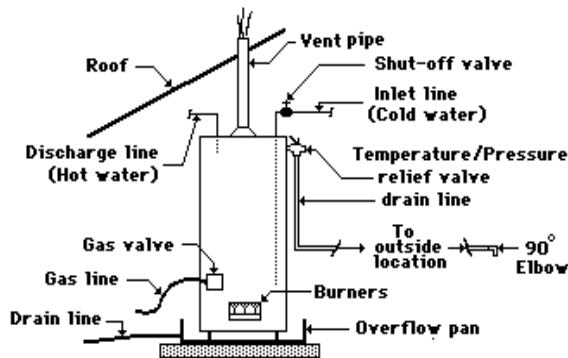
Gas Water Heater

The water heater was functional at the time of the inspection. However, due to the age and/or condition of the equipment, it is the opinion of the inspector that it has only a limited amount of life remaining. Normal life expectancy of a water heater in the Houston area is approximately 7 to 10 years.

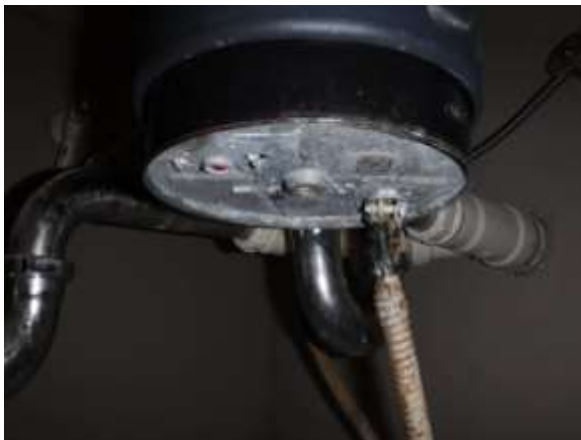
The electrical wiring for the disposal is only partially encased in conduit.

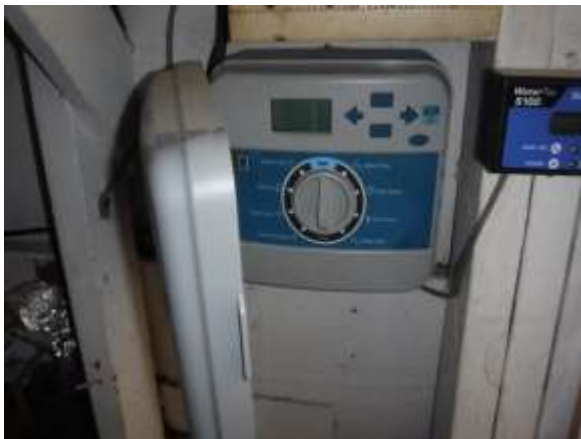
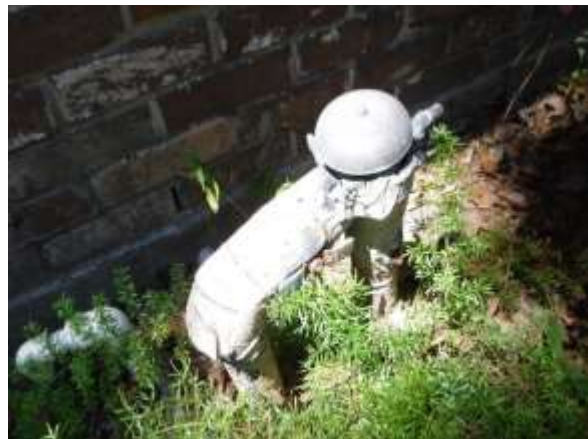
The backflow prevention device was installed too low and needs to be elevated. The device should be a minimum of 12 inches above the highest sprinkler head in the system. One shutoff handle on the Febco was missing and needs to be replaced.
