RESIDENTIAL INSPECTION

2930 N Island Dr
Seabrook TX 77586

Edward Turbeville
JULY 31, 2020

PROPERTY INSPECTION REPORT

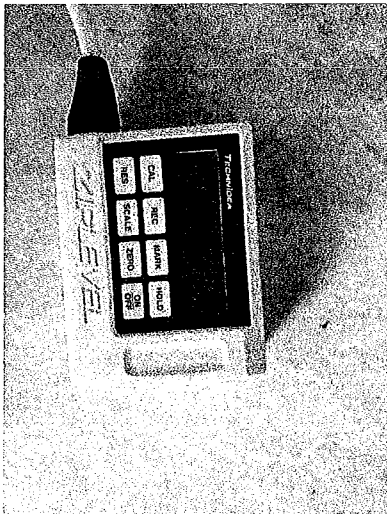
Zero reading taken in middle of foundation.

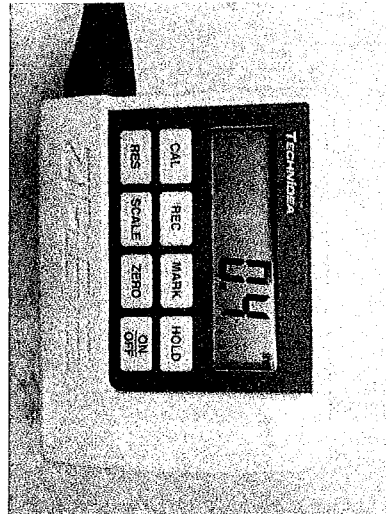
.4" higher at left side of foundation.

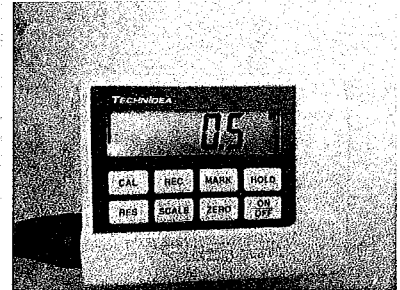
.5" higher at rear of foundation

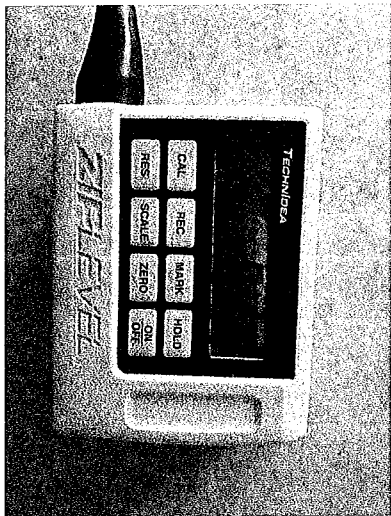
. 4" higher at right side of foundation.

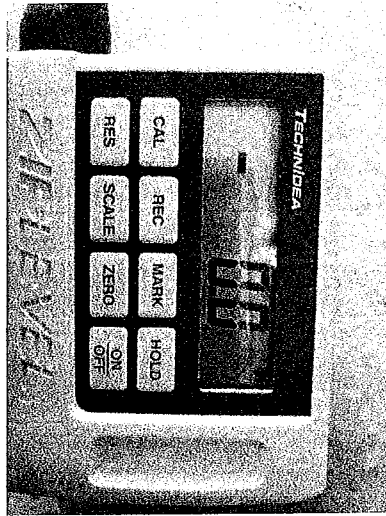
Even at front of foundation.

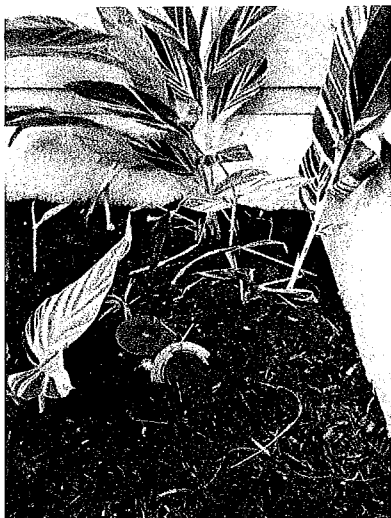
1: Insufficient clearance from foundation to grade

It is recommended there be at least 4" of clearance from brick siding to the ground and at least 6" for other types of siding. It is recommended to remove some of the dirt and vegetation from around the foundation to allow for proper drainage.

There should be a minimum of 4" clearance between earth and siding here

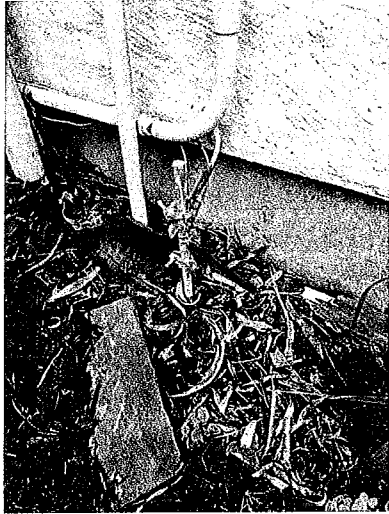
Ground rod should be driven flush into the ground

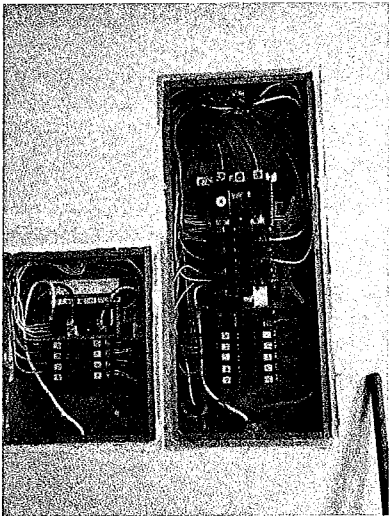
2: White wire used as hot power wire

Multiple white wires were used as power supply wires from breakers. While this is not forbidden, the white wires are supposed to be taped or marked black or red to avoid any confusion. These wires should be taped or colored appropriately to help avoid any accidents in the future.

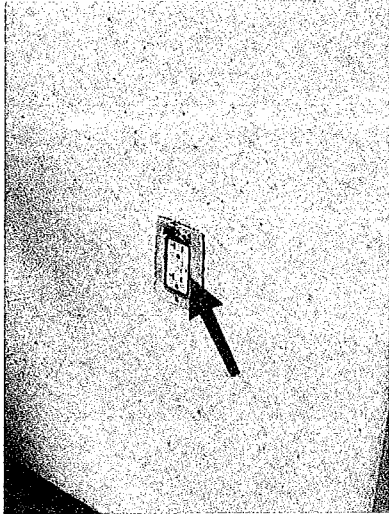
One or more receptacles are missing a cover plate. This causes short and shock risk. Covers should be installed over outlets in wet areas.

Outlet on rear exterior wall of home should have a cover over it to prevent water from entering outlet.

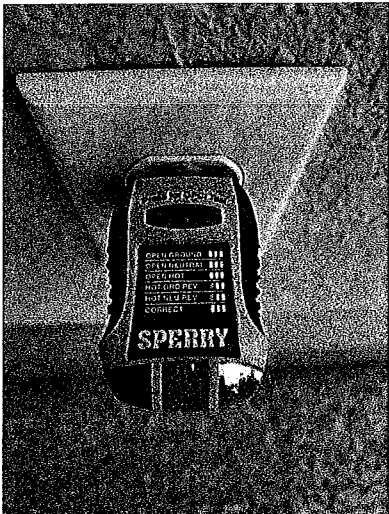
2: Improper Wiring

Improper wiring was observed at the time of inspection. Recommend a licensed electrician evaluate and repair.

Upstairs bedroom was found to have an open neutral. The neutral provides a safe path for electricity back to the main panel.

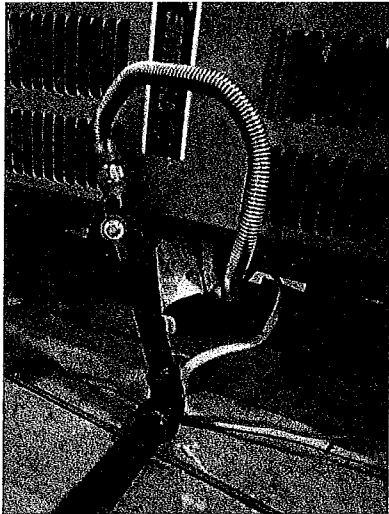
1: No Sediment Trap Present

The gas piping contained no sediment trap. Sediment traps or drip legs are generally required, depending on your local jurisdiction. The purpose of a sediment trap is to prevent particulates or moisture from entering and clogging the furnace gas supply, which could trip the furnace and possibly lead to an expensive service call. We recommend consulting a local licensed, qualified HVAC technician concerning sediment trap installation. This is a cheap way to help avoid potentially costly repairs in the future.

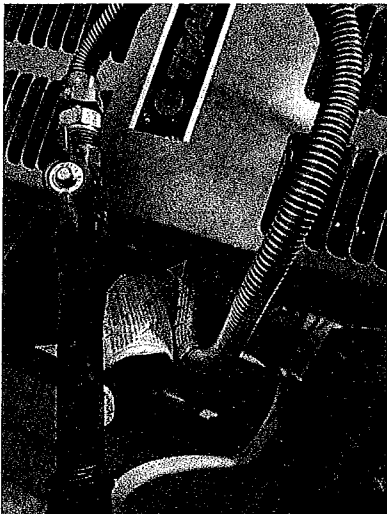
2: Flexible Gas Line Extends Inside Cabinet

Flexible gas lines are not permitted to extend inside the appliance cabinet. There should be a piped nipple extending inside the furnace cabinet to supply fuel gas to the burners. This is only present on the upstairs furnace unit.

Flexible gas lines should not extend inside furnace cabinet.

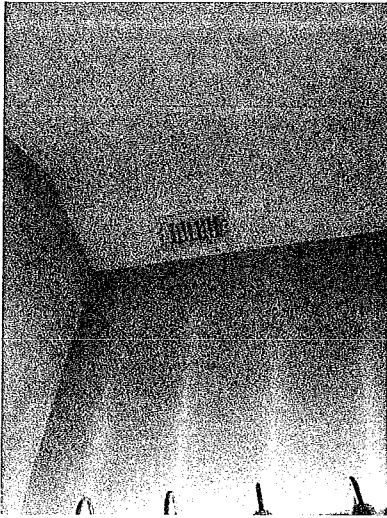
The supply air register in the downstairs half bath is closed. This will prevent conditioned air from getting into this bathroom. Recommend opening this air register.

Closed air register

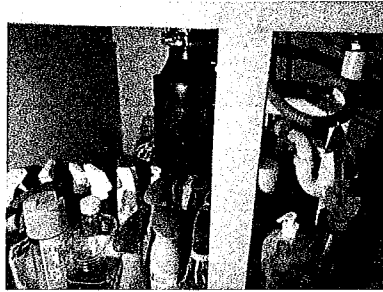
This drain hose should be elevated

It is recommended the drain hose from the dishwasher be elevated and secured to the underside of the counter to help prevent the backflow of waste water into the dishwasher.

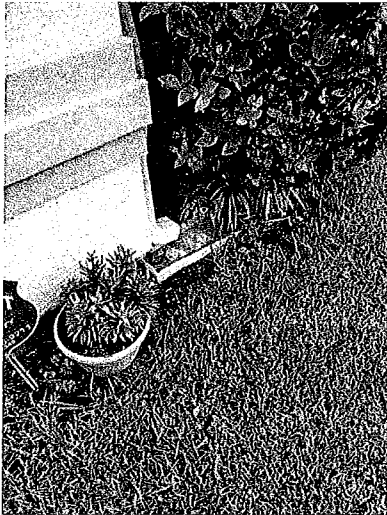
The downspouts were discharging too close to the foundation. We recommend having water discharge a minimum of five (5) feet away from the foundation and directed to flow away from the foundation when leaving the downspout. If you are unable to route water discharge 5 feet away, at a minimum I recommend installing splash blocks under the downspout discharge to help direct water away from your foundation.

Gutter discharge should be routed away from home.

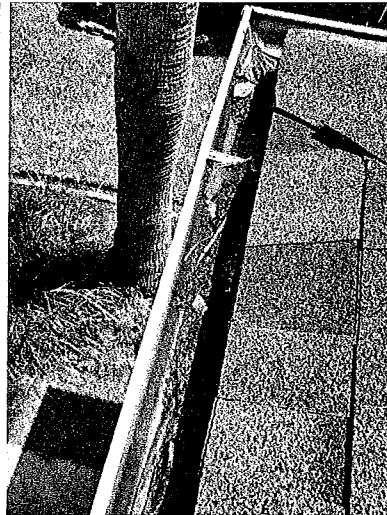
The gutters/downspouts were full of debris and leaves. If left in this state water can fill the gutters and damage the eaves of the roof. Water can also overflow the gutters and spill out directly next to the foundation, potentially causing damage.

Gutters full of debris and standing water

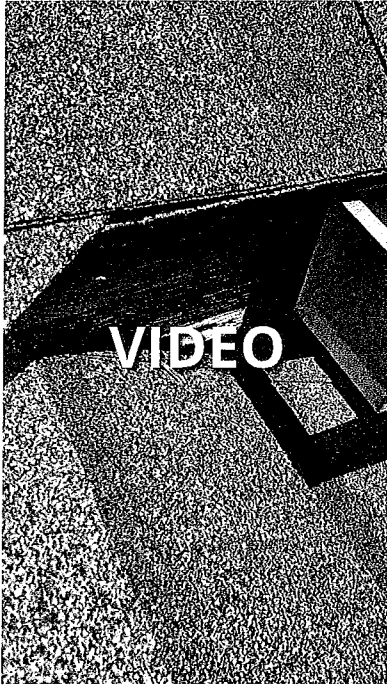
2: Rotten fascia boards

Fascia boards were observed to be rotten. These boards should be replaced.

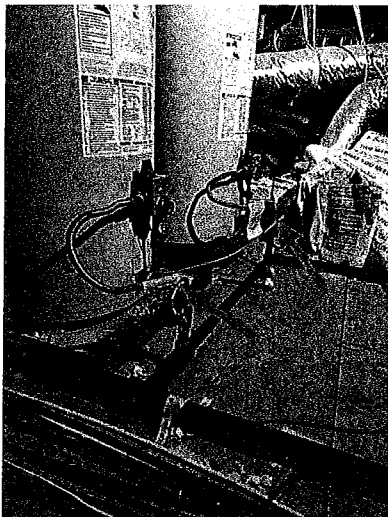
2: Missing Sediment Trap

There is no sediment trap present as required. Sediment traps prevent any contaminants from entering the burner, which could lead to the burner plugging and a potentially expensive repair. Installing a sediment trap is a cheap and easy way to help avoid this.

No sediment traps present

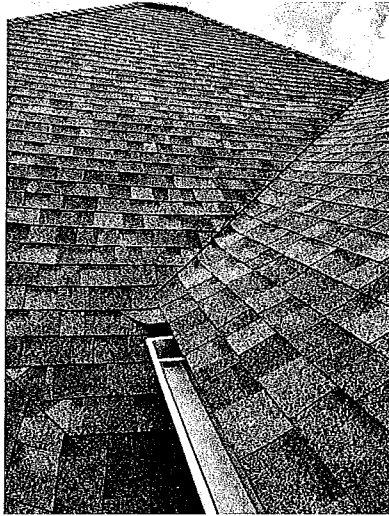
Sections of gutter from upper sections of the roof were discharging directly onto lower sections of roof. While this is not prohibited, it should be noted that this will lead to premature wear of the lower roof system, as all of the water from the upper roof is being directed across the lower roof.

Upper roof gutter is routed to discharge onto lower roof

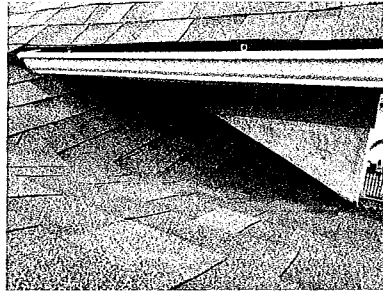
Upper roof discharging onto lower roof

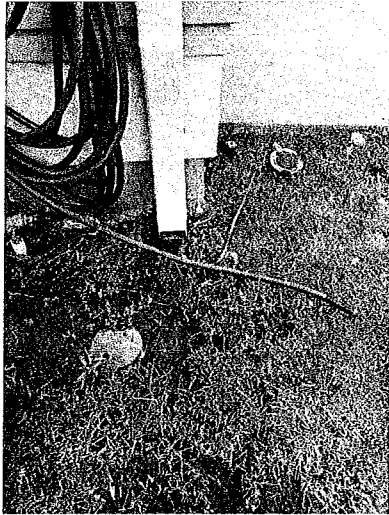
Gutter discharge is washing away the ground at the front left corner of the house.

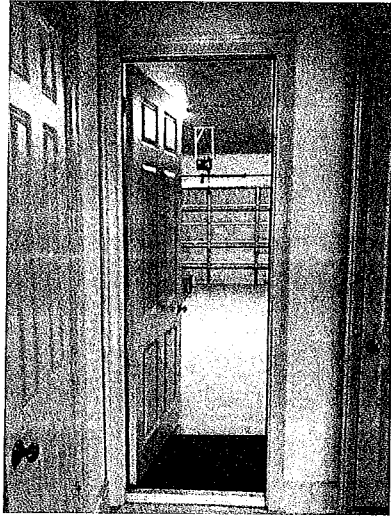
Door leading from garage into living space should be self closing.

This door should close by itself.

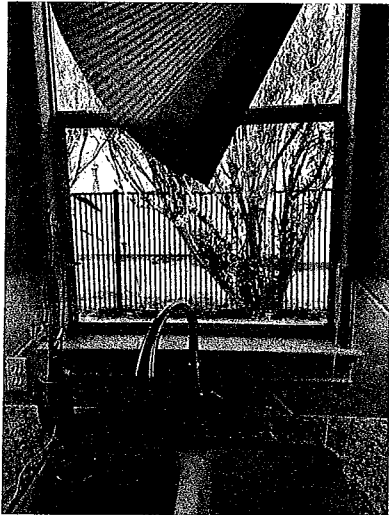
Kitchen window does not want to open and will not stay open.

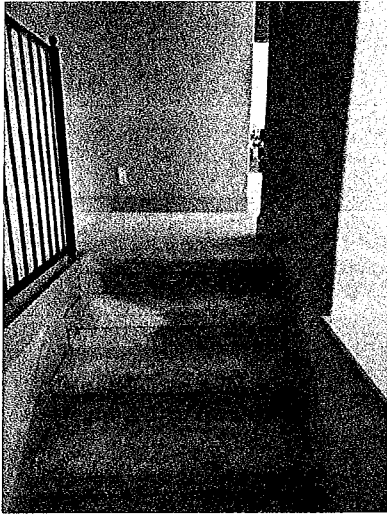
1: Handrail Missing

Staircase had no handrails. This is a safety hazard. Recommend having a graspable handrail installed at the upper section of stairs.

No hand rail

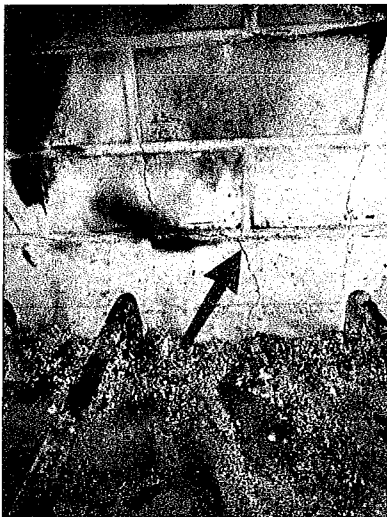
1: Firewall Cracked

The brick lining of the fireplace was cracked in one or more places, which could lead to chimney damage or toxic fumes entering the home. Recommend a qualified fireplace contractor evaluate and repair.

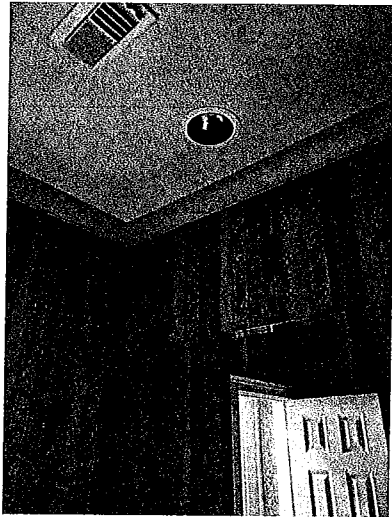
Light not working

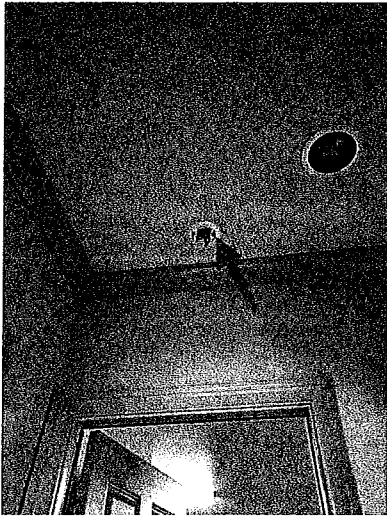
Smoke detectors were observed to be missing. Installing smoke detection is a cheap and easy way to ensure your safety. I recommend installing these.

Missing smoke detector

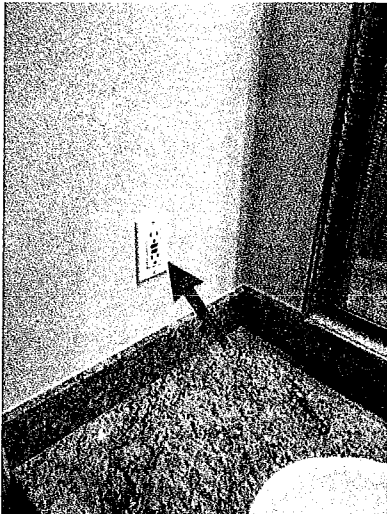
4: Dead Outlets

Outlets were found to not have any power to them. I recommend having a licensed, qualified electrical address this.

Downstairs half bath outlet is dead

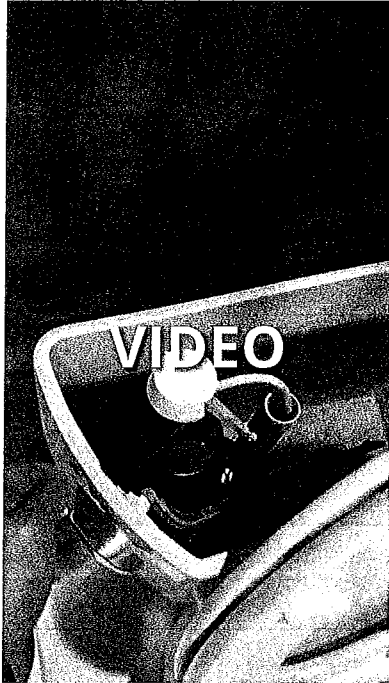
Water supply has been shutoff to the upstairs right guest bathroom toilet. Recommend asking seller why this toilet has had the water blocked away from it and fix any issues.

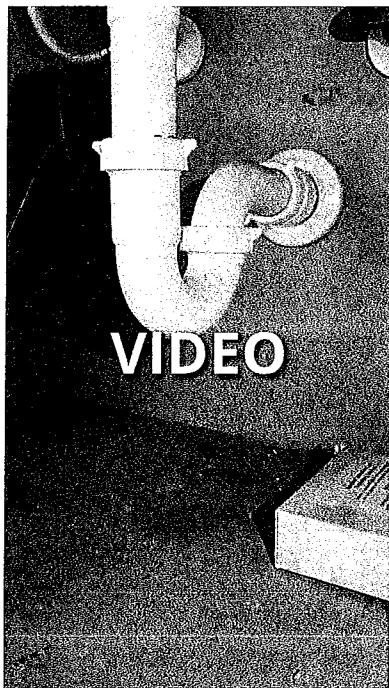
1: Leaking fixture

Water leaks from the drain in the right master bathroom sink as depicted in the video.

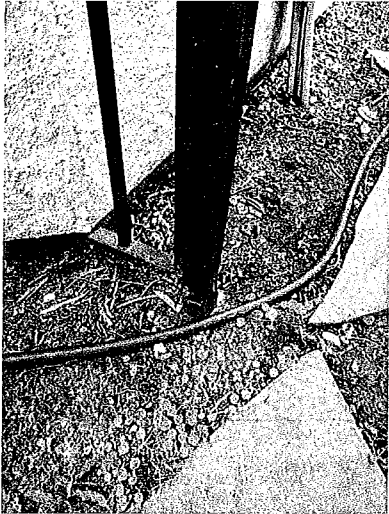
Sections of the fence were observed to be rusted out.

Rusted fence
