2411 Dabney Manor Ct.
Katy, TX 77449

PROPERTY INSPECTION REPORT

Concerning: 2411 Dabney Manor Ct., Katy, TX 77449
(Address or Other Identification of Inspected Property)

By: Nicholas Jones, Lic #9019 11/01/2018
(Name and License Number of Inspector) (Date)

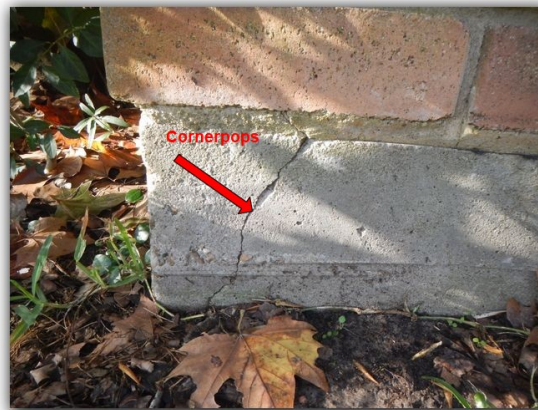
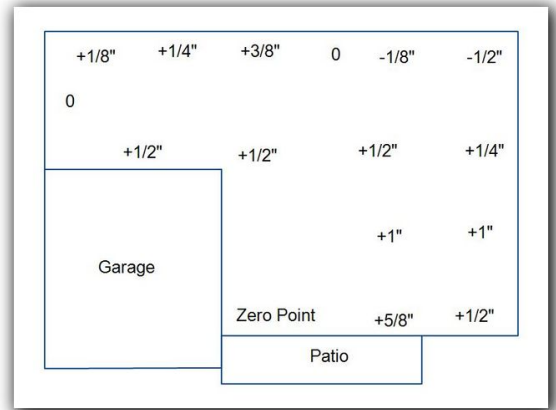
- Cracks noted at the corners of the foundation walls at various locations. These cracks are referred to as "cornerpops" and while not a structural issue at this time, should be repaired to prevent further deterioration.

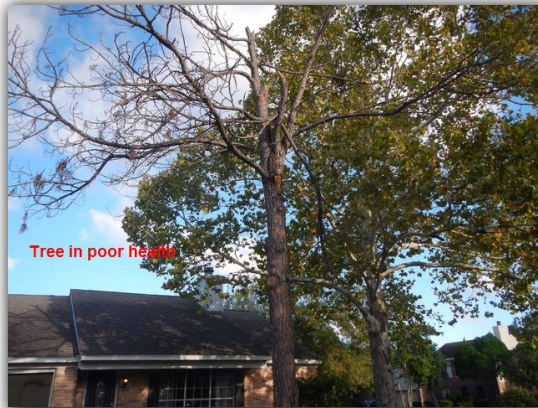
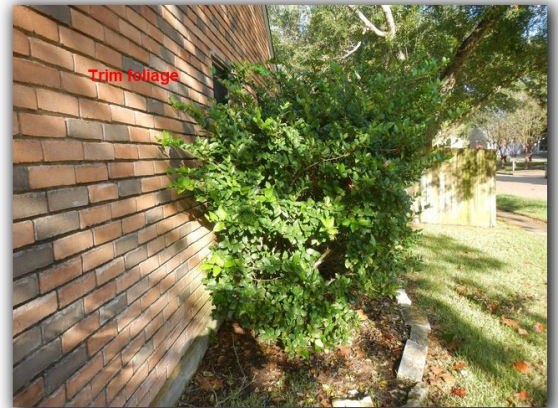
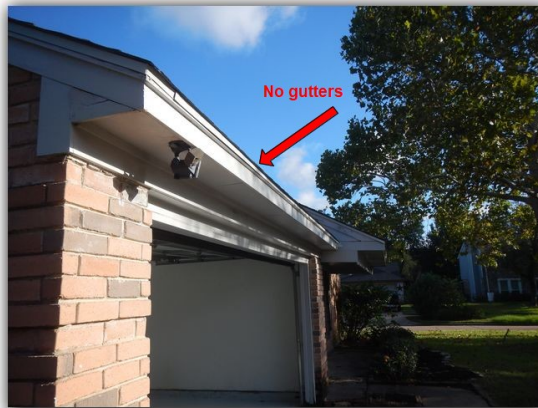
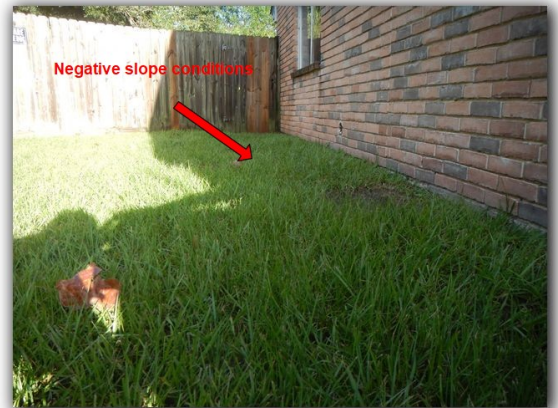
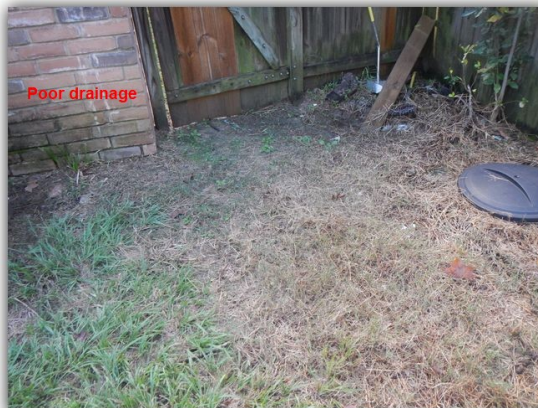
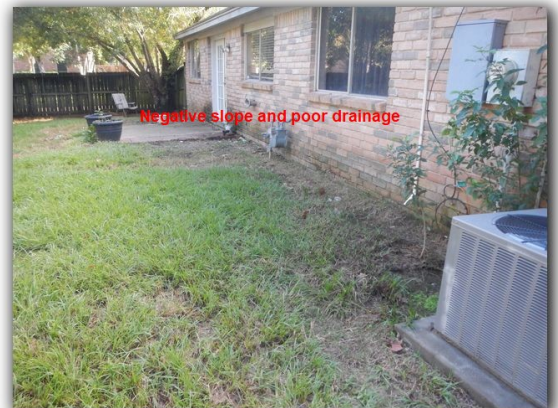
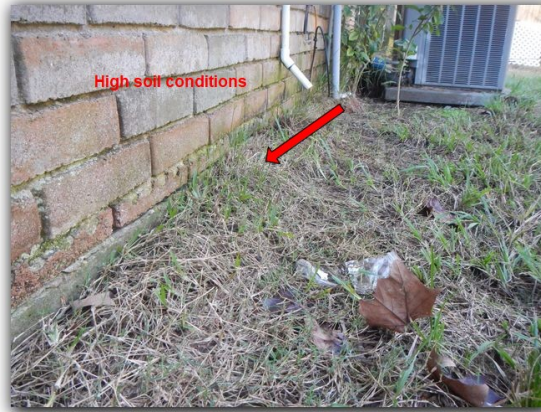
- The pine tree at the front of the home was observed to have been recently trimmed and the overall health of the tree appears poor. Recommend further evaluation and correction as needed. It is likely the tree will need to be removed.

- No gutters were observed to be installed at roof slopes around the home. Gutters are highly recommended and should be installed to prevent soil erosion resulting in standing water near the foundation.

- There appears to be improper grading and drainage of the property at multiple locations around the home. Issues observed include negative slope towards foundation, soil erosion around perimeter of the home, and inadequate slope of the grade around property to ensure proper drainage. Recommend further evaluation and correction of all drainage issues to help promote the health of the foundation.

- High soil conditions observed at various locations around the perimeter of the home. The soil level should be reduced to allow for a minimum of 2-4" of foundation exposure, while still providing positive drainage away from the home. Recommend correction.

I recommend you consult with a qualified, competent landscape contractor to evaluate further, determine the best method of repair, estimate costs, and perform the repairs.

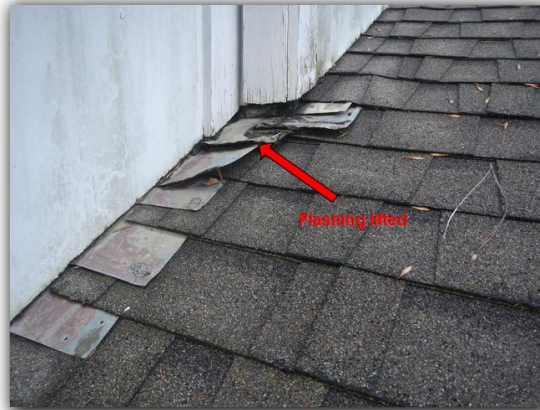
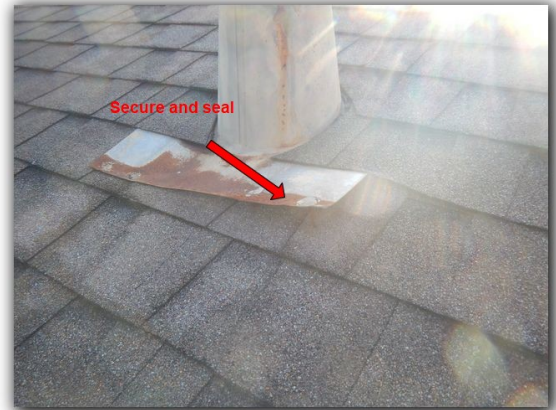
- The flashings at multiple locations around the roof structure were observed to be lifted and need properly secured and sealed.
- Several locations where the nail heads are exposed and need sealed. These locations include around vent jacks, flashings, and hip and ridge caps. Recommend correction as needed.
- Roof leak observed around the chimney structure at time of inspection. See the Ceilings and Floors section of the report for more information.

I recommend you consult with a qualified, competent roofing contractor to evaluate further, determine the best method of repair, estimate costs, and perform the repairs.

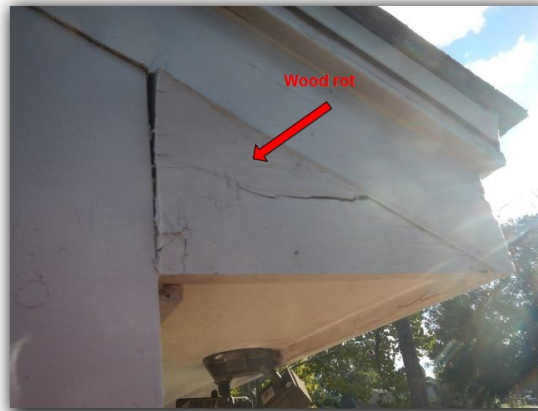
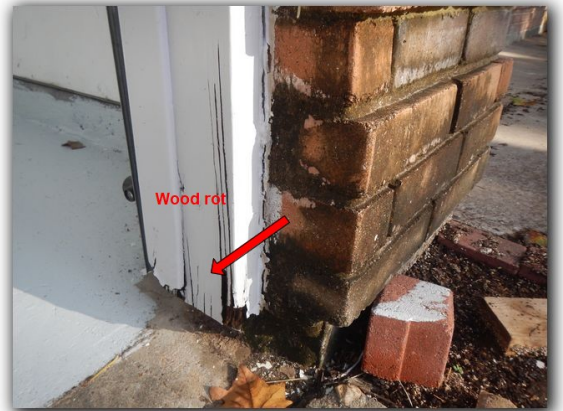
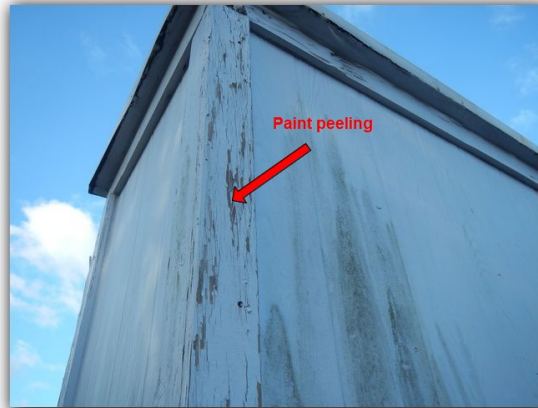
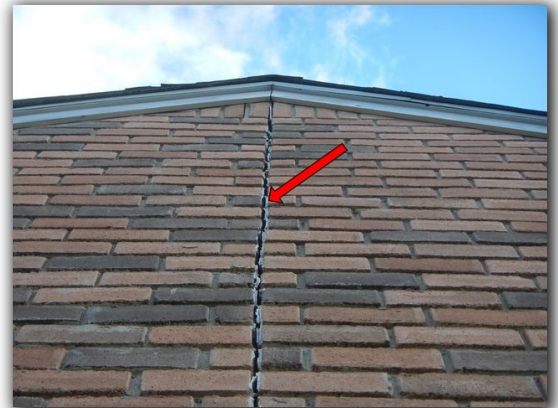
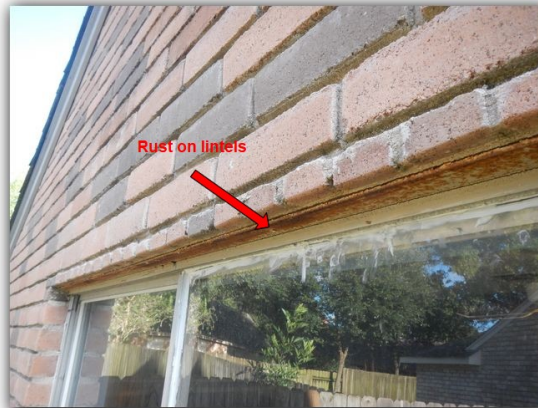
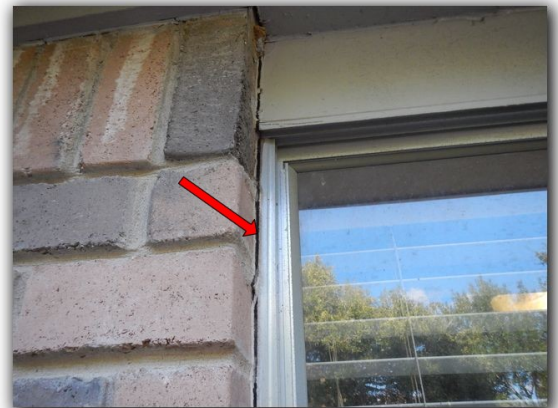
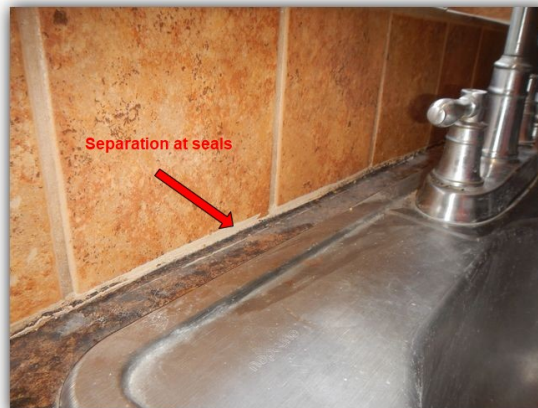
- Wood rot observed to various elements of the siding at multiple locations around the home. These locations include sections of the cornice, garage door trimmers, ceiling and trim elements at the front porch, and siding above the roof line. Recommend further evaluation and correction as needed. The paint on various elements of the siding is worn and needs redone to prevent further deterioration.

- Excessive separation observed in the finish elements around the home, including at the brick control joints as well as around the windows. Caulking and sealing is needed at multiple locations around the exterior of the home, including around all light fixtures, outlets, and any other penetrations through exterior finish. Recommend correction.

- Rusting observed on the steel lintels at multiple openings around the exterior of the home. Recommend these lintels be properly sanded and painted to prevent further deterioration.

- Separation observed in the seals at the kitchen counter and backsplash. Recommend correction.

- Minor damage observed to the drywall at various locations around the interior of the home. Recommend correction as needed.

I recommend you consult with a contractor to evaluate further, determine the best method of repairs, estimate costs, and perform the repairs.

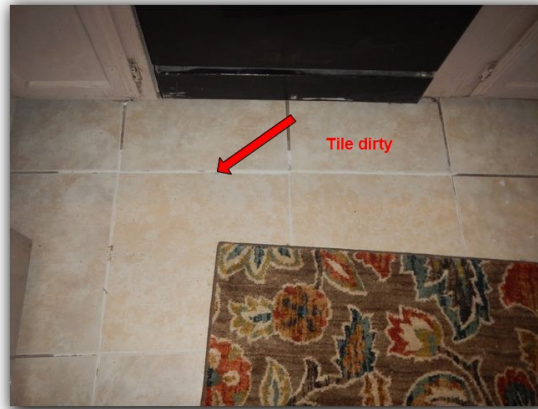
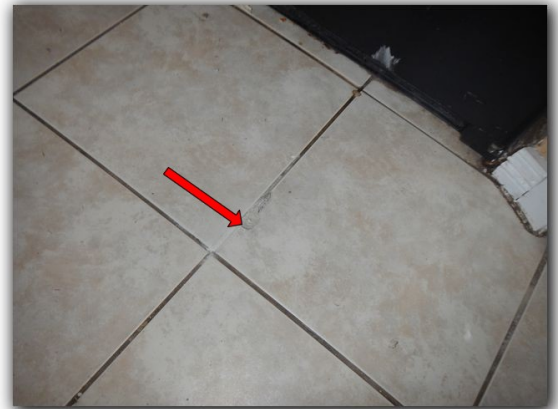
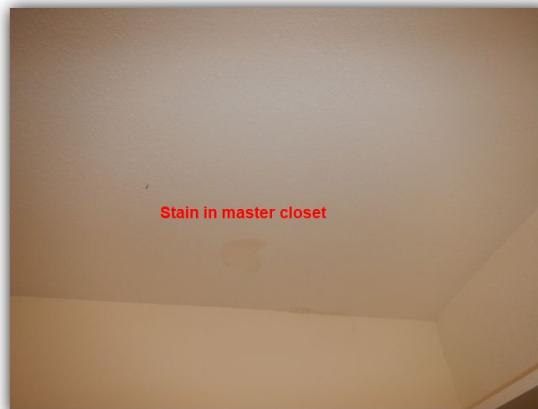
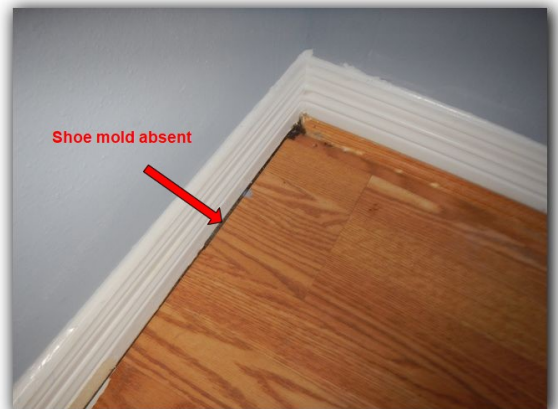
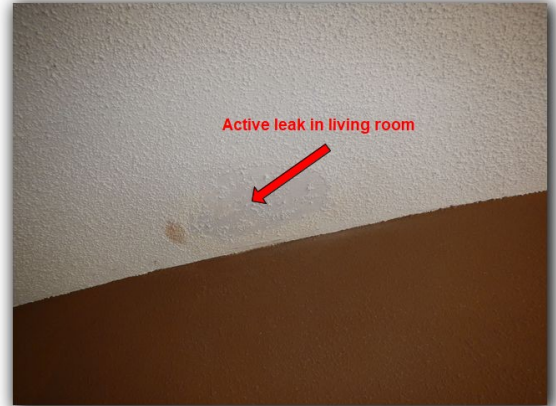
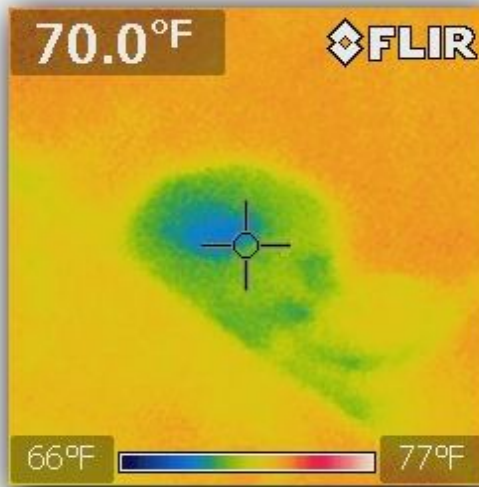
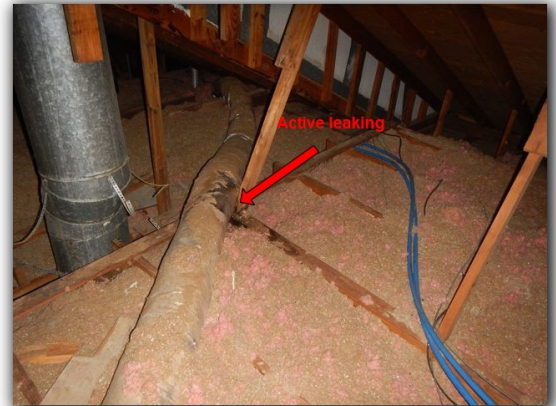
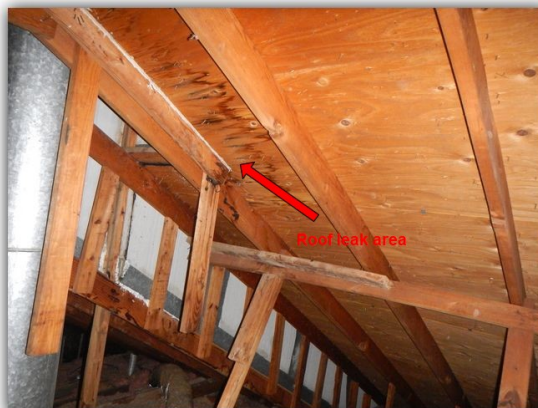
- The tile floor at multiple locations around the home is dirty and needs properly cleaned. Wear and tear damage observed to the laminate floor surfaces at multiple locations around the home. Recommend you budget for cleaning and repair as desired.

- Shoe molding is absent at various locations around the home. Recommend correction as desired.

- Water staining observed at the interior of the home at the ceiling in living room and in the master bedroom closet. Thermal imaging revealed no signs of active moisture at the closet, but the staining in the living room appears to be related to an active roof leak (see thermal imaging below). Recommend further evaluation and correction as needed. Recommend you budget for repair of the leaking issues and cosmetic repair of the affected areas.

I recommend you consult with a contractor to evaluate further, determine the best method of repairs, estimate costs, and perform the repairs.

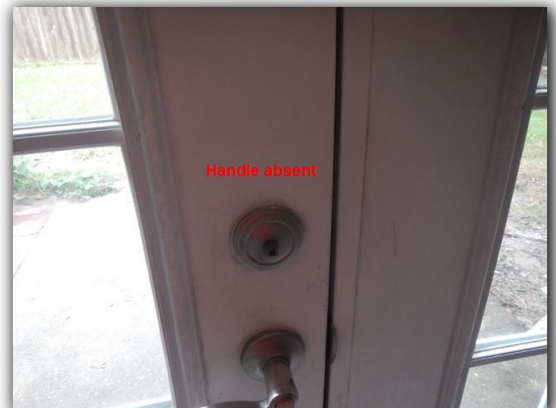
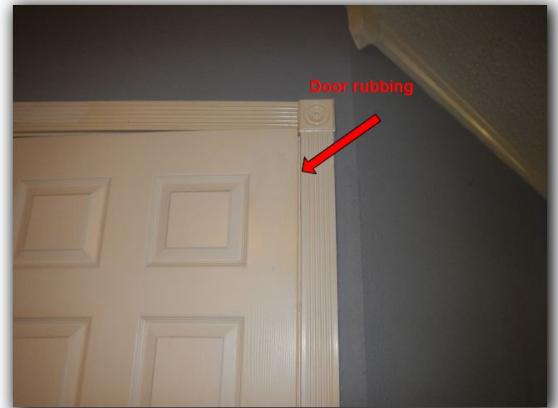
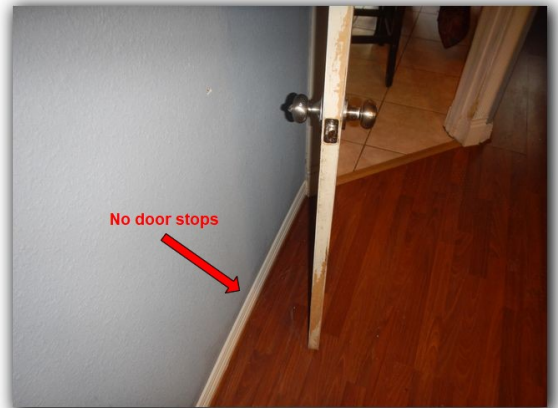
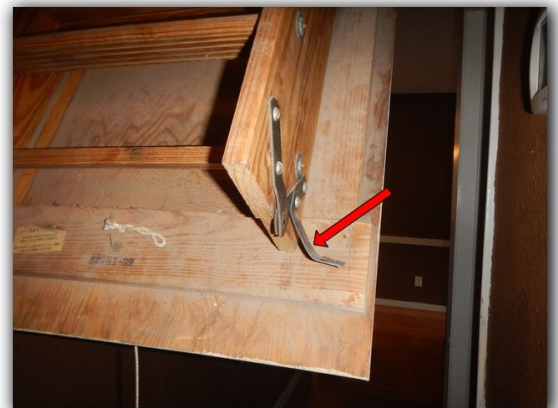
- Wood rot observed to the door assembly at the back exterior door and signs of moisture intrusion observed around the base of the door resulting in water damage to trim components at this location. Damage observed to the door from animals clawing at the door assembly as well. The handle for the dead bolt is absent from the hardware. Recommend further evaluation and correction as needed.

- Several of the interior doors are in need of adjustment. Issues observed include door rubbing inside jamb, not catching properly on strike, damage to the door, or missing stops or damaged hardware. Recommend further evaluation and correction as needed.

- Inadequate weather seal observed installed at section of the interior garage door. Recommend correction.

- The attic access door is not insulated or weather stripped, the hardware on the door is damaged and loose, the ladder is not properly cut, and the door does not seal properly when closed. Recommend correction for safety and energy efficiency reasons.

I recommend you consult with a qualified, competent handyman to evaluate further, determine the best method of repair, estimate costs, and perform the repairs.

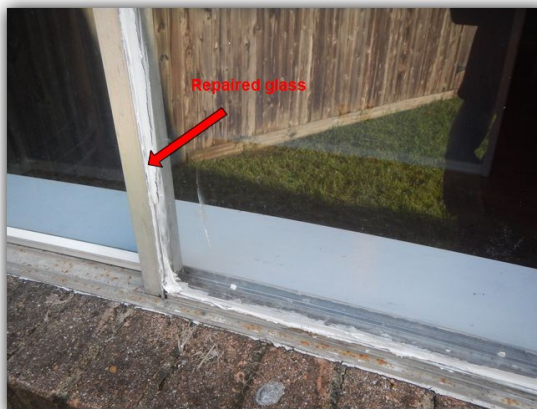
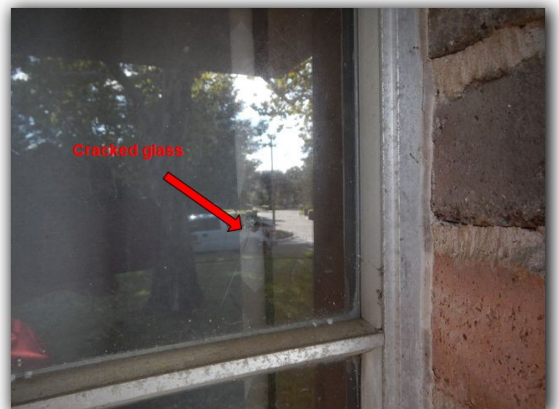
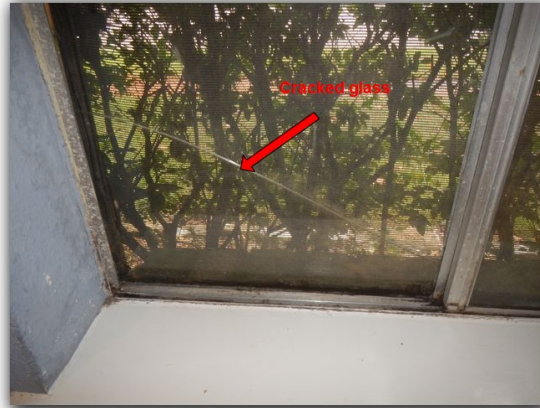
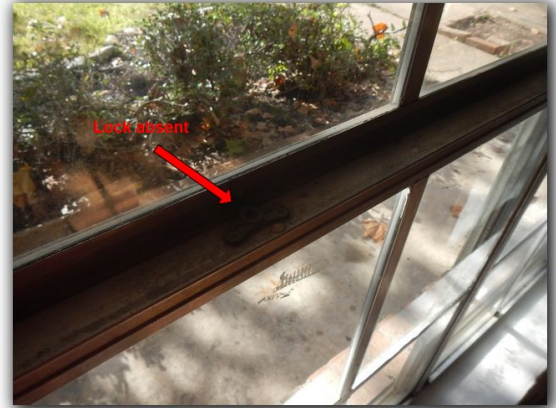
- Repaired piece of glass on window at the left bedroom is not properly secured inside the frame and loose. Recommend correction.
- Cracked glass observed at several windows around the home. Recommend correction as needed.
- Locks absent from multiple windows around the home. Recommend correction as needed.
- Multiple screens for the windows around the home are damaged or absent. Recommend correction as desired.

I recommend you consult with a qualified, competent window company to evaluate further, determine the best method of repair, estimate costs, and perform the repairs.

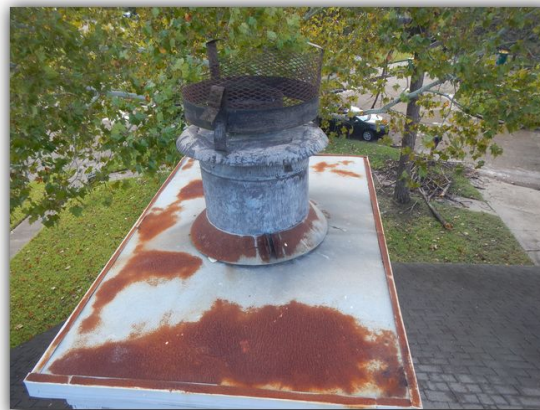
- Damage and excessive rusting observed to the cap assembly on the top of the chimney. I recommend you consult with a qualified, competent contractor to evaluate further, determine the best method of repair, estimate costs, and perform the repairs.

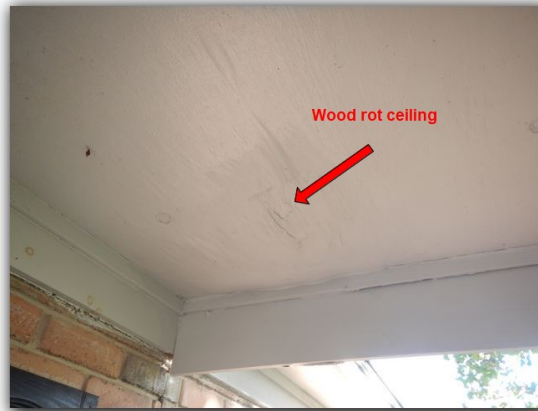
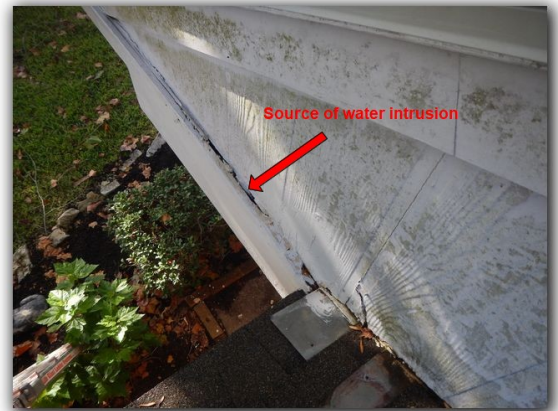
- Wood rot observed to the ceiling at the right side of the front porch. This appears related to roof water discharge at the adjacent roof slope making its way between the trim and siding elements at this location. Recommend further evaluation to ensure no more water is discharged improperly and repair of all areas of wood rot. I recommend you consult with a contractor to evaluate further, determine the best method of repairs, estimate costs, and perform the repairs.

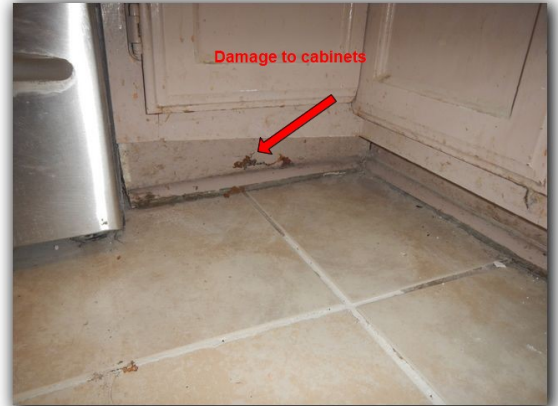
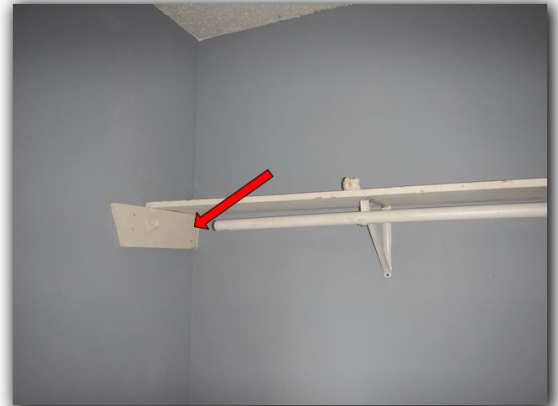
- Sections of the fencing around the home are damaged and need repaired. Recommend further evaluation and correction as needed.

- Extensive rodent (mice) infestation has been observed in the kitchen space. Excessive amounts of droppings observed in the cabinets, pantry, and in the oven unit. Damage observed to the cabinets at various locations. Recommend further evaluation to manage the rodent infestation, properly clean and disinfect all affected areas, and budget for repair/painting of the cabinets and other related damaged components.

- Clothes rod at the left bedroom closet area is not cut properly. Recommend correction as desired.

I recommend you consult with a contractor to evaluate further, determine the best method of repairs, estimate costs, and perform the repairs.

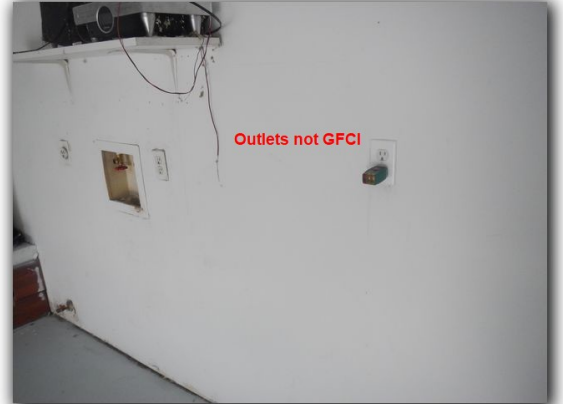
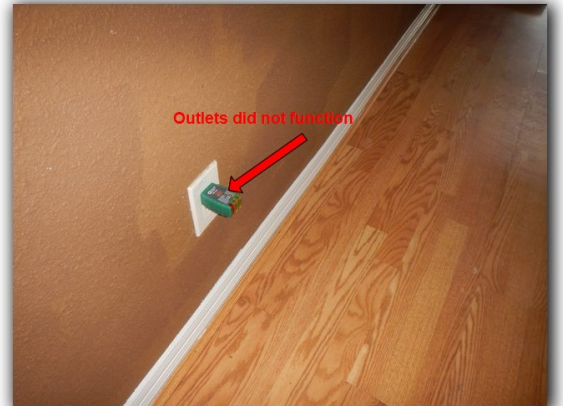
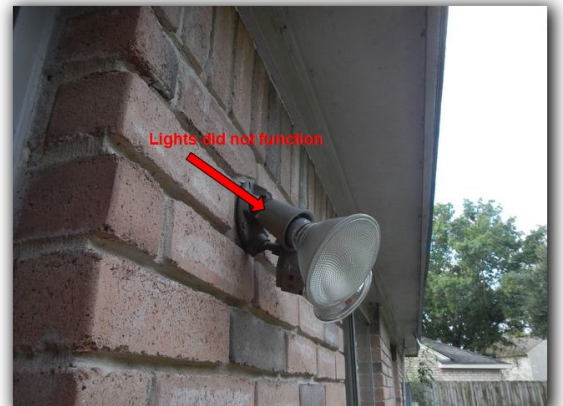
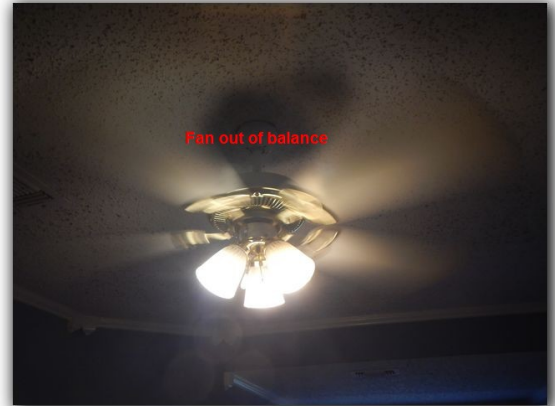
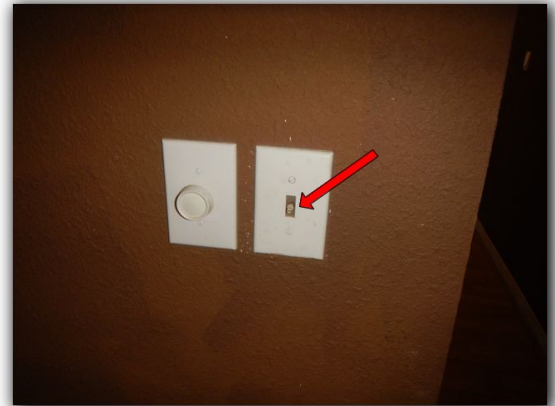
- The doorbell at the home is absent. Recommend correction as needed.
- No GFCI (Ground Fault Circuit Interrupt) protection is present for some the outlets at the "wet areas" around the home. This includes all outlets at the exterior, kitchen counters, garage, bathrooms, and laundry room. Modern codes require GFCI protection at ALL outlets at these locations. I highly recommend that you consider upgrading outlets at all applicable locations to GFCI protected for safety reasons.

- The GFCI outlets at the kitchen counter area did not function properly at time of inspection and would not reset after being tripped. Recommend further evaluation and correction as needed.

- Several of the outlets in the living room did not function at time of inspection. Recommend further evaluation and correction as needed.
- The bulbs in the closets are bare incandescent light fixtures. I highly recommend you consider replacing these lights with globe protected type for fire safety reasons.

- Several of the lights around the home did not function at time of inspection, potential bulb related issues. Some of the ceiling fans were observed to be out of balance or missing the pull string components. Recommend correction as needed.

- Several of the cover plates around the home are damaged or absent. The dimmer switches at the living room are missing pieces and not functioning properly. Recommend further evaluation and correction as needed.

- Smoke alarms not present at all required locations and existing units appear aged. Recommend installation of new units at all required location and installation of a carbon monoxide alarm.

I recommend you consult with a licensed, qualified electrical contractor to evaluate further, determine the best method of repair, estimate costs, and perform the repairs.

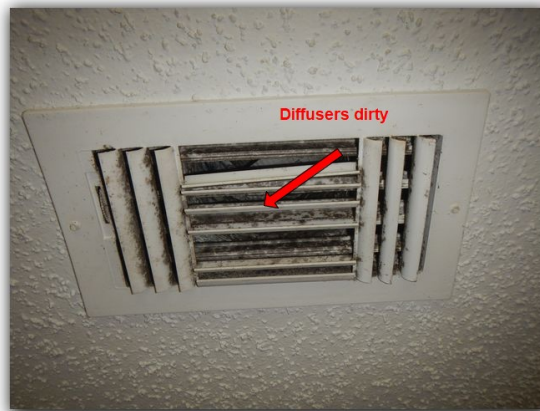
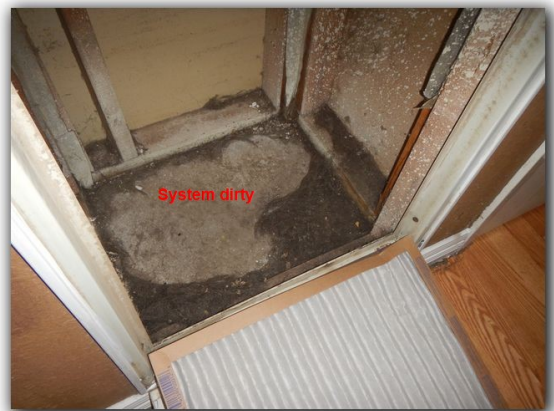
- The system shows signs of being excessively dirty. I highly recommend you budget for professional cleaning/service of the ducts and cleaning or replacement of the air diffusers around the home. I recommend you consult with a contractor to evaluate further, determine the best method of repairs, estimate costs, and perform the repairs.

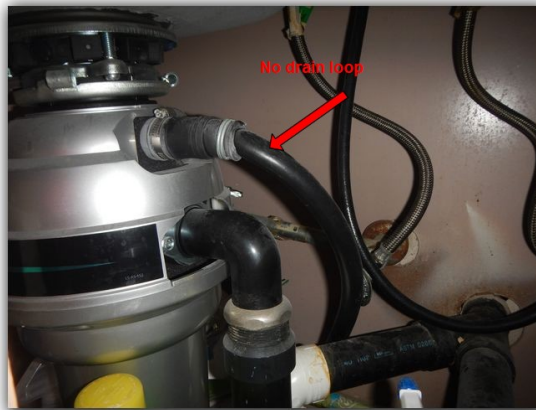
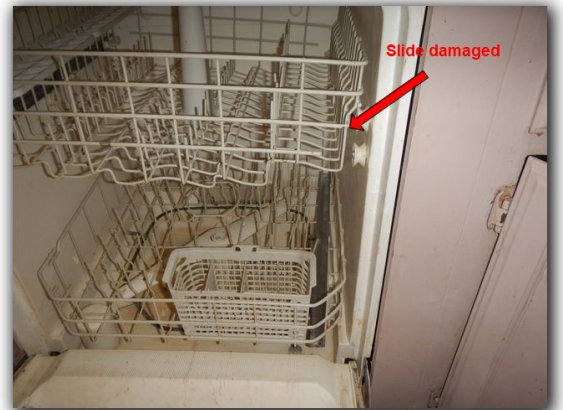
- The slide for the upper rack is damaged and rust displayed on the racks. Recommend correction.

While the dishwasher was performing as intended, due to the age and condition of the unit, I recommend you budget for replacement.

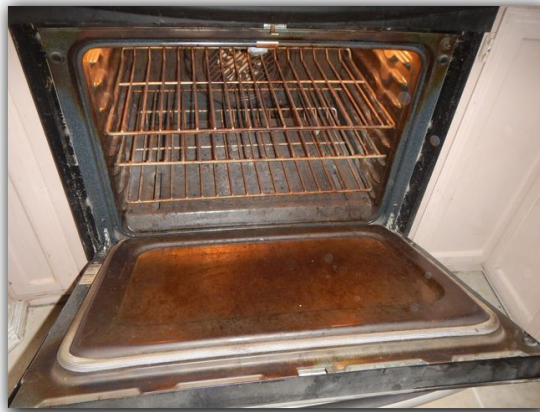
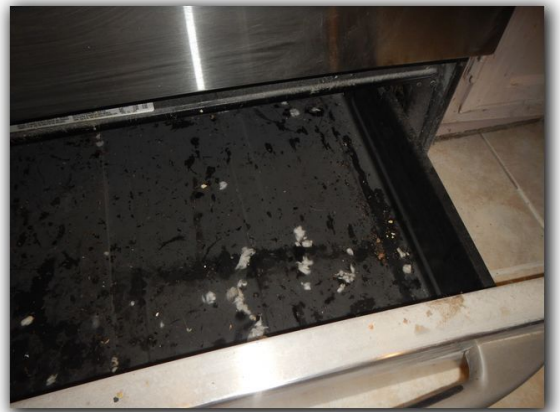
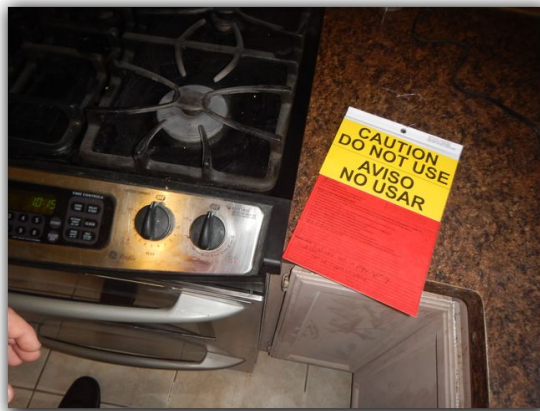
- The oven was not operational at time of inspection. The unit is excessively dirty and shows signs of rodent infestation in the form of droppings in the unit. Recommend you budget for replacement or extensive cleaning and disinfecting.

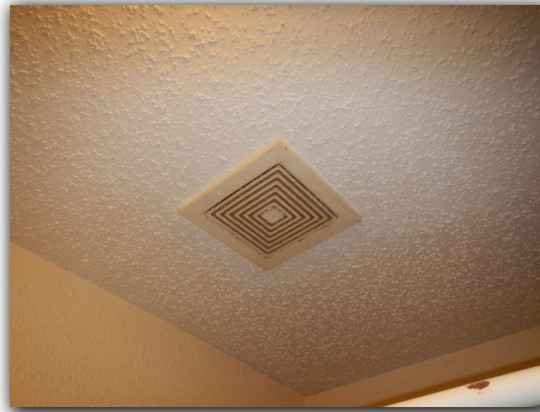
- The unit in the master bathroom is not functioning at time of inspection. Recommend further evaluation and correction as needed.

Note: The units are not vented to the exterior of the home. Modern codes require that the units be vented to the exterior of the home. Recommend you consider correction to ensure all exhaust goes to the exterior of the home.

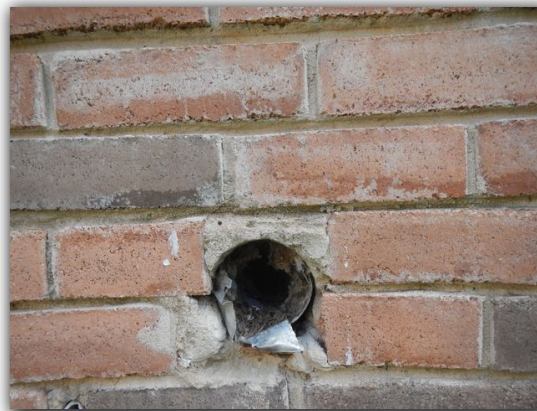
- No dryer vent cap in place on the unit. The duct shows excessive amounts of debris in the unit and excessive lint build up observed in the area below the water heater unit. Recommend further evaluation and correction as needed.
