PROPERTY INSPECTION REPORT

Prepared For:	Jill Zavaleta			
		(Name	e of Client)	
Concerning:	13110 Blue Flora			
		(Address or Other Identification	cation of Inspected Property)	
Ву:	Chris Kanyuck	#7449		04/28/2021
	,			(Date)
(Name, License Number and Signature of Sponsoring Inspector, if required))

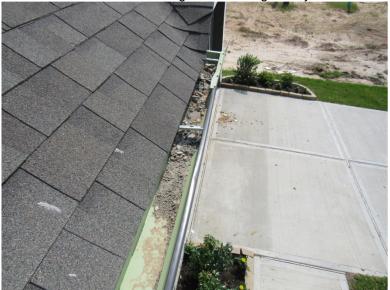
The swales (in effect, a wide and shallow ditch) on the left side of the home appear to have areas that will hold water. Proper drainage of the side yard to the street is needed. The drainage swale should be improved to divert storm water away from the house and ultimately off the lot.

The gutters have construction debris in them and are in need of cleaning in order to properly drain.

Splashblocks or extensions are required at the end of the gutter downspouts to avoid soil erosion and to discharge roof drainage away from the foundation. IRC R801.3

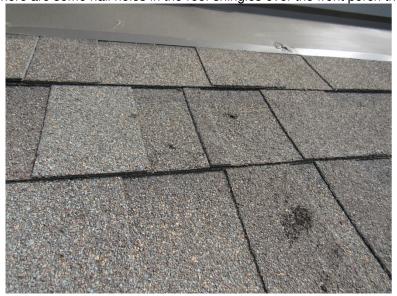
There are some nail holes in the roof shingles over the front porch that needs to be sealed.

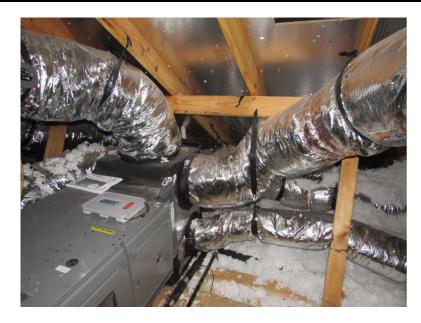
Additional soffit vents are needed at the back of the home and for the garage attic. Proper ventilation will help to keep the house cooler during warm weather and extend the life of roofing materials. This should be done in accordance to the IRC R806

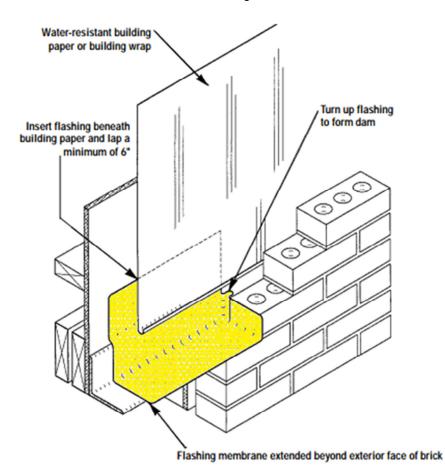
Flashing Detail

Properly installed flashing was not observed over the garage door steel lintel. This flashing was observed to be installed over the windows but not over the garage door. This flashing should be installed to help protect the garage door lintel. [ref: TREC 535.228(k)(2)(E)(iii); IRC R703 Flashing.

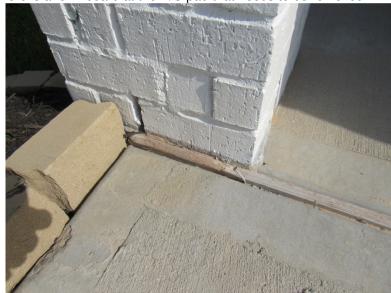
driveway and walkway to the home. 1/2" asphalt board should have been installed in this area. It is hard at best to add asphalt board after the concrete has been laid. There are sealant materials that can easily fill these voids after the wood has been removed.

The wrong type of form material (wood) has been used between the foundation at the

There is a section of the sidewalk that is cracked. This section of the sidewalk would need to be replaced for a repair.

There is a form board at the A/C pad that needs to be removed.

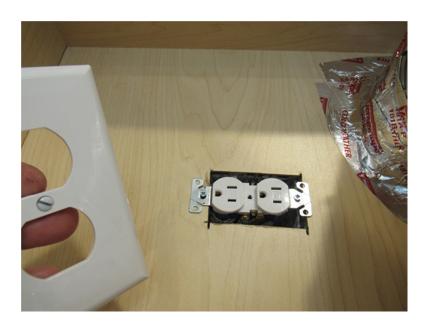
The outlet in the cabinet over the microwave is not properly installed. A surface extension is needed to help protect the finished surface from the potential of fire.

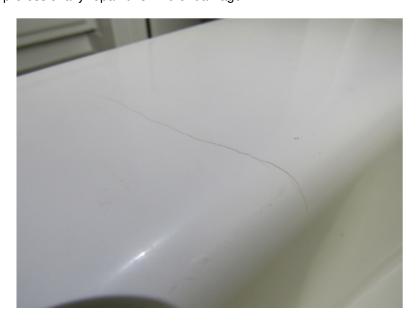
The master tub has been cracked and is in need of repair. There are companies that can professionally repair this kind of damage.

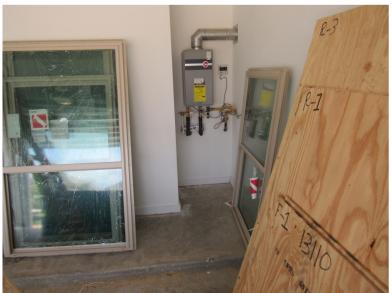
The condensate drain has not been installed. This should be installed as described in the installation instructions.

Condensate formation can occur in high efficiency direct vent appliances. Without proper drainage, this condensation can damage the heat exchanger.
