Inspection Report

PROPERTY INSPECTION REPORT

Concerning: 645 Davis Rd., League City, TX
(Address or Other Identification of Inspected Property)

By: Brad Leland, Lic #TREC #5229 10/04/2017
(Name and License Number of Inspector) (Date)

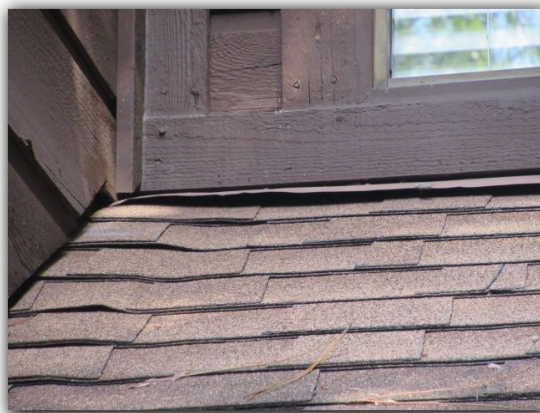
Comments: The flashing has lifted above the plane of the roof line at the lower roof in the front of the home. This condition is considered a conducive condition for water penetration and can be uplifted in high winds. Securing/sealing the flashing is recommended.

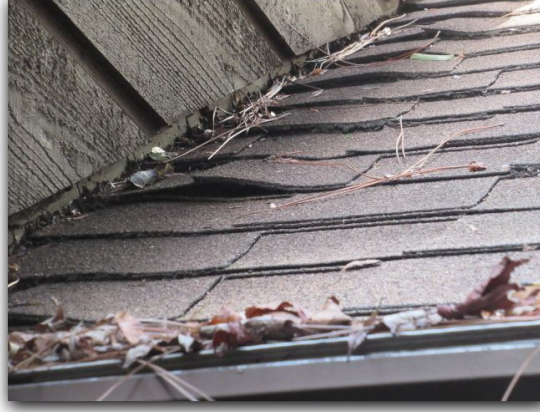
There are lifted shingles that may be caused by nails backing out on the lower roof in front of the home. A qualified roofing contractor should be consulted regarding this condition.

A qualified roofing contractor should be consulted regarding the repair of the above items as well as check the entire roof covering for any other possible defects.

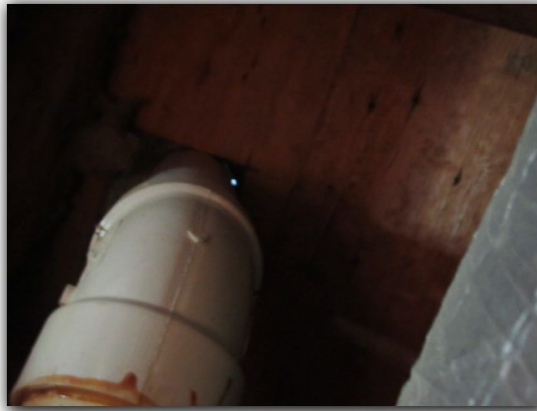
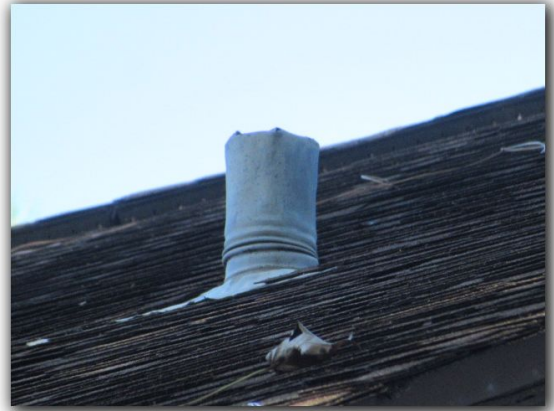
Plumbing drain vent pipe/pipes are not sealed as daylight can be seen in the attic area. This will allow rain water to enter this/these areas.

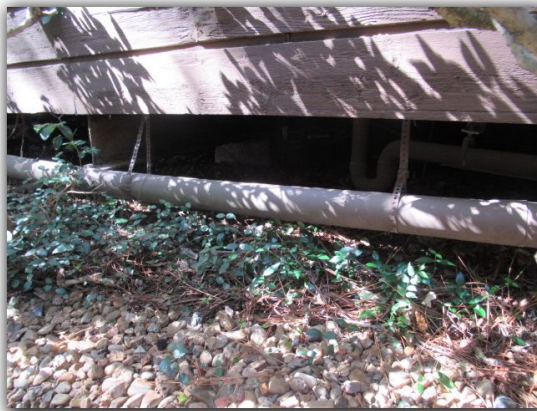
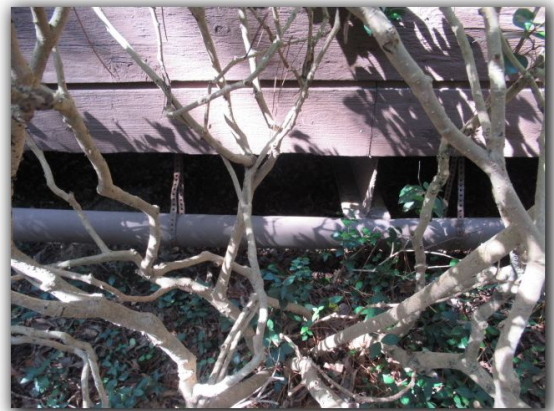
The drain pipes for the gutter system were not sloped properly in some areas.

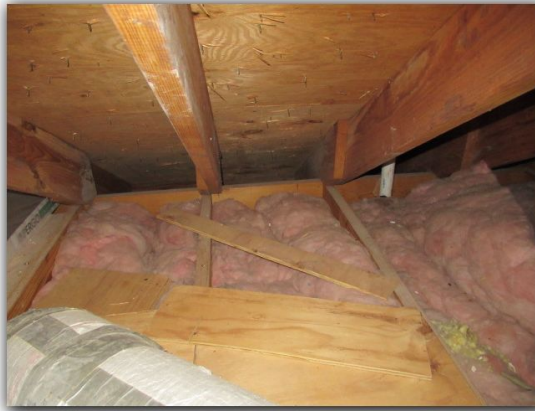
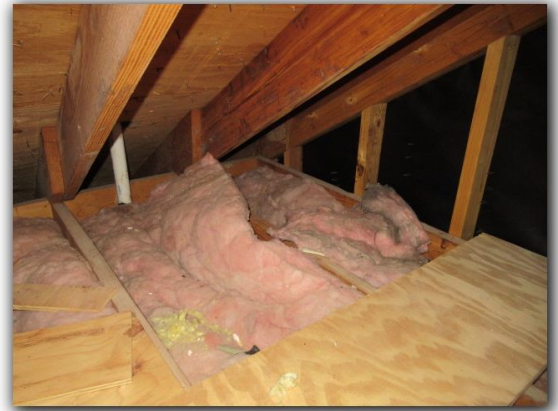
Comments: The insulation on the attic floor appeared thin to meet minimum current standards (R-30, 113/4"). It is recommended that additional insulation be added for energy efficiency.

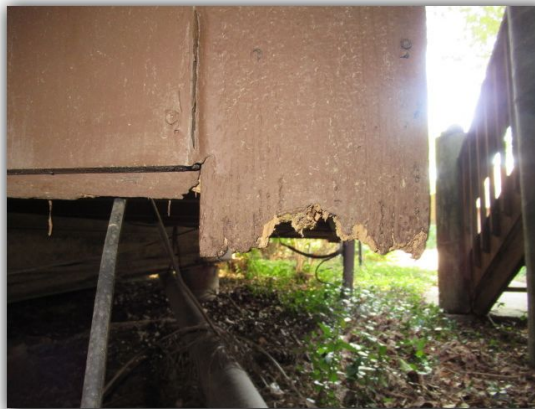
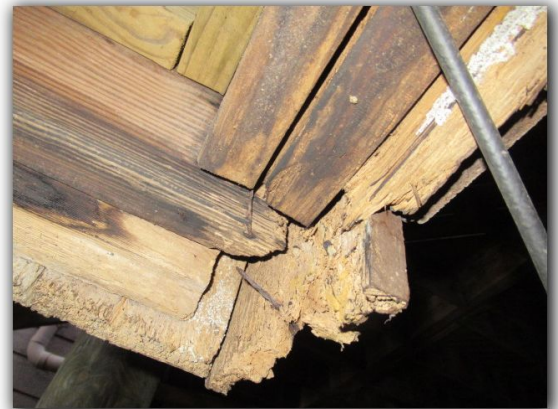
Comments: There is water damage to the exterior siding/trim outside the front bedroom. All damaged material should be repaired/replaced.

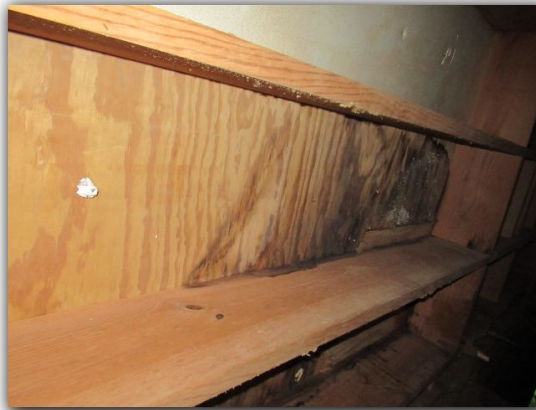
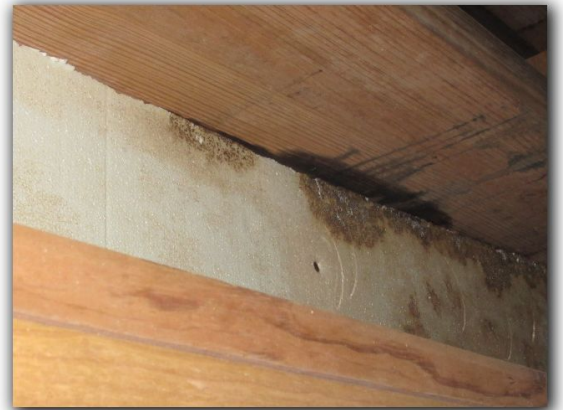
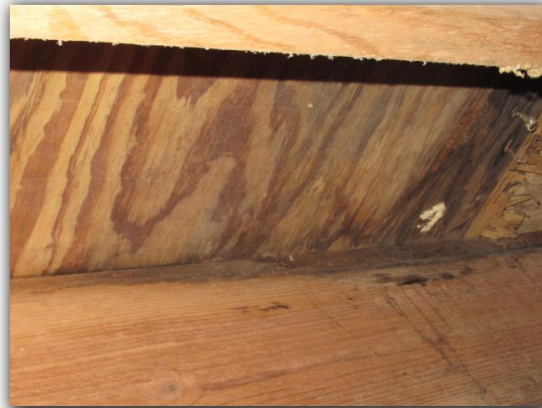
Comments: There are water stains/water damage and previous repairs to the subfloor/floor structure under the water heater, washer and dryer location. All damaged material should be replaced by a qualified contractor.

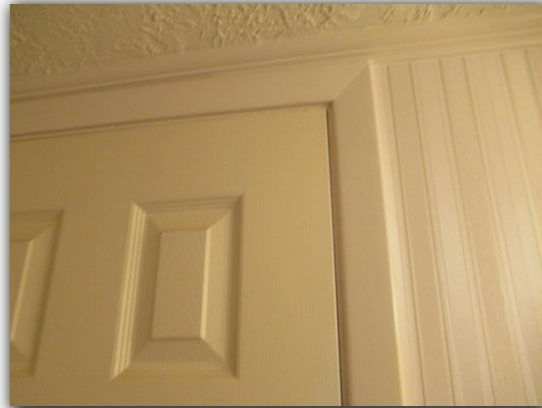
Comments: The hall bathroom door sticks when operated. All doors should be present and in working order. Doors that stick or do not latch properly can usually be adjusted. In most cases, doors that stick or do not latch properly are an indication of past movement in the structure.

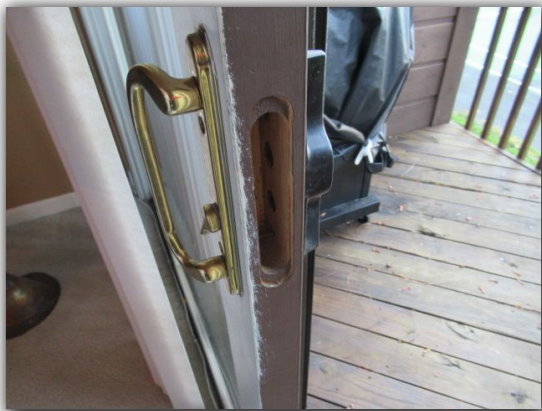
The latch for the living room sliding door was not complete.

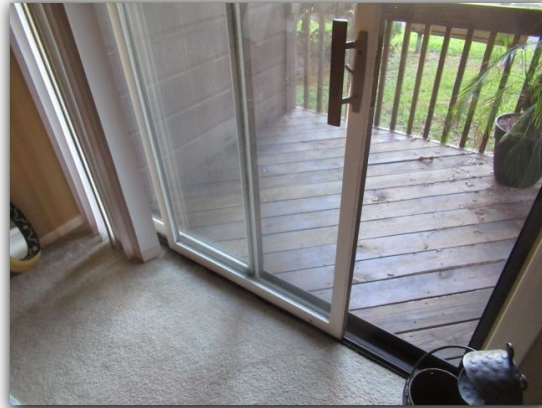
The downstairs sliding door does not open easily.

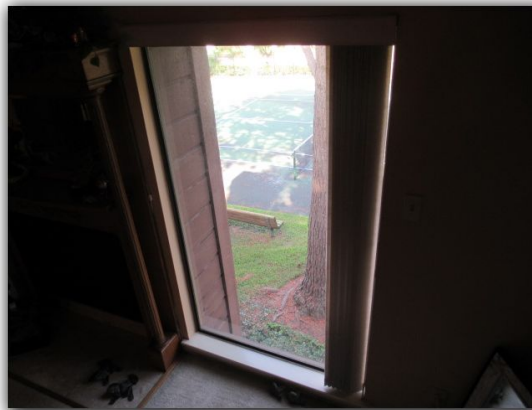
Comments: The picture window in the living room is now required to be made from safety glass. All windows that are below 18" from the floor and greater than nine square feet and also all windows within 24' of doors and bathroom windows are required to be a safety glass type for the safety of the occupants. I could not find/observe markings on the glass panel(s) of the window(s) within 24 inches of the arc of closed door to indicate the presence of required tempered/safety glass with is a recognized safety hazard and code requirement. Ref. CABO 308.4.6 UBC 2406.4.6 IRC R308.4.6

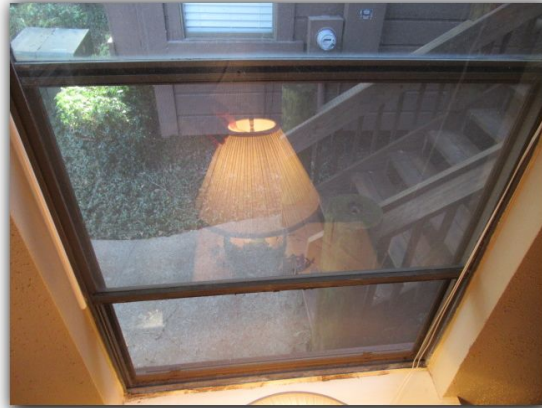
The front window in the downstairs front bedroom would not open completely.

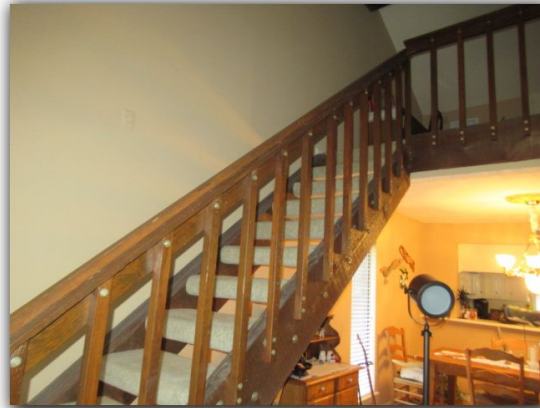
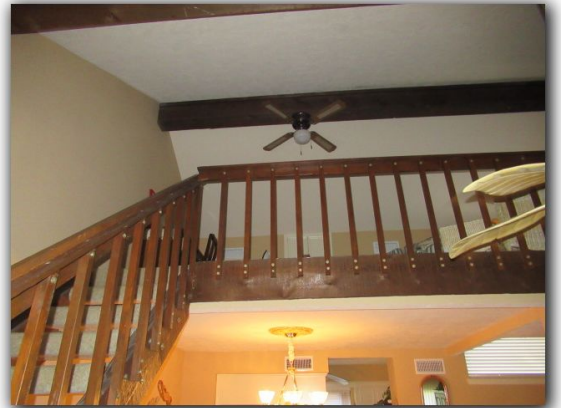
Comment: The banister and baluster spacing is insufficient at the staircase and loft handrail. If the spacing of these posts is more than 4" we mention it in our report as a courtesy to our clients because it may be a safety concern with regard to small children.

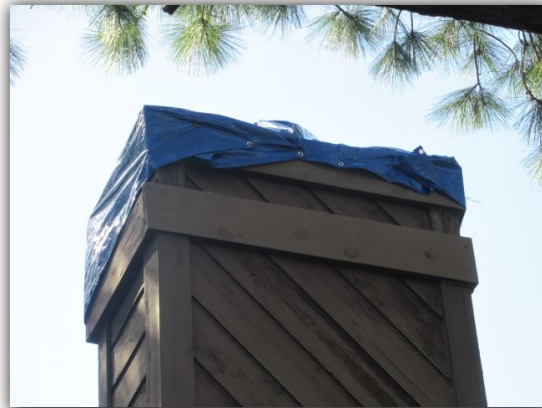
Comments: The chimney cap is covered with a tarp which is an indication of a leak in this area.

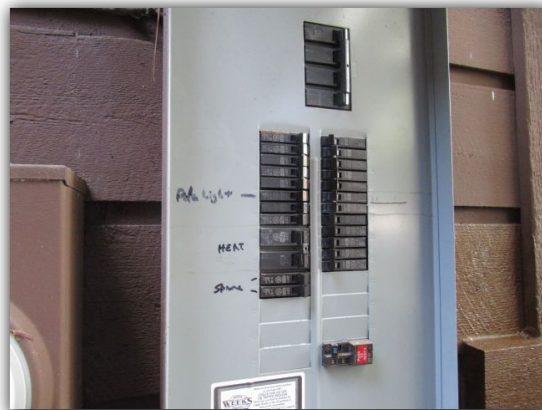
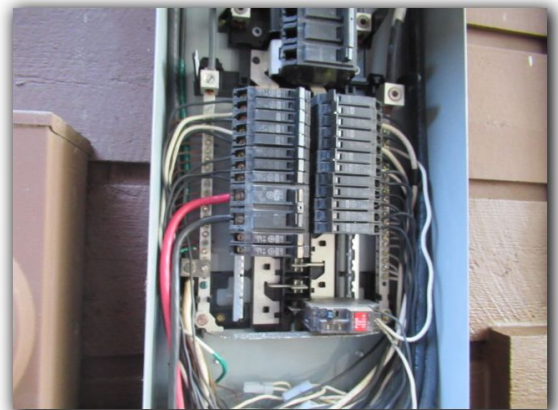
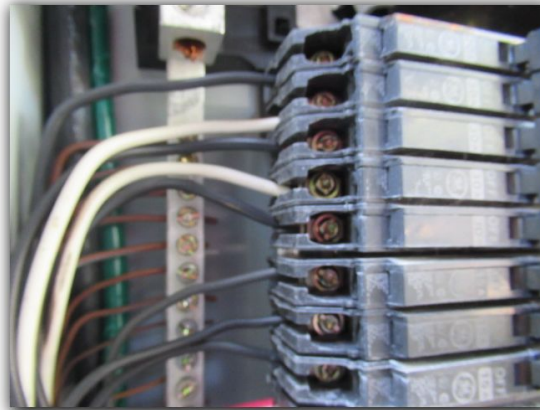
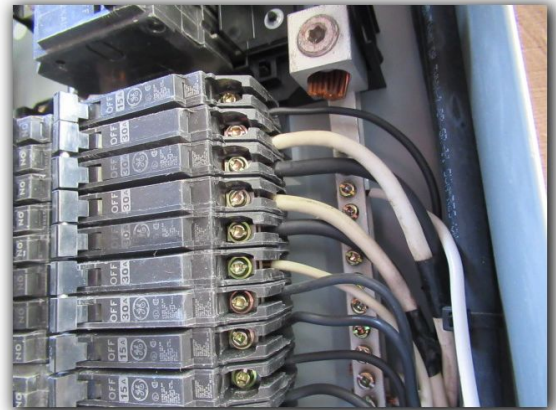
Comments: White wires were used as a "hot" wire and are connected to a circuit breaker. In most instances the white wires are the grounded conductors, and if they are used as a "hot" wire, they must be wrapped with black or red tape to identify them as a "hot" wire.

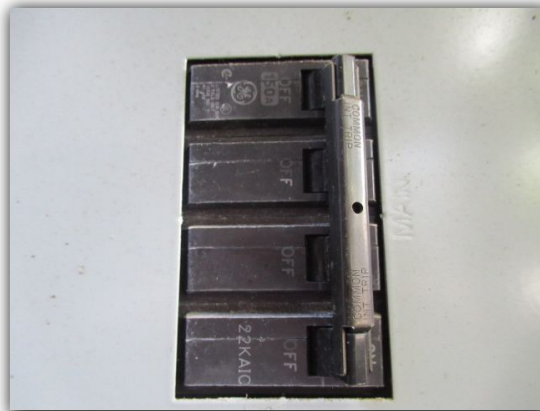
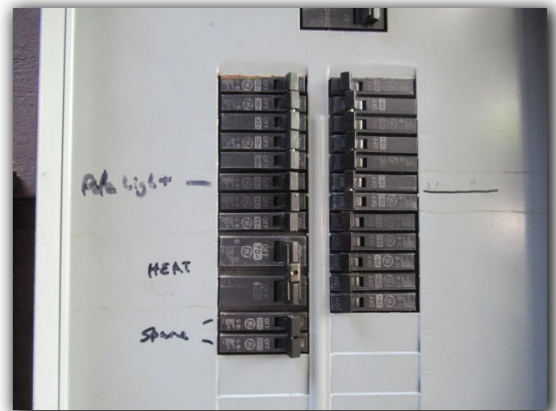
The breakers were not labeled completely at the service box as required.

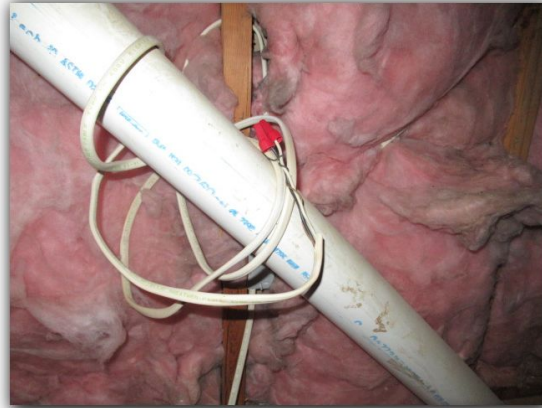
Comments: Wires were improperly terminated in the attic and in the return air chase. Wire ends or splices should be in junction boxes that are properly mounted. This condition is considered an electrocution/fire concern and should be serviced by a licensed electrician.

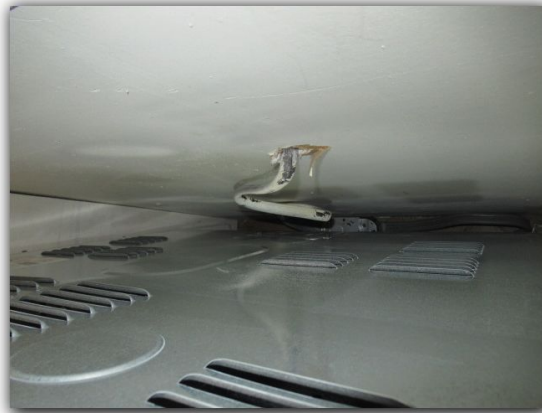
The 220 outlet box for the range was not secured to the wall.

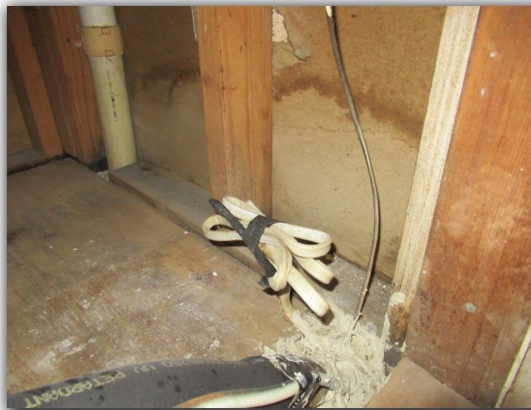
Comments: Wires were found in the return air chase. Wires in the air chases can distribute toxic gassed in the event of an electrical fire or short circuit. The electrical wiring should be sealed away from the breathable air supply.

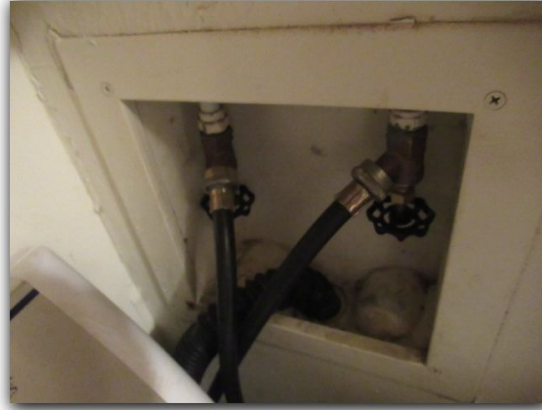
Comments: The hot and cold water supply valve handles have not been distinguished at the washing machine hook up location (either identified or color coded - red /hot, blue/cold.

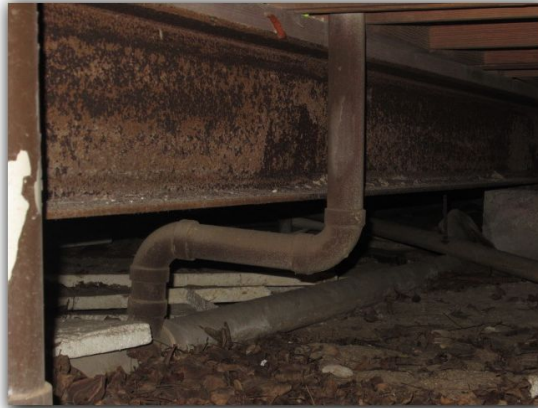
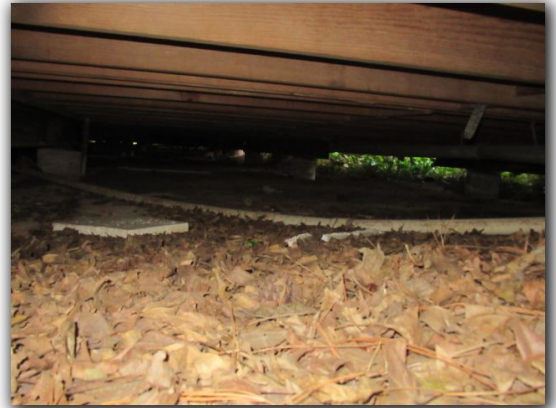
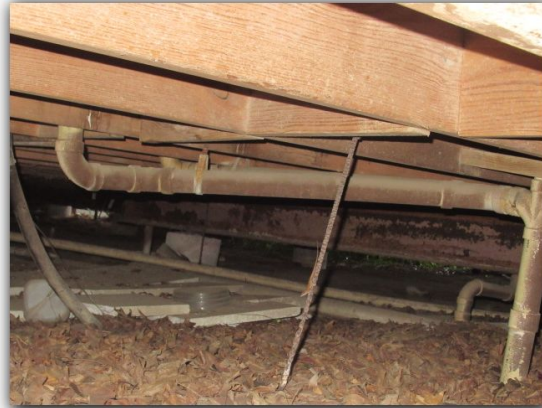
Comments: Drain pipes under the home are not sloped positively.

A qualified plumber should be consulted regarding the repair of the above items as well as check the entire plumbing drain system for any other possible defects.

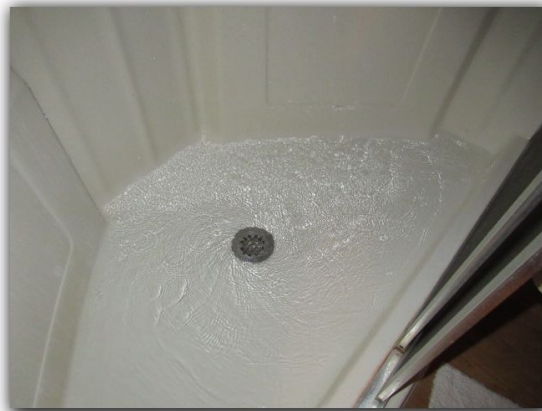
The master bathroom shower was slow to drain. This is an indication that there is an obstruction in the drain line.

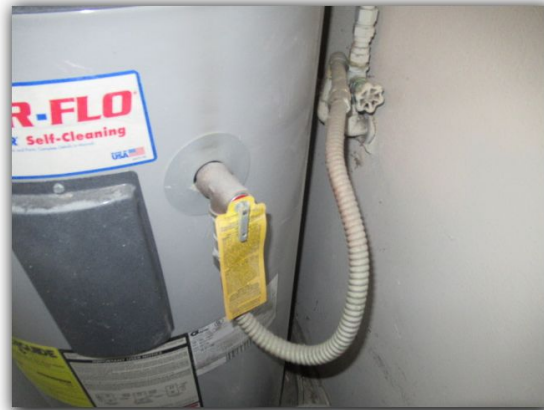
Comments: The temperature and pressure relief valve should drain into a line that is plumbed to the outside and may go horizontally or down, but cannot go back up. (This keeps debris from going back to the valve) This line can be 3/4" C.P.V.C Plastic (not reduced in size) and should terminate from 2 to 6 inches from the ground.

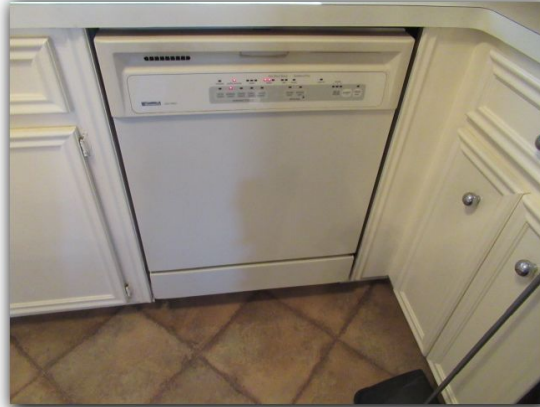
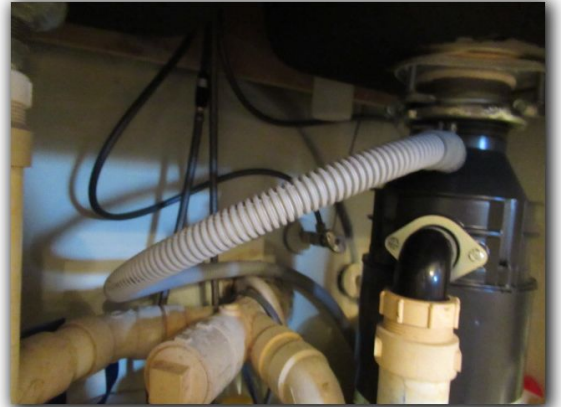
Comments: The dishwasher drain line (discharge hose) did not have an anti-siphon valve or a vacuum break. The dishwasher drain line usually attaches to the garbage disposal. The drain line should arch above the level of the sink drain, have an anti-siphon valve, or have a vacuum break. This keeps debris in the disposal from siphoning back to the clean dishes. The drain lines should be elevated or a back flow device installed.

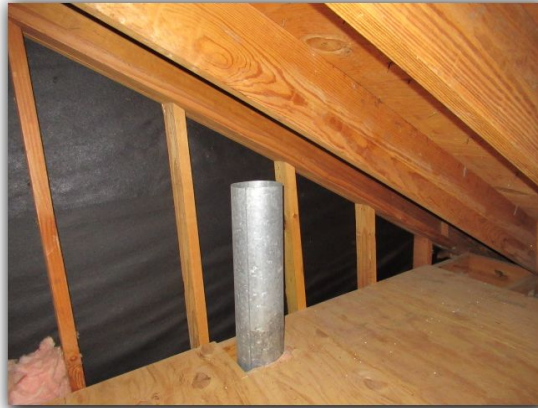
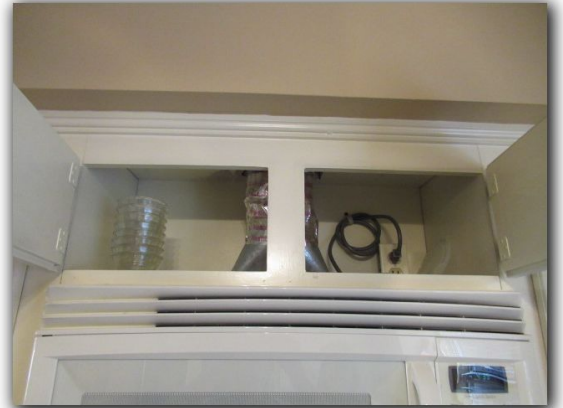
Comments: The range exhaust fan vent duct terminates inside the attic. This condition adds moisture, grease, heat and odors in the attic. The exhaust vent should terminate near one of the roof vents. Additional duct material can be purchased at most home improvement stores.

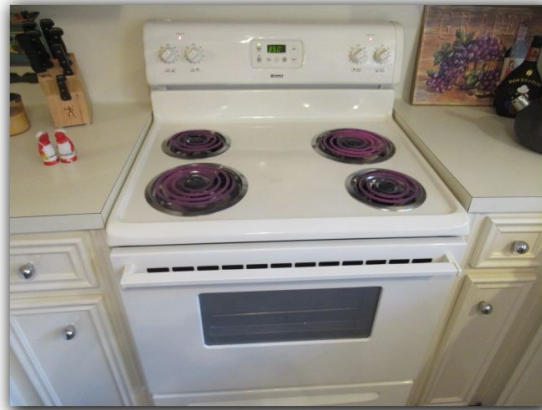
Comments: The range is not secured to the surrounding cabinet or wall and the anti tip device is not securing the range as intended. Children can tip the oven over if the door is used as a stepping stool. All ovens are now required to be secured in some fashion. An anti-tip device should be installed.

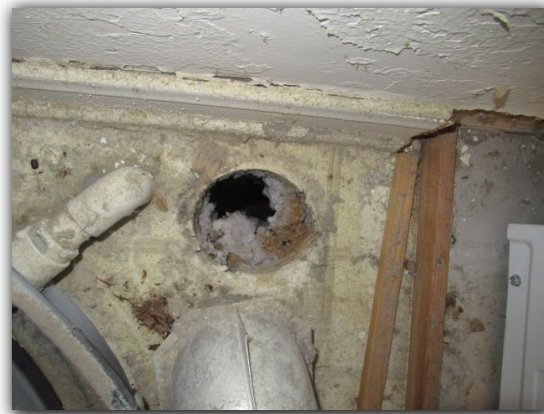
Comments: The dryer vent terminates at the floor which is not an ideal condition as this adds moisture and a build up of lint in this area.
