HEDDERMAN SERVICES

MECHANICAL INSPECTION

11010 Wickersham Ln
Houston TX 77042

MARCH 4, 2021

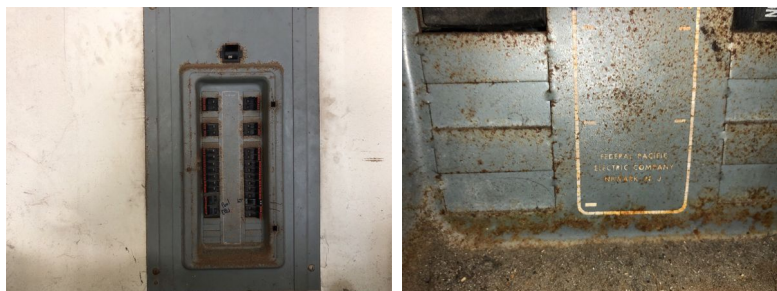
It is a general recommendation that all circuit breakers be tripped off and on at least once a year to ensure that they are still physically able to trip off. Occasionally, the points on a breaker will fuse to the main bus in the panel, preventing the breaker from tripping off, even if there is an overload on the circuit. If this condition occurs, it can be a fire hazard. This is particularly true on Federal Pacific Electric breaker panels, as they are well known in the industry for having this problem. It is recommended that an electrician be contacted to provide a cost estimate to replace the breaker panel, as Federal Pacific has lost their UL Listing, and are no longer manufactured in the USA. It is recommended that you research Federal Pacific breaker panels online for further documentation regarding these conditions.

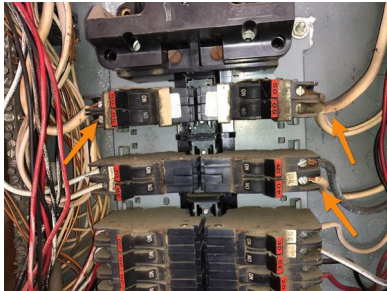
3: Power Wire - White insulation

We observed one or more white wires that were used as a power wires, and were connected to a circuit breaker. Typically, the white wires are the grounded/neutral conductors, and if they are used as a power conductor, they must be permanently marked or wrapped with black or red tape to identify them

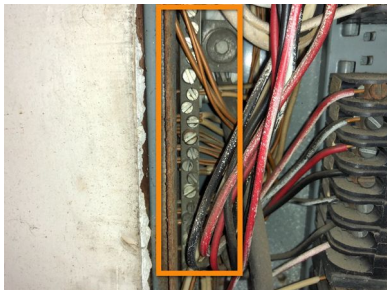
The aluminum conductors were not coated with an anti-oxidation solution. This can allow the conductor connections to oxidize, which can be a fire hazard.

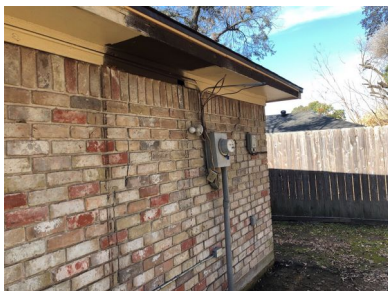
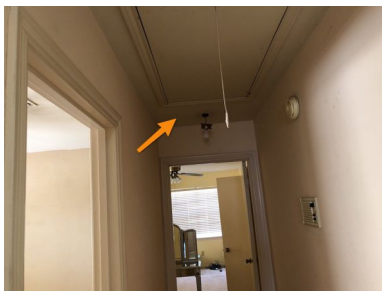
2nd Floor Hallway

A light fixture that was non-functional when the switch was on was observed. The problem may be a burned out bulb, defective light fixture, or defective switch.

Further investigation is recommended.

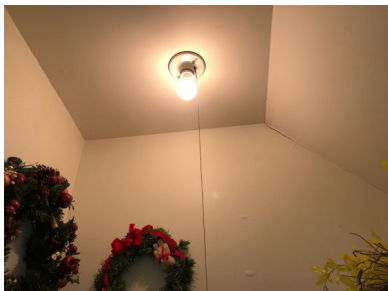
Throughout house

6: Light Fixture - Closet missing cover

One or more of the closet light fixtures are missing covers. For safety purposes, it is recommended that protective covers be installed over the bare bulbs.

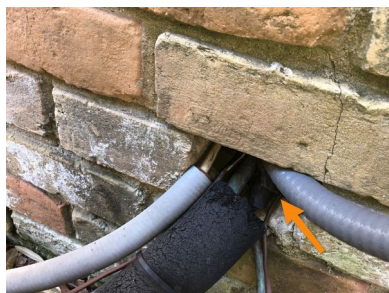
4: Primary Drain Line - Terminated outside

The primary condensate drain line terminates outside at the side of the foundation. Over time, the constant moisture that is produced by the HVAC system and emptied onto the ground can contribute to foundation settlement. The drain line should be rerouted to an approved location.

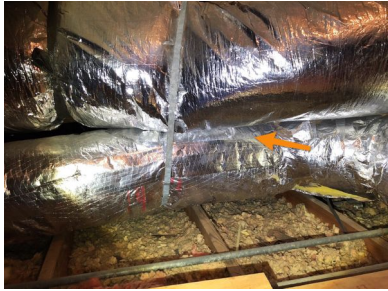
1: Ducts - No clearance between ducts

We observed that some of the air ducts in the attic were in contact with each other, which can cause condensation to form on the outside of the ductwork. It is recommended that the ducts that are touching be separated. Typically, this is done by inserting a piece of fiberglass batt insulation or duct board between the ducts.

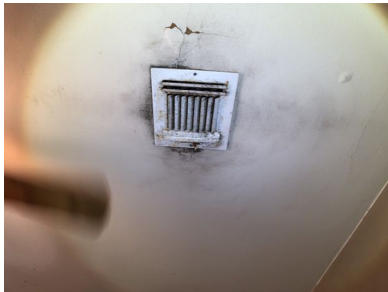
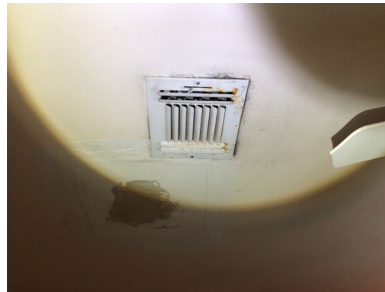
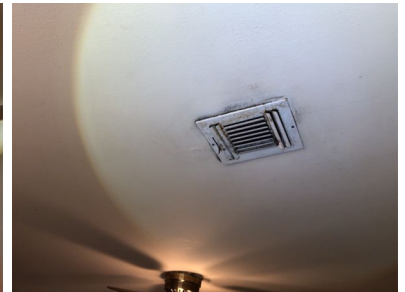
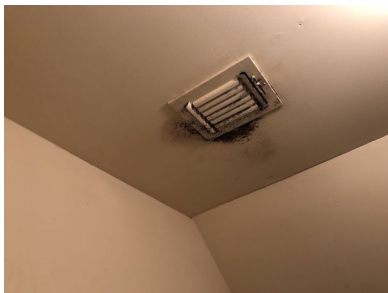
Throughout house

2: Registers - Microbial growth observed

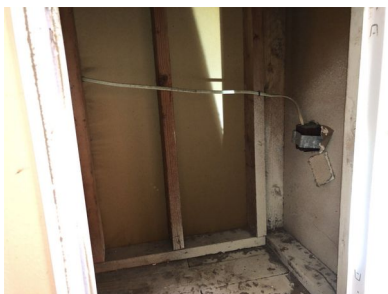
3: Return Air - Wires inside chase

Wiring was observed to have been run in the return air chase. It is pointed out that wiring can give off poisonous gases when it is burned, and these wires could be hazardous, should they be affected by excess heat. The wiring needs to be encased in conduit, rerouted, or encapsulated into the wall cavity.

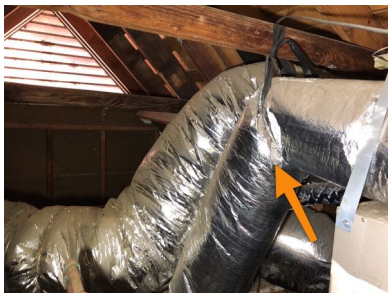
4: Ducts - Crushed/Pinched/Kinked

One or more of the air ducts were crushed/pinched/kinked causing a restriction in the air flow through the system. The ducts need to be adjusted or repaired.

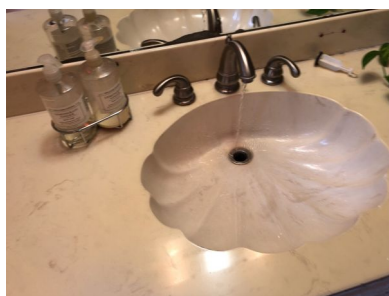
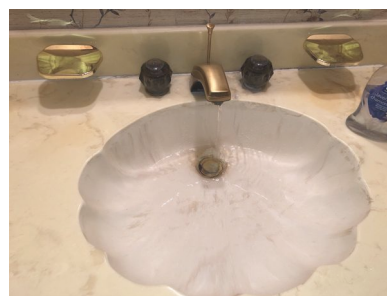
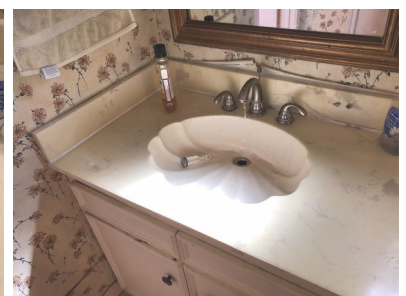
1: Water Pressure Low

The water pressure was lower than normal, and the source of the problem was not apparent at the time of the inspection. It is recommended that a service company find the source of the problem and provide a cost estimate for any necessary repairs.

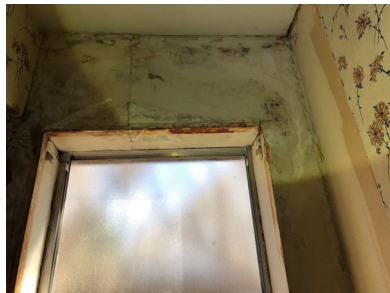
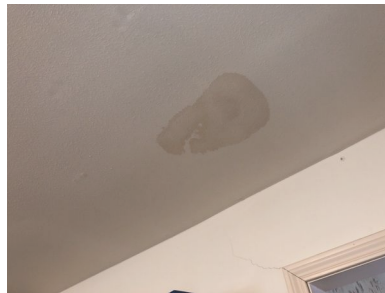
Master Bath

3: Water Stains/Damage Observed

Water damage/stains were observed indicating a current or previous leak. The source of the condition was not determined, with certainty, at the time of the inspection. Further investigation is recommended with a contractor to determine the source of the condition and to make any necessary repairs to correct the moisture condition and, if present, any secondary damage.

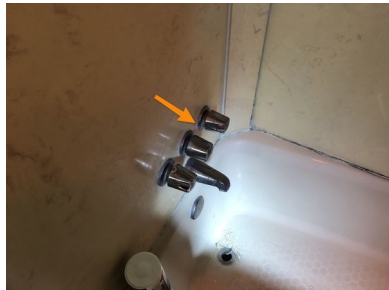
2nd Floor Bathroom

5: Valve Damaged - Rotates 360

A water valve was observed that does not stop when turned to the "off" position, but rather the valve rotates past the stopping point. The damaged valve/faucet needs to be repaired or replaced.

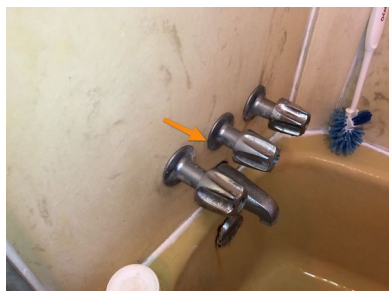
Master Bath

8: Tub/Shower - Diverter nonfunctional

The diverter valve was nonfunctional and should be repaired.

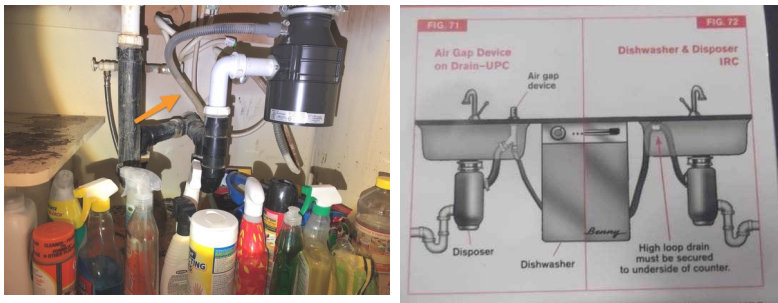
1: No Anti-Siphon

The drain line under the sink was not equipped with an anti-siphon device, nor was it looped up so that the top of the loop is at least six inches above the entrance of the drain line into the disposal. It is recommended at least that the drain line be looped to prevent the water from the garbage disposal from siphoning back into the dishwasher, or an anti-siphon device installed.

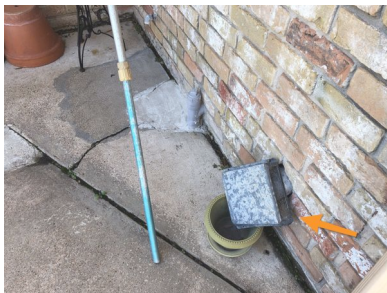
1: Vent - Cover damaged

The dryer vent cap was damaged and needs to be replaced.

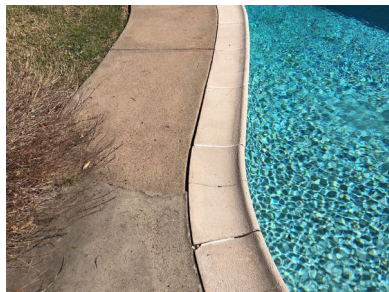
2: Coping Tiles - Sealant needed

The joint between the concrete deck and the coping tiles needs to be sealed.

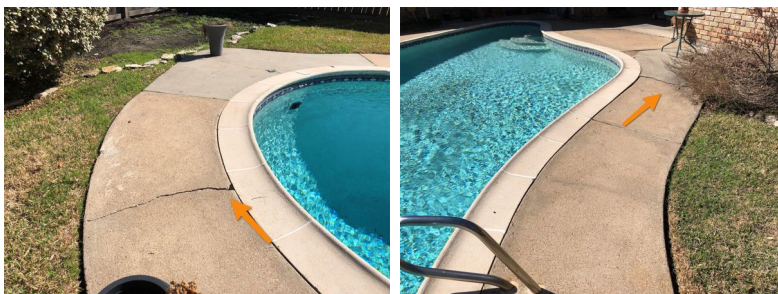
9: Pool decking lifting/settling

The pool decking has settled and is lifting/sinking in one or more locations around the pool. This condition is a tripping hazard and should be repaired. It is recommended that a contractor be contacted to provide a cost estimate for any needed repairs.
