HEDDERMAN SERVICES

STRUCTURAL INSPECTION

11010 Wickersham Ln
Houston TX 77042

MARCH 4, 2021

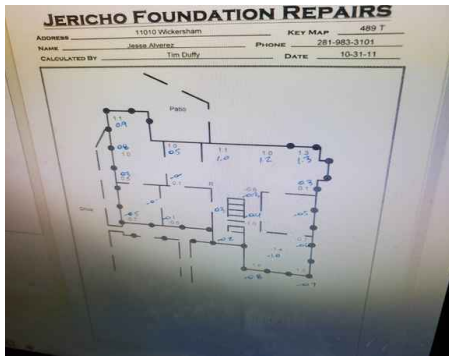
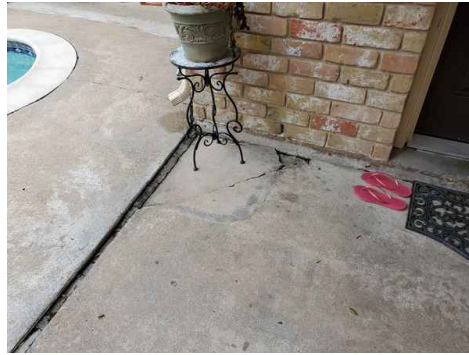
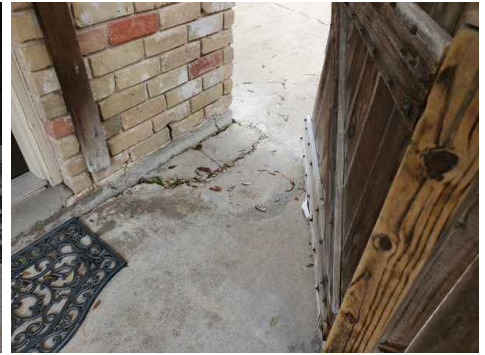
Description: Previous repairs w/Sketch

It was observed/disclosed that the foundation of this house has been repaired previously. The scope of the repairs reportedly included piers installed as shown in the sketch below provided to HEI. It is pointed out that HEDDERMAN ENGINEERING, INC. cannot and does not take any responsibility for the adequacy and/or future performance of the repair work. Any opinions given in this report concerning the levelness of the house are for the day of the inspection only, and are not a warranty against future foundation movement of the house. It is recommended that you obtain all available information and warranties from the homeowner relating to the foundation repair(s).

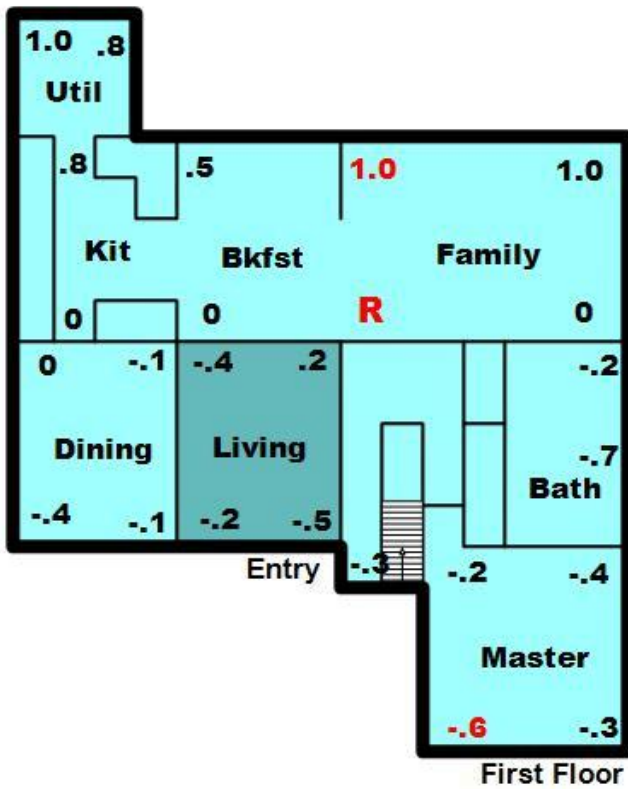
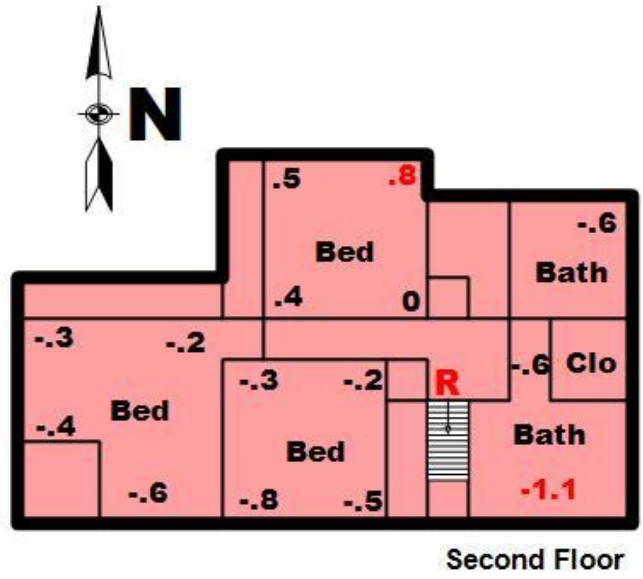
Elevation Readings
11010 Wickersham Lane

See our field sketch below showing the elevation readings for this structure. Note that the "R" on the sketch is our randomly chosen starting reference point, where the elevation is 0, and all other elevation readings are taken relative to the reference point, and are measured in inches to the nearest 1/10 inch. Height adjustments were made for variations in the height or thickness of the various floor coverings. If there is a step up or a step down into an area such as a garage, sunken room, balcony/patio area, or raised rooms, the elevation readings will have larger numbers due to the amount of the step.

The floors were checked with an electronic level, and were observed to be sloping from the rear towards the front of the house. The difference in elevation between the high point and low point was 1.6 inches on the first floor, and 1.9 inches on the second floor. The first floor high point was located at family room, and the low point was located at master bedroom. The unlevelness takes place over a horizontal distance of approximately 45 feet.

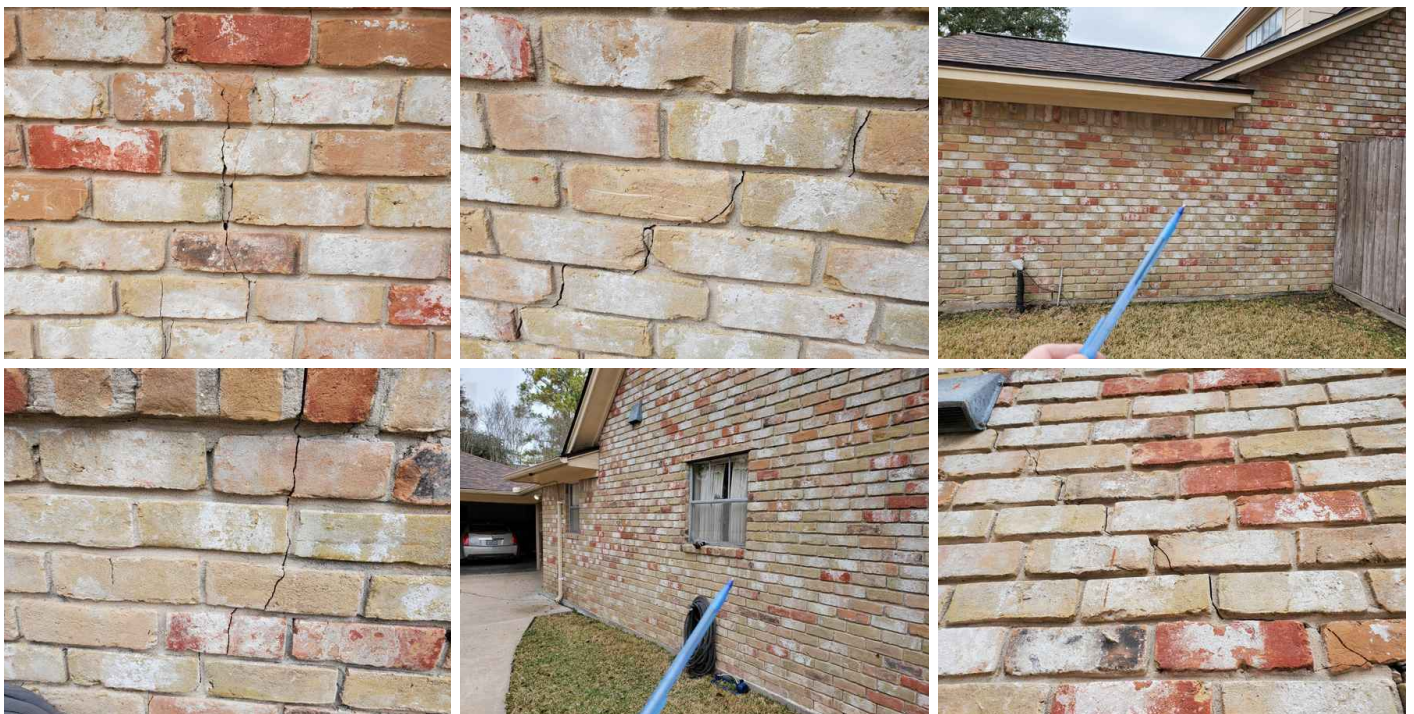
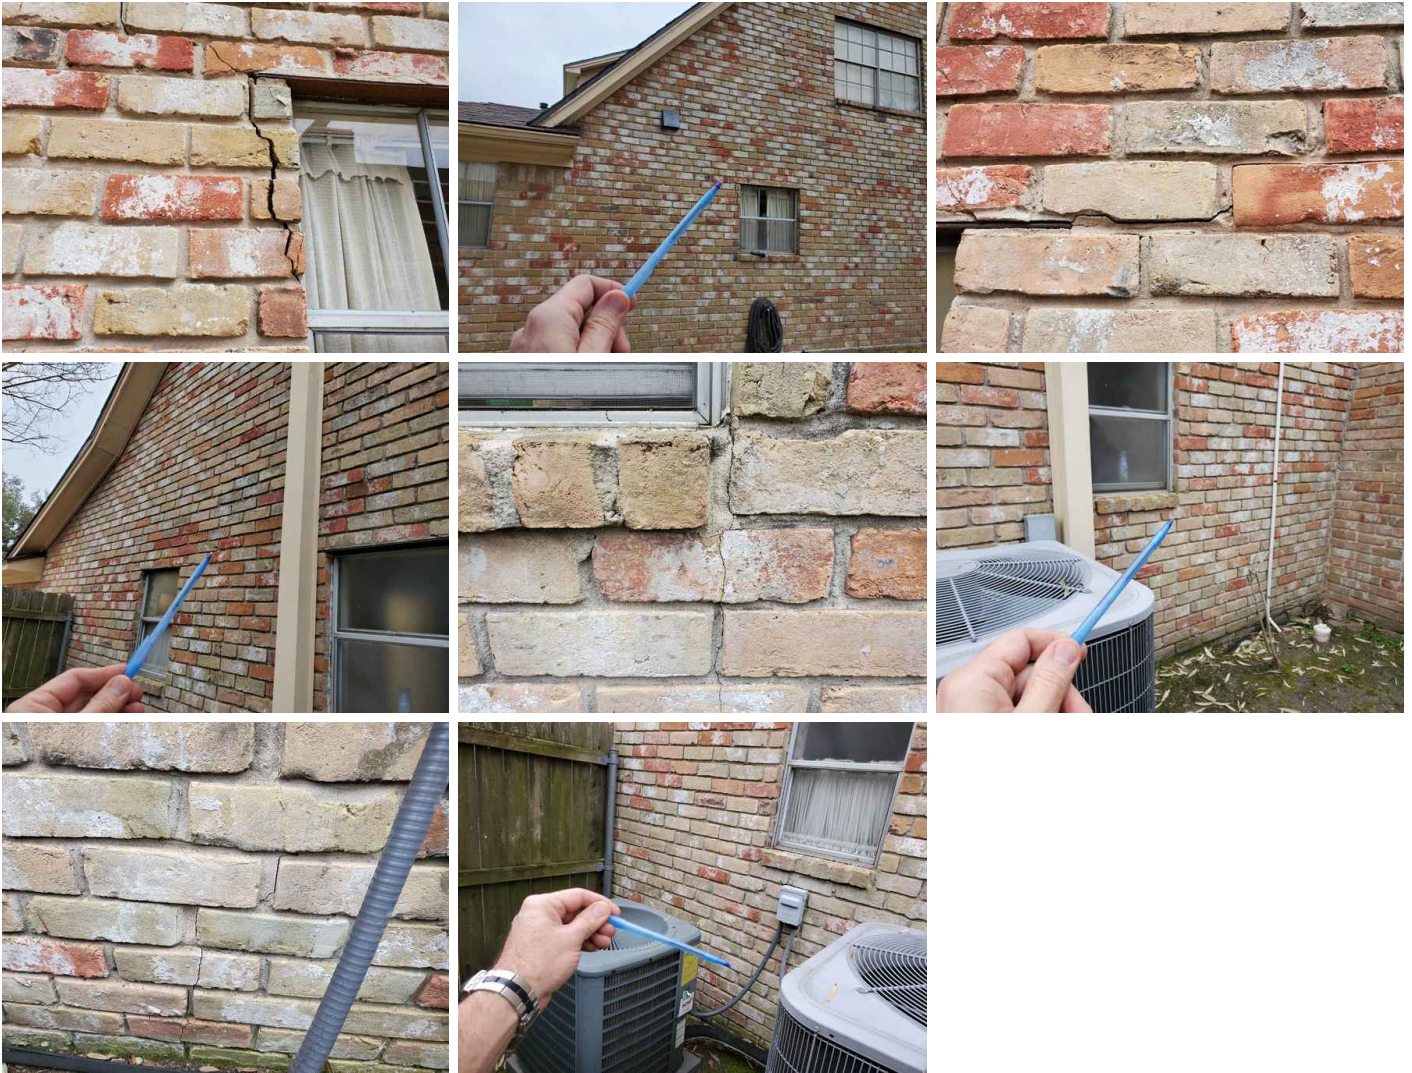
Differential Movement: Veneer - Cracks/Patches

Cracks and/or patches were observed in the exterior veneer at the time of the inspection, including at the above locations.

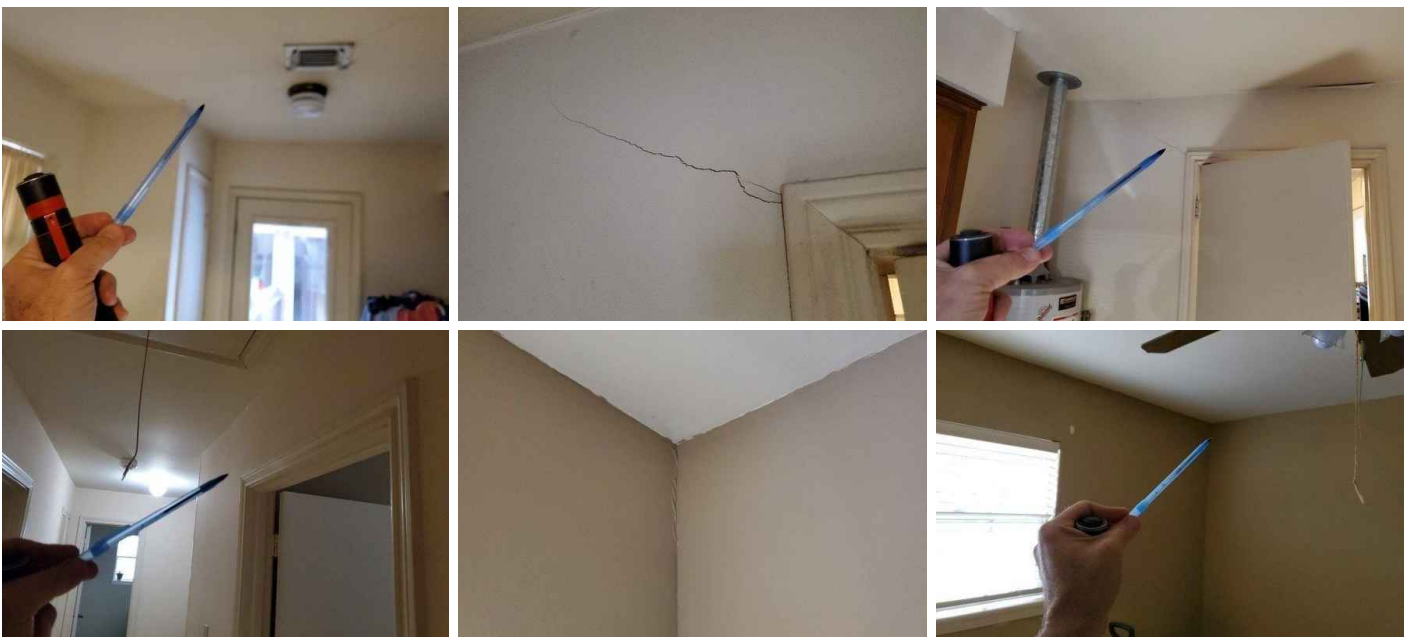
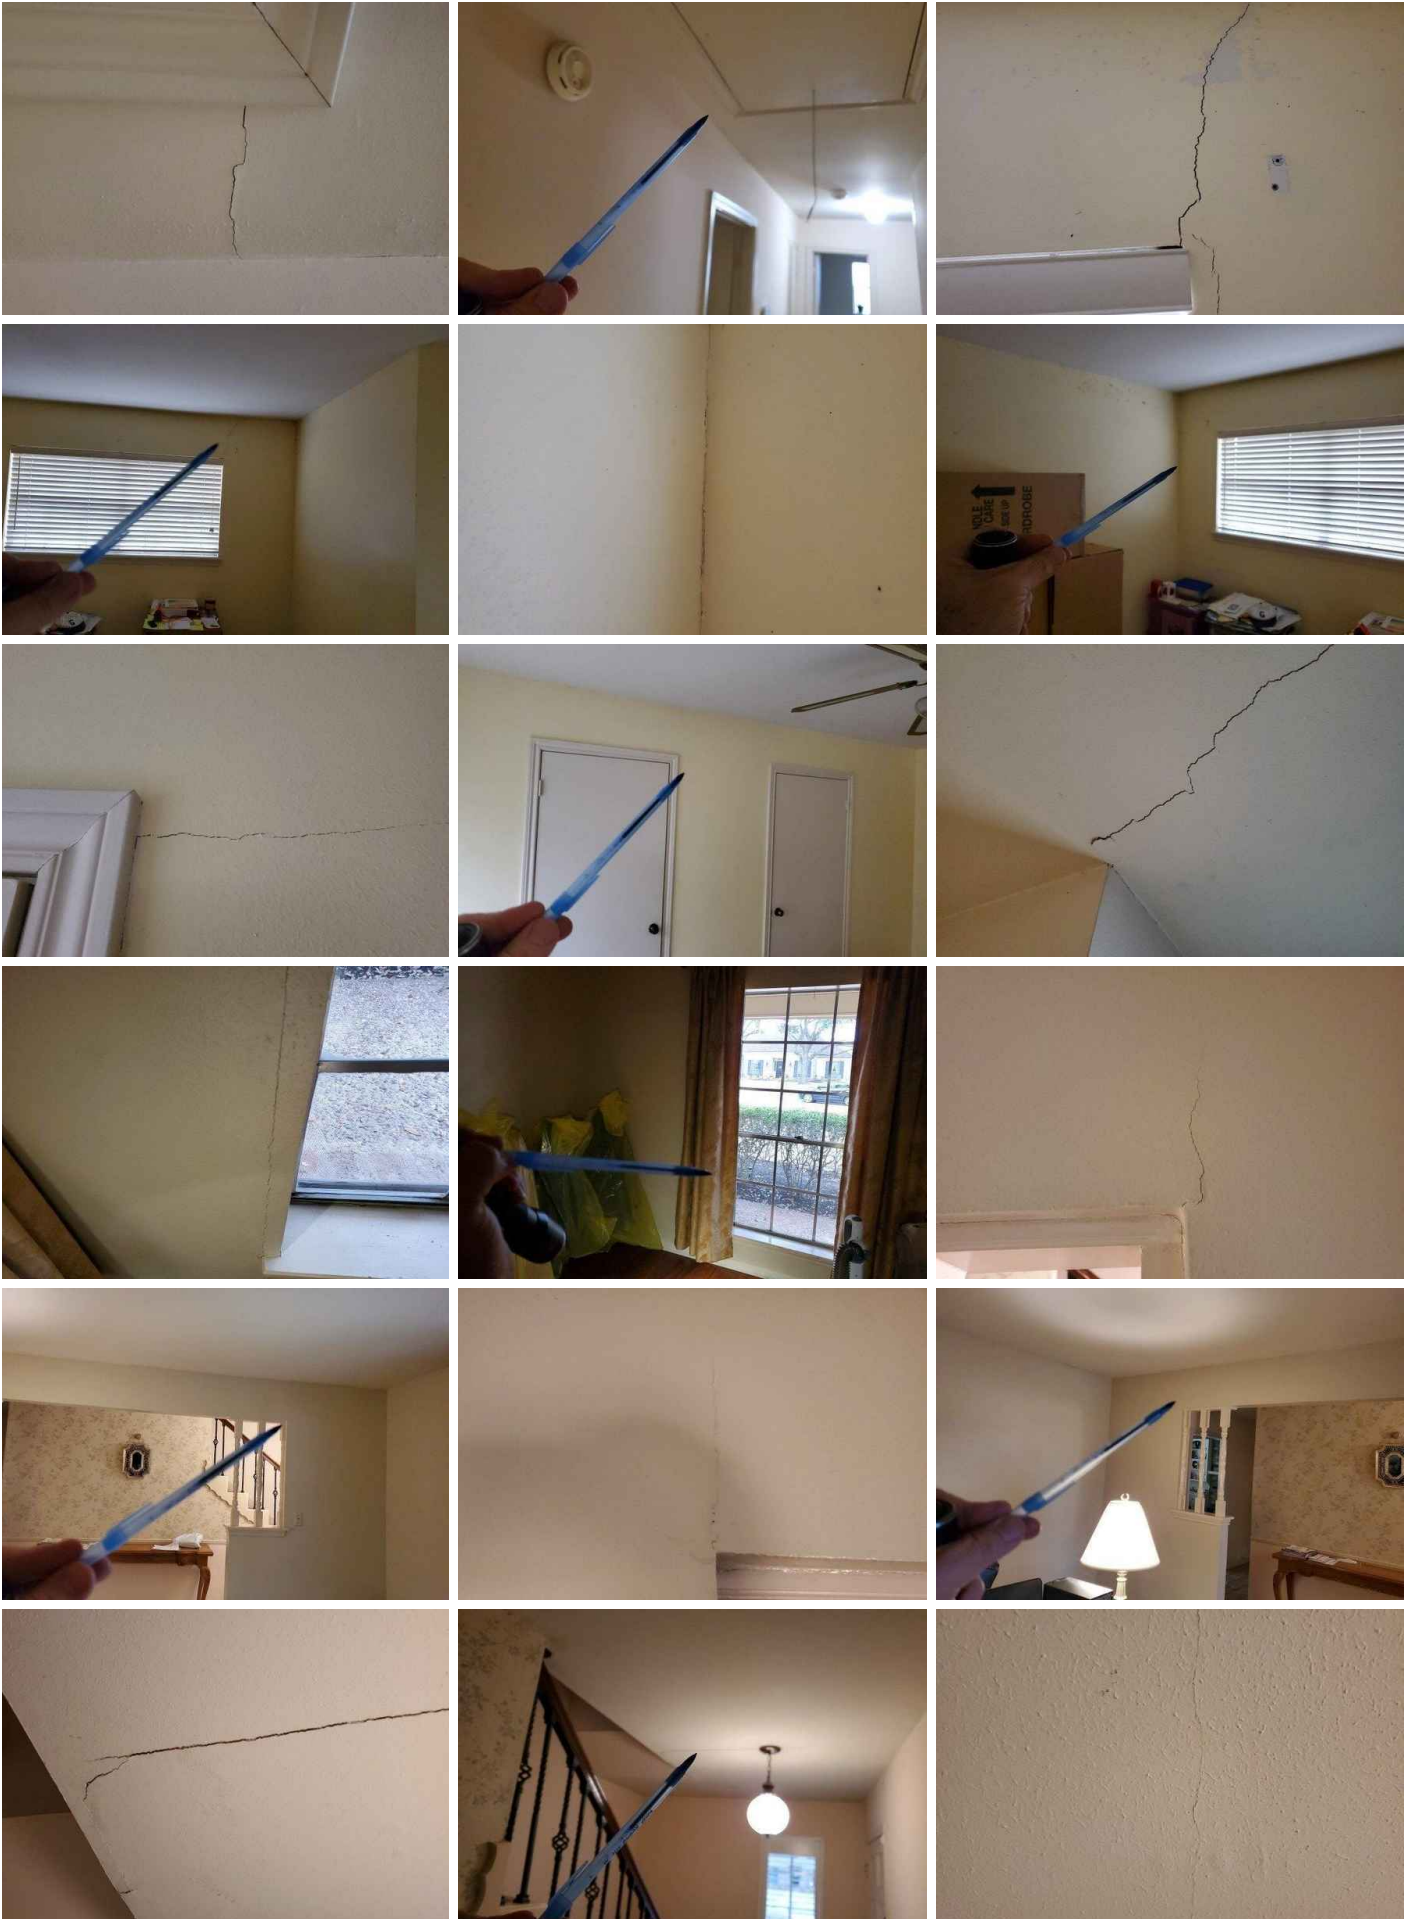
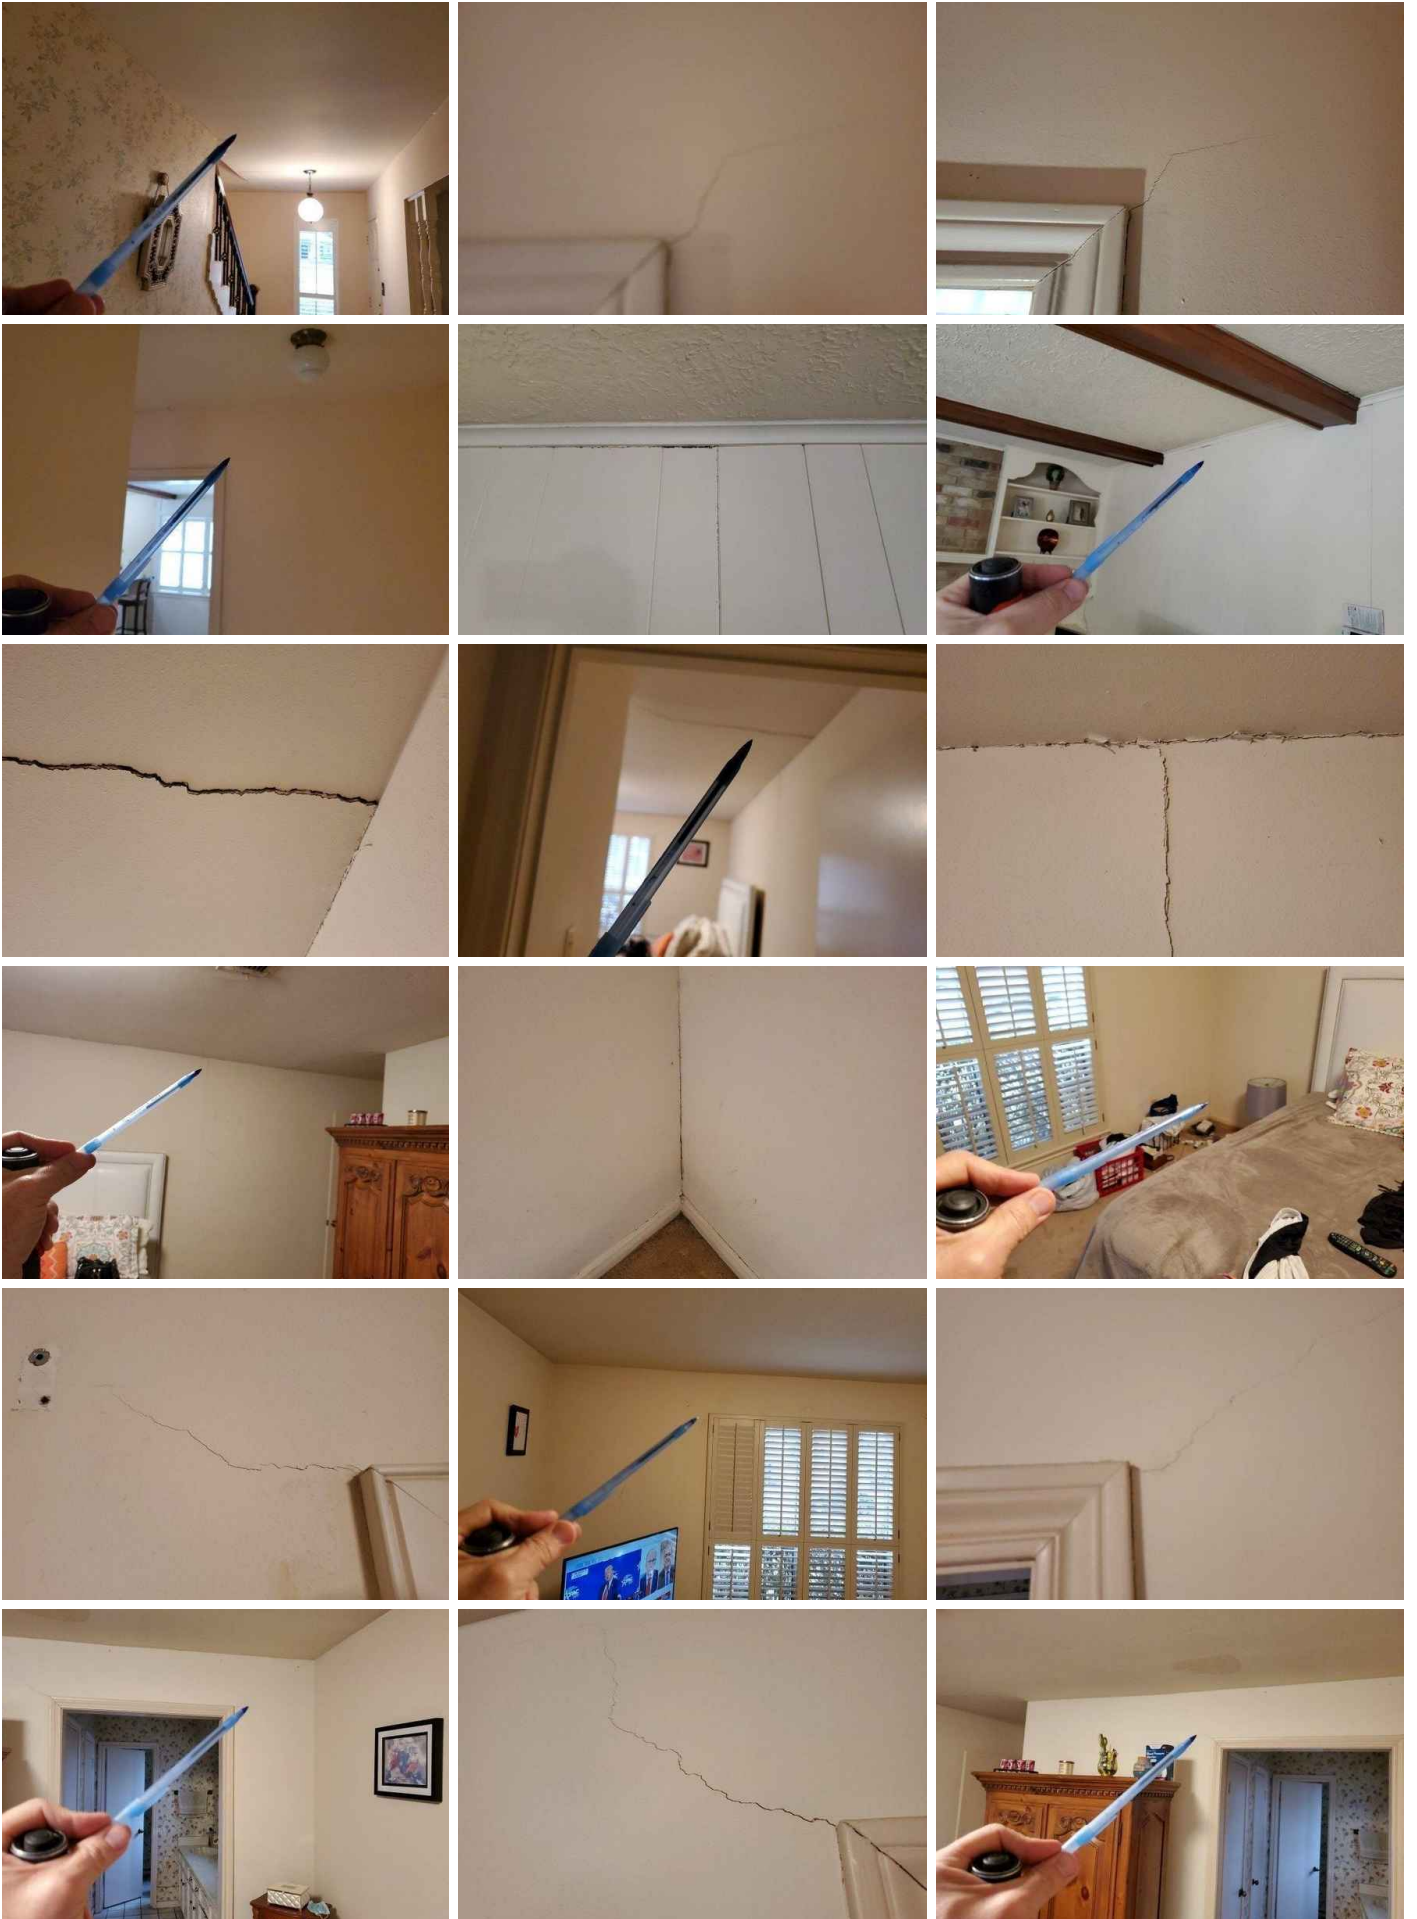
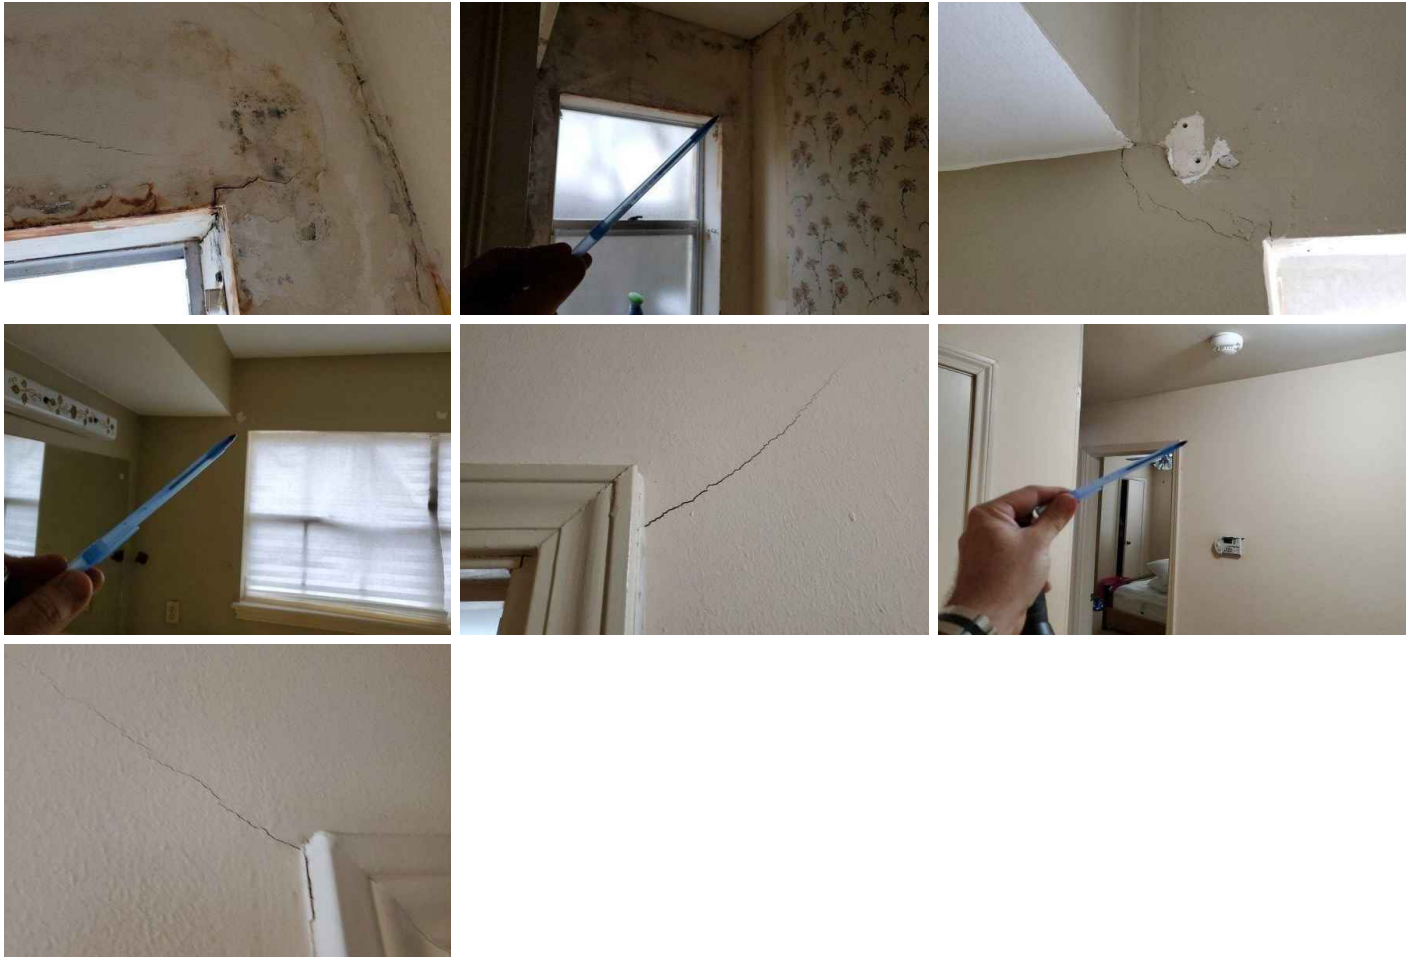
Differential Movement: Sheetrock Cracks/Patches/Compression ridges

Sheetrock cracks, patches, and/or compression ridges were observed in the house during the inspection, including at the above locations.

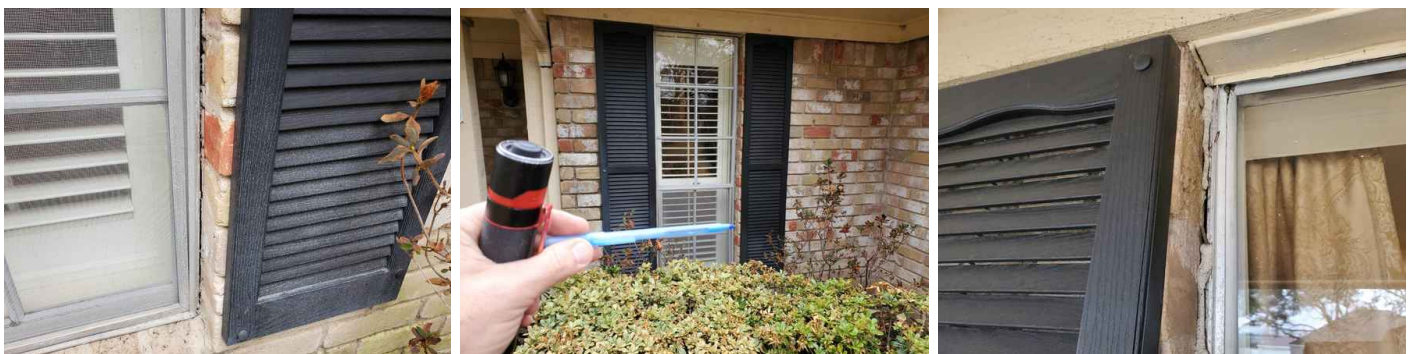
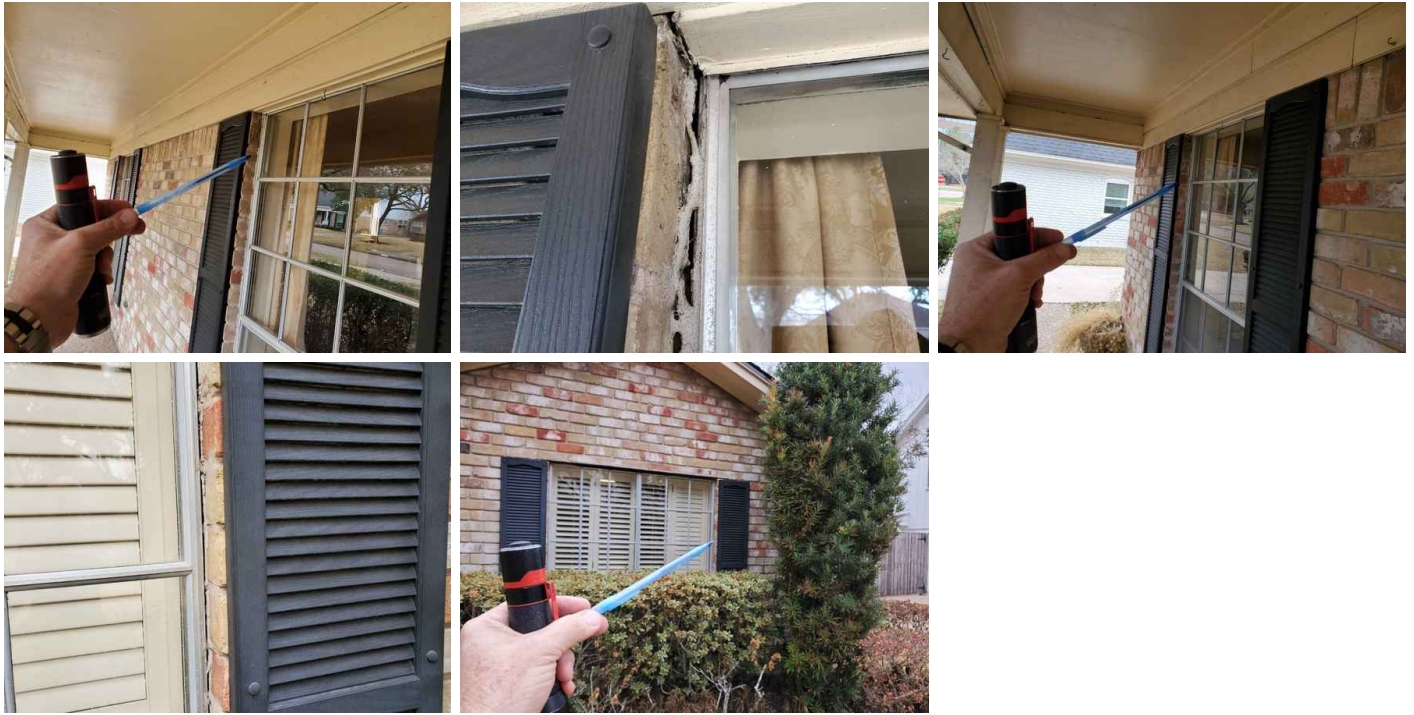
Separation of Materials: Window frame

The window frame was separated from the exterior brick veneer apparently due to movement. The separation was observed to be approximately 1/2 inch.

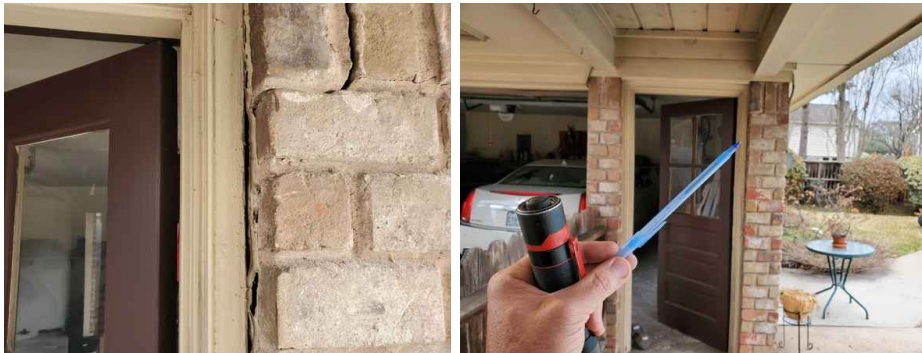
Separation of Materials: Door frame

The door frame was separated from the exterior brick veneer apparently due to movement. The separation was observed to be approximately 1/2 inch.

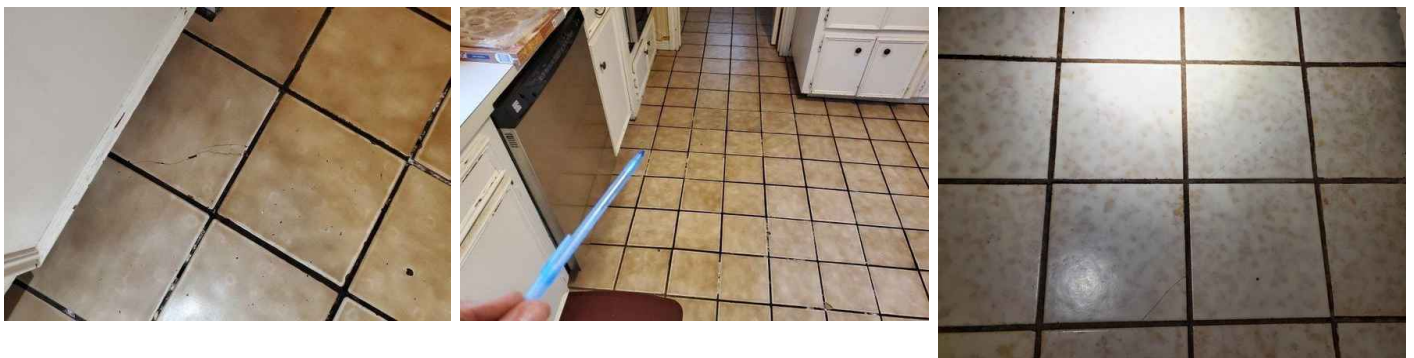
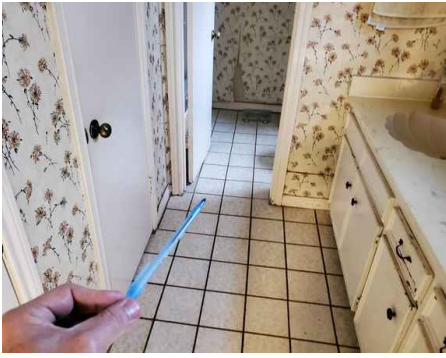
Separation of Materials: Cracked floor tile

We observed that the floor tile was cracked at one or more locations which can be an evidence of foundation movement.

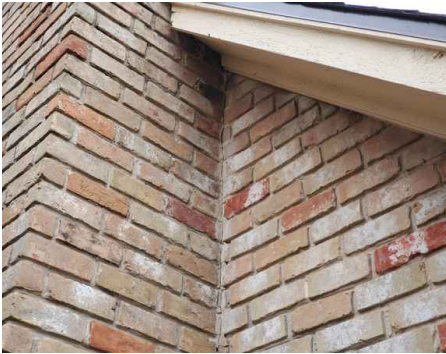
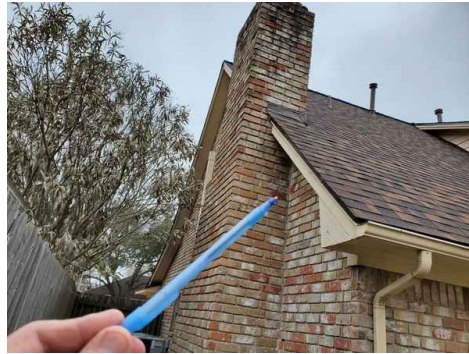
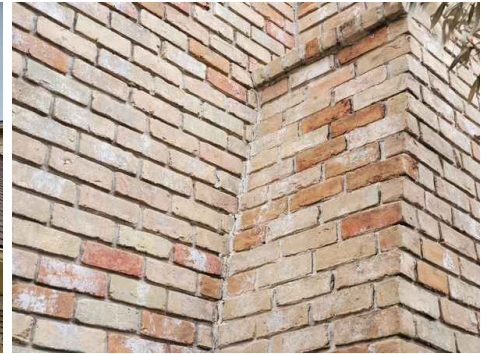
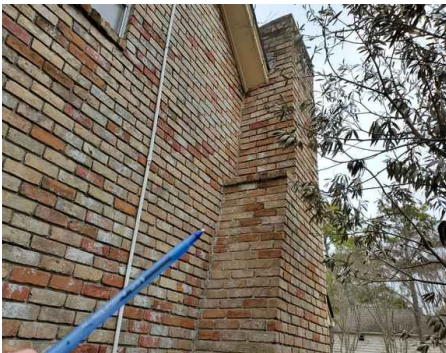
Separation of Materials: Chimney separated

The chimney was separated from the exterior wall due to movement of the foundation.

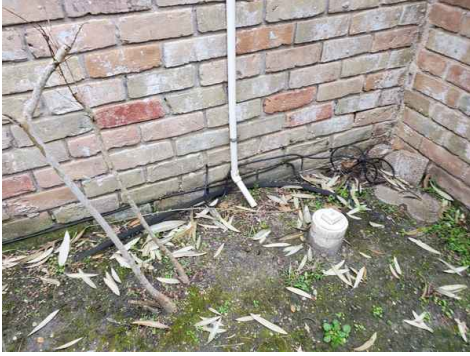
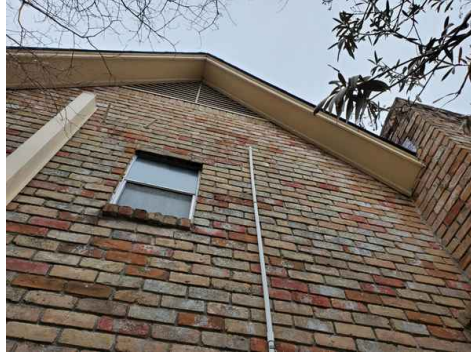
The primary condensate drain line from the air conditioning unit was emptying its water next to the foundation. This can cause the soil in that area to stay saturated, and contribute to differential foundation movement. It is recommended that the drain line be routed to a bathroom sink drain line.

Contact a qualified plumbing contractor.

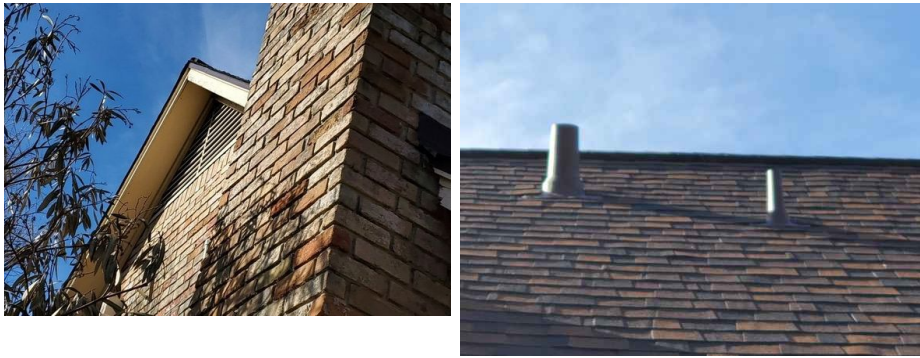
Continuous Ridge Vent, Gable Vent(s)

The ventilation for the attic space was observed to include the following vents listed above.

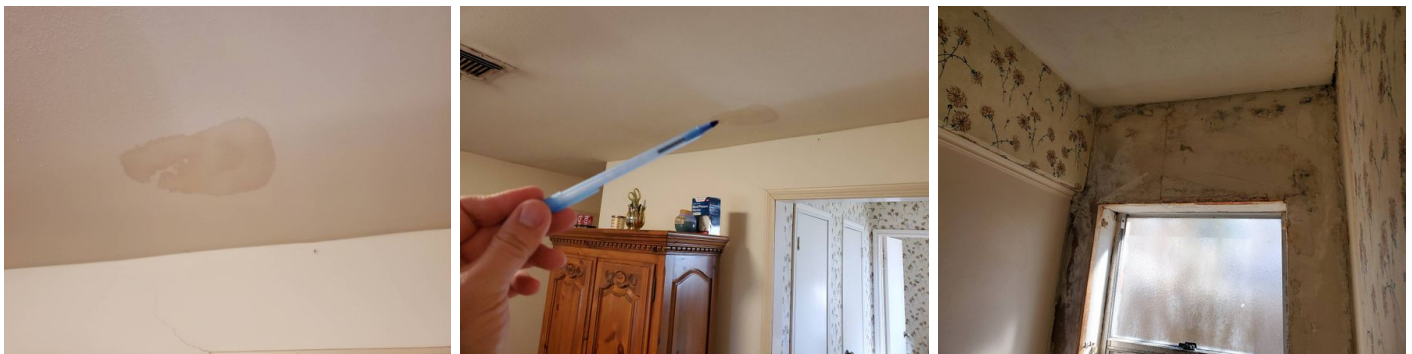
Roof Leaks: Stains appear to be from previous leaks

After observing the interior of the structure, evidences of current roof leaks were not visible. The absence of evidences of roof leaks does not guarantee that roof leaks were not present; rather, that no evidences of leaking were visible at the time of the inspection. Some stains were visible, but the stains appeared to be related to previous roof leaks. It is recommended that you check with the owner and/or a service company concerning the stains.

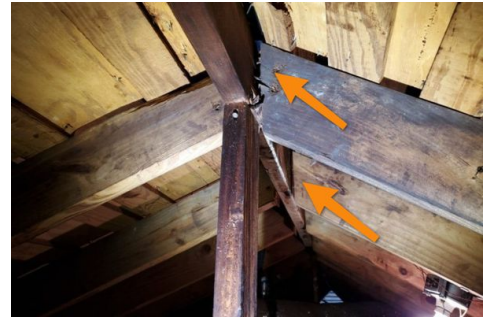
We observed rafters that were separated at the top of the rafter, where the rafter meets the top ridge beam. Rafters should be flush against the ridge beam, and it is recommended that 3 foot make-up pieces be "sistered" onto the rafters, so that the make-up pieces are flush against the ridge. This will allow the rafters to bear against the ridge beam for the entire length of the miter cut on the rafter.

Contact a qualified professional.

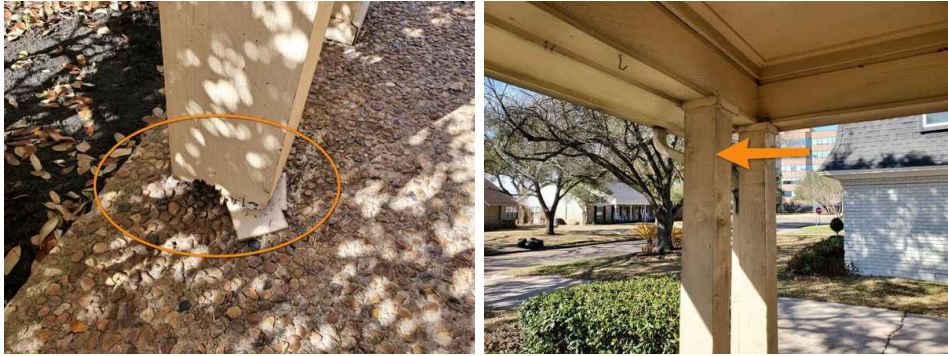
One of the front exterior column was observed to be loose and was not supporting the beam. Repair is needed.

Contact a qualified professional.

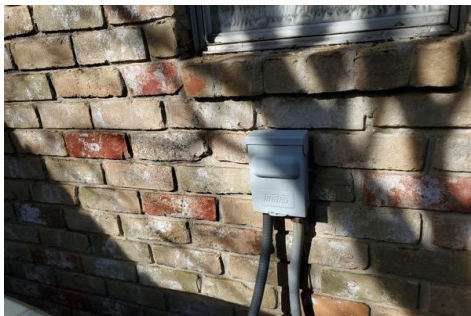
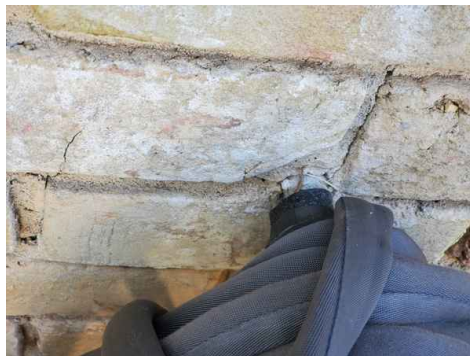
A substantial vulnerability to water penetration was observed at penetrations/openings through the exterior building envelope, and it is recommended that all penetrations/openings be sealed against water penetration. Typical examples on a structure may include light fixtures, air conditioning refrigerant lines, water piping, gas piping, vent caps, windows, doors, expansion joints, etc. Below is a representative sample of locations and/or photographs showing some, but not necessarily all, locations where there is a vulnerability to water penetration. Have a contractor provide a cost estimate to seal all vulnerable areas on the exterior building envelope against water penetration and/or open up any clogged weepholes in the veneer.

Contact a qualified professional.

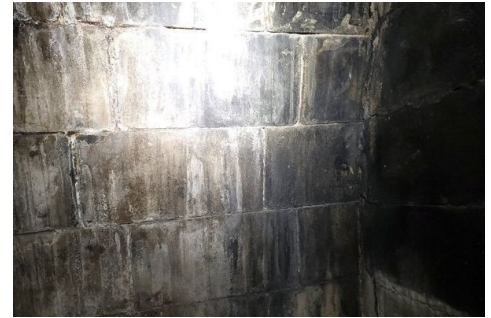
GROUT MISSING - FIREBOX

Some of the grout was missing at the joint of the front wall of the firebox, which can be a fire hazard as it can allow the heat of the fire to enter the wall cavity, and it is recommended that the separation be properly filled with mortar.

Contact a qualified professional.

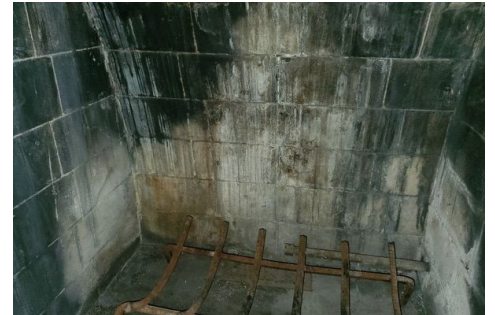
We observed whitish, powdery deposit inside the firebox, which appears to be efflorescence. Efflorescence is formed when water penetrates through the mortar and evaporates, leaving the deposit. The efflorescence appears to be related to water penetration down the chimney flue due to an opened flue cap, and it is recommended that the flue be properly capped.

Contact a qualified professional.

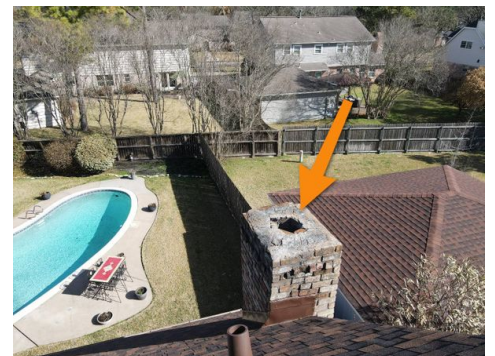
WEATHER CAP - MISSING

The top of the chimney flue did not have a spark arrester/weather cap installed in the flue to prevent water penetration down the chimney and bird entry into the chimney. Evidences of water penetration were visible at the firebox, where the firebrick was stained.

Contact a qualified professional.

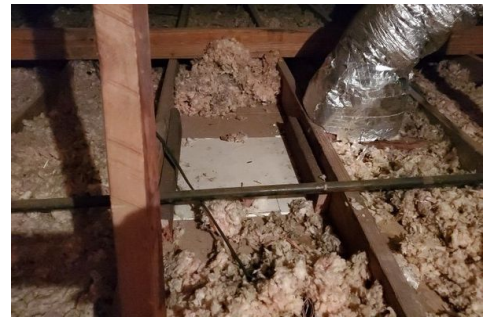
INSULATION MISSING - BETWEEN JOISTS

The insulation in the attic was missing from between some of the joists. Have a service company provide a cost estimate for repairs.

Contact a qualified professional.

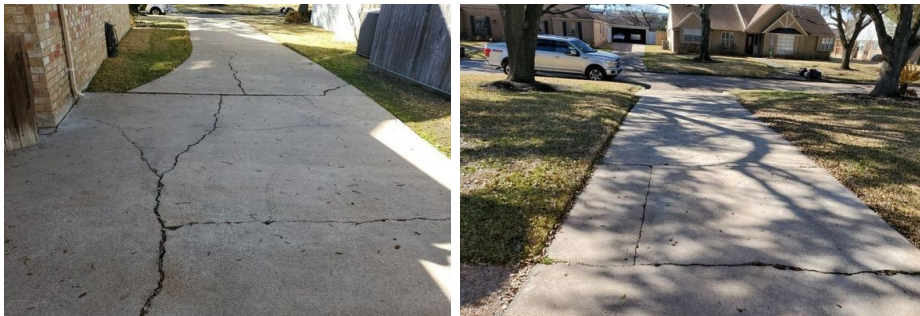
Flatwork Concrete/Patios/Walkways: Cracks Driveway

Cracks and some separations were observed in the driveway concrete. In our opinion, the driveway is still in serviceable condition at this time.

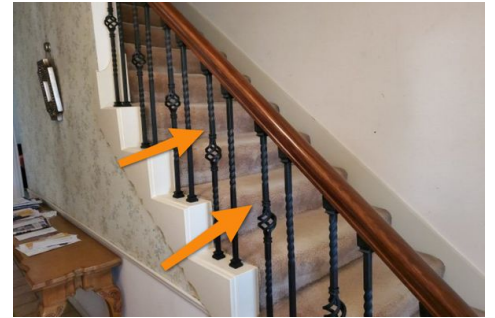
HANDRAIL BALUSTERS > 4"

The handrail was not constructed according to the current building code standards (obviously, given the age of the house). Therefore, the width between the balusters is greater than four inches. If this condition is of a concern to you, then further investigation with a contractor is recommended.

Contact a qualified professional.
