FOUNDATION INSPECTION

11010 Wickersham Ln
Houston TX 77042

Jesus Alvarez & Irma Alvarez

MARCH 1, 2021

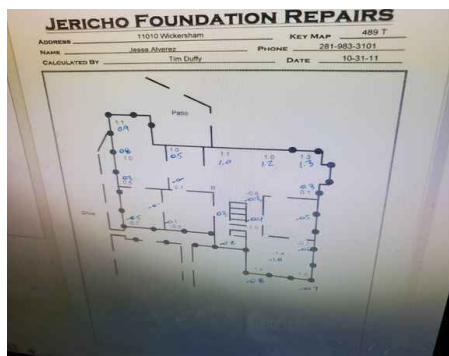
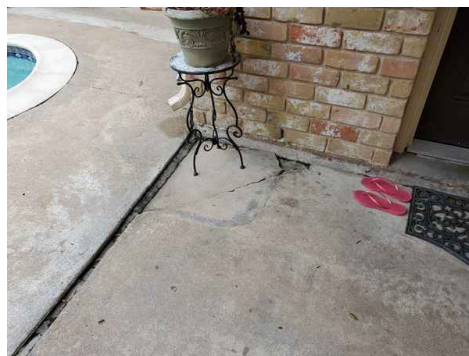
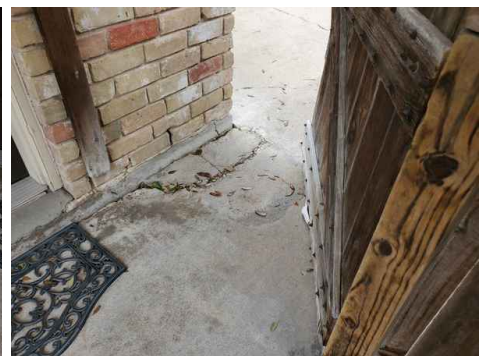
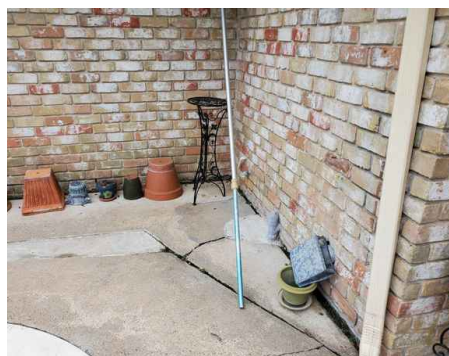
It was observed/disclosed that the foundation of this house has been repaired previously before 2011 with many piers around the exterior of the house, then in 2011 with one more pier. The scope of the repairs reportedly included piers installed as shown in the sketch below provided to HEI. It is pointed out that HEDDERMAN ENGINEERING, INC. cannot and does not take any responsibility for the adequacy and/or future performance of the repair work. Any opinions given in this report concerning the levelness of the house are for the day of the inspection only, and are not a warranty against future foundation movement of the house. It is recommended that you obtain all available information and warranties from the homeowner relating to the foundation repair(s).

It is pointed out that the readings in the pictures are from October 2011 and in blue ink from January 2021.

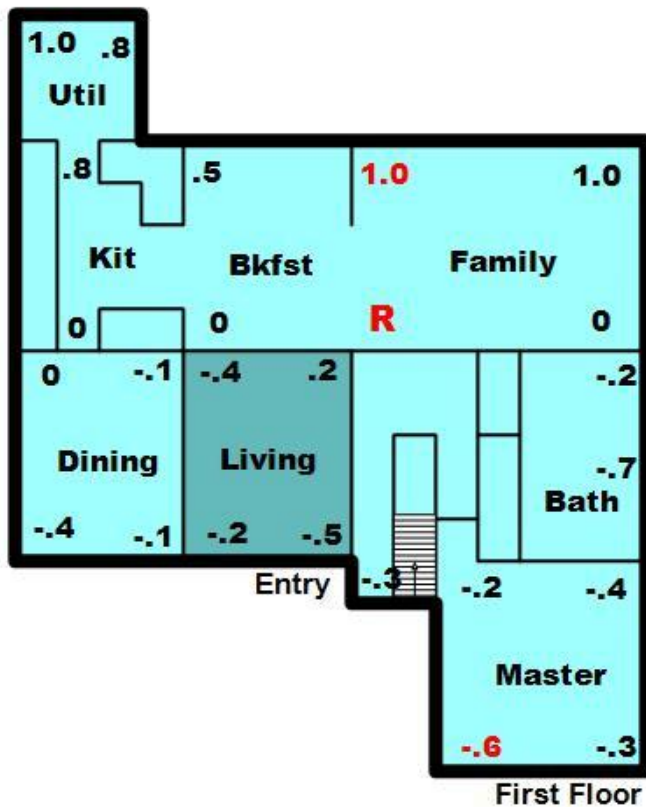
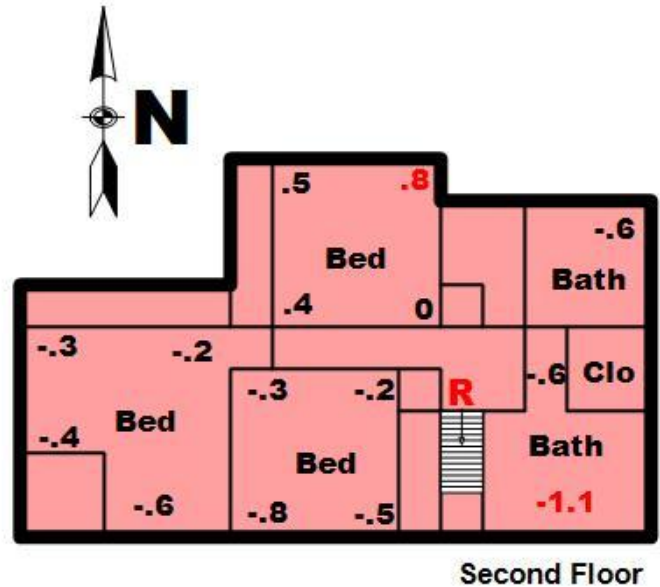
**Elevation Readings
11010 Wickersham Lane**

The floors were checked with an electronic level, and were observed to be sloping from the rear towards the front of the house. The difference in elevation between the high point and low point was 1.6 inches on the first floor, and 1.9 inches on the second floor. The first floor high point was located at family room, and the low point was located at master bedroom. The unlevelness takes place over a horizontal distance of approximately 45 feet.

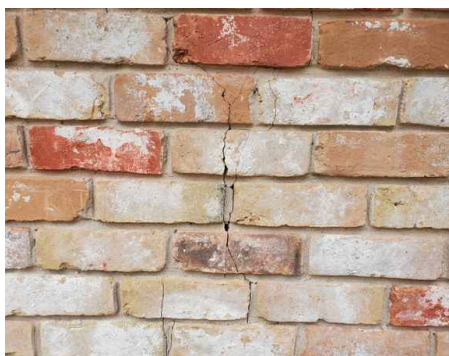
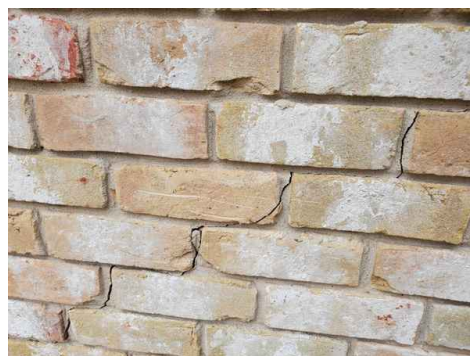
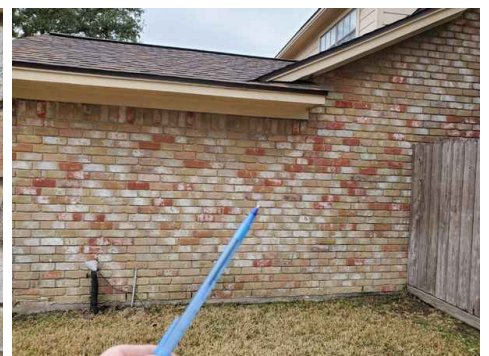
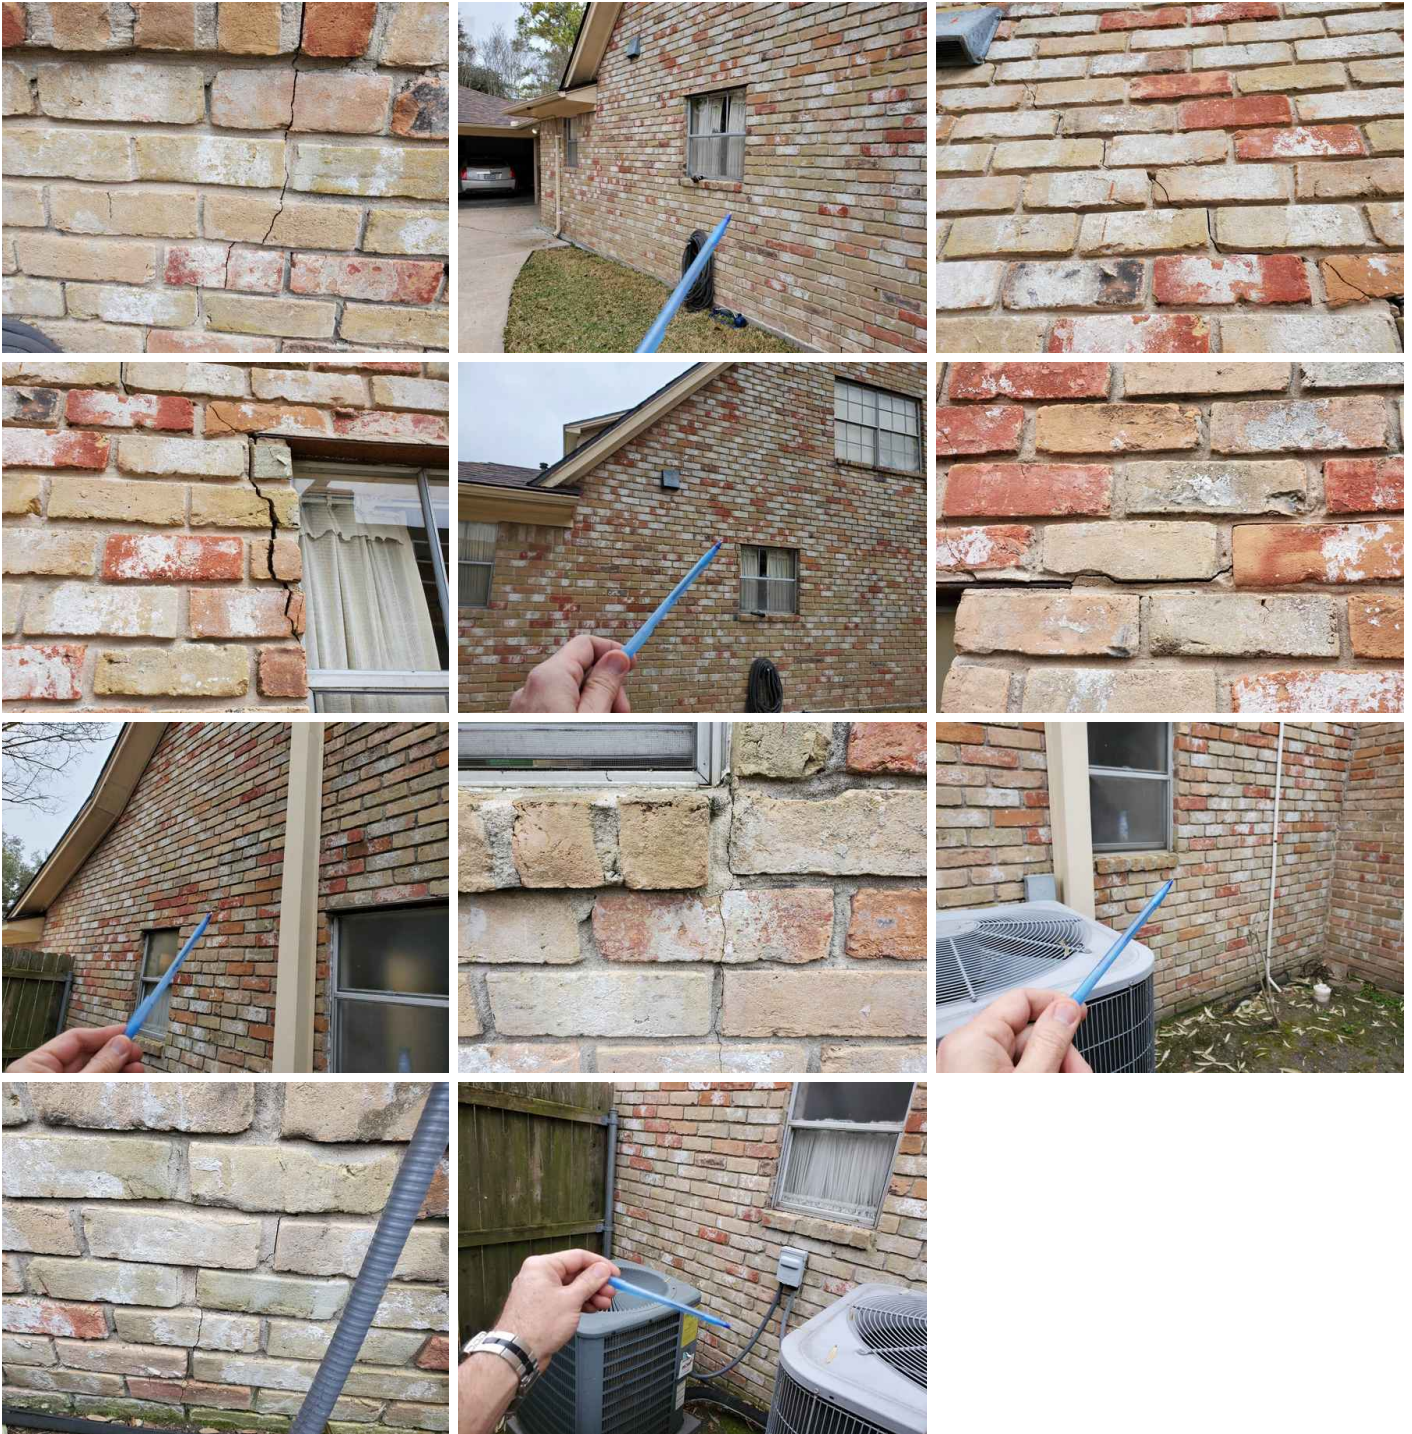
Throughout the house

Cracks and/or patches were observed in the exterior veneer at the time of the inspection, including at the above locations.

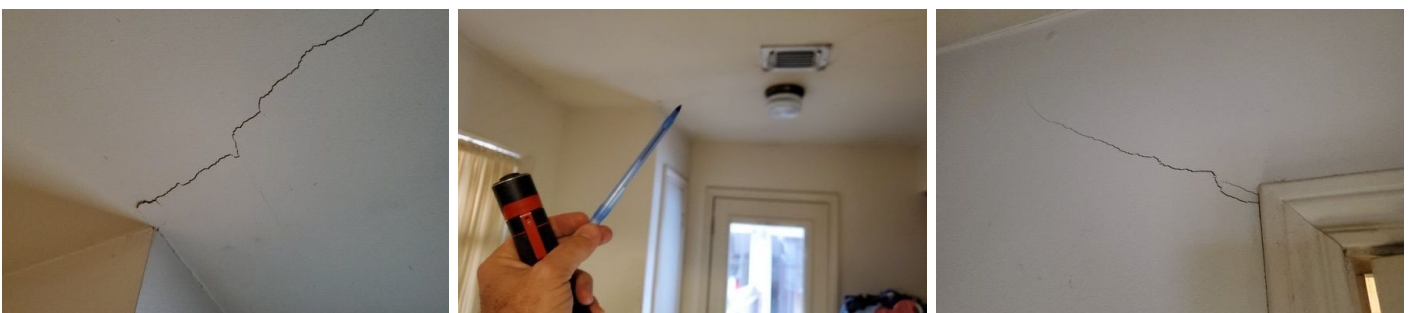
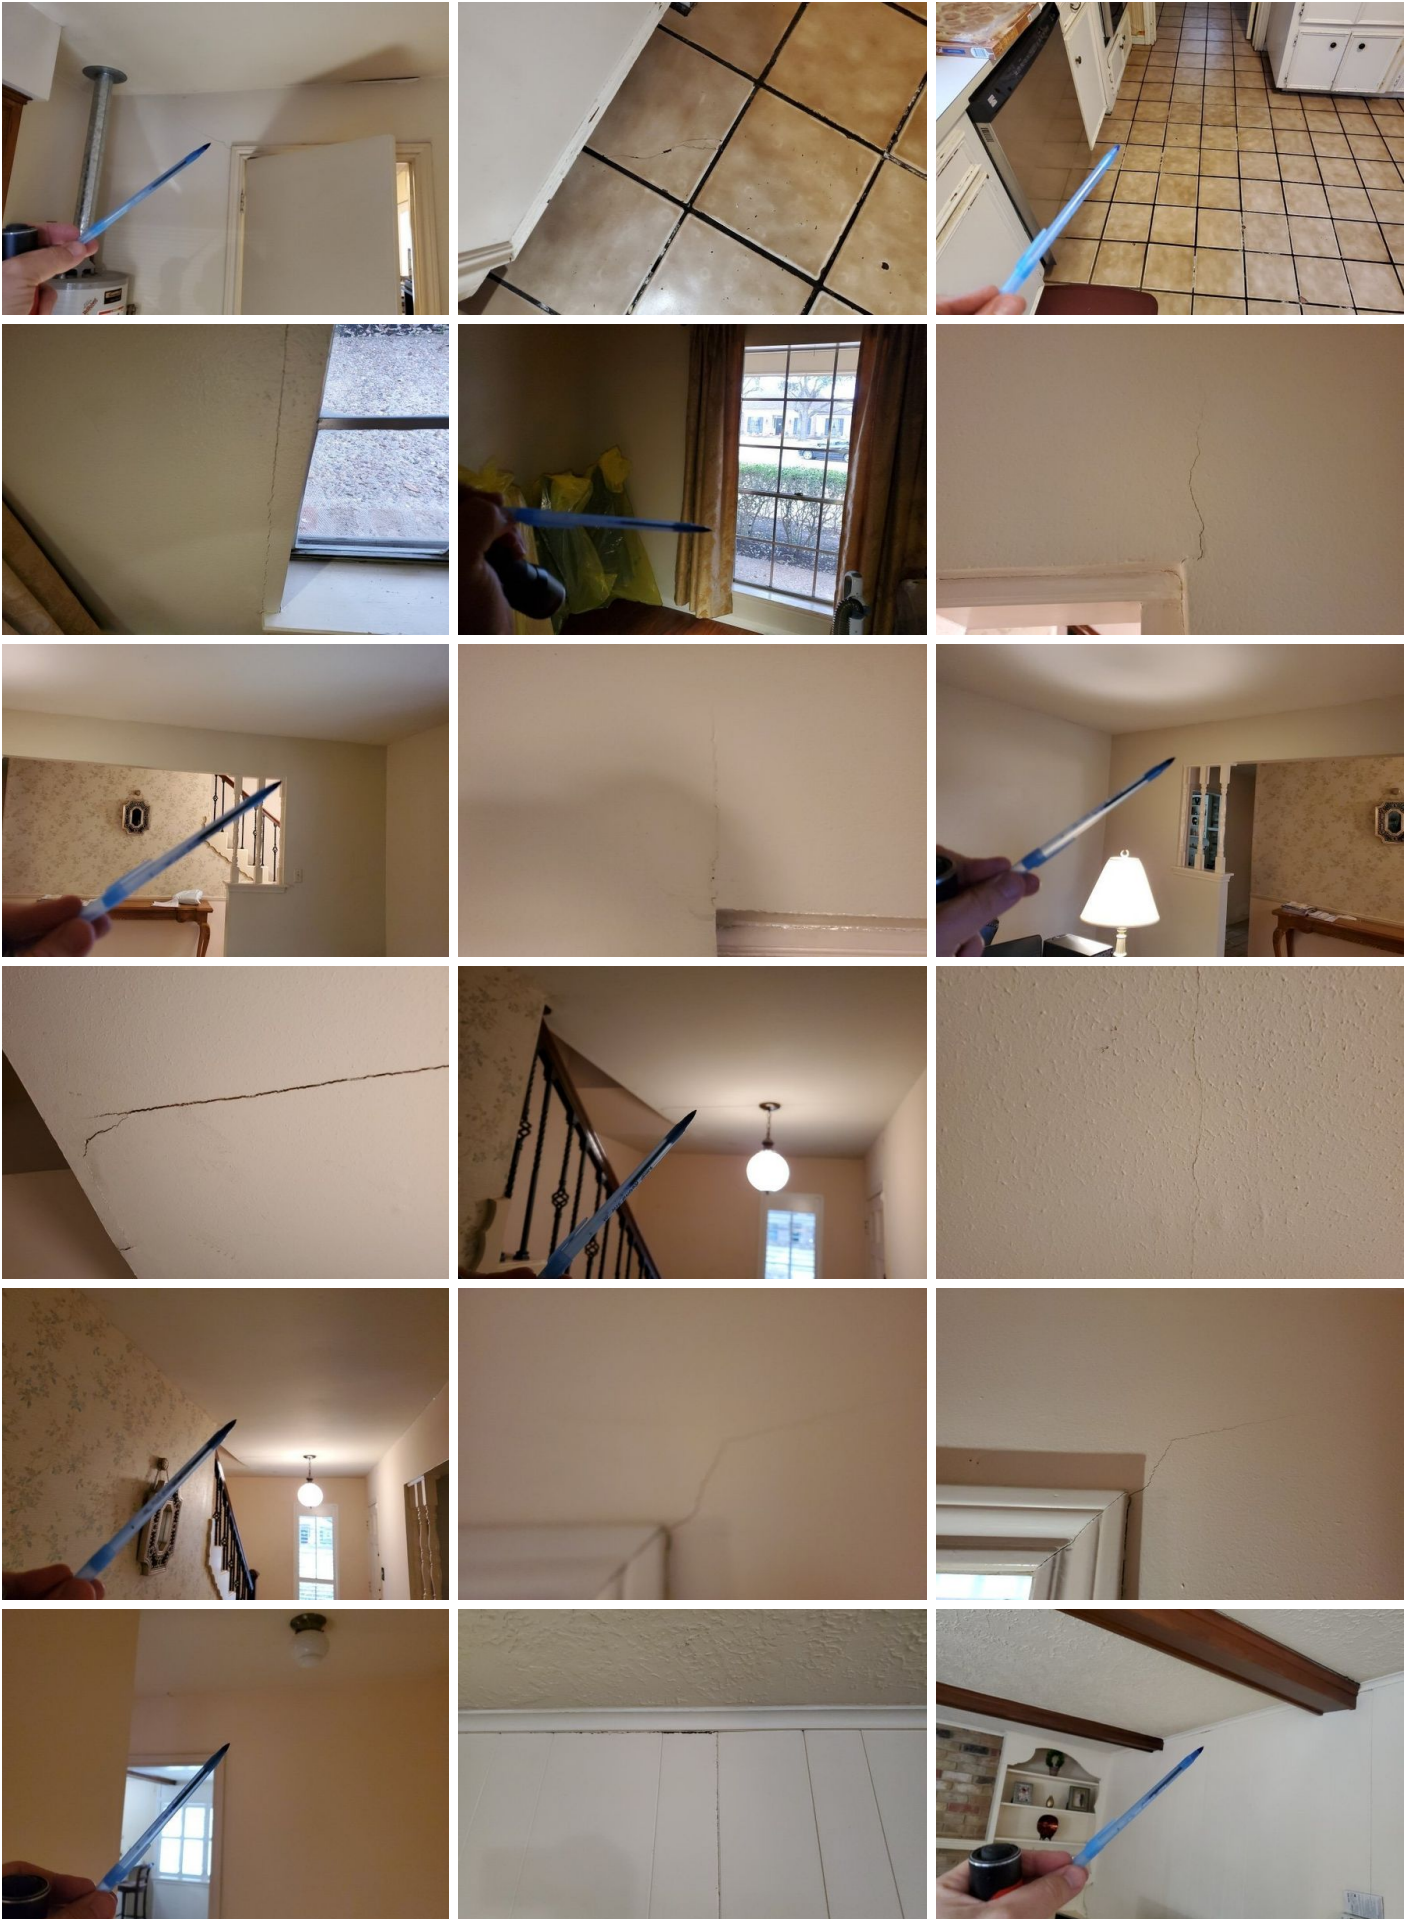
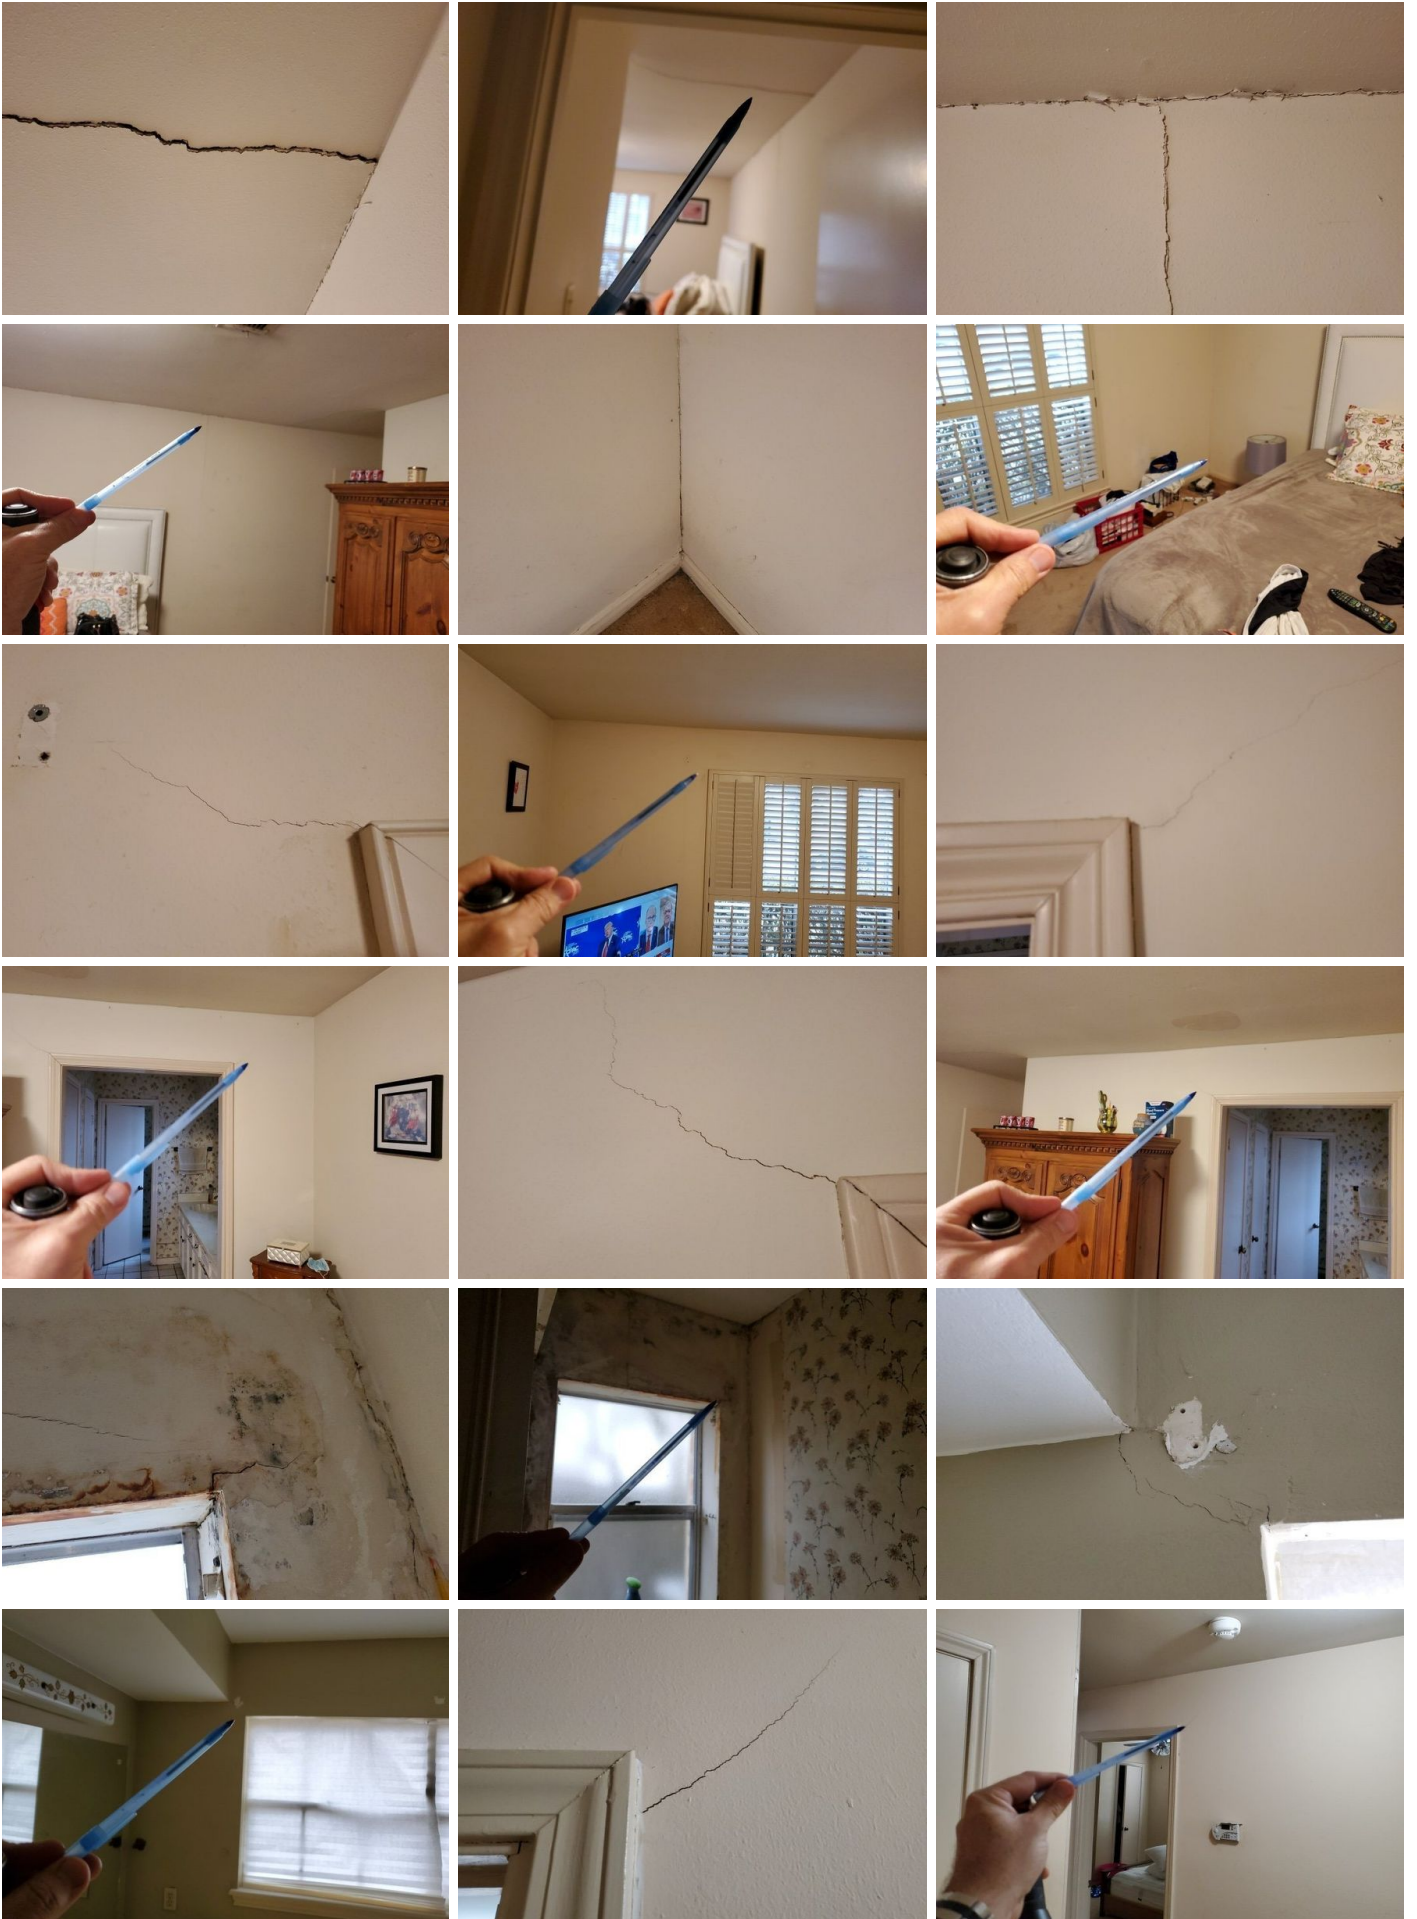
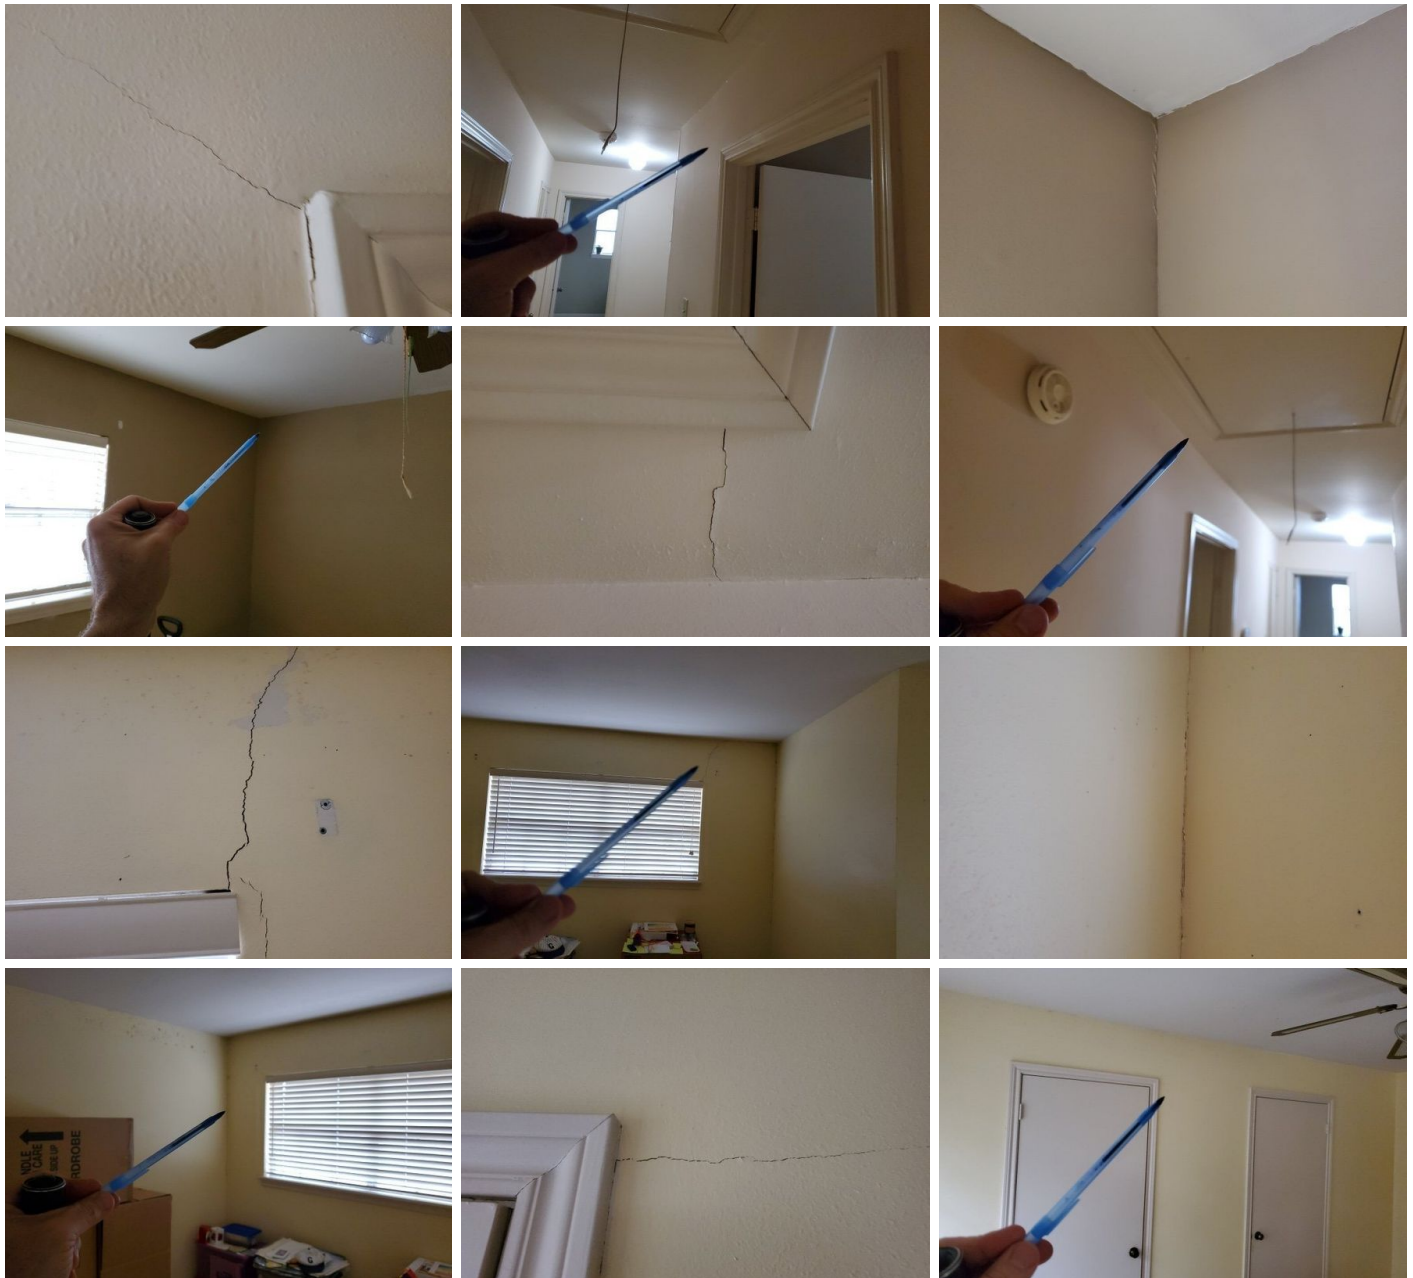
Sheetrock cracks, patches, and/or compression ridges were observed in the house during the inspection, including at the above locations.

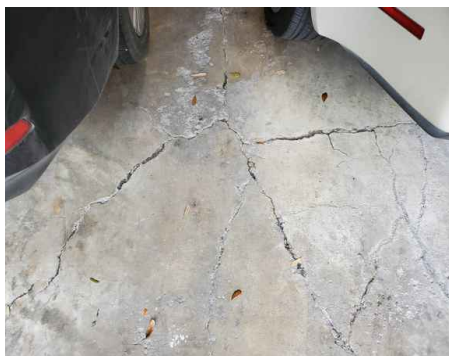
Cracking of the foundation concrete exists in virtually all foundations. It is pointed out that cracking is a normal property of concrete and other brittle materials, and Hedderman Engineering, Inc. assumes no responsibility should cracks be found that are not mentioned in this report. Some cracking was observed in this concrete foundation, including at the garage floor.

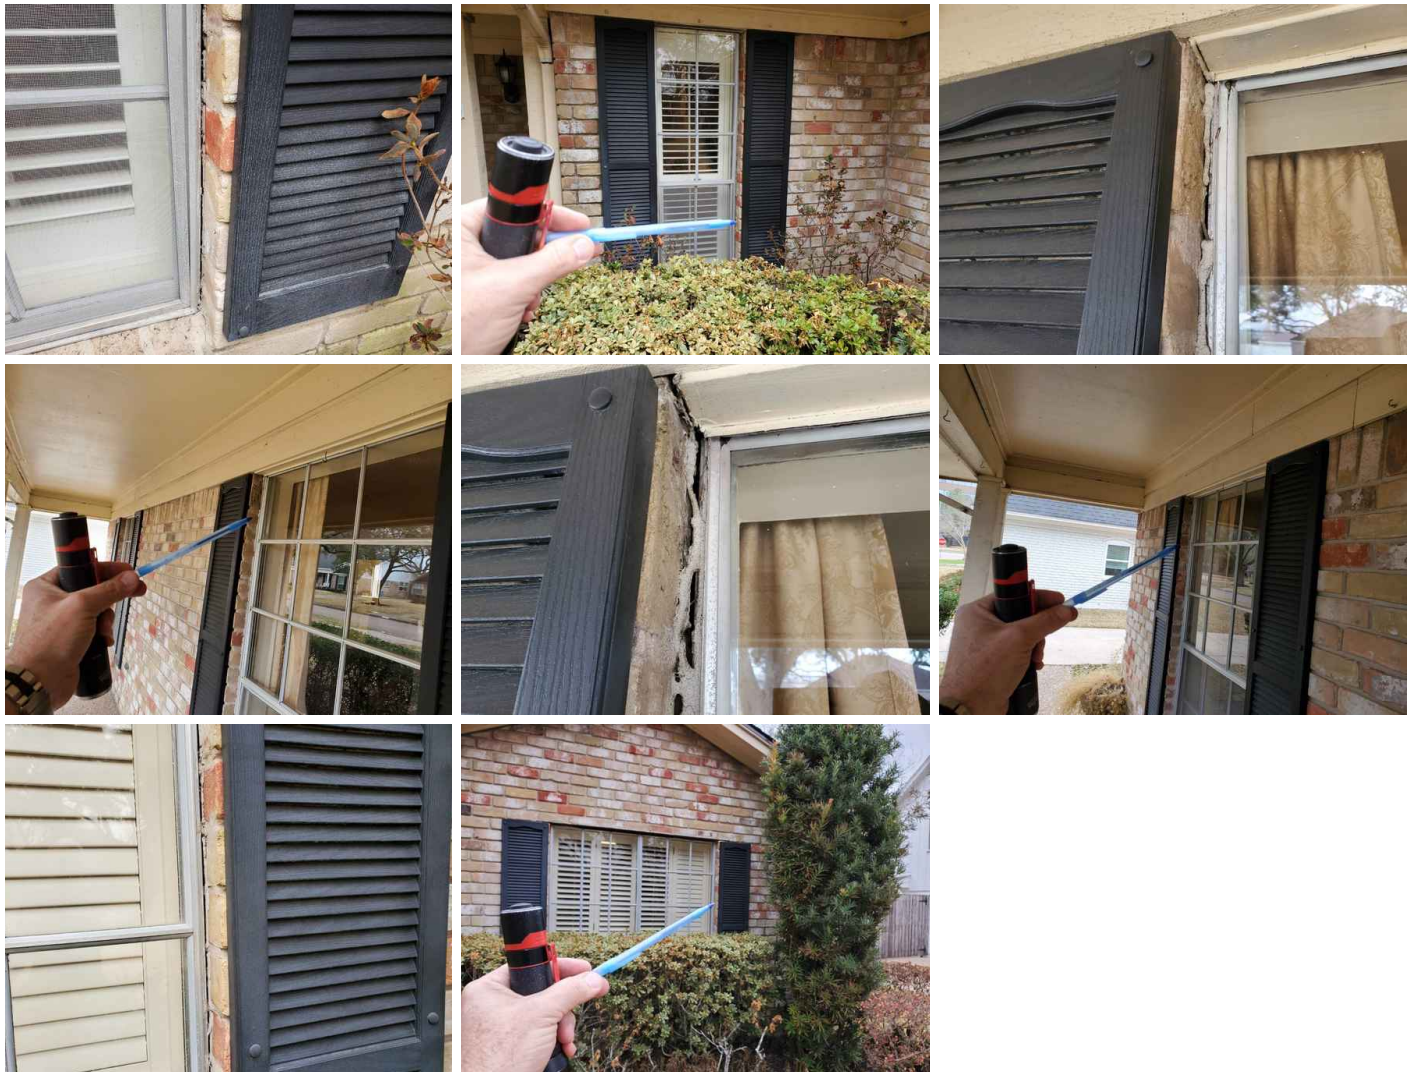
The window frame was separated from the exterior brick veneer apparently due to movement. The separation was observed to be approximately 1/2 inch.

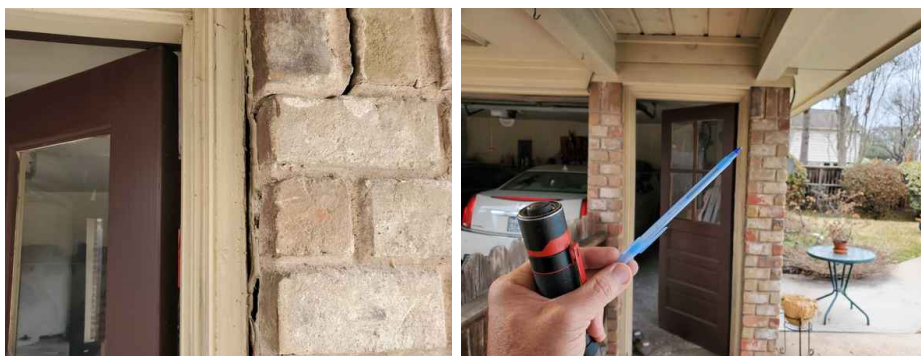
The door frame was separated from the exterior brick veneer apparently due to movement. The separation was observed to be approximately 1/2 3/4 1 inch 1-1/2 2 inches

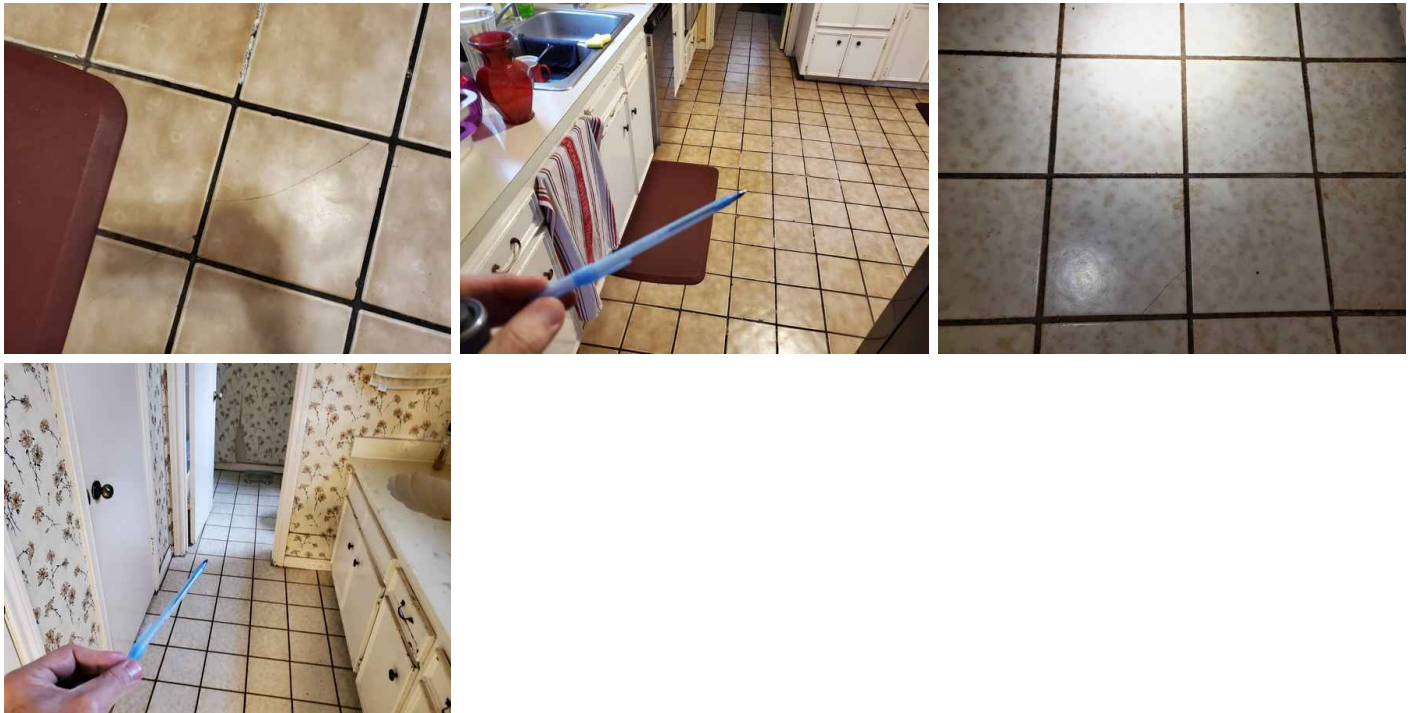
Kitchen , Master Bath

We observed that the floor tile was cracked at one or more locations which can be an evidence of foundation movement.

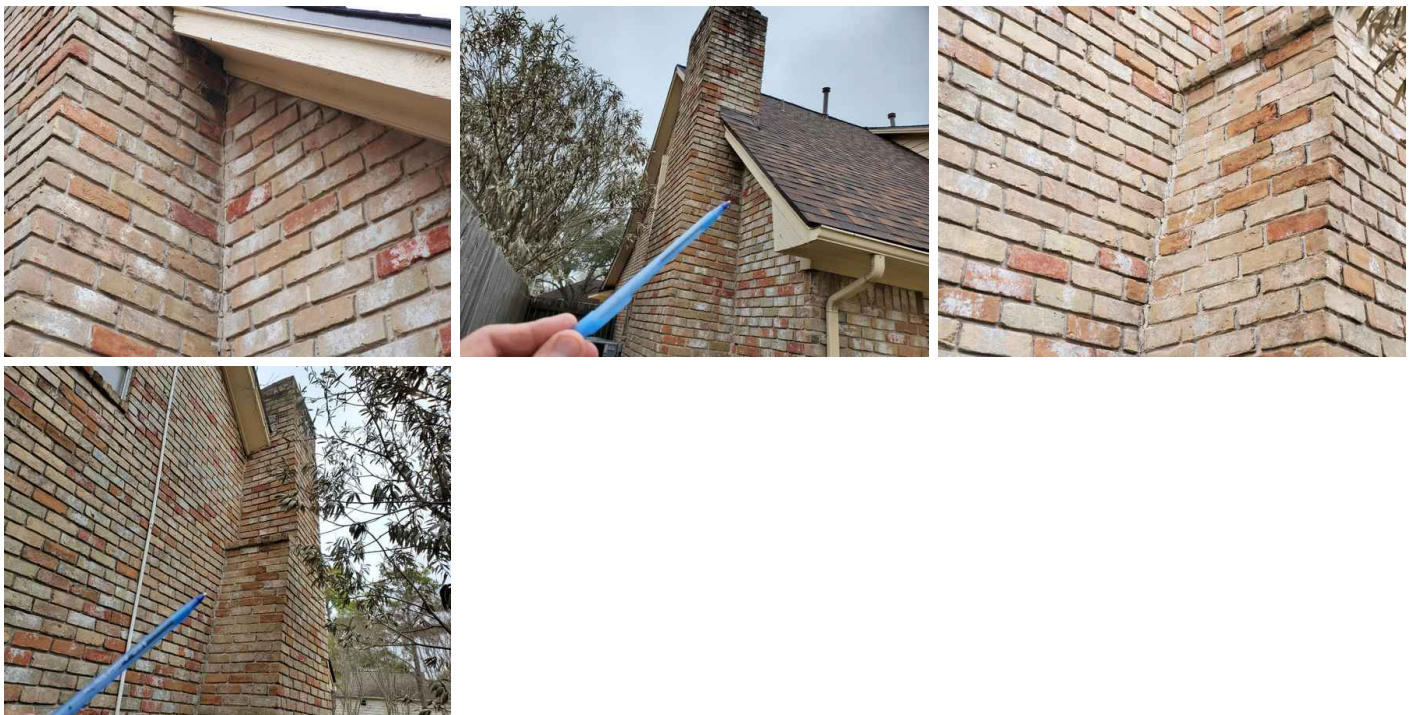
The chimney was separated from the exterior wall due to movement of the foundation.

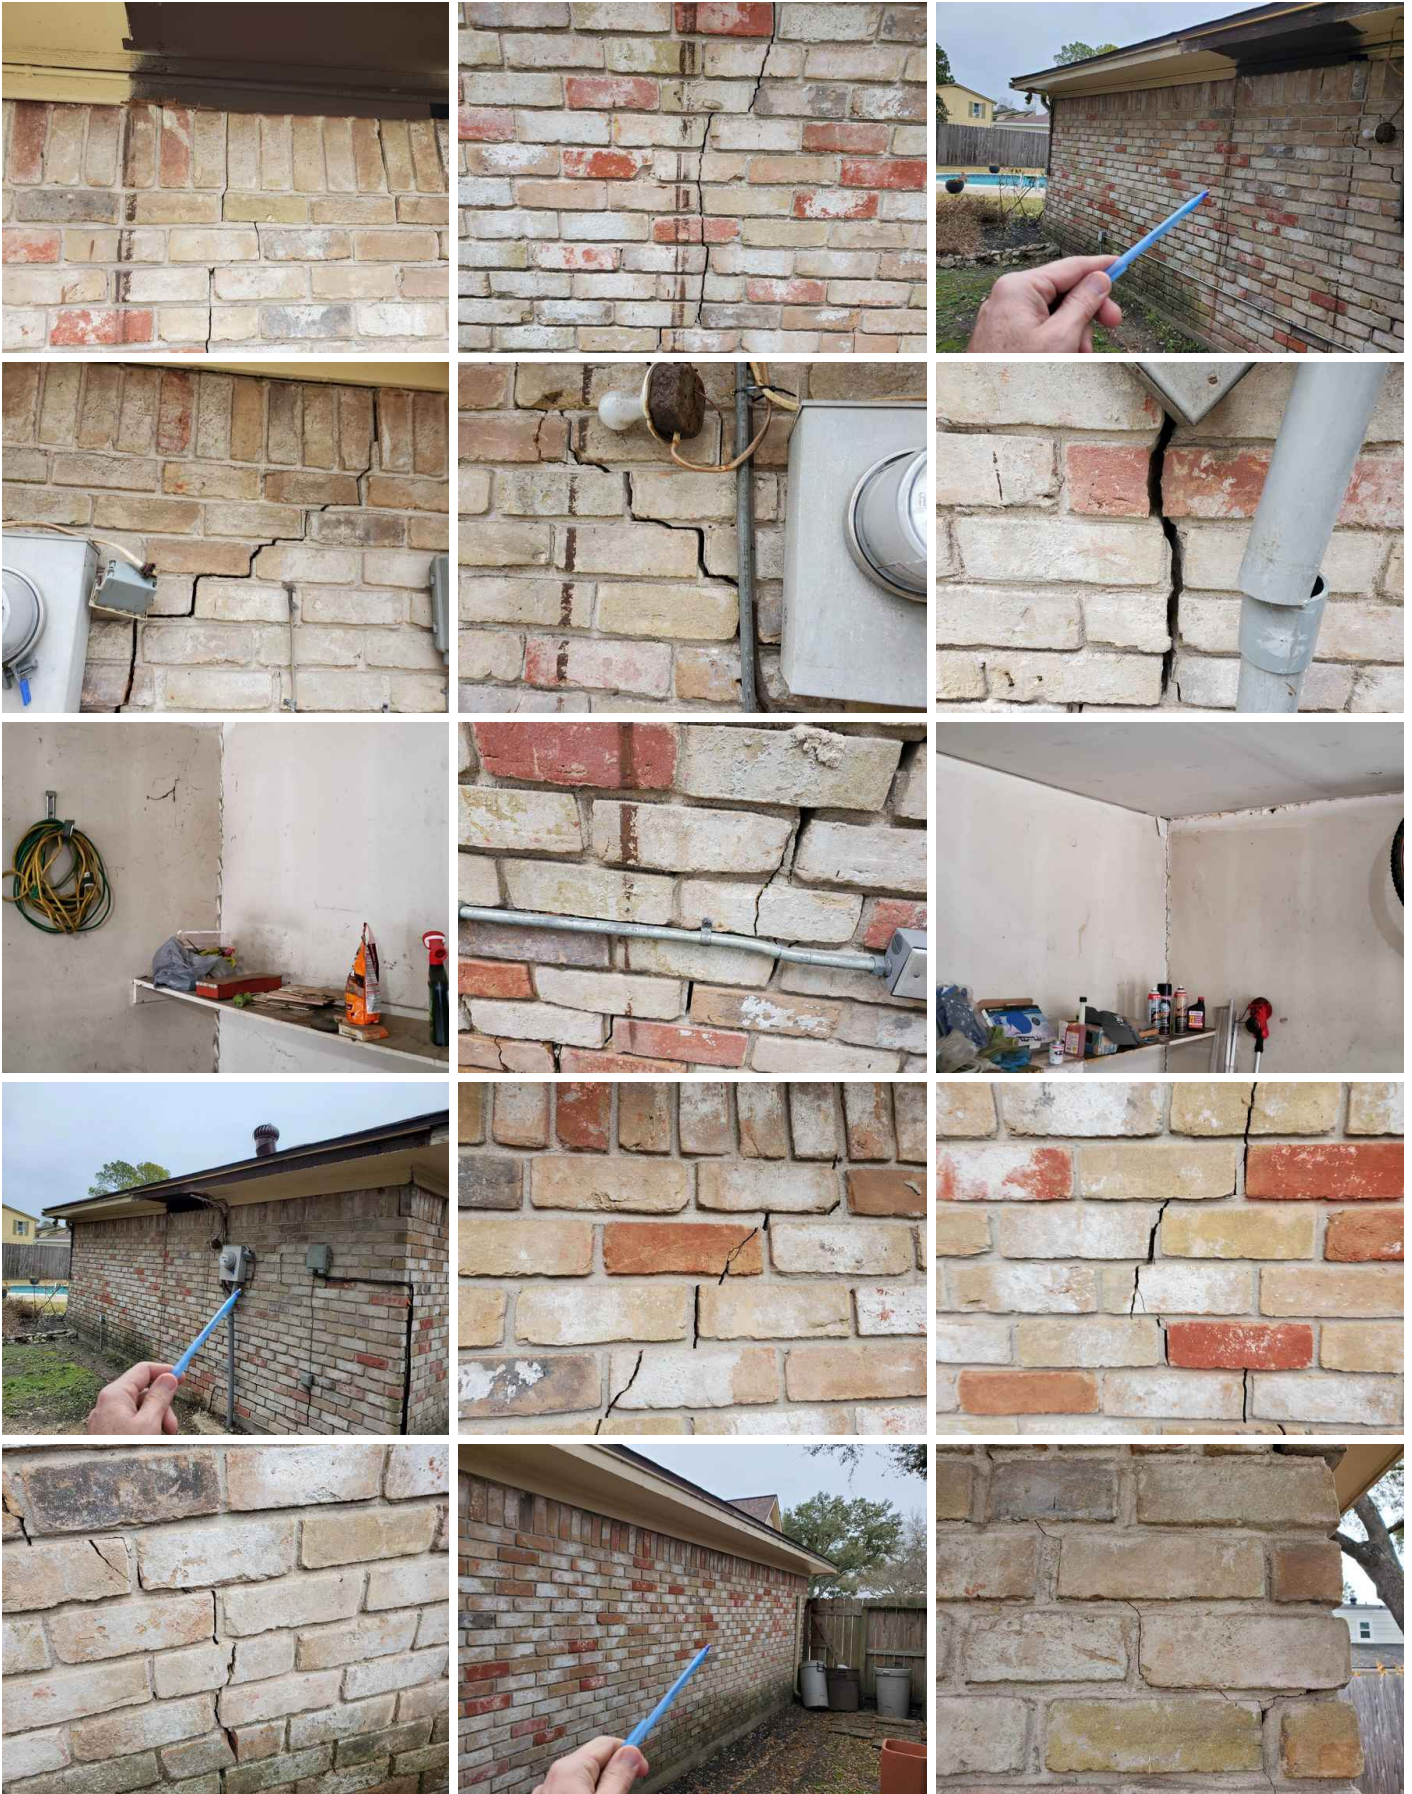
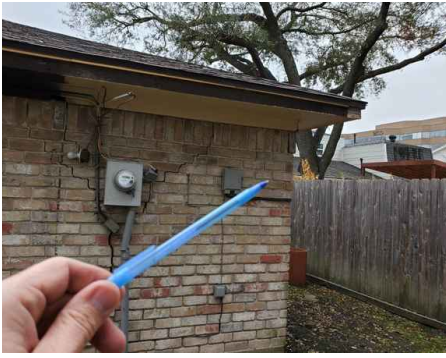
Garage

Most of the structures previously inspected by this firm have experienced some degree of differential foundation movement, and this structure was no exception. After careful examination, it is our opinion that the degree of the foundation movement is such that the condition of the foundation can still be considered as acceptable, yet marginally so. It is recommended that the evidences of differential movement be monitored in the future to determine if the condition has stabilized, or if the foundation is continuing to settle. It is emphasized that repairs could become necessary in the future should the foundation continue to settle, particularly in the areas outlined above. It is pointed

out for your information that, due to the nature of the soils in this area, it is reasonable to expect that some movement of the foundation will happen in the future.

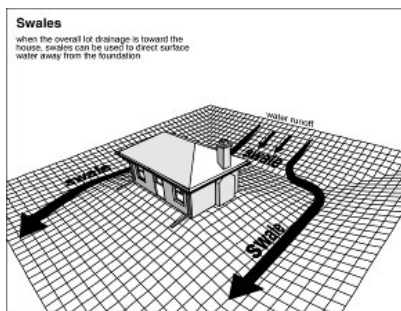
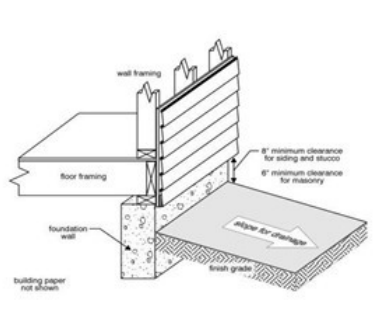
4.7.1 Perimeter Grading/Drainage

HIGH FLOWER BED/GRADING

The flower bed and/or perimeter grading was too high at some areas, and was graded near or above the top of the foundation. It is recommended that the beds/soil be regraded as needed to prevent water penetration into the house, and to allow for proper drainage.

Contact a qualified landscaping contractor

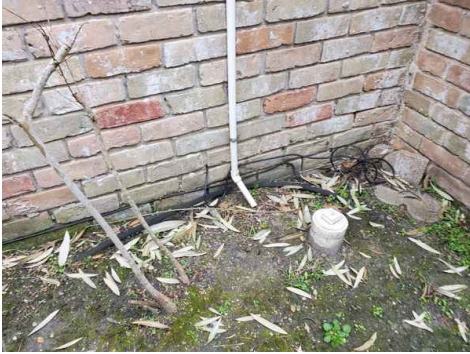
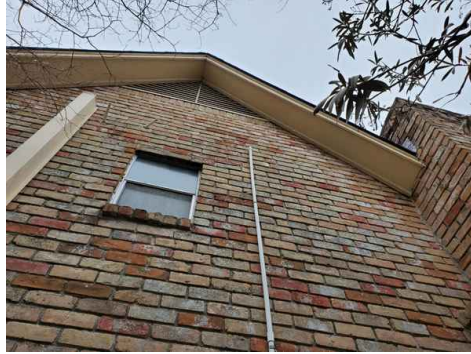
4.7.3 Perimeter Grading/Drainage

CONDENSATE DRAIN LINE

The primary condensate drain line from the air conditioning unit was emptying its water next to the foundation. This can cause the soil in that area to stay saturated, and contribute to differential foundation movement. It is recommended that the drain line be routed to a bathroom sink drain line.

Contact a qualified plumbing contractor.
