TEXAS OFFICIAL WOOD DESTROYING INSECT REPORT

10 Balboa Rd

10 Balboa Rd
Montgomery, TX 77356

PROPERTY INSPECTION REPORT

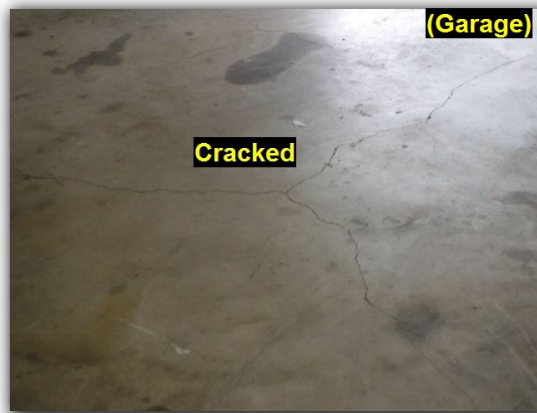
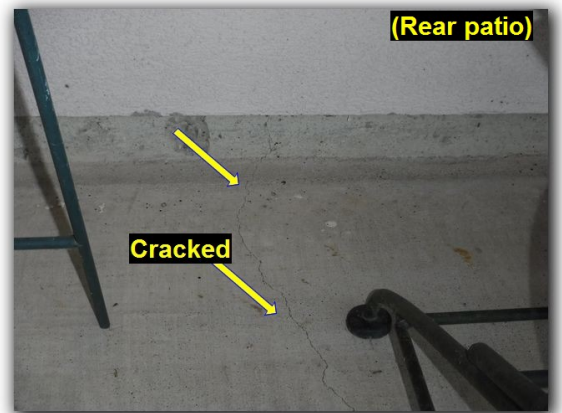
Observed evidence that suggests foundation movement (larger than normal cracks in garage & rear patio area). Some foundation settlement is normal, but I recommend further evaluation by a structural engineer or foundation repair professional to ensure no repairs are needed.

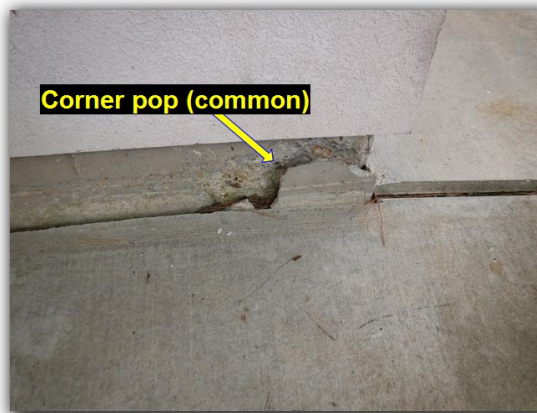
Spalling (i.e., corner pops) at one or more corner(s), Corner spalling is common to slab foundations and does not affect the structural integrity of the foundation.

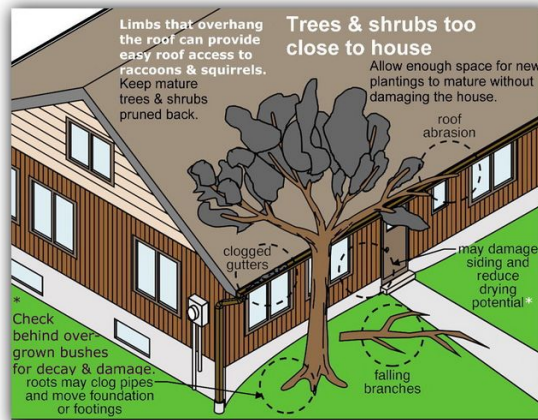
Recommend vegetation be cut back away from exterior of home to prevent damage.

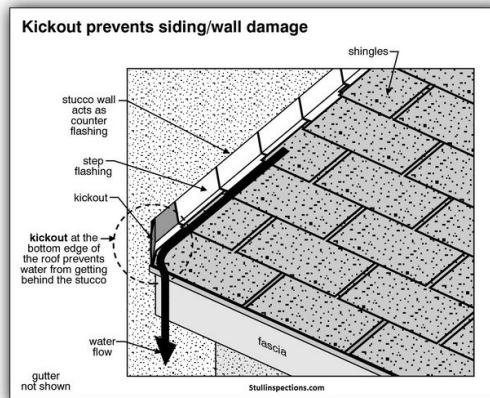
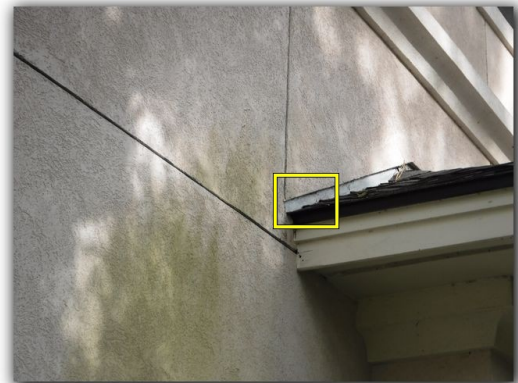
Did not observe kick out flashing installed in one or more areas. Current standards call for kick out flashing to be installed to help prevent water from getting behind the wall which can cause damage.

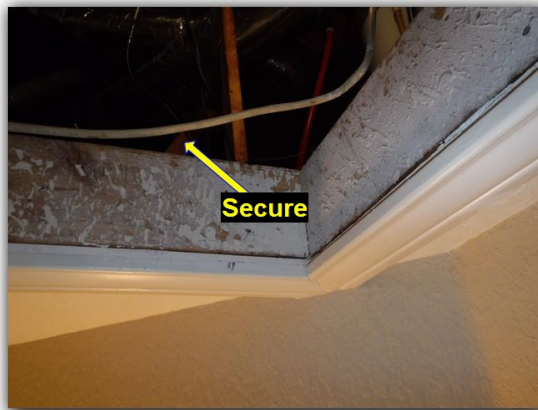
Observed wiring too close to attic access opening. Wiring should be at least 6 feet away from attic opening. One reason for this code is that someone falling from the access ladder might grab onto an electrical wire. Usually securing the wiring so that it can not be grabbed will alleviate this danger.

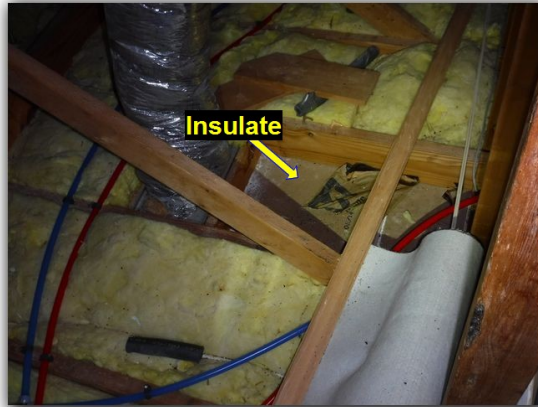
Observed insulation removed/missing in one or more areas of the attic. Recommend adding or reattaching insulation for optimum energy efficiency.

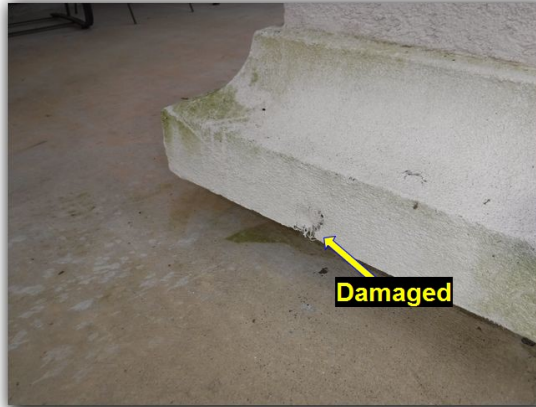
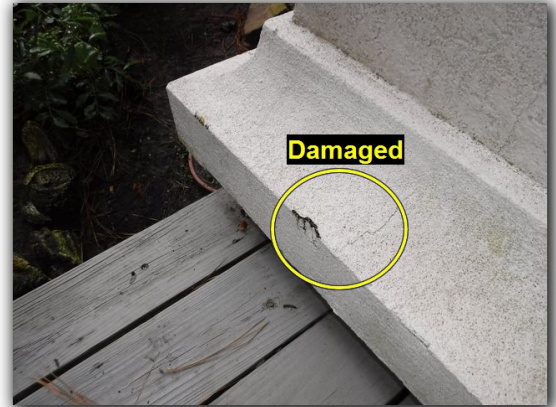
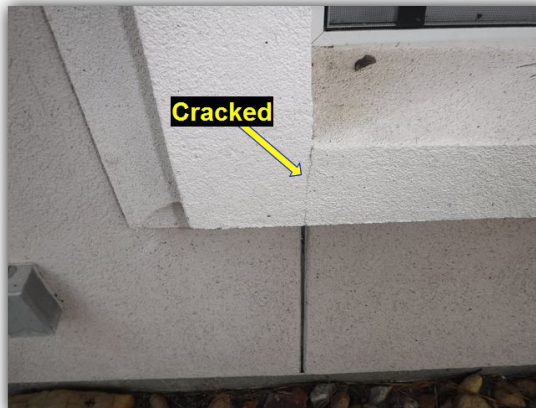
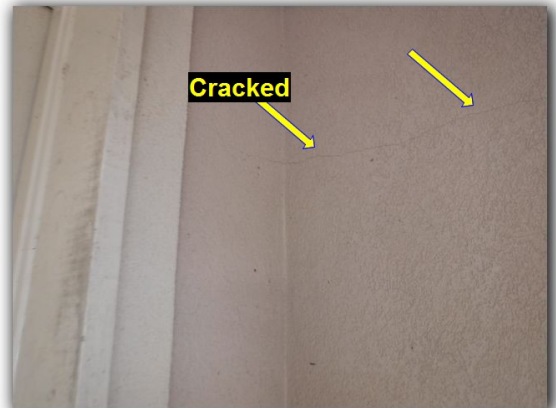
Observed the EIFS siding was damaged and not sealed in several areas around the exterior. Recommend further evaluation and repairs / sealing as needed by a qualified contractor. Recommend the contractor evaluate to ensure no water is trapped behind the siding which could cause damage.

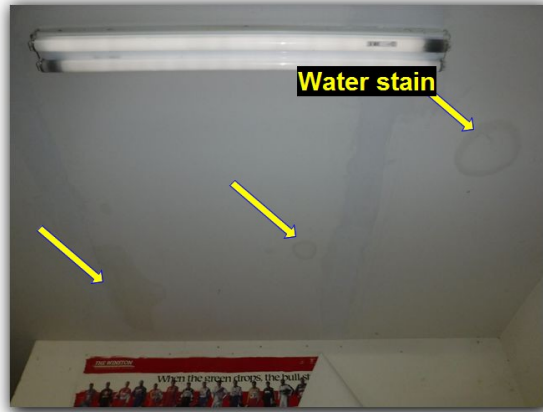
Observed water stains on the ceiling in the garage. Moisture readings were low at time of inspection which usually indicates the stains are from previous leaks, but I could not be certain. Recommend asking the seller about previous leaks that may have been repaired or having further evaluation by a contractor.

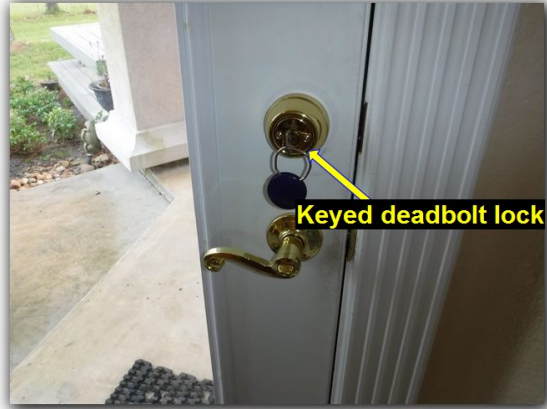
One or more exterior doors use "keyed deadbolt locks" on the inside. Although commonly used for security against intruders, this is not the best practice. For safety purposes in case of fire, all exterior locks on egress doors should be thumbblacked on the inside.

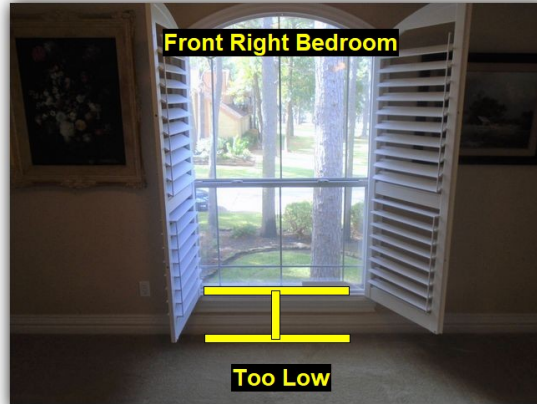
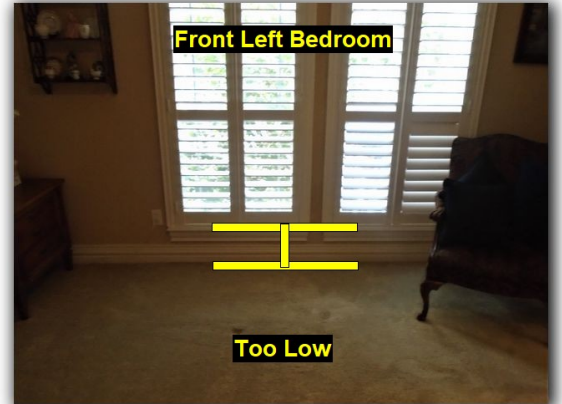
Observed several windows that were too low to the floor. Although this may have been allowed at time of construction, current standards call for second story windows to be at least 24 inches from the floor. This is to prevent small children from falling. Recommend installing safety locks that will not allow the window to open more than 4 inches.

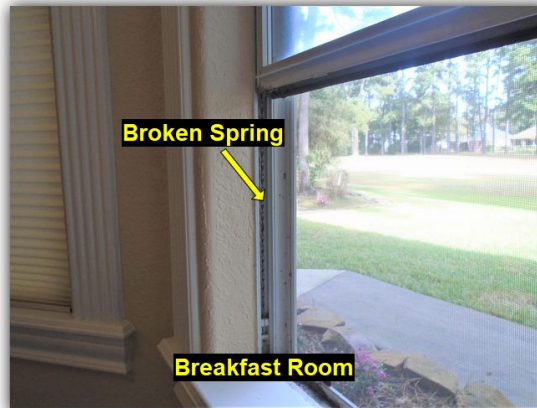
Observed breakfast room window that has a broken window spring. The windows springs hold the windows up when opened.

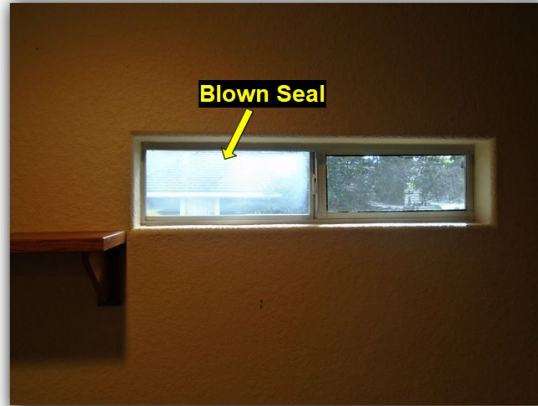
Observed the thermal seal was broken on one or more windows. A broken seal allows condensation to form between the panes which causes a cloudy film to develop. This cloudiness will continue to get worse until it is difficult to see out of the window.

Note: It is sometimes difficult to determine. Recommend have further evaluation by a professional window contractor.

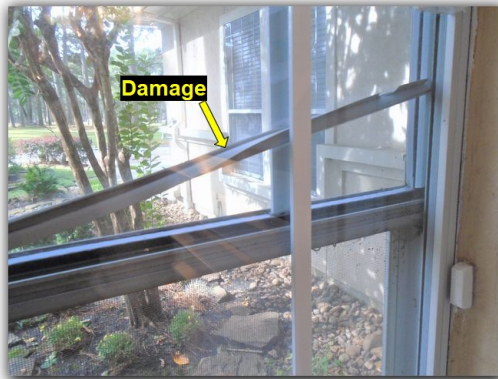
Observed one or more damaged window trim.

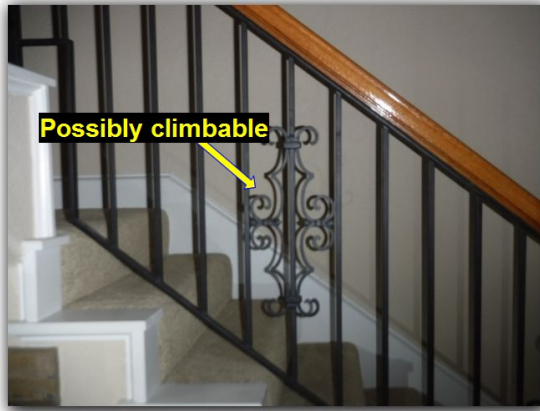
Buyer's note: The handrail / guardrail is possibly climbable. Recommend using caution if children are on the stairs or near the second floor guardrail.

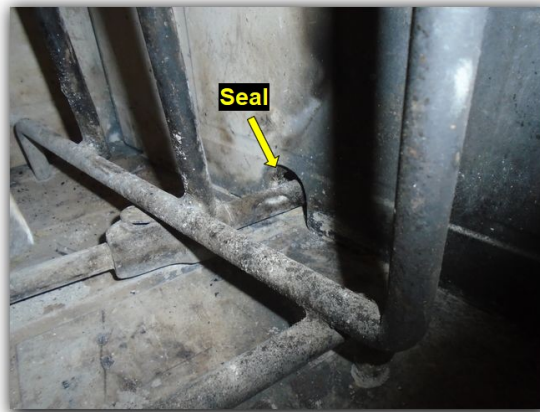
Observed the gas line penetration into the firebox had not been sealed. This is recognized as a fire hazard. In need of sealing.

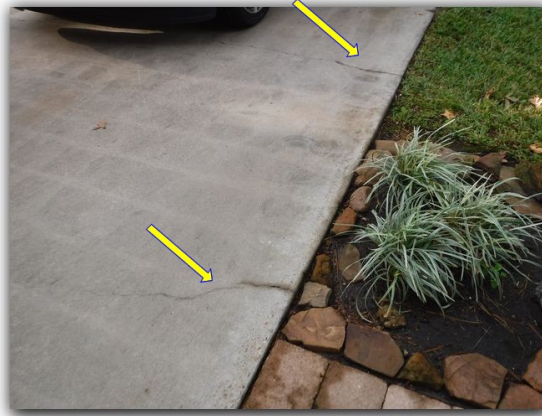
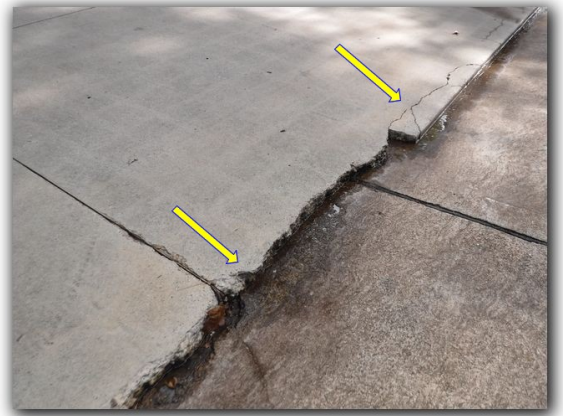
Cracks in walkways, driveway and/or garage concrete observed, typical.

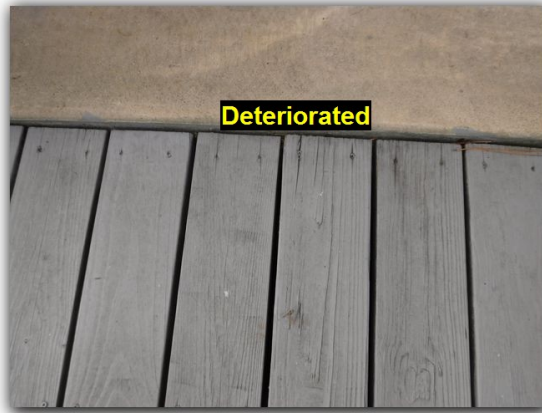
Deteriorated wood observed at the rear deck.

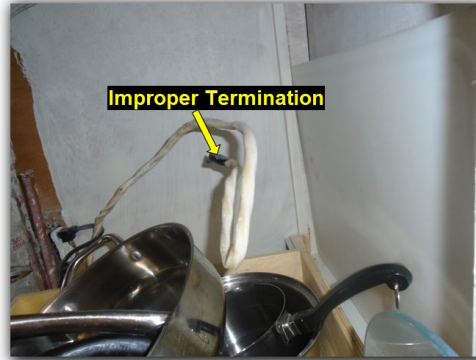
Improper termination of wiring in the counter under the cook top.

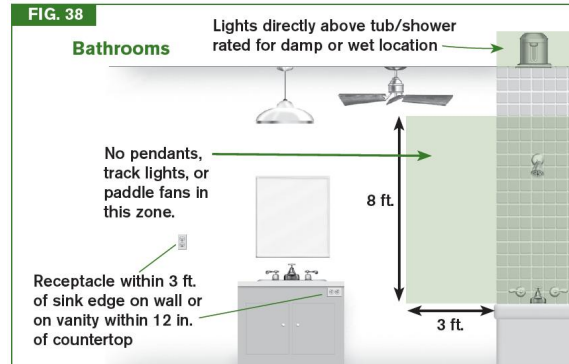
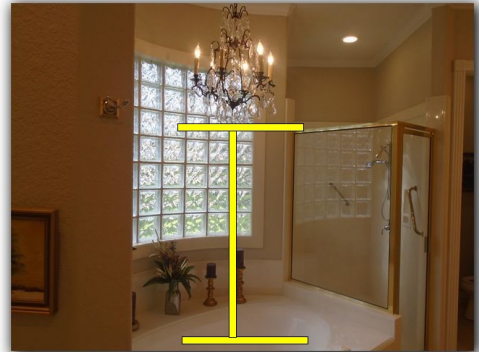
Observed an improper light fixture above the primary bathtub. Light fixtures directly over bathtubs should be rated for wet locations.

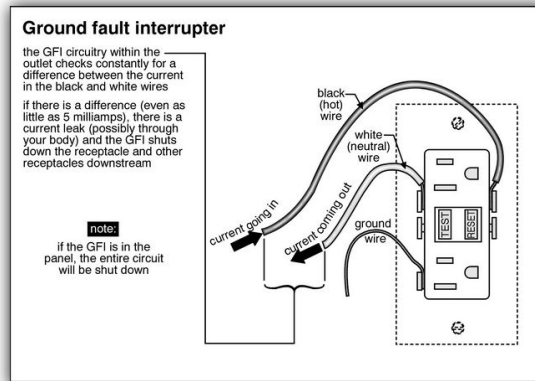
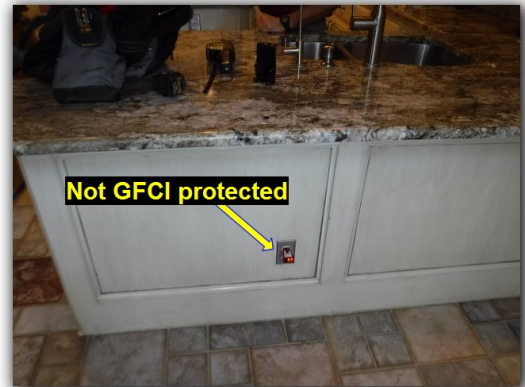
Did not observe GFCI protection for all outlets in the kitchen, laundry room, garage, exterior & living room side of the kitchen bar. Current standards call for GFCI protection for all outlets in kitchen, bathrooms, laundry room, garage, exterior and any outlet that is within 6 feet of a water source. This is a recognized safety hazard.

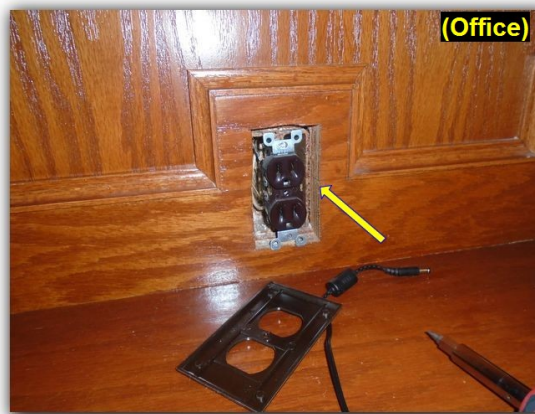
Observed one or more outlets that did not have a spark ring installed. Currents standards call for junction boxes mounted within a surface of wood or other combustible surface to be flush with the combustible material to prevent a fire hazard.

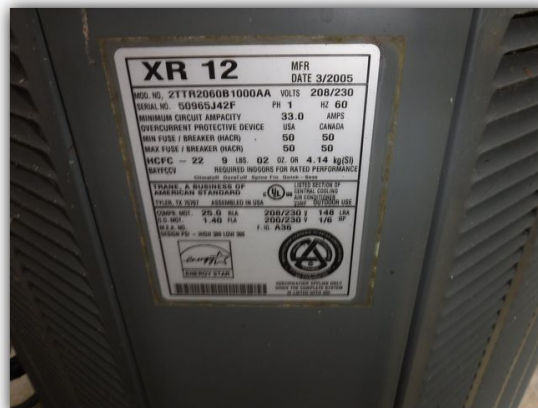
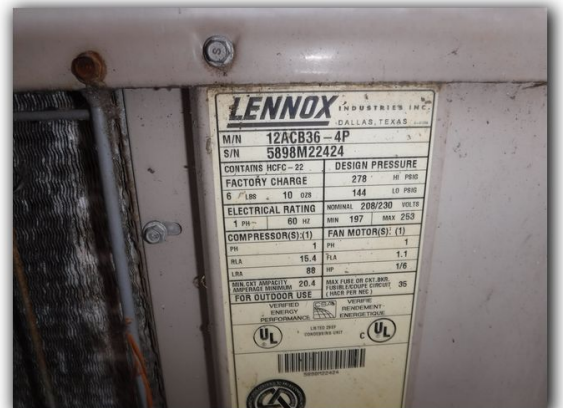
CONDENSING UNIT(S): TRANE (2005), LENNOX (1998)

Based on the age of the Lennox condensing unit, I recommend evaluation and servicing by a licensed a licensed HVAC technician.

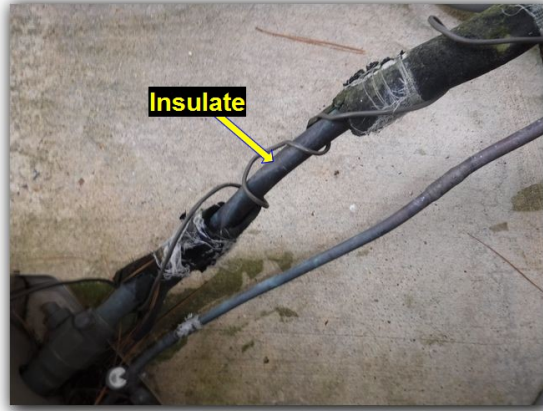
Observed the suction line is missing insulation. For optimum energy efficiency I recommend re-insulating the suction line.

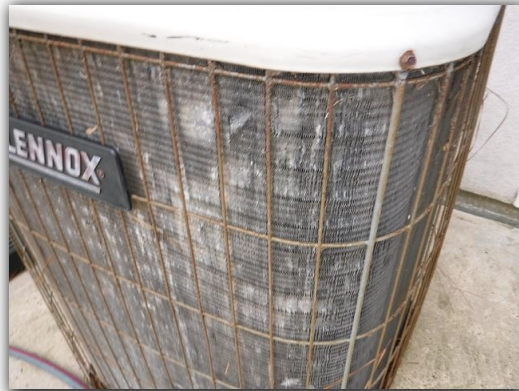
Bent / damaged fins observed. Recommend straightening bent / damaged fins to promote proper air flow.

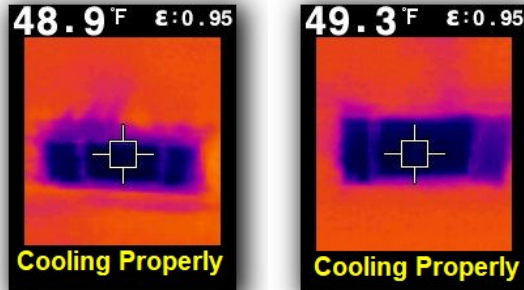
A thermal image of the air vents show the air conditioning unit(s) was / were cooling properly at time of inspection.

TEMPERATURE DIFFERENTIALS: 18 degrees (67, 49) **GOOD**
19 degrees (68, 49) **GOOD**

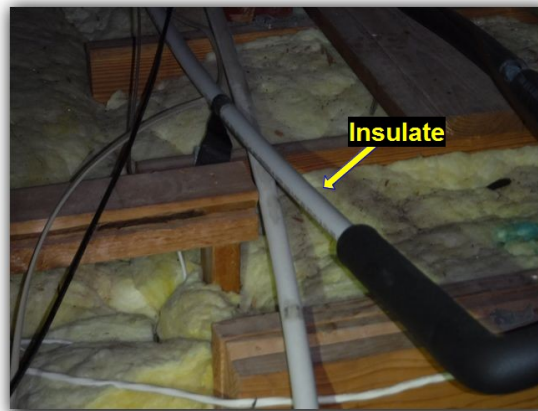
Observed the condensate line was missing insulation in the attic. Condensate lines will sweat and can drip condensation. Recommend insulating exposed areas of condensate line.

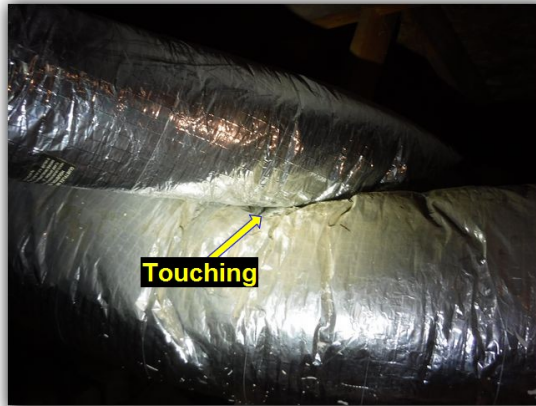
Observed ducts touching in one or more areas in the attic. This can allow condensation to form between the ducts which can drip onto the attic floor or ceilings below. Recommend separating the ducts or placing a piece of insulation between the ducts to prevent condensation from forming.

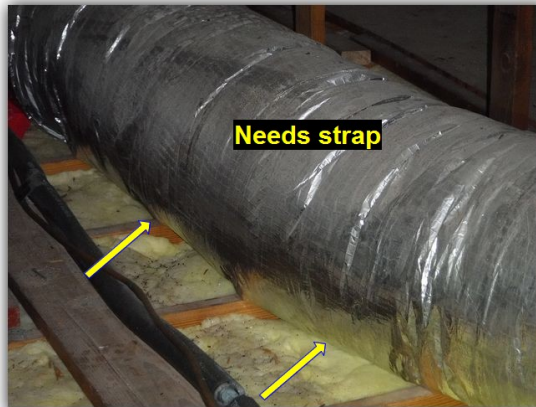
For optimum efficiency duct work should be suspended from the attic floor. Recommend consulting an HVAC technician for more information.

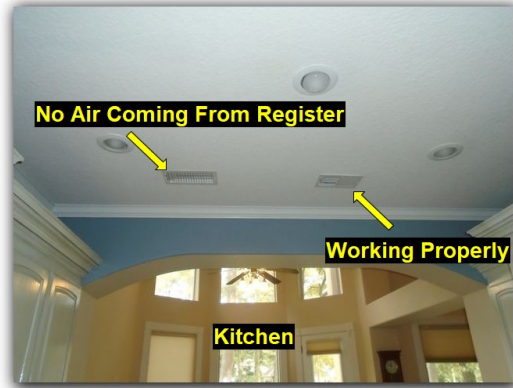
Observed one kitchen register (vent) that did produce proper warm / cold temperatures when tested. Possibly setup as a return register but I could not determine. Recommend further evaluation by a licensed HVAC contractor.

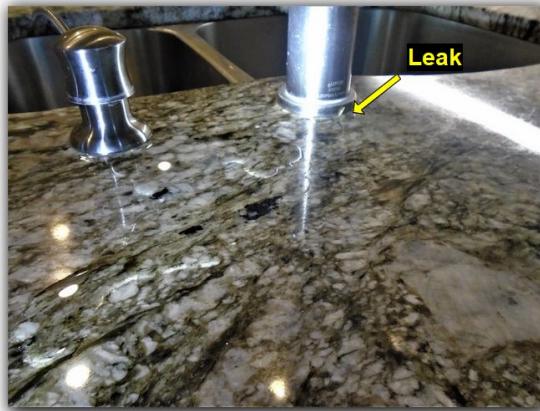
Observed the faucet at the kitchen sink loose and a slow leak from the countertop. In need of repair.

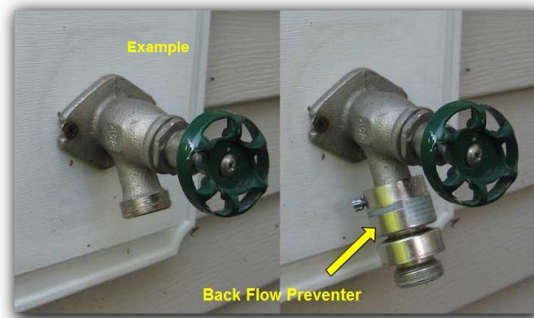
Some exterior hose spigot(s) do not have code approved anti-back flow devices installed. Note: Back flow preventers cost approximately \$5.00 and are easy to install.

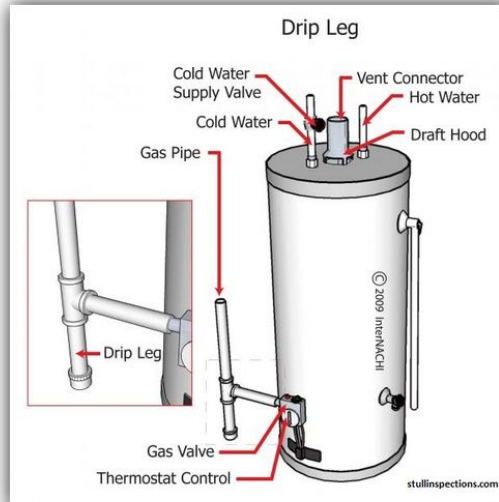
Did not observe a drip leg (sediment trap) for gas line at water heater(s). Sediment traps are necessary to protect appliance gas controls from the dirt, soil, pipe chips and other debris that can enter the piping during installation or repair and cause damage to the unit. As inspectors we are not required to report this as a deficiency, but you might consider installing drip legs if you every have repair work performed or replace the water heater(s).

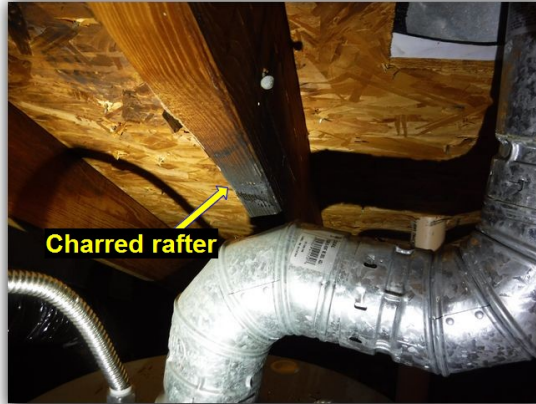
Observed the exhaust duct for the water heater was too close to combustibles. Current standards call for at least a one inch separation from combustibles. This is a fire hazard. In need of repair.

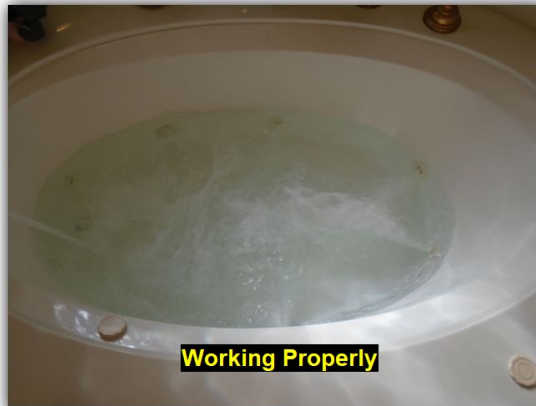
Observed hydro-massage therapy tub working properly at the time of inspection.

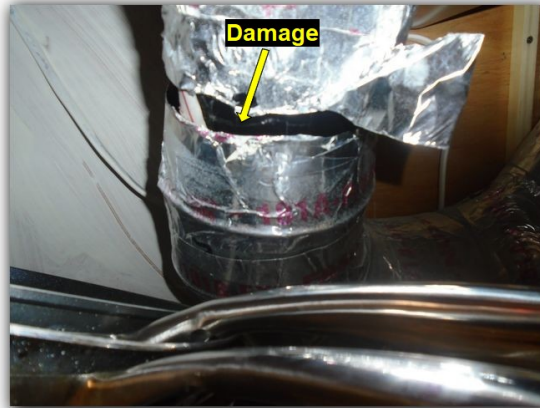
Observed a gap that needs to be sealed at the air duct for the countertop range. In need of repair. Current standards call for the duct must be made from galvanized steel, stainless steel or copper. It must have a smooth interior, and be air tight.

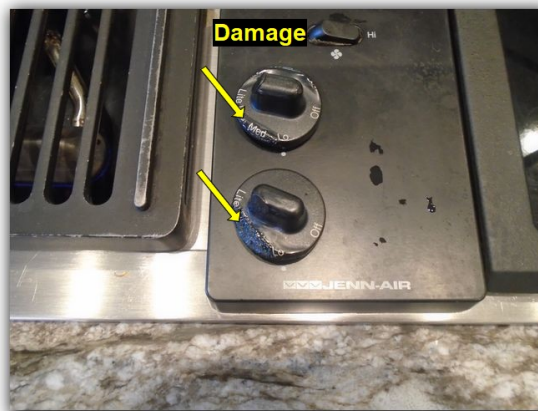
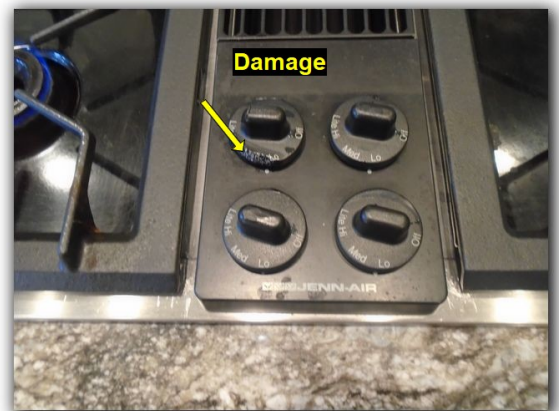
Multiple knobs were damaged/melted but were able to operate the cooktop.
