## PROPERTY INSPECTION REPORT

Concerning: 19434 Bay Bower Lane , Katy, TX 77449  
(Address or Other Identification of Inspected Property)

By: Terrence Foster Lic.#: TREC #5182 10/20/2021  
(Name and License Number of Inspector) (Date)

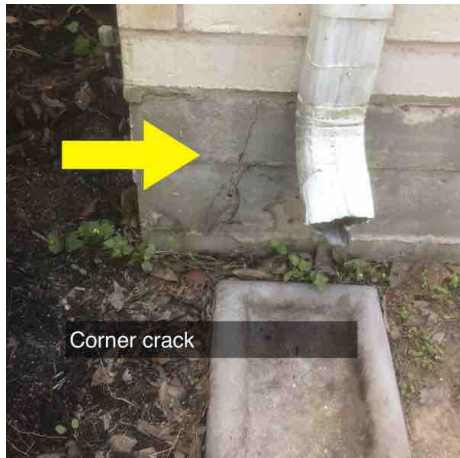
- Corner crack observed on the northeast, southeast and northwest corners of the foundation, fill in cracks in order to reduce chance of rust damage to post tension cables, cracks appear to be cosmetic and common to many homes.

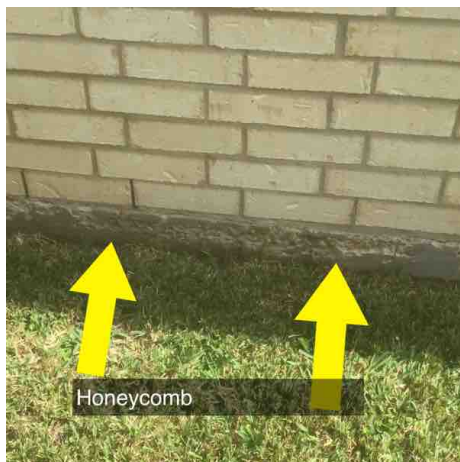
- Foundation has a honeycombed surface on the west side that needs to be reparged (covered).

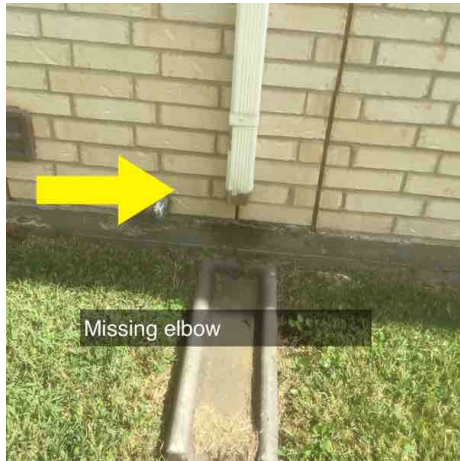
- Missing gutter elbows on the middle of the east and west sides of the house, need to be installed.

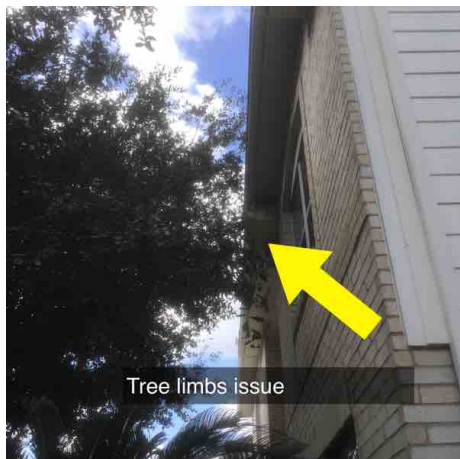
- **Need to trim the tree limbs away from the house to reduce chance of damage to the roof, should evaluate the front of the house for possible damage.**

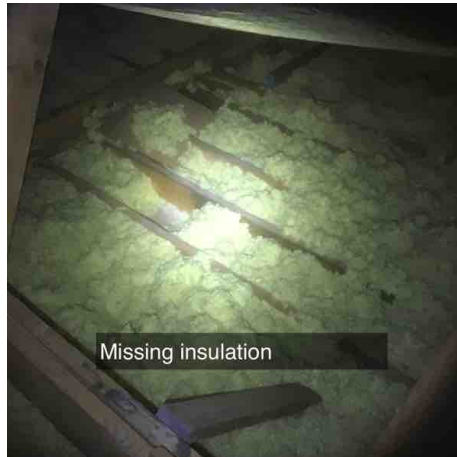
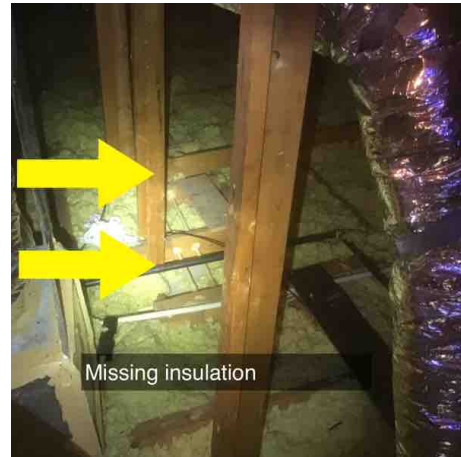
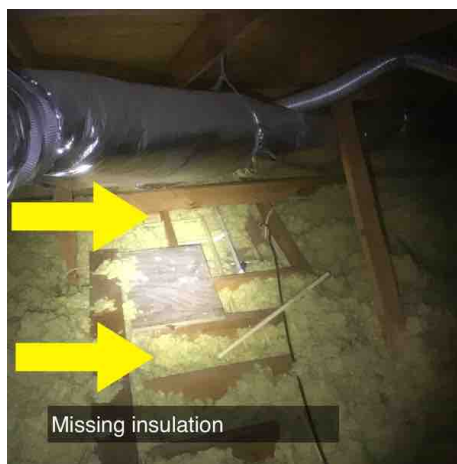
- Attic ventilation is soffit vents, roof vents and ridge vents. Insulation prevents visual inspection of pipes, wires, fixtures and structural components underneath.
- **Need to install more insulation in the attic to reduce energy costs and provide added comfort, there are many areas missing insulation and others with not enough. Average attic insulation in new homes is appx. 12 inches or more of loose/batt insulation.**

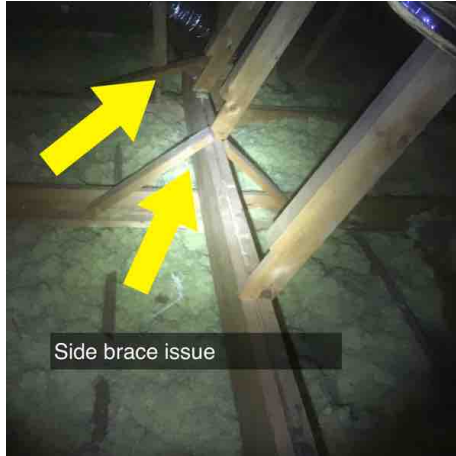
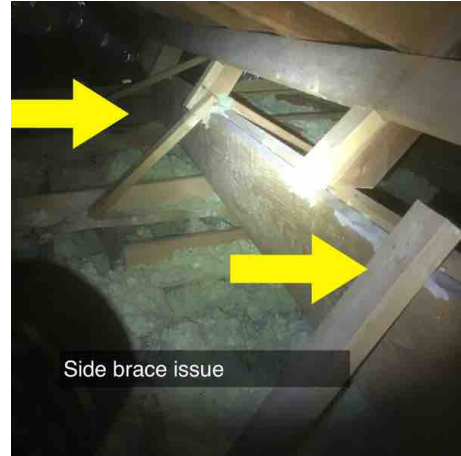
- There are beams on the attic floor that the purlin braces/struts from the purlins are nailed to for support of the roof structure, the beams should be evaluated further by a qualified contractor because they do not appear to have proper side bracing to reduce the chance of the beams moving, side braces are nailed to the top of the beams instead of being butted up and nailed to the side.

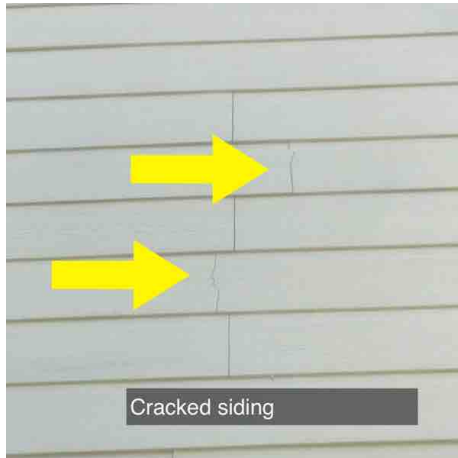
- Many of the concrete composite siding boards on the exterior are broken on the corners, appears to be from poor installation, this could possibly cause the siding to become loose, siding needs evaluation and repair as needed. They also need to be caulked where the siding boards meet.

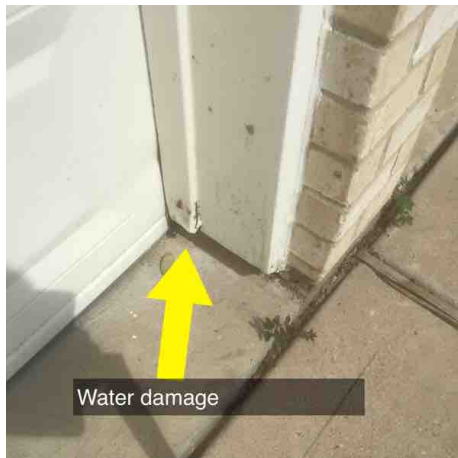
- The exterior trim boards for the garage doors have water damage to the bottom of them, need repair.

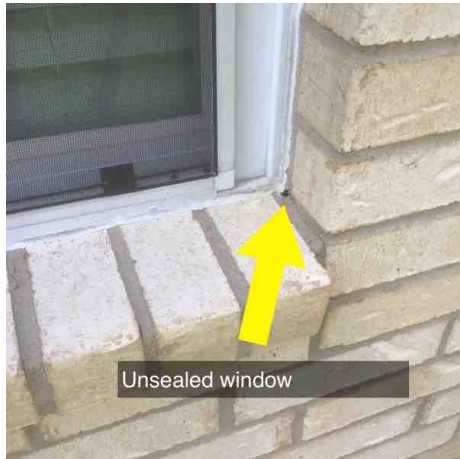
- Need to caulk and seal around the exterior windows to reduce possibility of water leaking in.

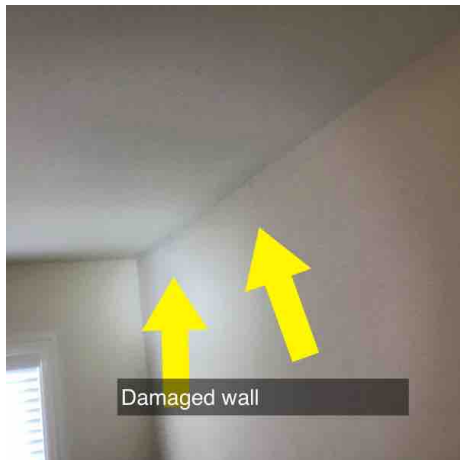
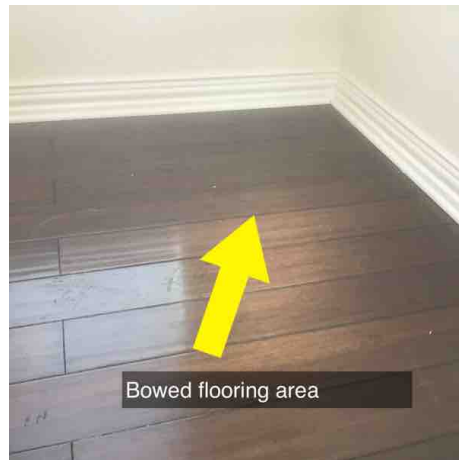
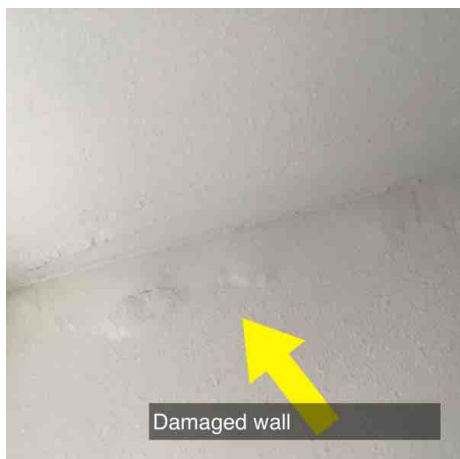
- The northwest bedroom wall and ceiling area to the right of the window has water damage to the surface, no moisture was detected at this time, there could be water damage issues behind the wall, recommend evaluation inside the wall and also under the flooring, because the flooring appears to be bowed in the same area.

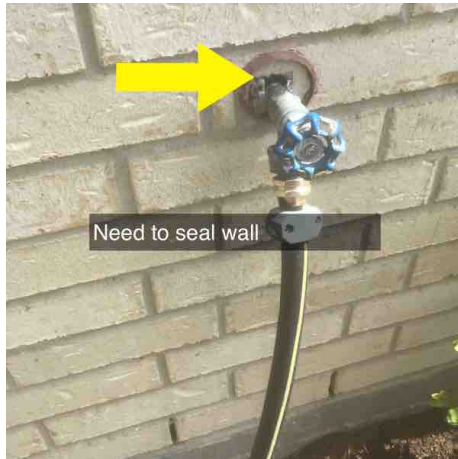
- Exterior walls of the house have open places in them around pipes coming out of the wall, need to be properly sealed up to reduce potential water intrusion.

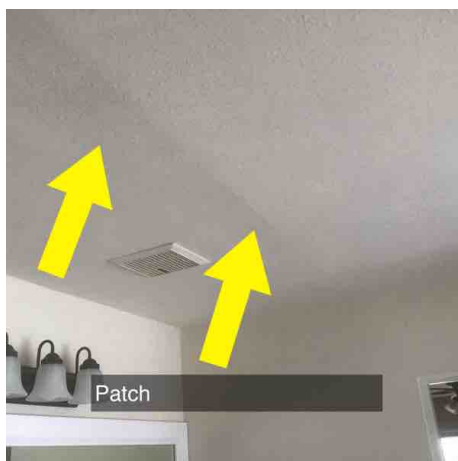
- Many ceilings upstairs have patched, repainted areas in them, and in the attic over these areas, there is missing insulation and some exposed plumbing pipes, it appears that there may have been freeze damage to some of the plumbing causing this, recommend further evaluation to see what type of freeze damage issues that the house may have had.

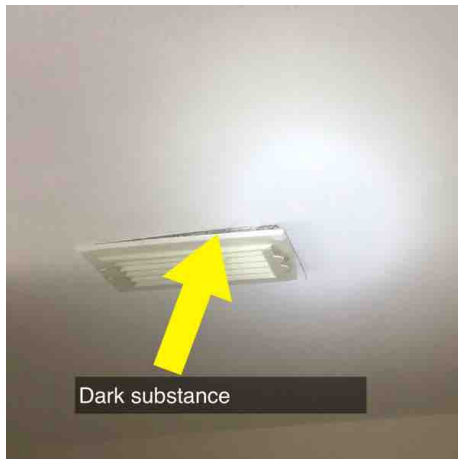
- Dark substance on the ceiling next to the supply register in the primary bath, appears to have been caused by a condensation issue, needs repair by a qualified contractor and recommend to evaluate the ceilings around the rest of the registers in the house. Recommend to have a qualified environmental, mold contractor be contacted to see if air samples and other testing should be done on the house for potential mold type issues and what repairs may be needed.

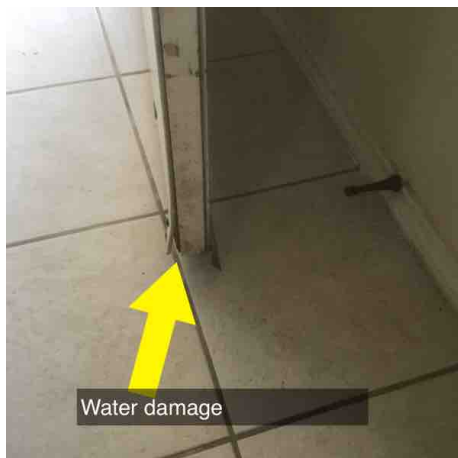
- Open/close/latched doors. Tested locks.
- Door from the garage into the house needs to have a self closing mechanism to close door for safety reasons.
- The rear patio door has water damage to the bottom of the door, needs repair and possible replacement.

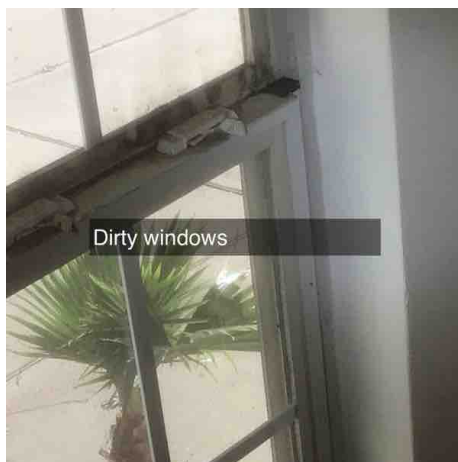
- The interior window frames above the front door are dirty, need to be cleaned properly, recommend further evaluation of substance on window frames to see what it is and if other investigation or repair is needed in case of an potential environmental issue.

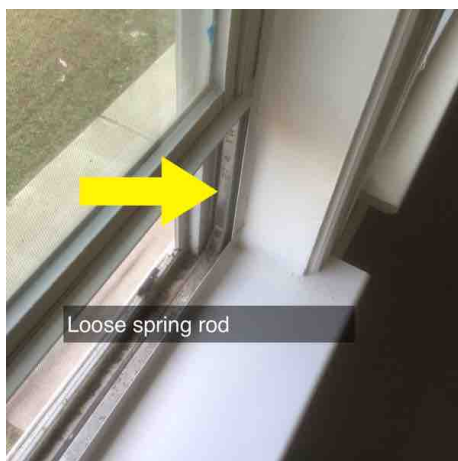
- Window screens are missing on some of the windows.
- The window has a loose spring rod on the side of the gameroom left side window frame which holds the window open, needs to be properly re-installed up into the frame.

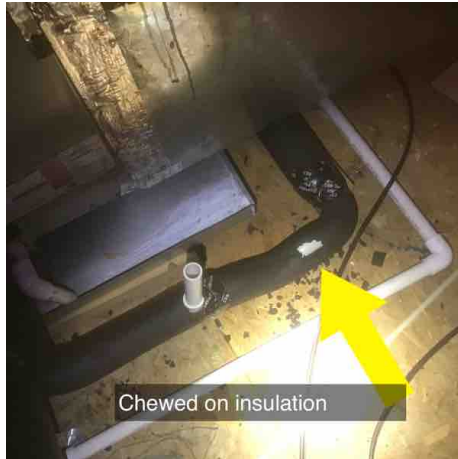
- Attic appears to have had a rodent issue because of some pipe insulation that appears to have been chewed on, should have further evaluation by a pest control contractor and seal the exterior areas of the house.

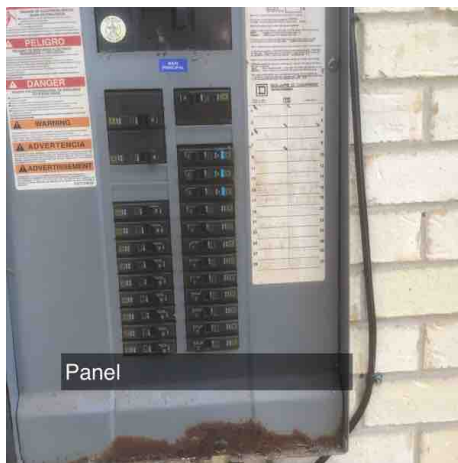
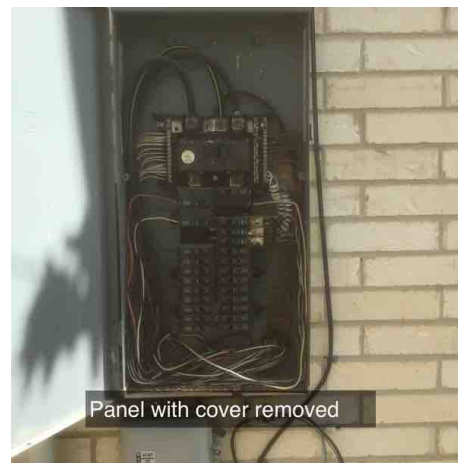
- Main service wire is aluminum. Main breaker is 125 amps, panel rating is 200 amps. Panel is located on the exterior west side of the house.

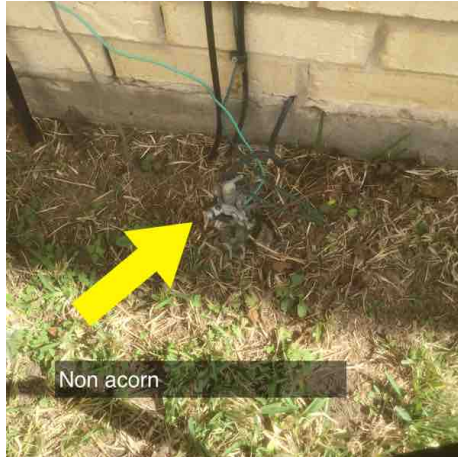
- Should replace the main ground rod clamp with a acorn type clamp instead of the pipe type clamp that is being used to reduce chance of loose connections in the future.

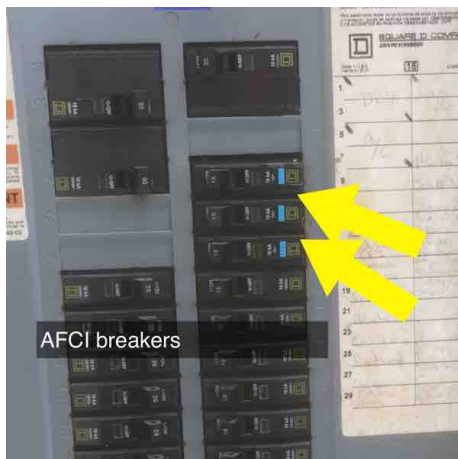
- Only located one ground rod for the house, not able to verify if resistance is greater than, >25 ohms, if it is not, then a 2nd ground rod is required, needs to be verified and repaired if needed.
- The AFCI (arc fault circuit interrupters) per current requirements, are meant to turn off all lighting and outlet circuits in the house other than major appliances and GFCI protected circuits, this was not required at the time that this house was built, only that they were for the bedrooms, which they are except for the northwest bedroom, it is not protected, needs repair. AFCI breakers should be protecting all required circuits.

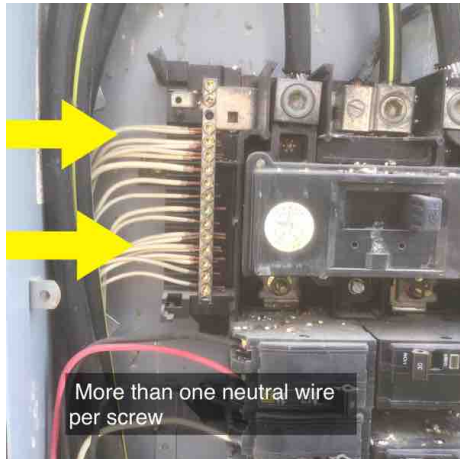
- **Neutral buss bar normally should have only one neutral wire attached to each screw, there is more than one wire on the screws, needs evaluation by a qualified electrical contractor.**

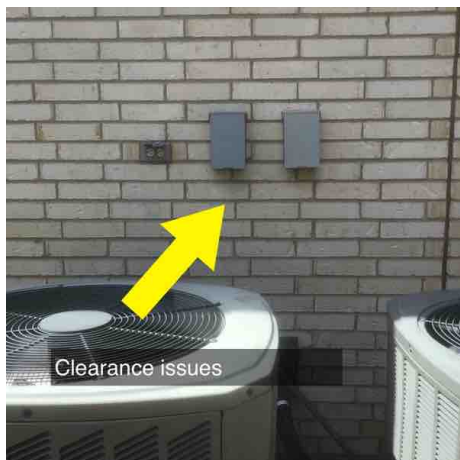
- **The exterior wall outlets on the house should be the type with all weather covers on them, this is a current requirement, needs repair.**
- **The service disconnects on the exterior for the A/C compressors do not have proper clearance on the front and sides for safety reasons when servicing them, needs further evaluation and repair as needed.**

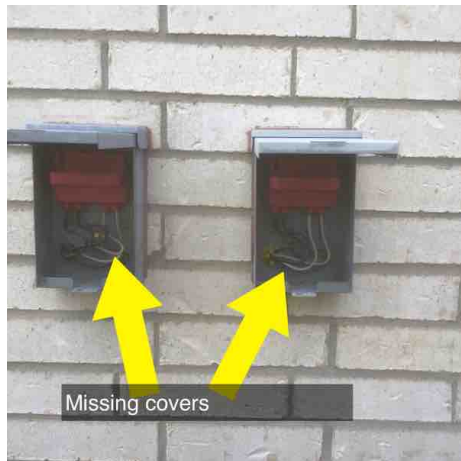
- **The inside covers are missing in both of the exterior service disconnects for the AC systems, need to install covers.**

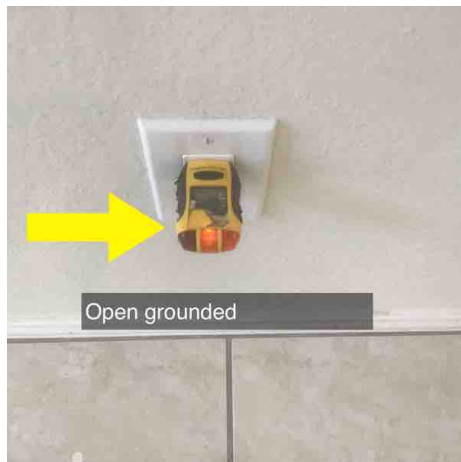
- 8 smoke alarms. Smoke alarms need to be tested at least once a year and batteries changed.
- **Current requirements is for all of the smoke alarms to be connected to each other so that when one goes off, they all go off, they are not connected together, needs repair.**
- Should install carbon monoxide detectors where needed.
- **The wall outlet on the back side of the kitchen sink wall is open grounded, needs repair.**

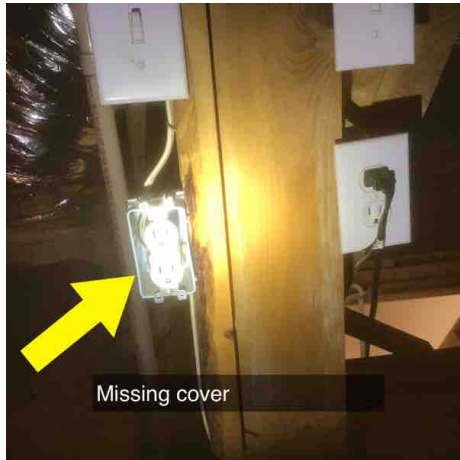
- Missing an outlet cover in the attic, needs to be installed.

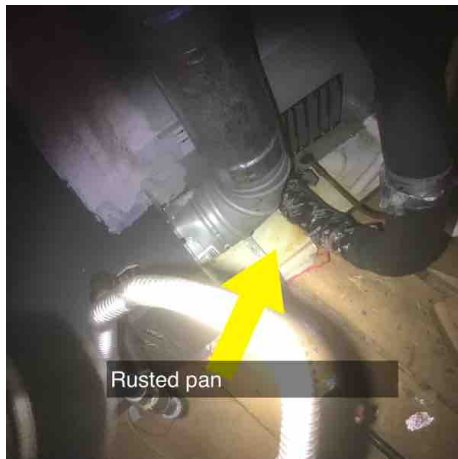
- **The secondary drip pan in the north attic has rust damage in it, recommend evaluation to replace pan and coils/system on the A/C system need further evaluation and repair as needed for possible damage issues.**

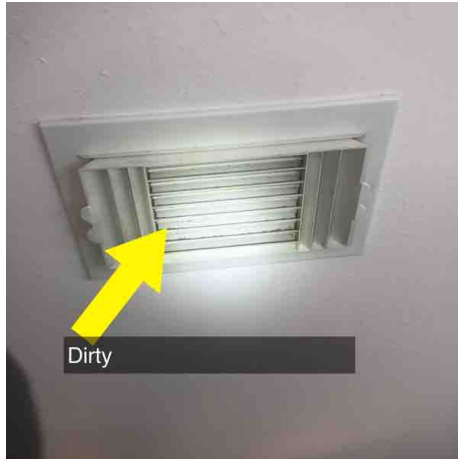
- Many of the supply registers, vents are dirty, dark substance on them, need to be cleaned and evaluated for cause and ducts should be evaluated for cleaning also, recommend further evaluation by a qualified environmental contractor for what the substance is on the registers if there is a potential environmental issue that would need further investigation.

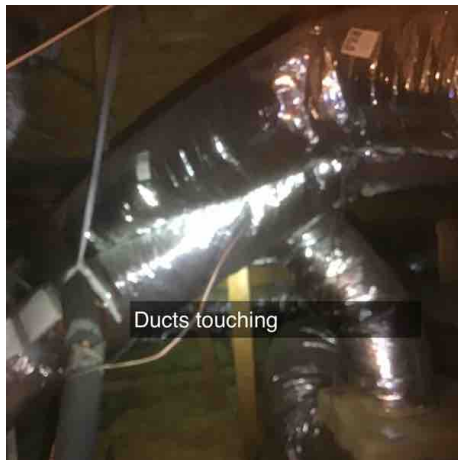
- Some of the ducts in the attic do not appear to be properly strapped because of them touching each other which can cause air flow restrictions and condensation issues, need to be repaired.

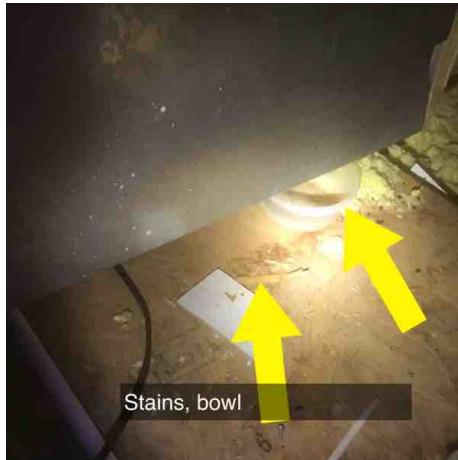
- The plenum in the south side of the attic at the heating and cooling systems appears to have had condensation, moisture issues because of water stains seen on the attic floor under it, has a plastic bowl under it also, system needs to be evaluated by a qualified HVAC contractor and repaired as needed to reduce chances of water damage related issues.

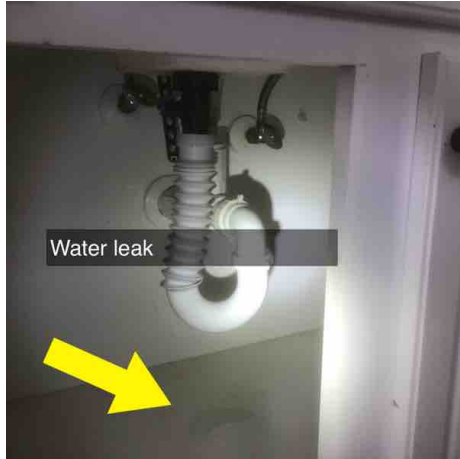
- Water leak from the primary bath right side sink drain pipe in the sink cabinet, and the left side sink drain had a slow drain, these issues need repair.

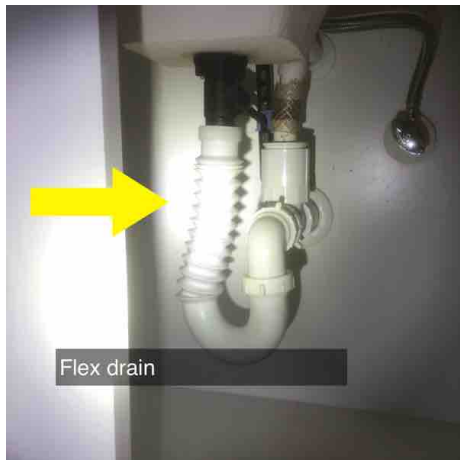
- The sink drains in the primary bath have part of them with flex type pipe, this can be easily clogged, need to be changed to a smooth wall drain pipes.

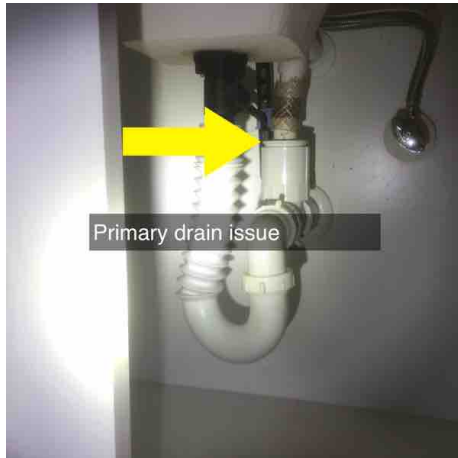
- The primary drain line connections from the attic A/C systems to the primary bath sink drains are on the wrong side of the sink drain traps, should be connected above the horizontal part of the drain pipe to the wall (which is above the weir), needs repair as needed by a qualified contractor.

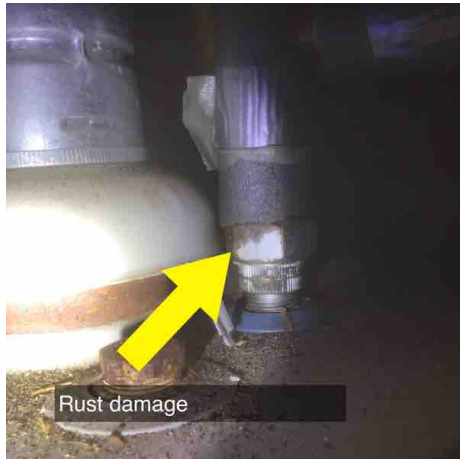
- There is corrosion and rust on the pipe connections on top of the tank, pipes/fittings need further evaluation and repair as needed by a qualified plumbing contractor to reduce chance of water leak issues.

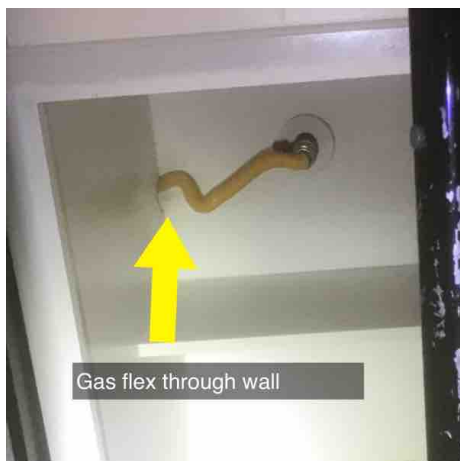
- The gas flex line in the cook top cabinet goes through the cabinet wall, this is not allowed for safety reasons, needs to be hard pipe through the cabinet wall, needs repair.

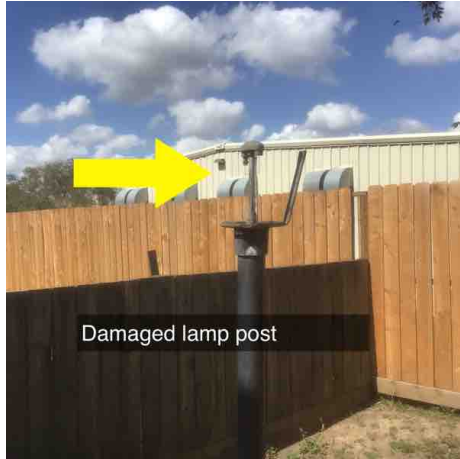
- The gas lamp posts were not tested, one is broken and the other is missing the mantles, also need to change the copper gas lines to a more suitable material to reduce the chances of damage and gas leaks.
