TEXAS OFFICIAL WOOD DESTROYING INSECT REPORT

4622 Banning Dr.

4622 Banning Dr., Houston, TX,77027

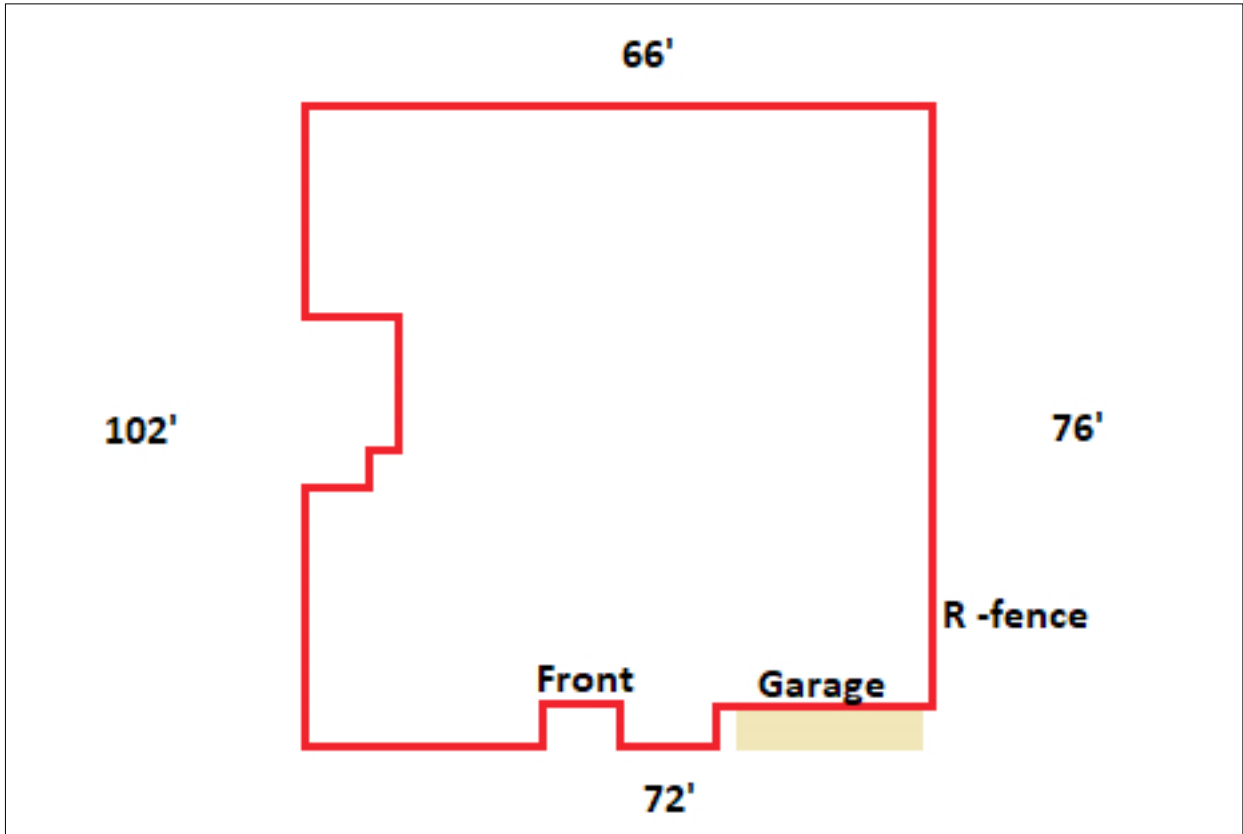
### Diagram of Structure(s) Inspected

Additional Comments NO VISIBLE EVIDENCE OF ANY WOOD DESTROYING ORGANISMS AT THIS TIME.

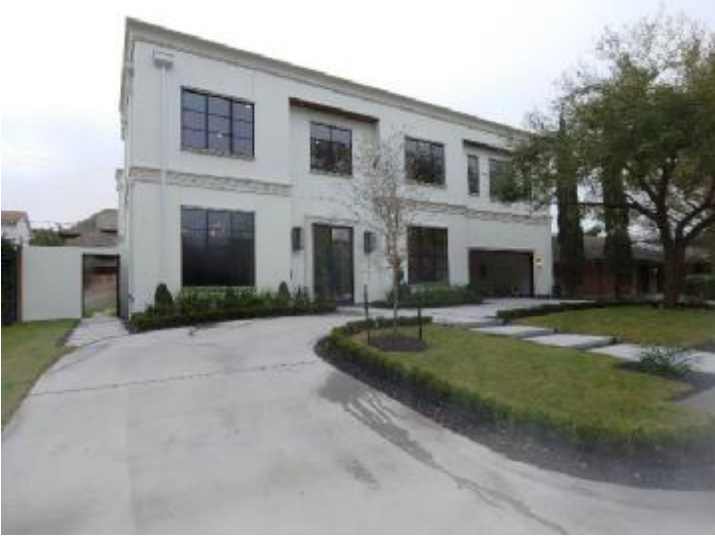
# 1

Front view

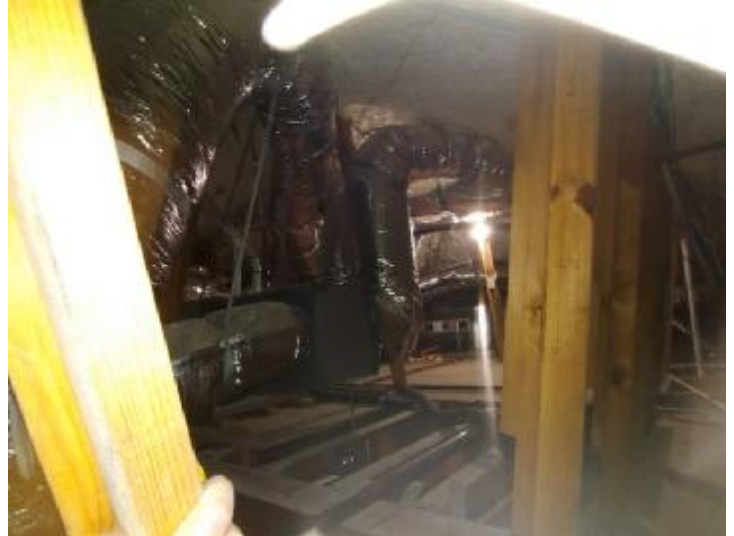
# 2

Attic view

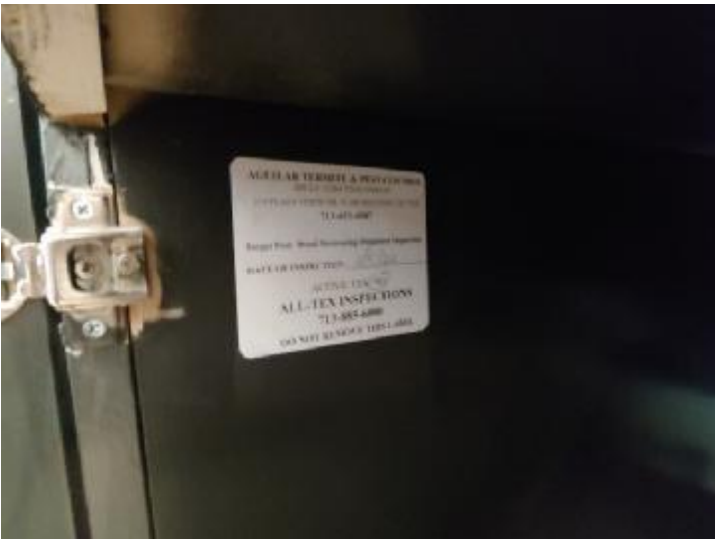
# 3

Inspection sticker
