RESIDENTIAL INSPECTION REPORT

4622 Banning Dr
Houston TX 77027

Basim Shami
FEBRUARY 5, 2020

Inspector
Allen Lott TREC 7484
TREC Professional Inspector 7484
713-885-6000
alltex@alltexinspections.net

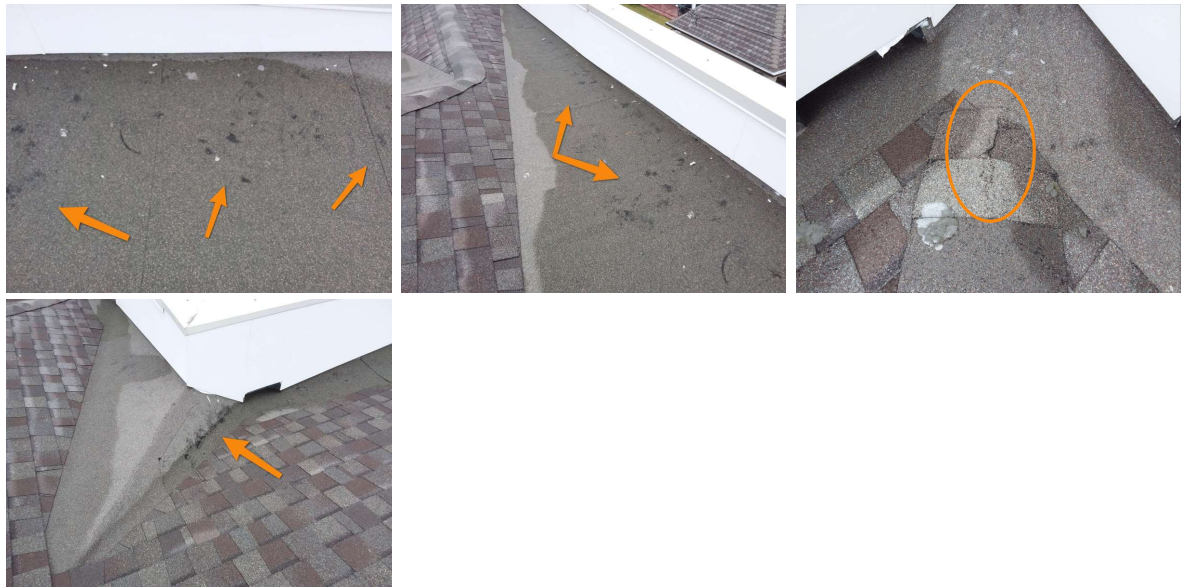
1: Damaged Coverings

Roof coverings exhibited general damage that could affect performance. Consider repair to prevent premature deterioration and/or moisture related issues.

Recommendation: Contact a qualified roofing professional.

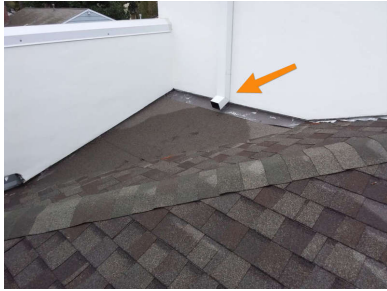
2: Gutter - Discharge at Roof

Gutter systems currently discharge on roof coverings. Shingle manufacturers (GAF and Tamko) specify that gutters discharge shall not occur directly at roof covering as this causes premature granular loss and/or deterioration. Additionally, watershed from roof coverings should be diverted away from the wall/roof intersection to prevent risk of moisture intrusion within the building envelope.

Recommendation: Contact a qualified gutter contractor

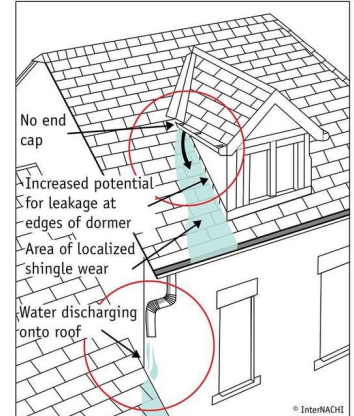
Gutter Improperly Discharging onto Roof

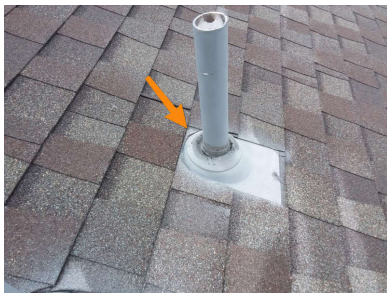
3: Plumbing Vent - Recessed

The rubber seal of the plumbing vent flashing is recessed or damaged. To ensure proper moisture discharge the recessed area should be repaired or replaced.

Recommendation: Contact a qualified roofing professional.

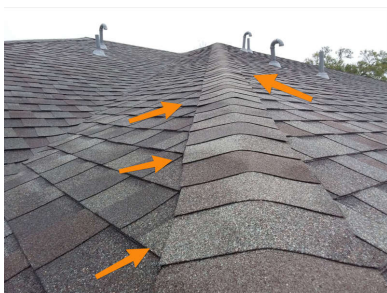
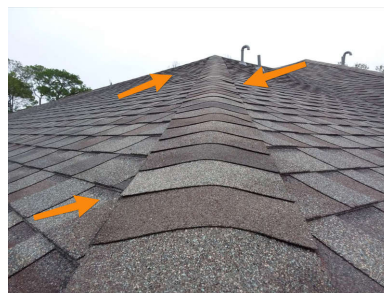
4: Raised Shingle(s)

One or more of the shingles, ridge caps or flashings are lifted and/or not sealed. To prevent possible wind lift and moisture intrusion (as a result of wind driven rain) all shingles and flashings should lay flat and be sealed to the respective components.

Recommendation: Contact a qualified roofing professional.

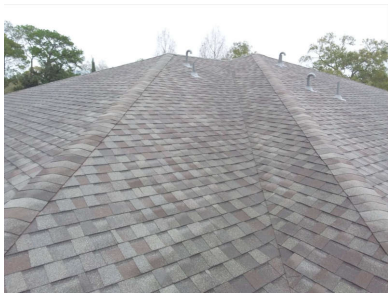
5: Ridge Shingle Incompatible

Ridge shingle 20 year. The type of roof covering installed (minus the ridge caps) is rated for 30 years or lifetime (depending on the manufacture). The ridge caps will fail and require replacement in 15-20 years. Contact the builder to obtain manufacture name. Verify specifications and installation requirements that are required for warranty.

Additionally, the lowest section of the roof coverings is covered with a rolled or selvage covering. This type of product has a much lower life expectancy and will likely require replacement sooner than the remainder of the coverings.

Recommendation: Contact a qualified roofing professional.

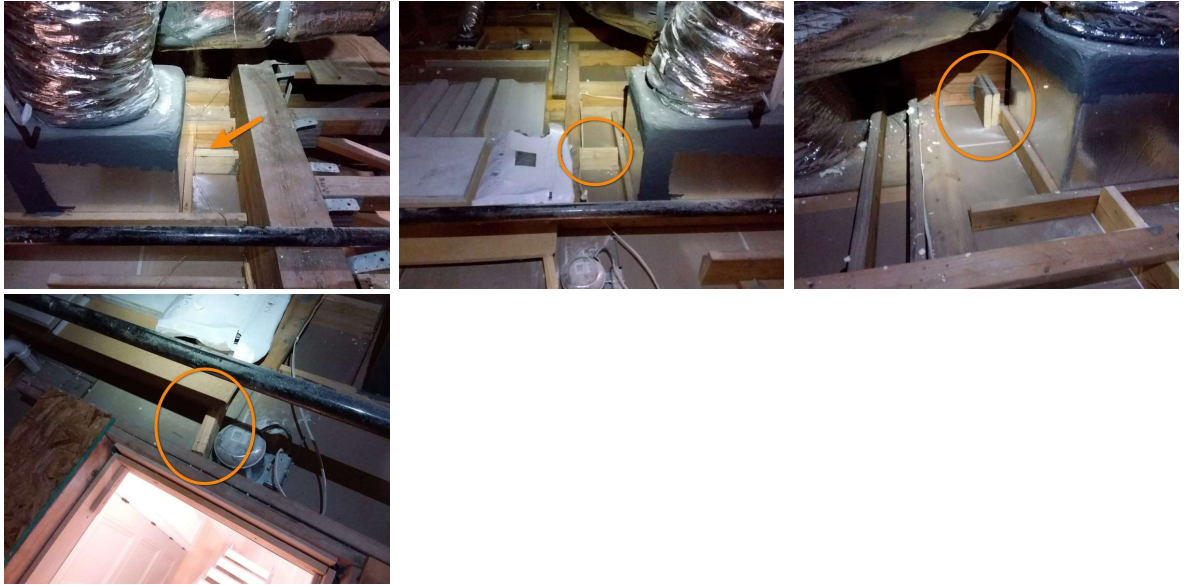
Joist hangers are missing or improperly installed. Current standards require that all joist shall be properly supported by framing members or the use of an approved mechanical fastener (hanger or bracket).

The section of ceiling joist appear to have been removed to allow room for the return air. This "removal" does not appear to have been performed with the structural integrity in mind and likely requires a proper repair and redistribution of the load path.

Recommendation: Contact a qualified carpenter.

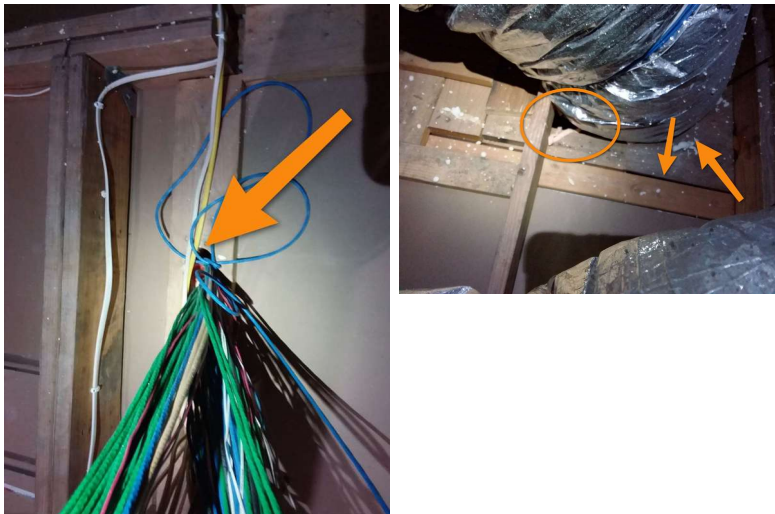
2: Separation Wall - Concealed Spaces

Fire blocking/ Draft stopping missing or improperly installed. Current standards require that all concealed spaces between floor levels or the dwelling and attic shall be properly sealed. Example: dryer exhaust, data cables, electrical and plumbing penetrations.

[2012 IRC R302.11](#)

Recommendation: Contact a qualified insulation contractor.

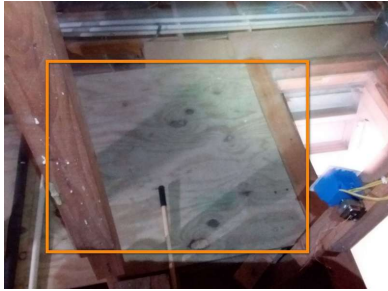
3: Service Decking - Undersized

Improperly supported near service access stairs

Service decking is improperly secured and/or improperly sized for the intended purpose. The moisture content in the attic may cause these materials to fail creating a step through hazard. Attic decking should be a minimum 5/8 inch plywood or comparable and properly secured to prevent fall hazards.

Recommendation: Contact a handyman or DIY project

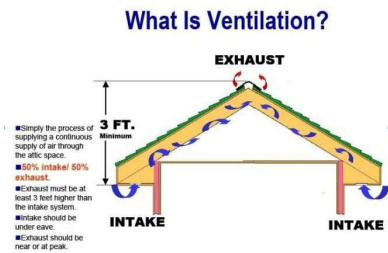
4: Ventilation - Inadequate

Attic ventilation may be inadequate for the area served. Current standards require 1 sq foot of ventilation per 150 sq ft attic space. Determining the adequacy of the attic ventilation is beyond the scope of this inspection. A lack of proper ventilation can result in increased energy cost, premature aging of the roof coverings and moisture related issues within the attic space. Proper ventilation should consist of "intake" such as soffit vents and "exhaust" such as ridge or passive vents.

The attic did not appear to have any type of circulation or ventilation system installed. Recommend consulting energy auditor or engineer of record to ensure that this insulating system complies with building design.

Recommendation: Contact a qualified roofing professional.

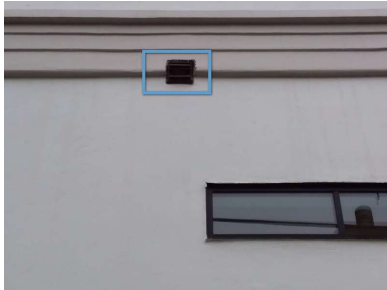
1: Damaged or Missing

Wall coverings are missing or damaged. Consider repair or replacement of the affected areas to prevent moisture intrusion and subsequent damage.

The decorative band was rough cut to install the exhaust caps. This area was not properly repaired and should be sealed to prevent deterioration (styrofoam).

Recommendation: Contact a handyman or DIY project

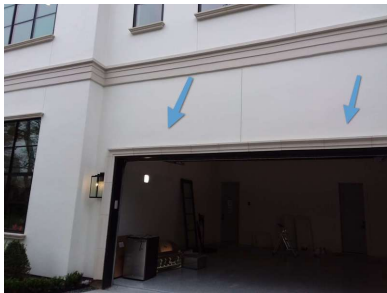
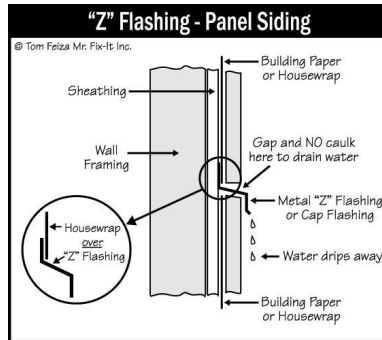
2: Flashing Horizontal Projections

Observed missing and/or improperly installed Z flashing at exterior wall coverings. Without proper flashing, moisture may enter between the horizontal seams. Manufacturers such as James Hardi and LP require all horizontal abutting materials to have flashing installed to divert water to the exterior.

Recommendation: Contact a handyman or DIY project

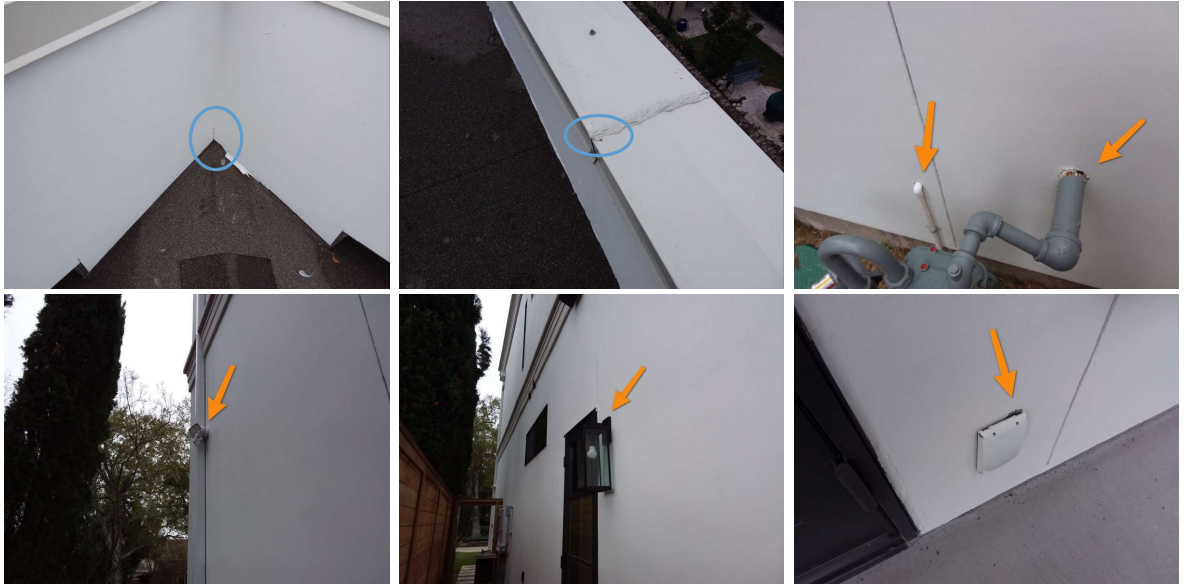
3: Seal - Penetrations

IRC 703.1.1

Recommendation: Contact a handyman or DIY project

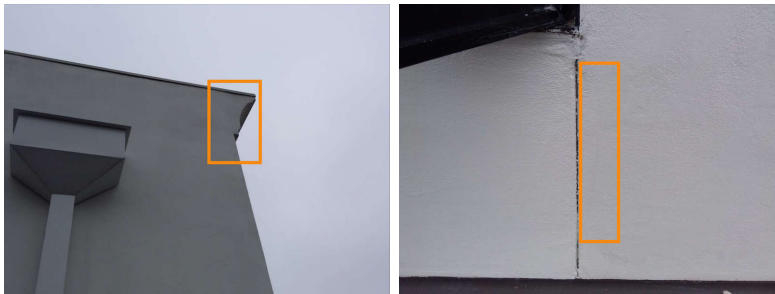
4: Stucco - Cracks

2nd Floor Northwest

Cracks observed at stucco/stone wall coverings. Consider sealing all cracks and penetrations to prevent potential for moisture intrusion.

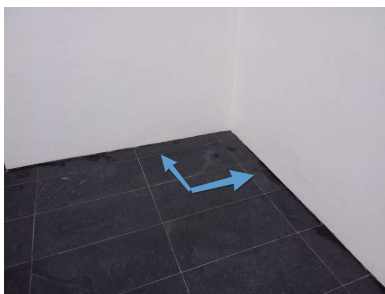
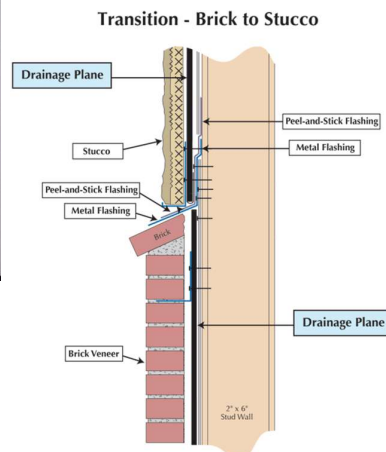
5: Stucco - Drainage Plane Not Visible

Wall covering are terminating at or below the grade. The drainage plane (or weep screed) cannot be verified at this location. Current standards require stucco and stone wall coverings to terminate 6 inches above grade.

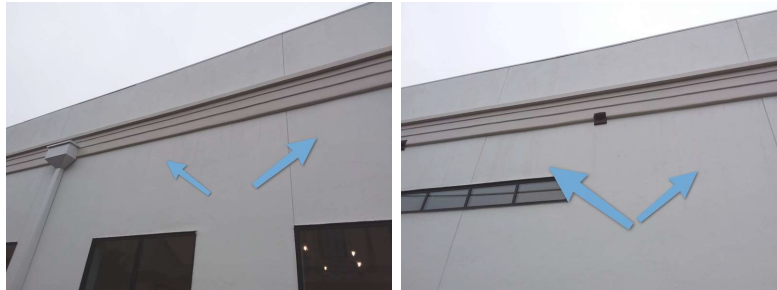
6: Stucco - Stains

North and west

Staining at wall coverings may indicate past or current moisture intrusion. Recommend further evaluation and repair as needed.

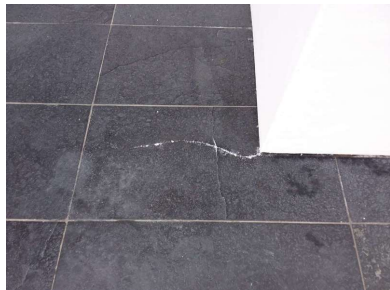
Cracks observed at tile floor coverings. Cracks may be the result of physical damage or minor settlement. When not severe, no repair is typically needed.

2nd Floor West Exterior

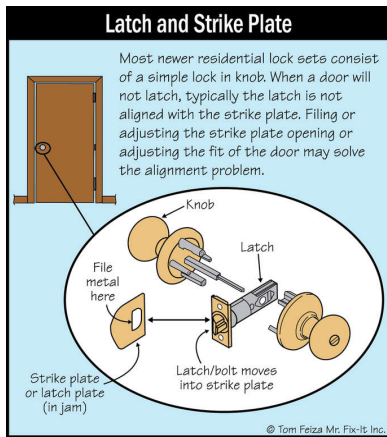
2: Latch Loose

Door doesn't latch properly. Typical repair includes adjustment of the strike plate or latch.

Recommendation: Contact a handyman or DIY project

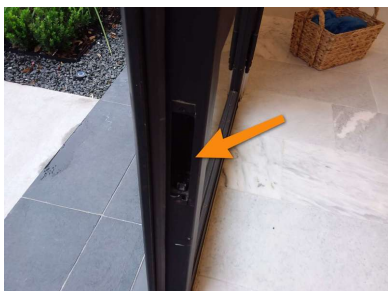
4: Lock Not Operating

Locking mechanism did not operate as intended. Typical repairs consist of adjusting and/or replacing the hardware or strike plate.

Recommendation: Contact a handyman or DIY project

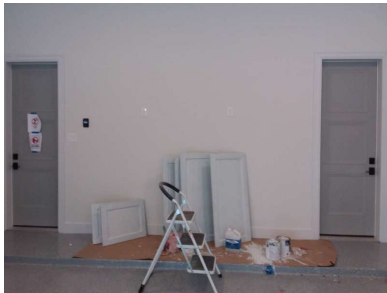
5: Service Door- Recessed panel

The recessed areas of the door reduce the overall thickness below the minimum requirements. Current standards require the service door between the home and the garage to be a minimum of 1 3/8 solid core lumber or a steel door with a solid core or a labeled door that has a fire rating of 20 minutes. Verify the door meets current standards or consider upgrading.

In new construction, buyer is advised to obtain manufacturer's documentation and retain for resell.

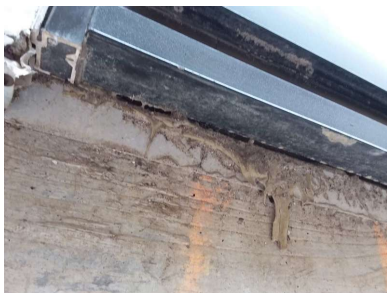
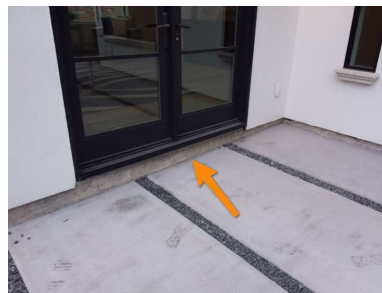
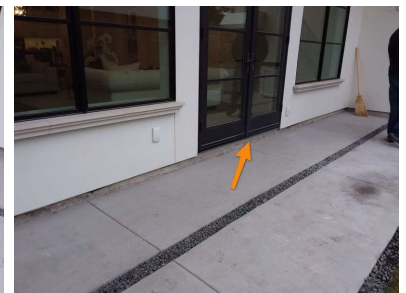
6: Threshold - Support

The door threshold was improperly secured and/or supported. The threshold has an unsupported projection of 2 to 2.5 inches. This will likely result in material wear and eventual failure. The threshold and sill pan should be properly supported. Consider applying structural concrete or epoxy to these areas.

Recommendation: Contact a handyman or DIY project

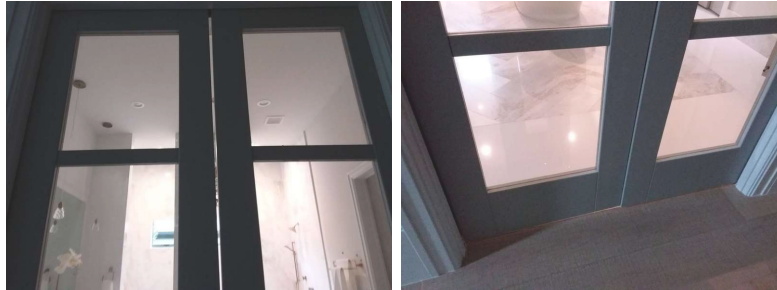
7: Alignment

Pocket, bifold, bypass or other double doors were improperly aligned. Consider repairs to ensure proper operation.

Recommendation: Contact a qualified door repair/installation contractor.

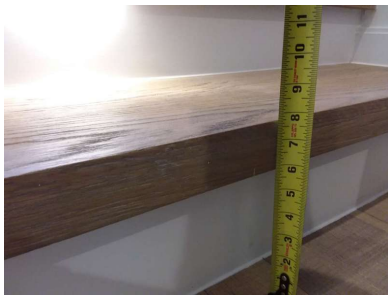
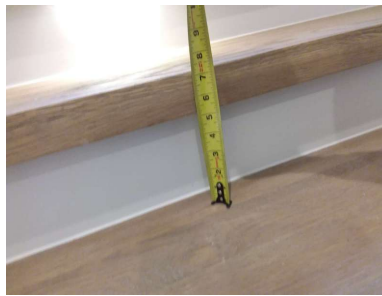
1: Tread - Rise

The stairs were "mostly compliant" with only minor excessive variations of 1/16 to 1/8 inch.

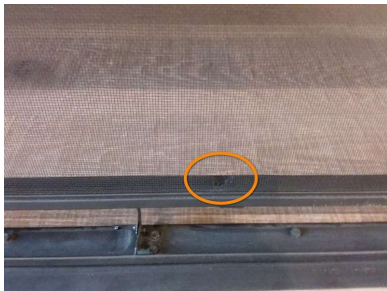
3: Screen Damaged

The screen cover was physically damaged at the bottom near the center.

Recommendation: Contact a qualified fireplace contractor.

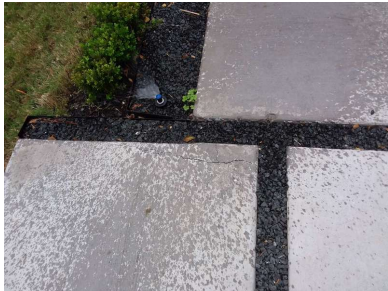
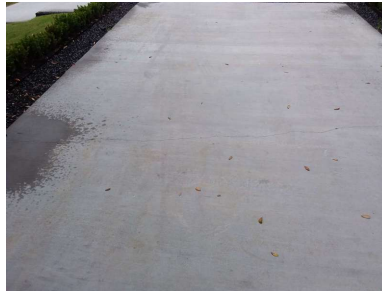
Concrete - Cracks Minor:

Surface cracks observed at concrete flat works. Cracks are considered typical due to construction type and expansive soils. Seal cracks and monitor cracks. Example: driveway, walkways and/or garage floor.

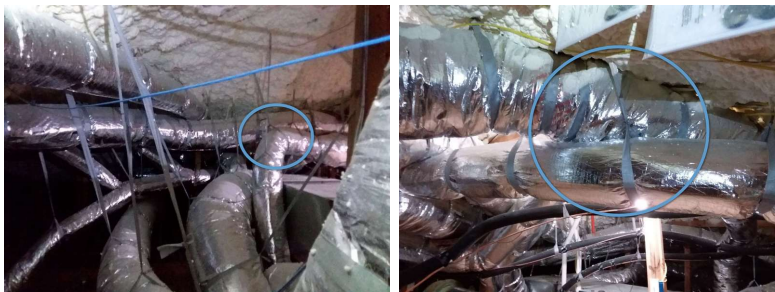
The flexible ducts are improperly supported. Current building practices require that the ducts be hung from the attic framing and supported at 4.5 maximum intervals. Ducts in contact with other ducts and at potentially different temperatures may cause condensate to form (internal or external) on the duct. Consider separating ducts with batt insulation or equivalent.
