March 24, 2022

**RE: STRUCTURAL ENGINEERING SERVICES
FOUNDATION OBSERVATION
8580 Thomas Drive
Orange, Texas
Project No. 22001-0019**

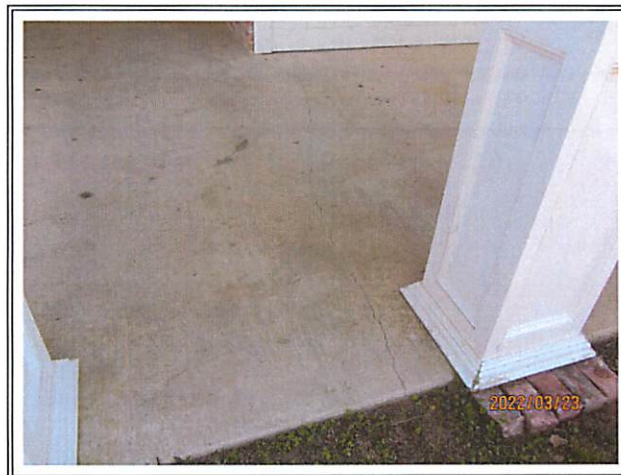
Photograph No. 2

likely that hairline cracks will occur in the tile floors. Should that occur, it is not necessarily an indication that the foundation has fractured and failed. Ceramic tile is very brittle and if there is a shrinkage (similar to Photograph No. 2) or temperature crack in the concrete it will reflect through the tile.

Back Patio - typical concrete shrinkage crack
(typical at other areas of exposed concrete slab)

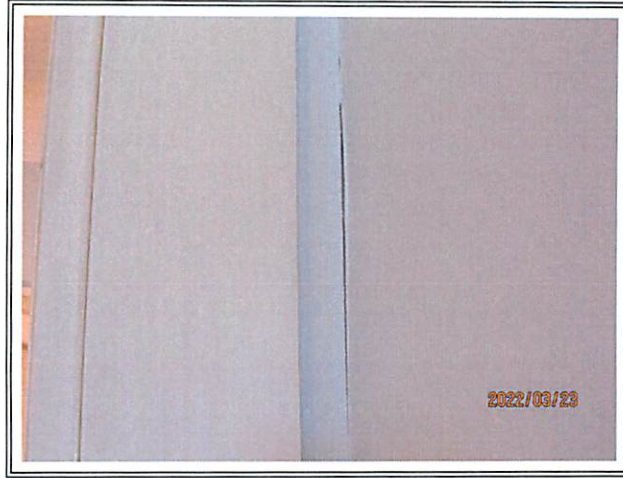
Photograph No. 3

The sheetrock/trim separation (Photograph No. 3) does not fit the pattern for differential foundation movement. The condition is a cut and fit issue, not a foundation issue.

Bedroom Hall - separation of sheetrock and trim

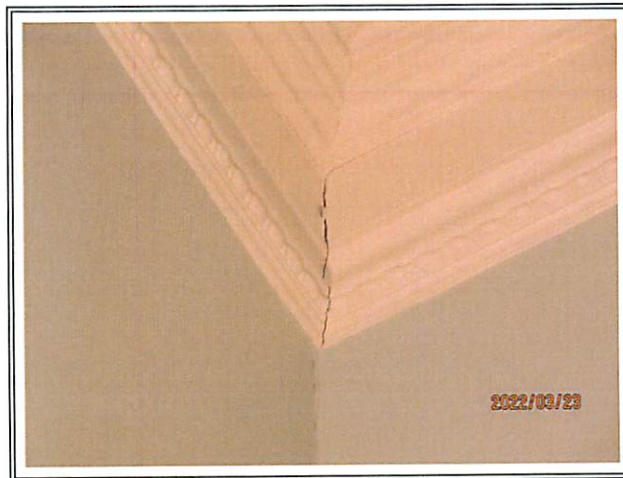
Photograph No. 4

The crown molding separation at joints (Photographs No. 4 and 5) are the result of the crown molding shrinking and pulling at joints. As I told you at the property site, I have been noticing this throughout the area including my personal home. The conditions are not foundation related.

Bedroom Hall - pulling of crown molding at joints
(typical throughout)

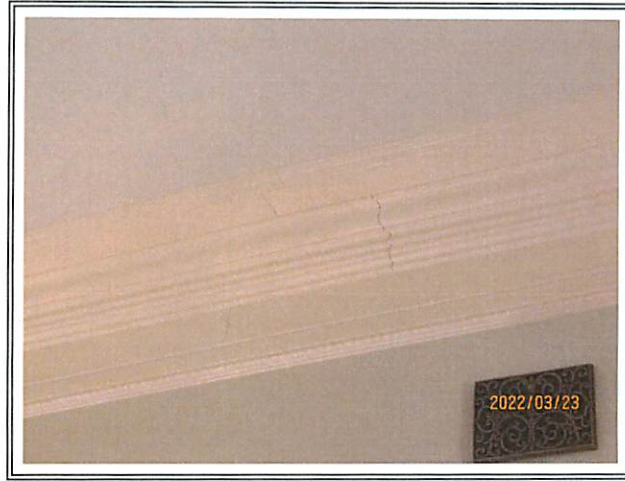
Photograph No. 5

Bedroom Hall - pulling of crown molding at joints
(typical throughout)
