**BPG Inspection, LLC**

**19059 Painted Boulevard  
Porter TX 77365**

Client(s): Carlson  
Inspection Date: 10/8/2020  
Inspector: Murray Campbell , TREC #22455

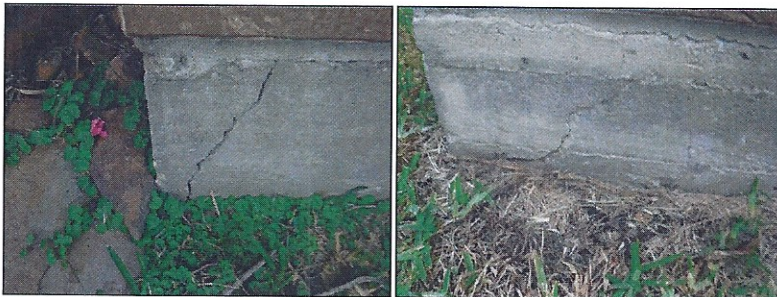
Corner cracks were observed at the corners of the slab foundation. Cracks of this nature are typical and occur when the exterior veneer is warmed by the sun and the wall expands. This condition is also a conducive condition for termite infestations. I recommend you contract foundation expert to repair mortar as needed to prevent further separation. Sidewalk repair caulking is the typical product used for this repair.

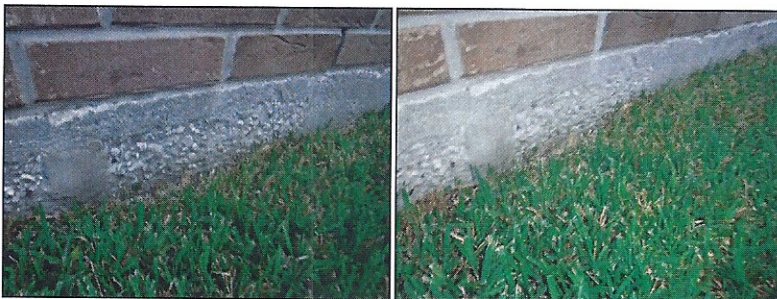
front, rear and sides of home foundation of home has honeycomb condition. A honeycomb area in a foundation is the result of improper vibration or settling of the concrete thus leaving voids and pockets in the wall. Injecting a urethane resin under pressure will seal and fill these voids and pockets thus stopping potential for leaking and further deterioration of area.

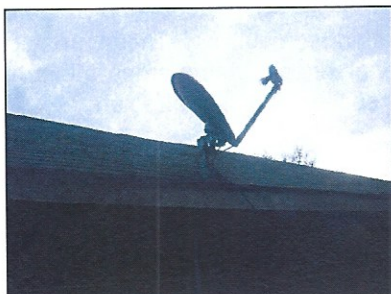
Mounting a satellite dish directly through the roof deck is not recommended. The preferred installation is on side of wall or eaves. In it's current installation, extra sealant is recommended on the fastening bolts.

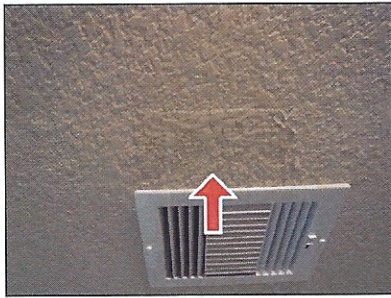
There is evidence of previous repairs on the ceiling in the right middle bedroom. There was no prior disclosure

of this repair, and no evidence of damage in the attic. I recommend you query the owner for the history on this area.

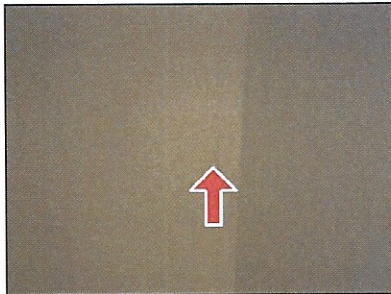
Cracks on ceiling in various areas, consistent with structural settling. Repair as needed.

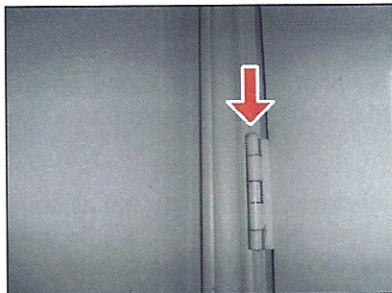
- 1. The occupant door leading from the attached garage into the house is not self closing. I recommend installing/ adjusting self closing hinges on the door leading from the garage to the living space as a safety feature to prevent exhaust gases (car, appliance) from entering the house.

The occupant door leading from the attached garage into the house is not self closing. I recommend installing/adjusting self closing hinges on the door leading from the garage to the living space as a safety feature to prevent exhaust gases (car, appliance) from entering the house.

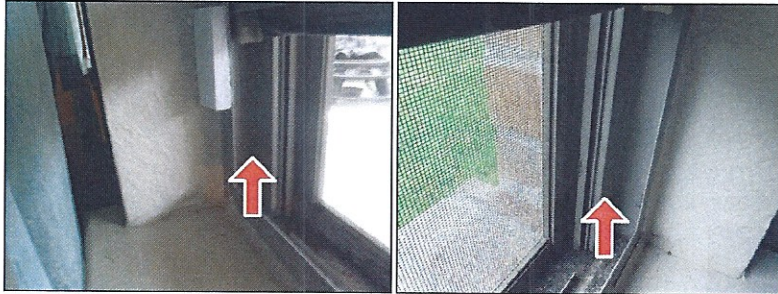
- 2. Window sash springs need adjustment or repair to allow windows to remain completely open, most notably in the right middle bedroom, and living room

Window sash springs need adjustment or repair to allow windows to remain completely open, most notably in the right middle bedroom, and living room

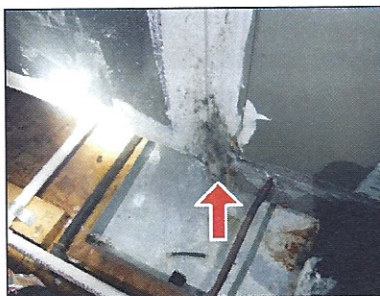
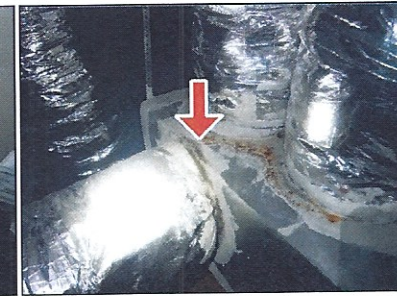
- 3. The cooling system plenum shows signs of past excessive moisture conditions (bio-growth stains). This is common for cooling systems that are installed in a interior closet, or even in the attic. Ensure air flow is not restricted (dirty filters) and the condensation drain line is periodically flushed to prevent drain line blockage. Consider having the unit serviced by a licensed HVAC technician.

The cooling system plenum shows signs of past excessive moisture conditions (bio-growth stains). This is common for cooling systems that are installed in a interior closet, or even in the attic. Ensure air flow is not restricted (dirty filters) and the condensation drain line is periodically flushed to prevent drain line blockage. Consider having the unit serviced by a licensed HVAC technician.

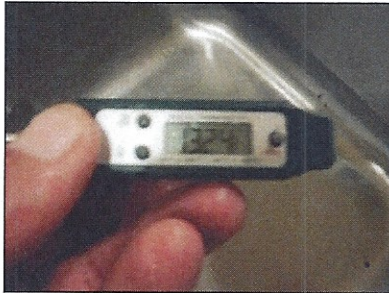
Temperature readings at sinks were measured at a higher than suggested setting. The U.S. Consumer Product Safety Commission (CPSC) urges all users to lower their water heaters to 120 degrees Fahrenheit. In addition to preventing accidents, this decrease in temperature will conserve energy and save money. Most adults will suffer third-degree burns if exposed to 150 degree water for two seconds. Burns will also occur with a six-second exposure to 140 degree water or with a thirty second exposure to 130 degree water. Even if the temperature is 120 degrees, a five minute exposure could result in third-degree burns. Consumers should consider lowering the thermostat to the lowest settings that will satisfy hot water needs for all clothing and dish washing machines.

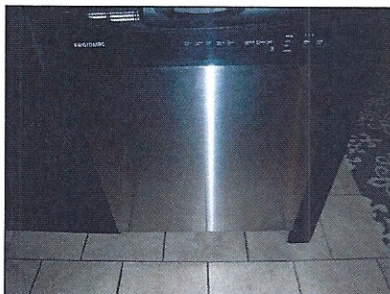
- 4. Water leaks at the bottom of the dishwasher. The source could not be readily identified. Have the unit evaluated and repaired by a qualified appliance contractor.

Water leaks at the bottom of the dishwasher. The source could not be readily identified. Have the unit evaluated and repaired by a qualified appliance contractor.
