## **INSPECTION GROUP**

Property Inspection Report #3/29/202210157 East Kemp Forest Drive  
8616 Daffodil St. Houston, TX 77063

## PROPERTY INSPECTION REPORT FORM

10157 East Kemp Forest Drive, Houston, TX 77080

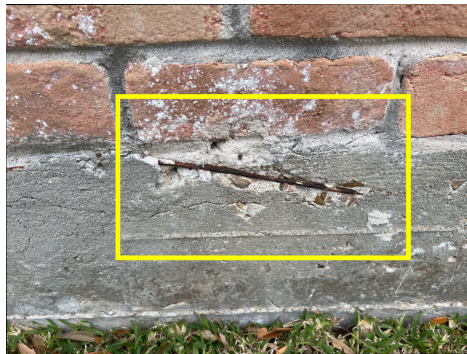
Exposed steel observed at one or more locations needs repair.

Exposed steel observed at west side of house.

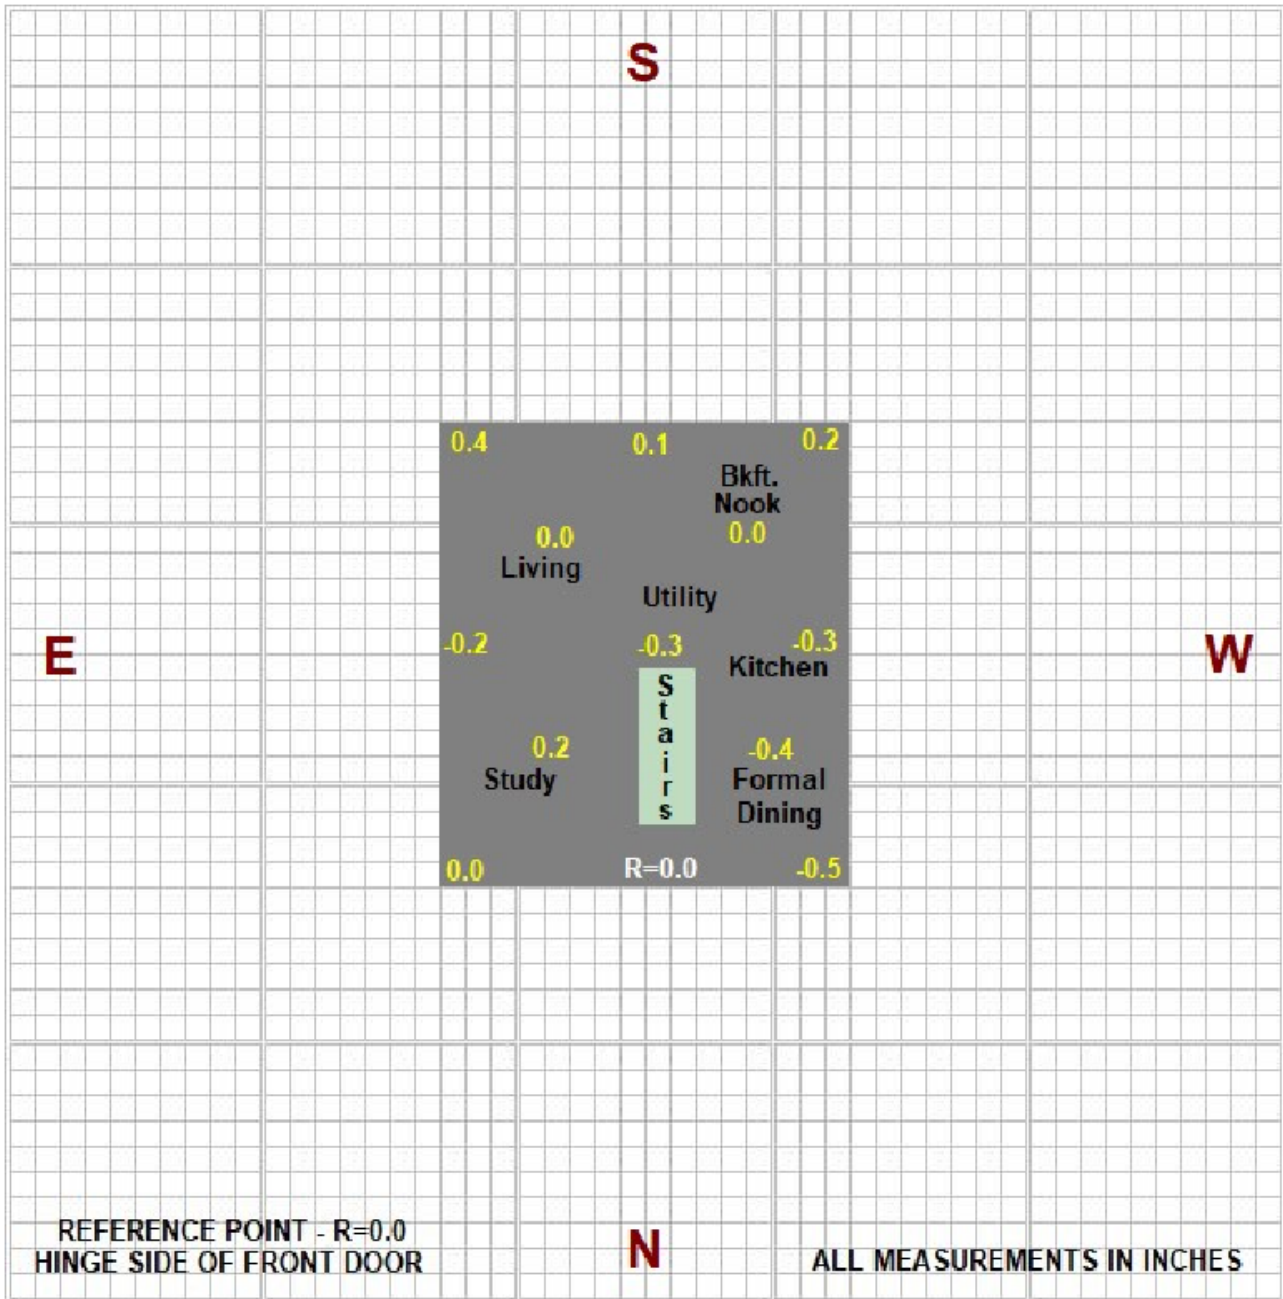
A foundation elevation survey was conducted during the inspection. The floor plan below represents data gathered using a Zip Level and adjusting for floor covering height differences. i.e. differences between tile, carpet and wood flooring (except step down to the garage). Measurements are listed to the nearest 1/10th of an inch. The greatest variance was 0.9". Not drawn to scale.

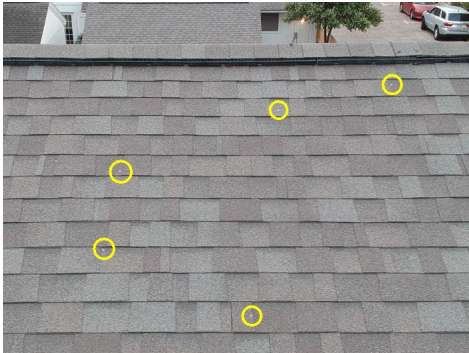
Exposed staples/nail-heads/fasteners observed on the roof are not properly sealed. Water entry possible.

Multiple exposed nail heads observed on the roof.

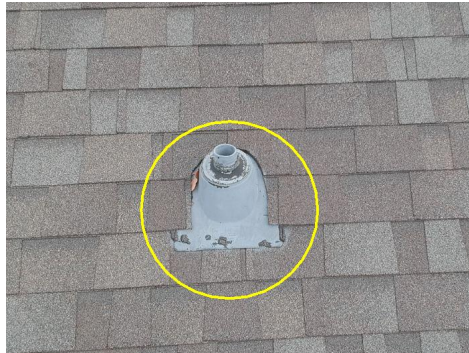
Drain waste vents should be a minimum of 6" above the roof line.

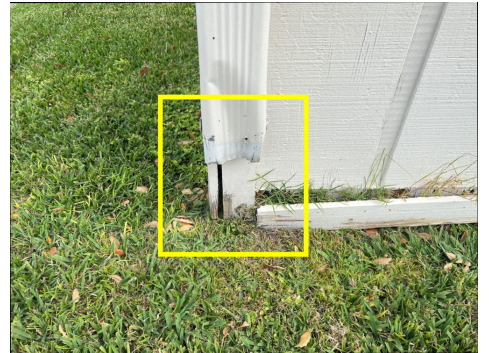
The elbow is missing at the end of the downspout at one or more locations.

Elbow is missing at the end of the downspout at SW corner of garage.

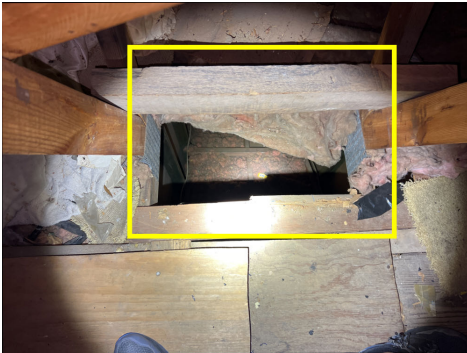
Observed open Chase an attic recommend it be sealed.

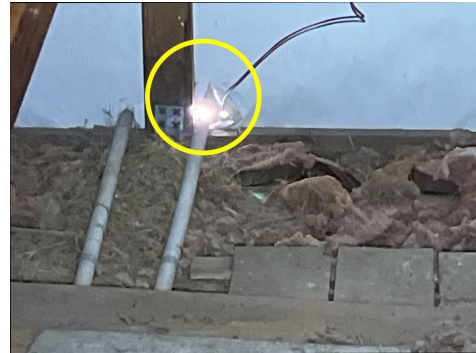
Daylight is visible from interior of attic at one or more locations. Recommend sealing these areas to prevent potential pest / rodent / water entry.

Daylight observed in the attic. Recommend sealing this area to prevent rodent entry.

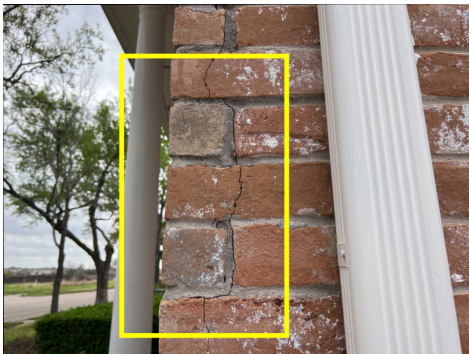
Brick crack observed at front northwest corner of house.

Cracks in brick / stone veneer and/or repairs, one or more locations, Recommend buyer take photographs of cracks, their location, and width [ruler across the crack] with a high-resolution camera that has a date stamp for future reference.

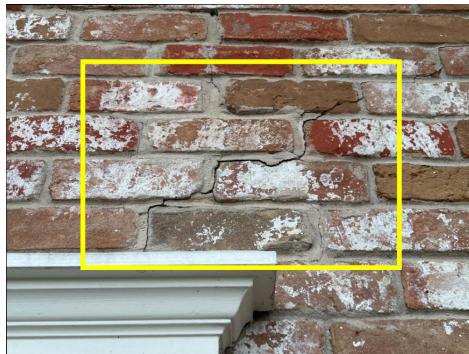
Brick crack observed over study window, north side of house.

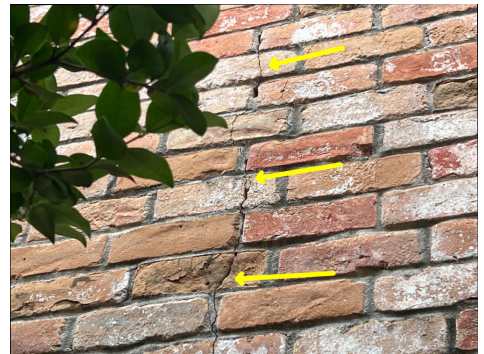
Significant large brick crack observed at the east exterior wall of house.

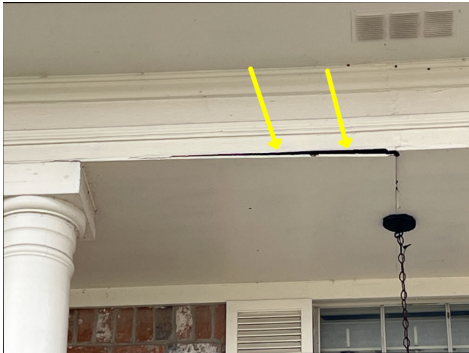
Observe large gap in the ceiling above the front door recommend repair to prevent rodent entry.

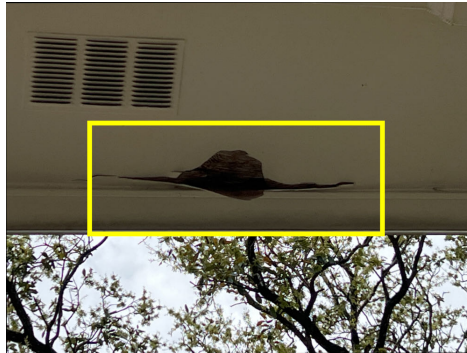
Area of wood rot observed at the soffit if the front porch.

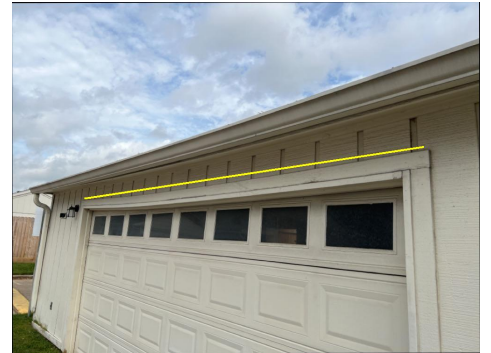
Sag in the double header over garage door. Possible indication of improper/inadequate framing and/or foundation settlement.

Observed sag in the double header over garage door, possible indication of improper/inadequate framing.

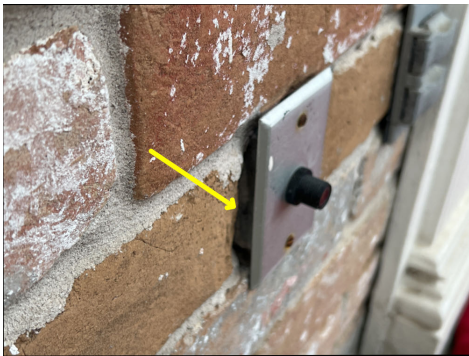
Recommend caulking all exterior penetrations to the house.

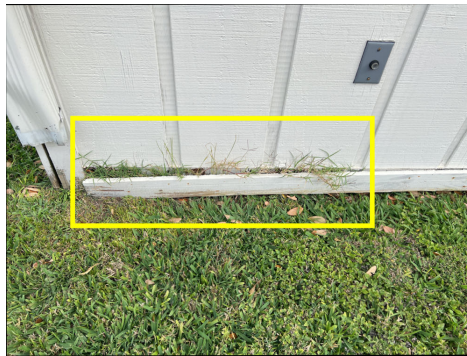
Trim / siding observed to be not secured down at one or more areas of house/garage.

Trim / siding observed to be not secured in place; SW corner of garage.

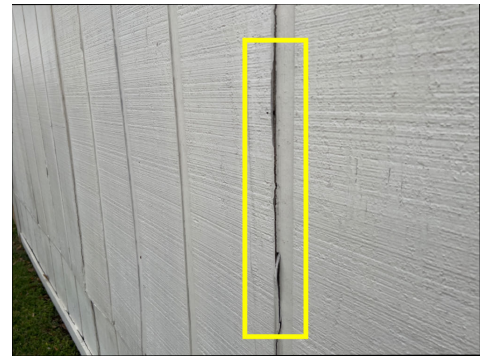
Caulking missing and/or deficient around windows / doors / vertical trim / joints in siding. May allow wind driven rain entry.

Recommend caulking all exterior vertical trim boards.

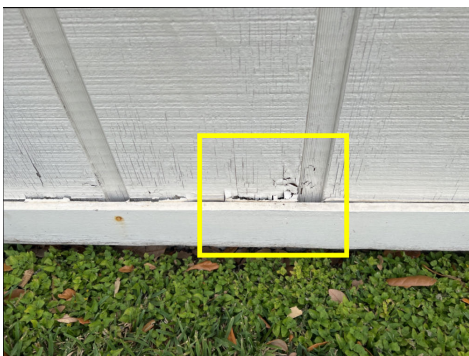
Wood rot observed on areas of house/garage.

Wood rot observed at exterior west side wall of garage.

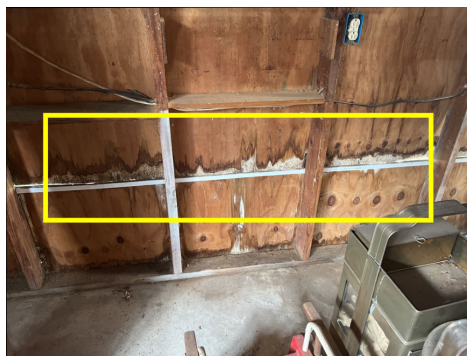
Water penetration observed at the interior wall garage.

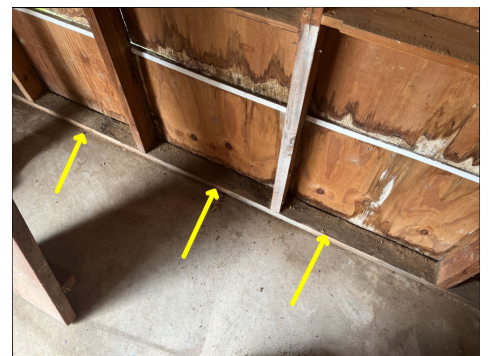
Sill plates are missing proper hold-downs, in. bolt minimum 7 in. embedment with a maximum spacing of 6 ft and within 12in. of the end of the sill. IRC 403.1.6

Sill plates are missing proper anchor bolts in the garage.

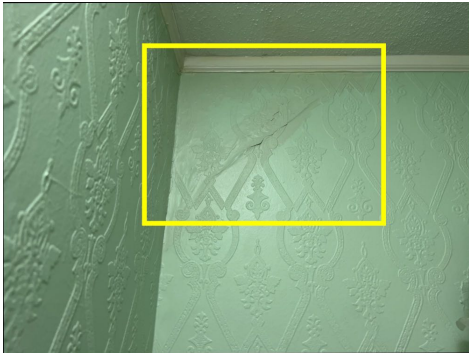
Water stains, damage or repairs observed, moisture meter indicated that stains are not active (wet) at the time of inspection; downstairs half bath, utility room, garage interior walls.

Water stains observed in half bath, moisture meter indicated that stains are not active (wet) at the time of inspection.

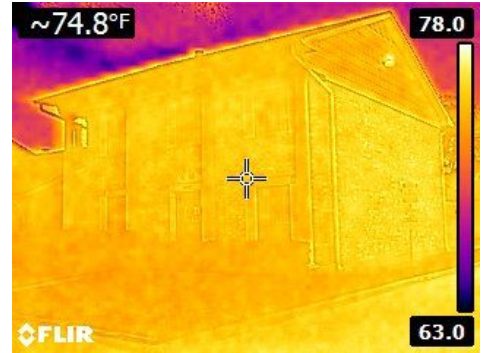
Thermal image of the front of the house.

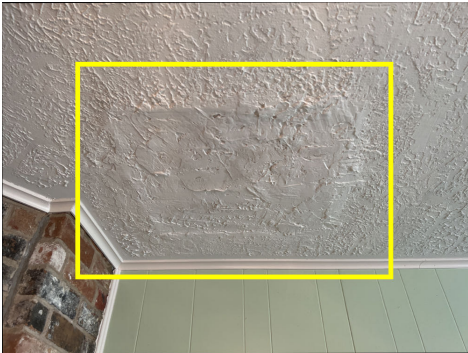
*Patch/repairs noted at; living ceiling. This inspection does not rate the substance or adequacy of these repairs.*

Observed patch repair to the ceiling in living room.

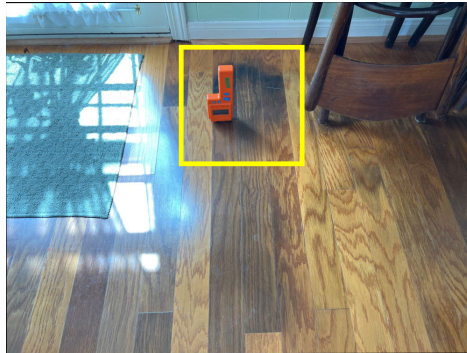
Water damaged wood flooring; breakfast nook, study, foyer.

Water damaged wood flooring observed in breakfast nook. Moisture meters registered a 18.4 showing the area was active (wet).

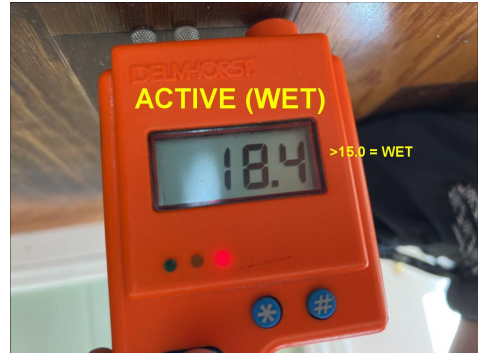
Moisture meter reading of floor in breakfast nook.

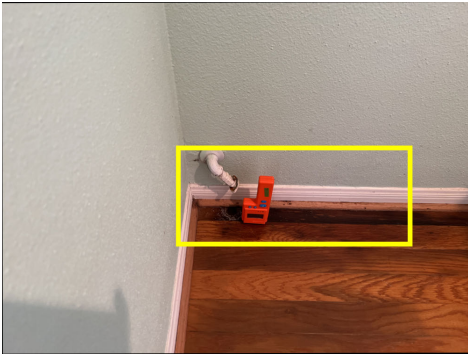
Water damaged wood flooring observed in kitchen. Moisture meters registered a 40.0 (max reading) showing the area was active (wet).

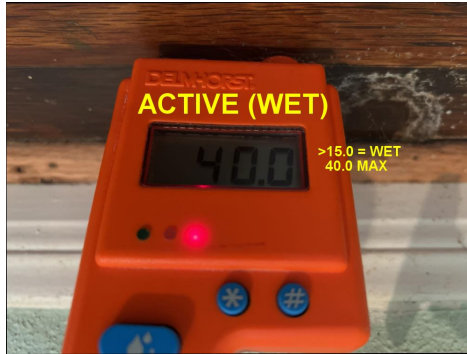
Moisture meter reading of floor in kitchen.

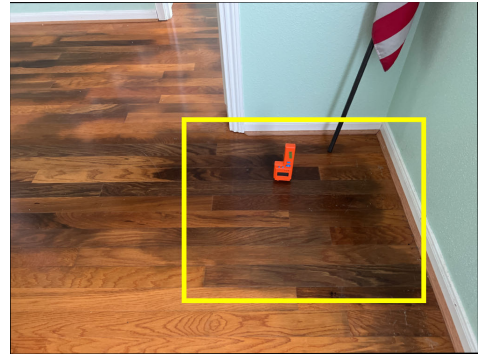
Water damaged wood flooring observed in study. Moisture meters registered a 21.8 showing the area was active (wet).

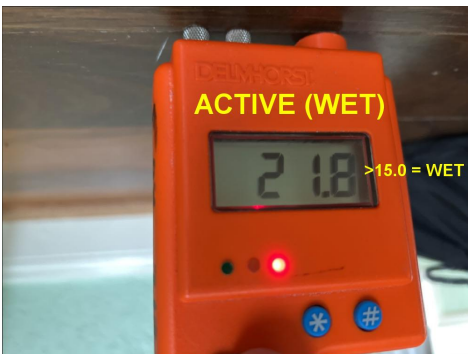
Moisture meter reading of floor in study (near front door).

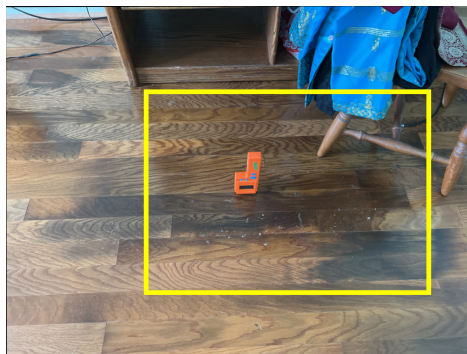
Water damaged wood flooring observed in the study. Moisture meters registered a 21.2 showing the area was active (wet).

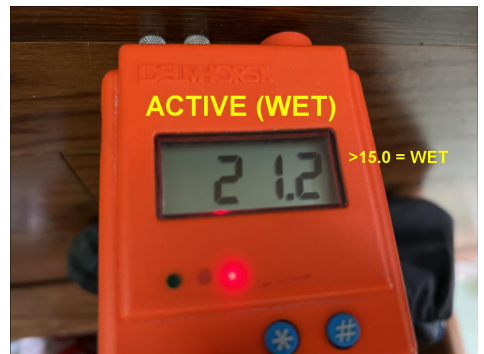
Moisture meter reading of floor in study.

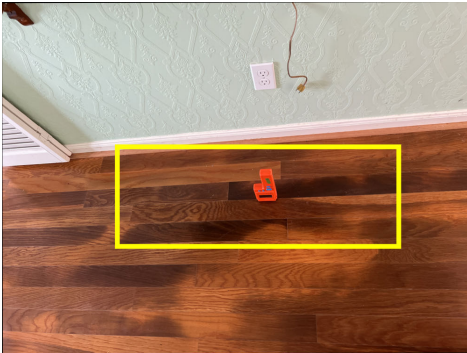
Water damaged wood flooring observed in the foyer. Moisture meters registered a 20.3 showing the area was active (wet).

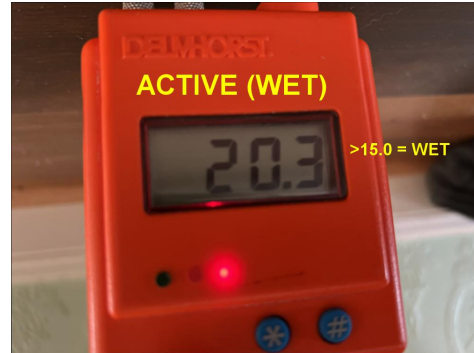
Moisture meter reading of floor in the foyer.

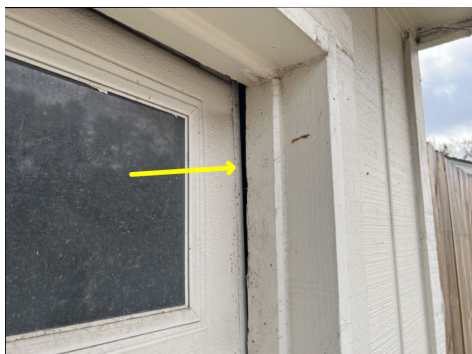
Observed Garage door opening is not square. Door jambs leans out, causing gap at side.

Observed gap at side of garage door.

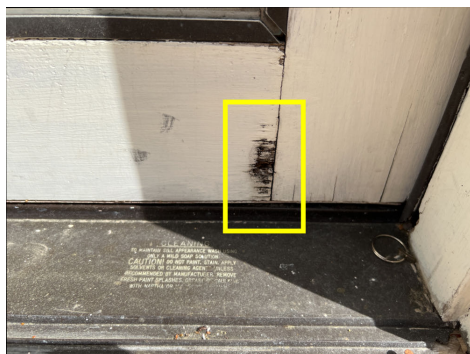
Wood rot of lower door and/or jamb; patio door.

Wood rot observed at the bottom of the patio door.

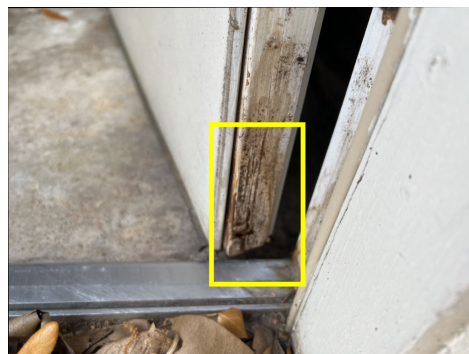
Wood rot observed at the bottom of the garage pedestrian door.

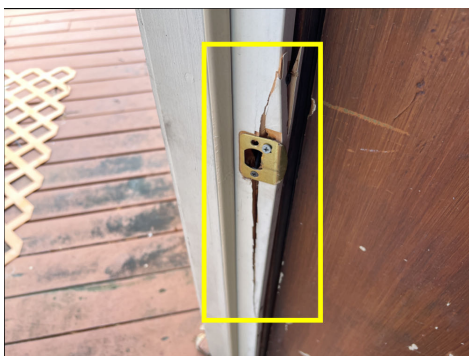
Observed broken/damaged door jamb; garage pedestrian door.

Damage door jam from forced entry at garage pedestrian door.

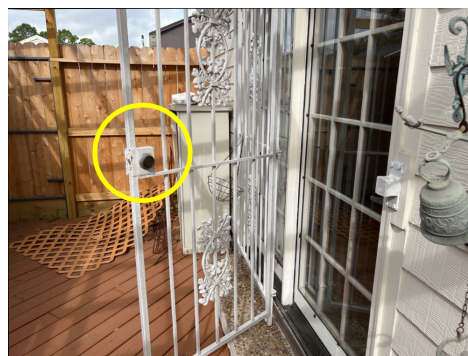
**Burglar bars at exterior doors that do not open without a key or special knowledge are a recognized fire/safety hazard.**

Exterior door with burglar bars, doors do not open without a key of locked.

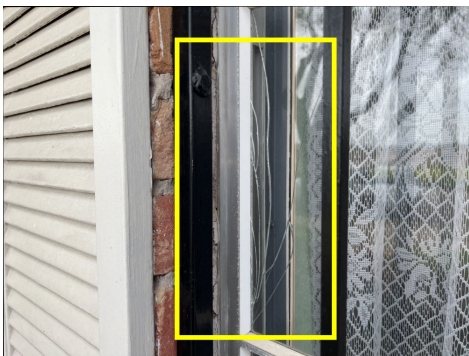
One or more windows had cracked/broken glass pane(s); formal dining room, study.

Cracked glass observed at front window of house in formal dining room.

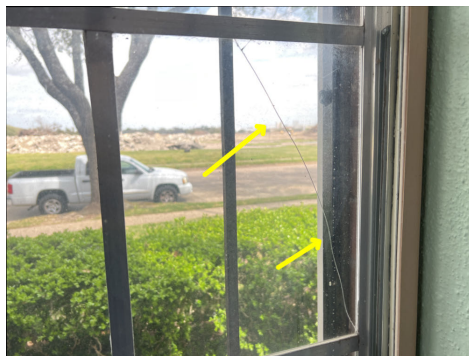
Crack window observed in the study.

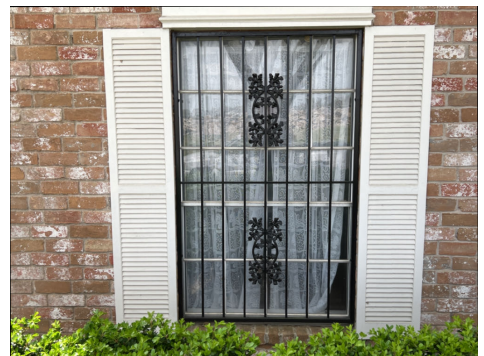
**Burglar bars in a bedroom that do not open without a key or special knowledge are a recognized fire/safety hazard.**

Burglar bars observed on study window and formal dining room window. Bars are affixed to the house and do not open.

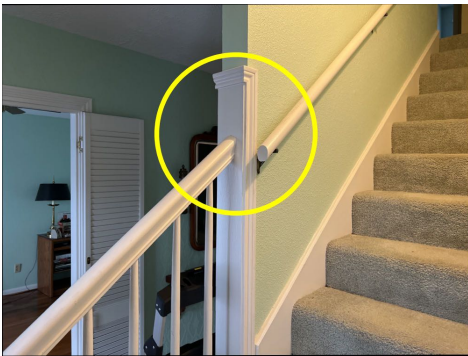
Hand railing is not continuous railing should be continuous the full length of the stairs.

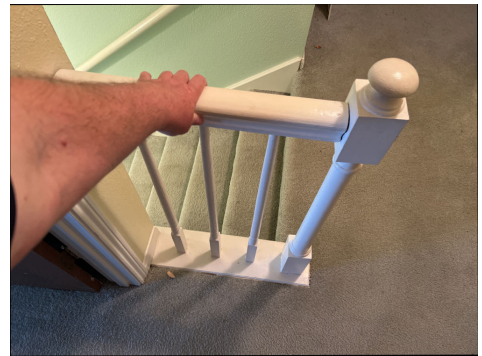
Railing at the upstairs landing is loose.

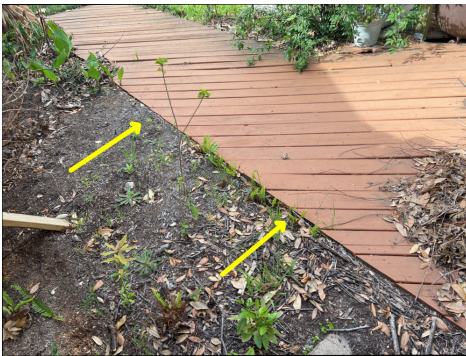
Patio decking is in contact with the ground which is kind do use it to wood rot.

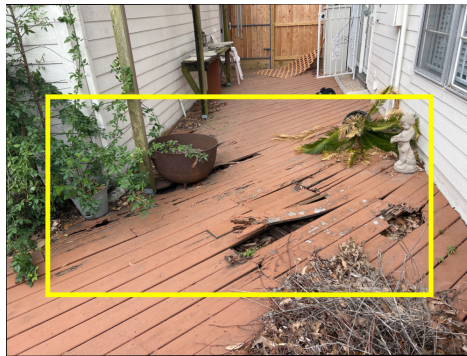
Multiple boards of wood decking are damaged due to wood rot recommend repair.

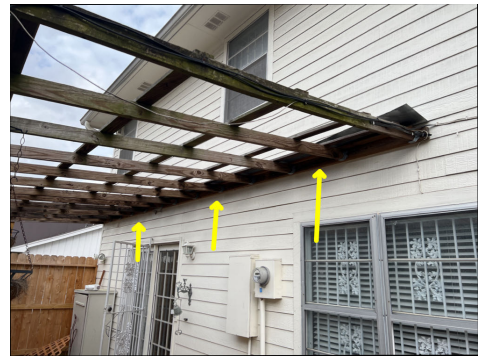
**Patio cover/deck/balcony does not appear to be properly secured - missing lag bolts to secure ledger board to structure and/or missing joist hangers to secure rafters/joists to ledger board. Deck ledger attachment with minimum 1/2 inch lag screws or bolts 09 IRC [502.2.2.1] If Joist span is <6 feet lag bolts should be every 30". Recommend repair.**

Patio cover does not appear to be properly secured - missing lag bolts to secure ledger board to structure.

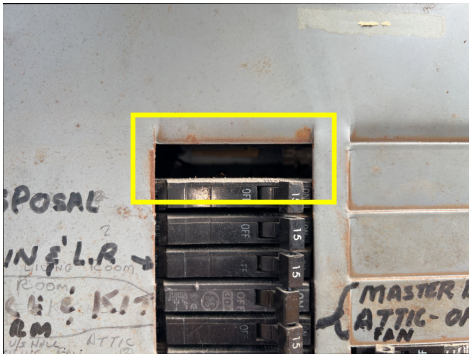
Missing one or more knockout cover.

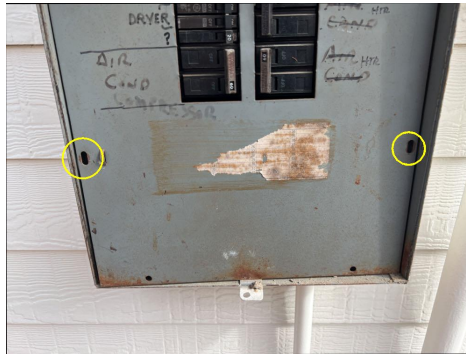
Dead front of breaker panel is missing screws.

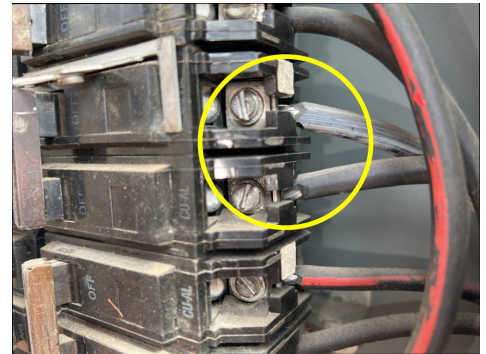
No anti-oxidant compound (grease) on all exposed aluminum wiring.

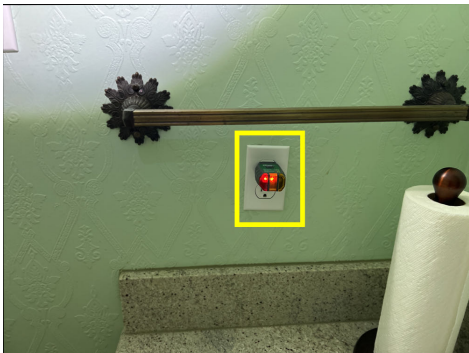
Outlet in half bath and improperly wired, recommend repair.

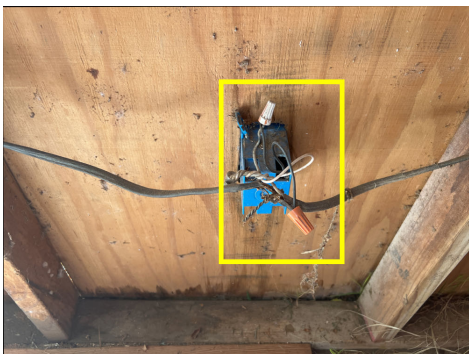
Amateurish wiring observed in the garage.

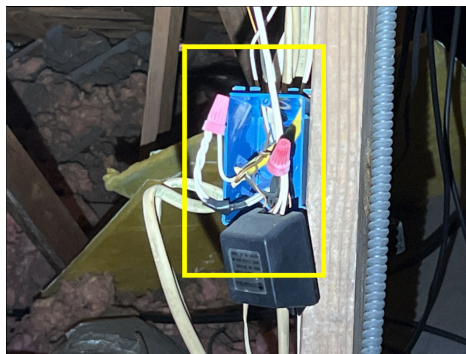
Wire splice missing cover in the attic.

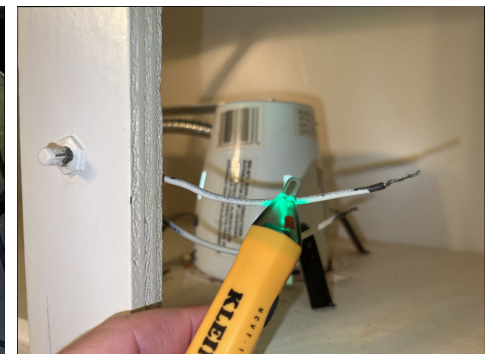
Wire improperly terminated above kitchen sink. Wired we're not hot (live) at time of inspection.

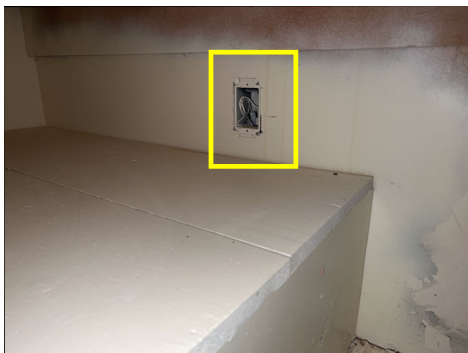
Wire splice missing cover left of kitchen sink under the cabinet.

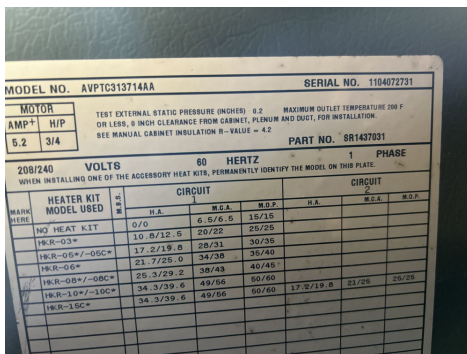
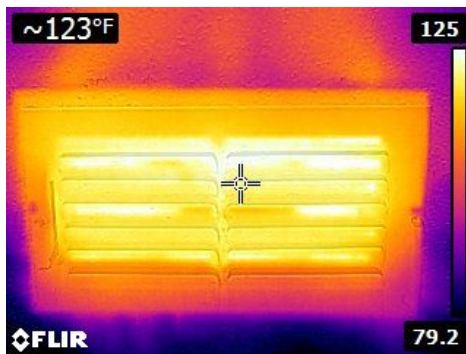
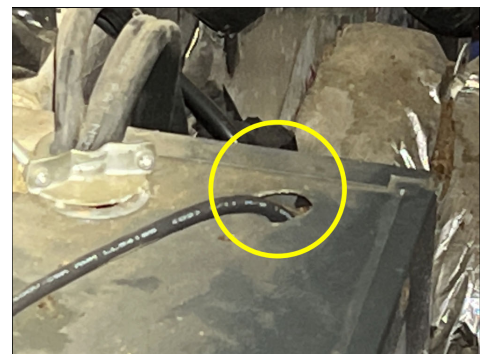
Furnace: 2011 Goodman (Electric)

Thermal image showing the furnace was functioning properly at time of inspection.

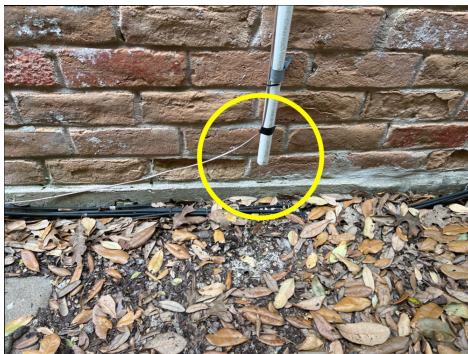
Primary drain line should not be allowed to discharge water right next to the foundation; east side of house.

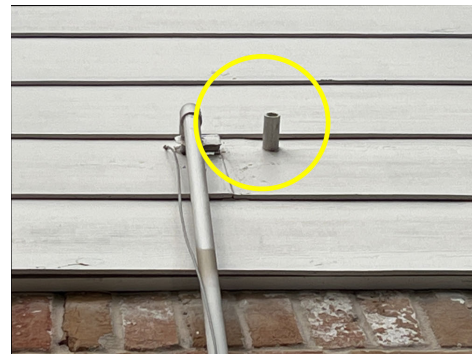
Missing 90 degree elbow fitting on end of emergency drain line at east exterior wall to prevent condensation dripping back onto the exterior wall.

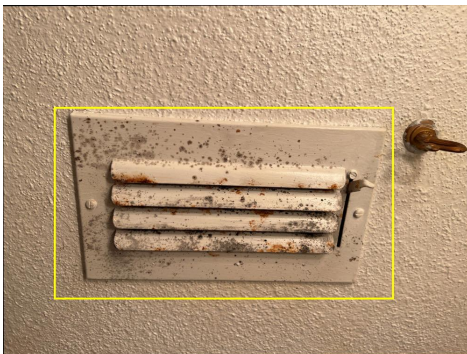
Observed possible microorganism growth on air supply grills / vents which may be a concern due to increased awareness of environmental issues associated with molds. If this is a concern or potential concern, Fox Inspections recommends having our company or a qualified professional of your choice for further information / investigation.

Microorganism growth on air supply grills / vents in upstairs hall bath which may be a concern due to increased awareness of environmental issues associated with molds. Recommend having an air quality/mold inspection done in the near future.

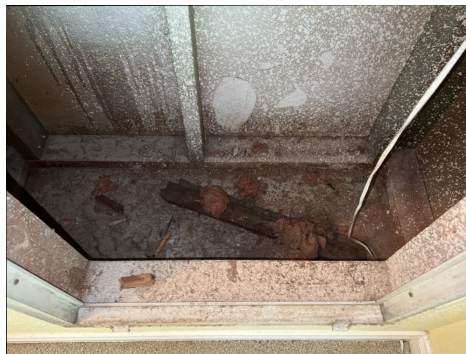
Return air chase is dirty, needs cleaning.

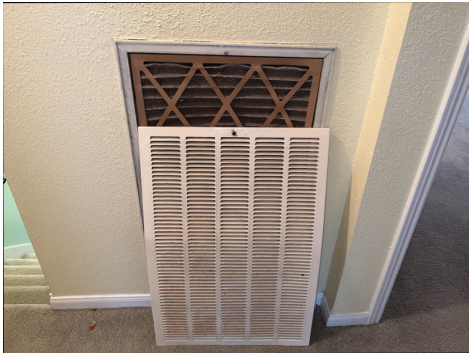
Return air chase grill was observed damaged and missing the screws which secured to the wall.

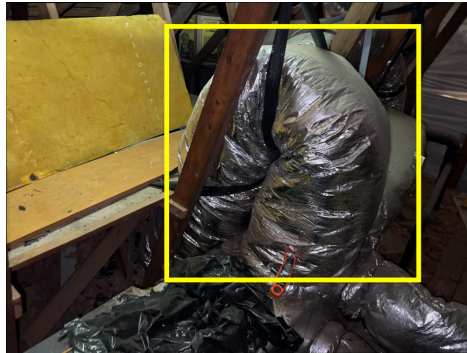
Flex ducts observed to be improperly routed with sharp bends and/or excess material in bends.

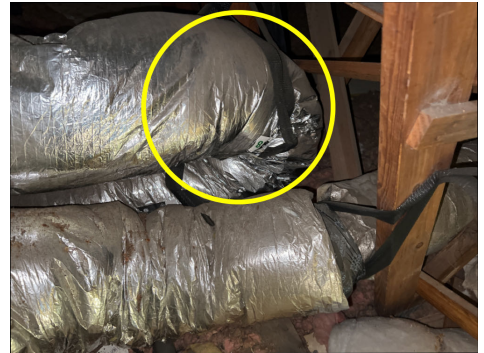
More flex ducts observed to be improperly routed with sharp bends.

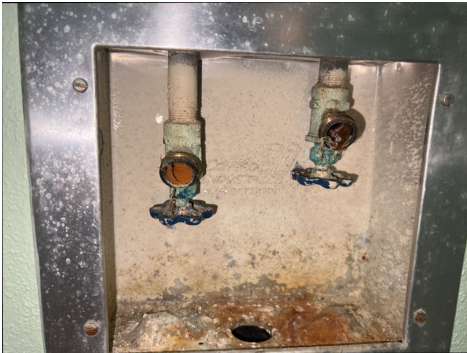
Corrosion observed on shut off valves to laundry connections.

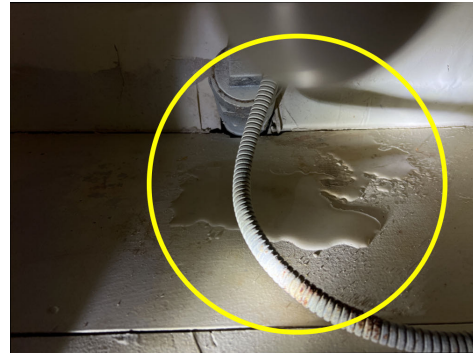
Water leaks under the kitchen sink.

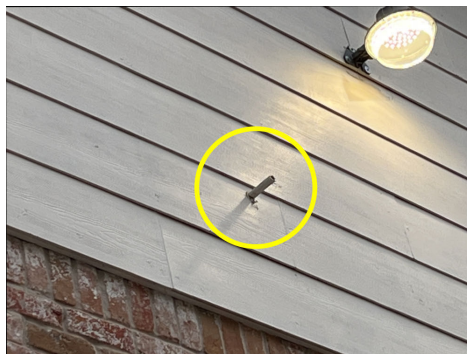
Observed an abandoned drain line that extends out through the west exterior wall. Recommend having the line removed and the opening in the exterior sealed.

Observed an abandoned drain line at west side of house.

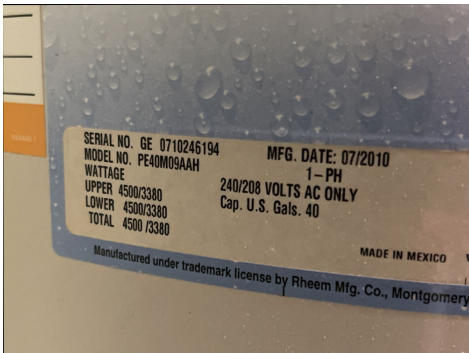
Water heater: 2010 General Electric 40 gallon

No drain pan under the water heater in utility room.

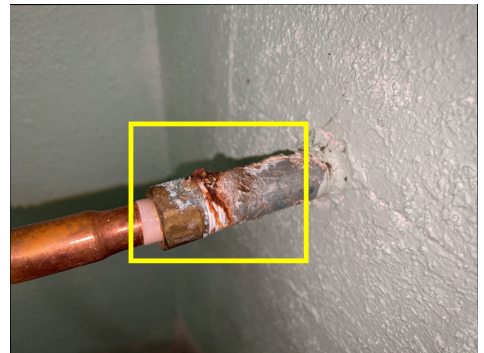
Corrosion observed on piping to water heater.

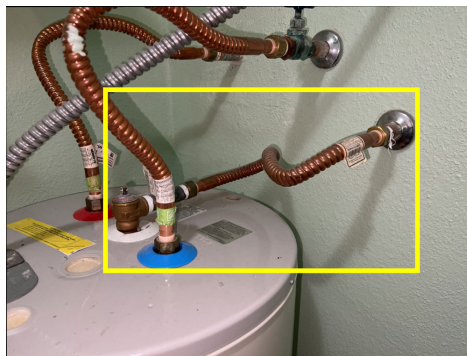
Drain line is improperly routed - does not provide for positive drainage {gravity flow} away from the valve.
