12702 Copper Mill Dr  
Houston, TX 77070

## PROPERTY INSPECTION REPORT

**Prepared For:** Diana Gonzalez  
(Name of Client)

**Concerning:** 12702 Copper Mill Dr, Houston, TX 77070  
(Address or Other Identification of Inspected Property)

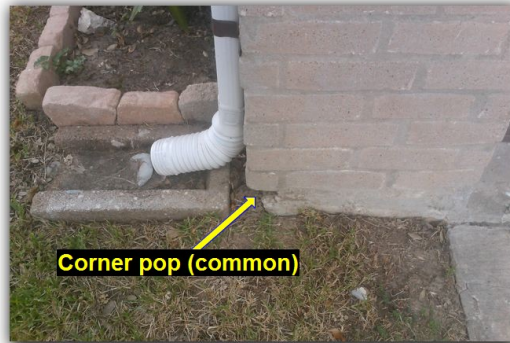
Spalling (i.e., corner pops) at one or more corner(s), Corner spalling is common to slab foundations and does not affect the structural integrity of the foundation.

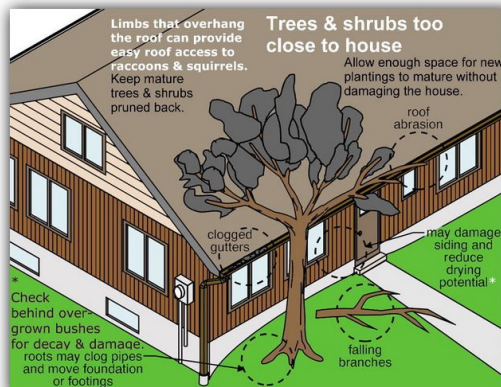
Recommend keeping vegetation cut back away from exterior of home to prevent damage.

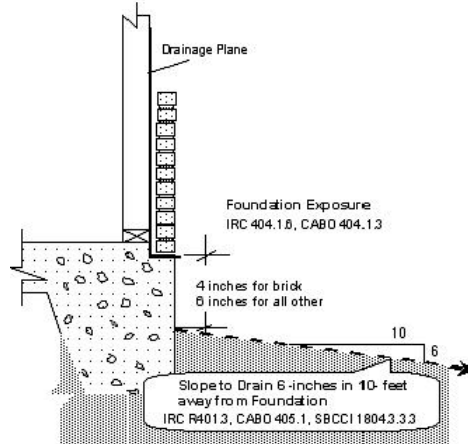
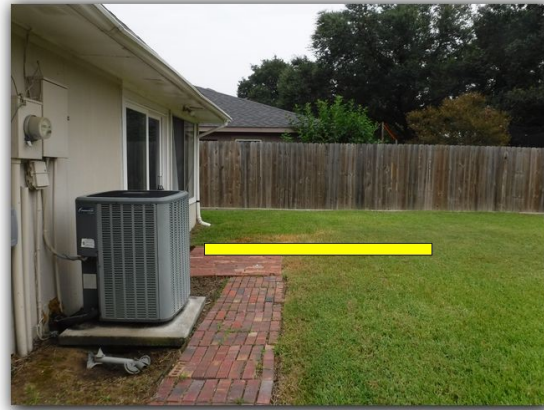
Observed the grading did not slope away from the home in one or more areas around the exterior. Current standards call for the grading to slope away from the home at least 6 inches per 10 feet. This is to prevent water from pooling close to the foundation which can cause damage. Remedies may include adding rain gutters, French drains or re-grading around the home.

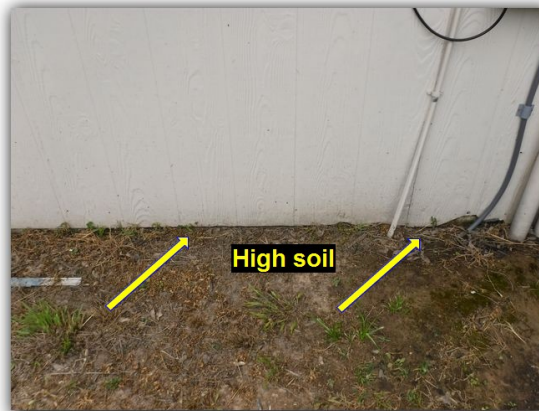
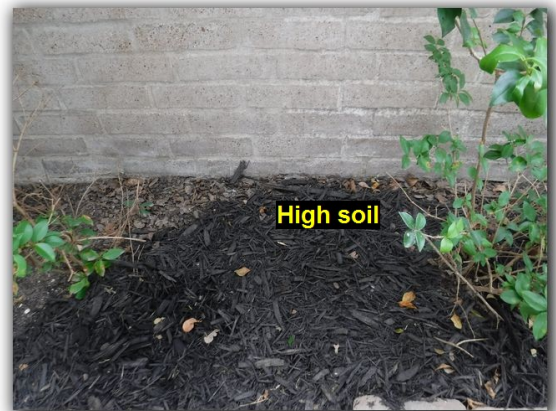
Observed soil levels too high around the foundation in one or more areas. High soil levels are considered a conducive condition to termite activity and water penetration.

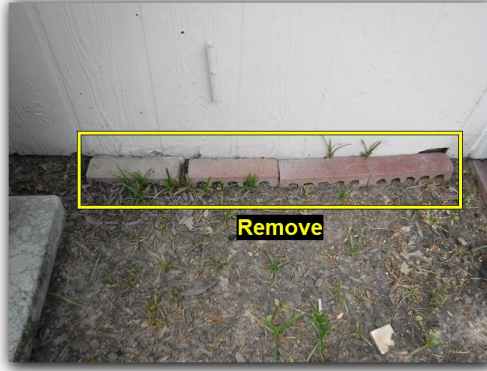
Bricks, stone, etc. should not be stored near house or garage, can hide evidence of wood destroying insect activity, recommend relocating away from house / garage.

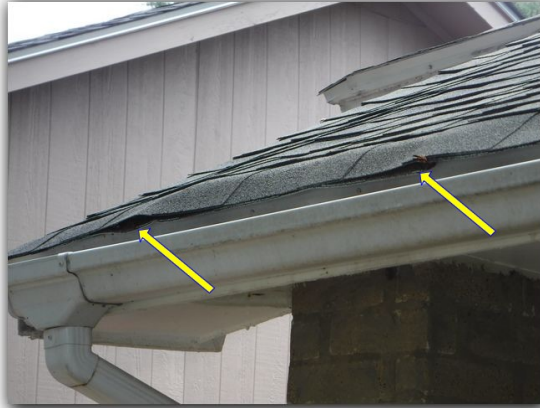
Observed raised shingles in one or more areas of roof. Recommend securing all shingles to prevent water penetration from wind driven rain.

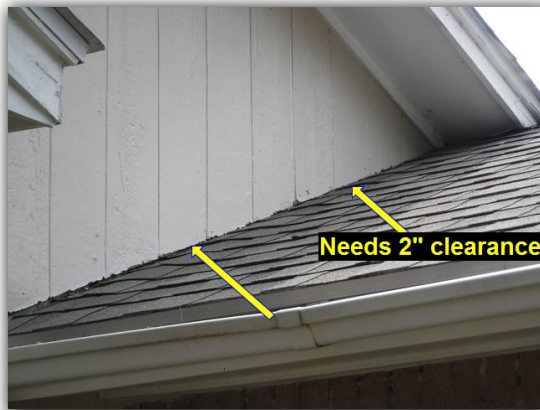
Observed siding touching shingles in one or more areas of roof. Common industry practice calls for at least a two inch separation from bottom edge of siding and roof surface. The two inch separation helps prevent moisture from being trapped which can cause deterioration.

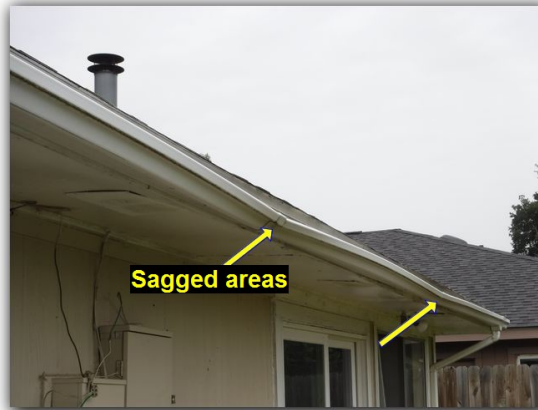
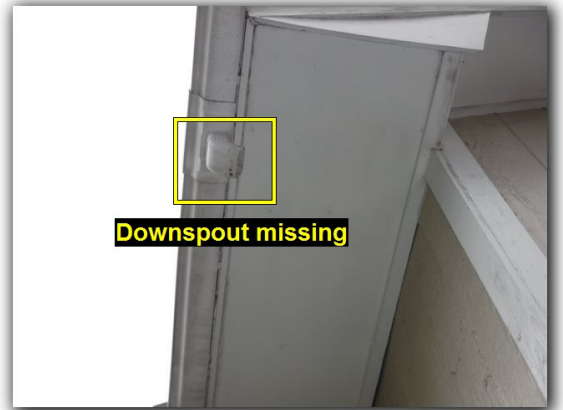
Observed missing downspouts & leaning / separated gutters. Recommend repair as needed for proper drainage.

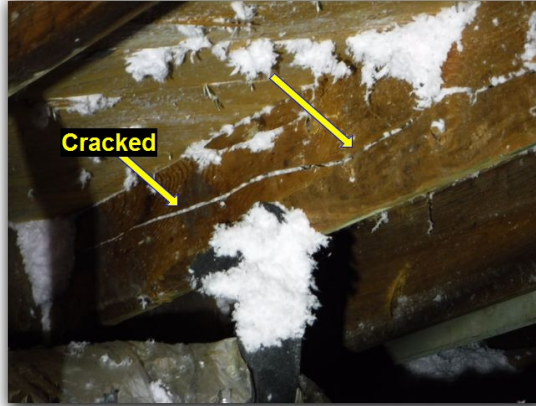
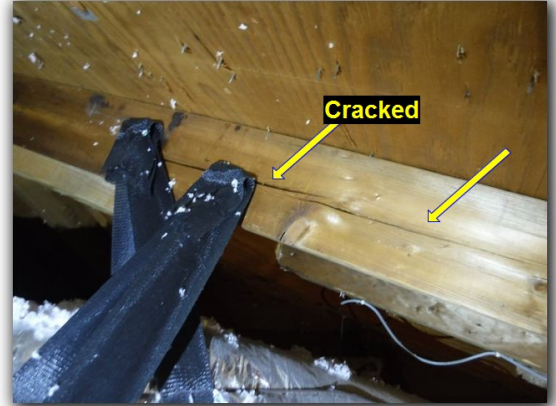
*Observed some cracked rafters near the attic access & behind the furnace. Recommend having a qualified contractor evaluate the roof structure and repair / add support as needed.*

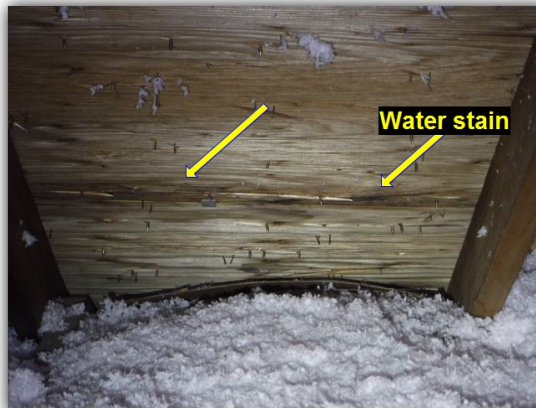
*Observed water stains to the roof decking in one or more areas in the attic. Moisture readings were low at time of inspection which usually indicates the stains are from a previous leak, but I could not be certain. Recommend asking the seller about a previous leak that may have been repaired or having further evaluation by a contractor.*

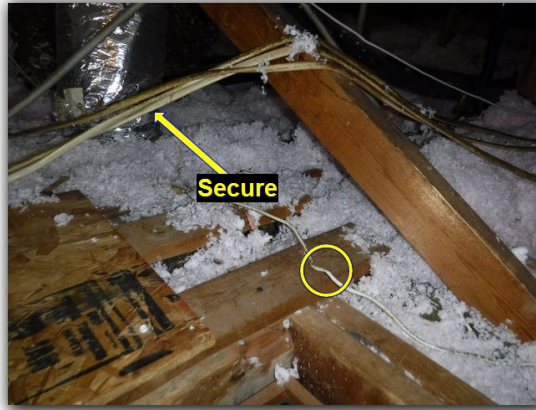
Observed wiring too close to attic access opening. Wiring should be at least 6 feet away from attic opening. One reason for this code is that someone falling from the access ladder might grab onto an electrical wire. Usually securing the wiring so that it can not be grabbed will alleviate this danger.

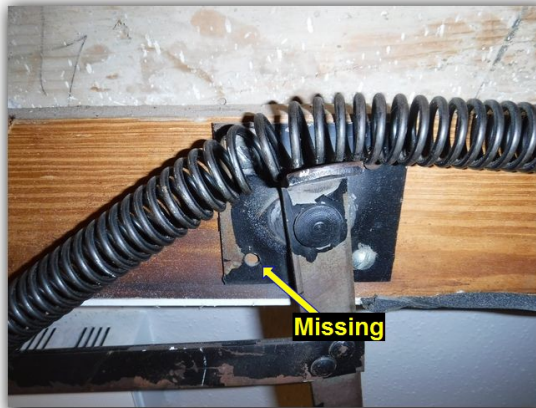
Observed one or more nails/screws missing from attic access ladder frame. Recommend installing a 16d nail or 1/4 inch diameter lag screw to properly secure stairway frame to ceiling.

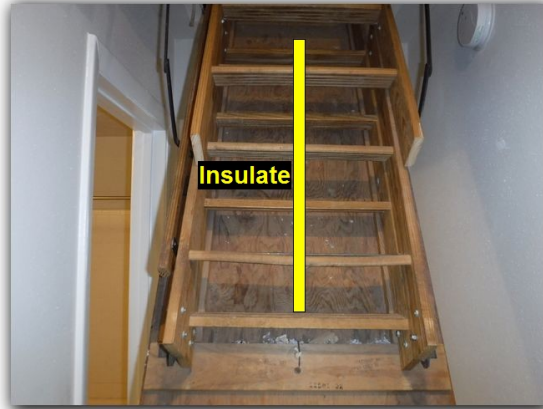
*For optimum energy efficiency, I recommend insulating the pull down attic access.*

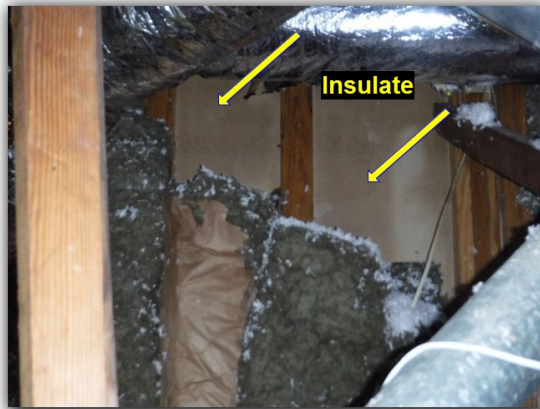
*Observed insulation removed/missing in one or more areas of the attic. Recommend adding or reattaching insulation for optimum energy efficiency.*

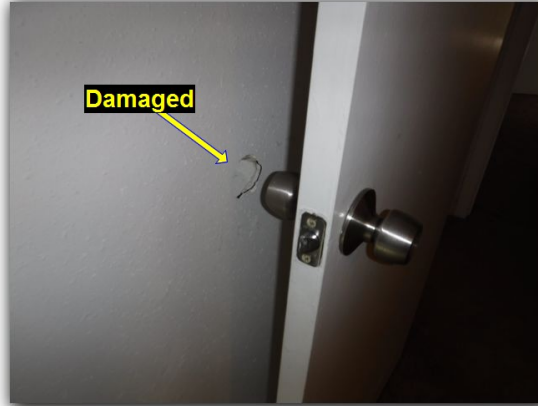
*Drywall damage observed in one or more areas.*

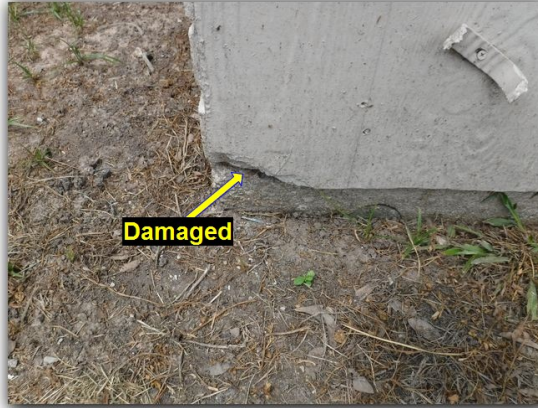
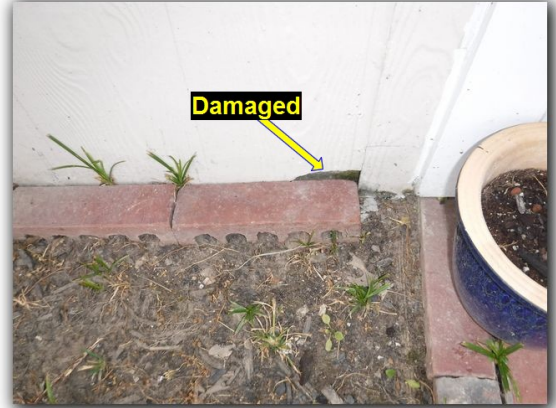
Damaged / deteriorated siding & trim observed at one or more locations.

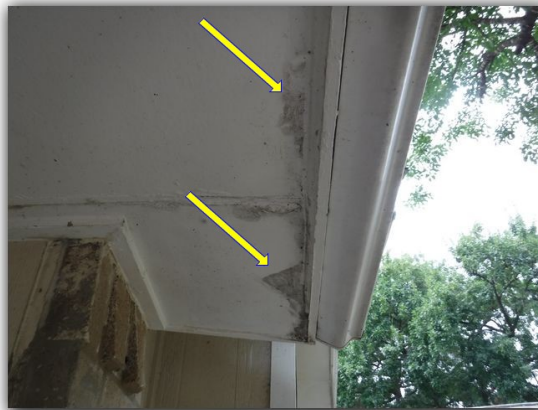
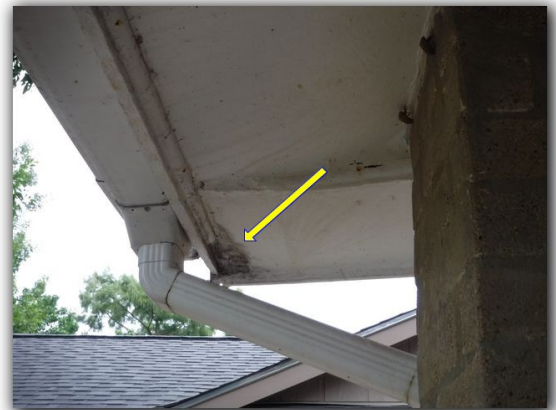
Observed some water stains / water damage to the soffits in multiple areas. This type of damage is commonly caused by gutters that need to be cleaned out of are damaged / sagging / not draining properly. Recommend having a qualified contractor repair as needed.

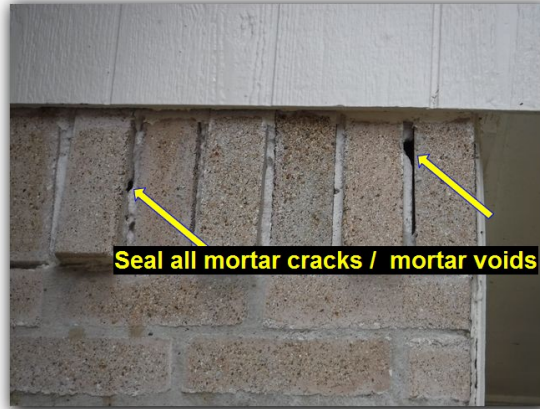
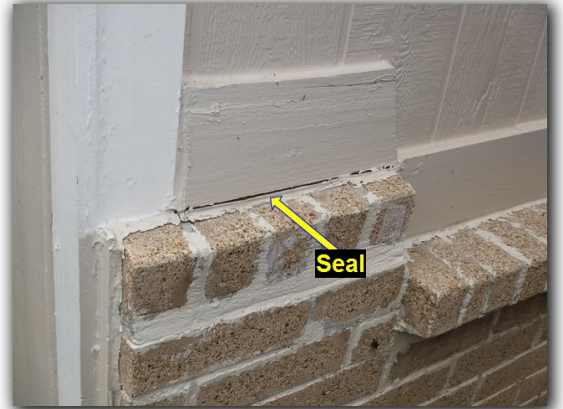
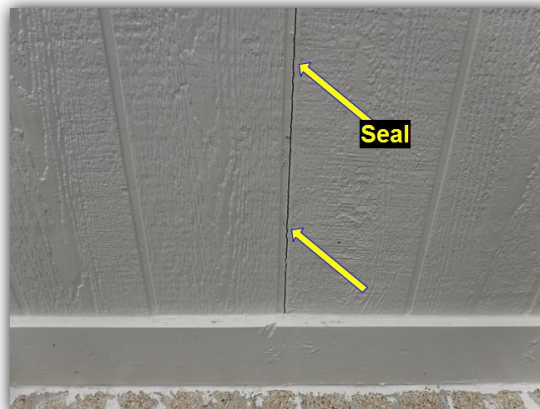
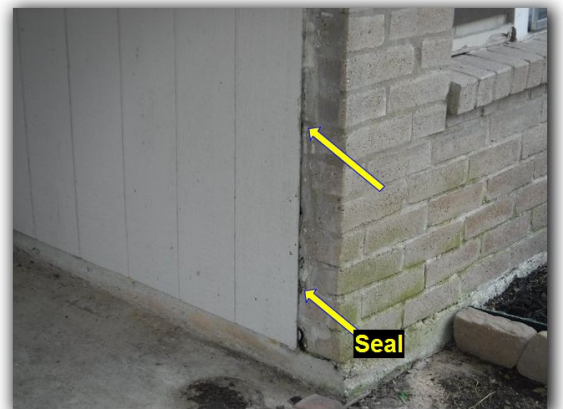
Observed cracks in the brick and/or mortar around the exterior in one or more areas. Recommend sealing/caulking around all holes, gaps, cracks and exterior siding penetrations to prevent water & pest entry. Repaired areas observed on brick siding.

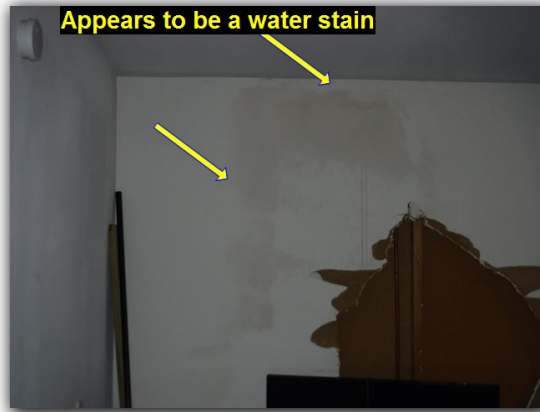
Observed what appeared to be water stains on the wall in the garage. Moisture readings were low at time of inspection which usually indicates the stains are from a previous leak, but I could not be certain. Recommend asking the seller about a previous leak that may have been repaired or having further evaluation by a contractor.

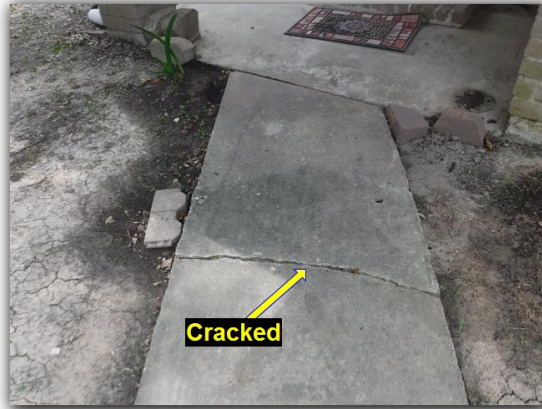
Cracks in walkways, driveway and/or garage concrete observed, typical.

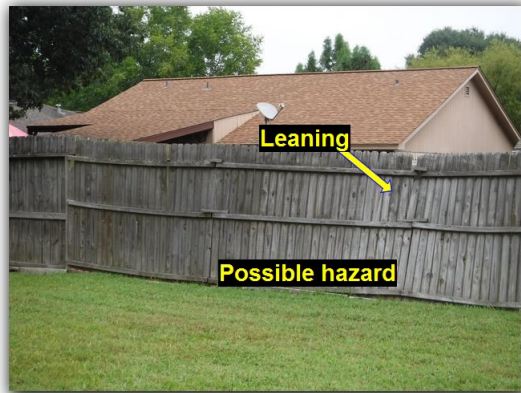
Observed leaning, damaged and/or deteriorated pickets on the fence in one or more areas.

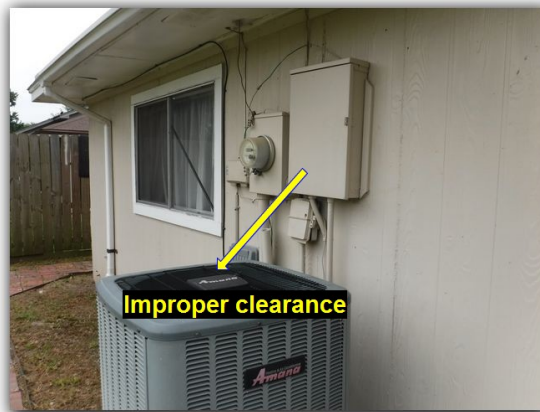
*Improper clearance to electrical panel, minimum clearance should be 36" in front and 30" from side to side.*

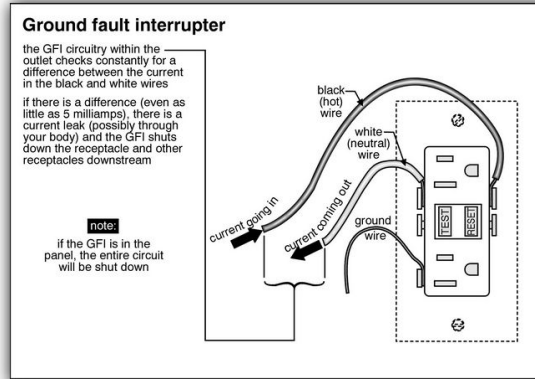
Did not observe GFCI protection for all outlets in required locations, including but not limited to; kitchen. Current standards call for GFCI protection for all outlets in the kitchen, bathrooms, laundry room, garage, exterior and any outlet that is within 6 feet of a water source. This condition is a recognized safety hazard.

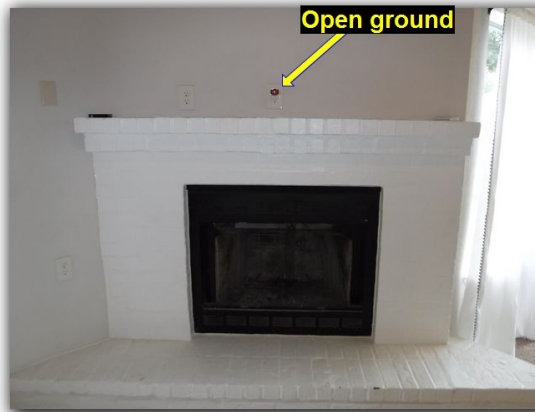
Observed an outlet in the living room that was wired incorrectly as open ground (ungrounded). Recommend having a licensed electrician repair as needed.

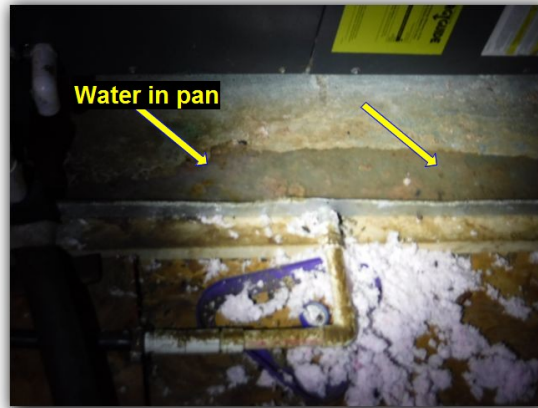
The secondary drain pan is filled with some water which is an indication that the primary drain is becoming clogged. Recommend further evaluation by qualified HVAC company.

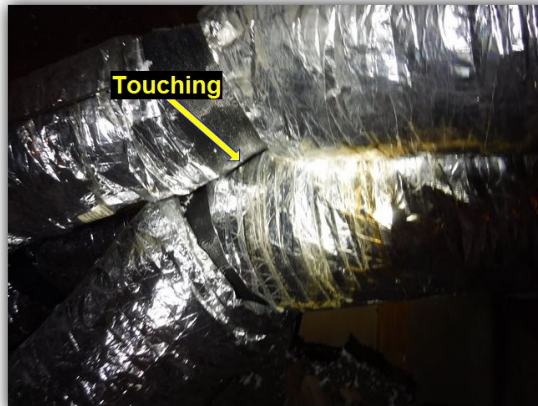
*Observed ducts touching in one or more areas in the attic. This can allow condensation to form between the ducts which can drip onto the attic floor or ceilings below. Recommend separating the ducts or placing a piece of insulation between the ducts to prevent condensation from forming.*

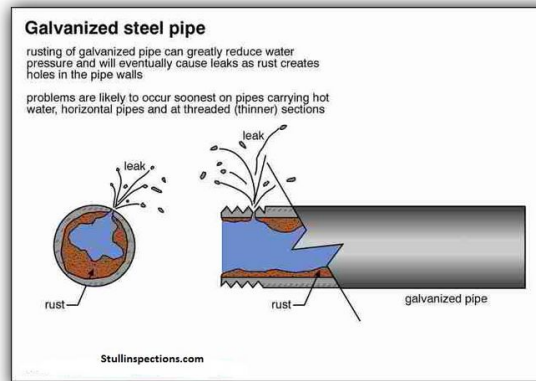
*Observed the plumbing supply piping to be made of a mix of copper & galvanized where visible.*

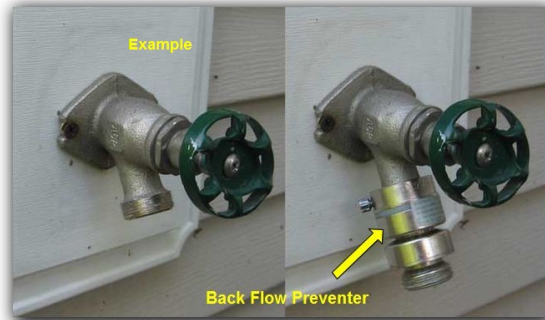
*Some exterior hose spigot(s) do not have code approved anti-back flow devices installed. Note: Back flow preventers cost approximately \$5.00 and are easy to install.*

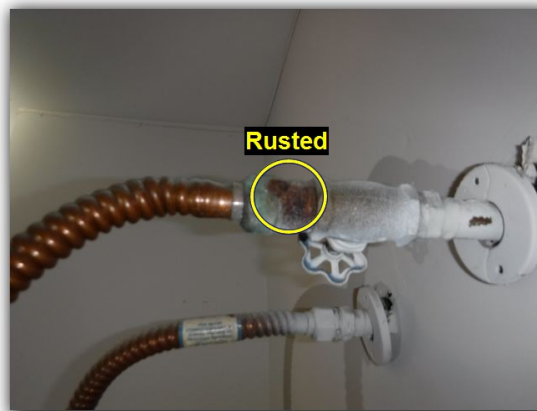
*Rust / corrosion observed at connections on top of water heater, corrosion can eventually lead to leaks.*

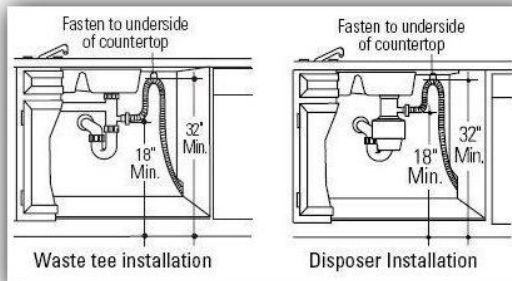
Did not observe a high loop or air gap installed for the dishwasher. The high loop or air gap prevents gray (dirty) water from backing into the dishwasher if the disposal or drain becomes clogged.
