## HEDDERMAN ENGINEERING, INC.

REF: CONDITION OF PROPERTY SURVEY

At your request, a visual survey of the house located at 8706 Lupton Lane, Houston, Texas, was made by Mr. Javier Almodovar and Mr. Daniel Koteles.

**8706 Lupton Lane**

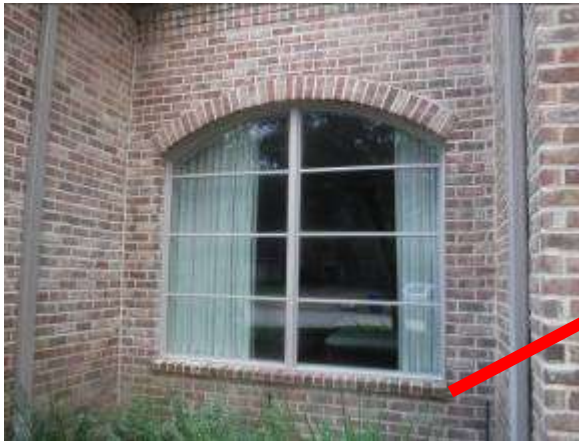
Front of the house

Cracks in the exterior veneer were minimal in number and degree. It is recommended to repair all the visible cracks.

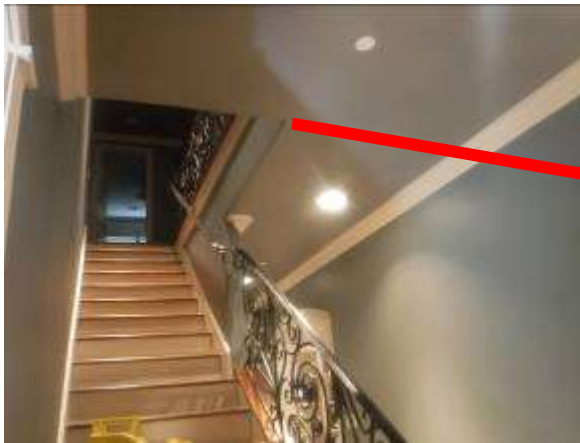
Stairs

Sheetrock cracks were observed, including at the 2<sup>nd</sup> floor southeast bedroom, stairs, game room, and the 2<sup>nd</sup> floor west bedroom. It is recommended to repair all the visible cracks.

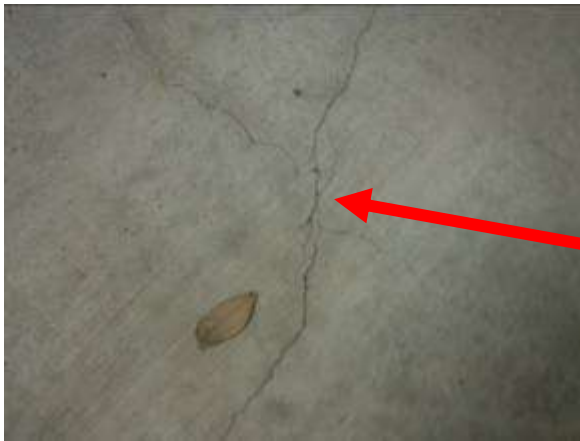
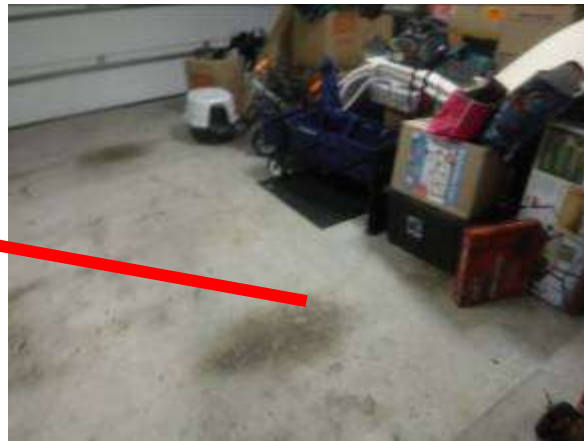
Cracking of the foundation concrete exists in virtually all foundations. It is pointed out that cracking is a normal property of concrete and other brittle materials, and Hedderman Engineering, Inc. assumes no responsibility should cracks be found that are not mentioned in this report. Some cracking was observed in this concrete foundation, including at the garage floor.

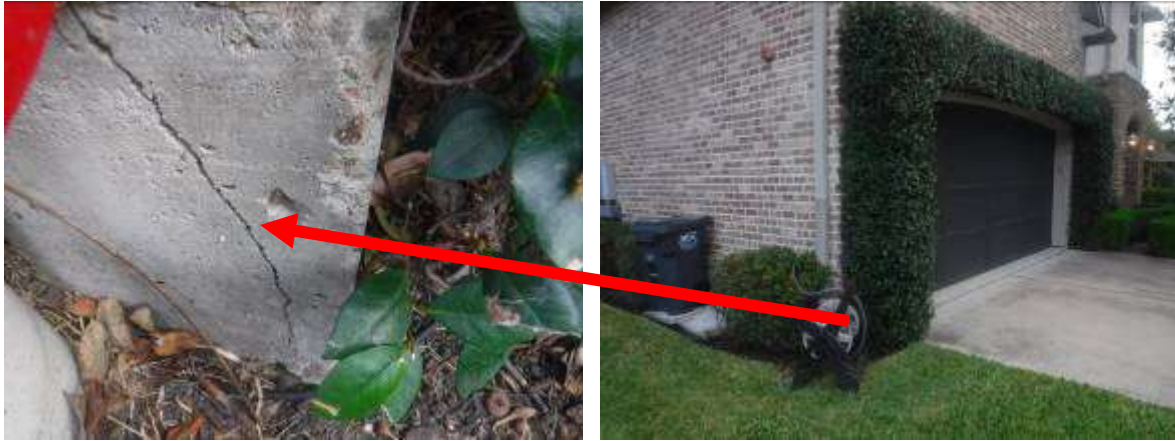
The corner of the foundation was observed to be chipped at the southwest corner. This condition is typically caused by differences in thermal expansion between the brick veneer and the concrete foundation. Also, this condition can be caused by a lack of reinforcement in the corner of the foundation during original construction. In our opinion, this condition does not affect the overall structural integrity of the foundation.

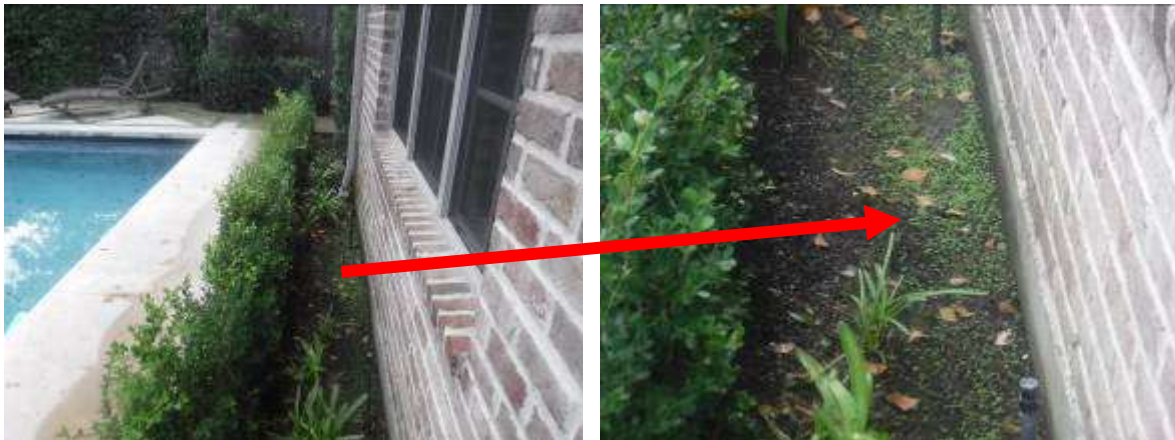
The perimeter drainage around the property appeared to generally be adequate. However, low areas were observed at the rear of the breakfast area where it is obvious that water pools after it rains. Have a service company provide a solution and cost estimate to eliminate the standing water.

**Obtain Cost Estimate**

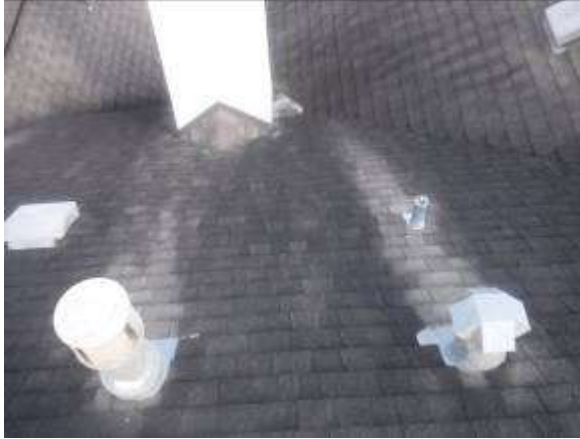
The composition roof surface was showing evidences of deterioration, including shingles that were discolored, and starting to lose their aggregate.

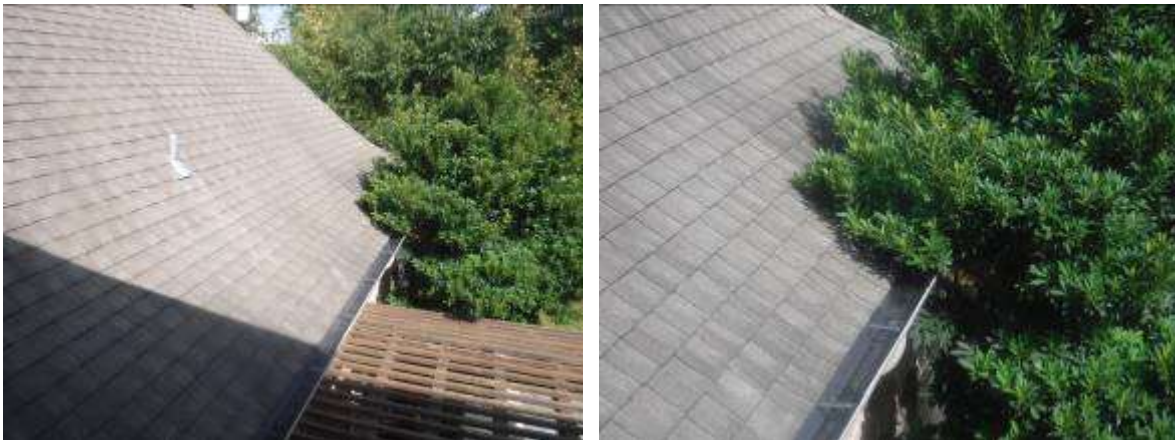
- \* Tree limbs were observed to be touching the roof, and need to be trimmed back to prevent them from rubbing across the roof surface.  
**Obtain Cost Estimate**

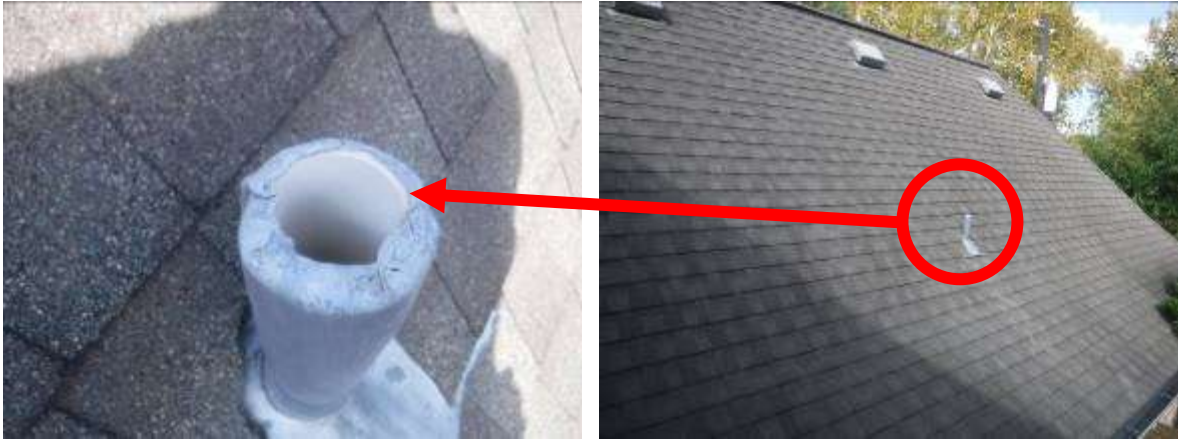
- \* The roof decking was observed to be “Tech-Shield” which is a radiant barrier roof decking that has aluminum foil on the underside, which helps to prevent radiated heat from entering the attic. This will, in turn, keep the attic cooler.
- \* It was observed that spacer clips were installed at the joints between the roof decking to allow for expansion of the roof deck.
- \* We observed from the attic space that the shingles were nailed rather than stapled, and that the nails had an adequate penetration through the roof deck.
- \* One of the lead roof jacks at the roof penetrations was not properly folded into the top of the vent pipe since the vent pipe is longer than the roof jack. Have a roofer

make the repairs to the vent pipe and roof jack.

**Obtain Cost Estimate**

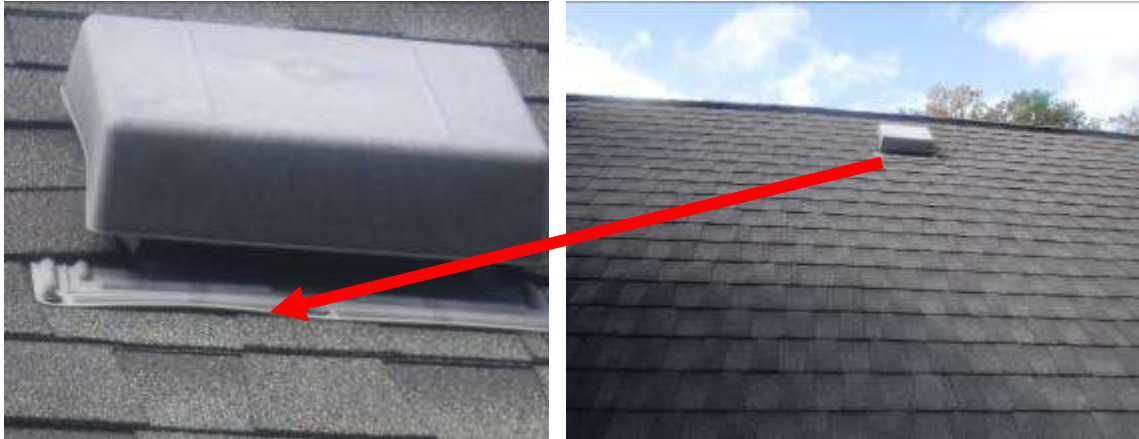
- \* The flashing at the static roof vents was not secured properly, and can allow wind-blown water to enter the living space. The flashing needs to be resecured to the roof.

**Obtain Cost Estimate**

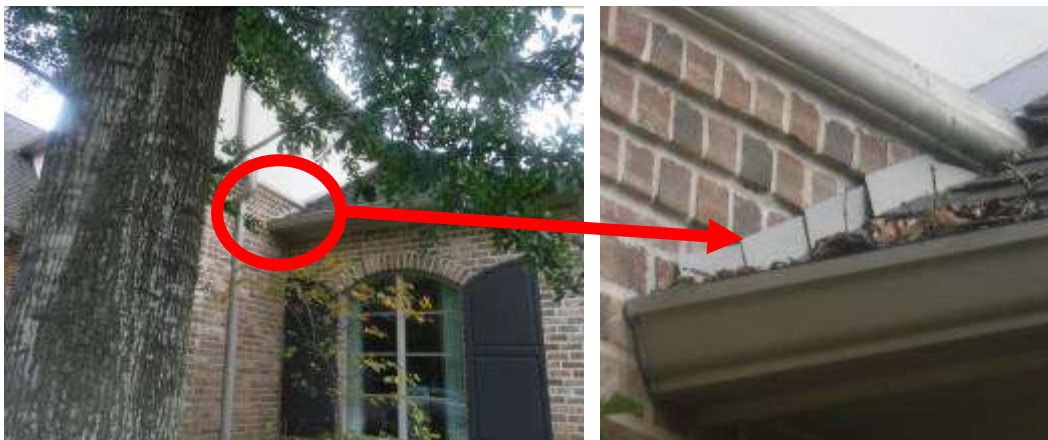
- \* The step flashing was not covered with counter flashing at the east side of the house. Contact a roofer to provide the needed repairs.  
**Obtain Cost Estimate**

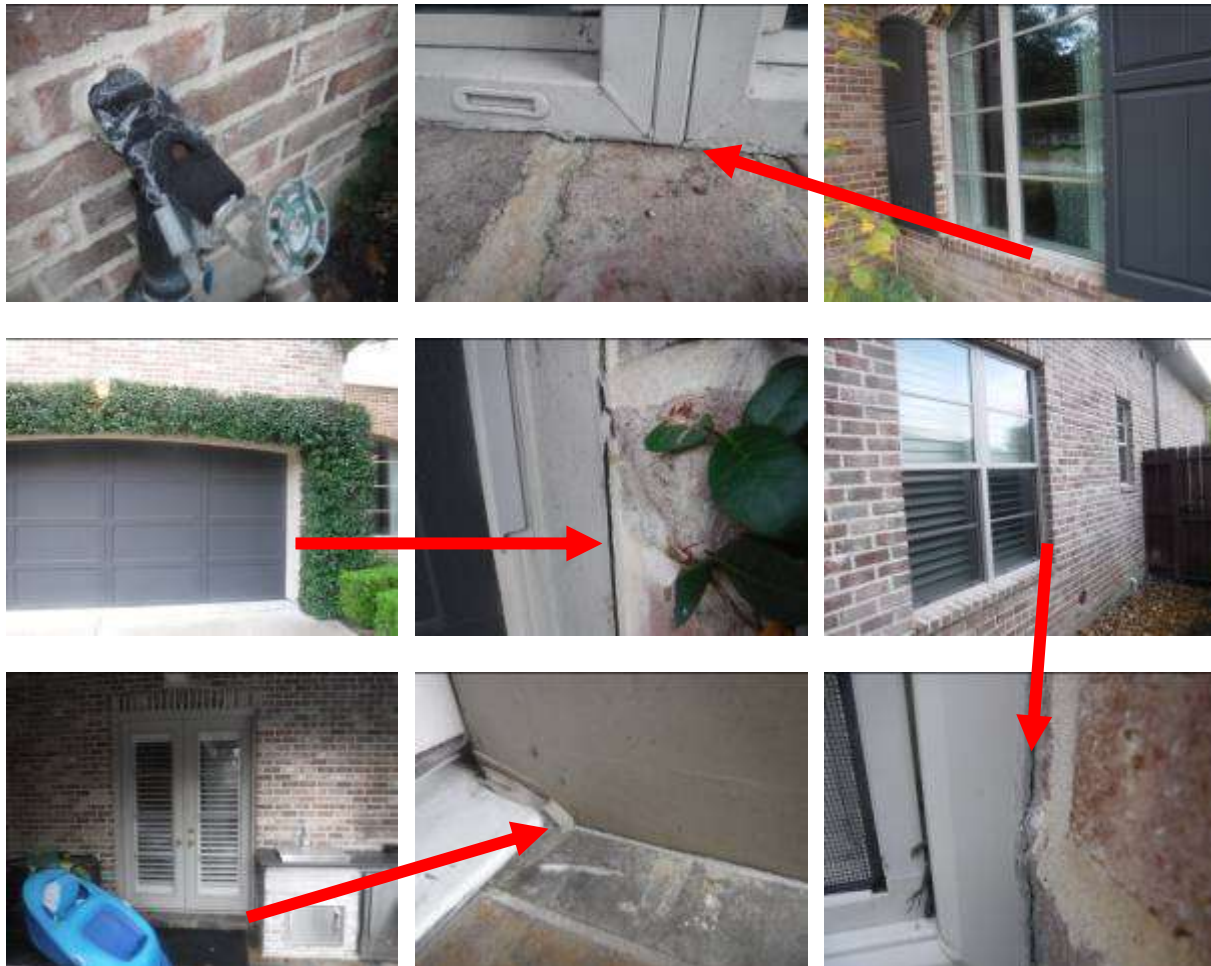
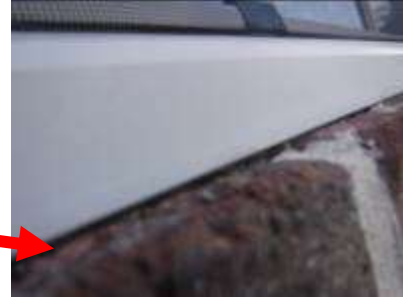
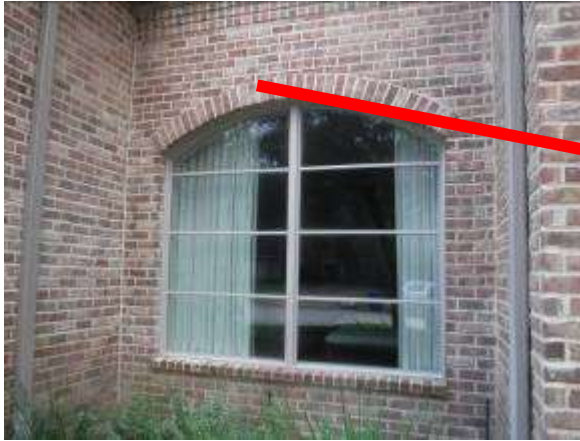
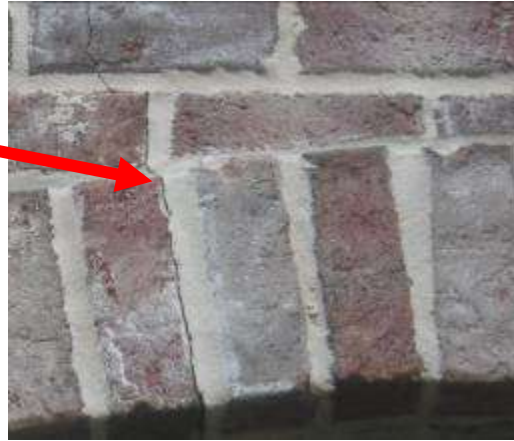
A substantial vulnerability to water penetration was observed at penetrations/openings through the exterior building envelope, and it is recommended that all penetrations/openings be sealed against water penetration. Below is a representative sample of locations and/or photographs showing some, but not necessarily all, locations where there is a vulnerability to water penetration. Have a contractor provide a cost estimate to seal all vulnerable areas against water penetration.

- Windows and doors where the caulking was cracked and/or missing.
- Piping penetrations.
- The brick veneer, where cracks were visible that can allow water penetration.

**Obtain Cost Estimate**

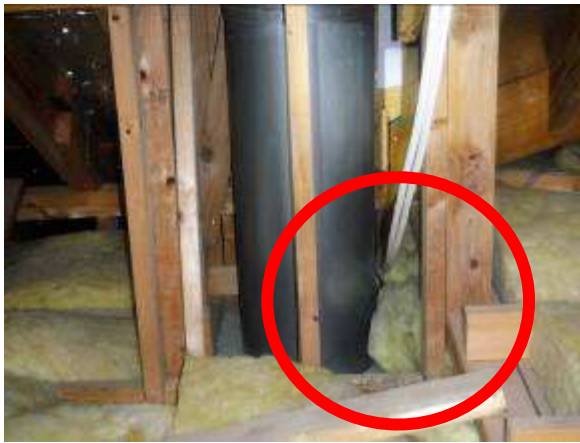
It was observed from the attic that the metal chimney flue pipe was in contact with insulation, which can be a fire hazard, and the insulation needs to be removed from the flue pipe, and a two inch air space provided around the vent pipe.

**Obtain Cost Estimate**

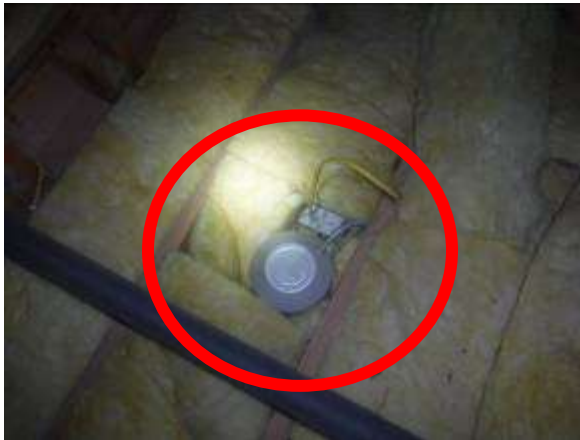
The insulation in the attic was in contact with the recessed lights, which may be a fire hazard. We saw no evidence on the outside of the recessed cans to indicate that the cans were rated as “IC”, which is the manufacturer designation for “Insulation Contact”. Further investigation is recommended, including dismantling the trim kit in the ceiling below. If the recessed cans are NOT “IC” rated, then the insulation needs to be pulled back, and a three inch air space provided around the lights to prevent overheating and a possible fire hazard.

**Obtain Cost Estimate**

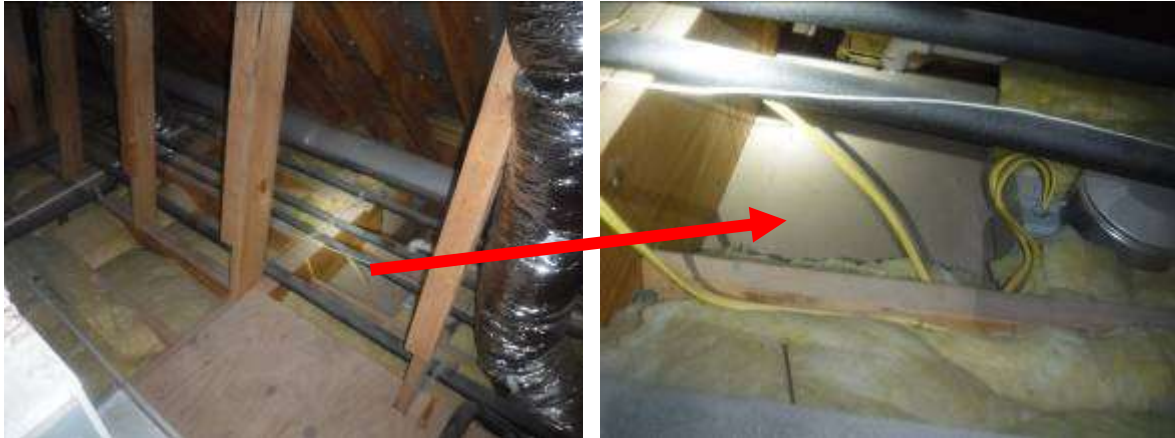
The insulation in the attic was missing from between some of the joists.

**Obtain Cost Estimate**

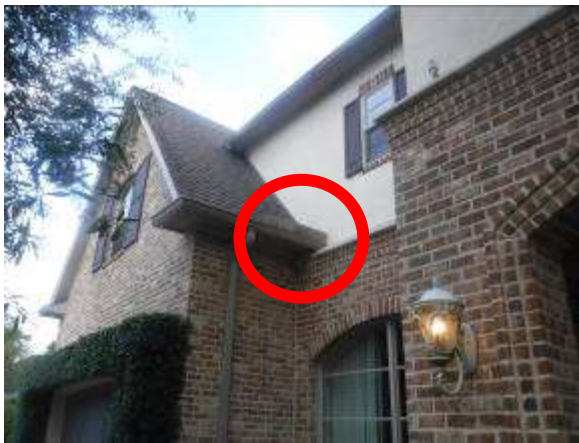
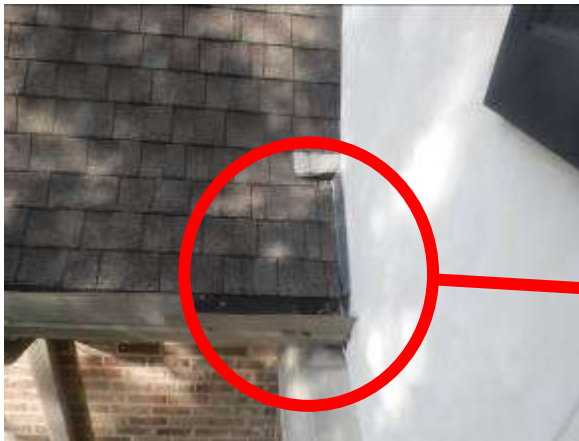
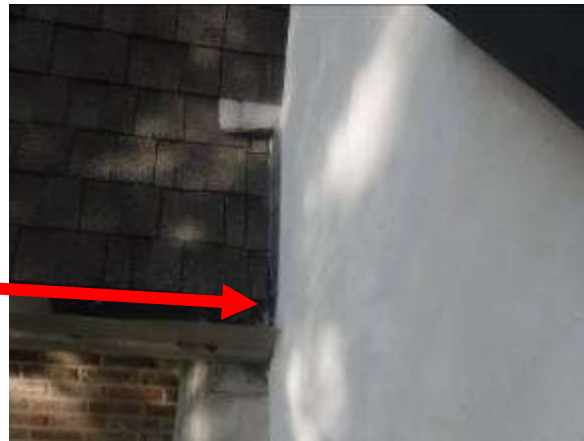
**Missing kickout flashing**

No kickout flashing has been installed at the roof/wall intersections. A lack of kickout flashing can possibly allow water to be routed off the roof into the wall cavities, causing wood rot, damage from wood destroying insects, mold, etc. We saw no evidence at the time of the inspection of any water penetration at the flashings, and therefore, no repairs are indicated. However, as a routine recommendation, we recommend that a contractor be contacted to provide a cost estimate to install the kickout flashing at all roof/wall intersections to prevent the possibility of water penetration in the future.

**Obtain Cost Estimate**

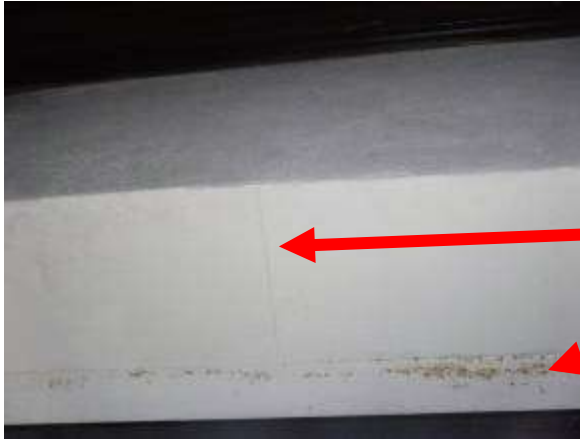
**Crack and visible rust**

A possibility of water penetration exists at the stucco veneer at the back porch, where cracks and some rust were visible on the stucco covered beams under a roof section that was heavily coated with caulking. It is recommended that a stucco specialist be contacted to perform invasive inspections by drilling holes at appropriate locations to determine the scope of the damage. Have a contractor provide a cost estimate for any

needed repairs.

**Obtain Cost Estimate**

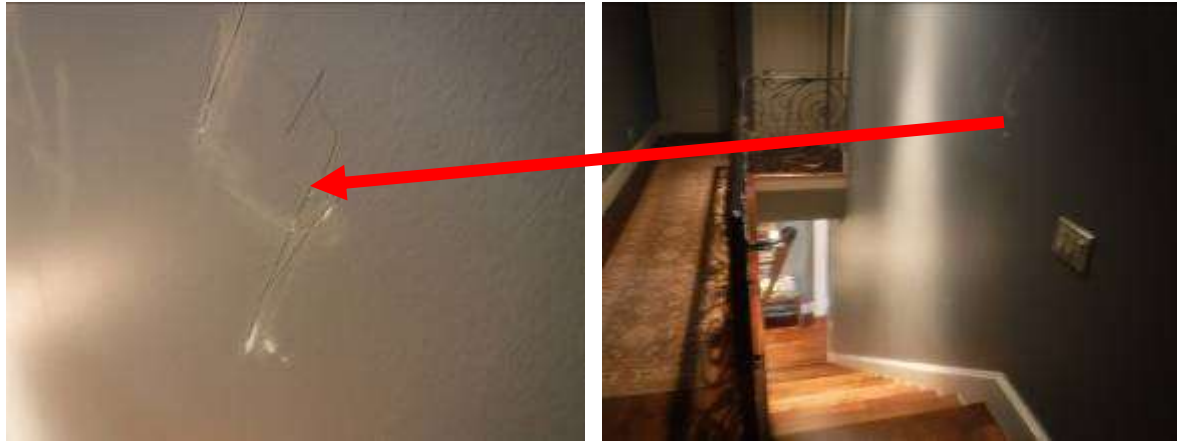
The sheetrock was damaged and needs to be repaired at the stairs walls.

**Obtain Cost Estimate**

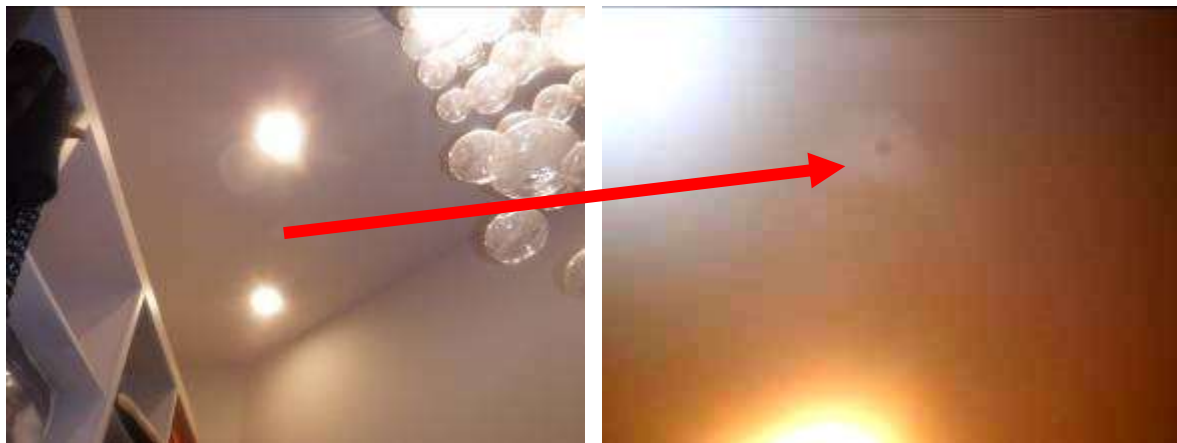
Patches in the sheetrock were seen at the ceiling of the master closet. The cause of the patching could not be determined at the time of the inspection, and further investigation into the cause of the patch with the homeowner is recommended.

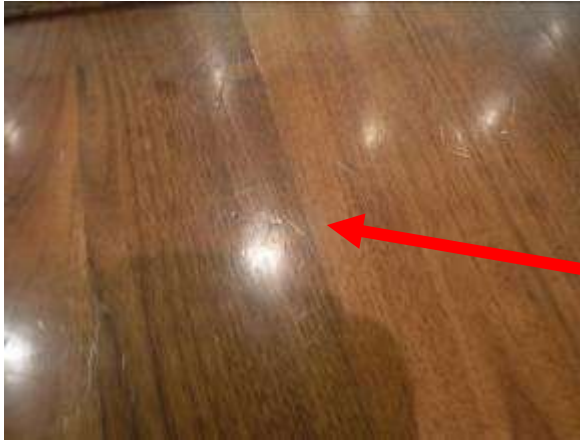
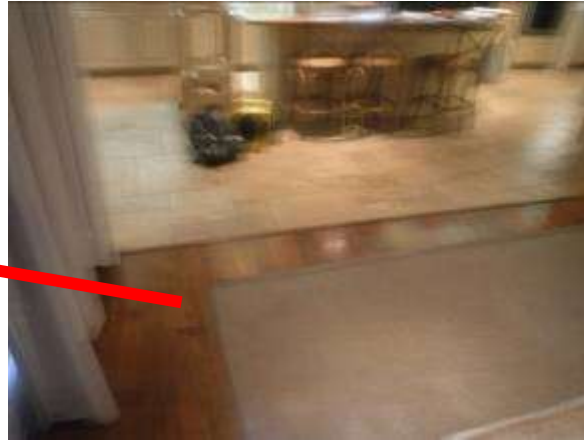
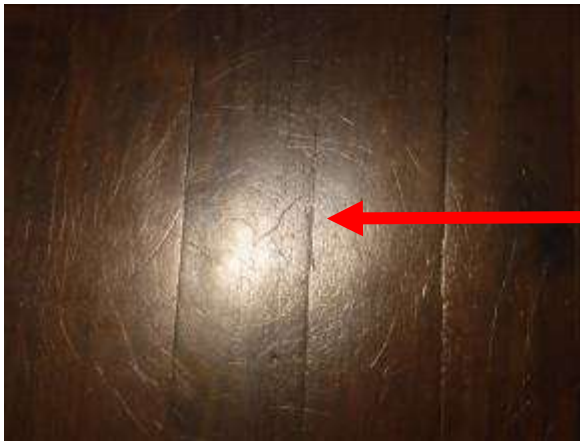
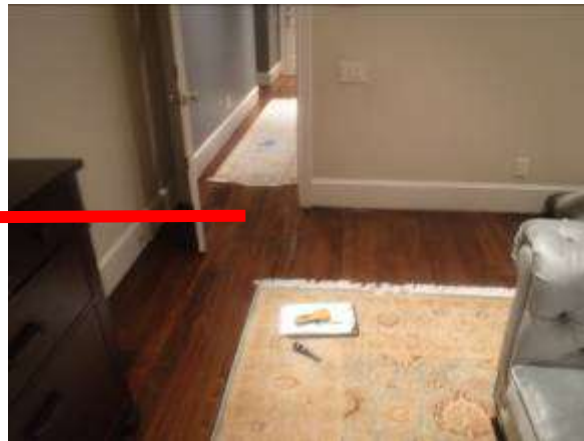
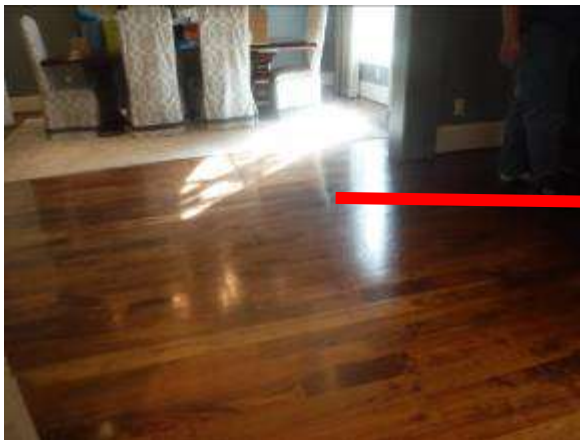
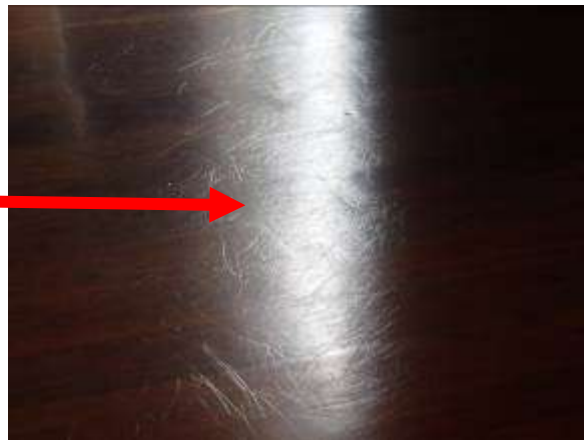
The wood floor was scratched through the first floor. Further investigation with a wood floor specialist is recommended.

**Obtain Cost Estimate**

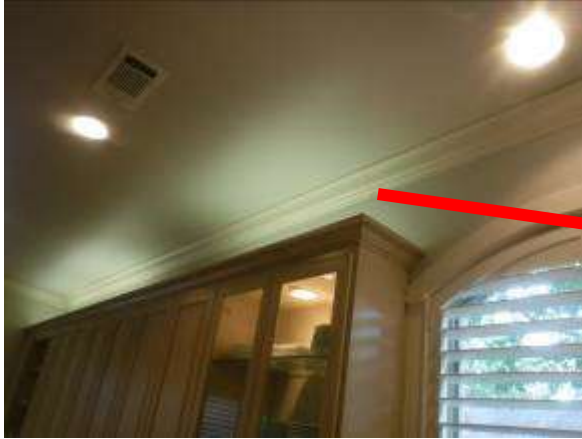
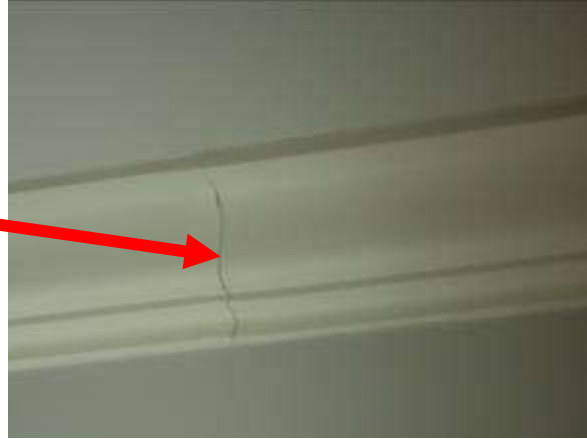
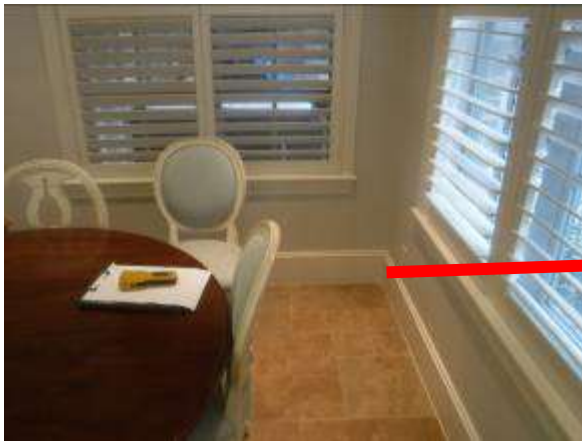
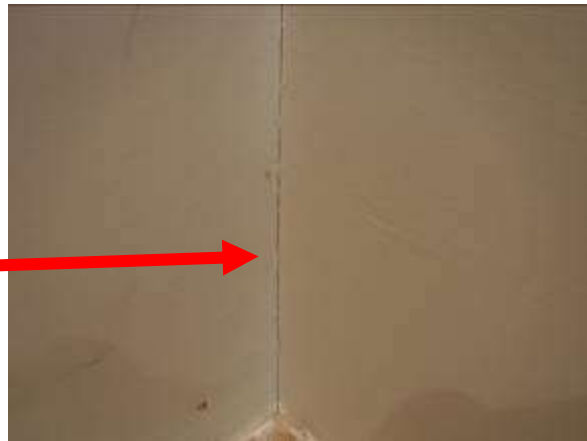
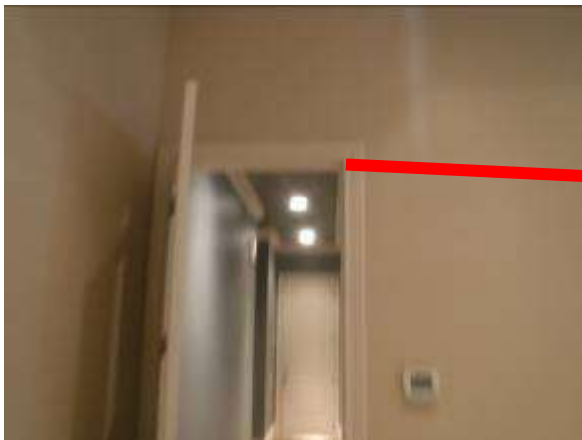
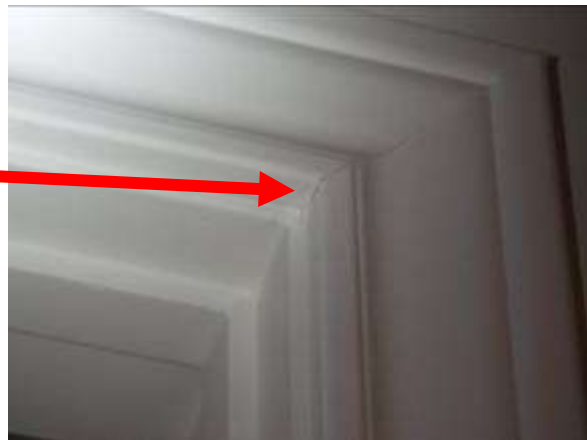
There were many separations at the joints and edges of the crown molding, baseboard, door trim, and window trim throughout the house. The separations appear to be related to drying and shrinking of the wood and caulking rather than to other causes. It is recommended to seal the separations.

**Obtain Cost Estimate**

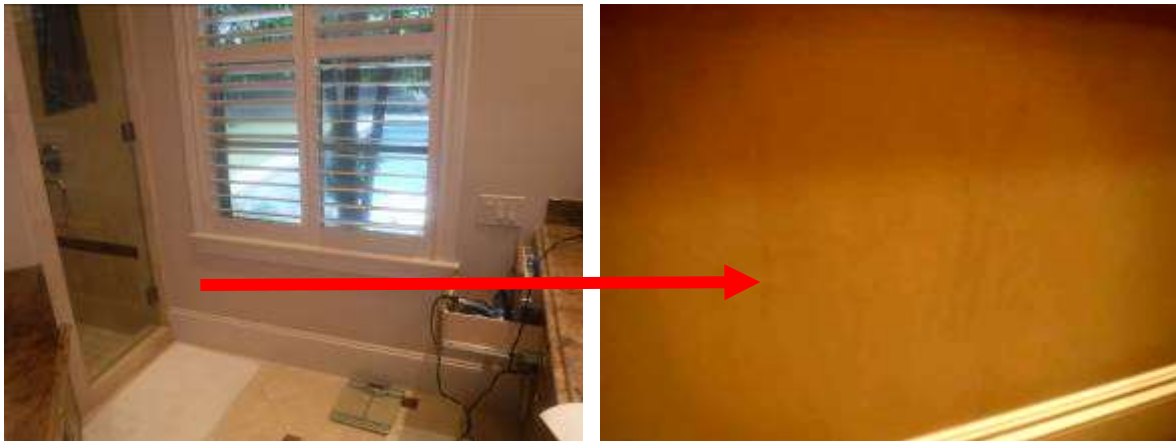
Water stains were observed at some of the walls of the master bathroom. The stains were checked with a moisture meter, and no higher than normal moisture readings were found. Apparently, the stains are related to the previous use of hot water without the use of the bathroom extractor fan. Not using the extractor fan when using hot water can allow the steam from the hot water to condense on the walls and/or ceiling, leaving water stains on the surface. The fact that the walls and/or ceiling were not wet (no higher than normal moisture readings) at the time of the inspection indicates that the stains appear to be a cosmetic issue.

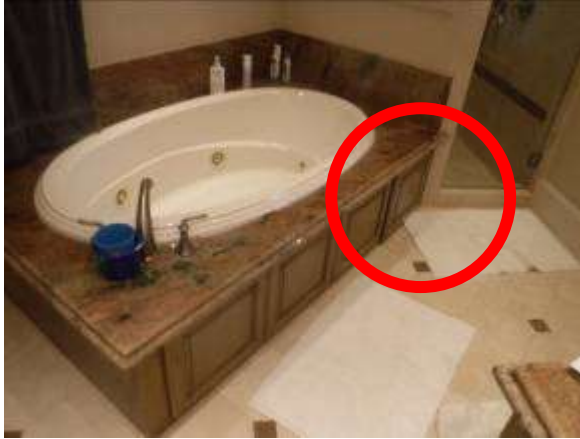
One of the doors under the master tub was not closing properly and needs to be adjusted.

**Obtain Cost Estimate**

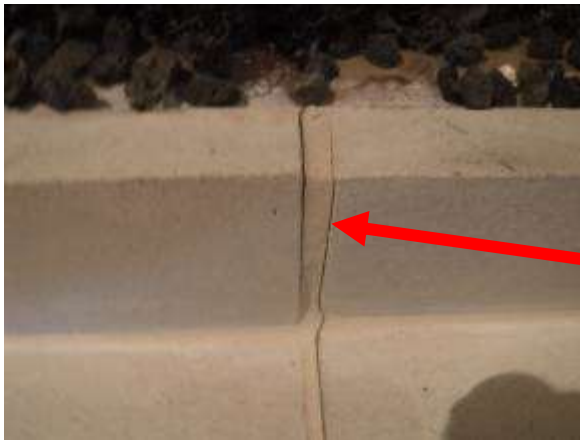
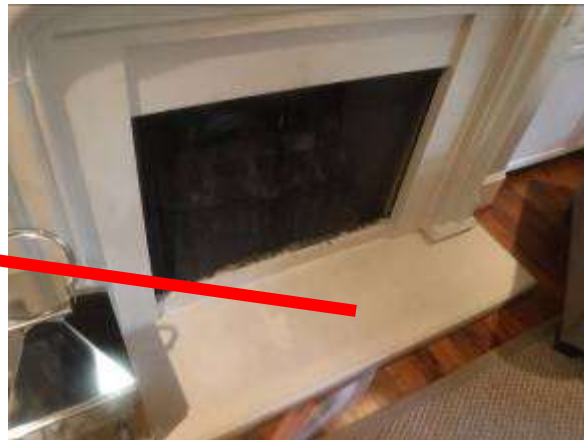
Gaps were visible in between the tiles in front of the fireplace. It is recommended to seal the visible gaps.

**Obtain Cost Estimate**

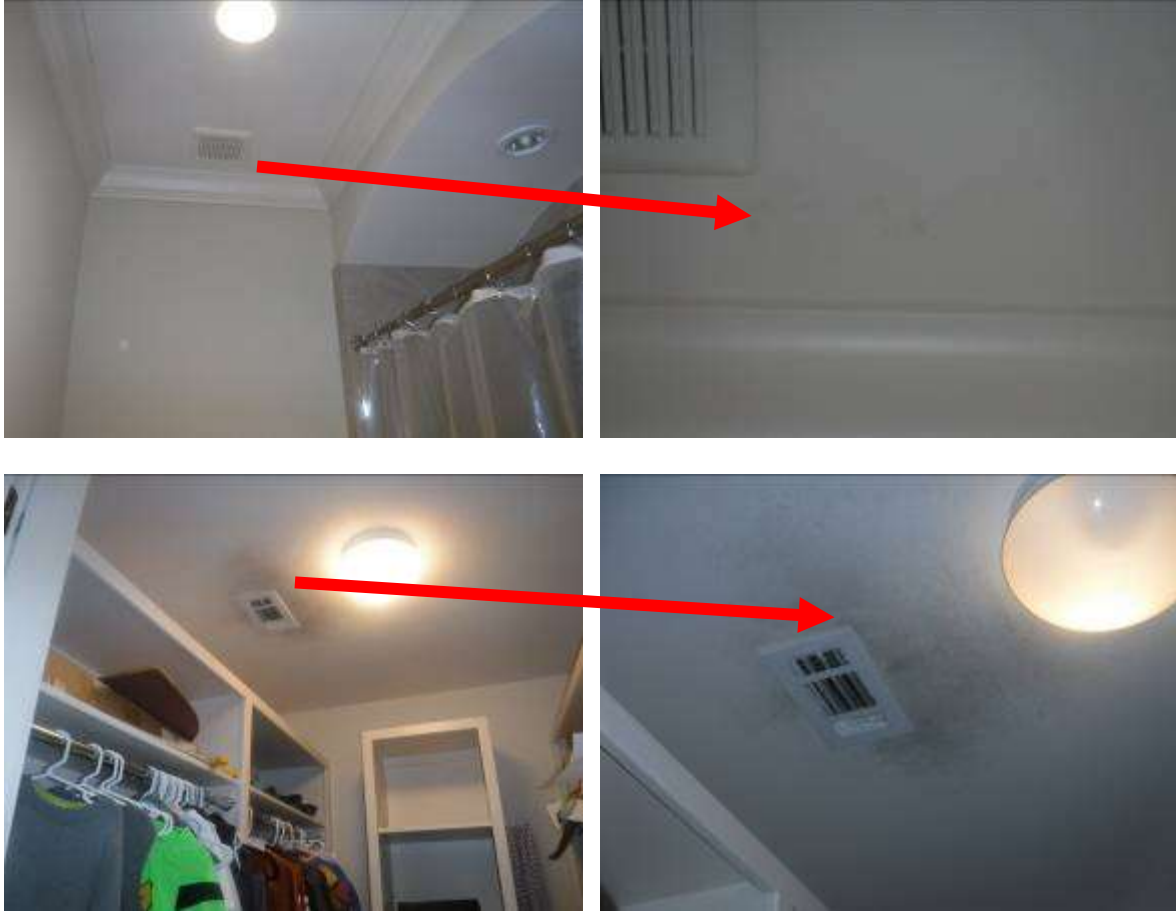
Mildew was observed on the ceilings of the bathroom and closet at the 2<sup>nd</sup> floor southwest corner of the house. The area with mildew was checked with a moisture meter, and no higher than normal moisture readings were found. Consideration should be given to contact a mold inspector.

**Obtain Cost Estimate**

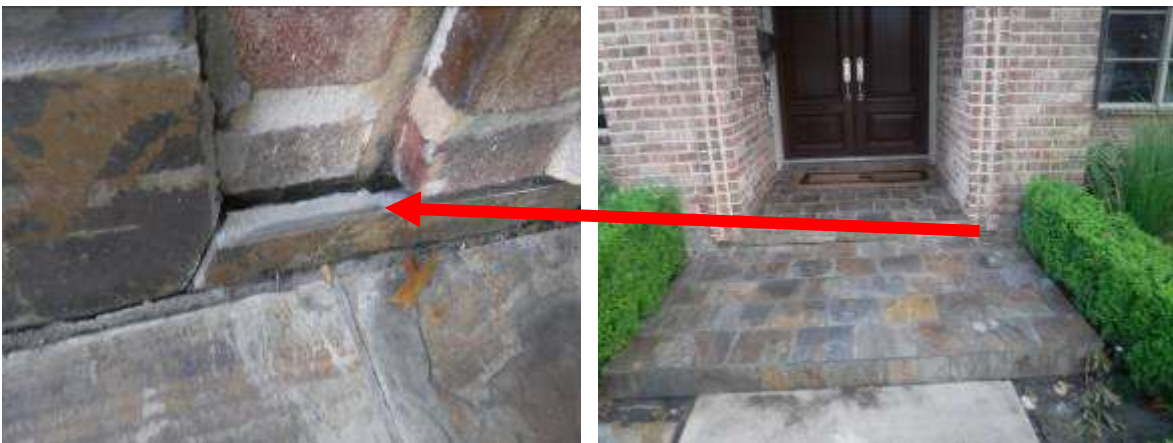
Lose tiles were observed at the entrance of the house.

**Obtain Cost Estimate**

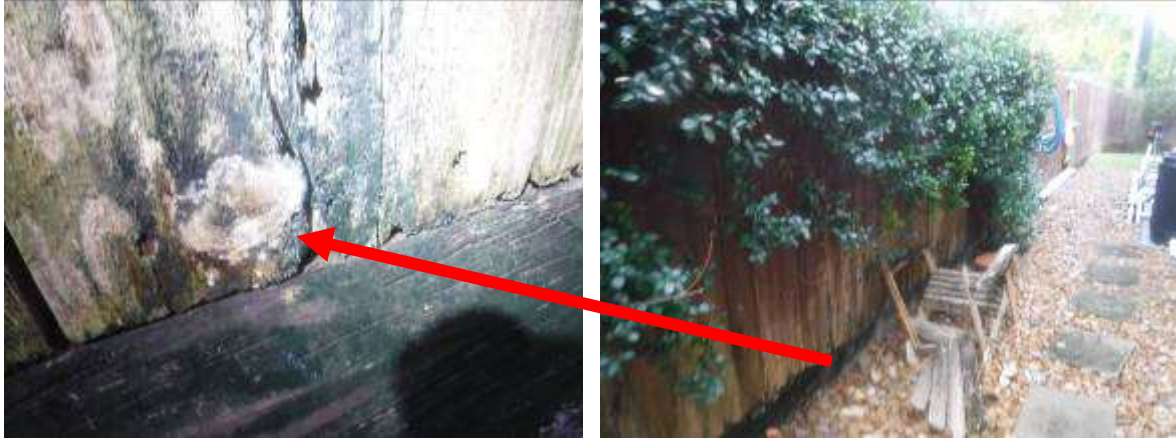
The wood fence had rotted boards. The fence is in need of repairs.

**Obtain Cost Estimate**

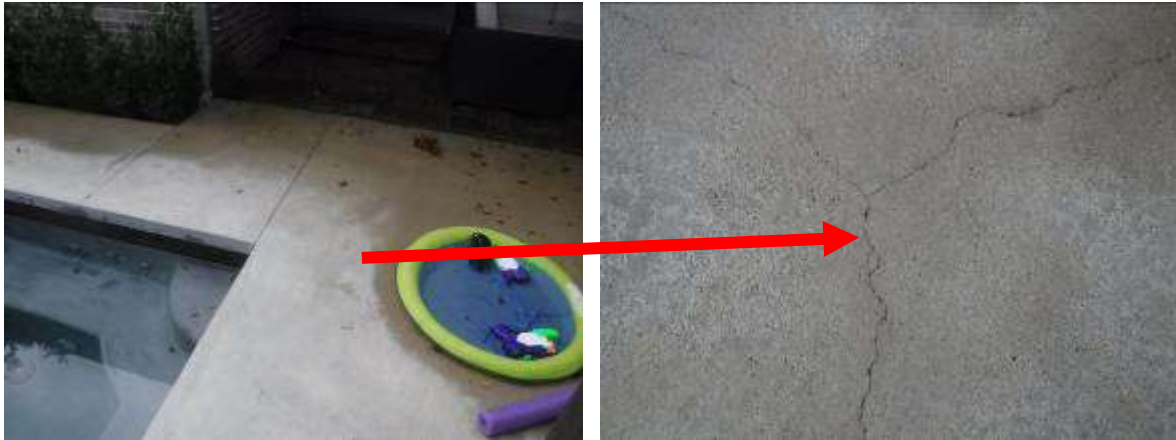
The rear patio had cracks in the concrete, but the patio is still functional.

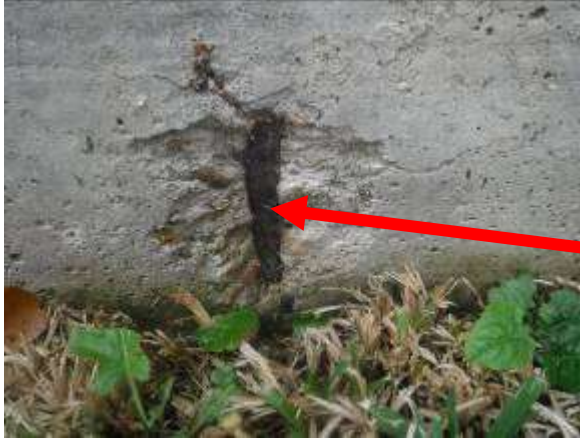
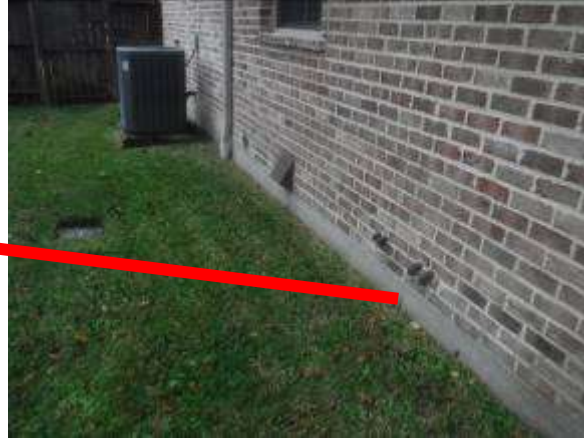
Locations included: East side of the house

The face of the foundation concrete was spalled, and the reinforcing steel used in the construction of the foundation was observed to be exposed. The rust should be removed from the rebar, and the rebar grouted to prevent further deterioration.

**Obtain Cost Estimate**

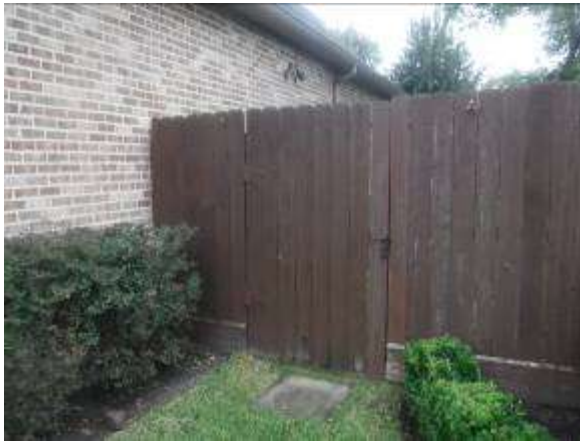
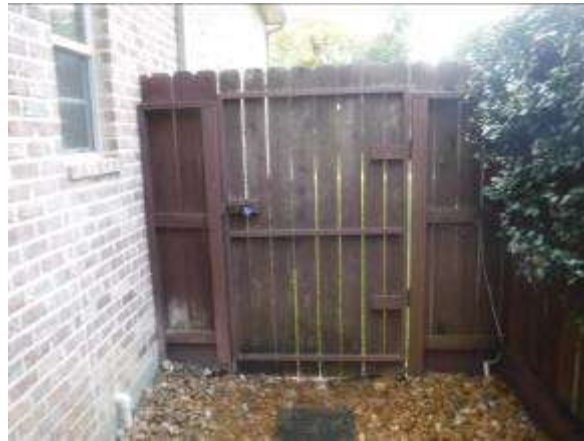
Both of the side gates were in need of repairs since they are sticking.

**Obtain Cost Estimate**

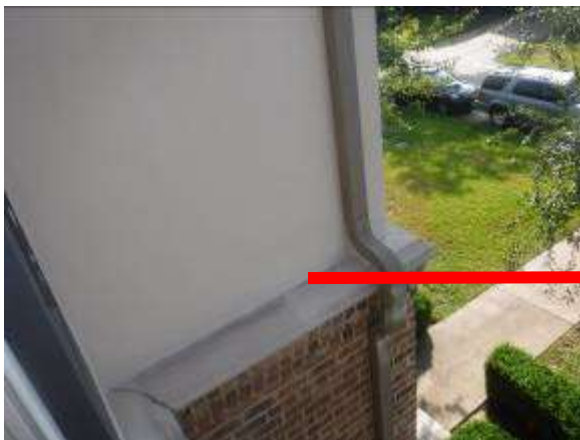
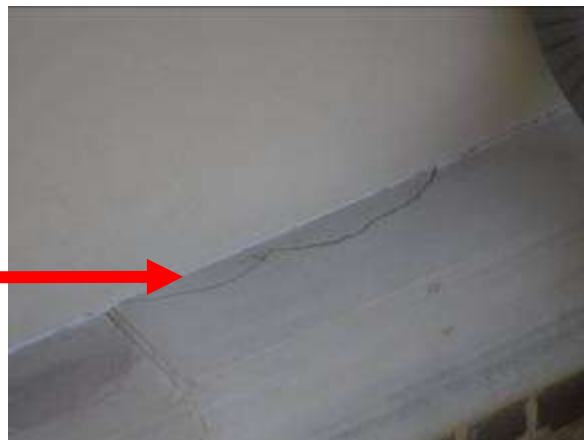
Gaps and cracks were observed on the stone trim in front of the house. It is recommended to re-grout/repair the areas in need.

**Obtain Cost Estimate**
