PROPERTY INSPECTION REPORT

Concerning: 8706 Lupton Lane, Houston, TX 77055
(Address or Other Identification of Inspected Property)

By: Daniel Koteles #21157 11-06-18
(Name and License Number of Inspector) (Date)

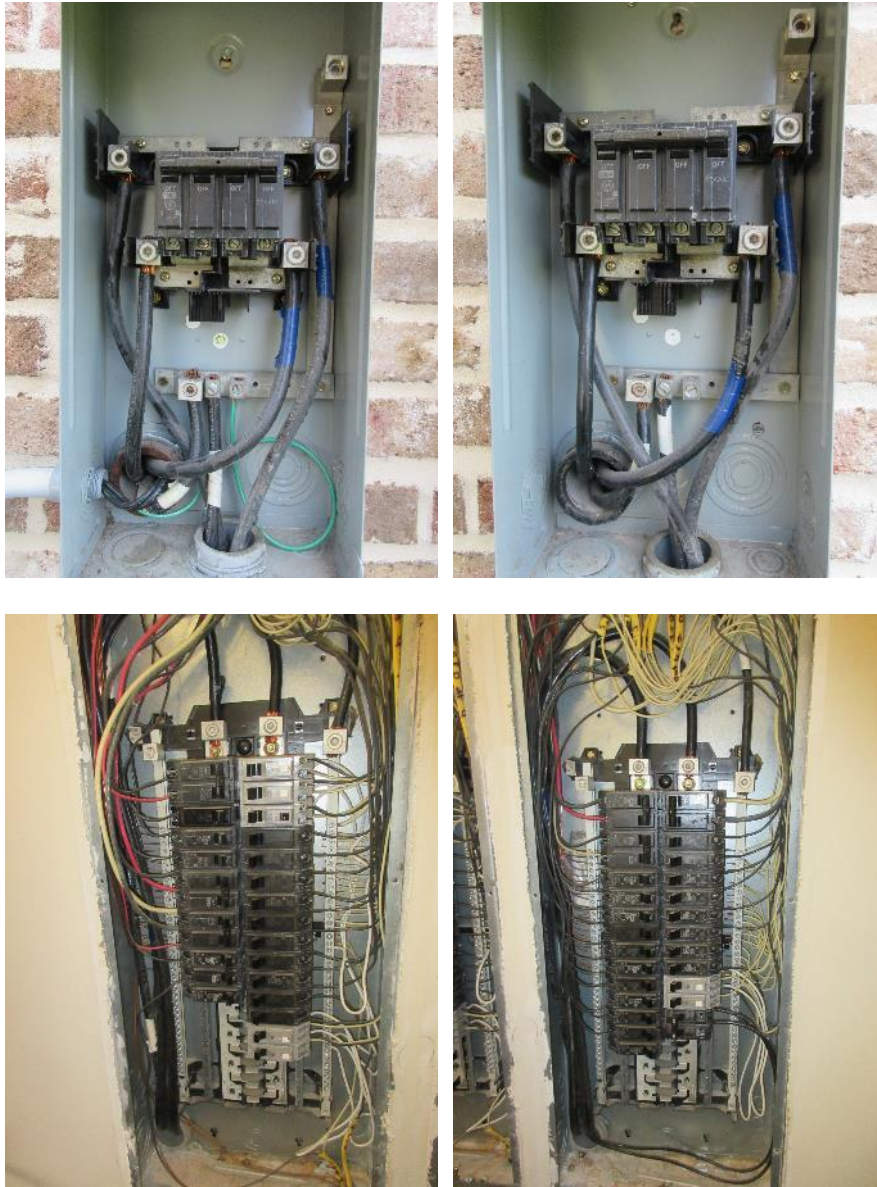
It is a general recommendation that all circuit breakers be tripped off and on at least once a year to ensure that they are still physically able to trip off. Occasionally, the points on a breaker will fuse to the main bus in the panel, preventing the breaker from tripping off, even if there is an overload on the circuit. If this condition occurs, it can be a fire hazard.

Foreign matter was observed in the panel box, which can be a safety hazard, and it is recommended that the panel be cleaned

Obtain Cost Estimate

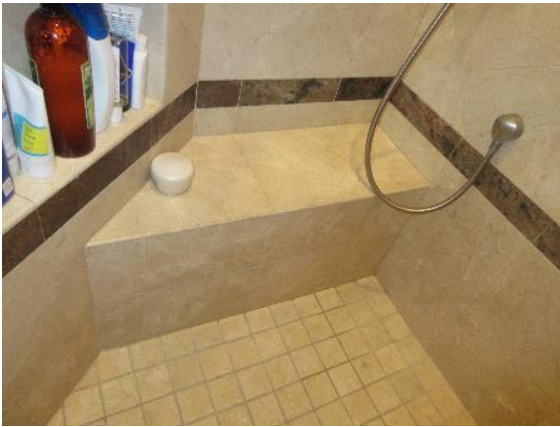
Locations included: the master bathroom

The shower stall(s) was constructed with a seat in the shower. It has been our experience that builders many times do not extend the shower pan material from the bottom of the shower up over the seat area to make a watertight detail. It can be anticipated that the caulking and/or grout around the seat will deteriorate, and, if there is not a shower pan installed under the seat, water will enter the wall cavity under and around the shower seat. This can cause wood rot, toxic mold, and other water related problems. It is recommended that you monitor the sealant around the seat on a regular periodic basis to ensure that the joints remain watertight.

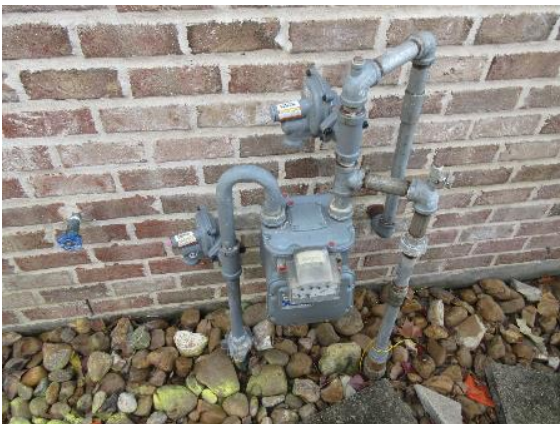
The gas meter, with the main shut off valve for the gas to the house, was located at the east side of the house.

The grounding strap for the gas meter was missing.

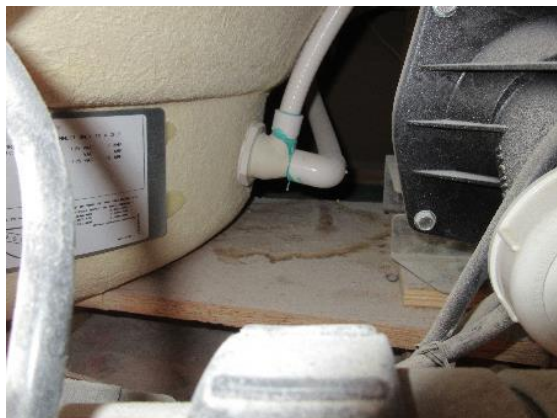
Water stains were observed at the rear of the tub. Further investigation with a service company is recommended to determine the source of the water and make any necessary repairs.

Obtain Cost Estimate

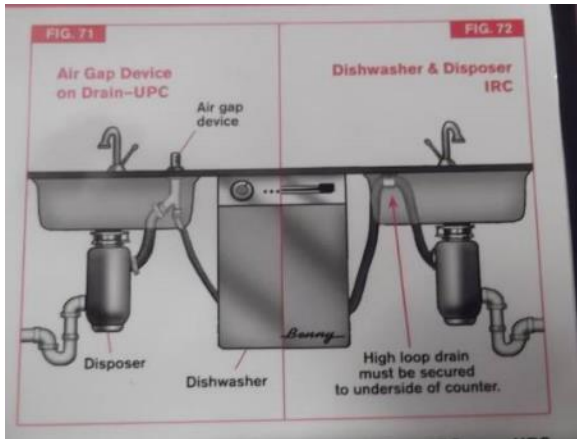
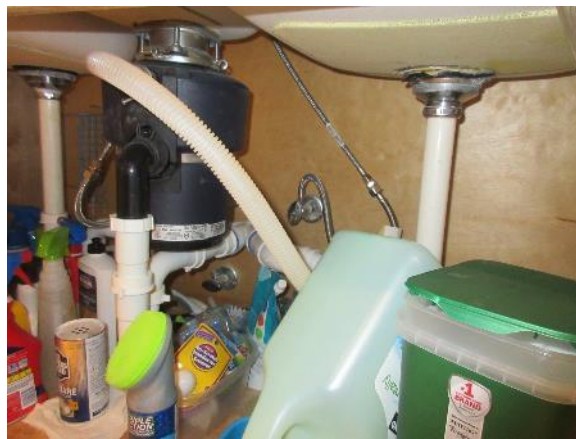
The drain line under the sink was not equipped with an anti-siphon device, nor was it looped up so that the top of the loop is at least six inches above the entrance of the drain line into the disposal. It is recommended at least that the drain line be looped to prevent the water from the garbage disposal from siphoning back into the dishwasher, or an anti-siphon device installed.

Obtain Cost Estimate

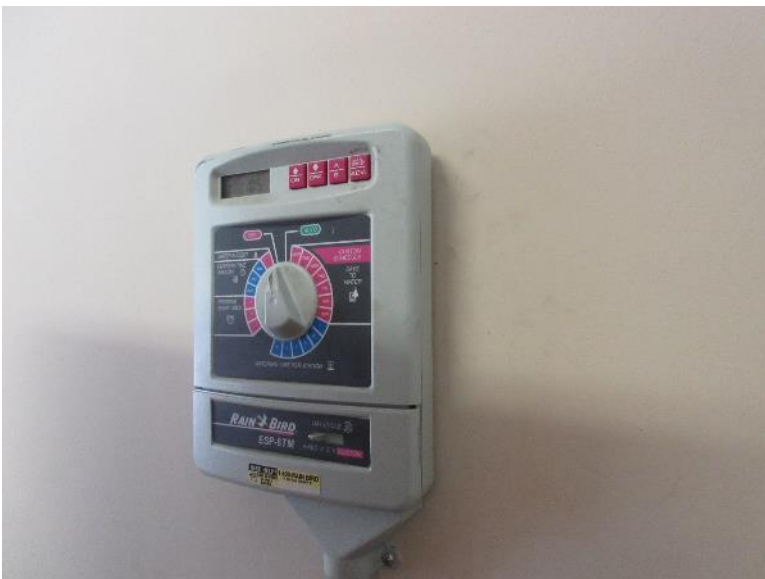
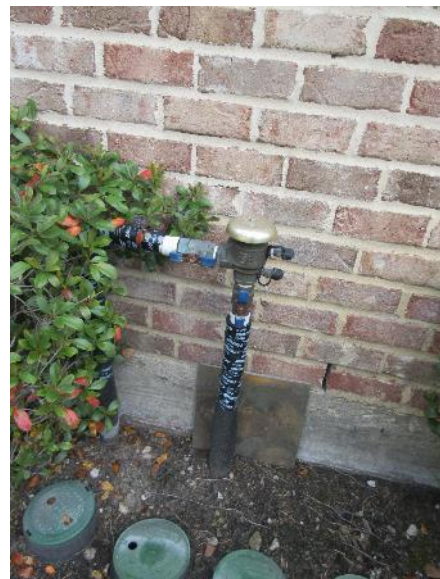
The backflow prevention device, with the two shut off valves on the water supply line to the sprinkler system, was located at the west side of the house.

Heads were spraying the house, and need to be adjusted on zones 1, 2, 3, and 4.

One of the heads was broken on zone 5.

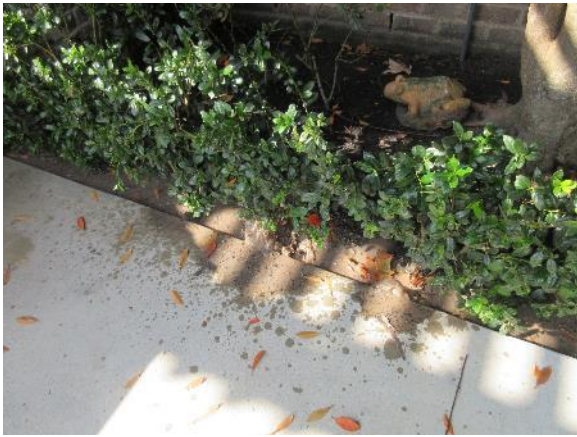
Water was observed to be bubbling up from the ground near the west side of the pool. Have a service company determine the source of the problem and make any necessary repairs.

Obtain Cost Estimate

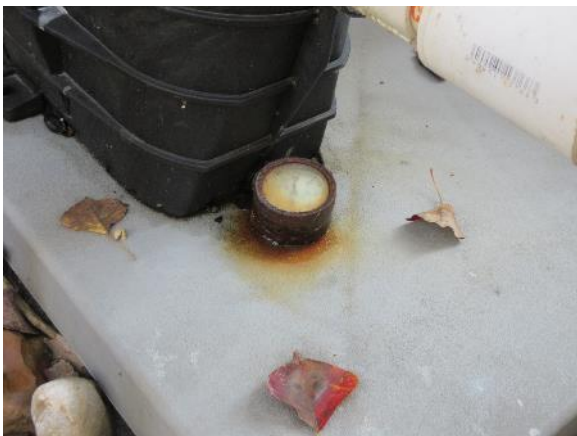
Water was leaking around the pressure gauge on the water feature pump. Have a service company determine the source of the leak and repair the rusted pressure gauge.

Obtain Cost Estimate

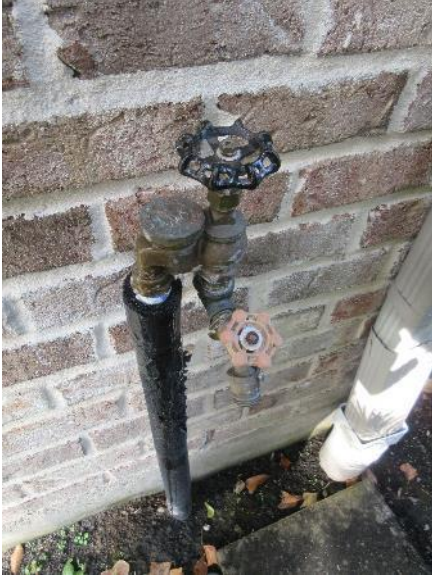
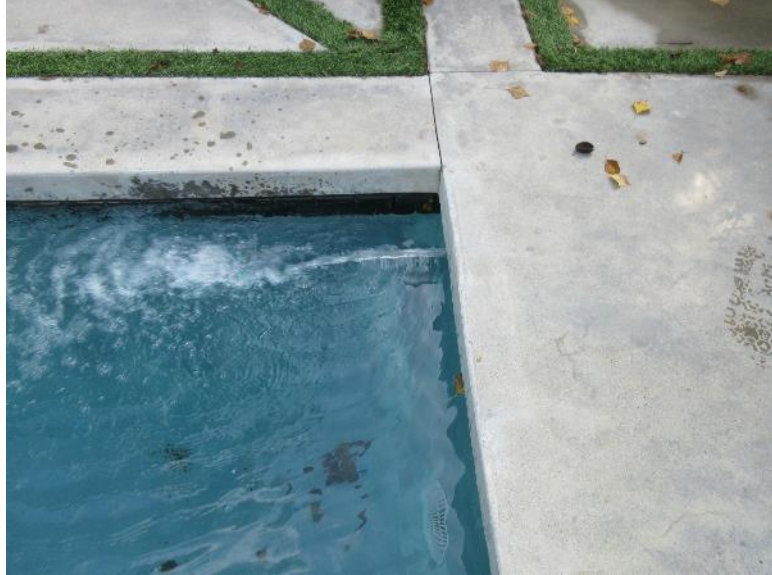
Pool Fill Line

The backflow prevention device on the pool fill line was leaking at the time of the inspection, and needs to be replaced.

Obtain Cost Estimate
