## HOME INSPECTIONS INC.

**Concerning:** 1922 Mistyvale Court Richmond, Texas 77406

March 23, 2020

Report Identification: 200322-2 1922 Mistyvale Court

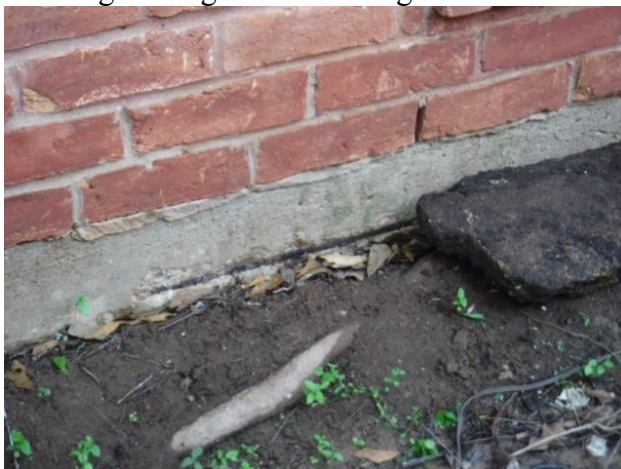
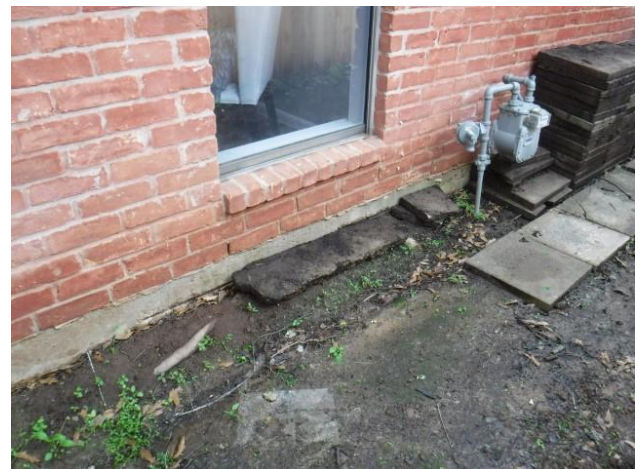
- ★ There is exposed steel on the foundation; remove the rust and apply a primer coat and then cover with a high strength non-shrink grout.

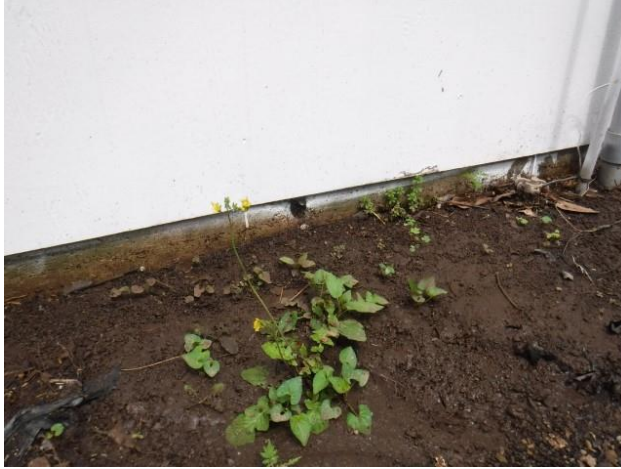
- ★ There is a hole at the back side of the garage that should be filled.

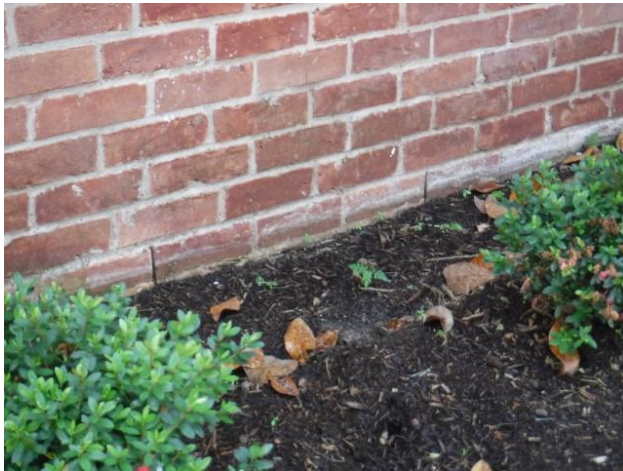
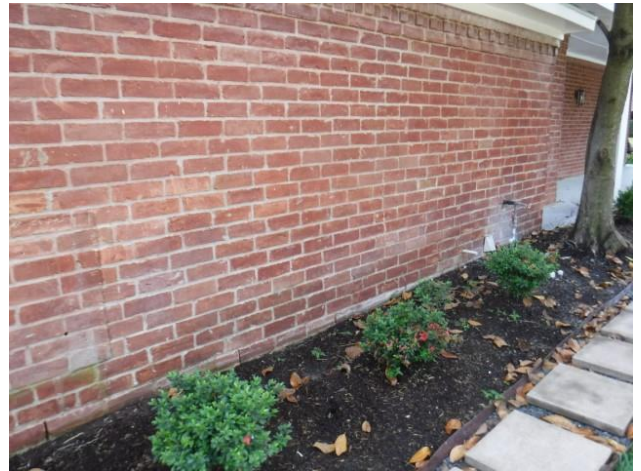
- ★ The soil level is too high at areas around the brick veneer. There should be a minimum of 4 inches of foundation exposure from the bottom of the brick to soil and 2 inches to paved surfaces reduce the chance for water intrusion during flooding conditions and easier to detect insects entering the home. REF R404.1.6

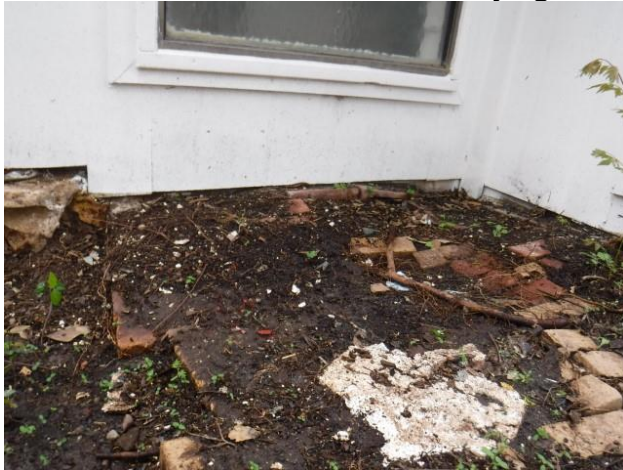
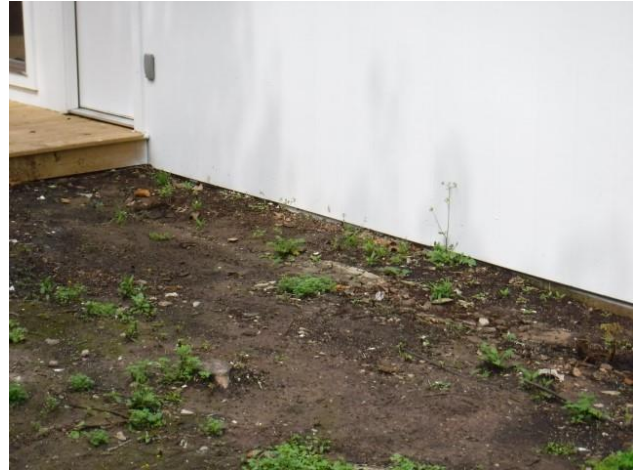
- ★ The soil level is too high around the wood siding material; master shower and garage area. There should be 4-6 inches clearance from the top of the soil to the bottom of the siding material. This condition is conducive to wood rot and wood destroying insects.

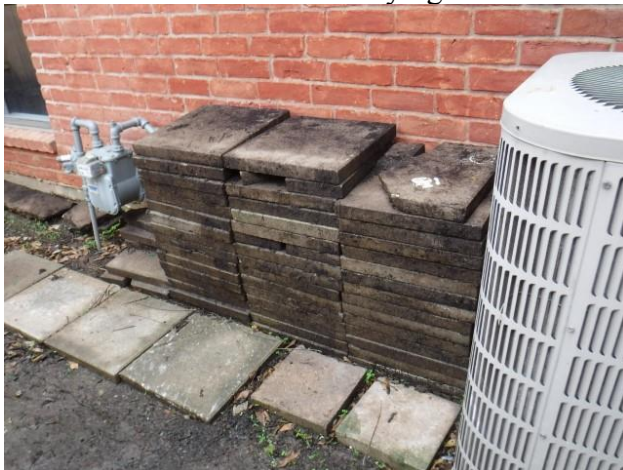
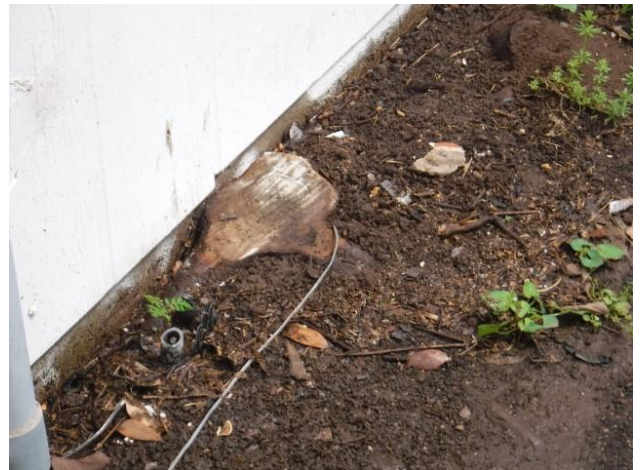
- ★ The bricks, stored items and debris should be removed away from the foundation to prevent masking evidence of wood destroying insects entering the residence.
- ★ There is a stump in contact with the foundation and should be cut below ground and add stump rot. It is conducive for wood destroying insects.

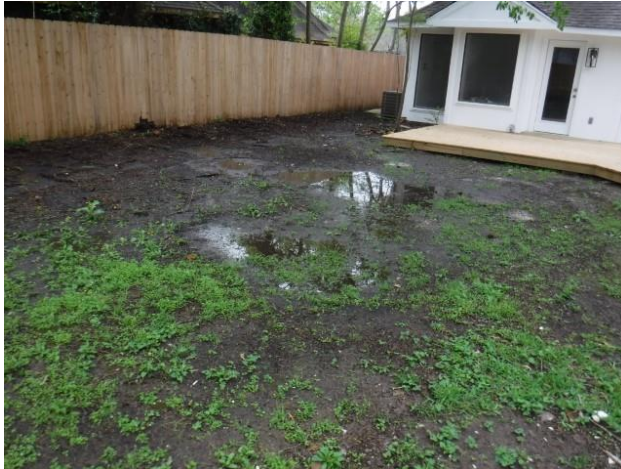
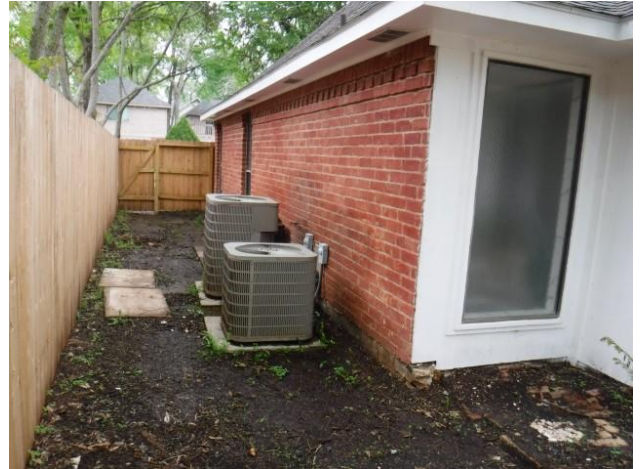
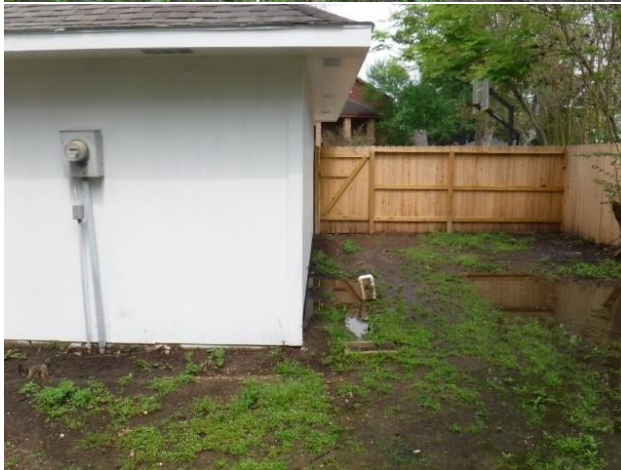
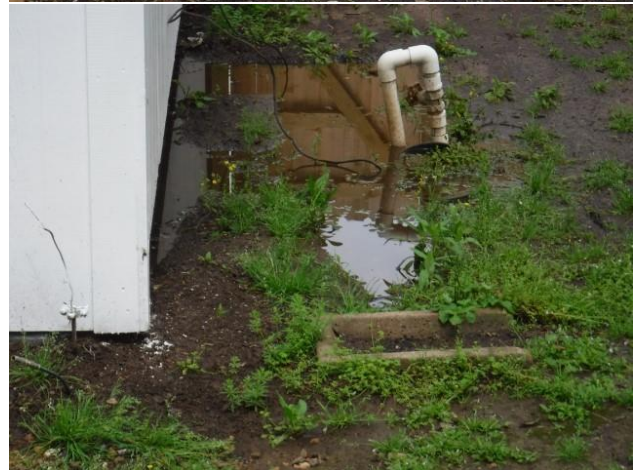
- ★ There are several low areas around the house and garage that allow standing water. Recommend doing one or more of the following if water is still present an hour after raining; re-grading the area, installing a gutter system, or installing an underground drainage system. Standing water can cause foundation problems, mosquito infestations and lawn disease.

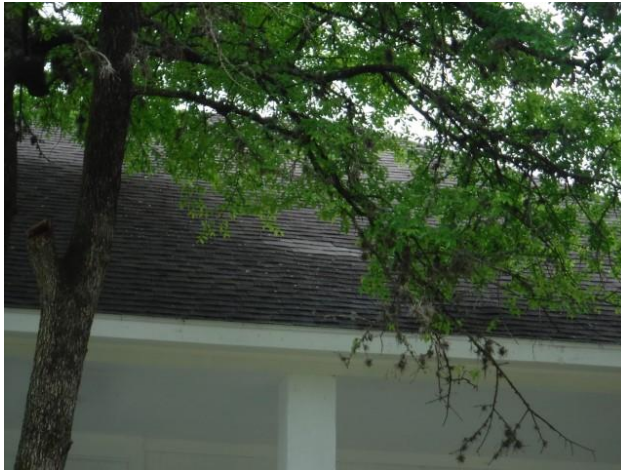
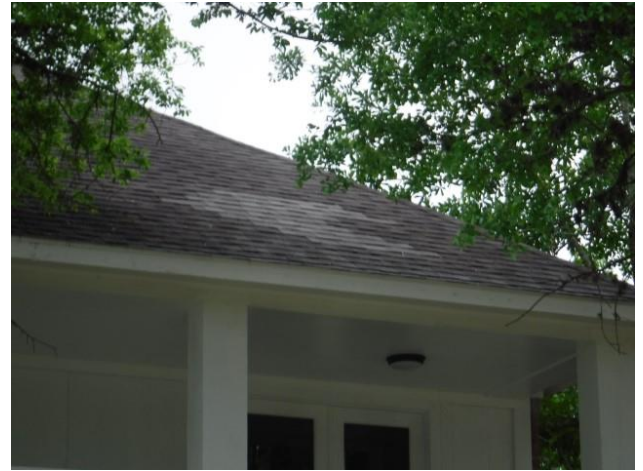
Note: There were areas of roof repairs observed from limb damage at the front of the roof.

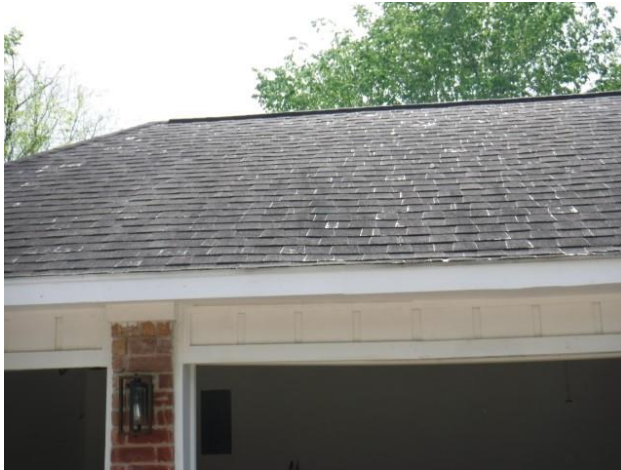
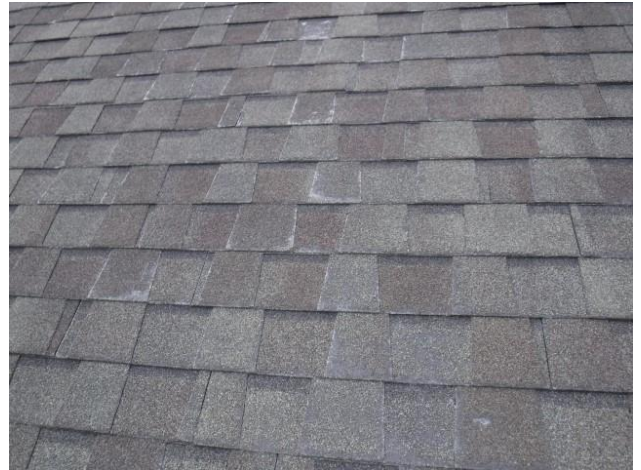
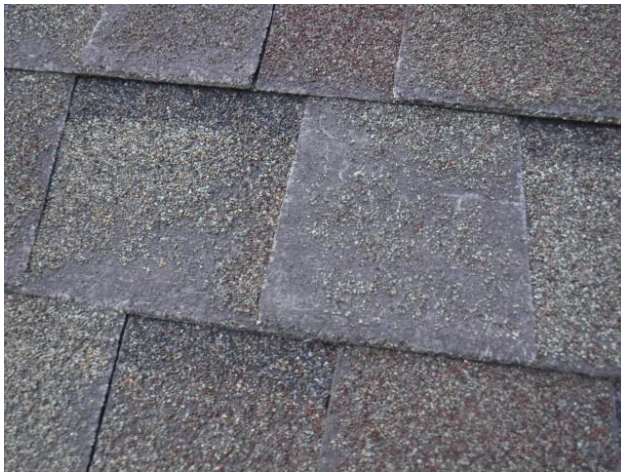
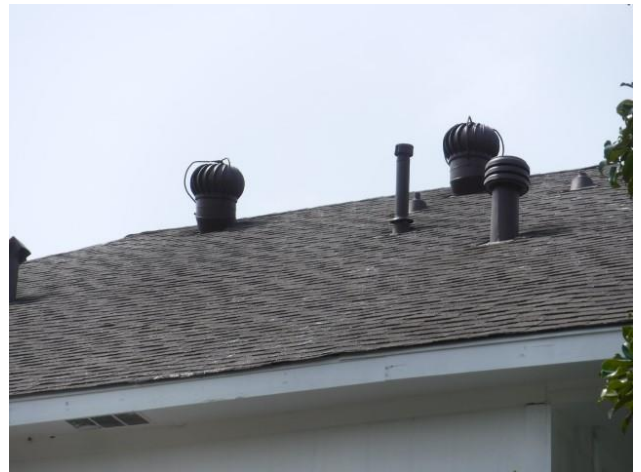
- ★ The roof is at the end of life in this inspector's opinion due to the following conditions; many worn shingles, curled ends and loss of granules. Buyer should budget for a new roof in the future.

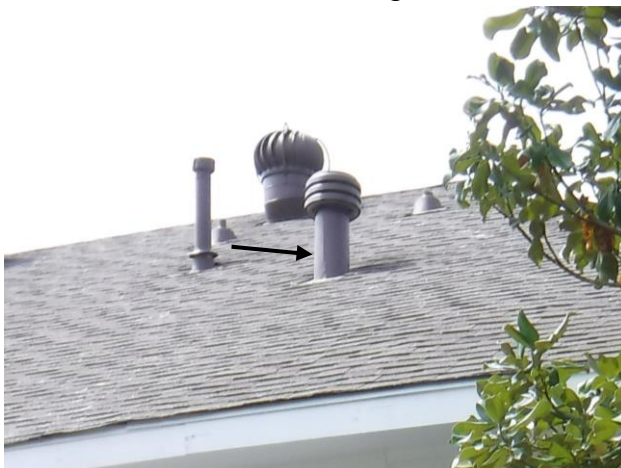
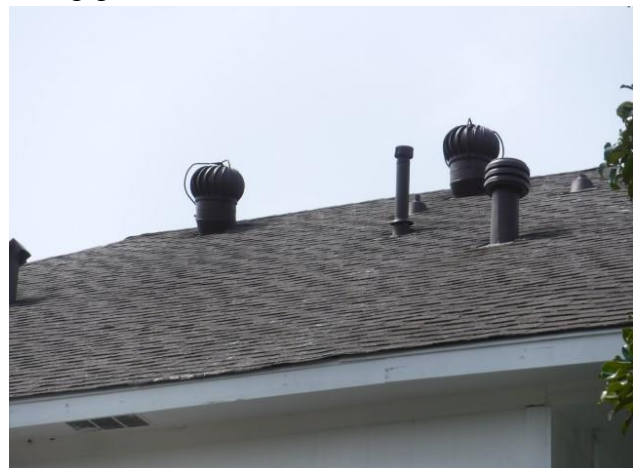
- ★ The heater exhaust vent is missing the storm collar on the pipe.

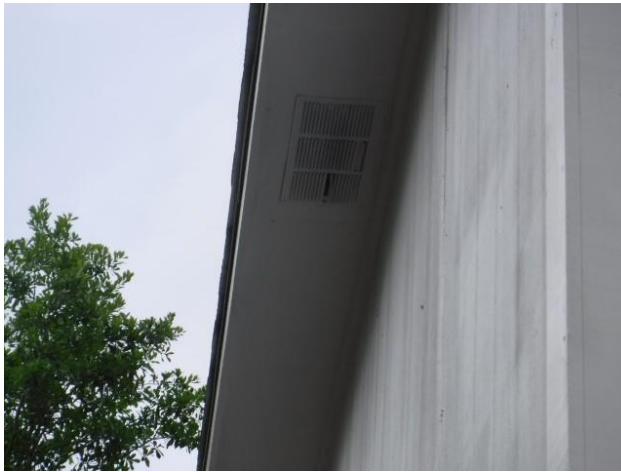
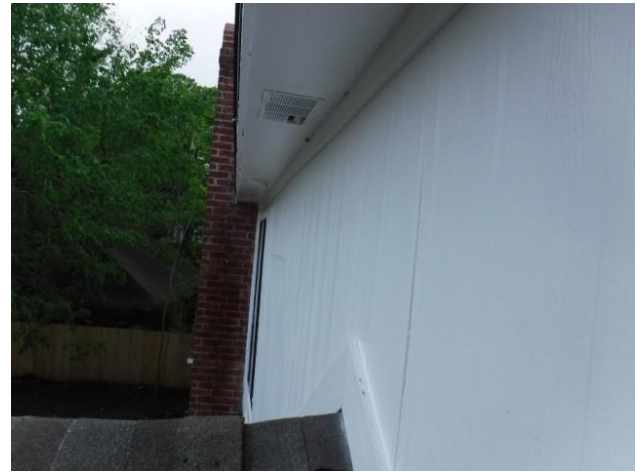
- ★ The soffit ventilation screen is damage at areas that can allow access to the home by rodents and birds.

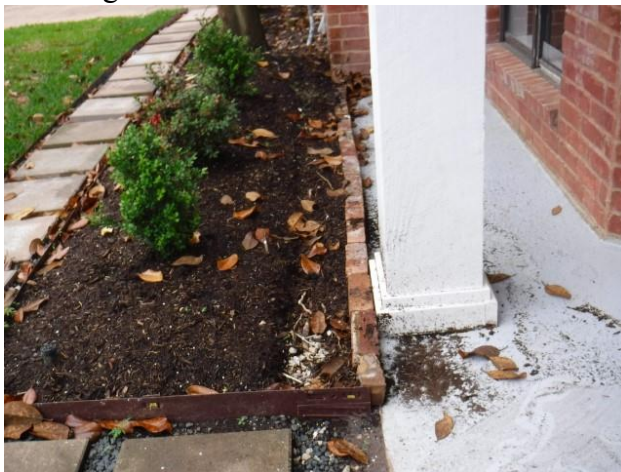
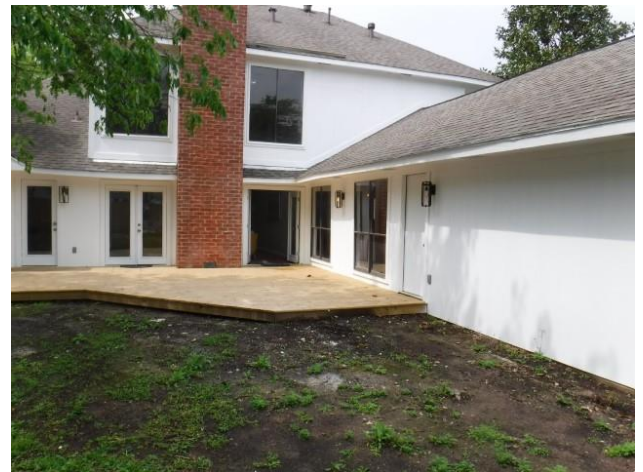
Note: Recommend gutters at all sides of the house to prevent water splashing on the home and erosion of the soil due to roof water runoff and with underground drains at low areas to prevent standing water.

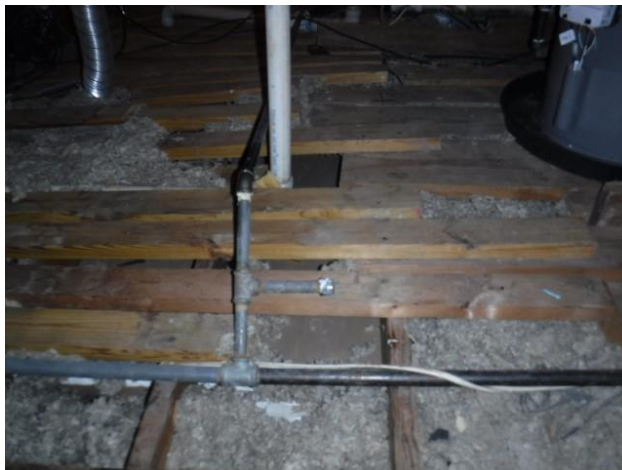
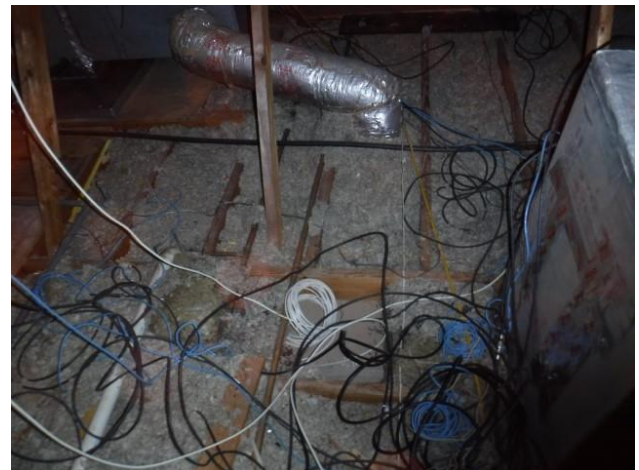
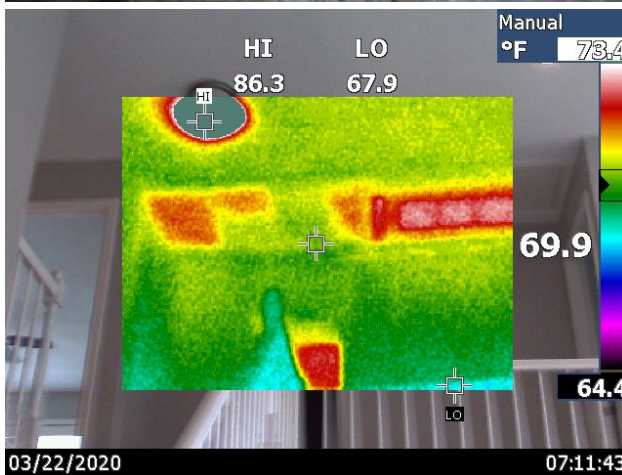
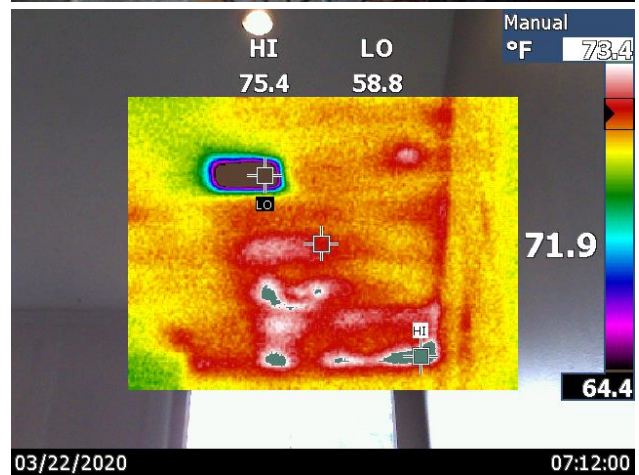
- ★ There is evidence of rodents in the attic by trampled, uneven insulation and of rodent droppings. Recommend quarterly pest control and eradication by a licensed professional.
- ★ The insulation installed in the attic is missing, uneven and misplaced throughout the attic. The thermal images show temperature differential and transfer of heat. Recommend installing 12 inches of loose fill attic insulation or the equivalent of an R-30 value to make the home more efficient. An R-30 value is the recommend R-value for this region. REF IRC TABLE N11023.1

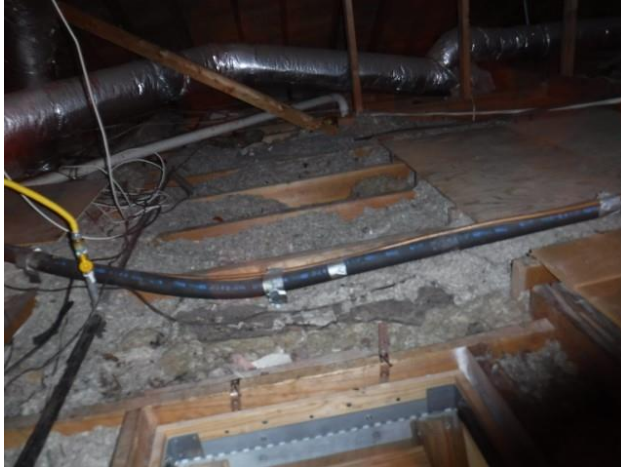
- ★ Particleboard is not an approved material to use for flooring. Particle board is flexible and easily damaged. Recommend upgrading to plywood in the attic.
- ★ There is loose / damaged decking observed in the attic. These areas should be nailed down or repaired as needed to prevent tripping hazards.
- ★ The attic access is inadequate to the water heaters and attic equipment, a minimum of a 24-inch-wide walkway to equipment. REF IRC M1305.1.3

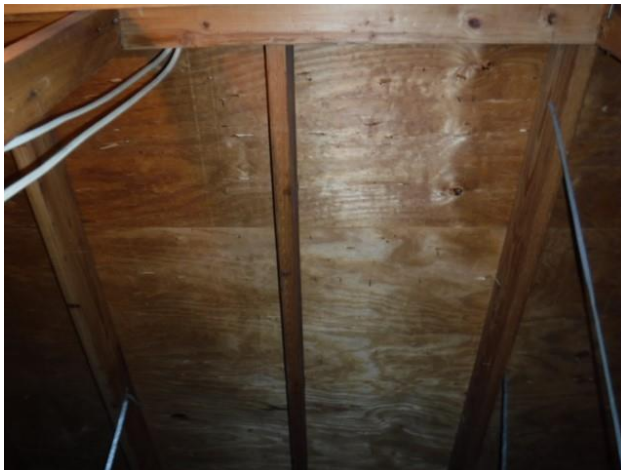
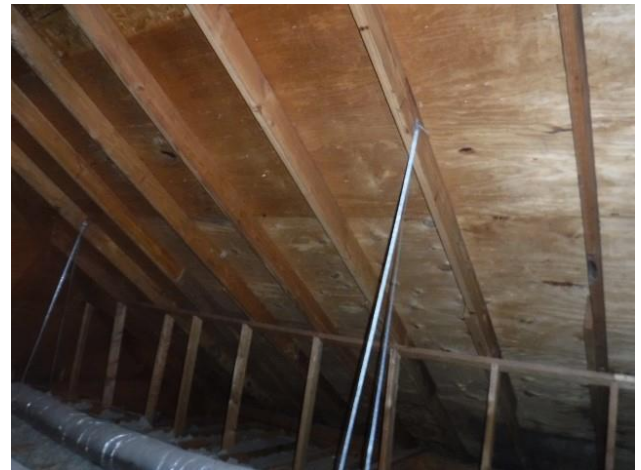
- ★ The roof decking is missing “H” clips. H-clips, also called panel-edge clips, are small steel devices that fit snugly between wood panels in order to provide them with edge support. They are often used with roof sheathing to keep it from feeling spongy or soft at its edges.

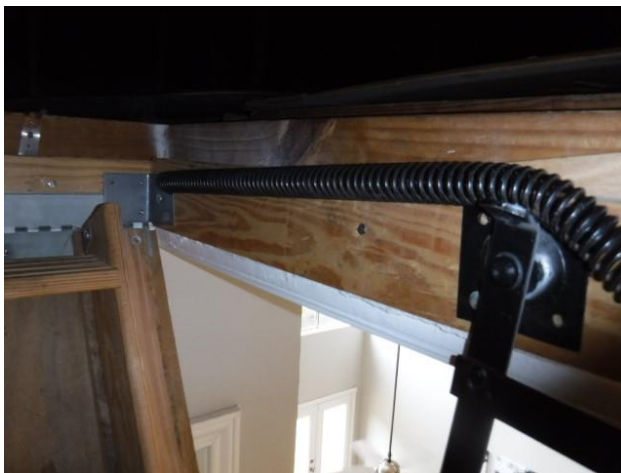
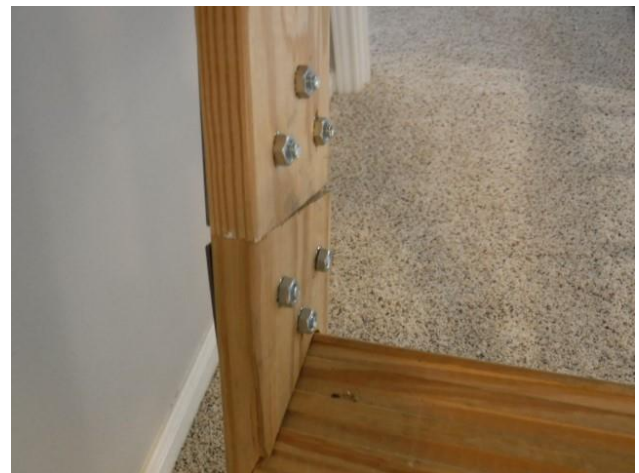
- ★ The stairs have bolts, screws, or nuts that are loose or missing.
- ★ The attic door attachment points to the frame are missing the required 16d nails or lag screws. All holes should be filled.

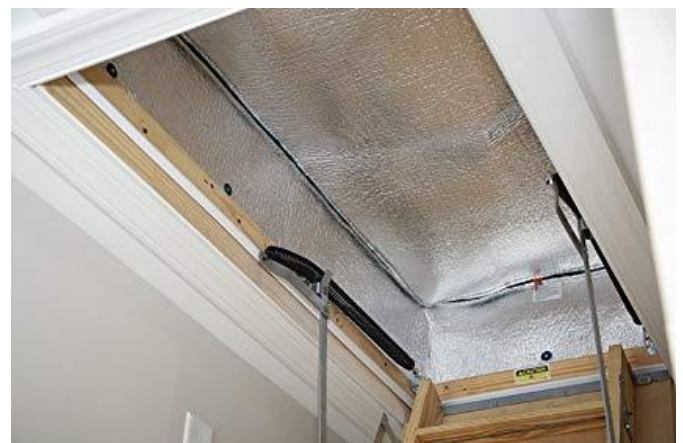
- ★ The attic access door is not insulated and the gap at the door frames are not properly sealed / insulated with expanding foam. The door should be insulated with a hardboard insulation panel. The thermal image shows the transfer of heat and temperature differential. Recommend installing a full door insulation tent or cover as seen in image at right. There are many different types available online or hardware stores.

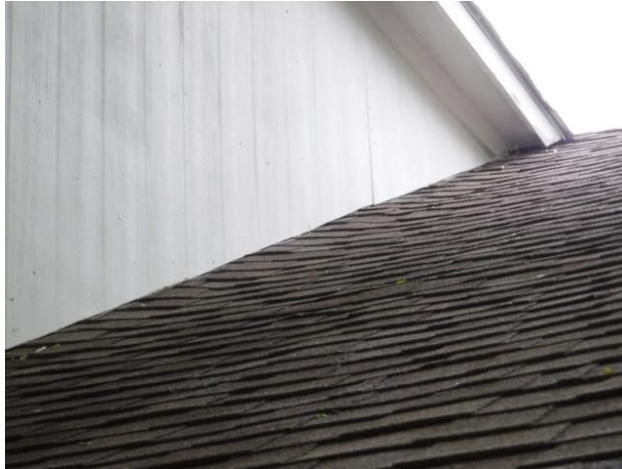
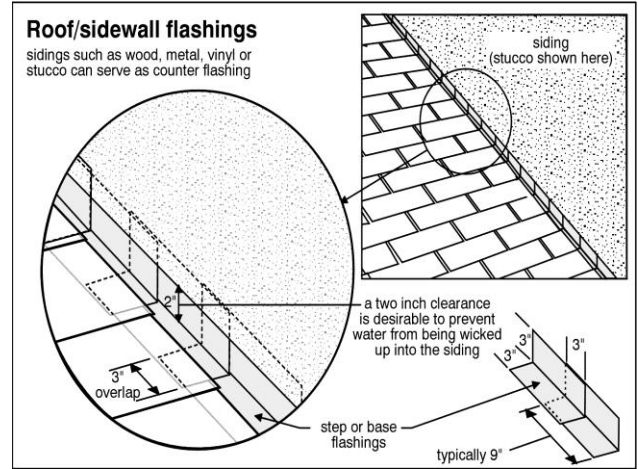
- ★ Exterior siding should be trimmed two inches above the roof to prevent water damage and wood rot.

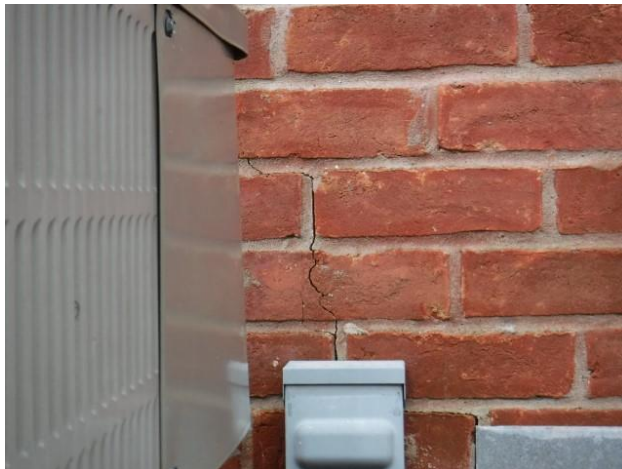
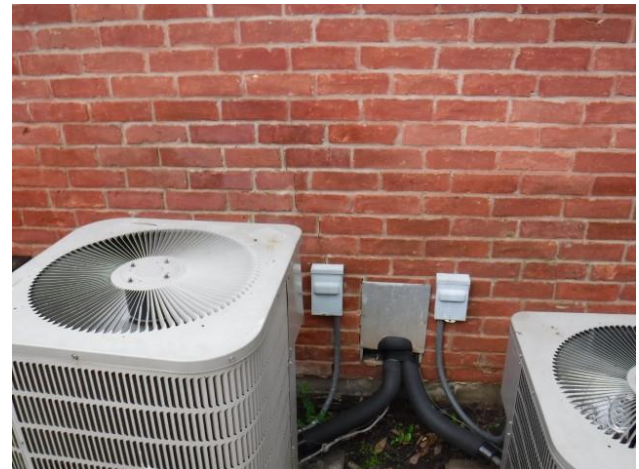
- ★ There were areas of brick cracks observed.

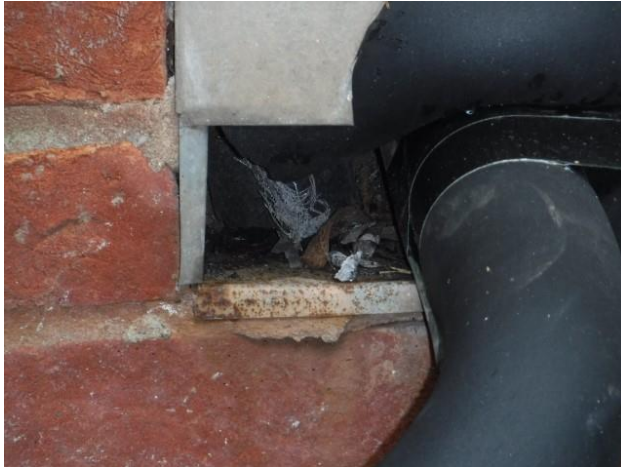
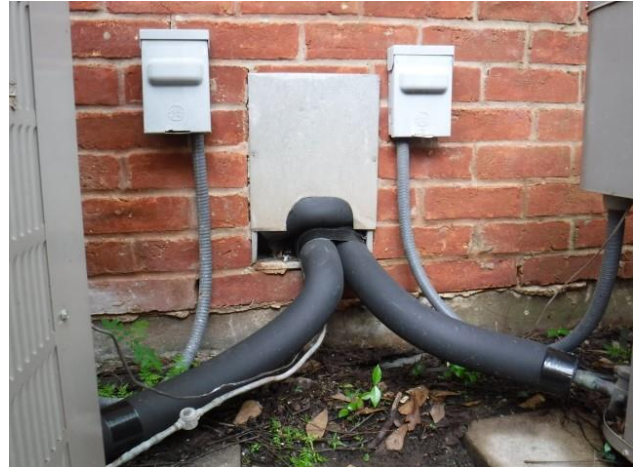
- ★ The a/c lines and conduit should be fully sealed where they enter the house to protect against pest penetration. This is a direct line to the attic space. Fill with poultry wire then fill over with spray foam.

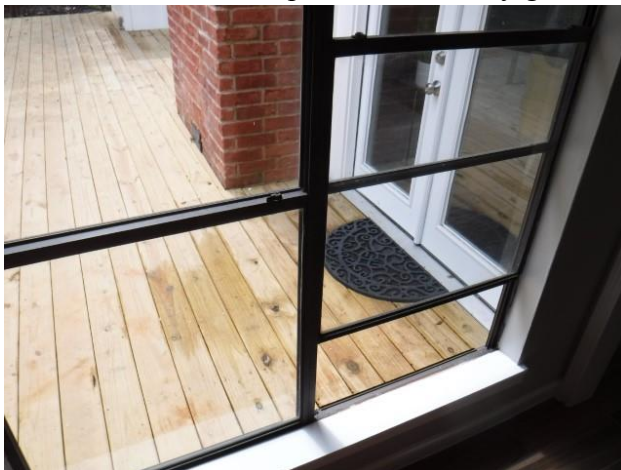
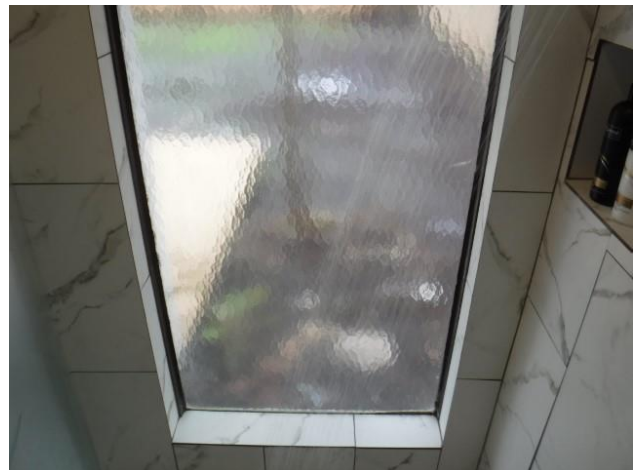
- ★ Unable to verify that the window near the master shower is approved safety glass. The label should be visibly acid etched, sandblasted, ceramic-fired, embossed mark, or shall be a type that cannot be removed. REF IRC R308.4#5
- ★ The windows by several exterior doors are not tempered safety glass. Glass in or within 24 inches of exterior doors are required to be safety glass. REF IRC R308.4

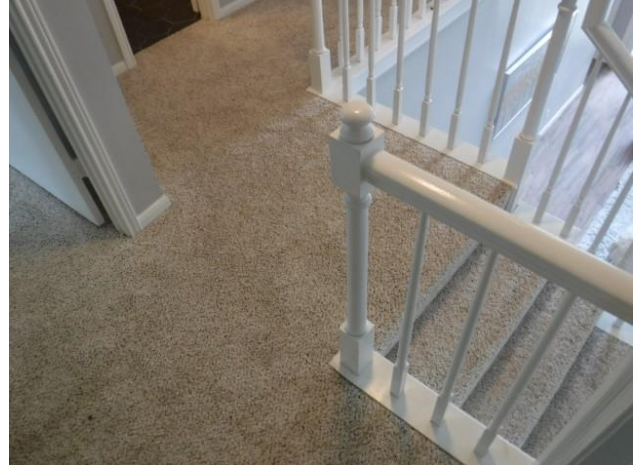
- ★ The flooring is uneven and has a soft spot at the top of the stairs.

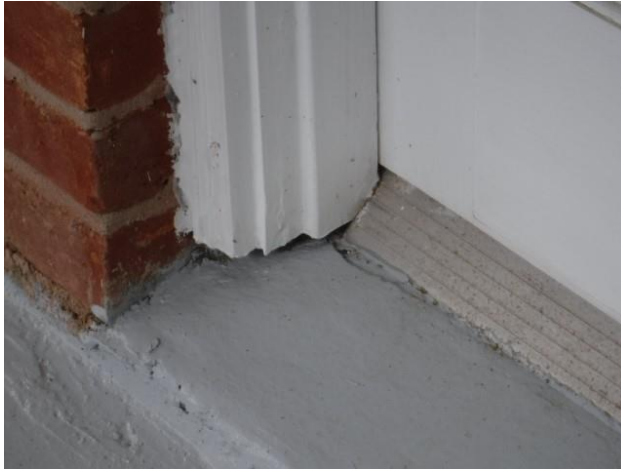
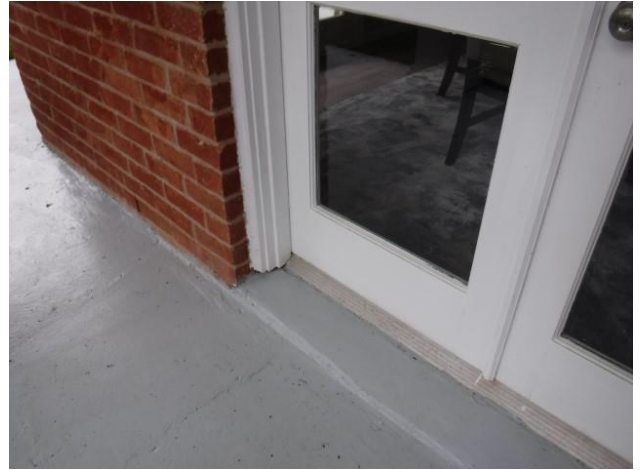
- ★ The bottom edge of all exterior door frames and threshold are not properly sealed. The bottom of the trim board should have a solid caulk bead around the entire exposed area to prevent wood rot. Note: The exterior trim is wood and the bottom cut end will absorb moisture and rot if not fully sealed.

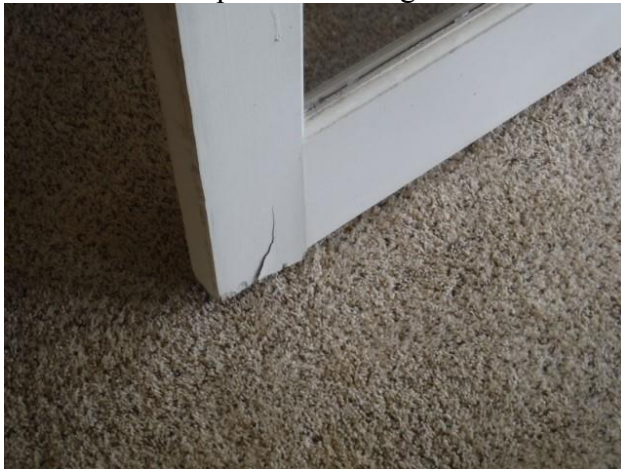
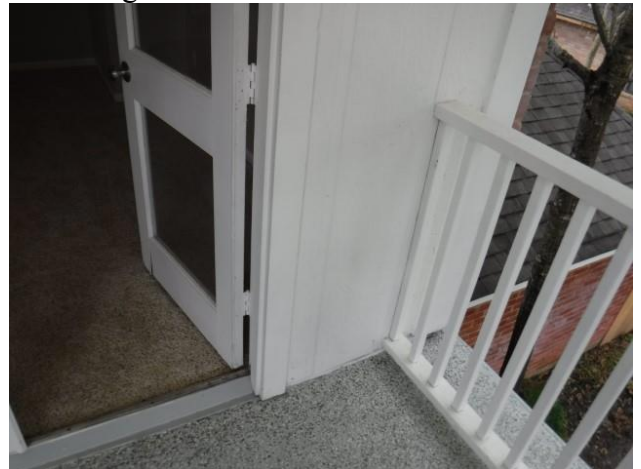
- ★ The bottom of the upstairs front-right bedroom door has damage at bottom.

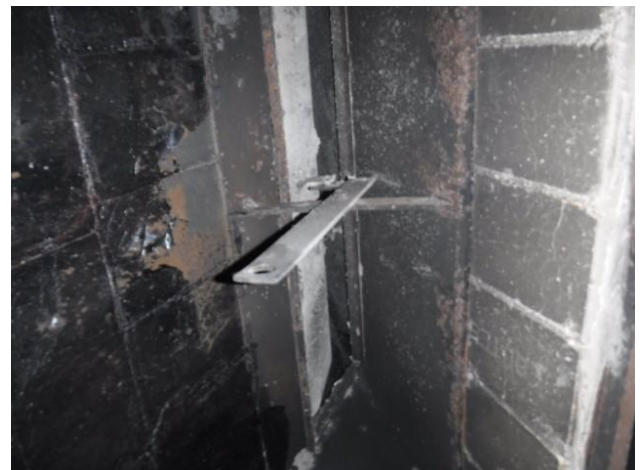
- ★ The house fireplace is missing the damper clamp. All gas fireplaces should have a required damper bracket that prevents the damper from completely closing to allow gas to escape to the exterior in the case of a gas leak. REF IRC 2433.1
- ★ The log rack is missing.

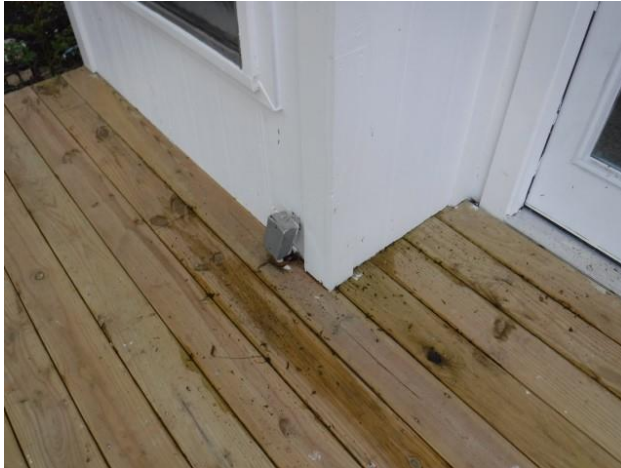
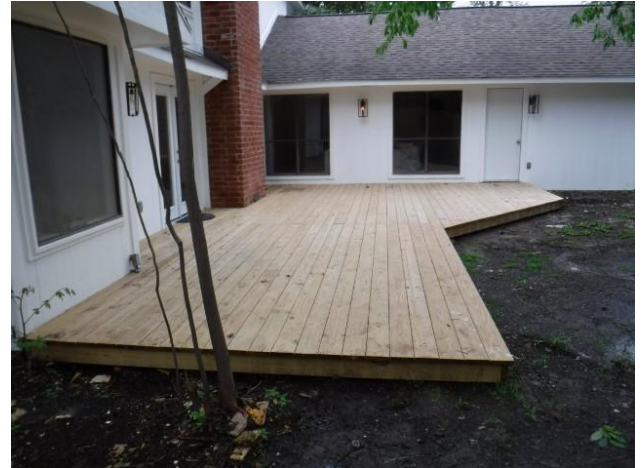
- ★ The decking wood / materials obscure the view of the foundation. This can hide termite and water penetration

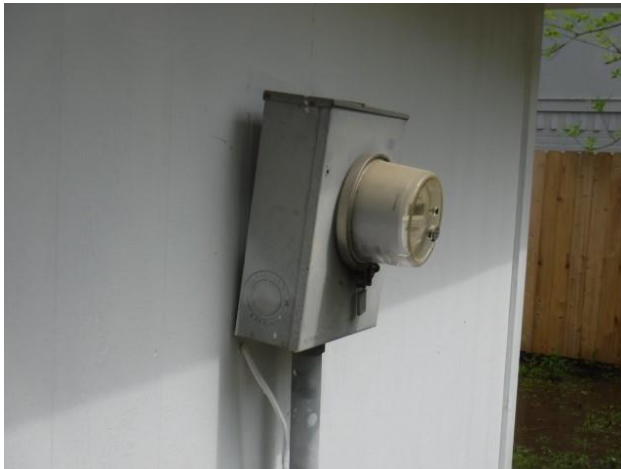
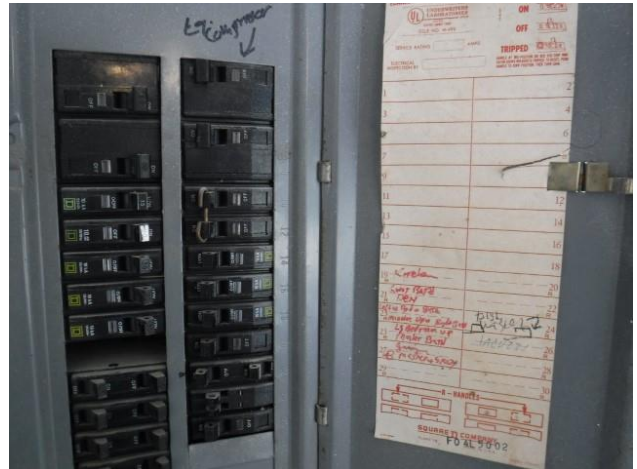
- ★ The meter can is loose from the wall.
- ★ There are circuit disconnects / breakers not properly labeled. All service disconnects should all be permanently labeled and specifically listed for their purpose. REF IRC E3501.6.1

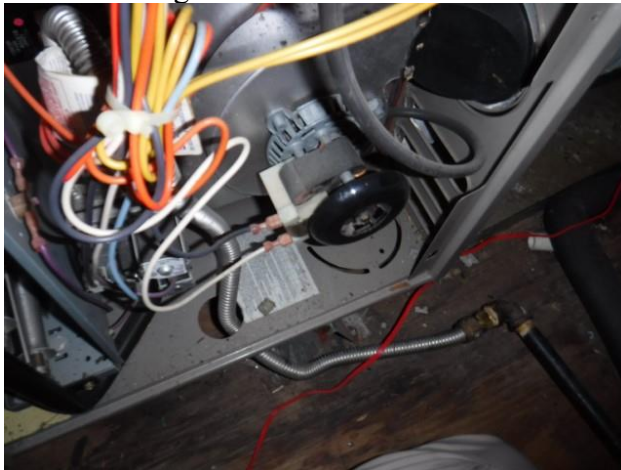
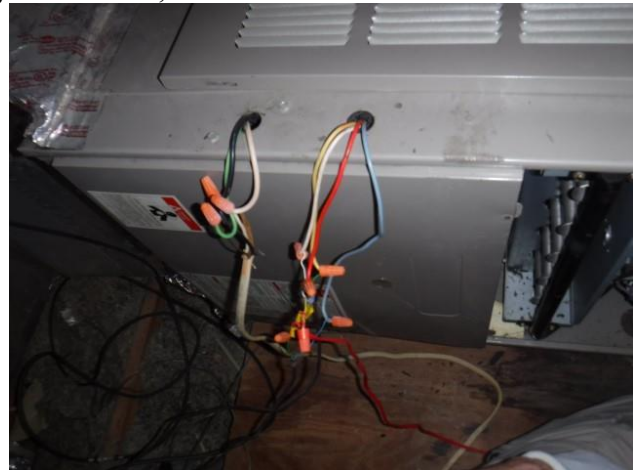
★ The heater wiring connections should be inside of a junction box; amateur.

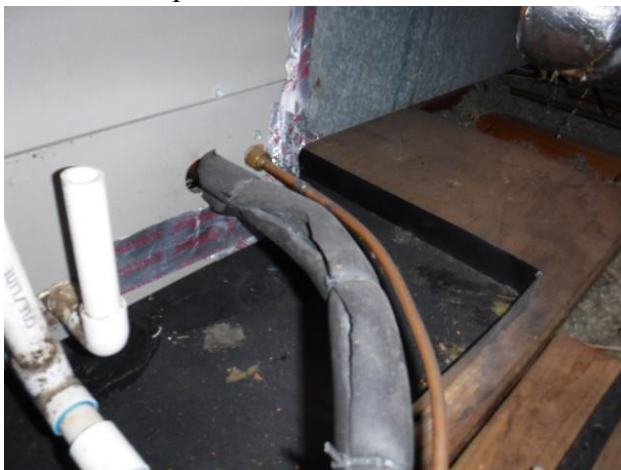
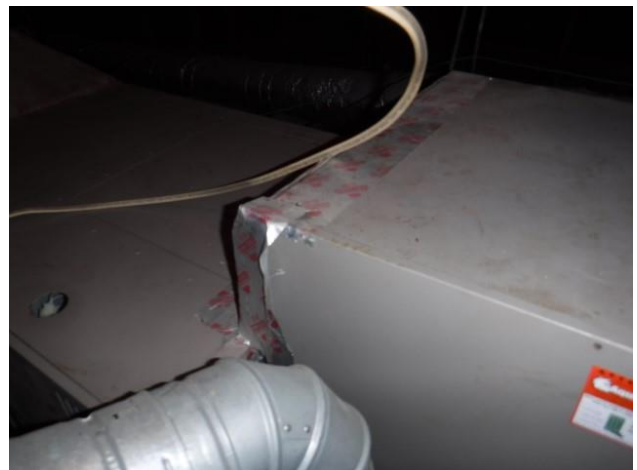
- ★ The temperature differential is low (should be between 18 – 22 degrees); recommend that the unit is serviced by a licensed professional.
- ★ The data tag was not legible or is missing; upstairs unit.
- ★ The suction line at the evaporator coil has damaged insulation. The line should be fully wrapped / covered.
- ★ There is loose tape at cabinet sections that can allow air loss.

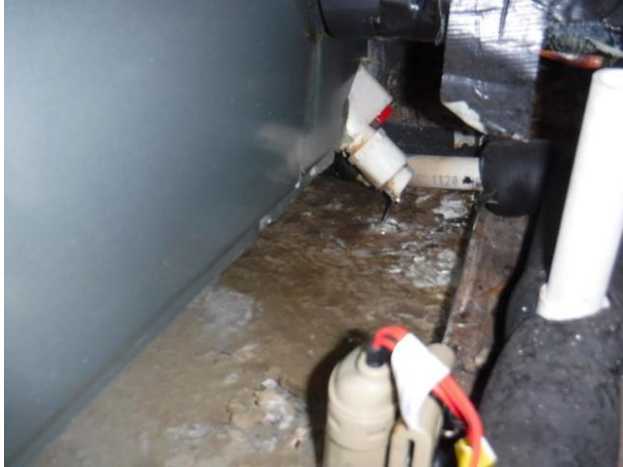
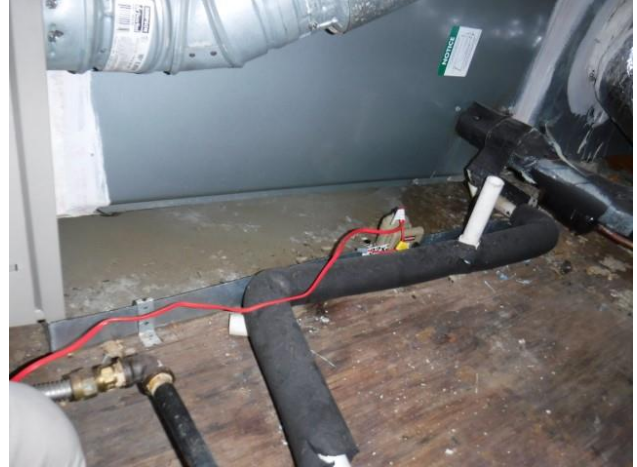
- ★ The evaporator coil main condensation drain line is improperly routed to an unapproved drain that may allow sewer gas to back up in to the ventilation equipment. Not a proper wet trap. During the winter months when the heater is used the moisture in the trap can evaporate allowing sewer gases to enter the system.
- ★ The downstairs unit drain pan is full of water from the a/c coil leaking. Recommend correcting as soon as possible by a licensed HVAC professional.

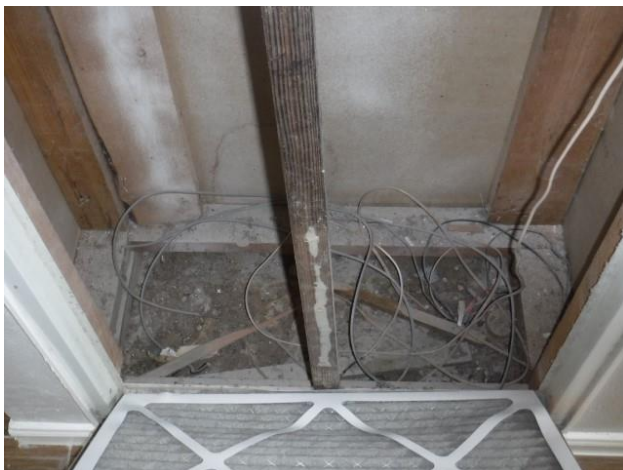
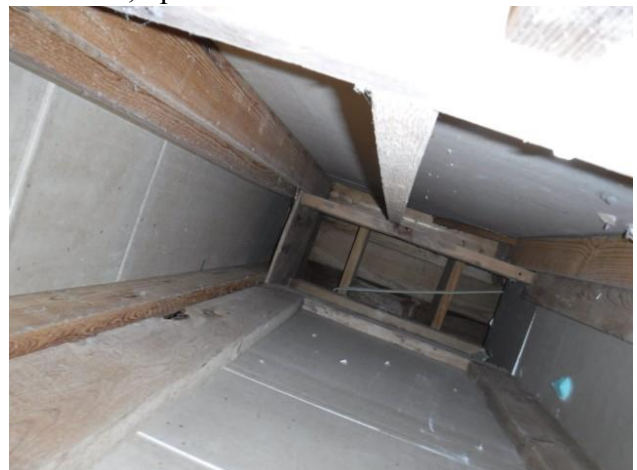
- ★ The upstairs returns are missing filters.
- ★ The return filters are dirty; downstairs. Dirty clogged filters make the unit work harder and cuts down on the efficiency and life of the unit.
- ★ The return air ducts are not sealed allowing air to be pulled from between the walls and flooring. This will reduce efficiency and increase operating costs.
- ★ The loose debris inside the return air chase should be removed; up and downstairs.

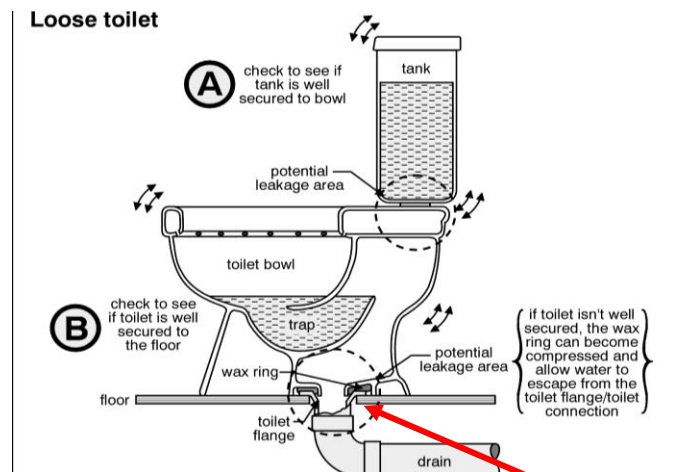
- ★ The base of the commode is loose where it connects to the floor; all baths. Recommend replacing the hardware and wax ring for the bowl and ensure there is not leakage at the floor; upstairs guest and 1/2 bath.

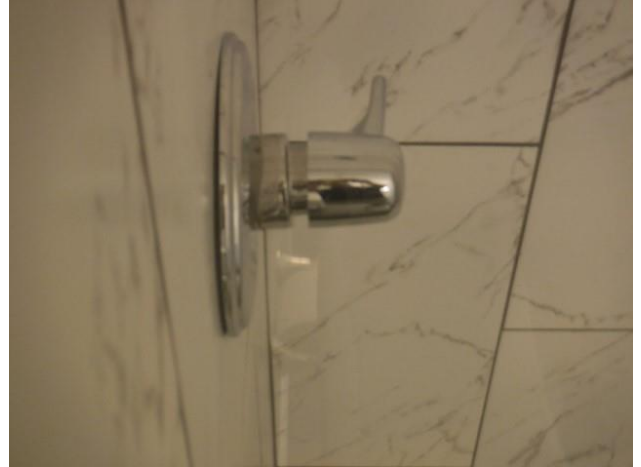
- ★ The water is off to the upstairs front bathtub. Waiting on a new faucet assembly.
- ★ The faucets require sealant at the wall to prevent moisture from penetrating behind shower / tub wall.

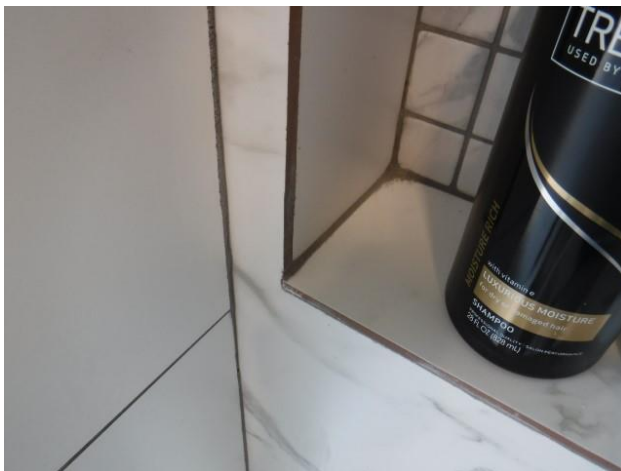
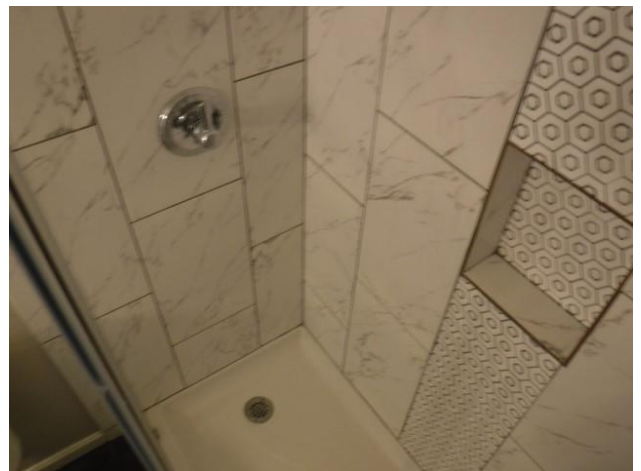
- ★ The bath shower sealant is missing at the corner locations. These areas must be properly sealed to prevent water penetration. Recommend a clear matt finish for an invisible seal. The grout must be sealed over as it will crumble over time at the corner locations.

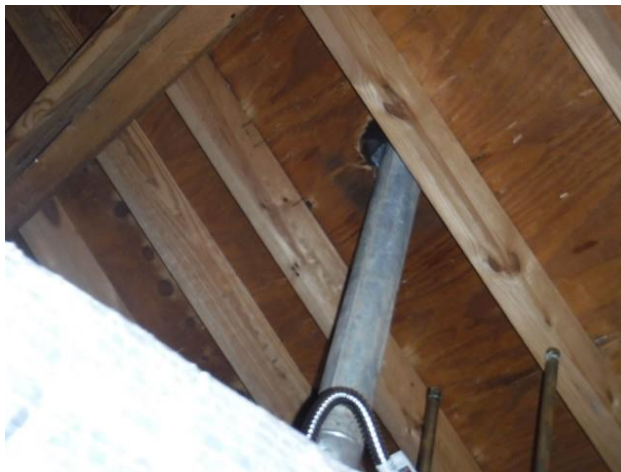
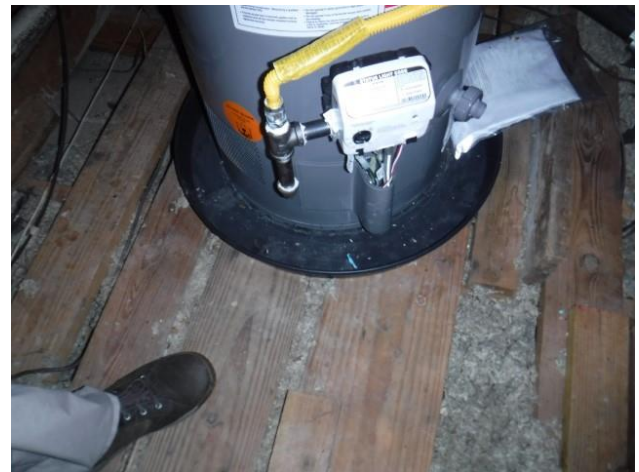
- ★ The vent pipe is not secured at the roof penetration. The exhaust vent should have a metal strap securing it to the rafters.
- ★ Gas fire water heaters should rest in a galvanized drain pan. The current drain pan is plastic which is only suitable for electric water heaters.

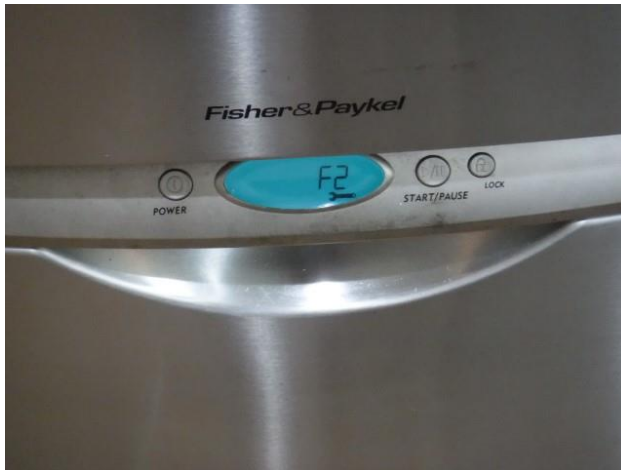
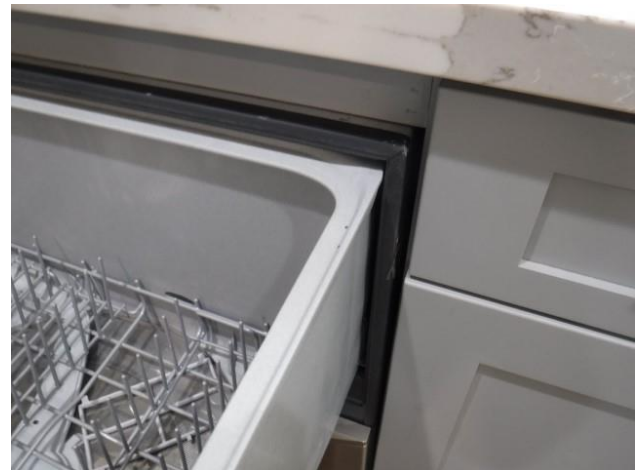
- ★ The bottom unit was not operable. It flashes a repair code F2.
- ★ The dishwasher is not properly secured under the cabinet.
