Professional Inspection Report

PROPERTY INSPECTION REPORT

Concerning: 7107 Brownbark, Magnolia, TX 77354
(Address or Other Identification of Inspected Property)

By: Michael Dorman, Lic #24633 07/28/2021
(Name and License Number of Inspector) (Date)

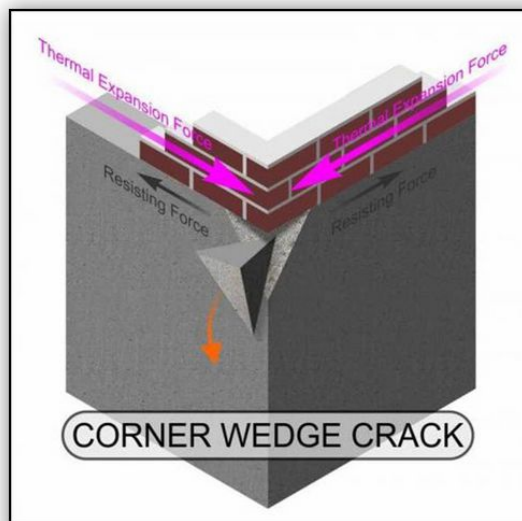
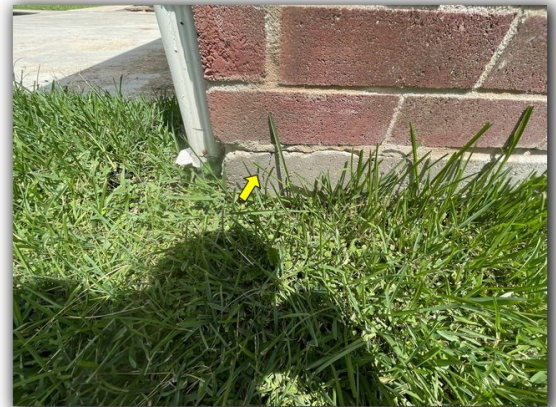
- One or more of the foundation perimeter beam corners were observed to be sheared off (corner pop). This is a common condition and is due to thermal expansion and contraction of the different building materials. This condition does not adversely affect the foundation performance. However, in some cases, some cosmetic improvements may be necessary.

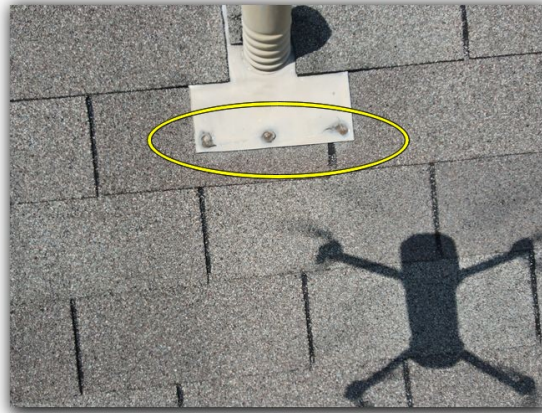
- One or more roof vents was observed to have exposed nail heads / deteriorating caulk. Recommend sealing to prevent water penetration.

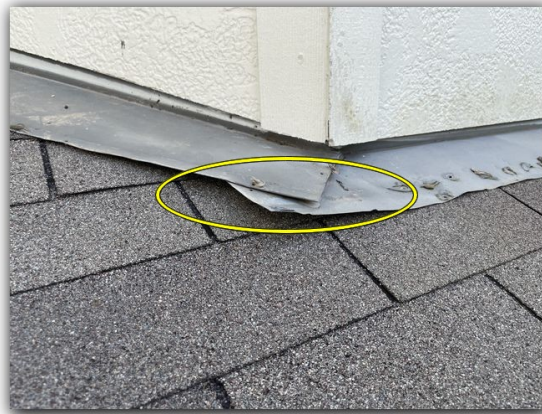
- One or more pieces of flashing was observed to be raised.

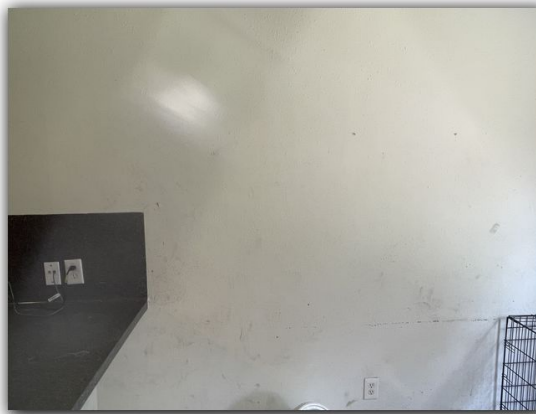
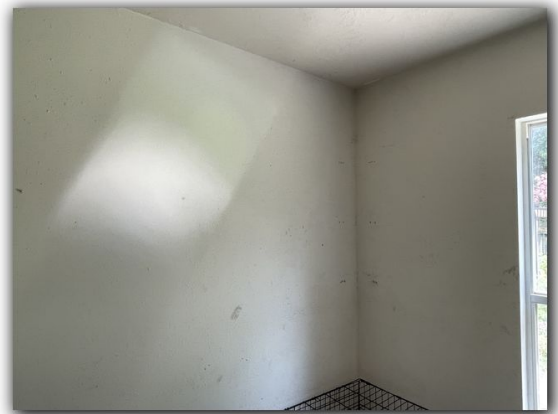
- Multiple areas on the interior walls were observed to have stains / cosmetic damage.

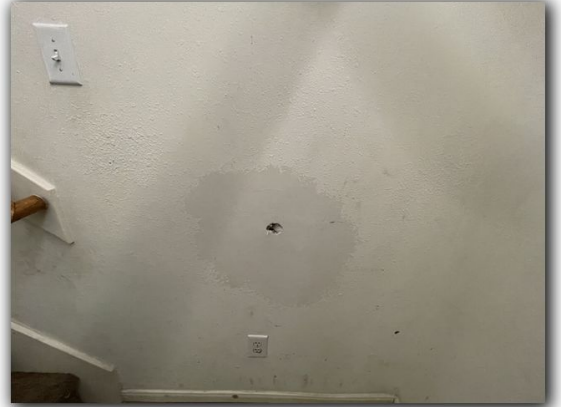
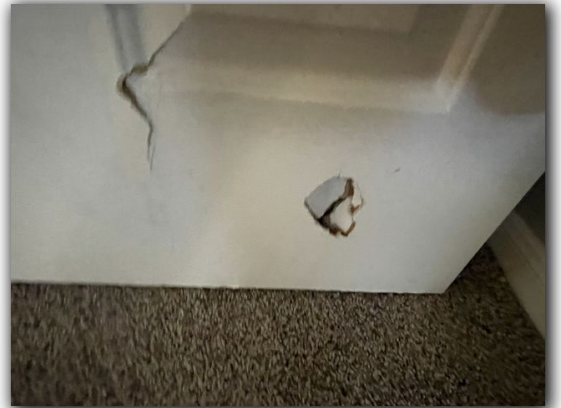
- Multiple holes were observed in the interior walls.

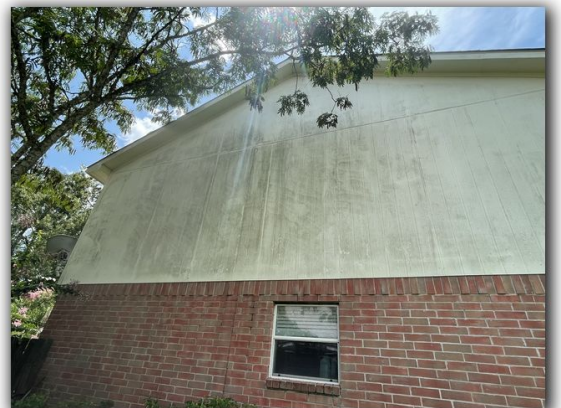
- Multiple areas on the exterior siding were observed to have algae growth.

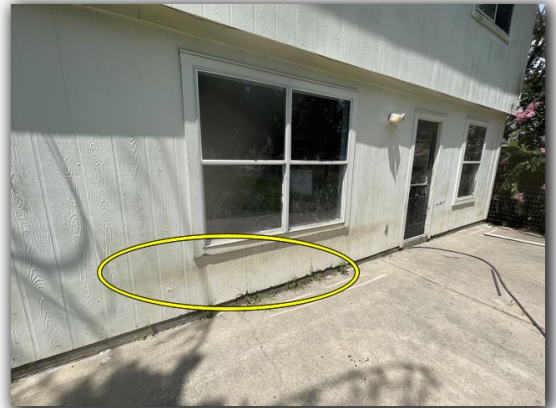
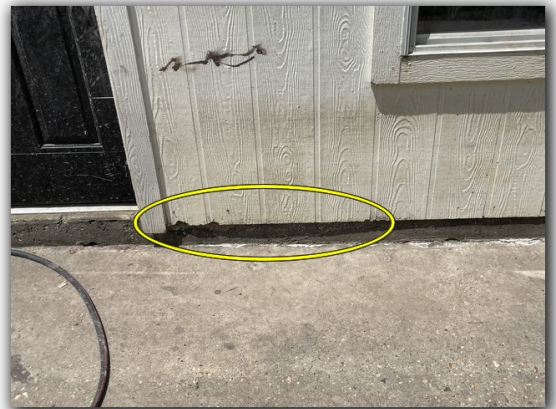
- Multiple areas of the siding were observed to have deterioration / damage.

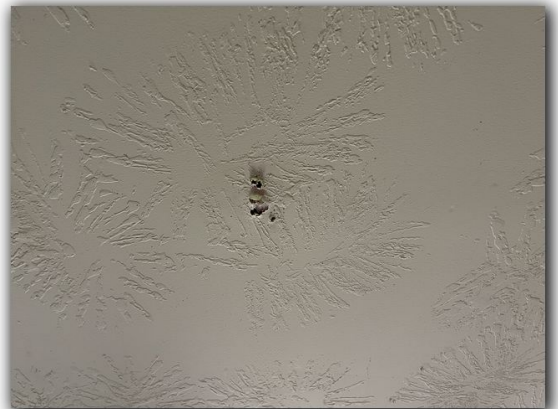
- Two or more areas in the living room ceiling were observed to be damaged.

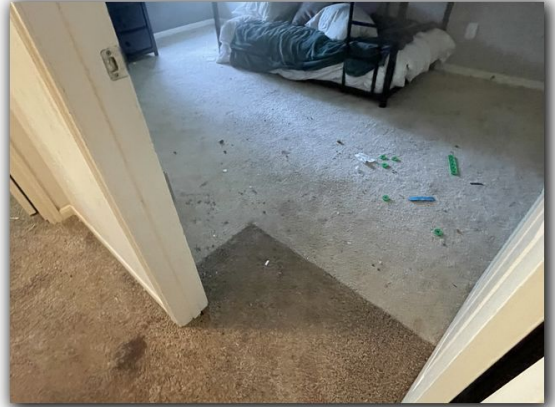
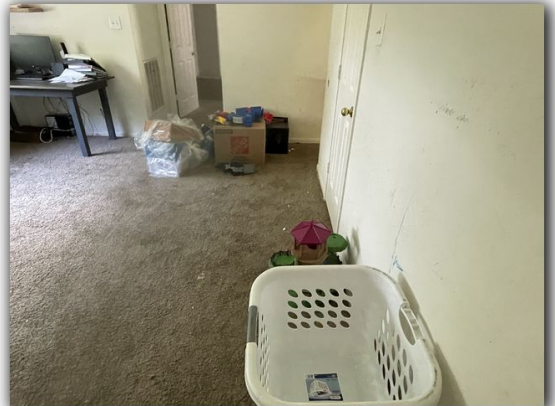
- The flooring in multiple areas upstairs needed to be cleaned.

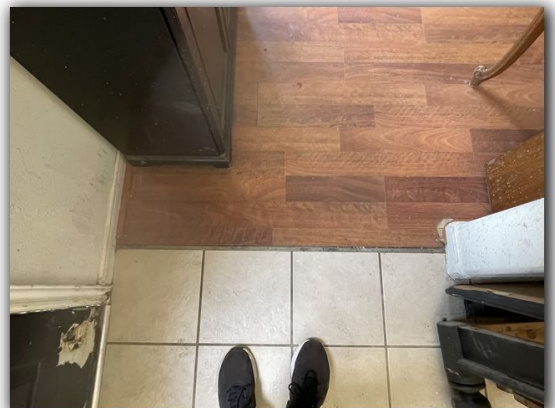
- Multiple transitions in the flooring downstairs were observed to be missing the transition piece.

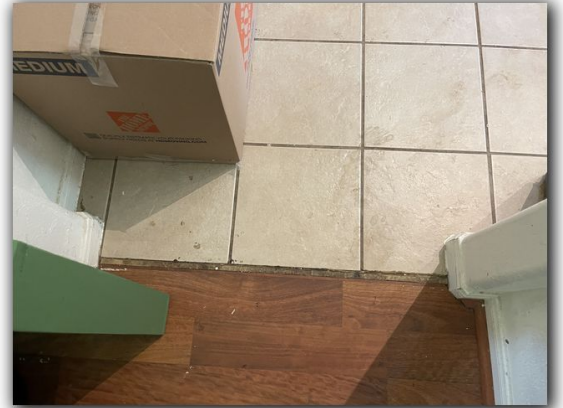
- There was a broken tile observed going into the laundry room.

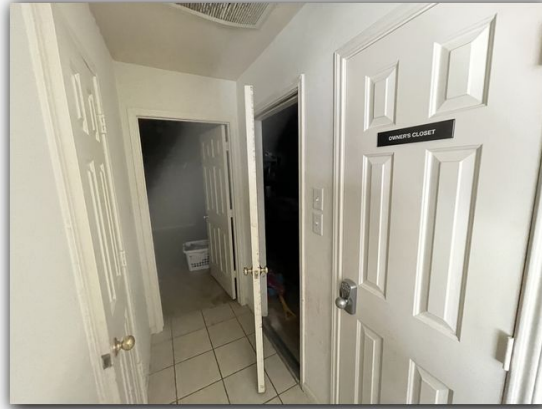
- The entry door from the attached garage was not equipped with a self-closing device. Recommend installing a self-closing device for safety reasons.

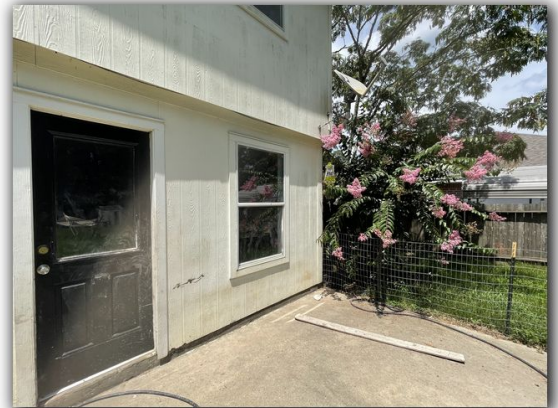
- Multiple windows were observed to be missing window screens.

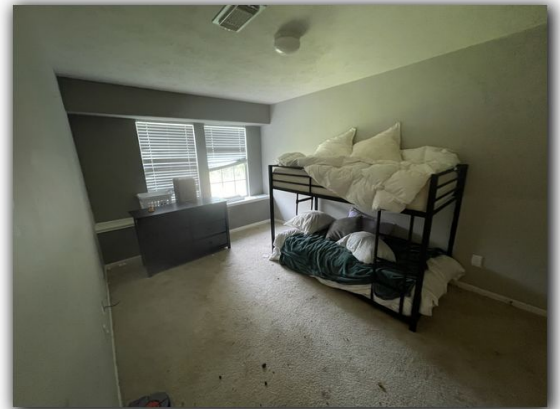
- Common for construction of this age, there were openable windows on the second floor that were less than 24 inches above the floor. As per IRC 612.2, windows above 72 inches above the finished grade or surface below should not be less than 24 inches above the floor. For safety reasons, it is recommended to install a window-opening limiting device to allow windows to open a maximum of 4 inches.

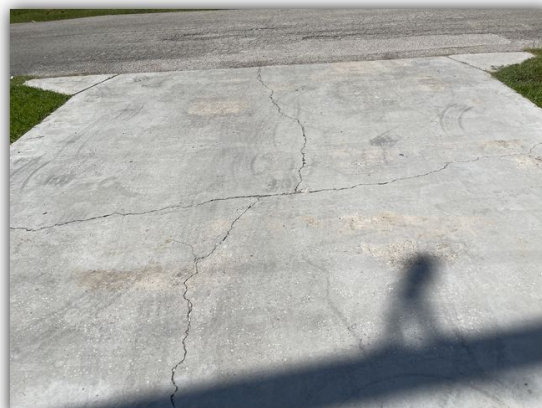
- Minor cracks and/or deficiencies were observed in the driveway.

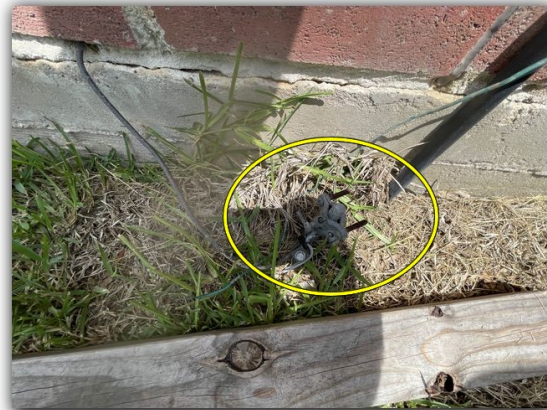
- The clamp for the ground rod is an improper style of grounding clamp. Recommend an acorn style clamp to be installed.

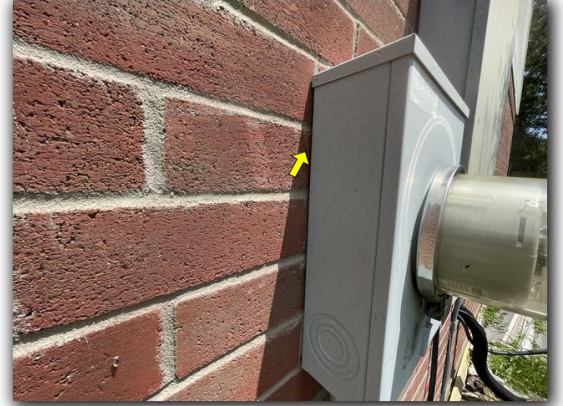
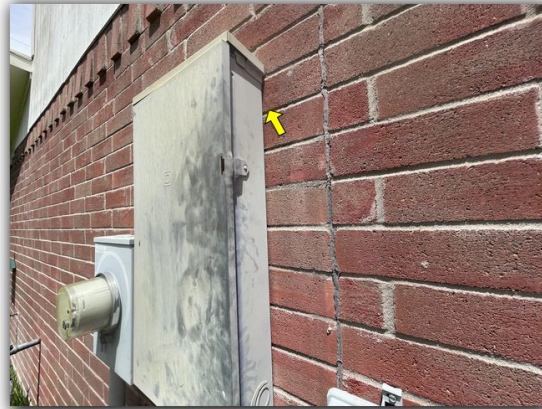
- The service panel and meter box were not sealed to the exterior wall. Recommend sealing to the wall to prevent moisture penetration to the back of the panel.

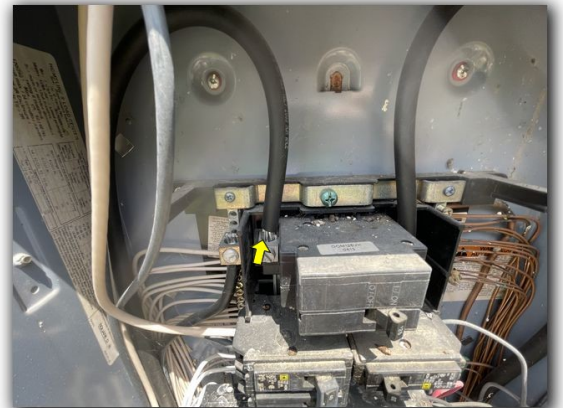
- There was no anti-oxidant gel observed on the exposed aluminum conductor terminations. The NEC and most panel manufacturers do not require the application of anti-oxidant gel on the aluminum service entrance cables, however, the TREC Standards of Practice require notification if anti-oxidant gel is not present. If the buyer has any questions about this issue, it is recommended to consult with a licensed electrician.

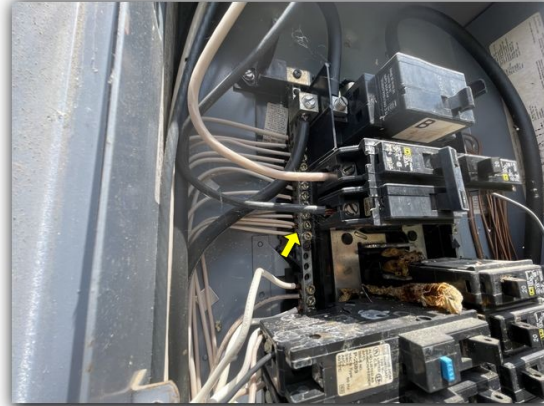
- The NEC Code 408.21 states with regard to grounded (neutral) connections: "Each grounded conductor shall terminate within the panel board on an individual terminal that is not also used for another conductor." While doubling of neutrals has been a common practice of electricians, it has been found to cause problems due to poor connections. The remediation is not expensive and can be done quickly by a licensed electrician. Terminate each grounded (neutral) connection to an individual terminal on the neutral bus bar.

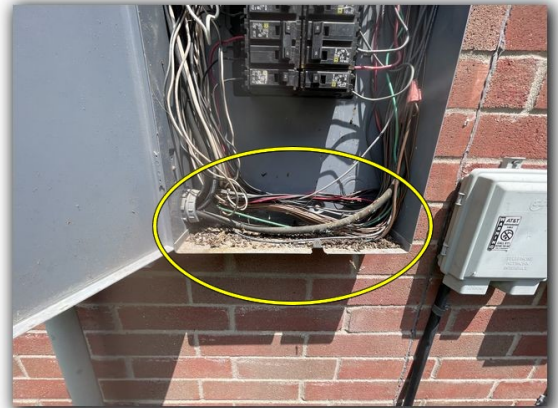
- There was a lot of debris and a dead lizard observed in the electrical box. Recommend cleaning.

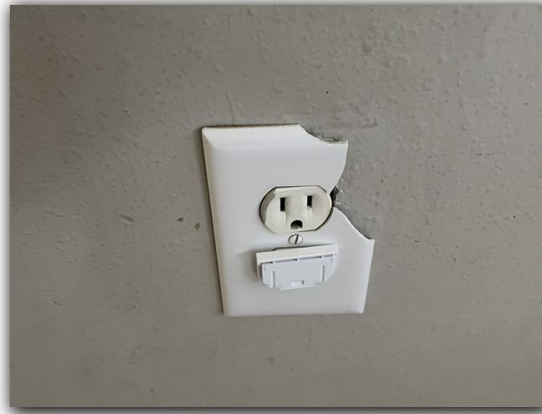
- One or more of the receptacle cover plates are damaged in the upstairs rear corner bedroom.

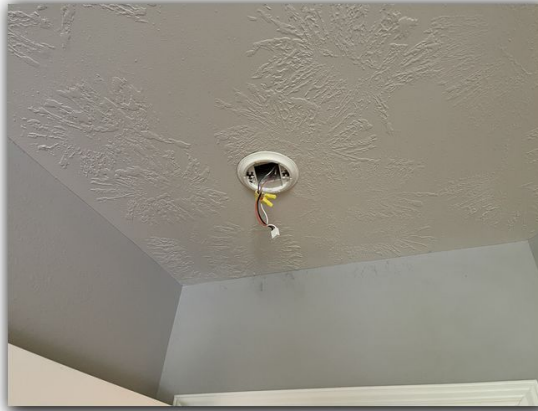
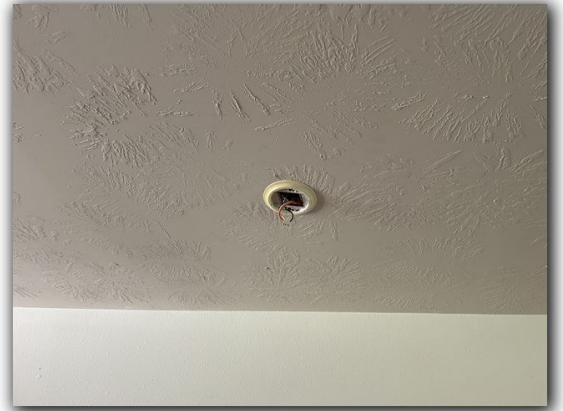
- Two or more smoke detectors were observed to be removed. Recommend replacing.

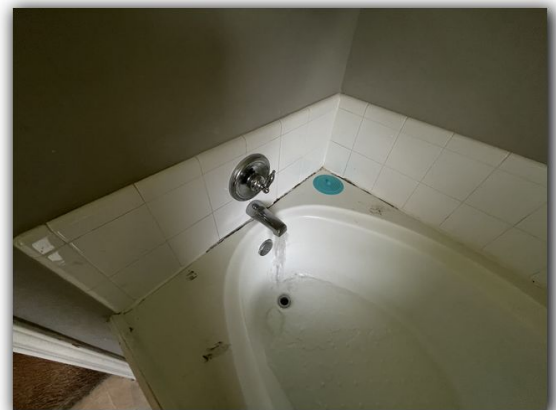
- Multiple bathtubs and sinks were observed to be missing the stopper.

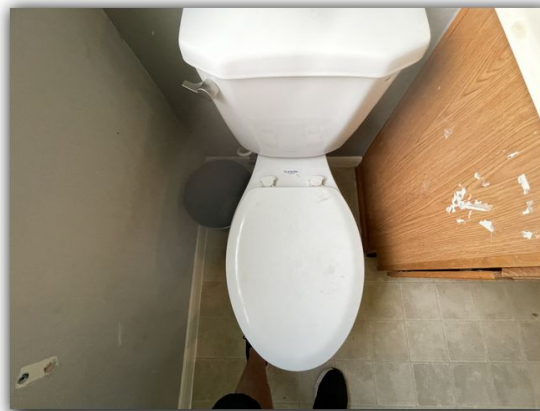
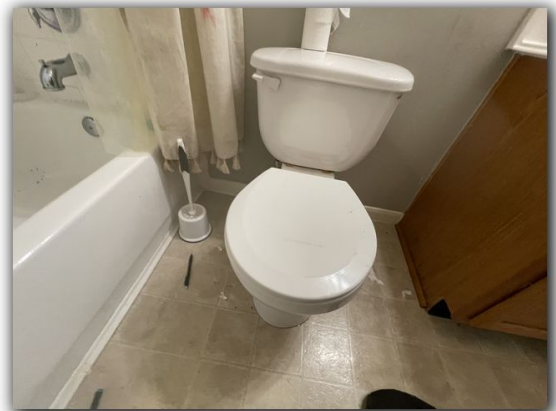
- The commode in the master and secondary bathroom were loose at the floor mount.

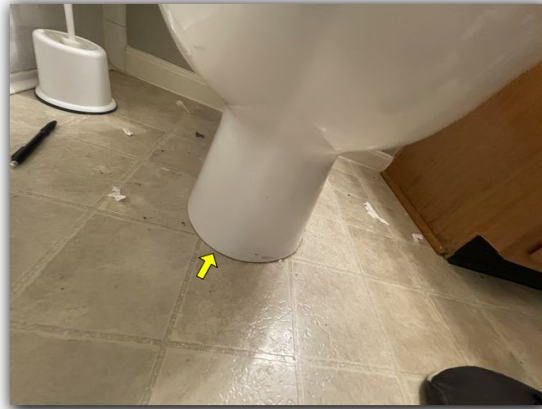
- The commode in the secondary upstairs bathroom was not sealed at the floor. Recommend sealing.

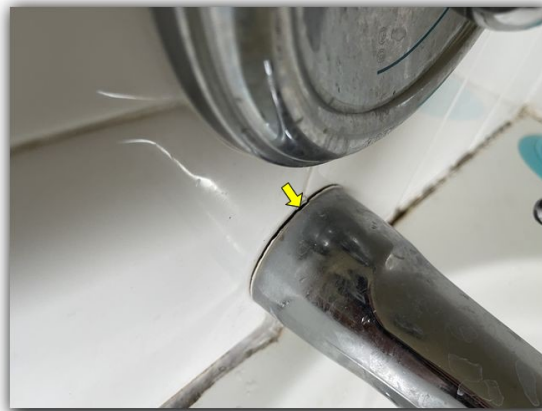
- The master bathtub faucet was observed to not be sealed at the wall. Recommend sealing.

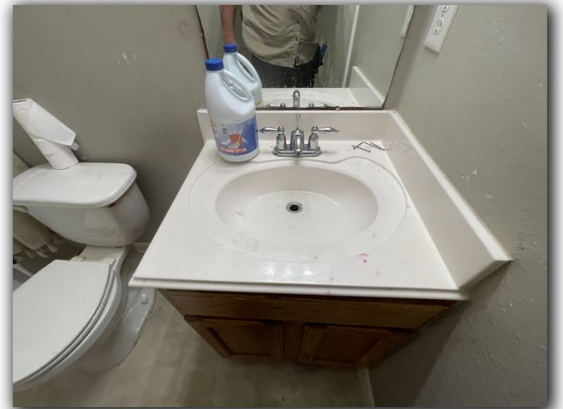
- The right side master sink and the secondary bathroom sink were observed to be slow draining.

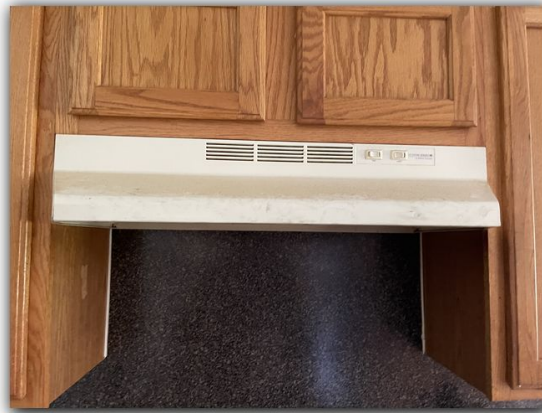
- The light at the range hood is inoperative.

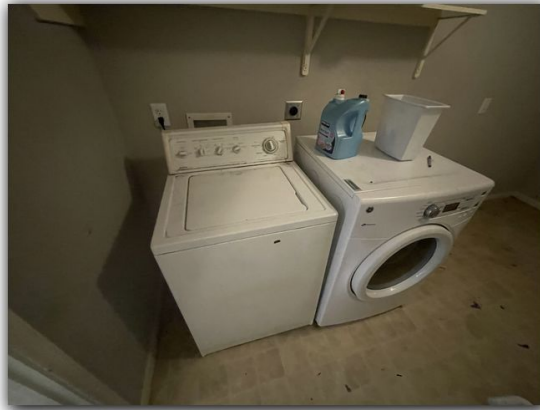
- Due to a dryer being installed in front of the interior dryer exhaust vent at the time of the inspection, the interior of the vent pipe could not be fully inspected. Buyer should ensure that vent duct is clean of lint and debris before installing a dryer and/or occupancy of the house.
