Report Identification: 321 Preston Ln, League City TX 77573 - November 15, 2021

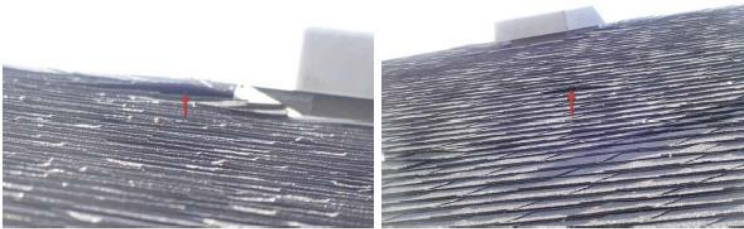
Left Slope

Shingle are lifted, secure and seal as needed.

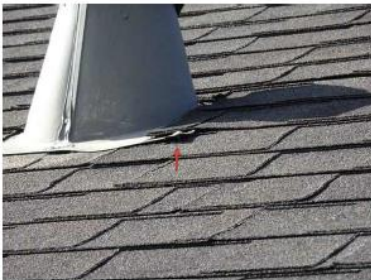
Rear Exterior

Lifted vent flashings may allow for water penetration. Secure and seal as needed.

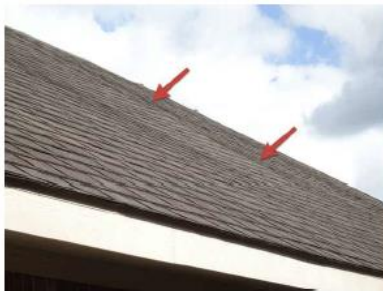
Right Slope

Deflection was observed in the roof decking indicating possible decking/framing issues under the shingles.

Attic framing and decking appear to be functioning as intended, if further evaluation is desired consult with a qualified contractor.

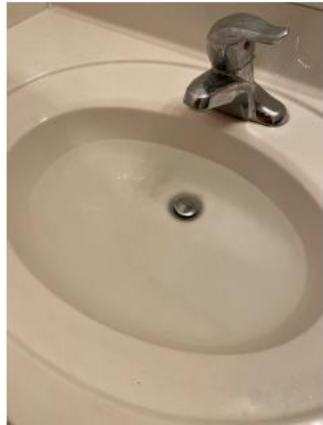
Hall Bathroom Sink

Slow drainage was indicated. The cause could not be determined. Recommend cleaning the drain line and re-evaluating or having a qualified contractor evaluate.

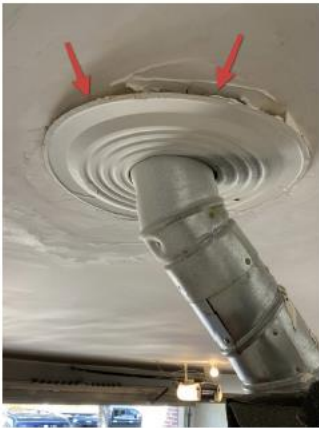
A vent pipe ceiling collar should be installed securely to the ceiling around the vent pipe.

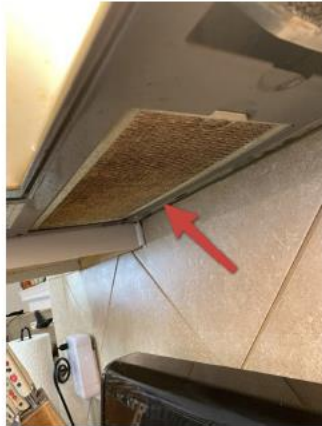
Grease build-up was observed on the kitchen exhaust filter (hazard); clean and/or replace as needed.

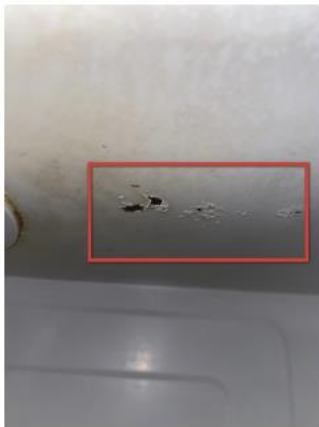
Rusting was observed inside the microwave. The unit was not operated due to risk of further damage.

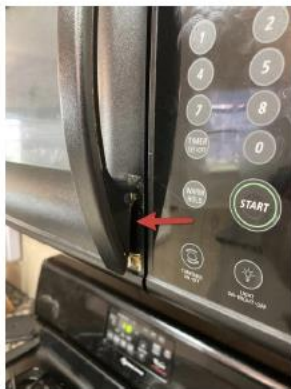
The microwave door handle is damaged. Remedy as needed.
