Inspection Report

Property Address:
321 Preston Ln.
League City Tx 77573

PROPERTY INSPECTION REPORT

By: Jared Buchanan 22516 22516 / Buchanan Home Inspection 11/2/2021

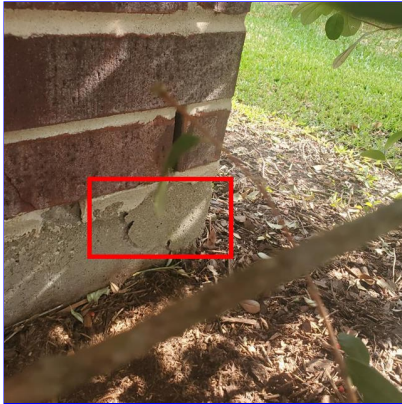
The foundation appeared to be operating as intended, however, several corner pops, that appear cosmetic, were noted in some areas and should be evaluated by a professional foundation contractor and repaired to help prevent further damage

A. Item 1(Picture) Corner pop in the foundation at the South West corner of the home

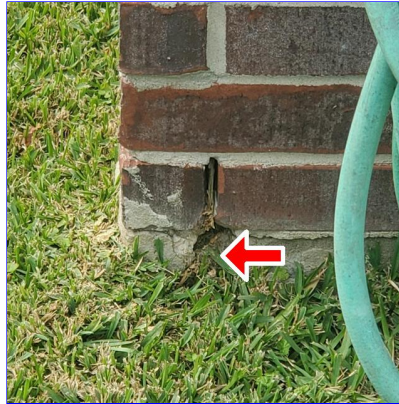
A. Item 2(Picture) Corner pop at the southeast corner of the home

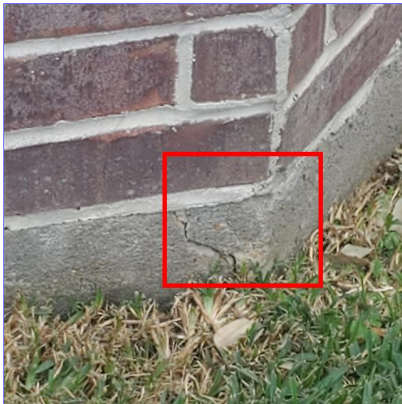
A. Item 3(Picture) Corner pop at the north side of the home

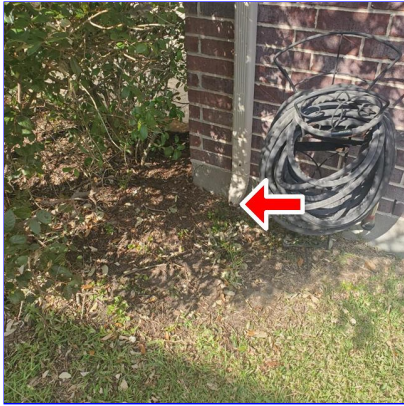
B. Item 1(Picture) Missing splash block at the southwest corner of the home

Recommend installing splash blocks or downspout extensions at all downspouts to help divert water away from the home

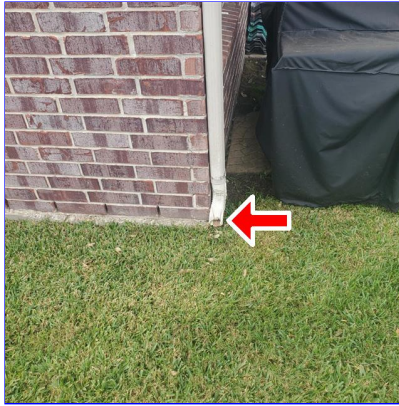
B. Item 2(Picture) Damaged elbow on downspout at the northeast corner of the home and missing splash block

Damaged gutter downspouts were noted in a few areas and should be repaired to allow for proper drainage

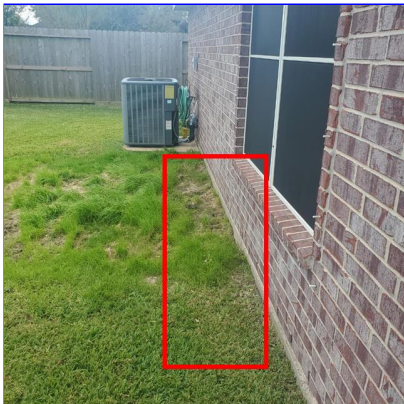
Areas for potential ponding water were noted next to the foundation in a couple areas at the back of the home and to the left of the front door at the front of the home. Recommend further evaluation by a professional landscaper for recommendations on remedy, especially if ponding water is still noted 48 hours after a hard rain.

B. Item 3(Picture) Area for potential ponding water at the back of the home

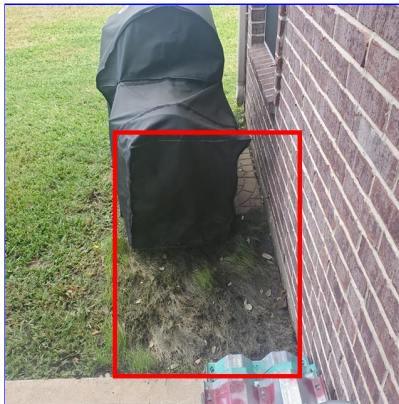
B. Item 4(Picture) Area for potential ponding water by the back patio

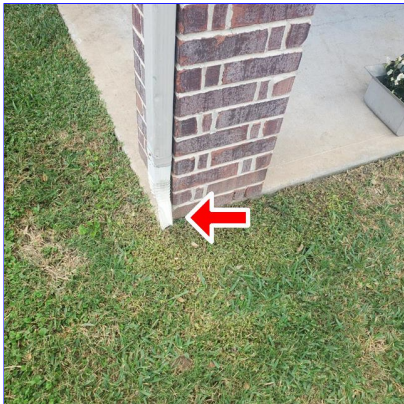
B. Item 5(Picture) Damaged gutter downspout and missing splash block at the back patio

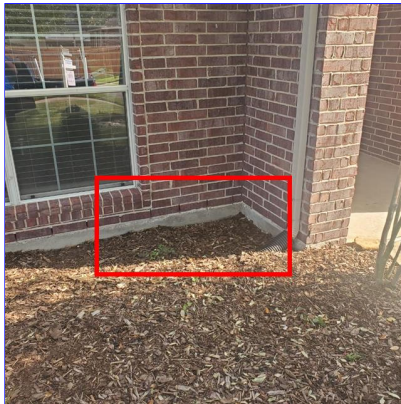
B. Item 6(Picture) rea for potential ponding water at the front of the home to the right of the front door

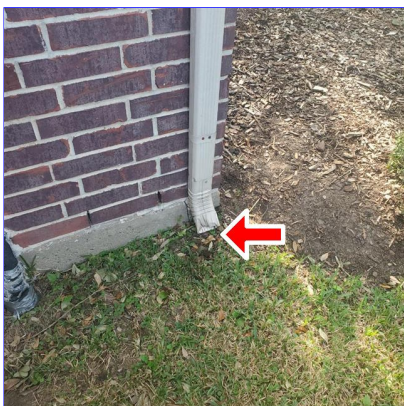
B. Item 7(Picture) Damaged gutter downspout and missing splash block at the northwest corner of the home

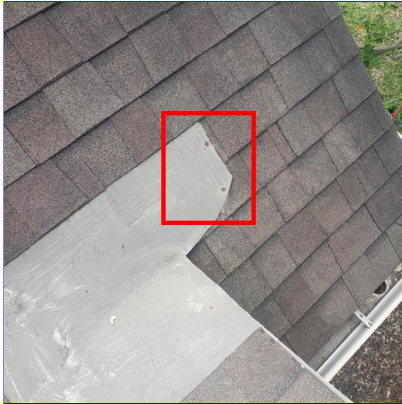
C. Item 1(Picture) Exposed nails on flashing at the front of the home

There were several exposed nails and screws in areas on roof coverings and flashings on the roof. These should be sealed to help prevent moisture intrusion. Recommend contacting a professional roofer for further evaluation and to give estimates on cost of repairs

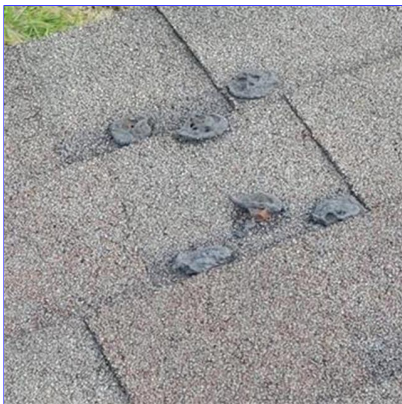
C. Item 3(Picture) Exposed lag bolts on back facet of roof appear to be from a satellite dish and are areas for potential roof leaks. There were two places this was noted at the back of the home.

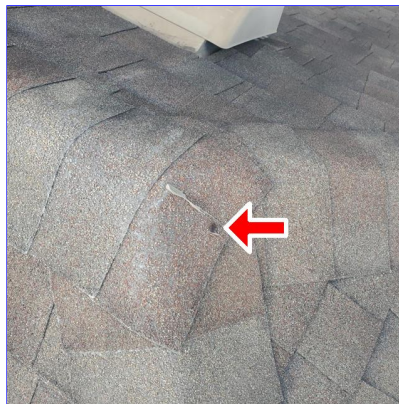
C. Item 4(Picture) Expose nails on ridge on the back facet of the home

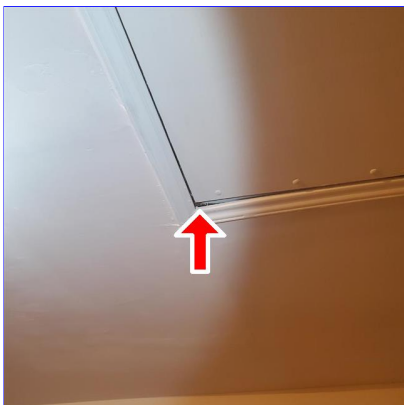
D. Item 1(Picture) Gap around the attic access in the garage be evaluated and repaired, as needed

Restrictions in attic appeared to be operating as intended, however, recommend evaluating and sealing gap around attic access, as needed.

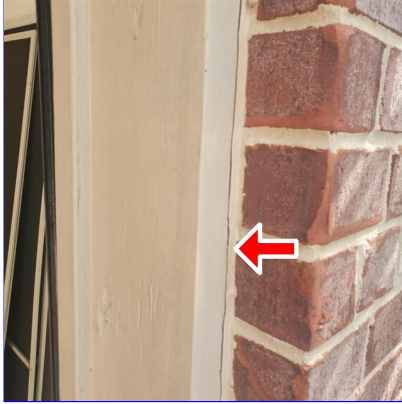
E. Item 1(Picture) Small gap in sealant around garage door trim

Small gaps were noted in sealant around some of the windows and should be sealed to help prevent moisture intrusion

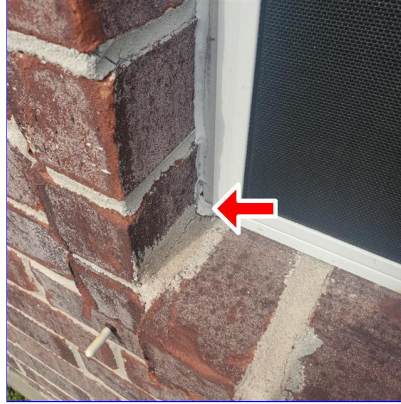
E. Item 2(Picture) Small gap in sealant at the bottom left corner of the first window at the south side of the home. This was noted that a few Windows around the home

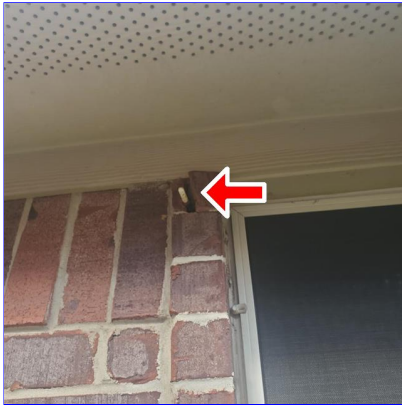
E. Item 3(Picture) Damaged brick at the top left corner of the first window at the south side of the home

Damaged bricks were noted above a few windows at the right side of the home and should be repaired to help prevent moisture intrusion and further damage

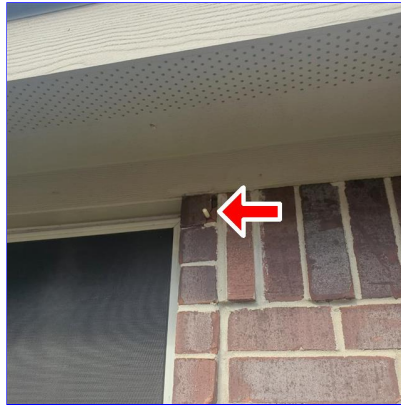
E. Item 4(Picture) Damaged brick above the second window at the south side of the home

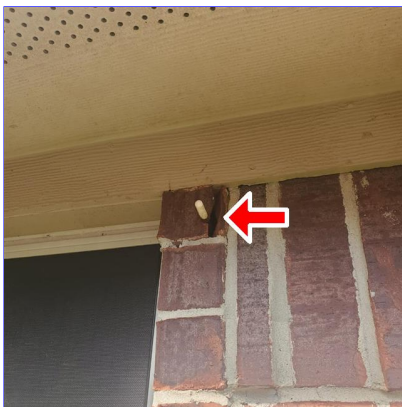
E. Item 5(Picture) Damaged brick at the top of the third window at the south side of the home

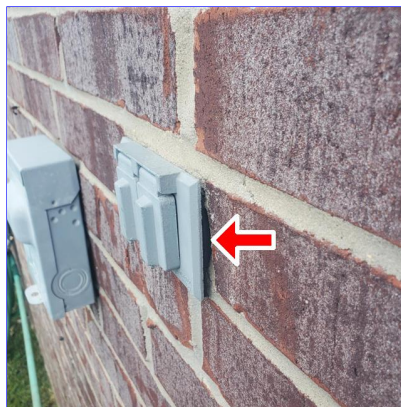
E. Item 6(Picture) Gap around electrical receptacle above the AC condenser should be sealed to help prevent water from entering this area

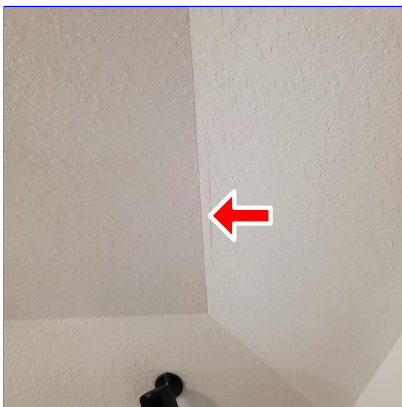
Crack in the living room ceiling appears cosmetic but should be sealed and monitored for growth and a structural engineer contacted if growth occurs

F. Item 1(Picture) Appears to be cosmetic damage to ceiling at the northeast corner of the living room

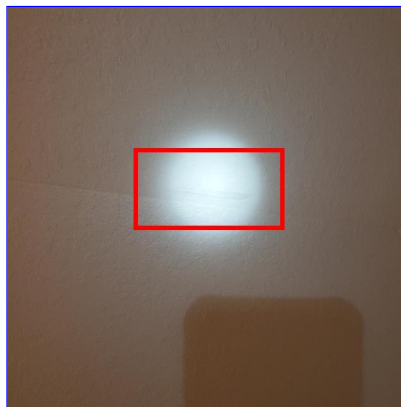
Previous repair to the ceiling in the master bathroom did not appear wet at time of inspection but should be monitored.

F. Item 2(Picture) Hairline crack and previous repair noted in the ceiling above the master bath tub

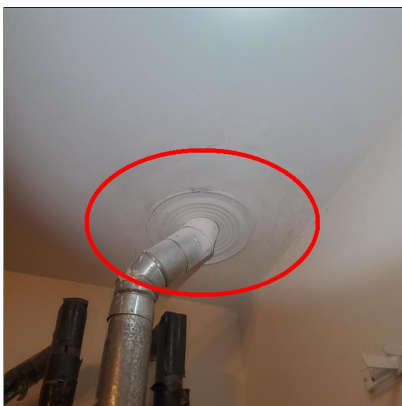
There was also a stain on the ceiling above the water heater in the garage that is possibly due to a roof leak and should be evaluated further. See ceilings and floors for picture of stain on the ceiling.

Stain on the ceiling on around the water heater flue pipe, in the garage, did not appear wet at time of inspection but should be evaluated further and monitored, at minimum

F. Item 3(Picture) Stain on the garage ceiling around the water heater flue pipe

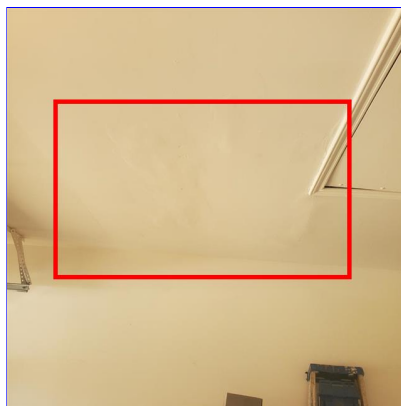
Unsure of cause a previous repair to the ceiling in the garage but recommend further evaluation and monitoring, at minimum

F. Item 4(Picture) Hairline crack and previous repair noted to ceiling in the garage

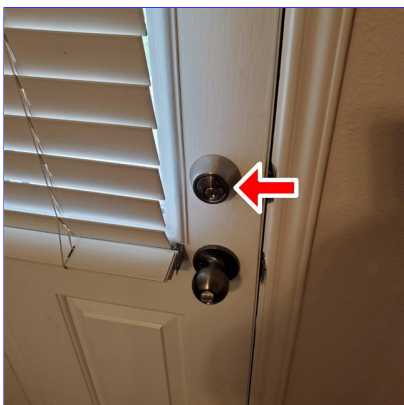
G. Item 1(Picture) Key only interior lock on the back door. This was also noted at the front door at time of inspection

Key only interior locks on the front and back door make emergency escape difficult. Recommend installing locks that do not need a key to open from the interior of the home

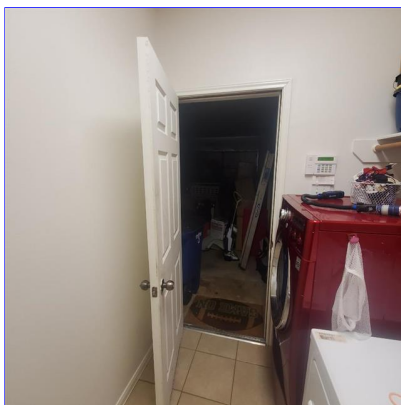
G. Item 2(Picture) Garage entrance door to the home is not self closing.

Self closing hinges should be installed on the garage entrance door to the home to automatically close door after opening, which helps prevent spreading of garage fires and carbon monoxide to the home

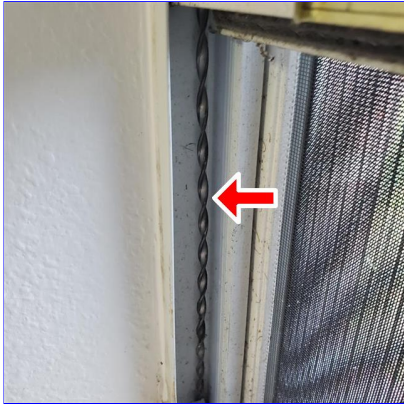
H. Item 1(Picture) Damaged spiral balances on the East breakfast nook window

Damage spiral balances were noted on several Windows throughout the home and should be evaluated further by a professional window contractor to give estimates on cost of repairs

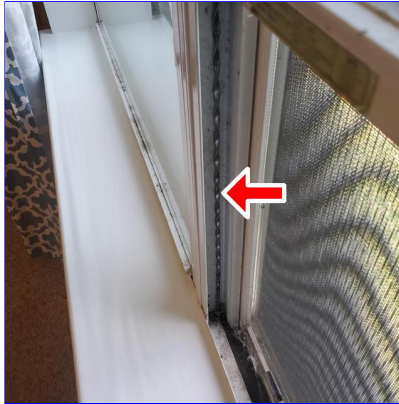
H. Item 2(Picture) Damaged spiral balance on the far south window on the East wall in the master bedroom

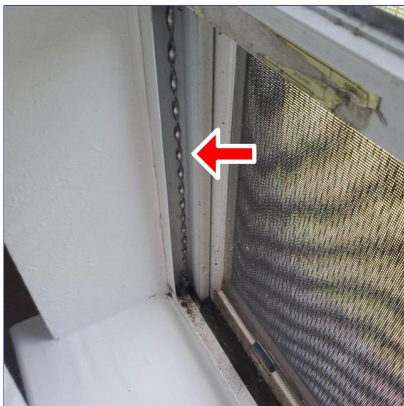
H. Item 3(Picture) Damaged spiral balance on North window on the East wall of the master bedroom

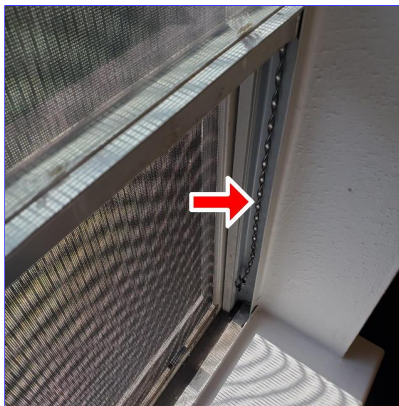
H. Item 4(Picture) Damaged spiral balance on window in the office/den area across in the hallway bathroom

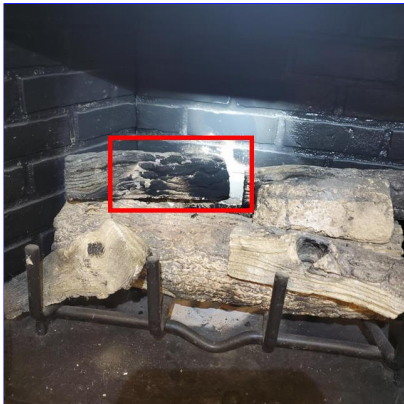
J. Item 1(Picture) Black soot on fire logs

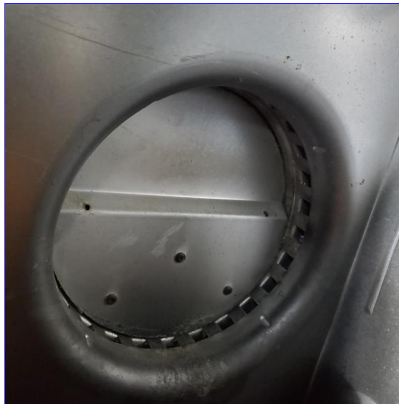
J. Item 2(Picture) Missing damper clamp on flue damper

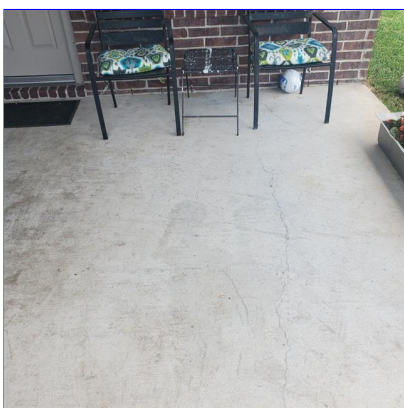
Cracks in the back patio are not severe but should be evaluated and repaired, as needed

K. Item 1(Picture) Small cracks in the back patio flatwork

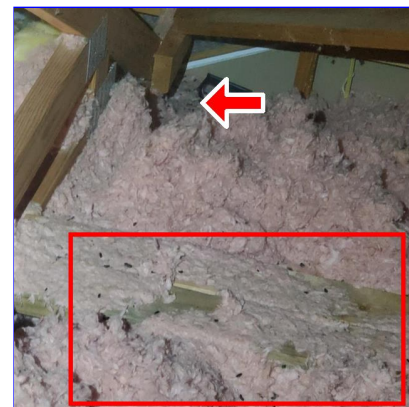
L. Item 2(Picture) Droppings and trails through insulation in the attic indicate possible critters or pests in the attic

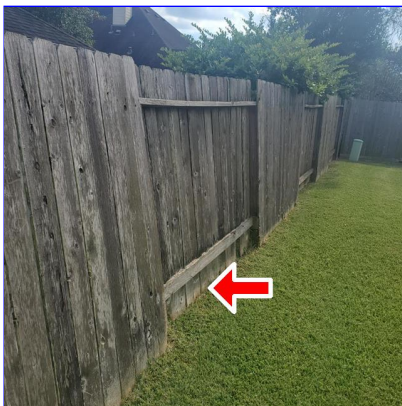
The fence is leaning in the backyard and is starting to rot at the bottom in several areas. Evaluate and repair, as needed

L. Item 3(Picture) The fence is leaning in the back yard and boards are starting to degrade and rot at the bottom of the fence in several areas

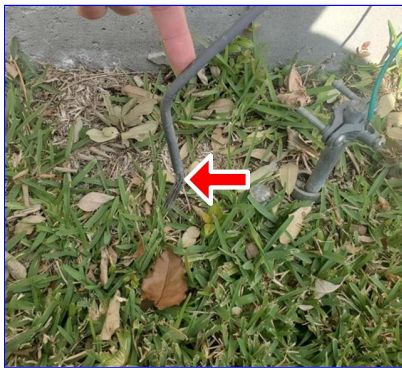
Ground wire is loose from the grounding rod at the meter base and needs repair

A. Item 1(Picture) Ground wire is loose from the grounding rod at the meter base and needs repair

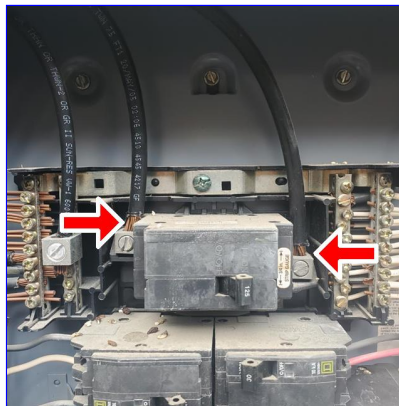
Exposed copper in the electrical panel is a shock hazard during maintenance and repairs and should be evaluated further trimmed by a licensed electrician

A. Item 2(Picture) Exposed copper in the electrical panel at the service entrance conductors

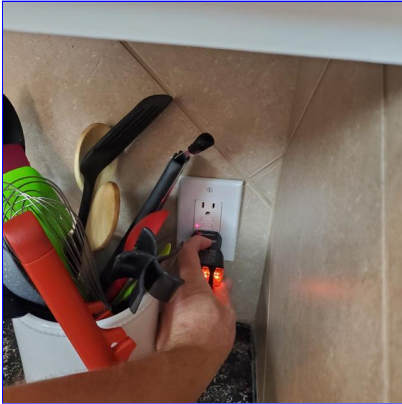
All the electrical receptacles above the kitchen counter and bathrooms would not trip when tested and needs repair for safety to help prevent possible shock hazard

B. Item 1(Picture) GFCI electrical receptacle to the right of the range would not trip when tested and none of the electrical receptacles above the kitchen counter would trip when tested.

Recommend contacting a licensed electrician for further evaluation and to give estimates on cost of repairs needed for safety AFCI's were not tested due to the home being occupied and the possibility of damaging/

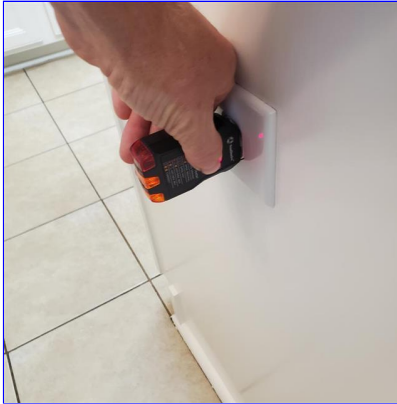
B. Item 2(Picture) Electrical receptacle on the kitchen island would not trip when tested and needs repair to help prevent possible shock hazard

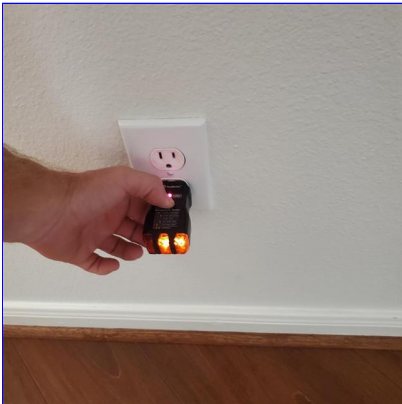
B. Item 3(Picture) Electrical receptacles within six feet of the kitchen sink on the back of the kitchen counter would not trip when tested and needs repair for safety

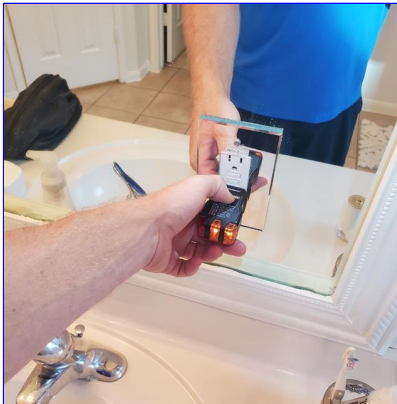
B. Item 4(Picture) None of the electrical receptacles in the master bathroom would trip when tested and need repair for safety

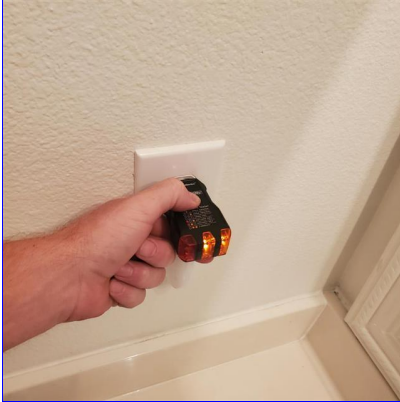
B. Item 5(Picture) Electrical receptacles in the hallway bathroom would not trip when tested

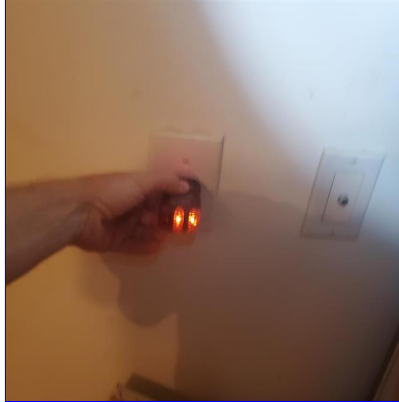
Non GFCI electrical receptacle in the garage should be replaced with a GFCI receptacle or labeled as a non GFCI receptacle for safety

B. Item 6(Picture) Electrical receptacle on the South Wall of the garage is not GFCI protected and is not labeled as a non GFCI receptacle. This is a possible shock hazard

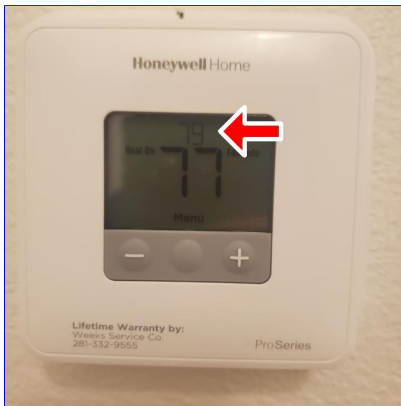
The furnace would not come on when the thermostat calls for heat and would not heat the home. Unsure of cause but recommend further evaluation by a licensed HVAC contractor

A. Item 1(Picture) The furnace was set to 79 degrees but would not come on and eat the home

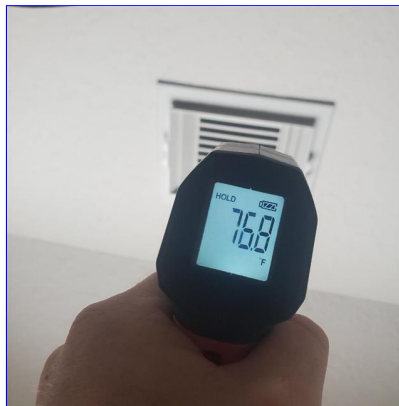
A. Item 2(Picture) Heater not heating after being on for approximately 15 minutes

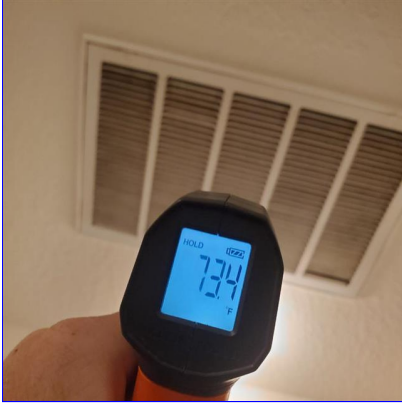
B. Item 1(Picture) Return air temperature was approximately 73 degrees. There should be a 14-22-degree drop between return and supply air temperature

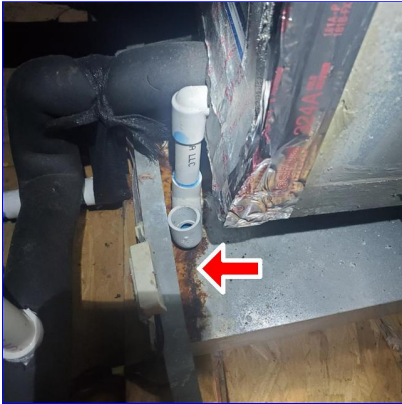
Cooling equipment appear to be cooling adequately at time of inspection, however, there was rust but no

water in the secondary drain pan and should be evaluated and repaired, as needed. The condensate line is also not insulated approximately about the hallway bathroom and should be repaired to help prevent line from condensating. Recommend contacting a professional hvac contractor for further evaluation and to give estimates on cost of repairs

B. Item 3(Picture) Rust in the secondary drain pan at time of inspection

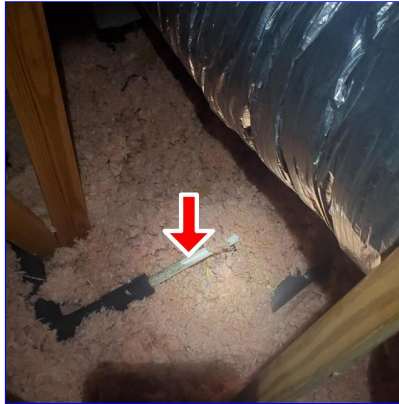
B. Item 4(Picture) Missing insulation on condensate line in the attic, approximately above the hallway bathroom, can cause line to condensate

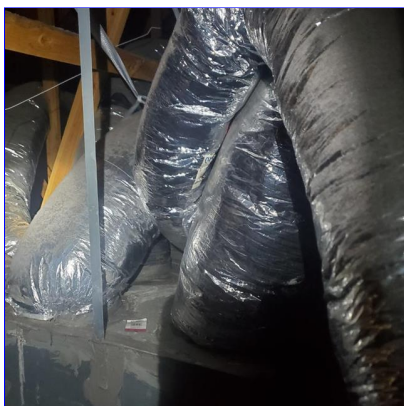
Touching ductwork above the supply plenum can cause ductwork to condensate, which is conducive to fungal growth, and should be separated

C. Item 1(Picture) Touching above the supply plenum in the attic

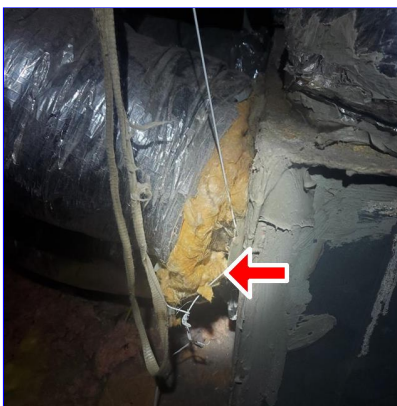
There's a loose duct on the back of the supply plenum that should be repaired to help prevent loss of conditioned air and condensation. Recommend contacting a professional hvac contractor for further evaluation and to give estimates on cost of repairs

C. Item 2(Picture) Duct loose from the supply plenum

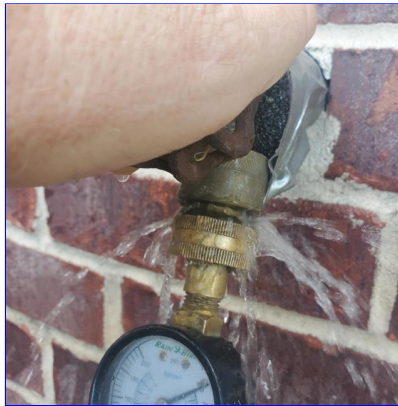
A. Item 2(Picture) Leaking anti-siphon device at the Northside the home above the main water shut off

Plumbing supply and distribution appeared to be operating as intended, however, recommend repairing leaking anti siphon device at the left side of the home, as needed

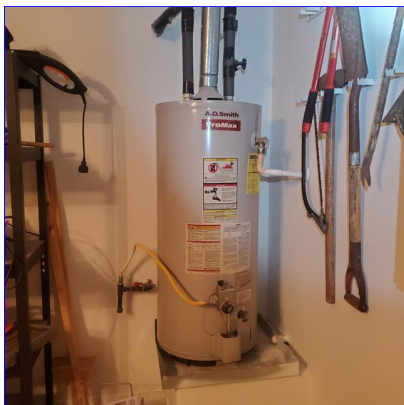
Water heater was fairly aged but appeared to be operating as intended at time of inspection. Recommend monitoring for any leaks on unit, or around connections, as well as for rust on unit. If this is noticed, recommend contacting licensed plumber to evaluate and remedy.

C. Item 1(Picture) General view of AO Smith 40 gallon gas water heater. This unit was manufactured in 2005, typical life expectancy is 8 to 12 years

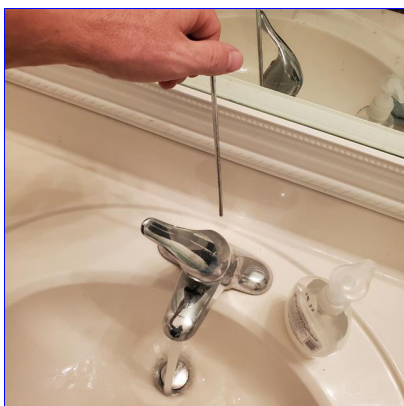
The drain stopper mechanism on the sink in the hallway bathroom is damaged and should be evaluated in repaired, as needed

E. Item 1(Picture) The drain stopper mechanism on the sink in the hallway bathroom is damaged

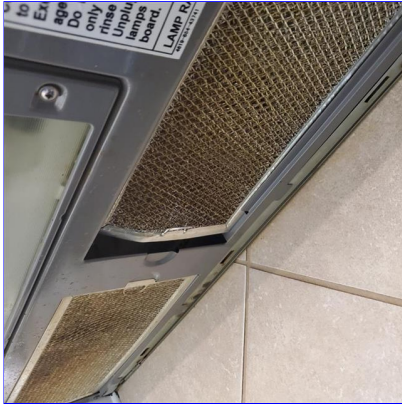
Damaged filter on the range exhaust should be replaced

D. Item 1(Picture) Damaged filter on the range exhaust

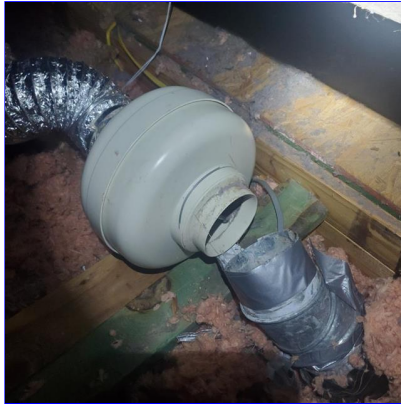
THE booster fan in the attic is loose and the dryers venting into the attic and needs further evaluation and repair by a professional contractor.

H. Item 2(Picture) Booster is fan loose in the attic and dryer is venting into the Attic

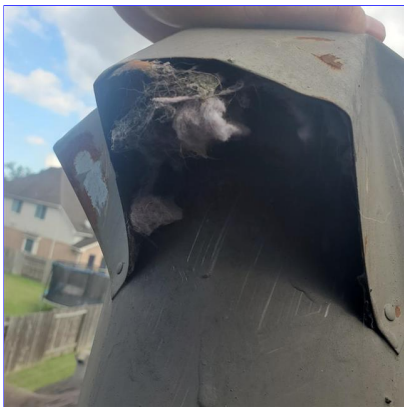
the rooftop dryer vent is filled with debris and should be evaluated further and cleaned to help prevent possible fire hazard

H. Item 3(Picture) Rooftop dryer exhaust vent is filled with debris
