RESIDENTIAL INSPECTION REPORT

2111 N Galveston Ave Pearland TX 77581

Concerning: 2111 N Galveston Ave, Pearland TX 77581

By: TPCL#0809155 06/07/2021 3:00 pm

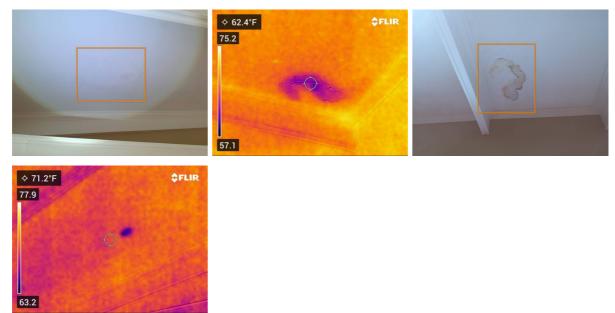
1: Ceiling: Evidence of Active Moisture Contact

Wall structure showed signs of water intrusion. Tested positive for moisture at the time of the inspection. Evaluate and remedy as needed.

Recommendation: Contact a qualified professional.
