PROPERTY INSPECTION REPORT FORM

Address of Inspected Property: 9219 Newburgh Houston, TX. 77095

Name of Inspector: Rod Scarborough TREC License # 7189

Date of Inspection: November 6, 2021

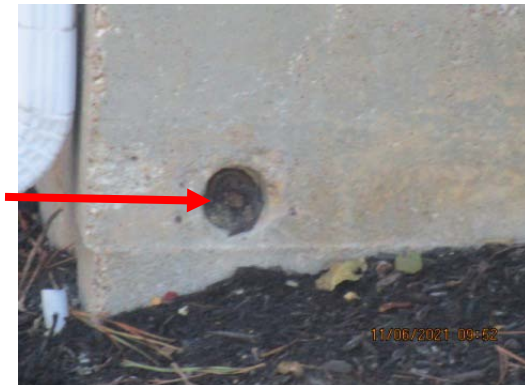
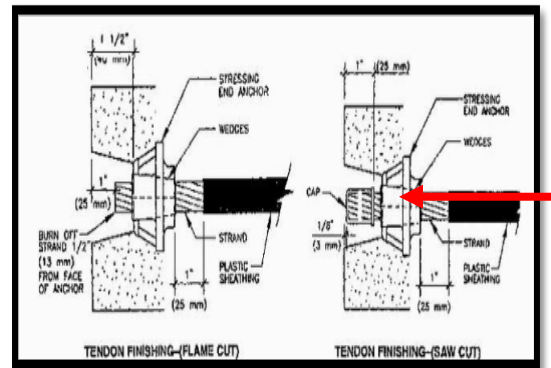
☒ Exposed rebar/tendon ports were observed but may not be limited to the right & front sides of the structure. Recommend sealing.

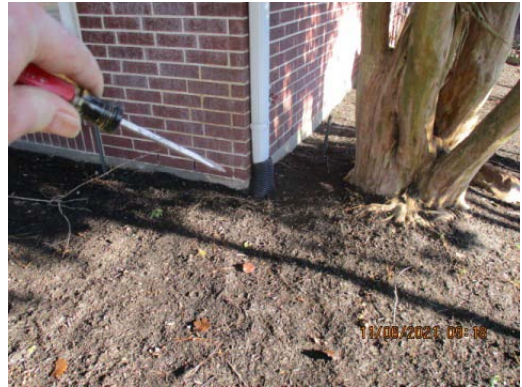
Stress crack was observed but may not be limited to the front right corner of the foundation and the corner of the foundation has sheared off. Recommend repair.

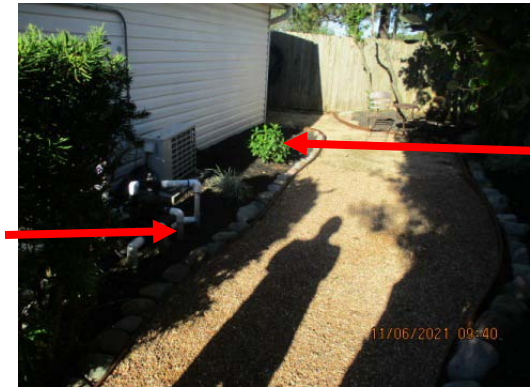
There were areas around the structure where the grading does not having the minimum clearances of 4" for brick & 6" for siding as required. Recommending pulling back/reworking the clearances in these areas to a minimum of 4" - 6" as required.

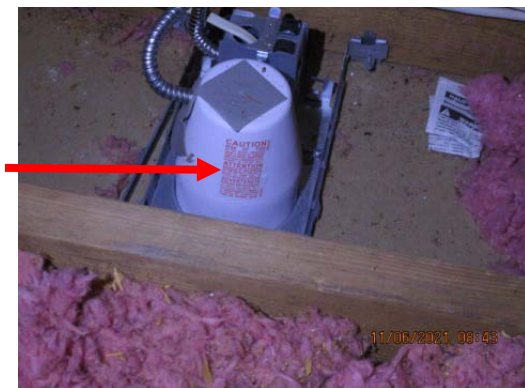
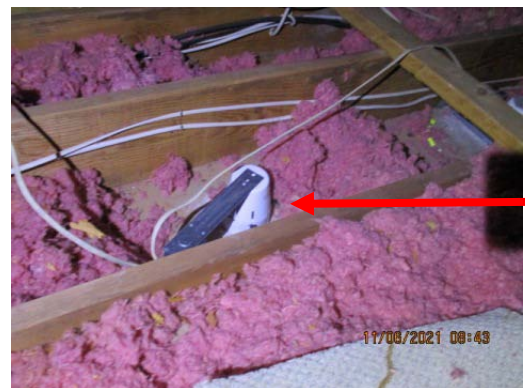
Insulation was observed within 3" of recessed light fixtures. Insulation should be maintained a minimum of 3 inches and wood a minimum of 1 inch from around all recessed fixtures to reduce possible fire hazard. Exception: when lights are listed and labeled as IC Rated (insulation contact) they may be in contact with insulation. Non IC label was observed, insulation should be pulled back a minimum of 3" from light fixtures.

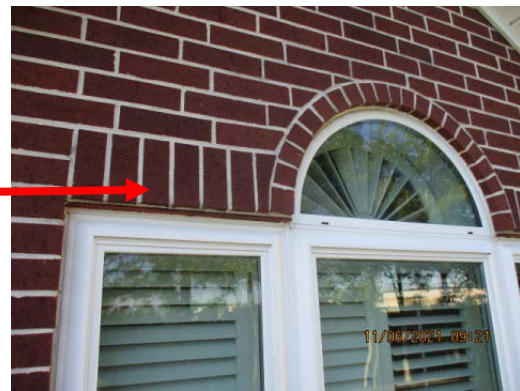
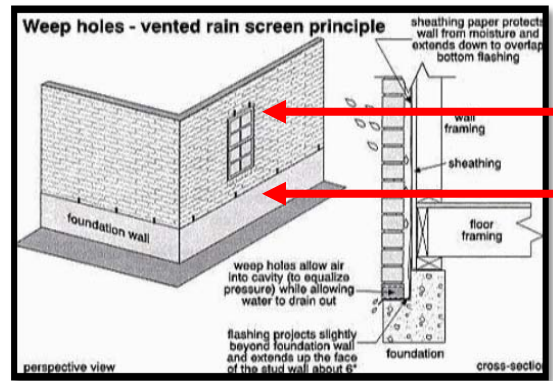
FYI Weep holes are not installed over the windows/doors & are plugged in some areas. Weep holes should be kept free of debris and spaced at a max of 33" on center.

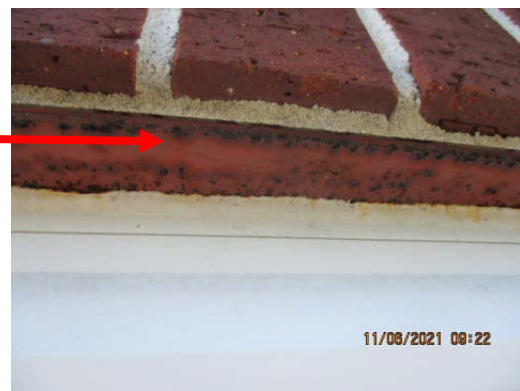
FYI Minor surface rust was observed on some of the lintels at openings above doors/windows etc. Recommend removing rust & priming/painting the lintels.

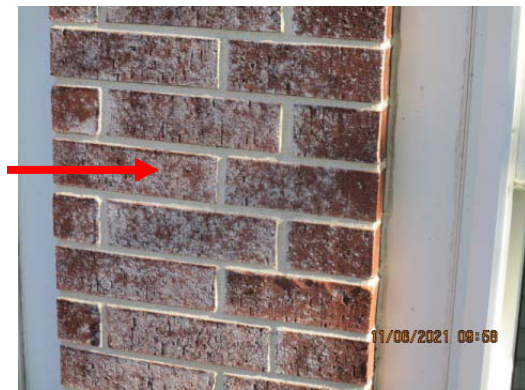
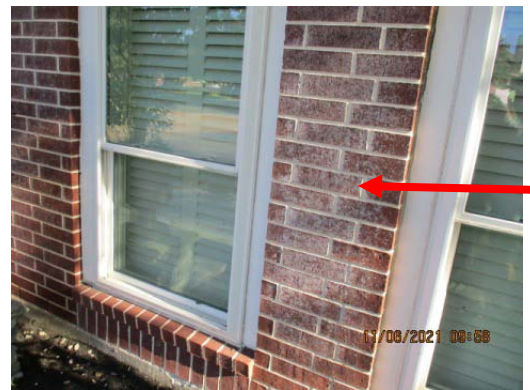
What appeared to be efflorescence was observed in multiple areas on the front wall of the home. Efflorescence is a deposit on surfaces of masonry, stucco or concrete & is white in appearance. Efflorescence has been a problem for many years & are, for the most part, water-soluble salts that come from many possible sources & there must be water present to dissolve and transport the salts. Groundwater is often a source of efflorescence.

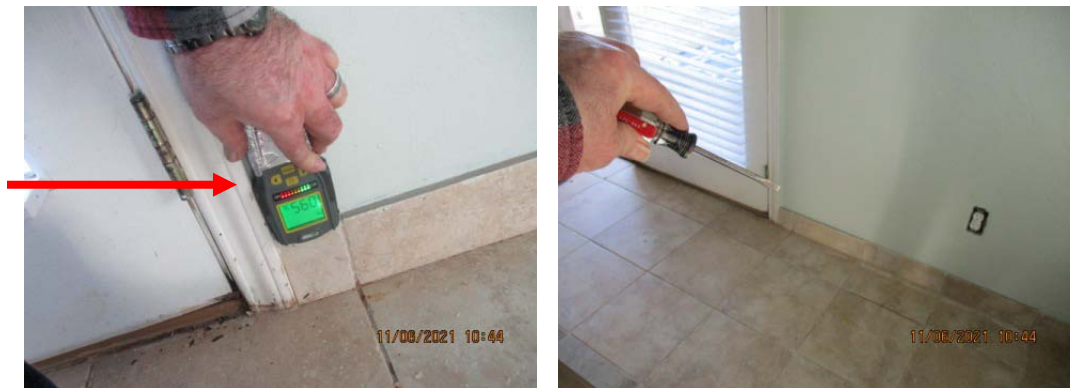
Existing/previous moisture penetration was observed but may not be limited to the base of the wall the storage area on the side of the garage. A moisture reading was performed & moisture was detected at the time of the inspection. Recommend further evaluation to determine if any hidden structure damage has occurred.

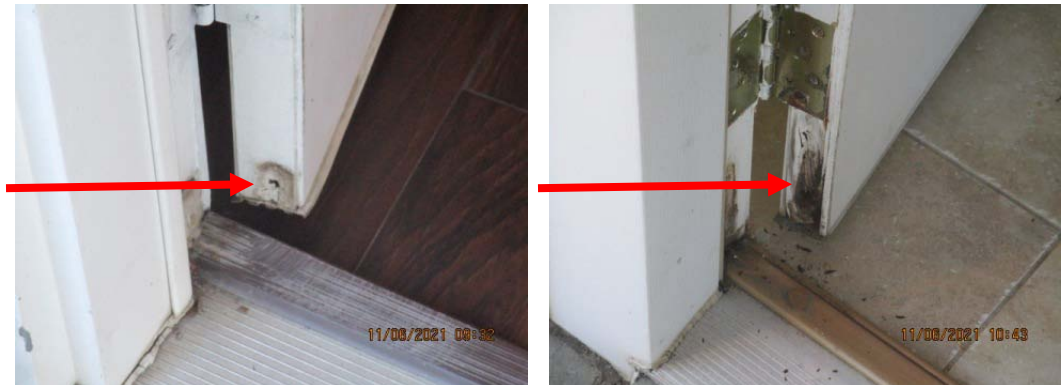
Damaged/decayed doors were observed at the base of the back door & door leading into the storage area off the garage. Recommend repair/replacing.

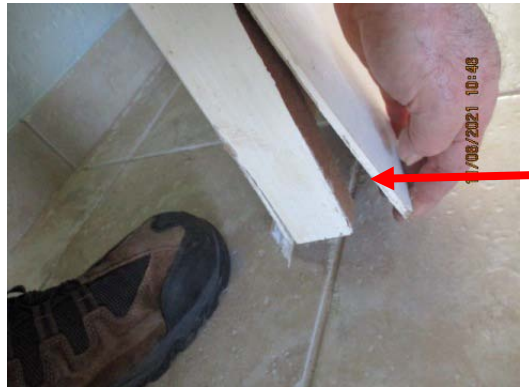
The door leading from the garage to the storage area off the garage is delaminating at the base of the door. Recommend repair/replacing.

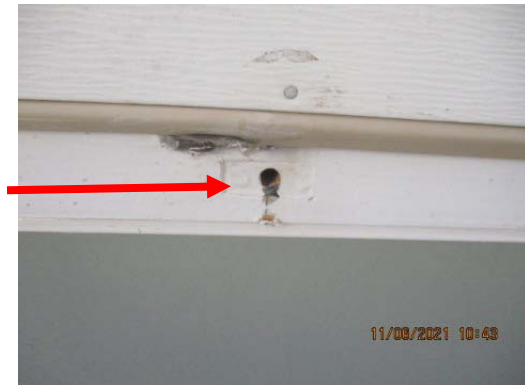
The top strike plate is missing at the double door leading into the storage area off the garage.

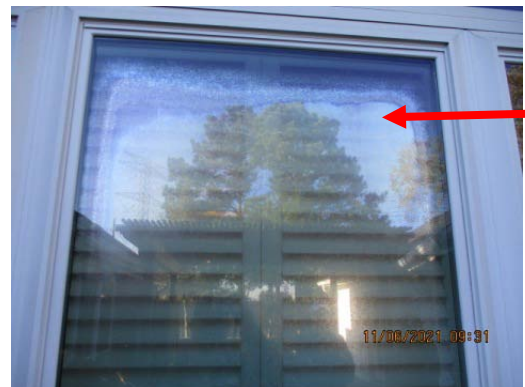
What appeared to be thermal pane/seal failure between the glazing panels was observed at the window in the main living area. Recommend replacing.

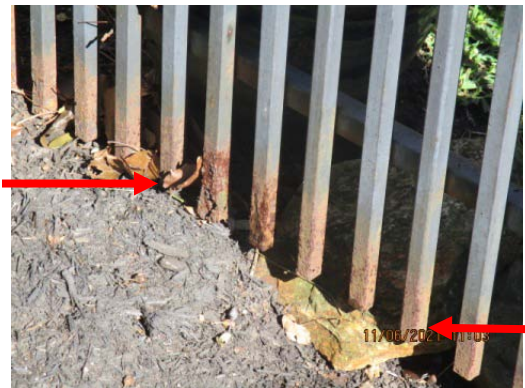
Fencing: Appeared to be functioning as intended however the iron fencing/material showed signs of aging/rusting damage in some areas. Recommend repair.

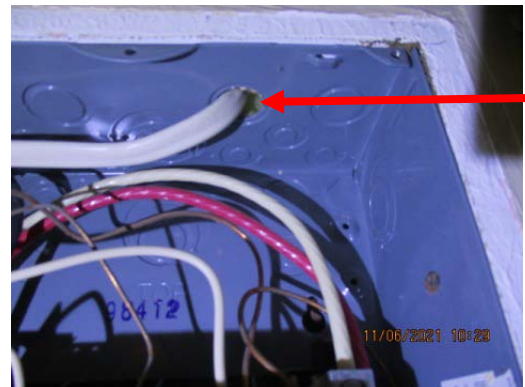
Conductors are not properly protected at penetration at the bottom, back & top of the panel.

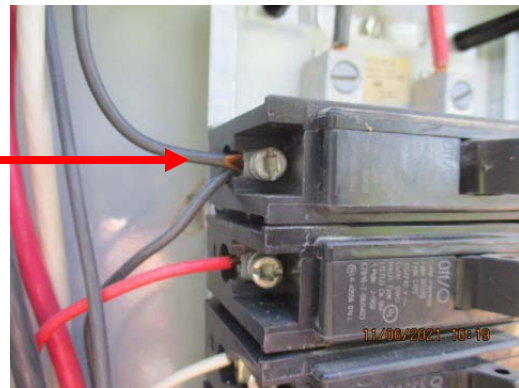
Double tapping of conductors was observed at the 20 Amp breaker at the top left side of the bus. Each neutral breaker should be single tapped. Recommend further evaluation/repair.

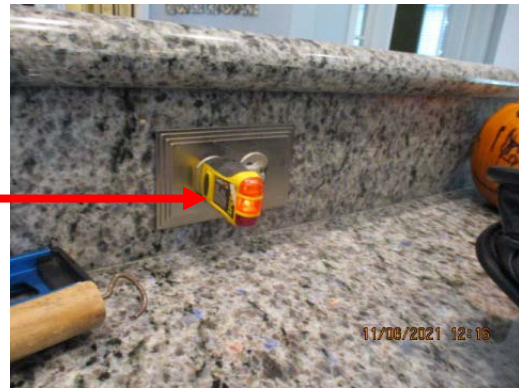
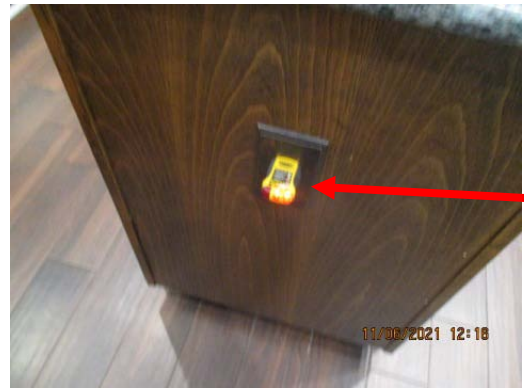
The outlets on the stove wall & at the island are not GFCI protected as required by today's standards. This is a safety issue, it is recommended that GFCI protection be added.

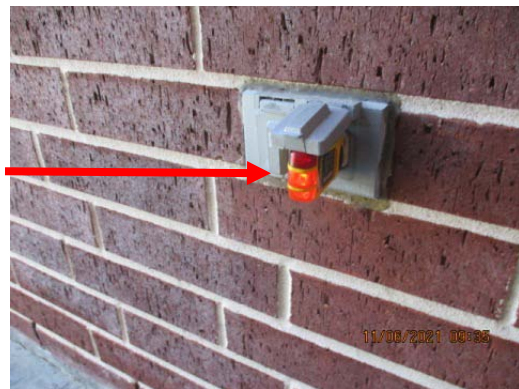
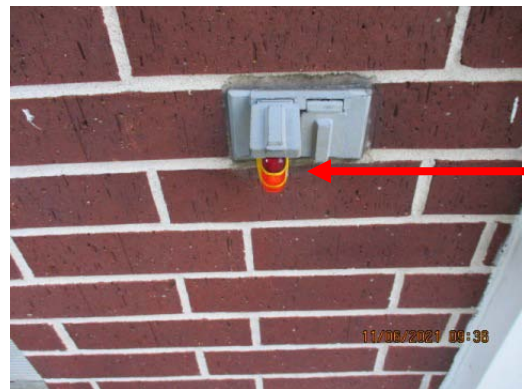
All of the exterior outlets are not GFCI protected as required by today's standards. Recommend adding GFCI protection as needed.

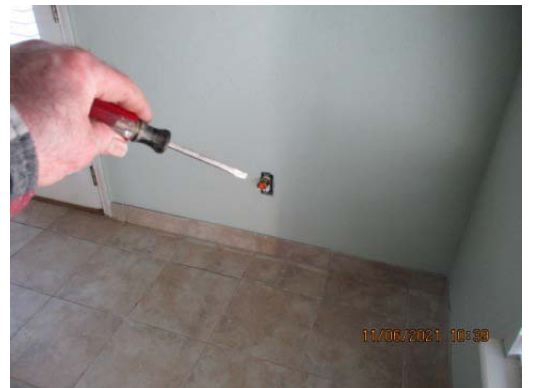
The outlet on the right wall in the storage area off the garage appears to have open ground. Recommend further evaluation.

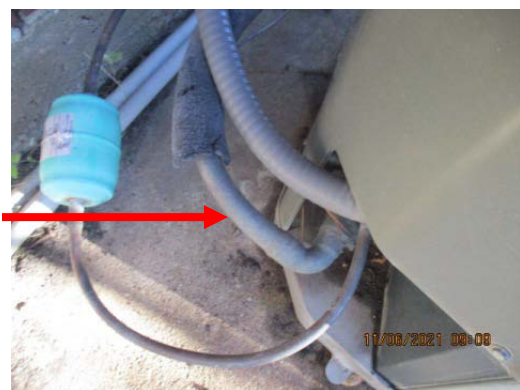
- Damaged/missing insulation on the refrigeration line was observed at the condensing unit. Recommend replacement.

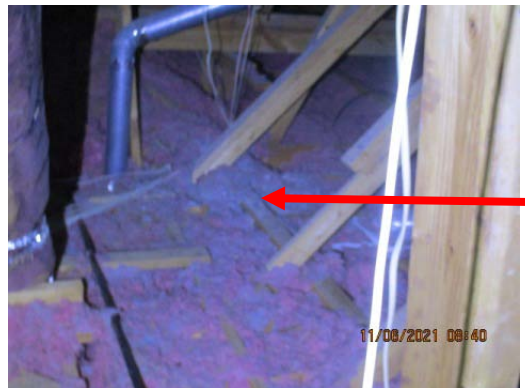
Dryer vent in the attic appeared to be dirty/filled with dryer lint & is dumping dryer lint into the attic space. This may be a potential fire hazard & should be properly cleaned.
