MOLD & MOISTURE INSPECTION REPORT

DATE: 01/20/2022

**PROPERTY: 10410 Gerlach St
Houston, TX 77034**

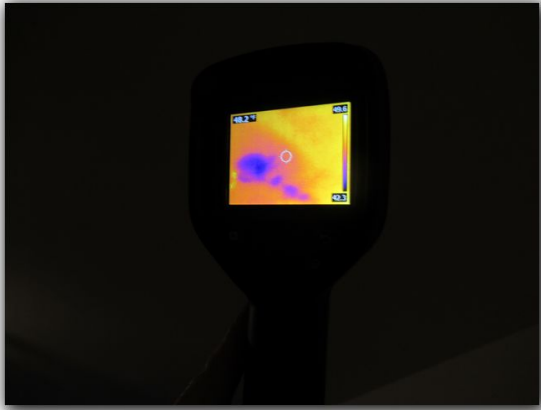
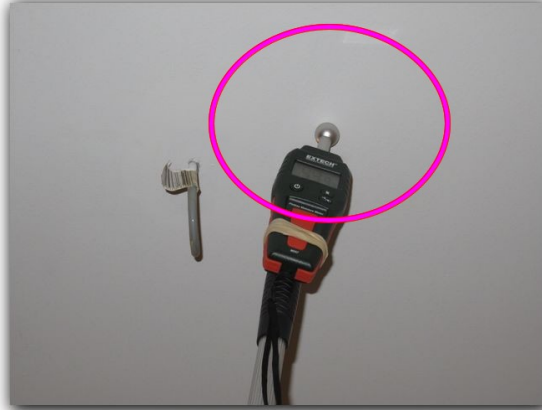
- **Garage;** Elevated moisture levels (wet) were evident in the left rear ceiling of the garage. This area is directly below an open attic space with no mechanical devices or plumbing. Leak may may due to a current or intermittent roof leak.

Home owner is advised to have the roof of the garage and attic space inspected for leaks by a qualified roofer. Once the source of the leak is addressed, any wet material should be removed and replaced.

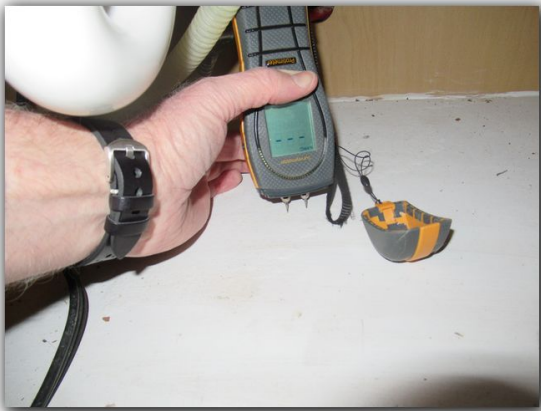
- **Kitchen Cabinet;** Moisture damage was evident under the kitchen sink cabinet, area tested dry at the time of the inspection. Damage appears to be from a previous leak.
