YOUR INSPECTION REPORT

2007 Town Hill Dr
Houston, TX 77062

INSPECTION DATE:
Saturday, June 2, 2018

PREPARED BY:
John Landry - License 21080

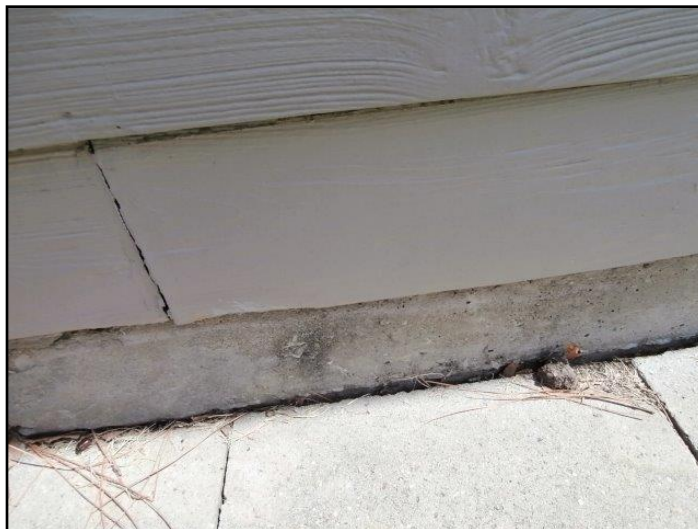
2. Condition: • Some wood rot/wear observed at base of siding at rear of garage. Some general wear to siding observed in various locations.

Task: Remedy as needed

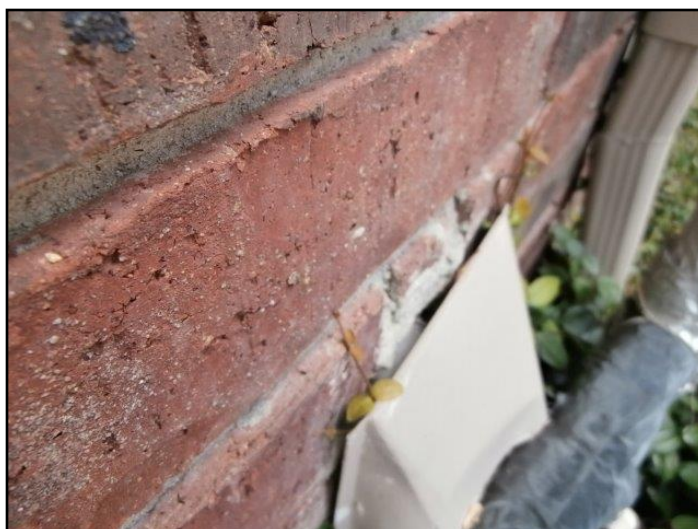
3. Condition: • Seal gap at dryer vent cover at the brick veneer at the left side of the dwelling.

Task: Remedy as needed

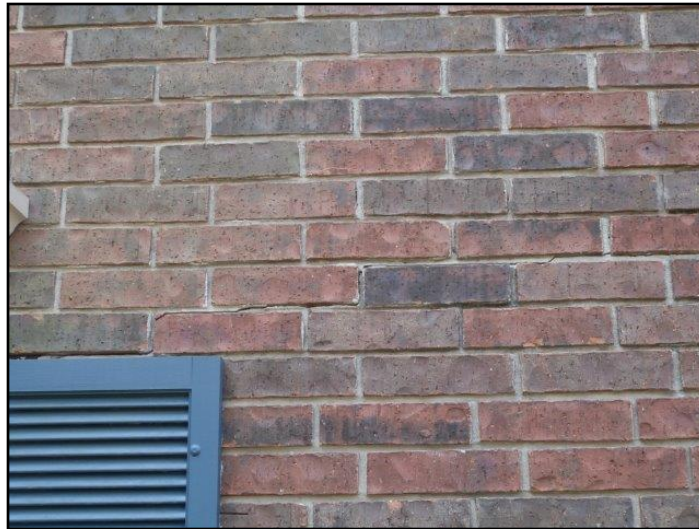
4. Condition: • Note: Cosmetic hairline cracks are observed in the masonry siding. Hairline cracks may be a result of thermal expansion of the veneer and/or normal structural movement.

Note: Cosmetic hairline cracks are observed...

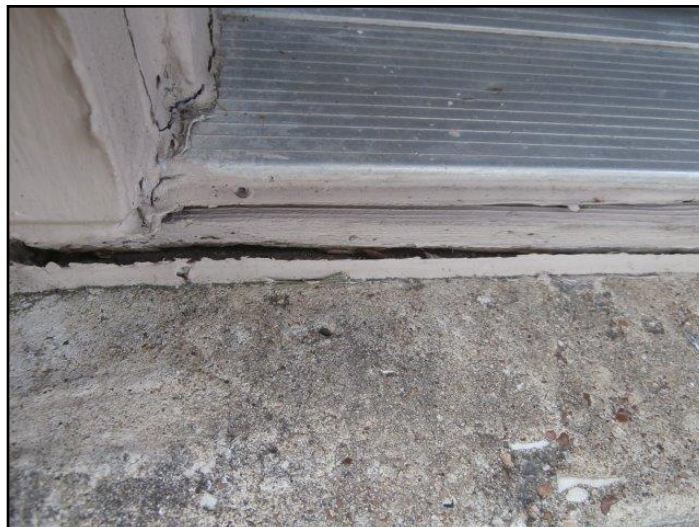
5. Condition: • Some rot observed at the rear door threshold.

Task: Remedy as needed

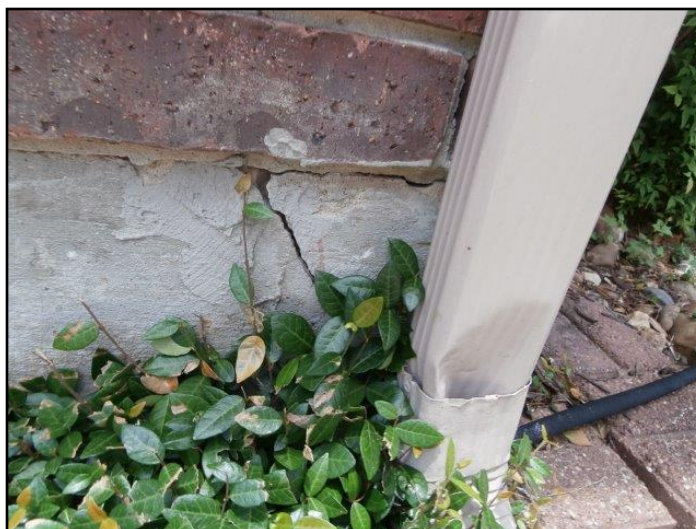
8. Condition: • Note: Shear cracking ("corner pops") observed at foundation corners is not normally associated with structural movement or deficiencies.

Note: Shear cracking ("corner pops")...

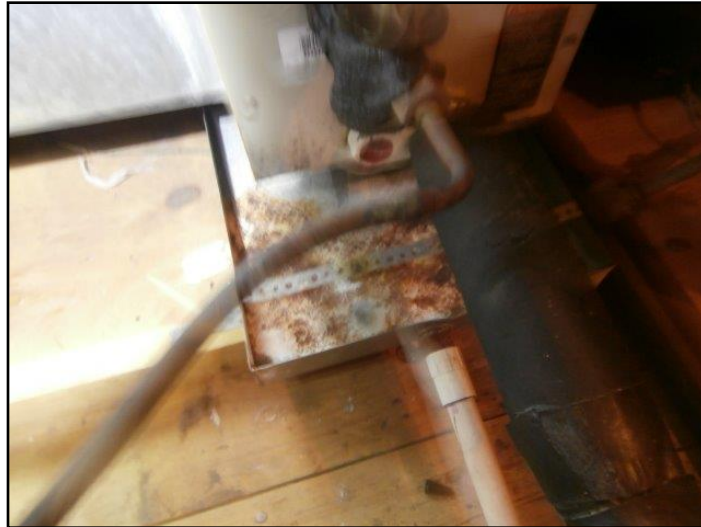
15. Condition: • Rusting in the evaporator condensate overflow pan indicates possible blockage of the condensate drain line(s) and a dirty evaporating system: service of the system is recommended.

Task: HVAC Company evaluation is recommended

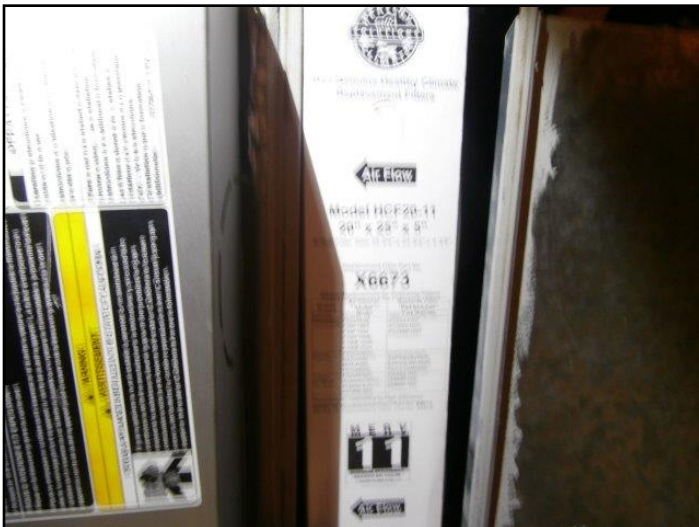
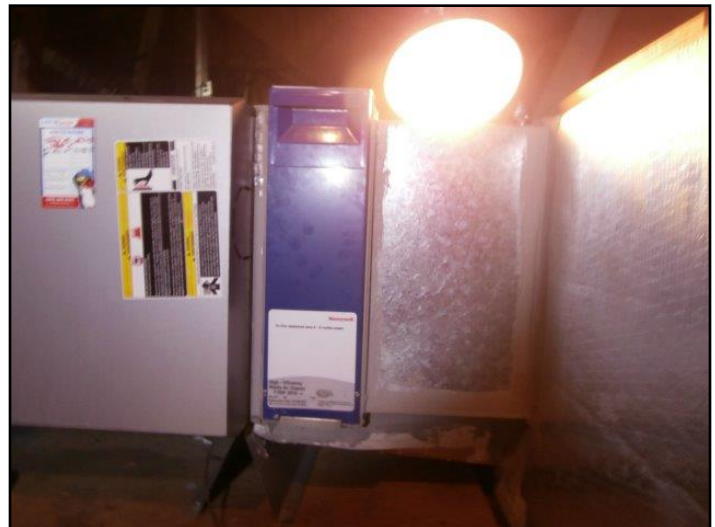
16. Condition: • Note: Media filter is located at the HVAC cabinet. This filter should be replaced every 6-12 months.

Note: Media filter is located at the HVAC...

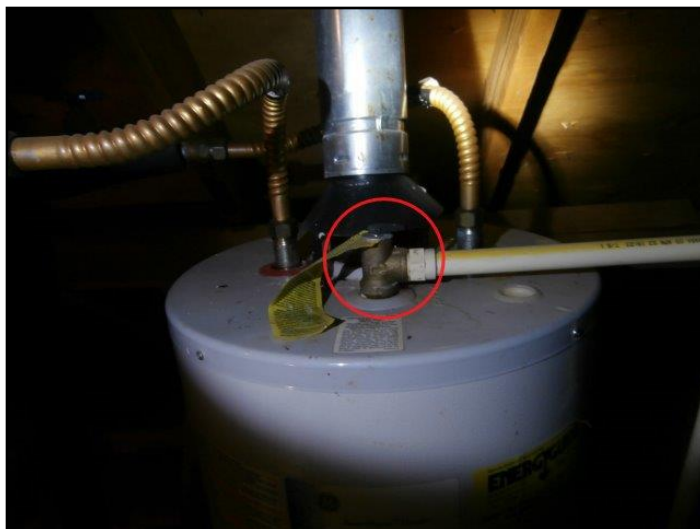
17. Condition: • Note: The manufacturer recommends replacement of the pressure relief valve every three years to ensure proper emergency function. Inspection company does not test TPR valves due to safety hazard or possible damage to unit.

Note: The manufacturer recommends...

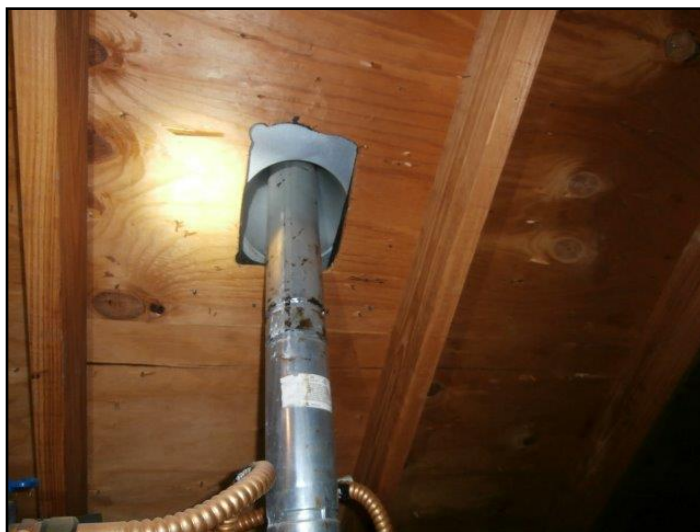
18. Condition: • The water heater combustion vent pipe is not properly supported / secured with strapping: remedy as needed.

The water heater combustion vent pipe is no...

Task: Remedy as needed

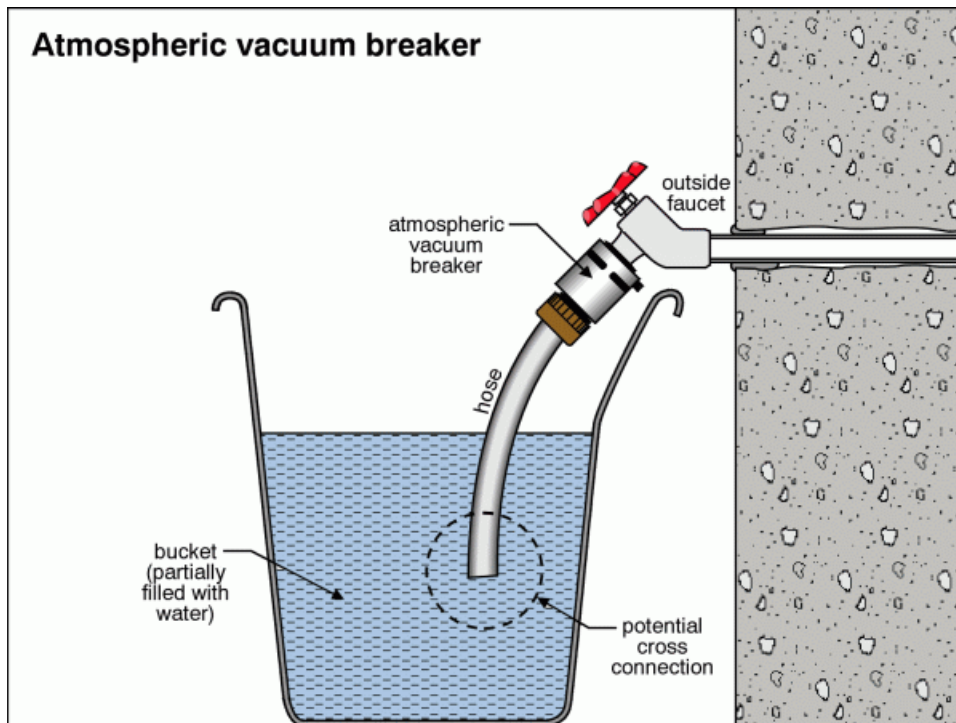
19. Condition: • [Backflow prevention missing](#)

Task: Remedy as needed

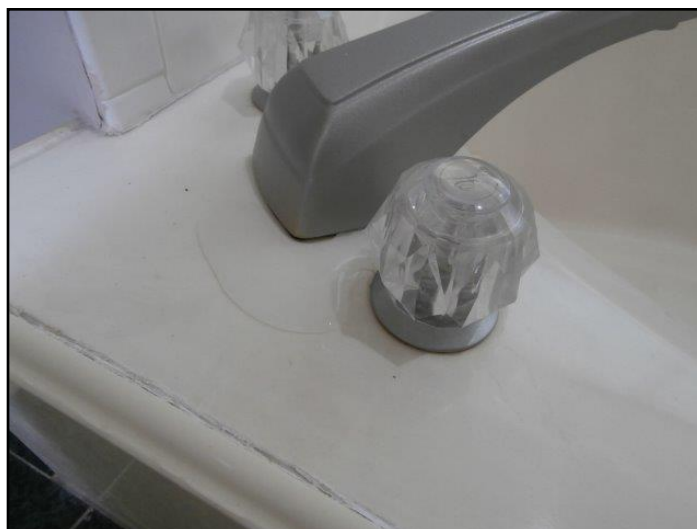
20. Condition: • Leaking faucet stem

Leaking faucet stem

Task: Remedy as needed

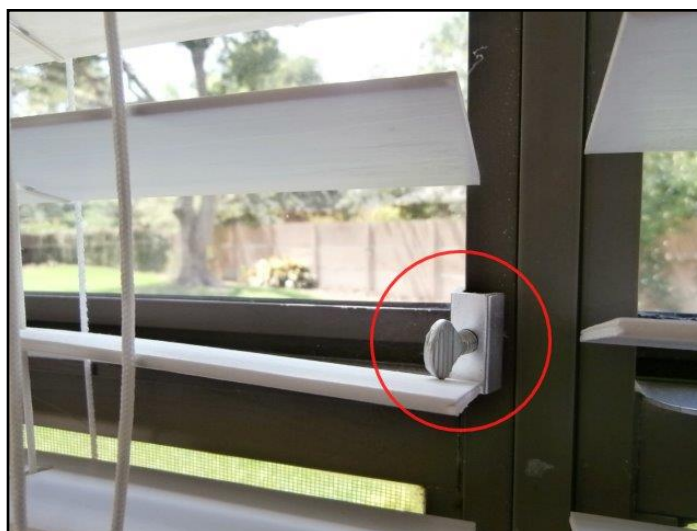
27. Condition: • Note: Most of the windows have an additional lock installed.
