## ***PROPERTY INSPECTION REPORT***

**Prepared For:** Afshin Gazerzadeh  
(Name of Client)

**Concerning:** 13822 Senca Park Drive, Houston, TX 77077  
(Address of Inspected Property)

**By:** Arash Dinyarian, TREC: 22735 08/02/2021  
(Name and License Number of Inspector) (Date)

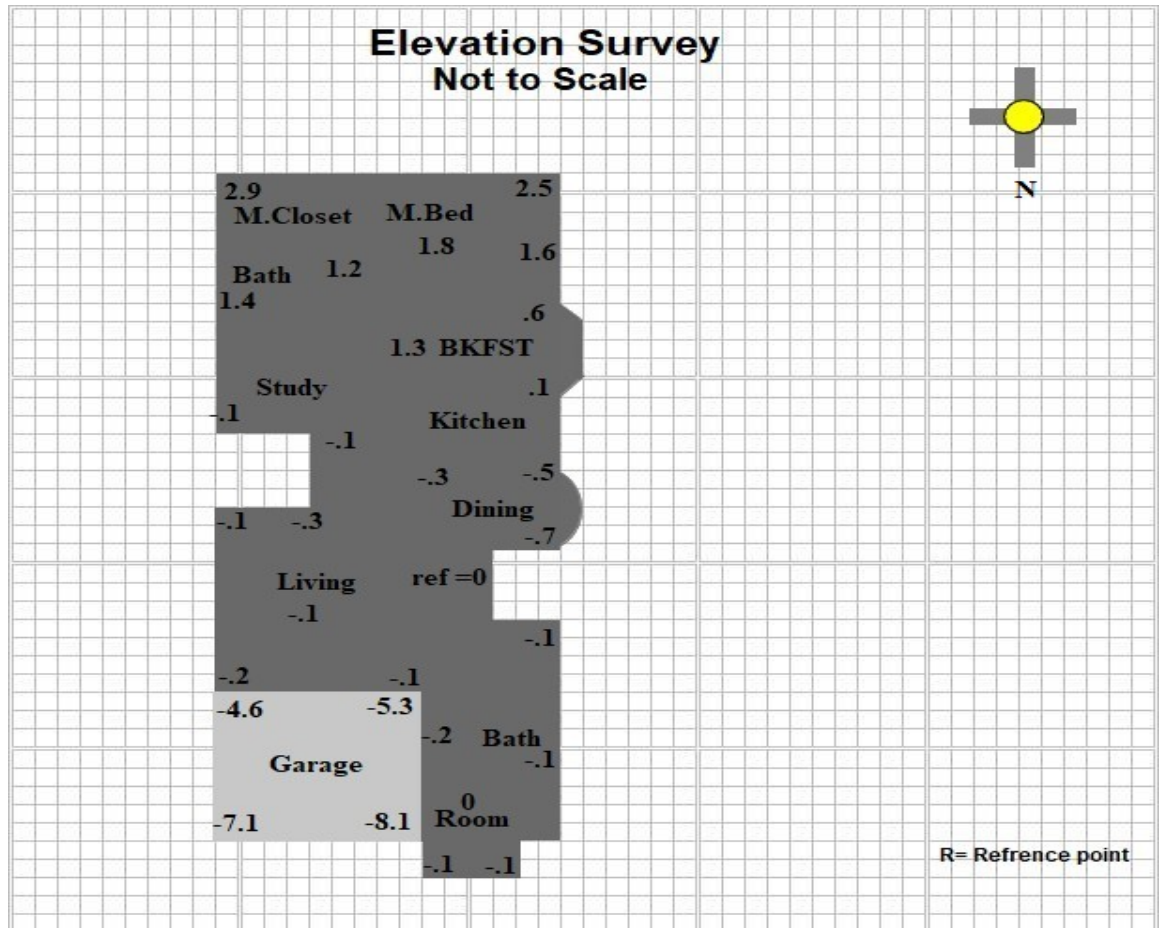
**Differential movement/settlement observed; indicated by one or more of the following observed conditions; Elevation readings, Cracks in brick veneer and/or foundation, Cracks in sheetrock over doors and windows, doors that are not square in the jamb, etc. In my opinion, the distress patterns observed at the time of inspection indicate that the foundation is not performing its intended function. Acceptance of present and future condition/performance/maintenance rests solely on the buyer.**

A foundation elevation survey was conducted during the inspection. The floorplan below represents data gathered using a Zip Level or similar instrument and adjusting for floor covering height differences. i.e. differences between tile, carpet and wood flooring(except step down to garage). Measurements are listed to the nearest 1/10th of an inch. Greatest variance was 2.9" and -.7"

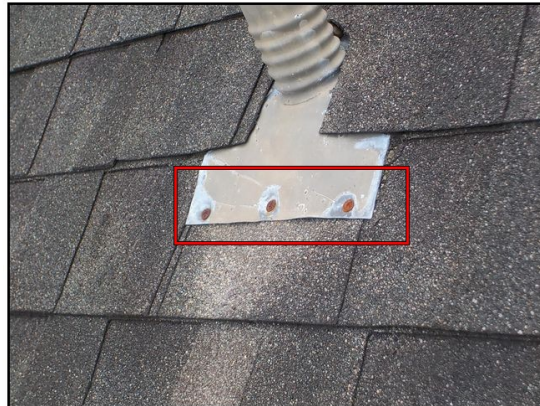
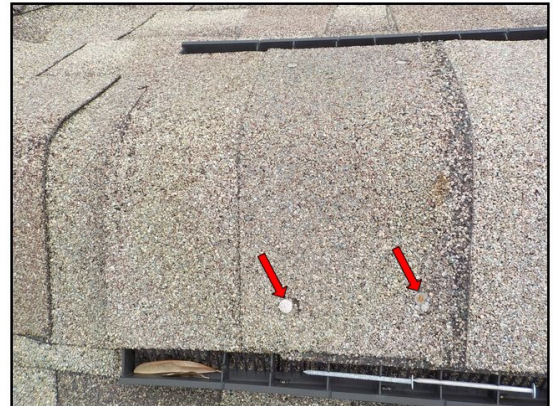
Exposed staples/nailheads/fasteners observed on the roof are not properly sealed. Water entry possible.

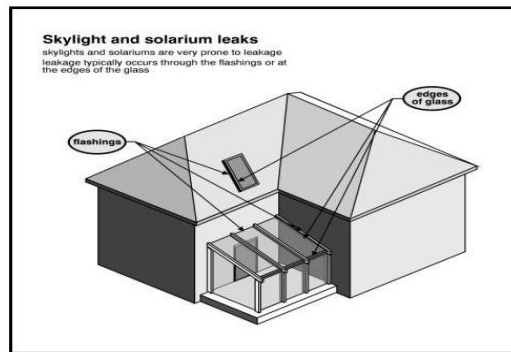
Roof skylight(s) are a likely place for water penetration, make sure flashing and glass edges are maintained.

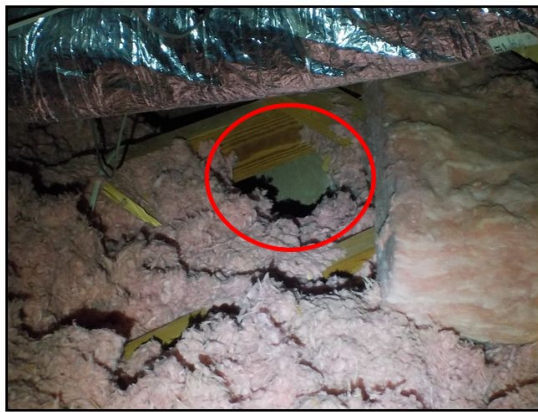
Open chases in the attic are not sealing/fire-stopped to the living area below. The current status does not comply with current industry standards, Code. (IRC 602.8).

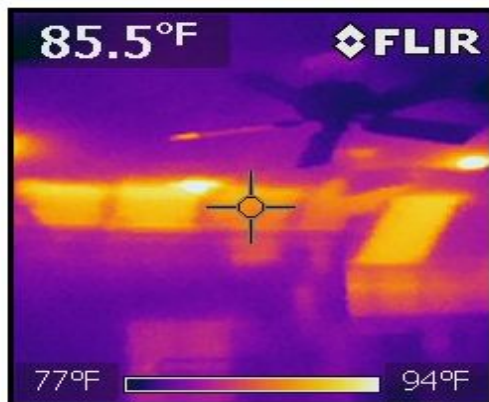
Insulation not properly positioned/missing in areas, etc.

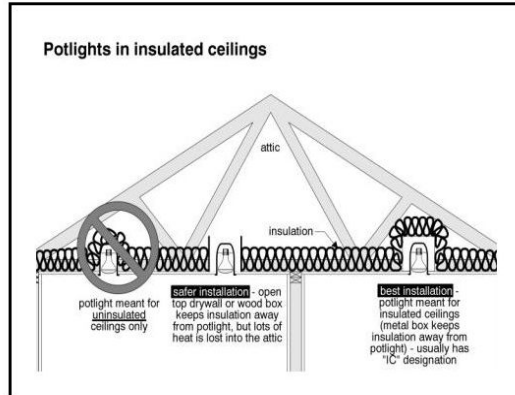
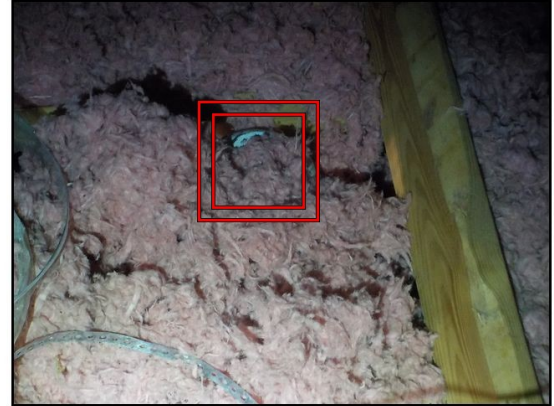
Ensure insulation has maintained a minimum of 3 inches and wood a minimum of 1 inch from around all recessed lights to reduce possible fire hazards.

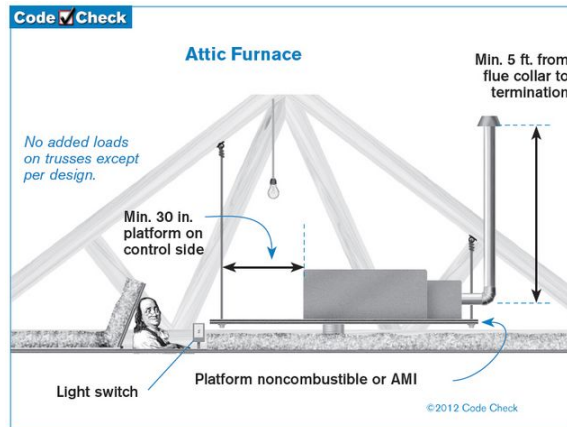
Floor decking in the attic is inadequate for service personnel servicing the HVAC system. Code [IRC 1305.1.3] requires a minimum of a 30-inch deep platform in front of the unit.

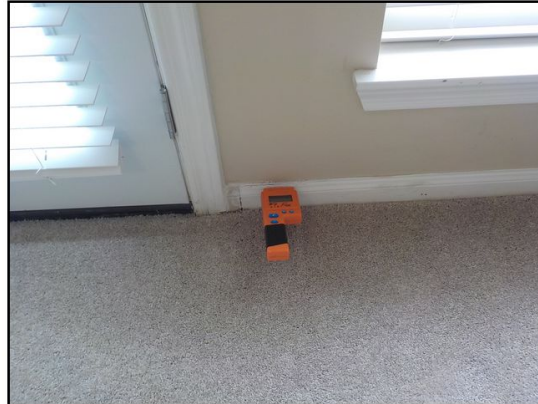
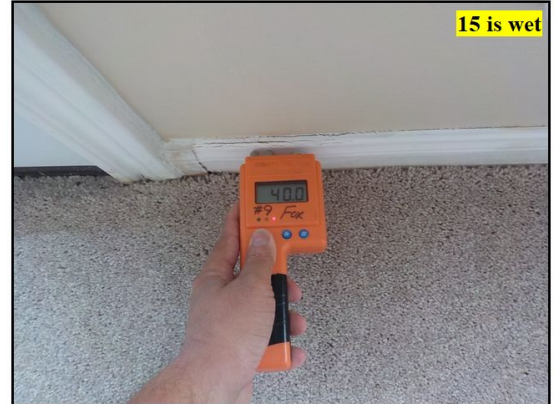
**Moisture meter registers water stains as active; base of master bedroom back door.**

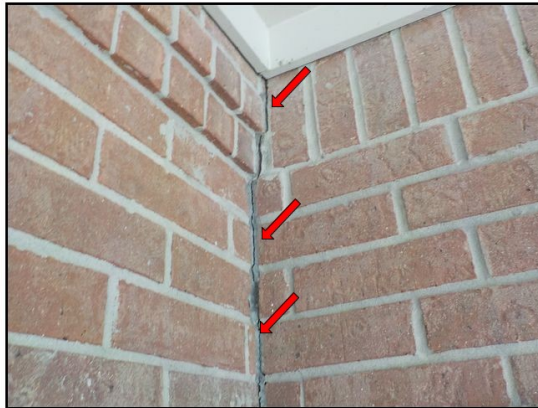
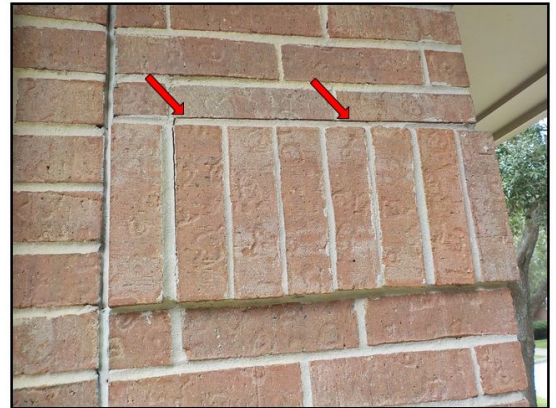
Caulking missing and/or deficient around windows / vertical trim / joints in siding. May allow wind driven rain entry.

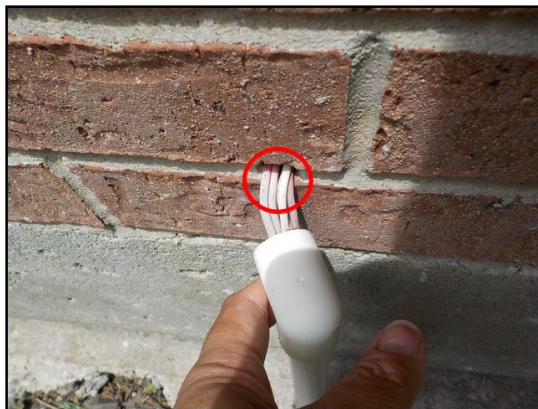
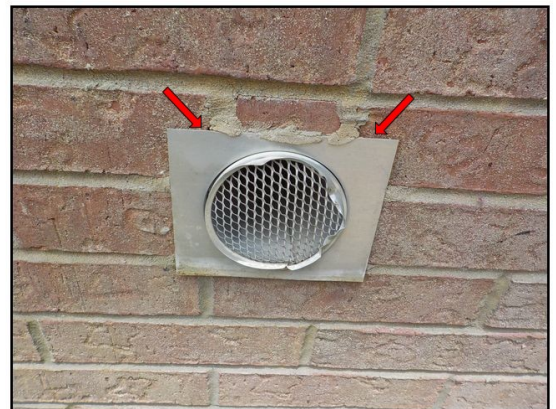
Need sealing/caulking around all holes and exterior siding penetrations on top and both sides, (leave the bottom open) to prevent water entry. Including but not limited to dryer, bath and range top vents, light fixtures, etc.

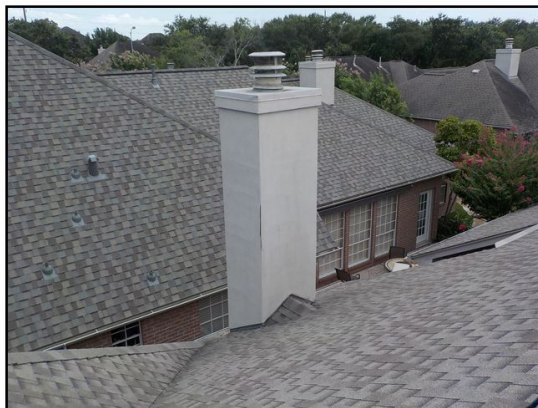
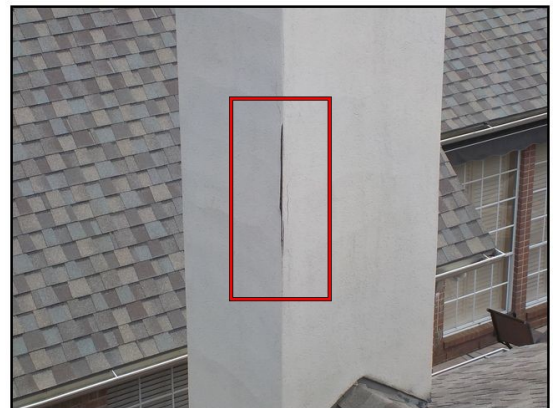
Possible water entry from cracks and/or penetrations in stucco siding, Recommend sealing/caulking around all cracks and exterior siding penetrations including but not limited to light fixtures, electrical outlets/service panels, dryer, bath vents, etc.

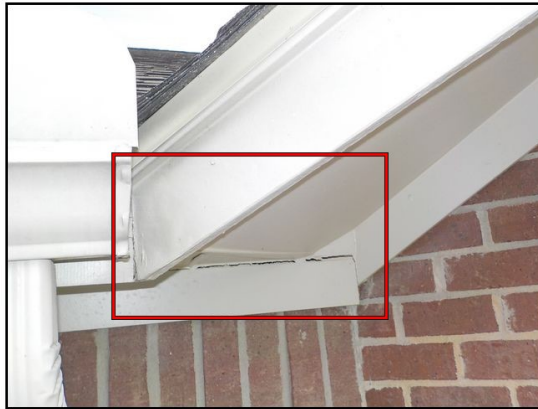
Wood rot observed on areas of house/garage. (north side of the house).

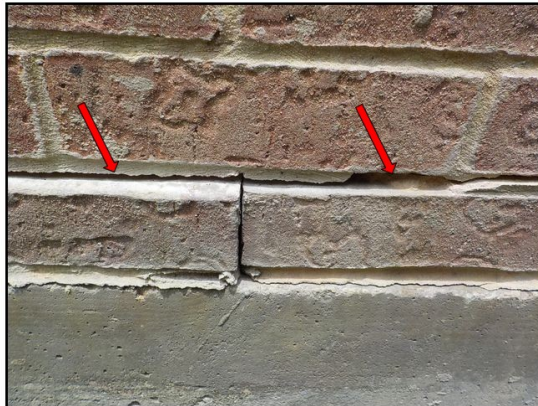
Cracks in brick veneer and/or repairs, one or more locations, Recommend buyer take photographs of cracks, their location, and width [ruler across the crack] with a high-resolution camera that has a date stamp for future reference.

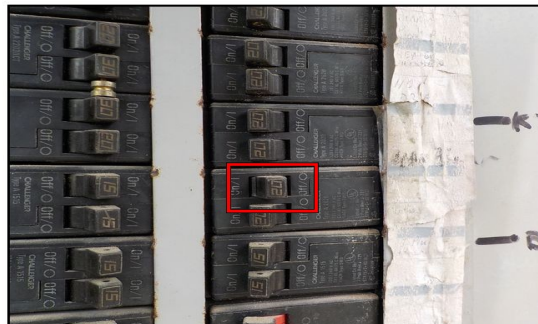
One or more breaker(s) were off at the time of inspection. Inspector does not turn on breakers found in off position due to potential short/electrical problem, recommend inquiring seller regarding information regarding any/all breaker(s) found in the off position.

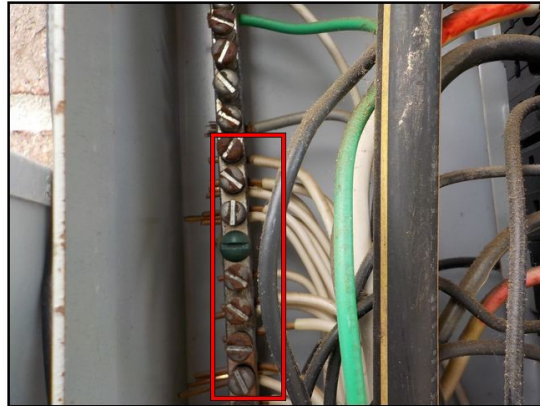
Observed two or more neutral conductors under one screw lug on the neutral bus. Current industry standards and National Electric Code permit one neutral conductor per screw lug.

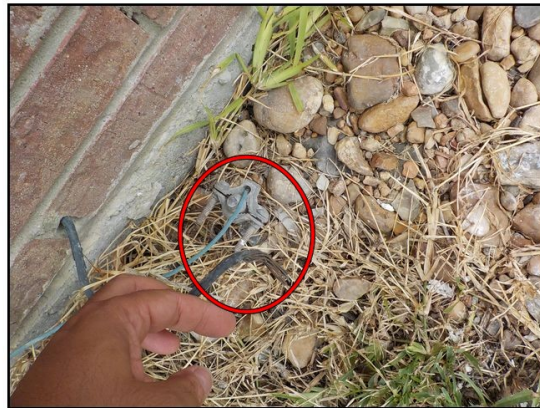
Ground clamp and/or wire not secured to ground rod below service meter.

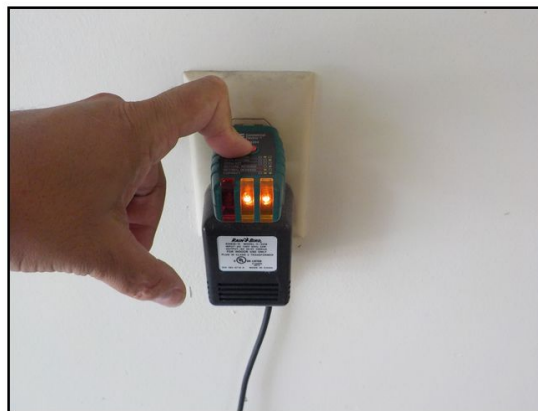
**GFCI outlet does not operate properly when tested with simulated short; in west wall of garage.**

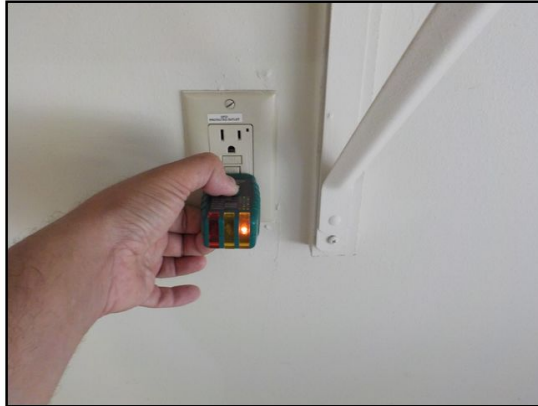
Did not observe GFCI protection of all outlets in required locations, including but not limited to the location marked below. This condition is a recognized safety hazard and needs repair.

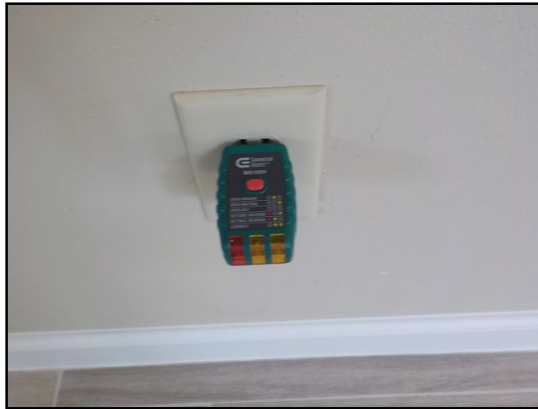
Outlet(s) found to be worn, does not hold the plug securely, recommend replacement, including but not limited to; in living room, some in master bedroom.

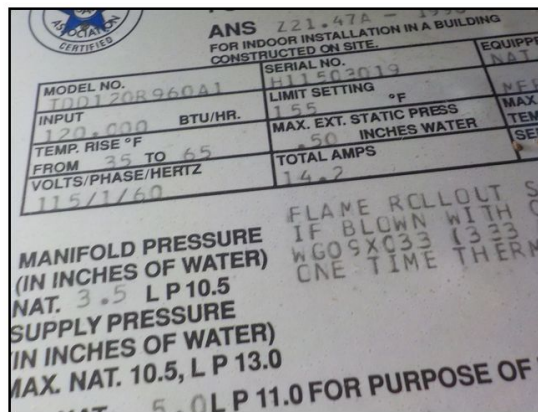
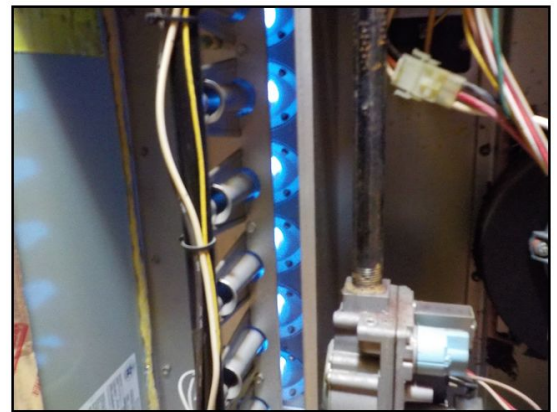
Age: 28 YEARS

**Furnace unit has exceeded its normal serviceable life span, replacement should be expected and budgeted for in the near future. Before use, recommend a qualified/licensed HVAC technician verify the integrity of the heat exchanger. a cracked exchanger allows combustion gasses (carbon monoxide, etc.) to circulate through air ducts.**

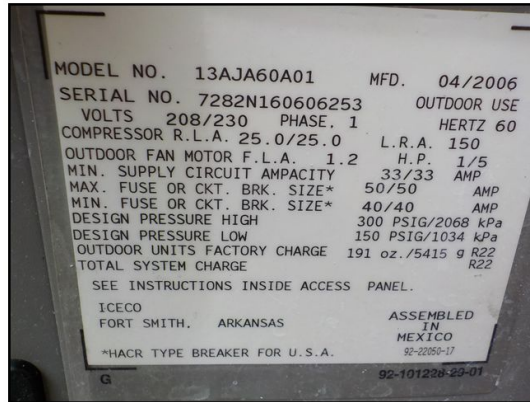
Make: ICECO  
Age: 15 YEARS  
Capacity: 5 TON

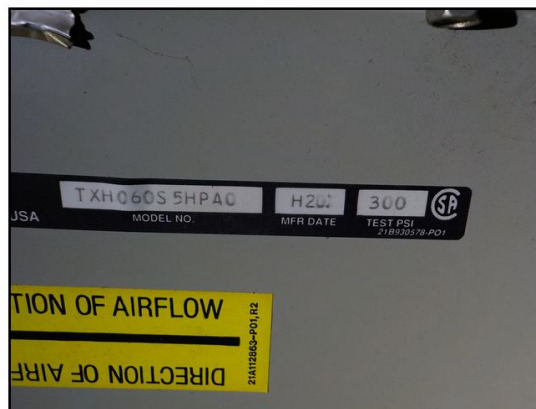
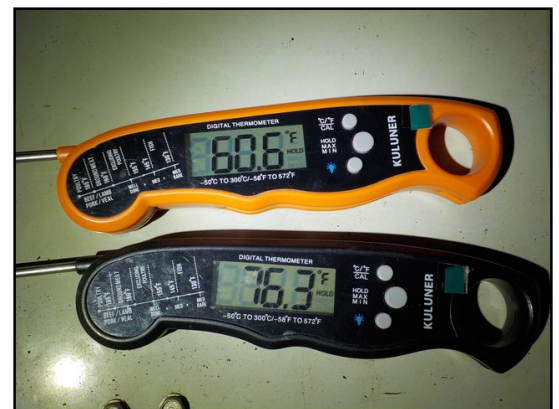
Age: Appeared to be 1993

**Recommend qualified/licensed HVAC technician service/repair/replace as needed. Not cooling well.**

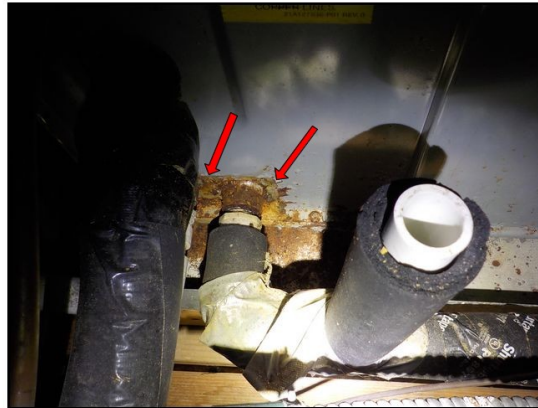
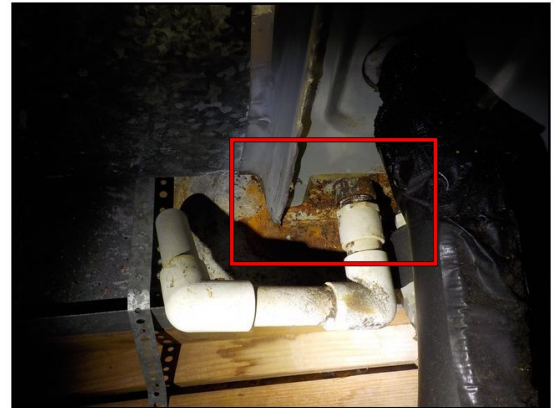
**The unit has exceeded its normal serviceable life span; replacement should be expected and budgeted for in the near future.**

The bottom of the casing has rust pitting, evidence of limited serviceable life.

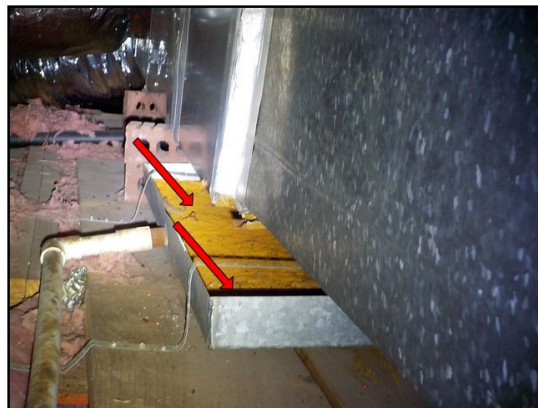
Secondary drain pan is very rusted, recommend replacement.

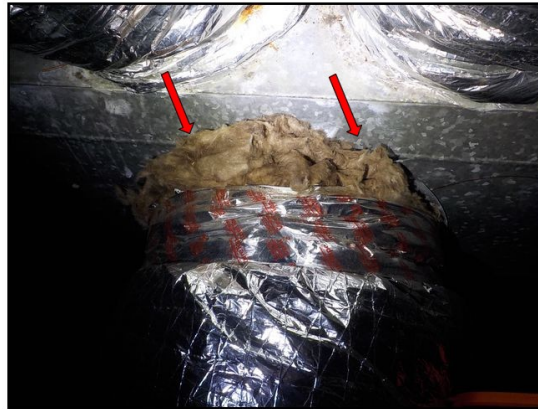
Observed several/multiple areas in the attic where flex duct mechanical connection zip ties are not snug fit / are loose as required by current industry standards. Appears proper use of a zip tie synching tool was sporadic. Loose mechanical connections increase the chance of duct separation in the future, recommend repair.

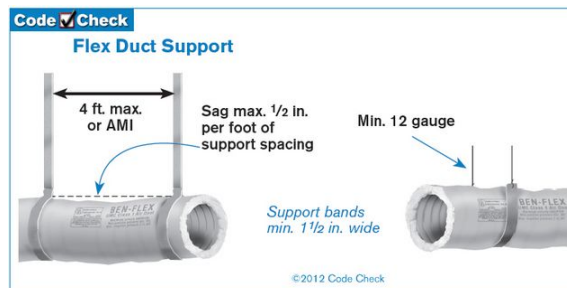
Some flex duct observed to be routed improperly, not to manufacturer's installation instructions. Recommend additional support and/or routing ducts to eliminate “snaking” drooping or crimping of flex duct more than 1” per foot which adds unnecessary additional resistance.

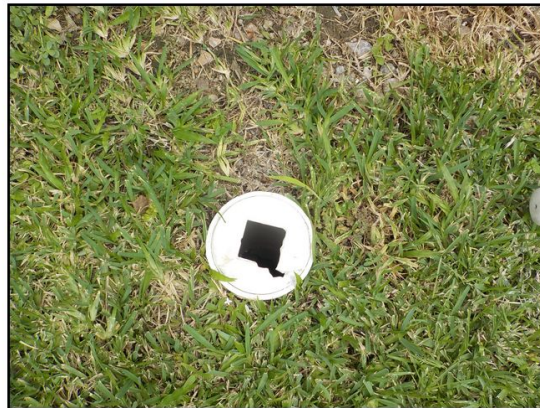
Missing/damaged drain cleanout cap,

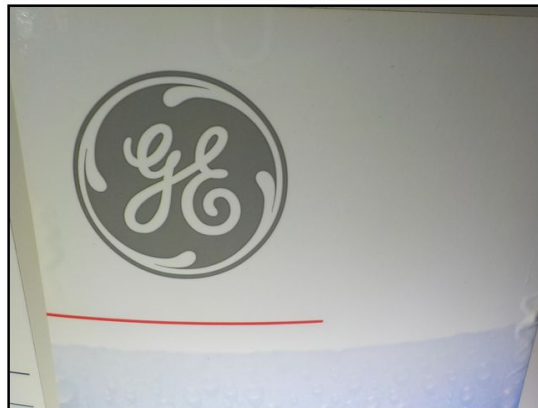
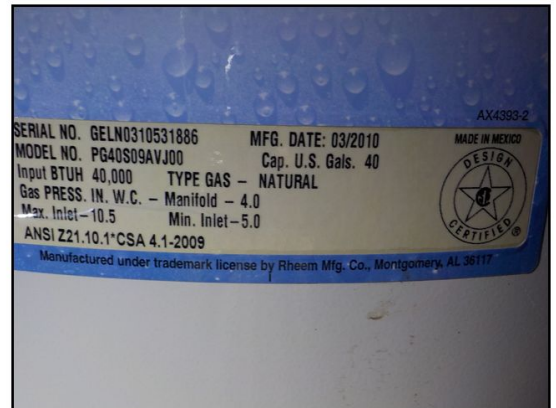
Manufactured in: 2010

**At or near the end of serviceable life. The client should budget for repair/replacement.**

Drain pan is very rusted, recommend replacement.
