November 18, 2021

PROPERTY INSPECTION REPORT

Concerning: 1519 Prince Street, Houston, TX 77008
(Address or Other Identification of Inspected Property)

By: Kyle Coats, Lic #22450 11/18/2021
(Name and License Number of Inspector) (Date)

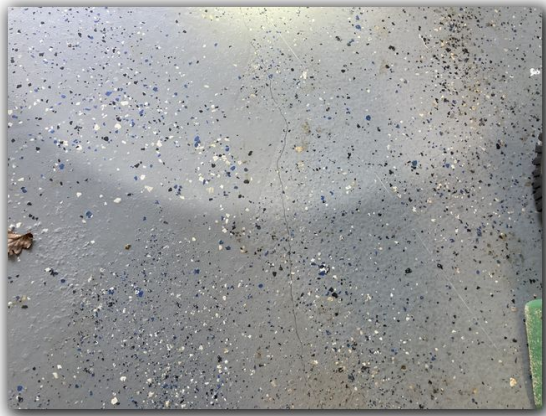
General Comments
Shrinkage cracks were observed at various visible locations on the foundation / concrete floors. Cracking is a normal property of concrete as it dries and shrinks during the curing process. Additional shrinkage cracks may be present under the floor coverings in the structure.

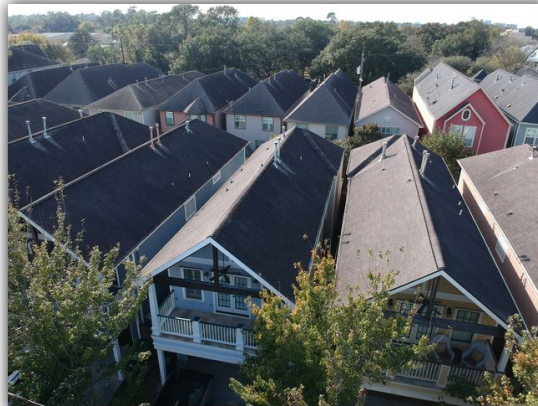
The roof covering appears to be nearing the end of its serviceable life. The roofing shingles have experienced severe loss of aggregate, curling, and cupping. A qualified tradesman should be consulted to evaluate the roof covering to determine if repairs can be performed or if replacement is needed.

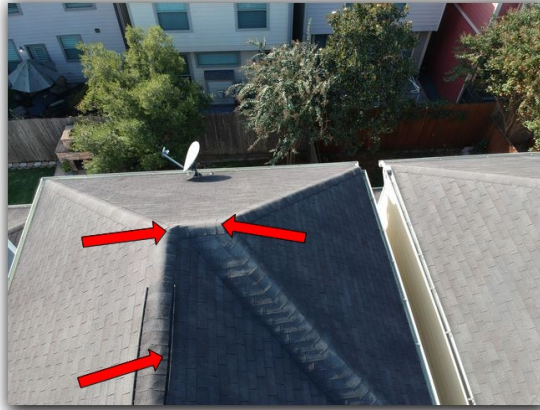
Damaged and / or missing shingles were found during the inspection of the roof covering. Recommend repairs by a qualified tradesman.

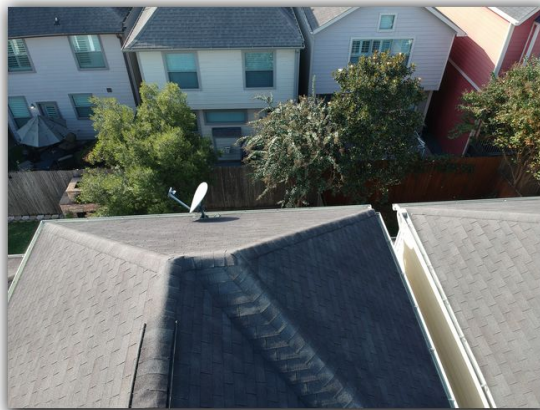
The fasteners used to secure the satellite dish to the roof should be sealed to prevent future roof leaks.

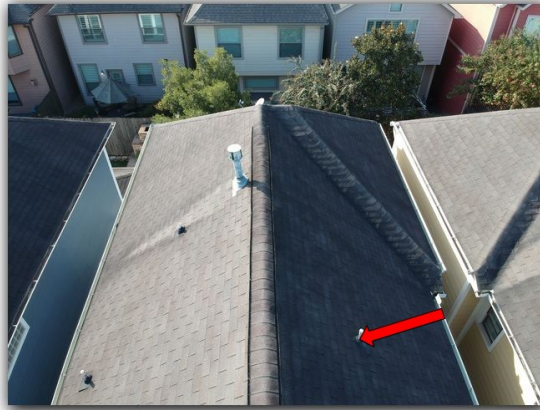
Cracked and damaged rubber / neoprene roof jacks were found. Recommend repairs or replacement of the roof jacks by a qualified tradesman.

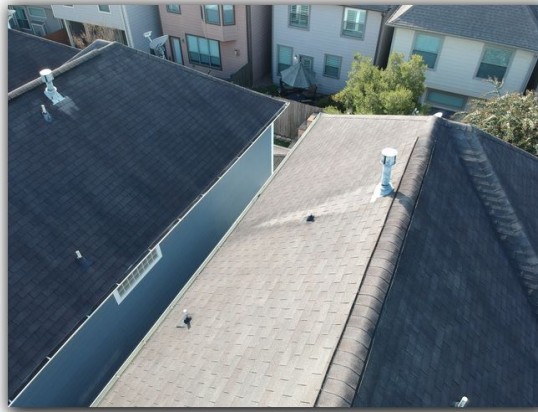
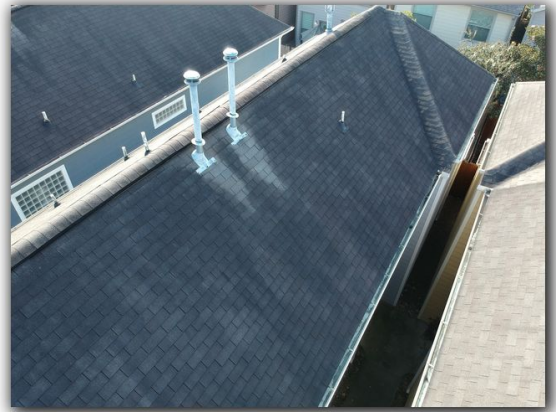
Loss of aggregate was noted during the inspection of the roof covering as evidence of aging.

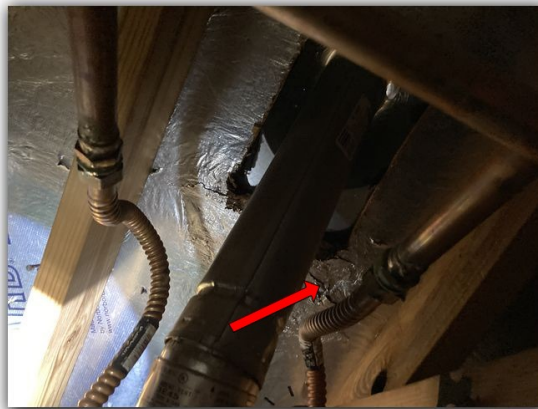
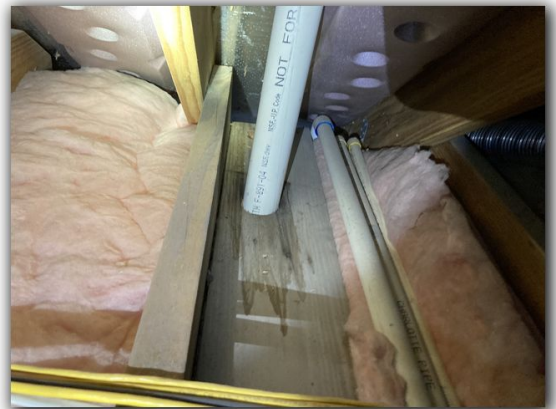
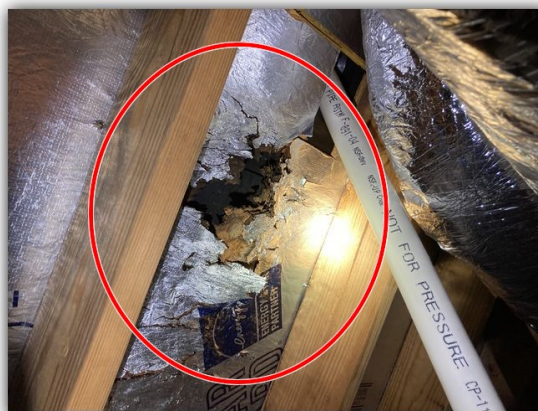
Staining was found at sections of the roof decking as evidence of active roof leaks. A qualified tradesman should further evaluate the roof and make the necessary repairs.

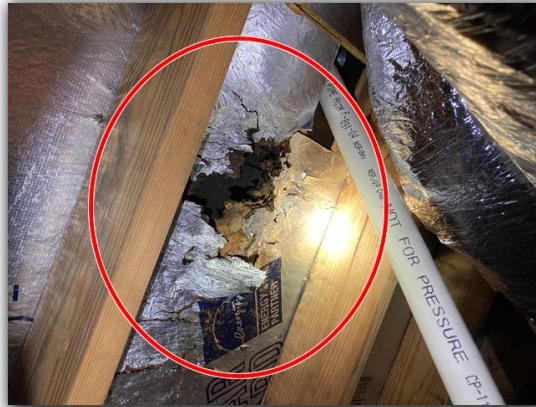
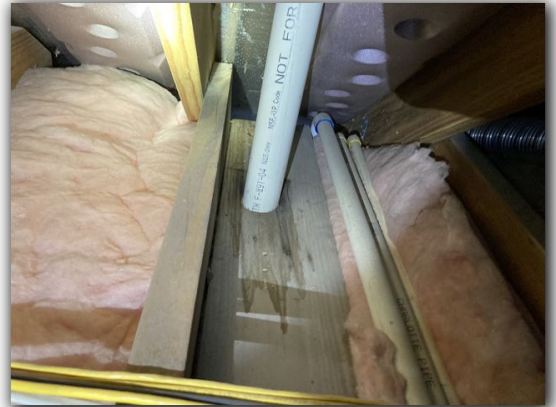
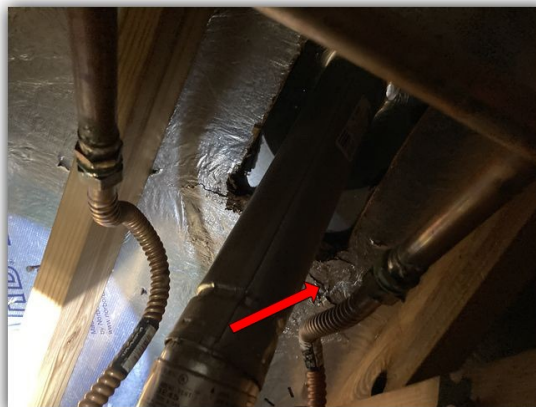
During the inspection of the roof covering active and / or previous water penetrations were observed. The client should advise the roofing tradesman to evaluate the roof decking during repairs to determine if hidden / concealed damage is present that is in need of repairs.

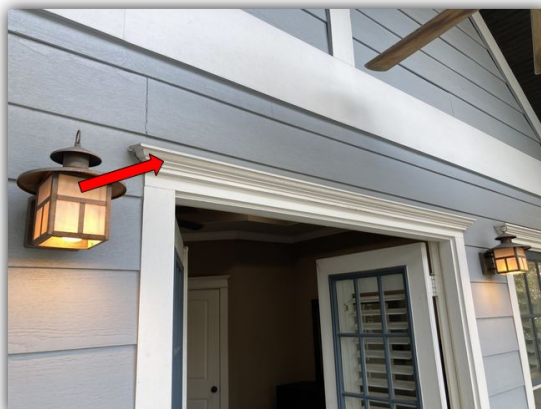
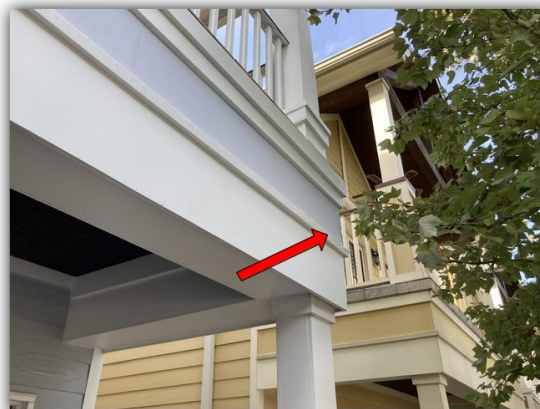
Areas where decay is present should be removed, exposing underlying materials for inspection prior to repair.

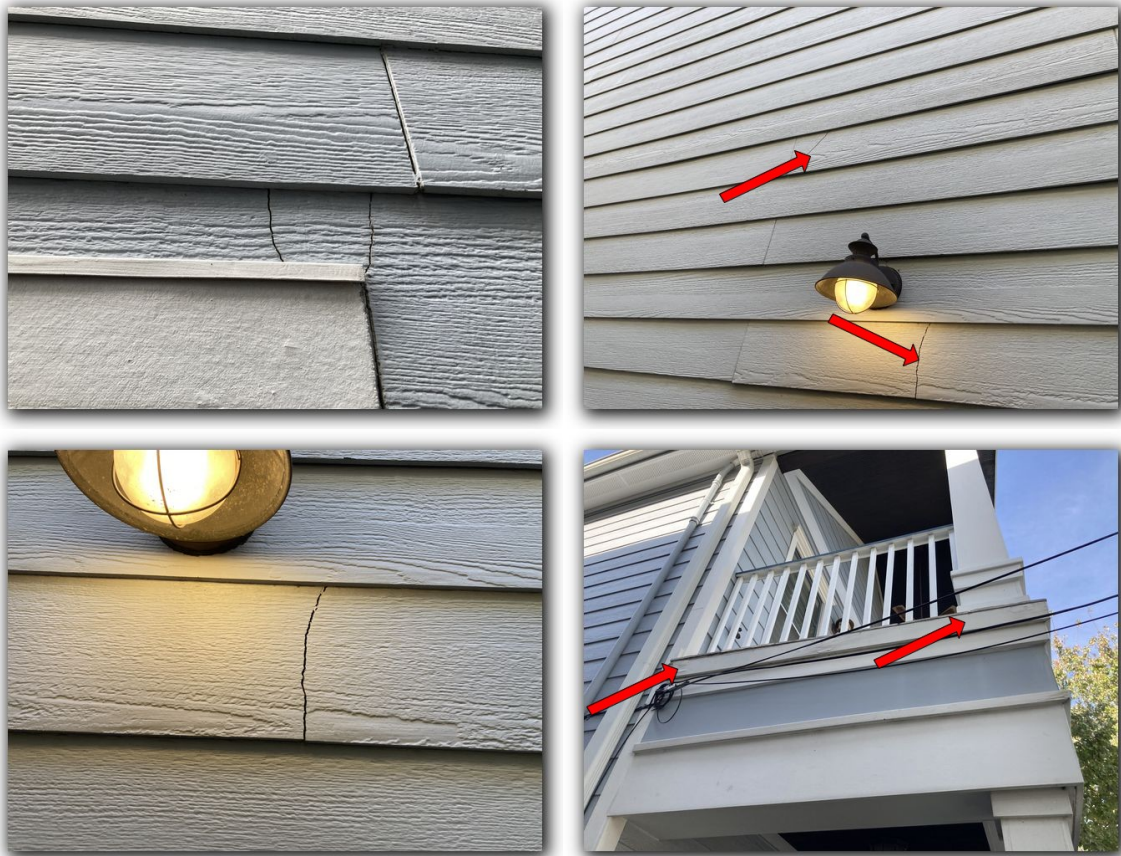
Damaged and / or missing items were found on the exterior of the property. Recommend repairs / replacement of the affected areas. In addition, areas where decay is present should be removed, exposing underlying materials for inspection prior to repair by a qualified tradesman.

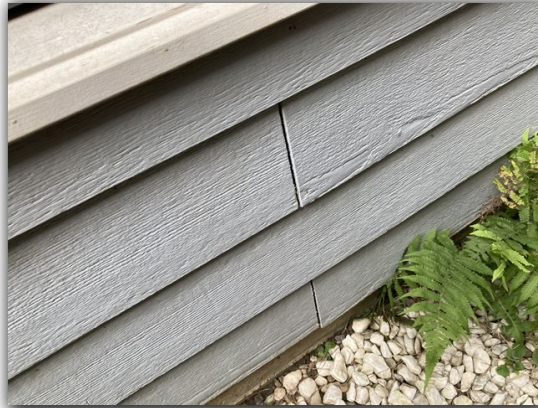
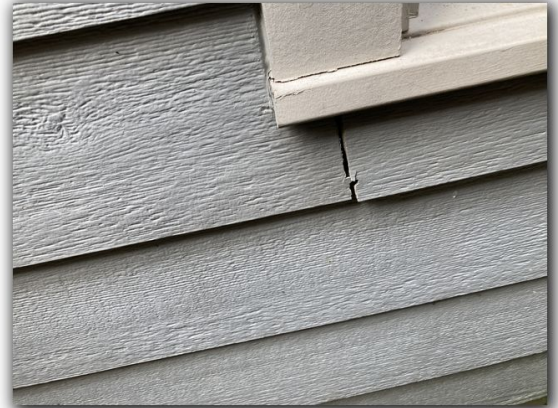
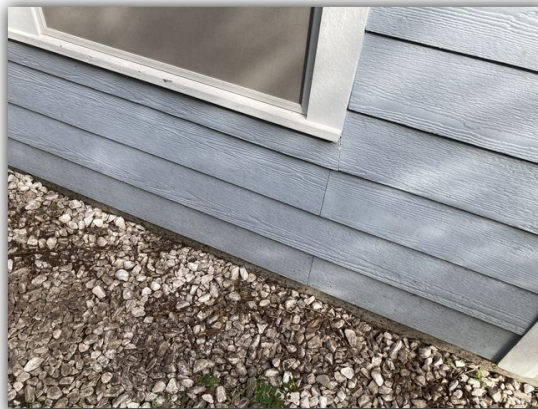
Damaged and missing sealant / caulking was found at joints, transitions, and voids on the exterior veneers. This material acts as a moisture barrier to prevent water from moving to the underlying wall cavity. The re-sealing of the exterior veneers should be considered.

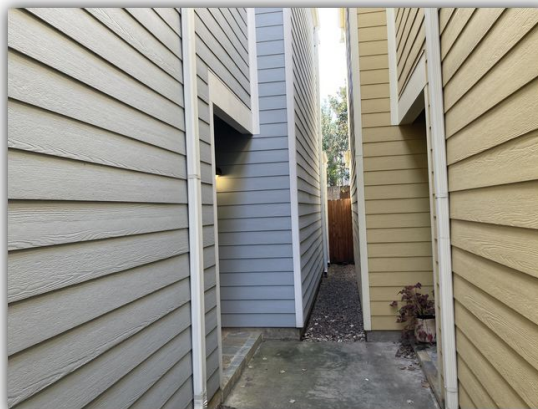
Waves / Waffling was noted at portions of the cement board siding.

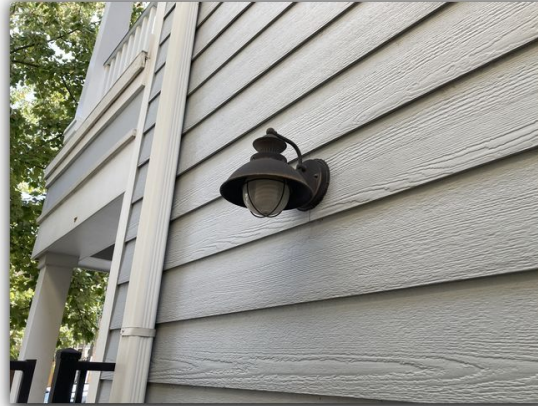
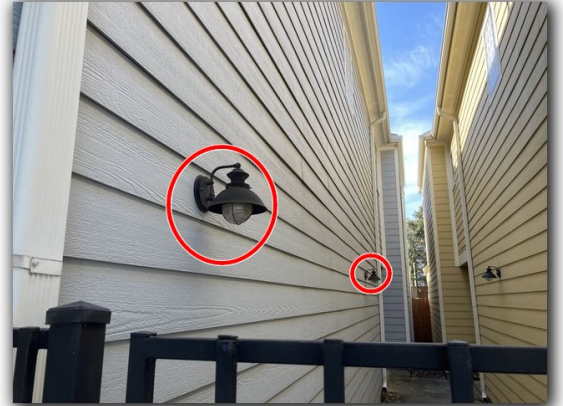
All exterior wall penetrations (electrical panels, electrical disconnects, light fixtures, etc.) and openings (expansion joints, windows, door thresholds, etc.) should be sealed with an approved material to prevent water penetrations into the wall cavities. Properly sealed exterior veneers help provide a barrier against the weather, insects, and enable environmental control of the interior spaces.

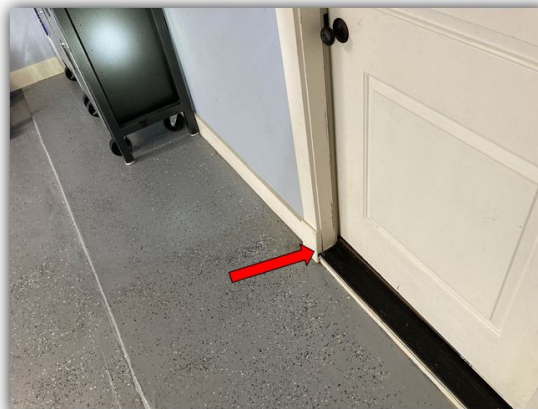
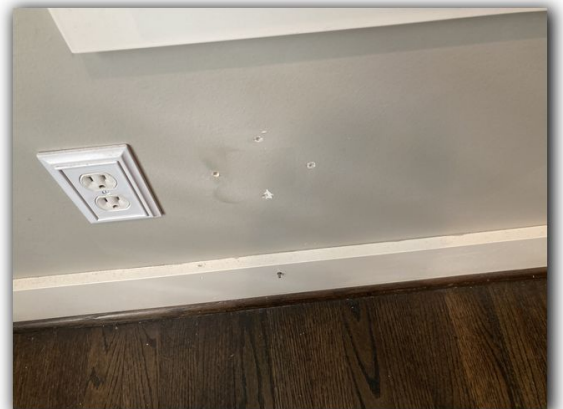
Damaged / missing area(s) were found at the interior of the property being inspected in the following locations:

The problems have been possibly caused by one or more of the following: water penetrations, insects, impact, foundation / structural movement, etc. Repairs should include replacement of damaged underlying materials where needed.

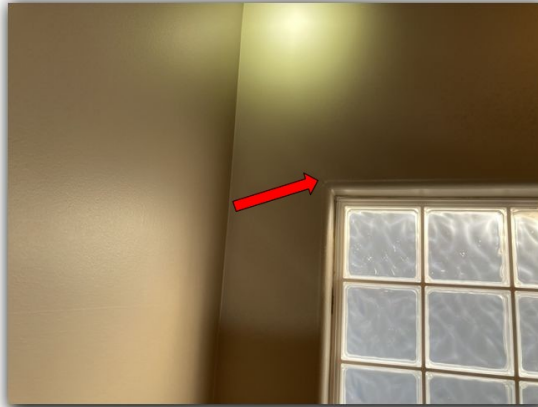
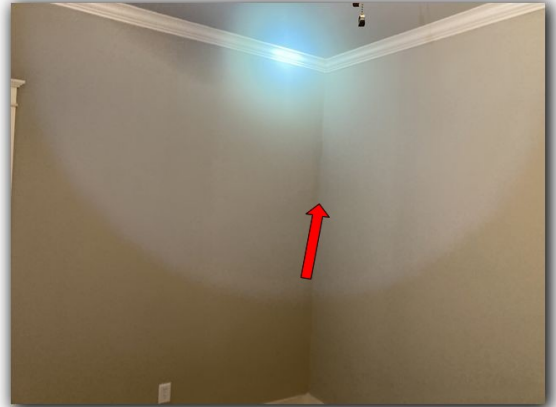
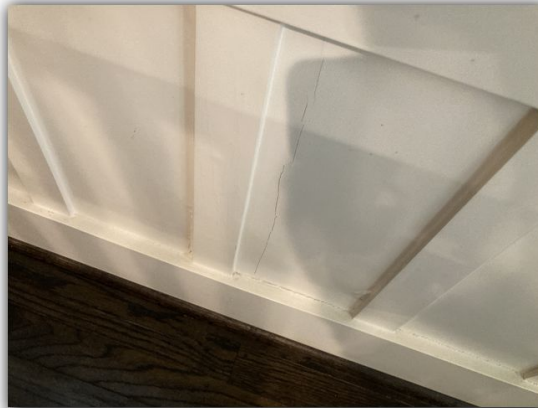
Hairline cracks were found on the interior of the property as evident of settlement.

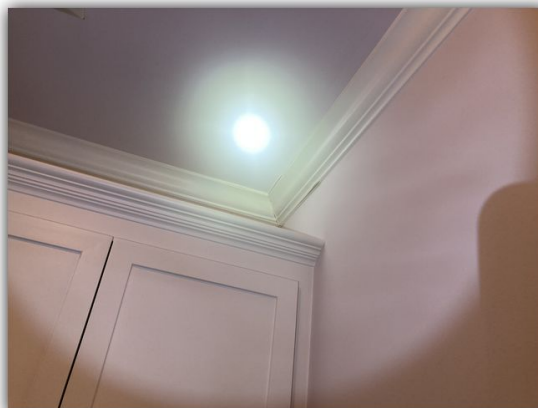
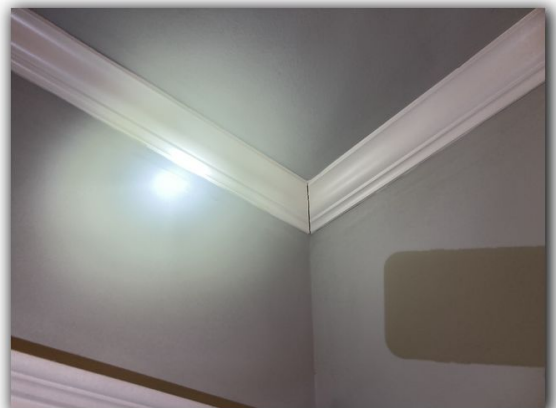
Separation was noted at sections of the interior trim and / or crown molding as evident of settlement of the structure.

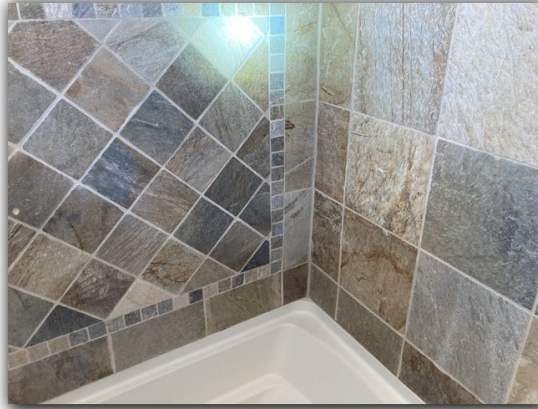
Damaged and missing grout/caulking was noted in the Guest Bathroom shower/bathtub enclosure.

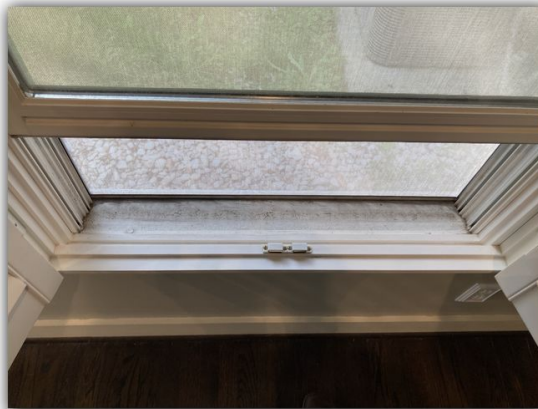
Staining and discoloration was found at the windowsills in the master bedroom guest bedroom.

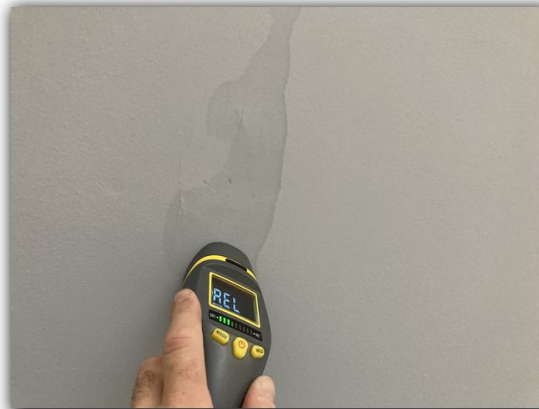
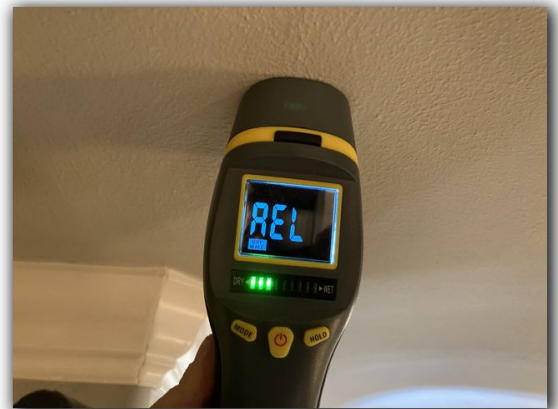
Damaged / discolored drywall was found in the Garage Kitchen during the inspection. No abnormalities were found at this area with the infrared camera and no elevated moisture readings were observed when inspected with a pinless (non invasive) moisture meter. Recommend further evaluation to determine the needed repairs.

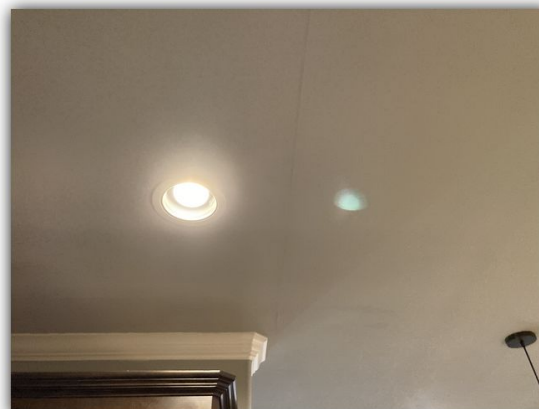
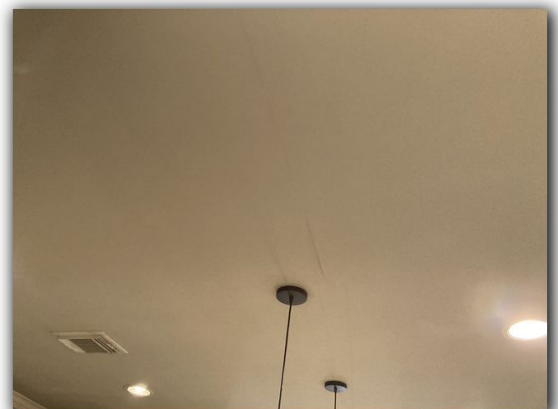
Cracking was noted on the interior ceiling of the property as evidence of settlement.

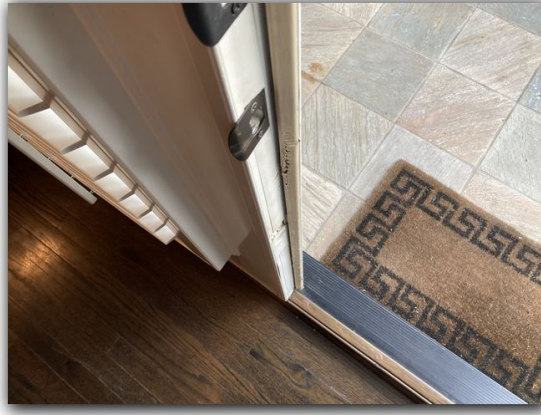
Damaged and missing weather stripping was noted at the Rear exterior door. The weather stripping should be replaced.

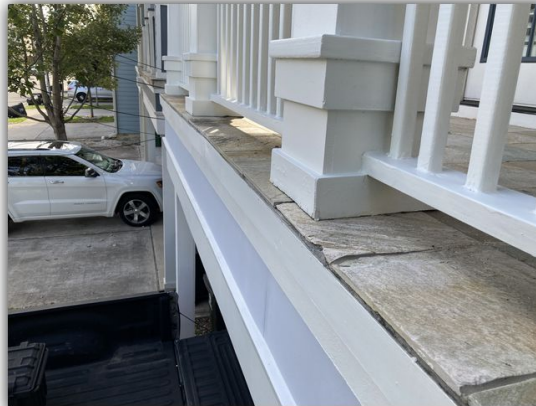
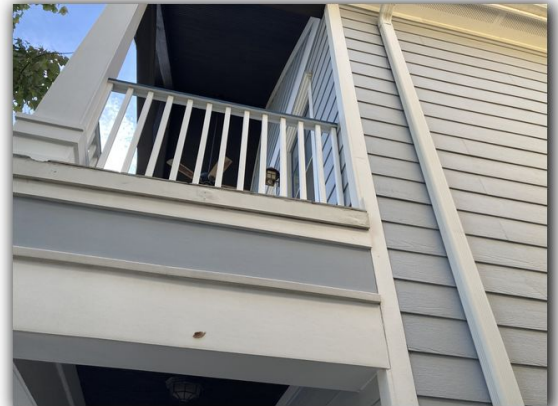
End dam and drip edge flashing not installed. Recommend repair by a qualified tradesman to prevent moisture penetration

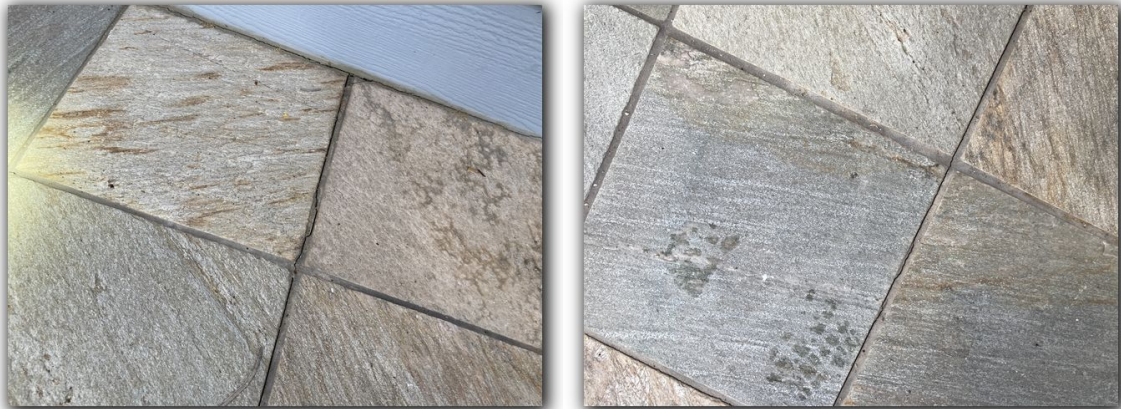
Damaged/missing grout was noted on the balcony. Recommend repair by a qualified tradesman

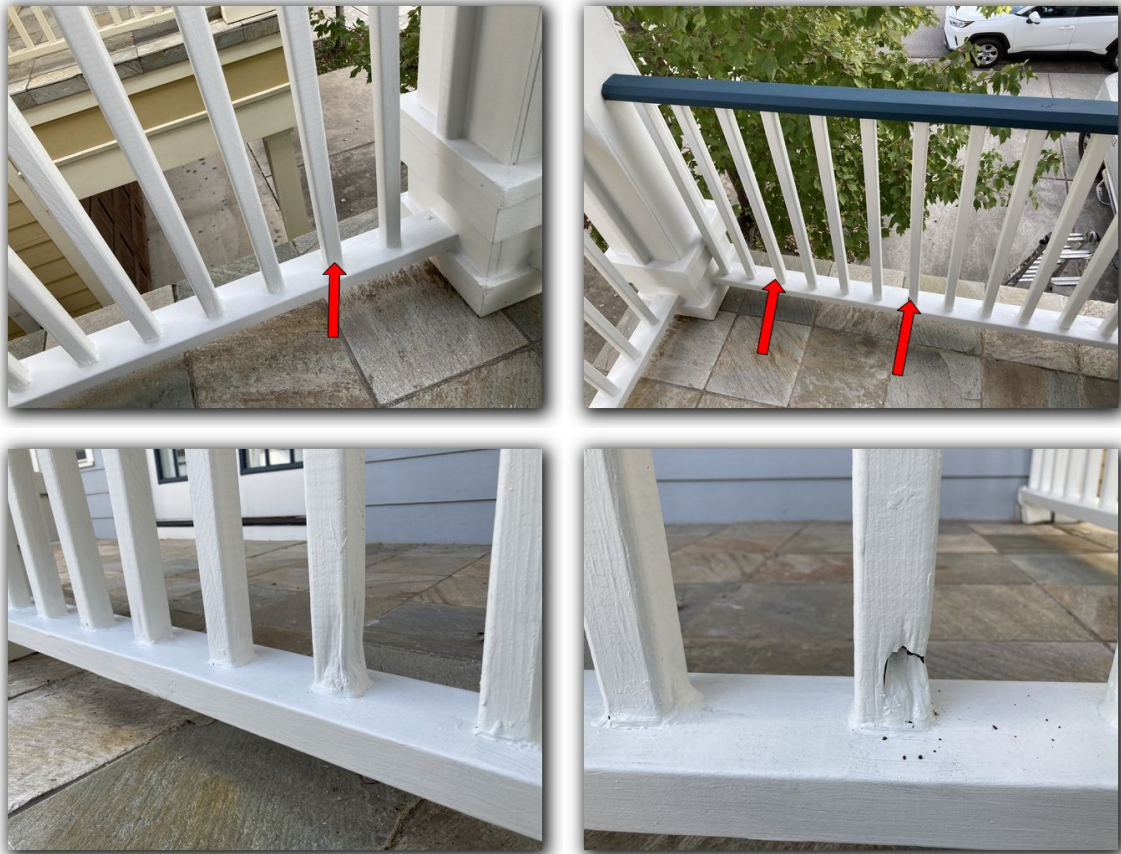
Wood rot was found at several locations of the deck balusters . The damaged wood should be repaired / replaced.

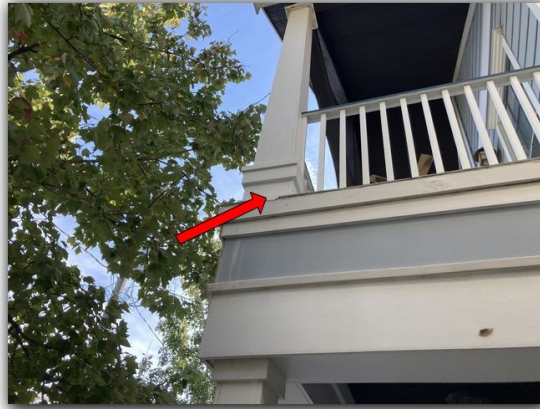
Damaged tile was noted on the balcony. Recommend repair by a qualified tradesman

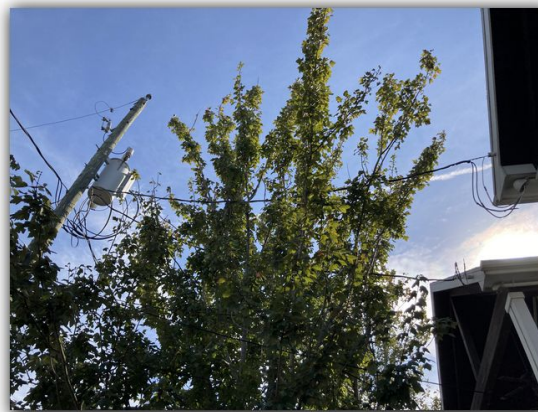
The tree limbs in contact with the overhead electrical conductors should be removed.

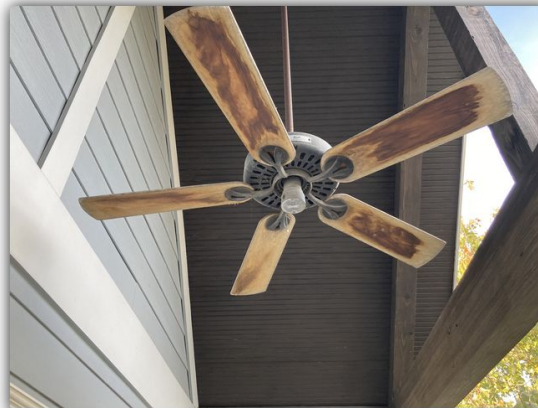
The ceiling fan is not functioning on the balcony

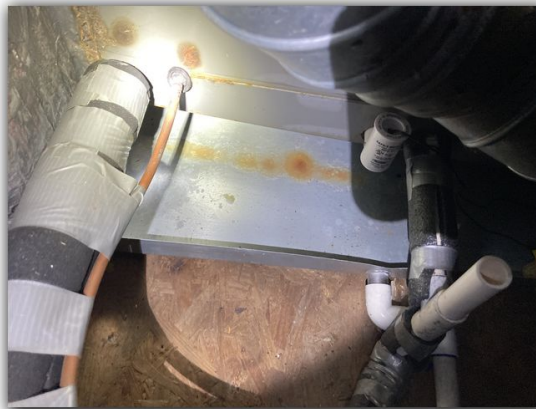
The overflow pan is rusted under the evaporator coil apparently from water overflowing from the condenser drain line in the past.

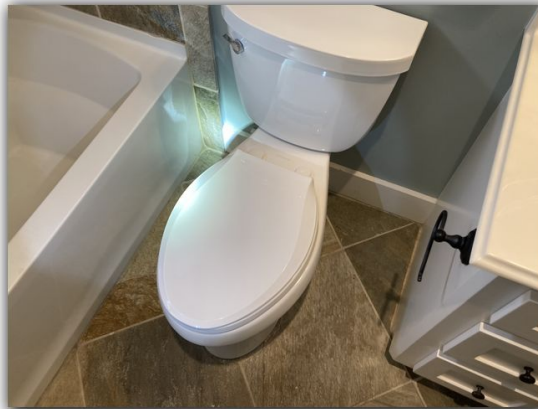
The toilet is loose at the floor. The toilet should be re-secured properly to the floor and the voids between the floor and the toilet should be sealed.

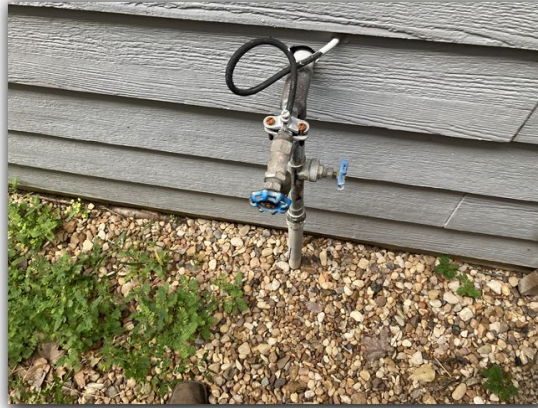
The supply piping on the exterior of the building / structure should be insulated to protect from freezing.

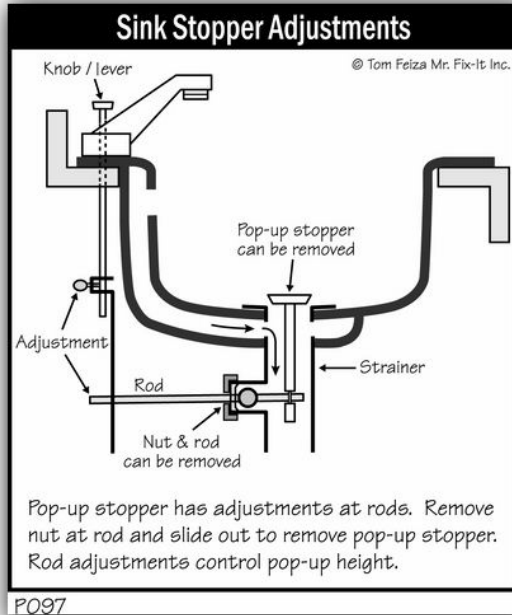
The stopper is not functioning properly at the bathroom sink.

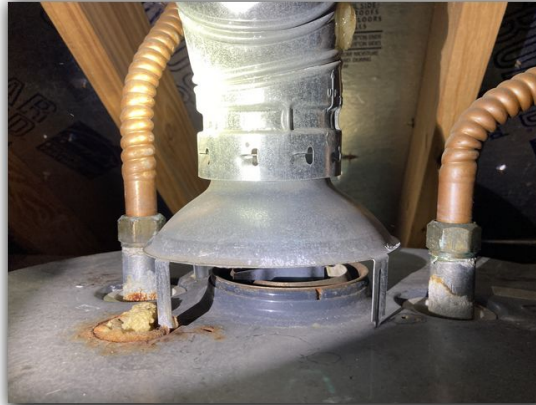
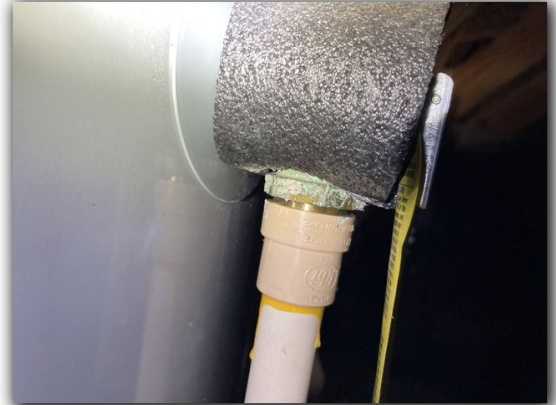
The supply piping shows evidence of corrosion where it meets the water heater. This usually occurs due to the use of dissimilar materials (copper/galvanized). The connections and corrosion should be corrected as leaks can develop. During repairs, dielectric connections should be used in an attempt to prevent future corrosion.

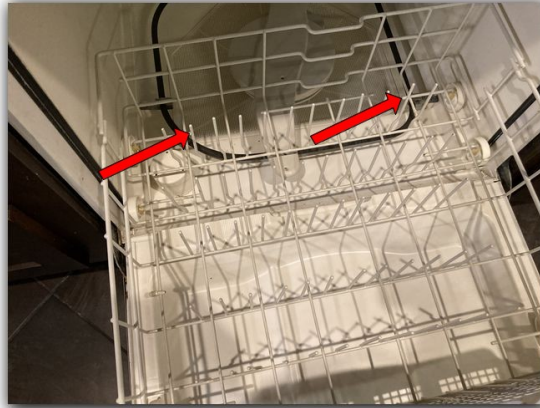
Observed rust on the dishwasher components. Recommend repair with approved materials.
