**Property Address: 28435 Eli Eagle Street
Katy, TX 77494**

PROPERTY INSPECTION REPORT

Type of inspection: Pre pour foundations
Year Built: 2021 / Builder,
Weather condition: Mostly cloudy,
Approximate Temperature Range: 65 Degrees Fahrenheit
Customer was present at the time of inspection.
Start Time / Date of Inspection: 7:25 AM on March 23, 2021

Type of property: Single Family Dwelling
Year Built: 2021 Builder,
Weather condition: Partly cloudy,
Approximate Temperature Range: 80 - 85 Degrees Fahrenheit
Customer was present at the time of inspection.
Start Time / Date of Inspection: 8:45 AM on October 26, 2021

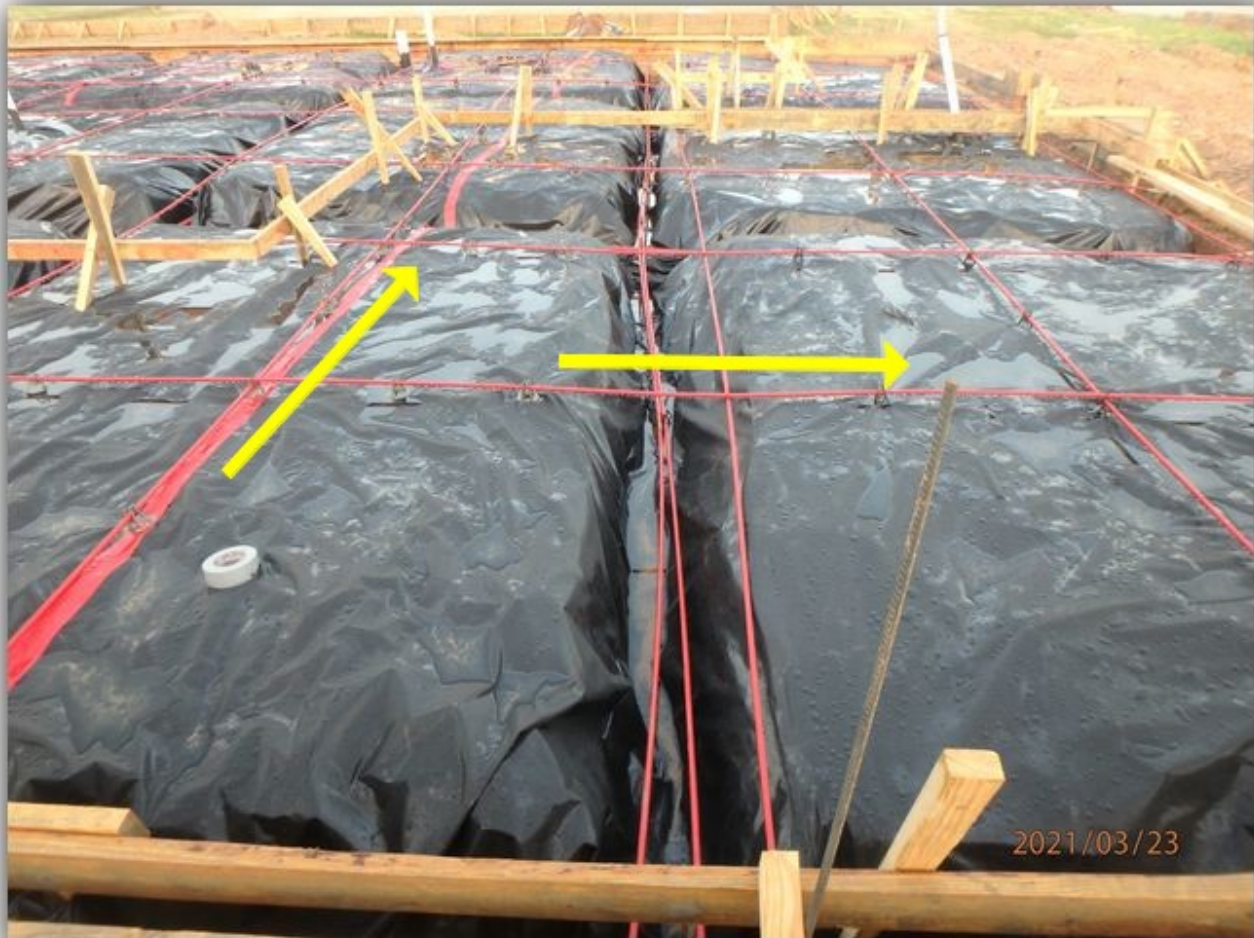
Number of strands / Tendons: As per the documents available on side at the time of this inspection, the number of strands installed should be 48 strands. There were 47 strands installed. Please reconfirm the number of strands installed as per the plan.

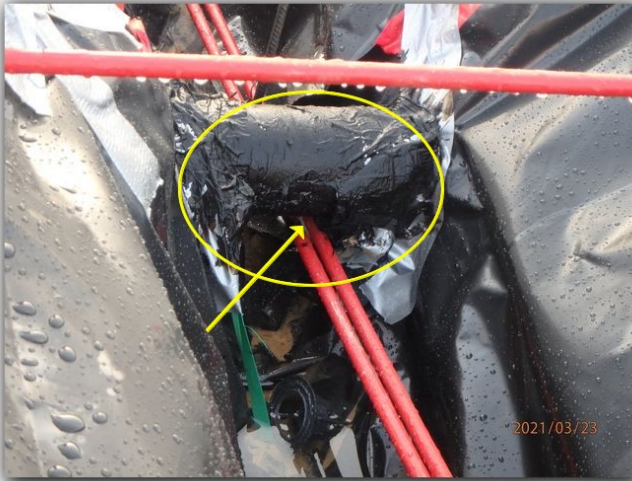
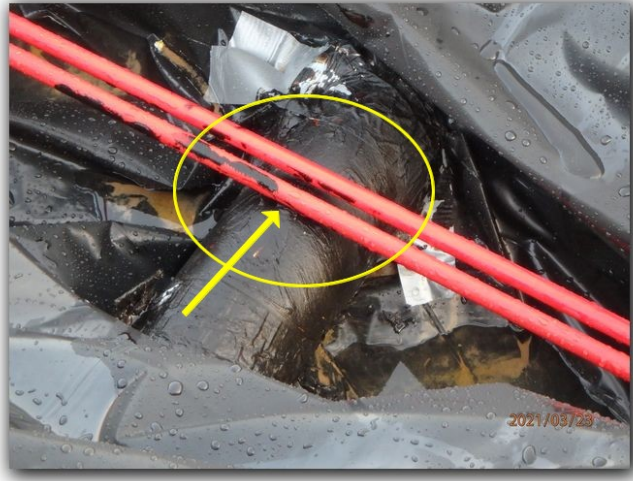
Plumbing drain pipes protection and chairs supports: Chair supports are required at all plumbing drain pipe locations. To be installed before the foundations pours.

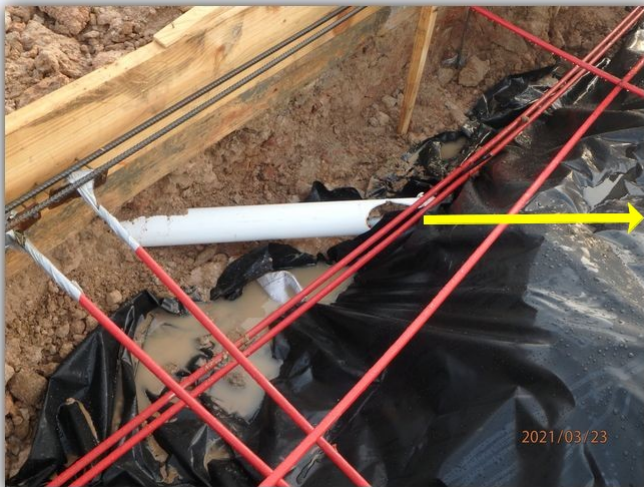
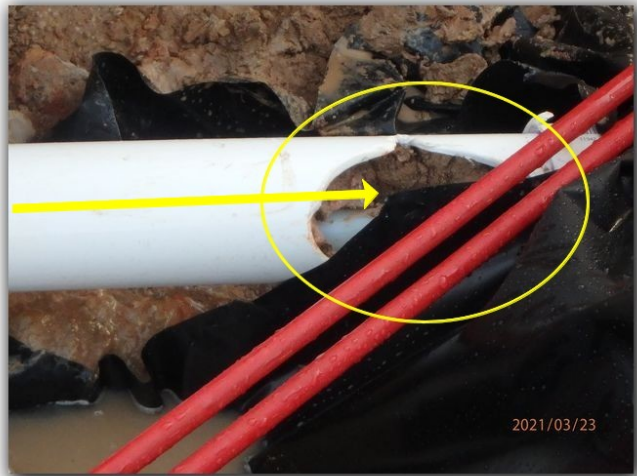
There was a broken pipe observed at the front footing. To be repaired / replaced as needed.

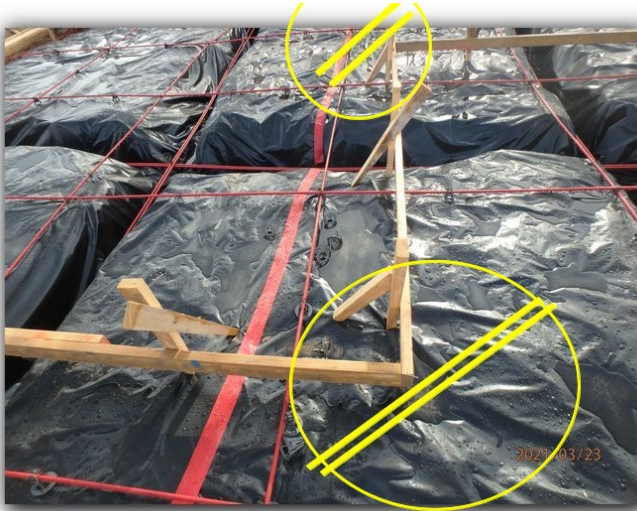
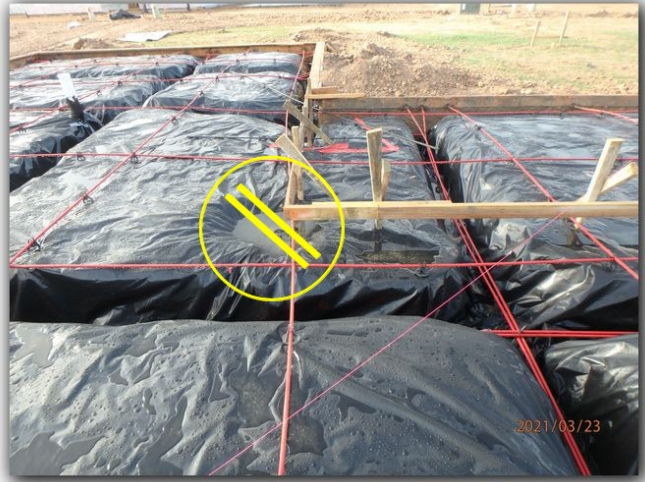
Cross bars: Front garage and rear patio corners: Install the missing cross bars.

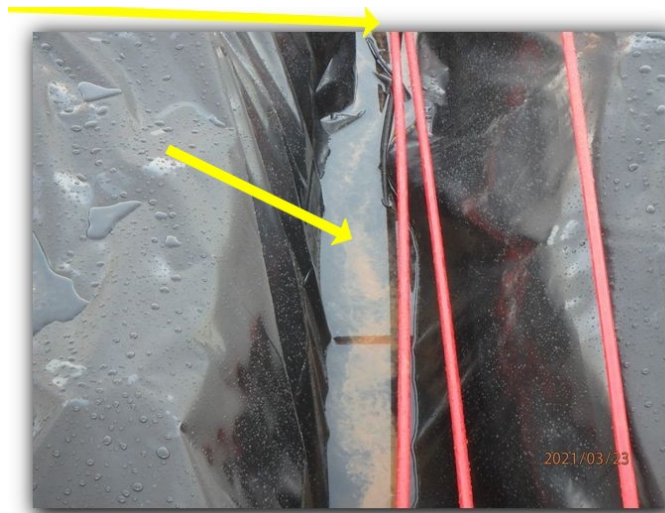
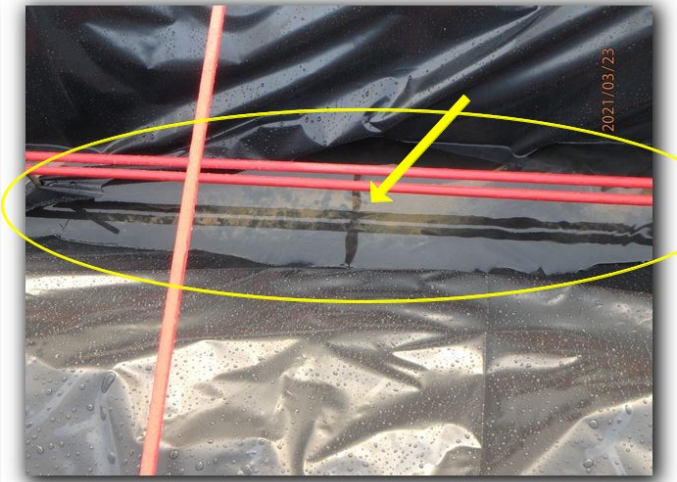
Standing water: Standing water was observed in most footings and also on slab areas, due to rain in early morning. Before foundation pour, the standing water should be allowed to be dried or should be pumped out.

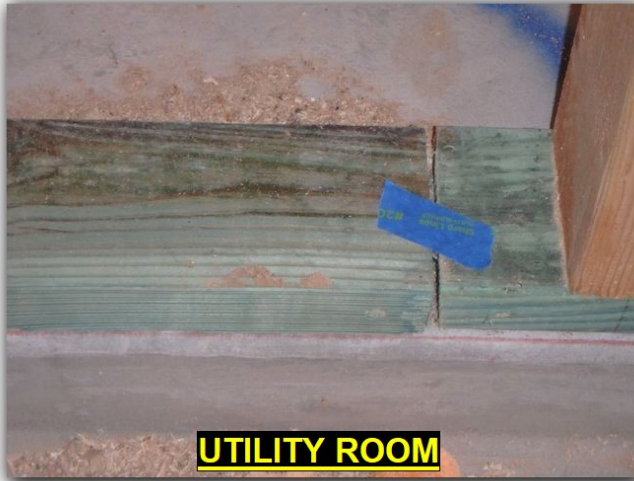
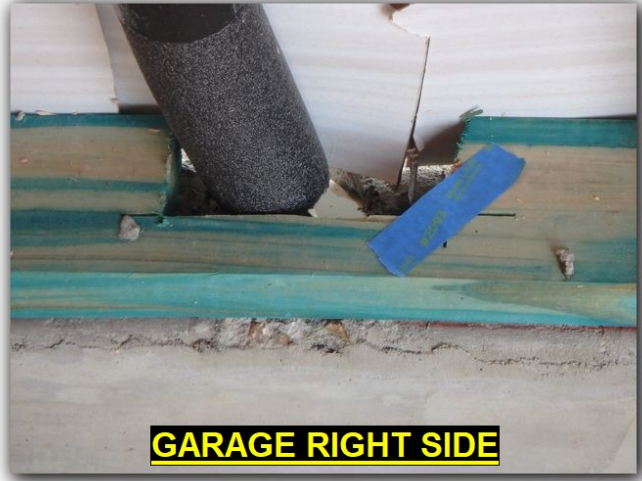
Sill Plates: The cut sill plates to be reinforced in different areas, such as on garage right side and in utility - washer dryer room.

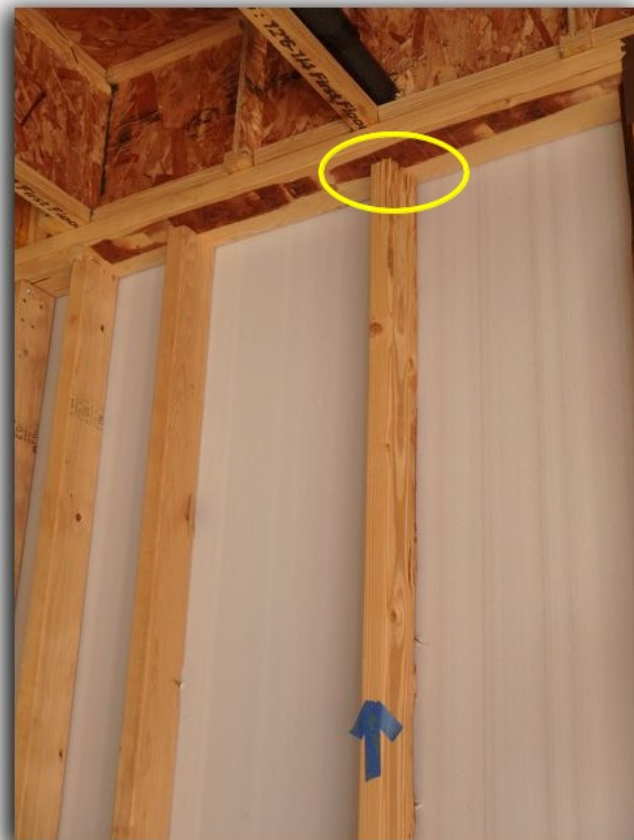
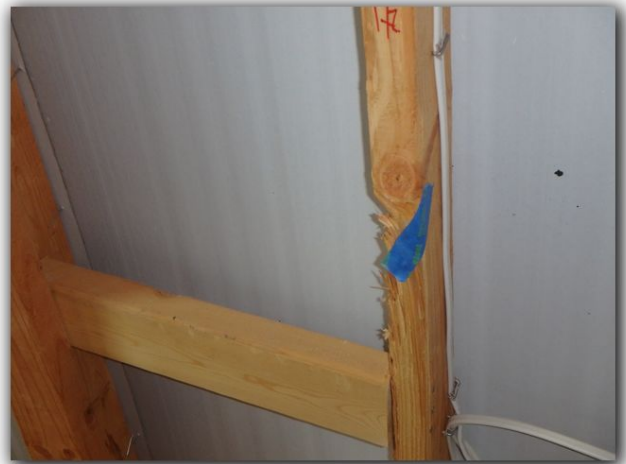
Deteriorated studs: A stud to be reinforced on garage right side.

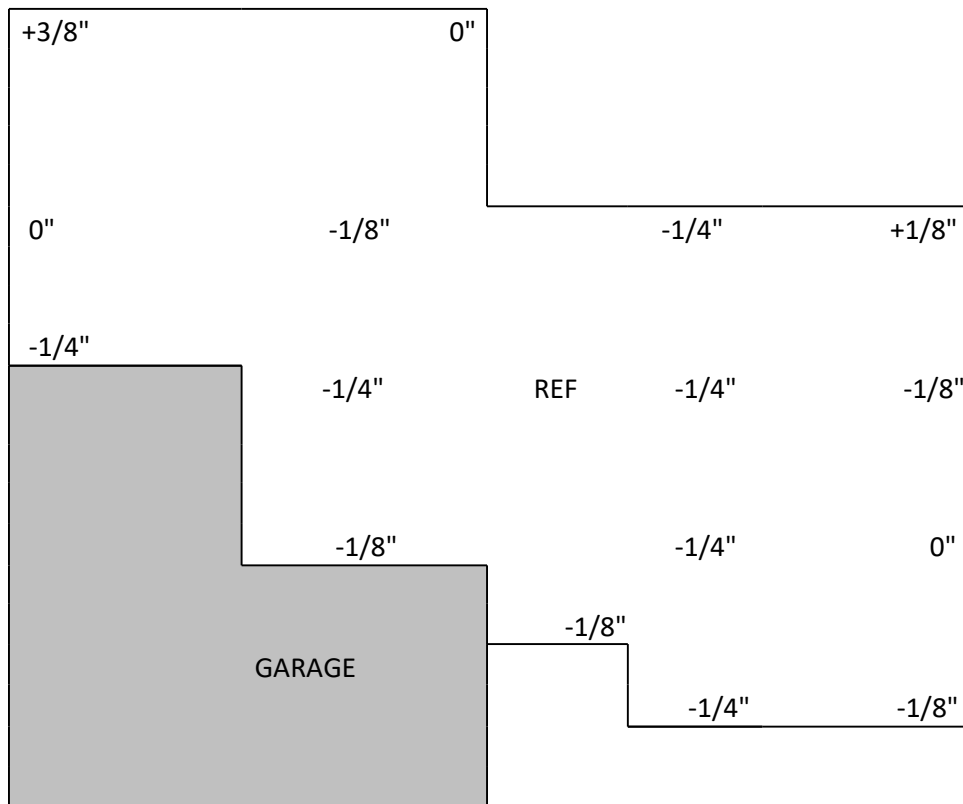
Interior elevations/measurements were taken from the reference point to the four corners and sides of the house. Elevations are accurate to within approximately 1/8" and were obtained with the use of a ZIP LEVEL® PRO - 2000. Elevations may be used as a reference for future foundation movement.

No visible signs of foundation deterioration were observed on the perimeter of foundations.

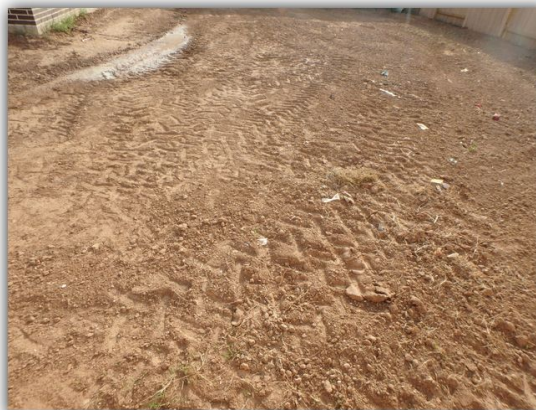
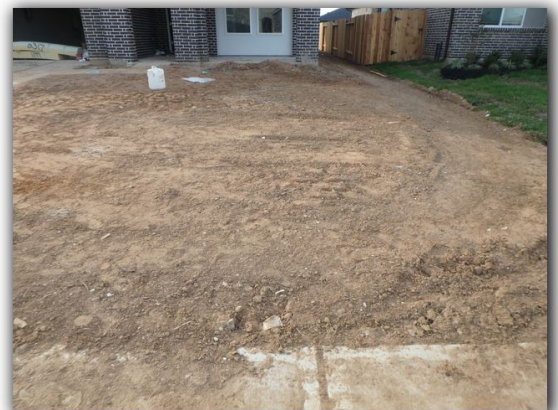
Landscaping: The grading / sodding / landscaping to be completed in all areas of the property, such as front yard, back yard, and on both the sides of the home. Please make sure that there is no standing water around the house, after the sodding is completed as standing water for an extended period of time negatively affects the structural integrity.

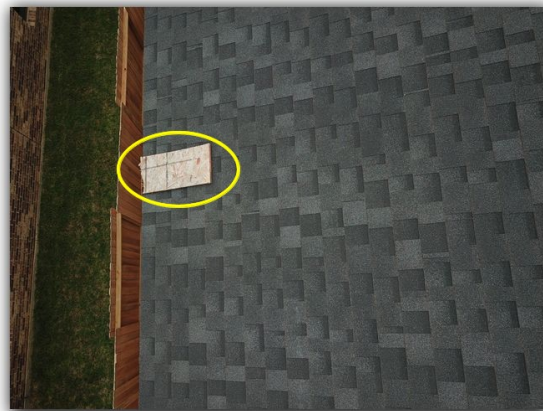
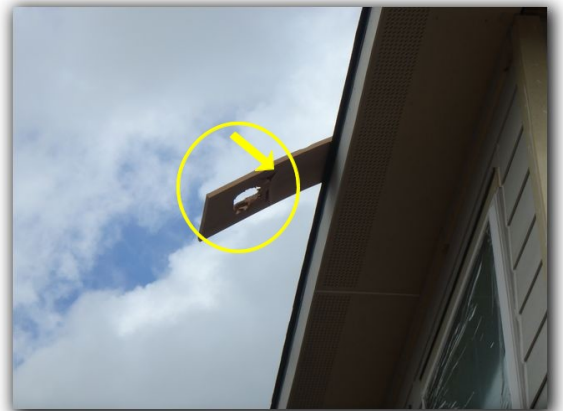
Some debris / boards were observed on each side of roof coverings. The area to be cleaned.

Exhaust duct and flashing: Central heat equipment: The metal exhaust duct extending over roof coverings, and all flashing at plumbing vents to be painted as needed. .

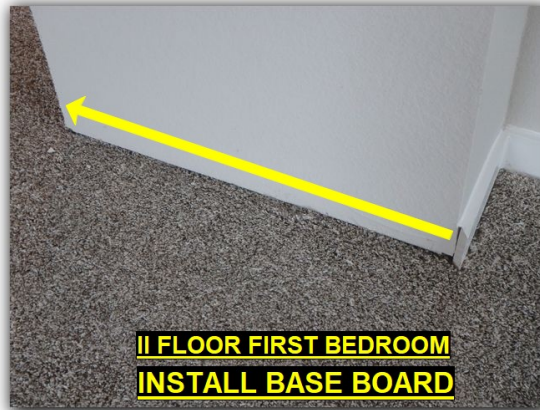
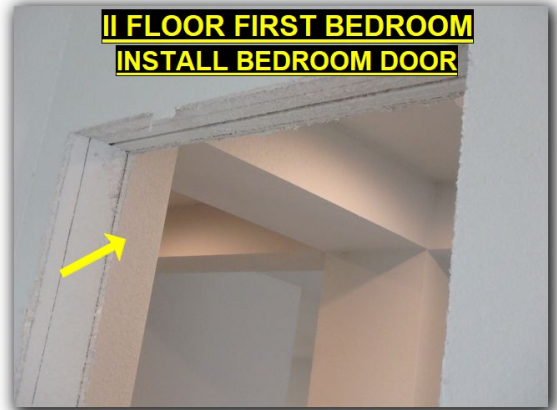
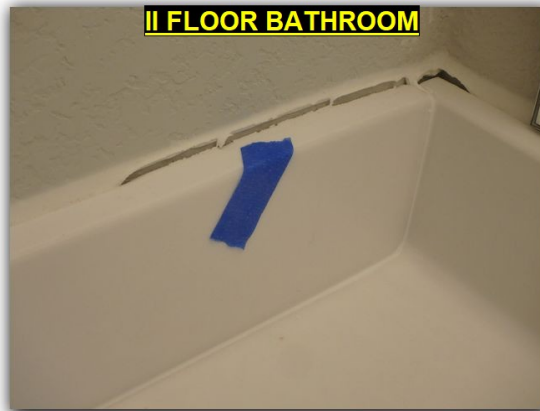
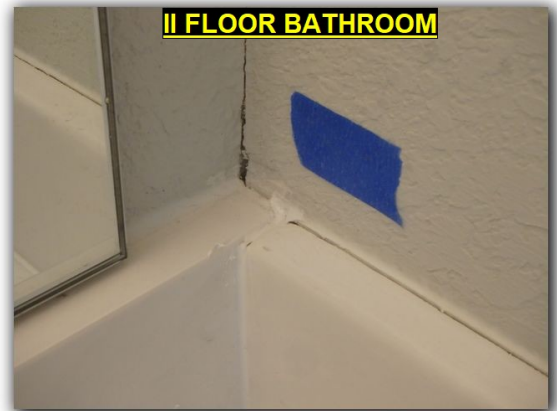
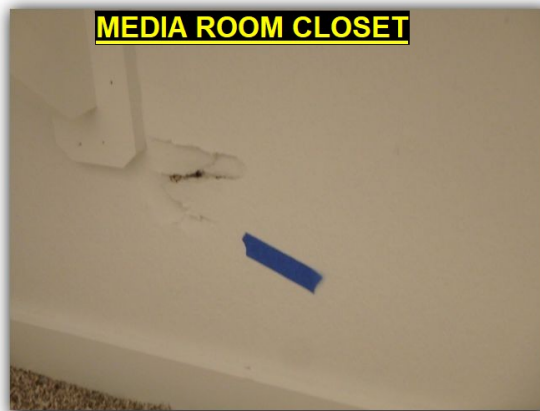
There are some interior areas, such as second floors bedrooms, and bathroom that need attention for minor repairs, caulking and / or paint touch ups. To be completed as needed.

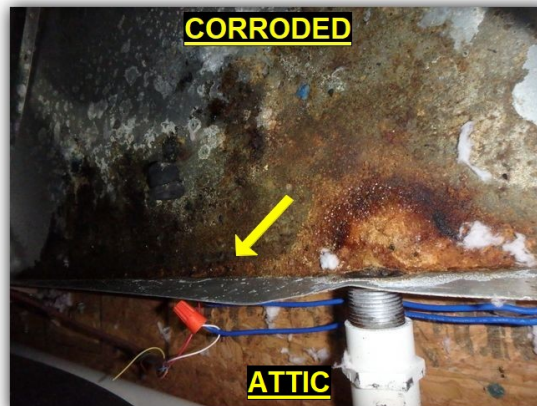
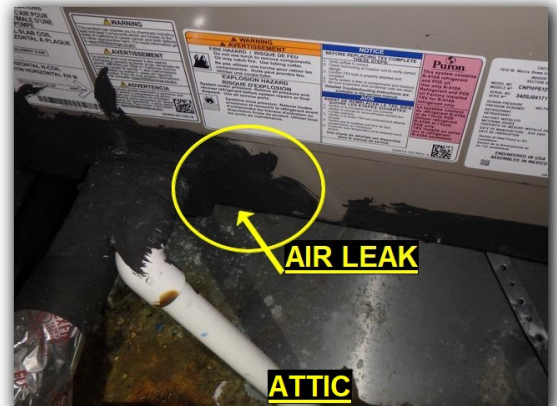
Secondary drain pan: The drain pan was significantly corroded. Also cool air was leaking from the front bottom edge near the primary drain pipe. To be further diagnosed and repaired by a licensed HVAC contractor.

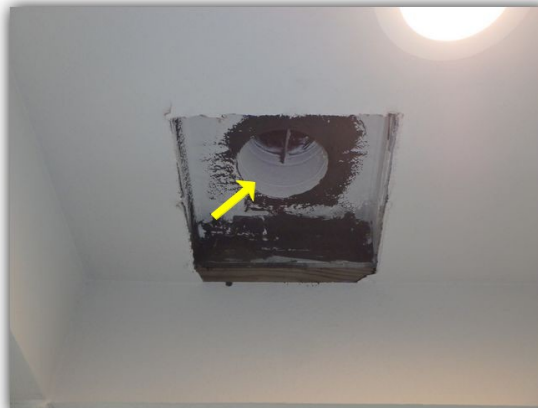
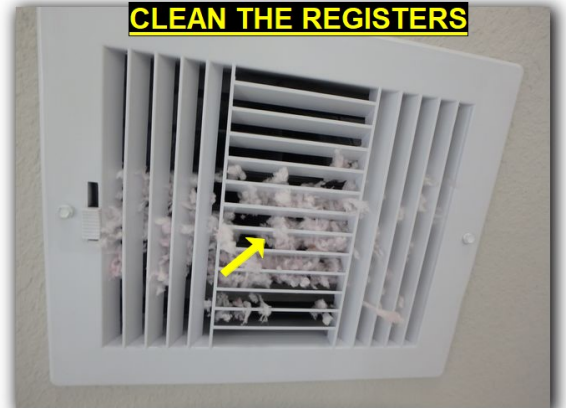
Second floor registers: Install the missing grille where required.

Clean the registers from clogged insulation in second floor front left bedroom / closet.

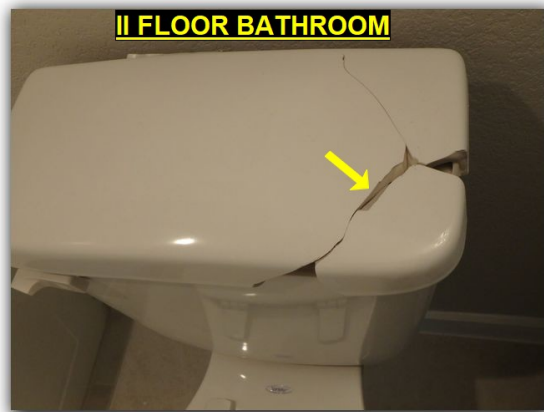
Kitchen Sink / Faucet: It was operational. Some leaked water was observed under the cabinet. The source of the water leak to be diagnosed and repaired as needed.

Water Closets: All units were operational.
Second floor bathroom: The cracked water tank cover to be replaced.

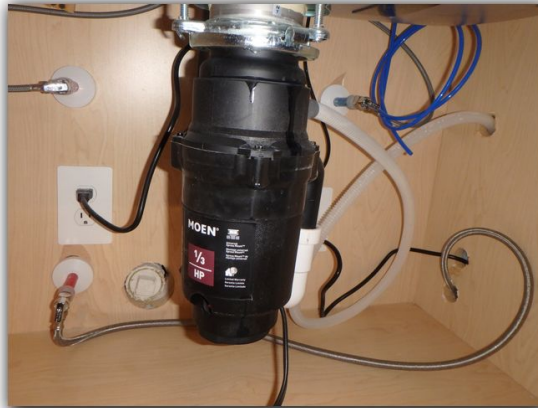
Comments: Make: MOEN
The unit was not operational.
