Property Inspection Report

710 Seaway Dr, El Lago, TX 77586 Inspection prepared for: Corey Garcia

Date of Inspection: 1/8/2022 Time: 10:00 AM

Inspector: James Duke License #21718 Huntsville, TX 77340 Phone: 936-439-5003

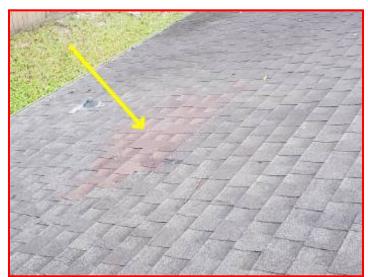
Repairs noted

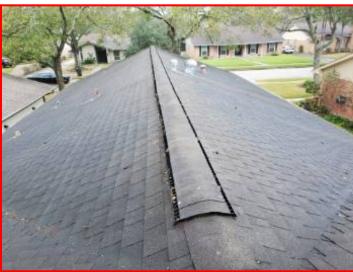
Damaged or missing shingles

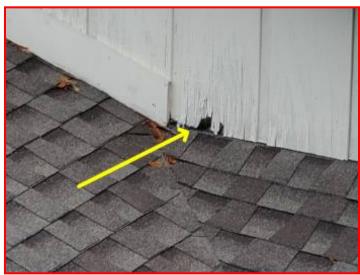
Damaged siding noticed in one or more areas.

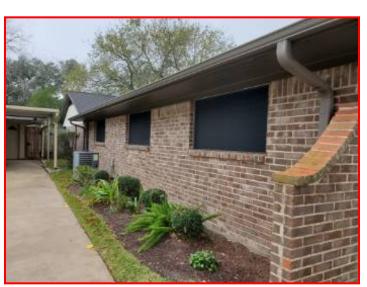
Cracks were noted.

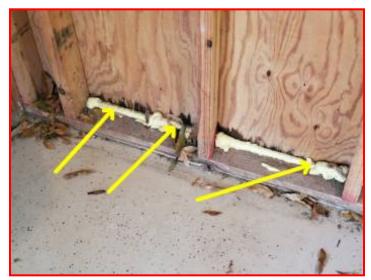
Stain noticed at the bottom of the garage walls.

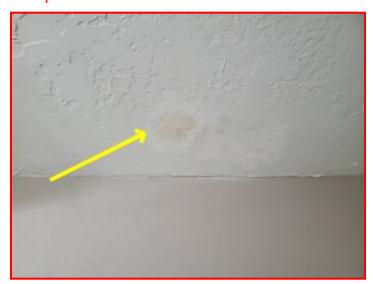
Water or liquid stain noted in one or more ares.

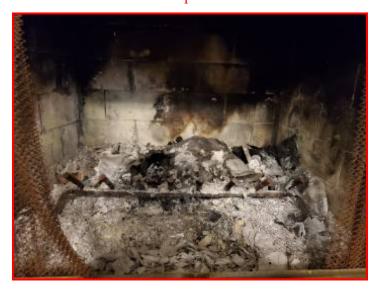
Damper doesn't work.

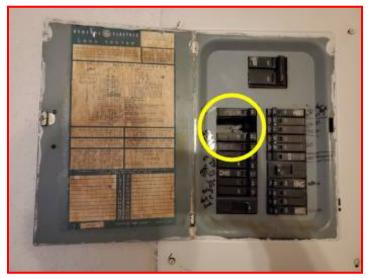
Blanks are missing on dead front cover and should be replaced so no sharp objects or insects can enter the breaker area.

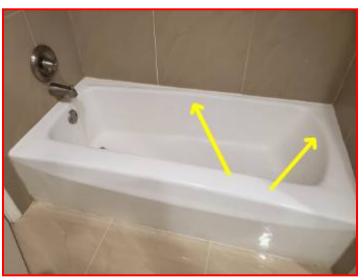
It was observed that the water pressure was reduced when two or more devices were turned on simultaneously and is recommended for further review by a licensed plumber

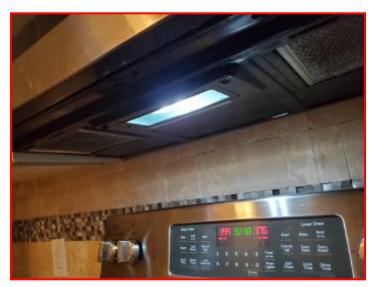
Anti-tip bracket is missing from range installation. All free-standing, slide-in ranges include an anti-tip device and is essential in the safe operation of the range. It provides protection when excess force or weight is applied to an open oven door

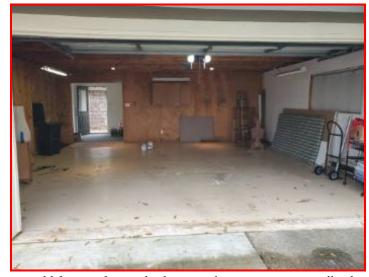
NOTE: The typical lifespan of a standard garage door opener is normally about {12} years
