McM Roofing & Restoration

1/7/2022 | 34 Photos

Roof Inspection

Micah with McM Roofing & Restoration inspected the home of Corey Garcia on 1/6/2021 around 3pm at the request of Kim League. Below are some general notes and details about the inspection.

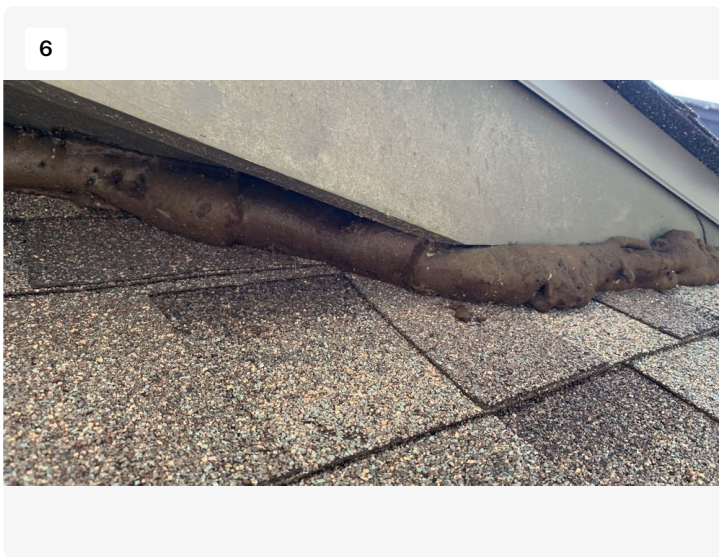
Foam and Wire mesh between soffit and shingle. We are assuming this was to keep an animal out of the attic.

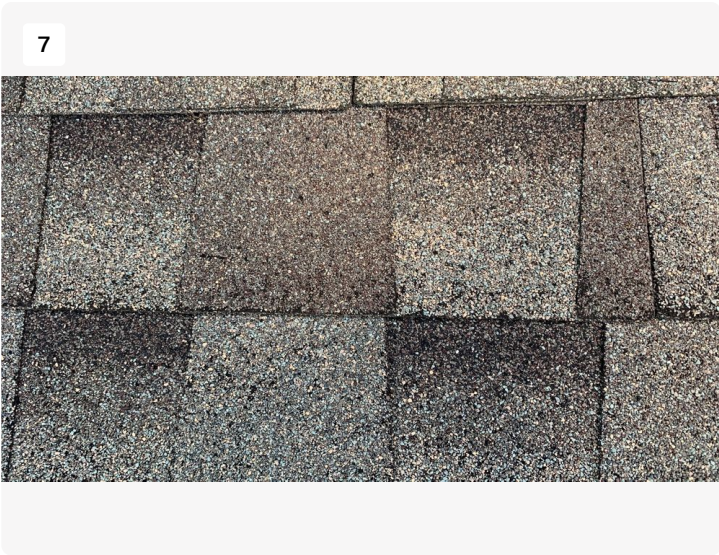
Issue 1: Both roofs are showing signs of heat blisters. This happens when a shingle overheats and starts to lose its protective granules. Once the granules are lost, the sun's UV rays will start breaking down the shingles quickly because the top protection layer is missing. The house shingles show heat blistering because of the older age and Texas heat and the garage roof appears to be lacking in attic ventilation. We would recommend replacing the roof and cutting in more vents on the garage roof when you replace the roof.

Evidence of heat blisters on the shingle. Heat blisters appear because the shingle overheats and loses granules. This starts the breakdown of the shingle prematurely. It is recommended that more attic ventilation be added to slow down the process that has already started.

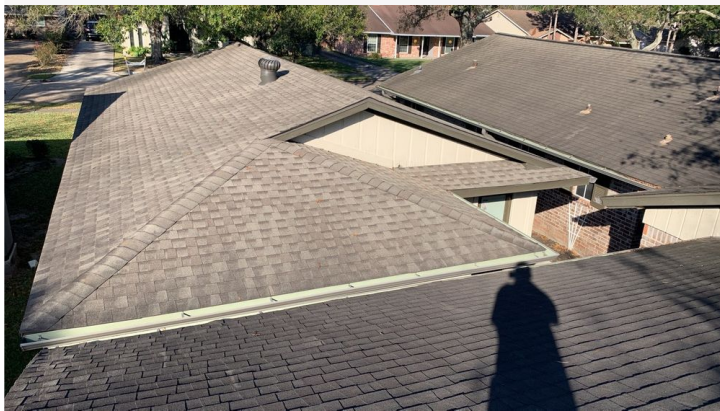
Overview of garage portion of the roof. It appears that the garage roof was a newer roof compared to the house roof by several years.

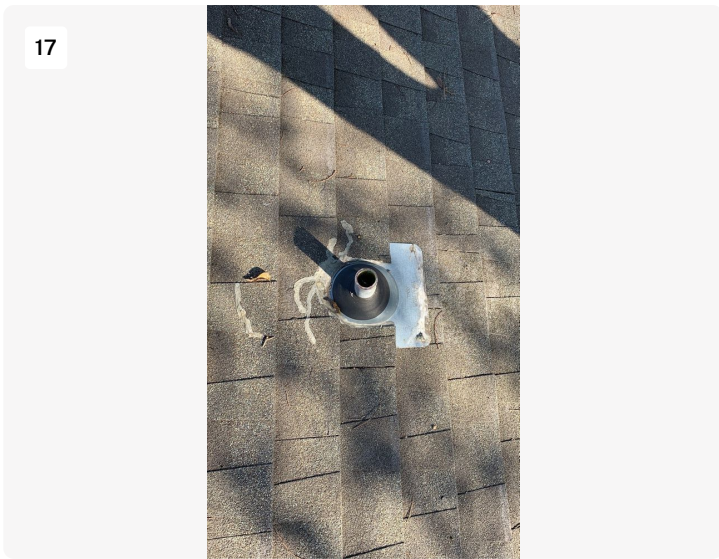
Plumbing Pipe with Rubber Boot. Notice the sealant to the left of the plumbing jack. The previous owner probably had issues with water leaks at this area and sealed the shingle with sealant instead of replacing the shingle.

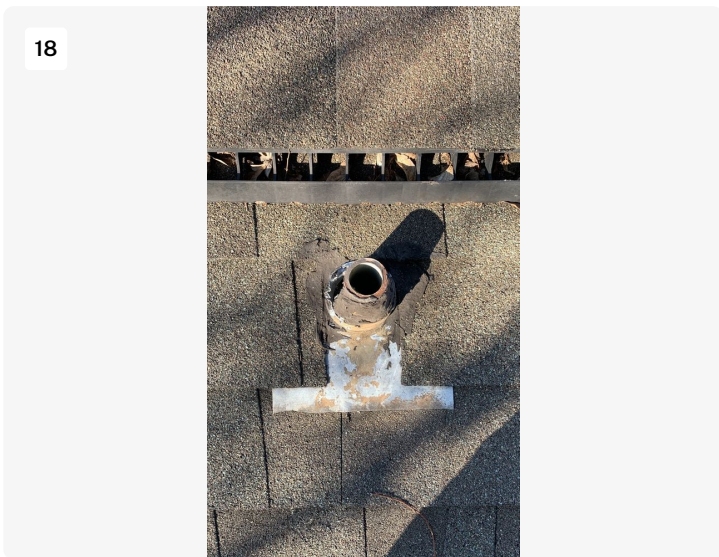
Issue 2: Pipe Jacks on the Plumbing Vents. Most of the pipe jacks appeared to be in good working order. There was one pipe jack that was deteriorated and needed to be replaced to keep water out of the home. There were two more that had larger pipe jacks than plumbing vents. This isn't a huge issue other than a pipe jack that properly fits the pipe keeps from having future issues with water in the house.

Plumbing Pipe with Rubber Boot. Please note that this rubber boot has deteriorated and is no longer providing a weather seal around the plumbing pipe. This will allow water into the attic during rains.

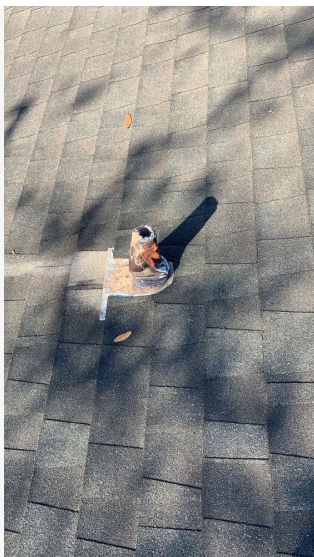
19

Plumbing pipe with lead pipe jack. Please notice that the lead jack is oversized for the plumbing pipe. The plumbing lead jacks should be properly sized for the pipe penetrations.

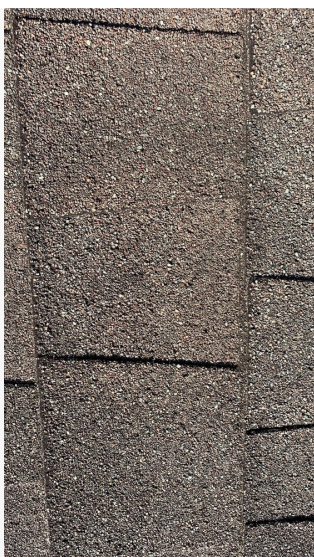
21

Closeup of the shingle on main house. Please see all the "dimples" in the shingle. This is the onset of heat blisters for the roof.

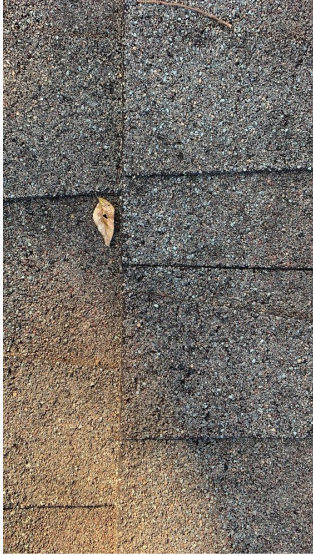
22

Closeup of the Shingle. Please see the "dimples" on the shingle which are the heat blisters starting to show on the shingle. There is a larger mark on the shingle that could be hail but we did not see enough hail damage on the roof to constitute a hail claim.

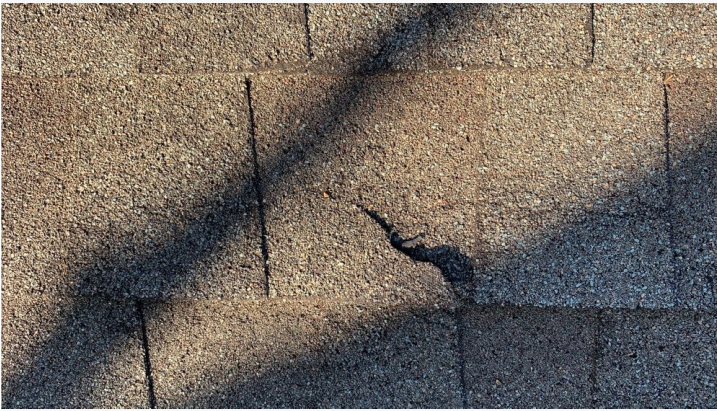
23

Issue 3: The back slope of the roof showed several signs of damage, deterioration, and issues that need to be corrected sooner than later. These issues included ripped shingles, heat blistering, and damaged shingles. It is our recommendation that this issue be corrected by installing new shingles.

On the back slope of the main house roof, there was a tear on a couple of shingles.

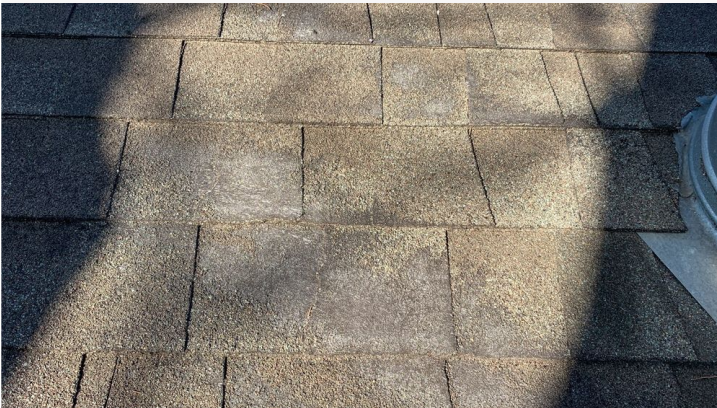
24

On the back slope of the main house, there is a patch of shingles that is deteriorated down to the fiberglass mat.

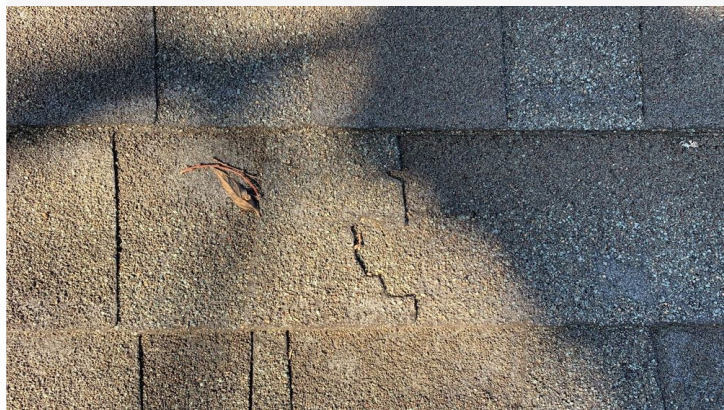
25

On the back slope of the main house, there is a patch of shingles that has deteriorated, or is wind damaged.

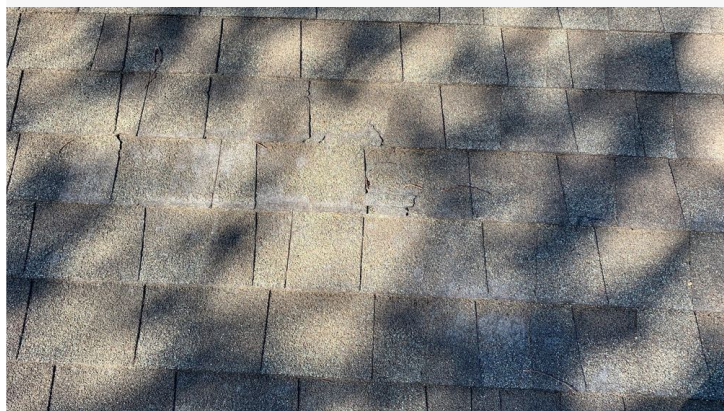
26

On the back slope of the main house, there is a patch of shingles that is deteriorated/damaged and needs to be replaced.

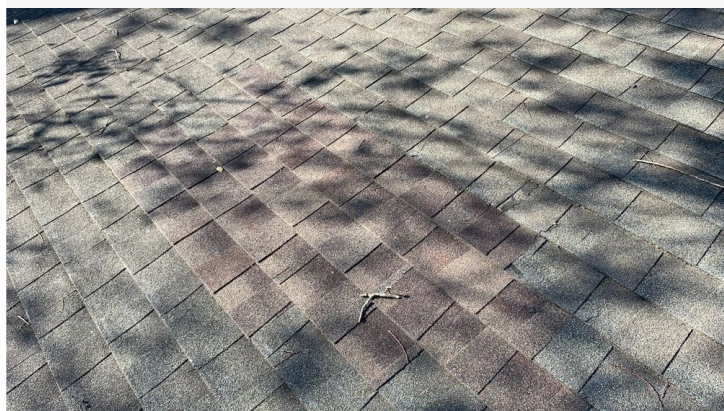
27

Previous owner had issues in this area and patched with new shingle. The patch looks good but the color is different (close but different).

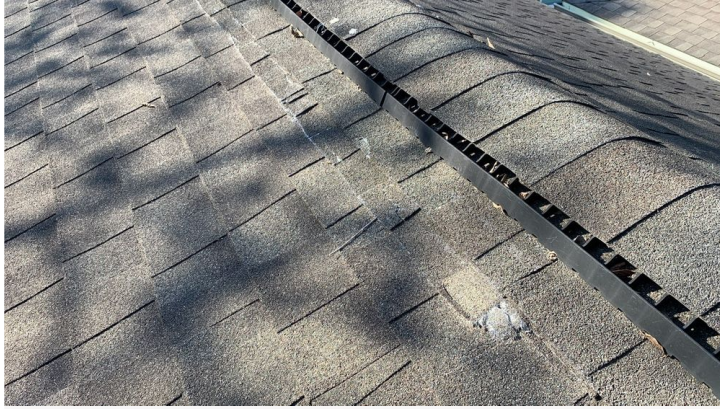
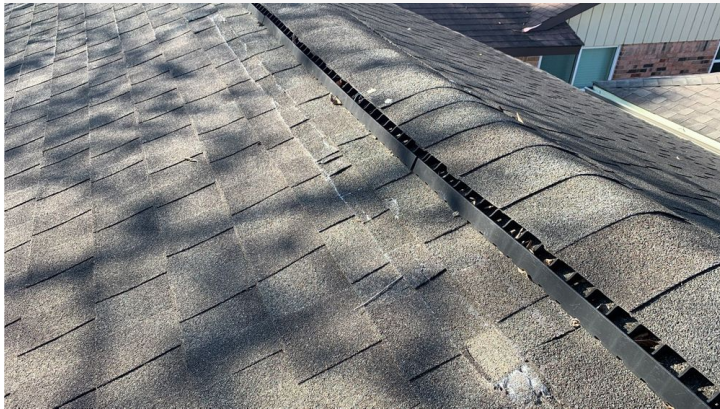
Ridge of Main House

Notice the deterioration and damage of the shingels just below the ridge vent. Caused by heat/wind/hail/etc...

Same area as previous photo. Just a overview photo.

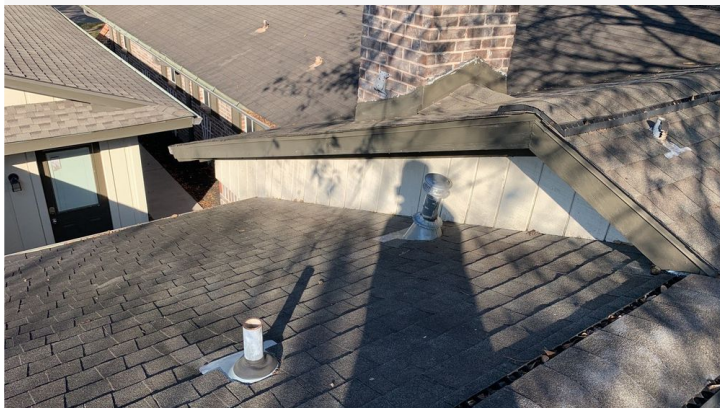
Flue Vent

This would be a question to ask the inspector or look up under building code but the flue pipe seems really close to the house structure and under the soffit. Might be fine but worth asking a building expert.

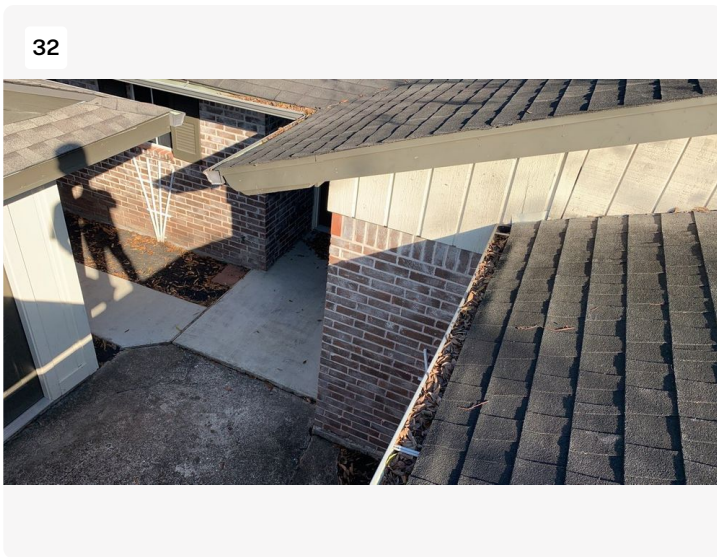
Gutters

Full of Leaves in areas.

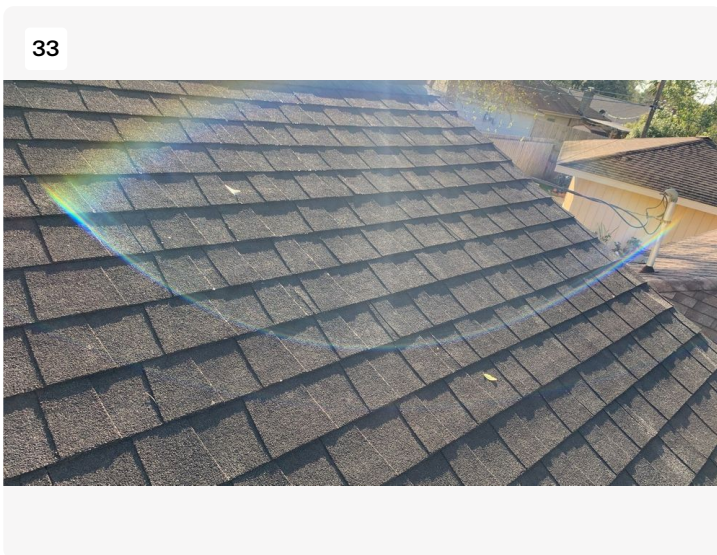
House Roof

Starting to show signs of fiberglass on the edges of the shingles (see the white areas of the shingle). This is a sign that the shingles are getting up in age and they are starting to break down.

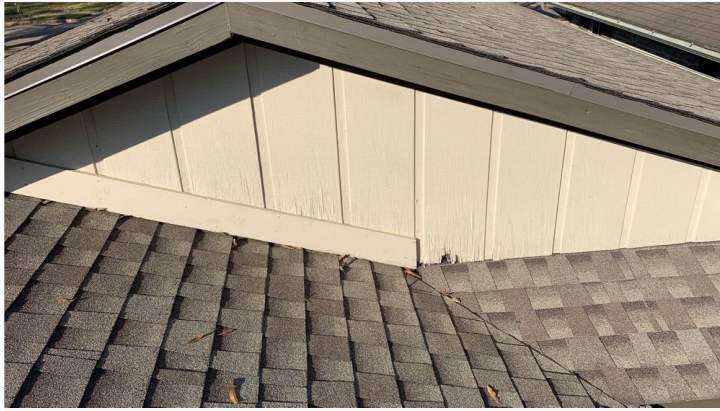
Siding on Roof

Issue 4: Siding touching shingles. Siding should have a gap between the shingle and the siding. Currently, there are several areas where the siding sits directly on top of the shingle. These areas are showing signs of rotten wood on the siding and will need to be replaced and installed correctly.

Siding is suppose to have a gap between the roof and the shingle. This siding is in direct contact with the roof which is causing the siding the rot.
