FIG Services LLC d/b/a FOX INSPECTION GROUP  
Property Inspection Report #181102DW-5630 Cheena Drive  
11227 Endicott Lane Houston, TX 77035  
(Office)713.723-3330 (Email) [office@foxinspectiongroup.com](mailto:office@foxinspectiongroup.com)

## ***PROPERTY INSPECTION REPORT***

**Concerning:** 5630 Cheena Drive, Houston, TX 77096  
(Address of Inspected Property)

**By:** David Wagner, 20531 11/02/2018  
(Name and License Number of Inspector) (Date)

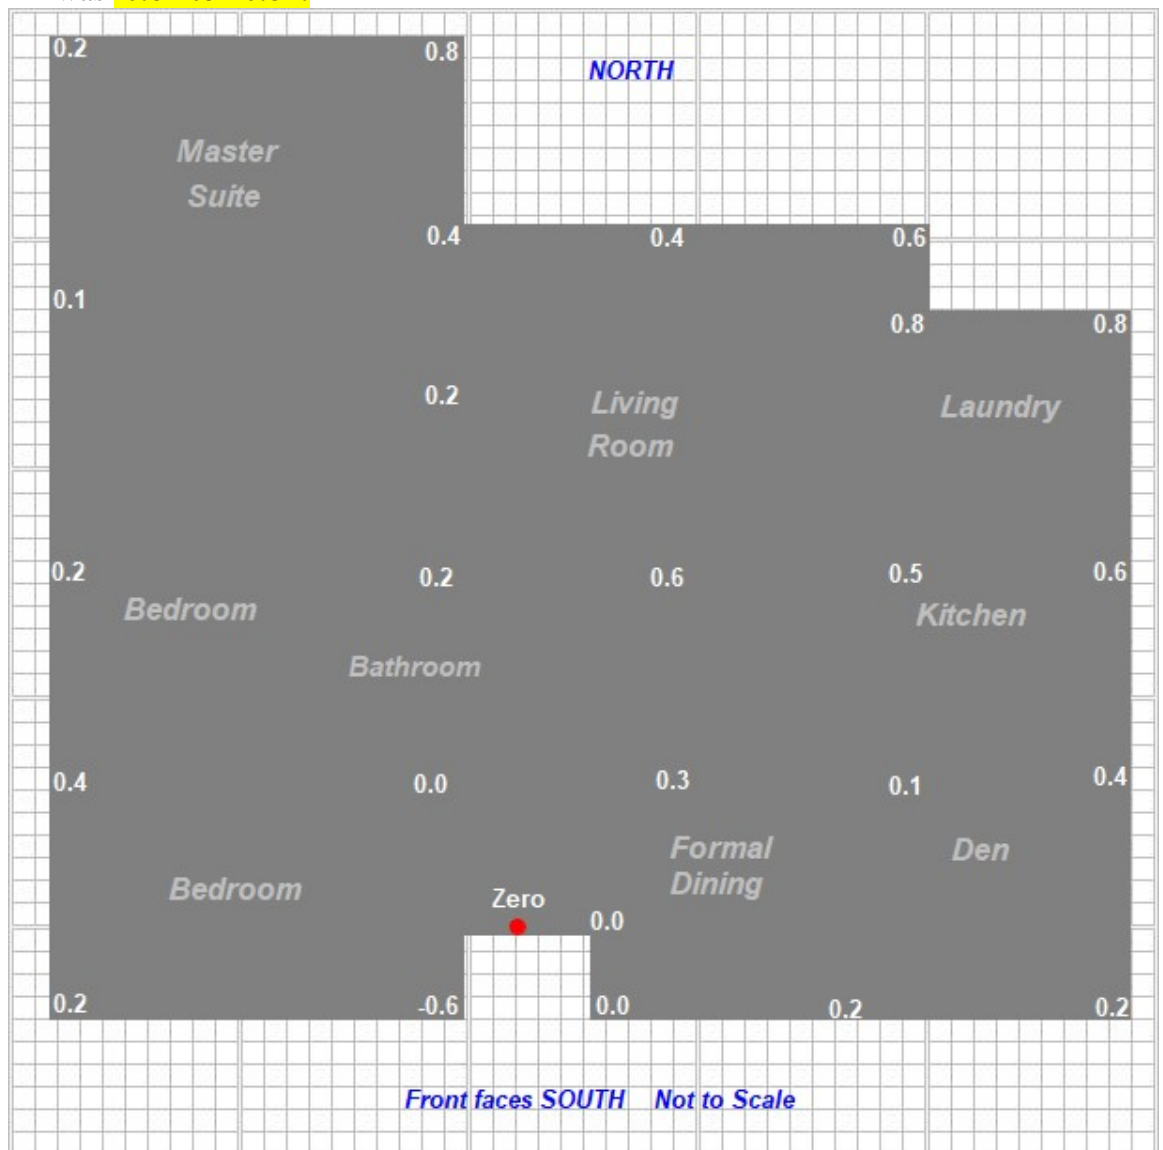
A foundation elevation survey was conducted during the inspection. The floor plan below represents data gathered using a Zip Level or similar instrument and adjusting for floor covering height differences. i.e. differences between tile, carpet and wood flooring. Measurements are listed to the nearest 1/10th of an inch. Greatest variance was **-0.6" to +0.8"**.

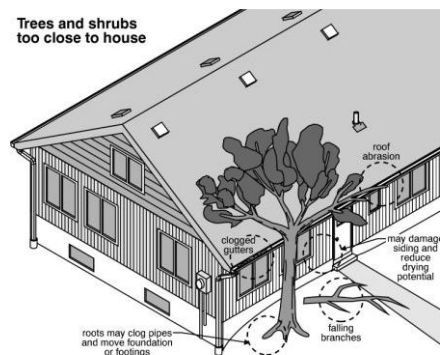
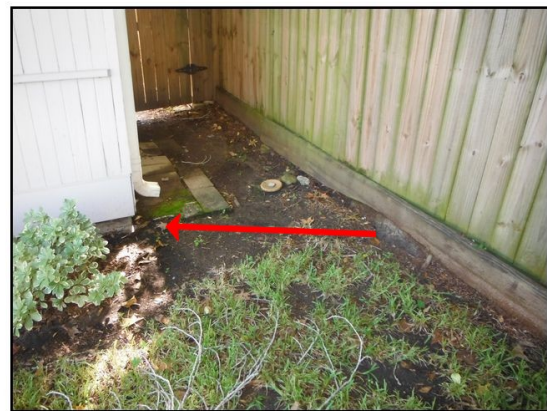
Observed tree(s) leaning toward house. Large limbs that fall could cause damage.

Large tree(s) near house foundation. This condition can have adverse effects on foundation performance. If this is a concern, recommend consideration of installing a root barrier or other preventative measure.

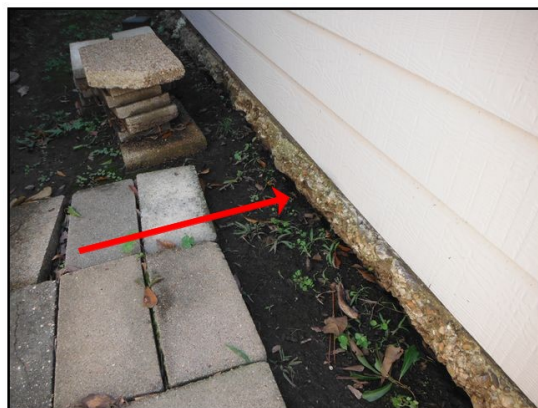
Soil has pulled away / separated from garage foundation. This situation should be addressed to prevent damage to foundation.

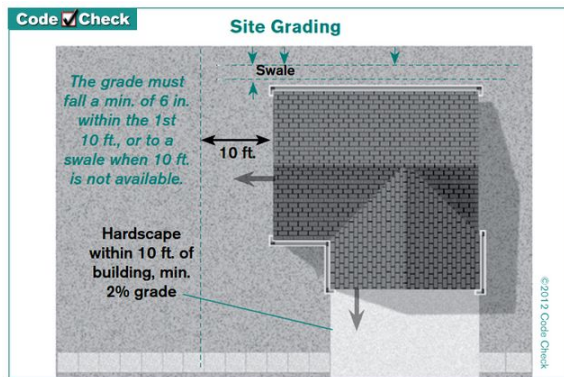
Soil grade and drainage patterns around some areas of house do not appear to properly direct water away from foundation to aid in controlling runoff water and could cause differential movement of the foundation or water penetration during heavy rains.

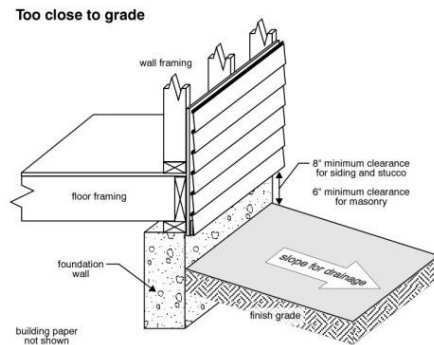
Soil level too high around areas with brick siding at multiple areas around house . Common industry practice requires a clearance of at least 4 inches from bottom of brick veneer to soil. High soil level near brick siding promotes wood rot and is considered a conducive condition to termite activity and water penetration.

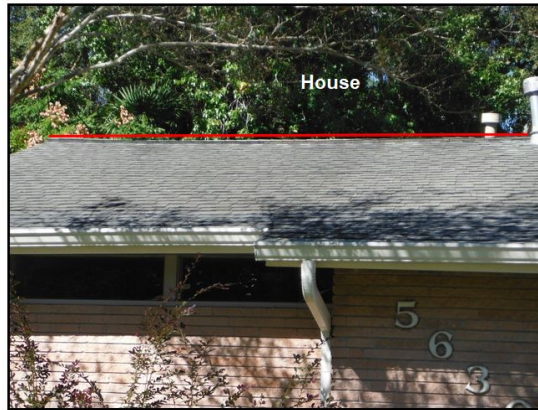
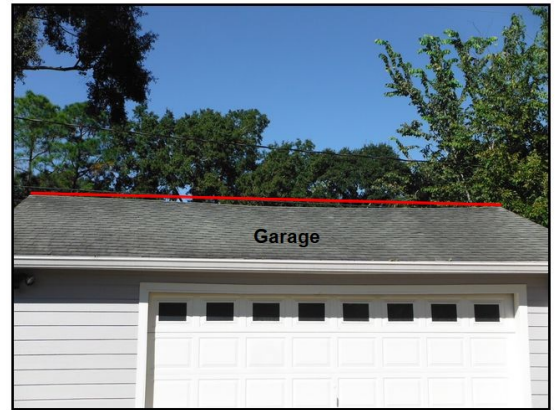
Sag(s) in roof decking observed. Probable cause is from improper/ inadequate framing in the attic and or settlement.

Sag(s) in roof ridge line observed. Probable cause is from improper/ inadequate framing in the attic.

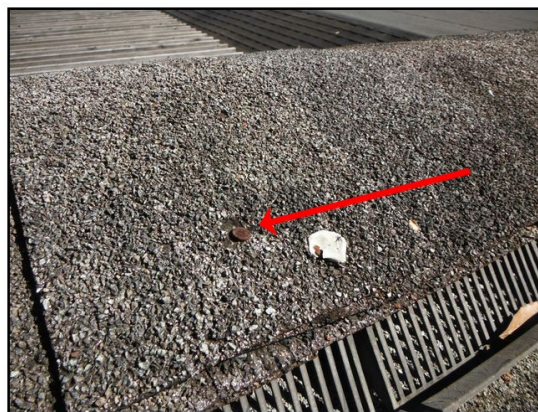
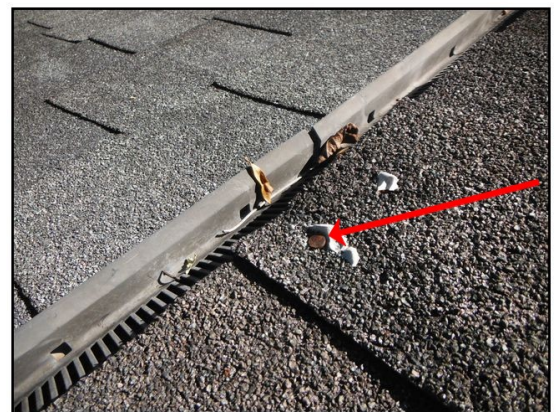
Exposed staples / nail heads / fasteners observed on roof are not properly sealed. Water entry possible.

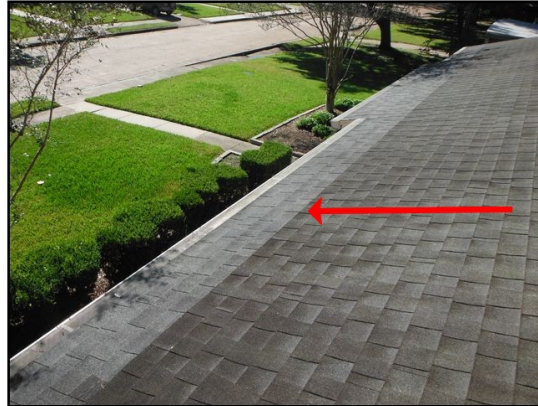
Observed scuffed / damaged shingles. Scuffing the mineral surface off of a composition shingle exposes the asphalt to ultraviolet light which causes it to deteriorate and can greatly reduce the life of the shingle. Replace scuffed shingles.

Observed spot repairs to roof surface.

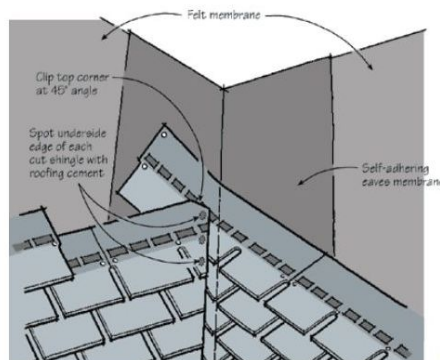
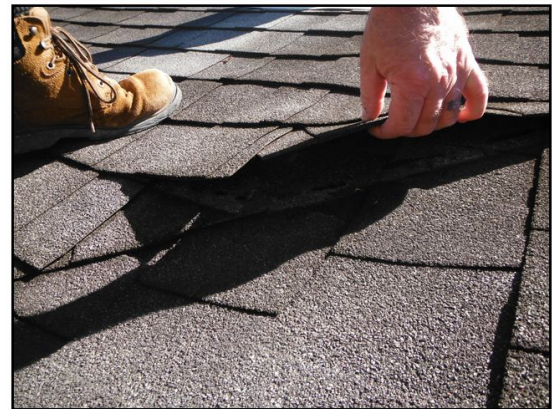
Valley shingles are installed improperly. Closed valley shingles are not embedded in roofing cement and/ or, the top corner is not clipped at a 45-degree angle. This prevents debris from getting caught in the shingles and accumulating in the valley, and also directs water toward the valley centerline.

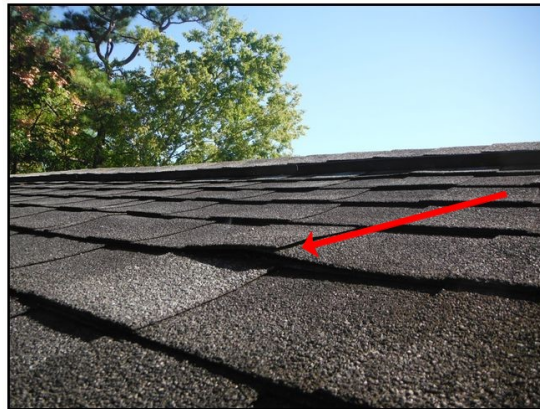
One or more areas of raised shingle tabs from fasteners not secured down properly or nail heads popping up through shingles.

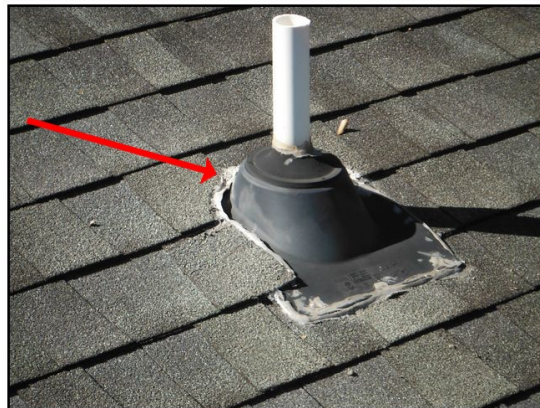
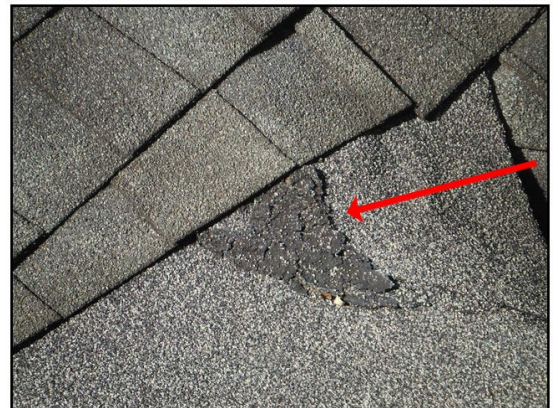
Roof tar repairs observed around roof penetration(s) and areas with missing flashing.

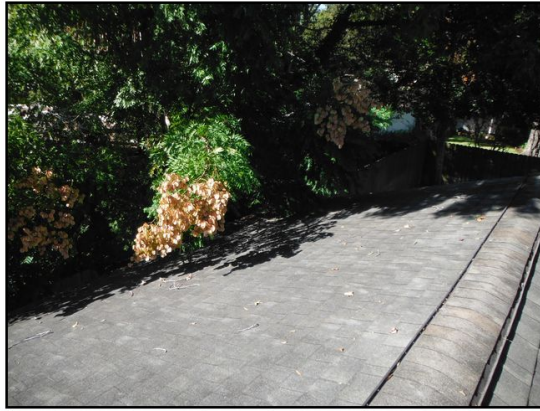
Tree limbs in contact with roof can/ will damage the roof.

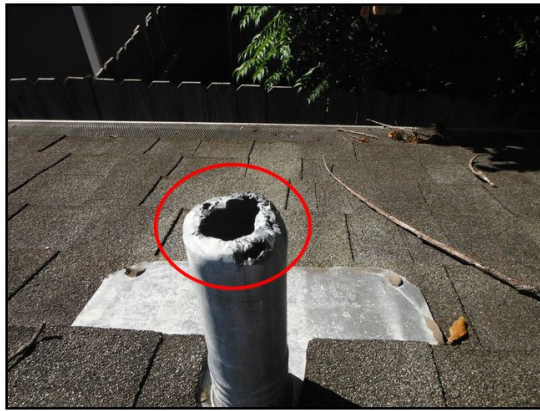
Not all lead flashing of drain waste vents are properly rolled down interior of plumbing vent pipes and/or are damaged by squirrels, may allow some rain water entry.

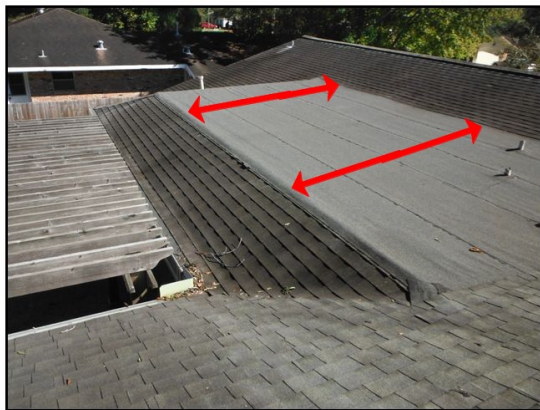
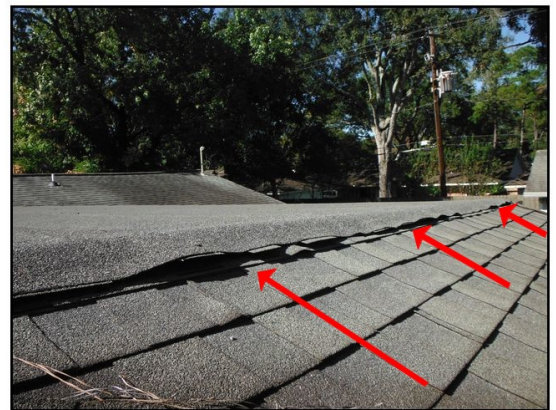
Flashing missing and/or improperly installed at flat roof edge.

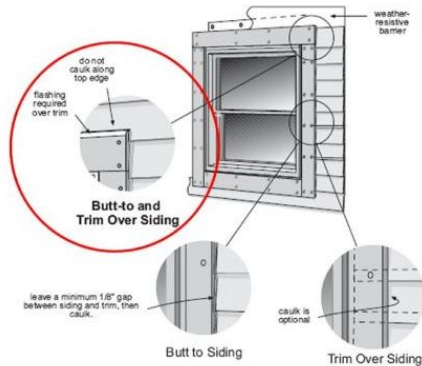
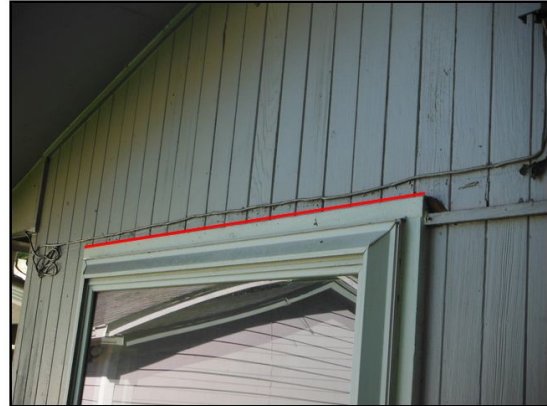
Head flashing missing over window/door trim pieces. Without head flashing over window trim, sealing must be maintained as a defense against water penetration.

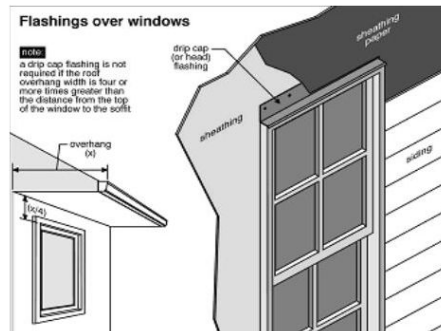
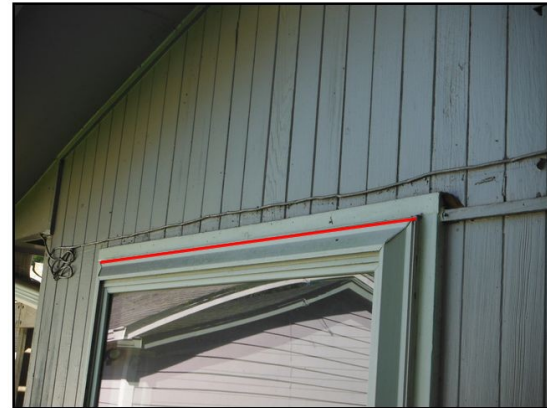
Head flashing missing over some windows / doors. Head flashing helps prevent water penetration. Without head flashing windows/ sealing must be maintained as the only defense against water penetration.

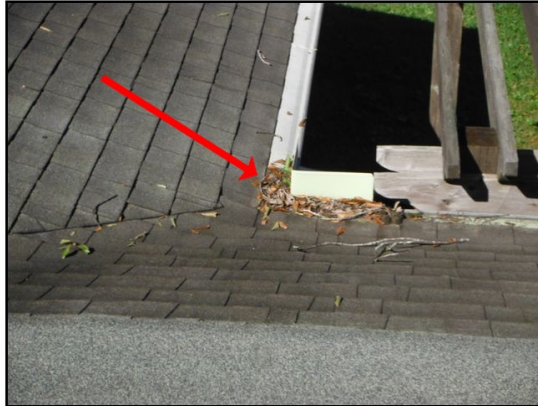
Need general maintenance, Clean out debris / re-secure to fascia board / tilt toward drains, seal leaks, etc.

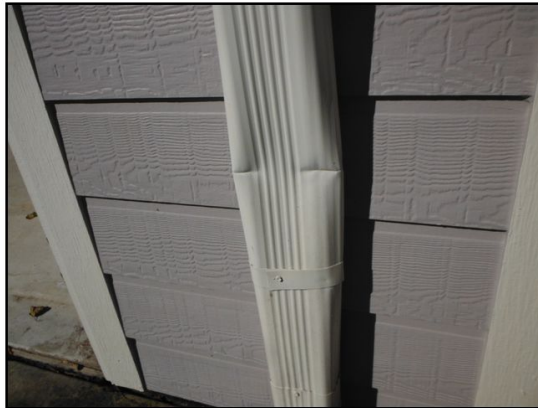
Observed one or more area(s) of damaged gutters.

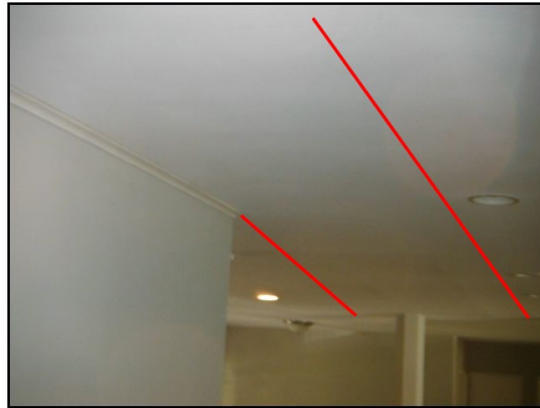
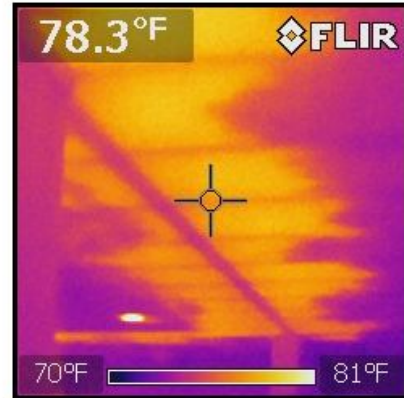
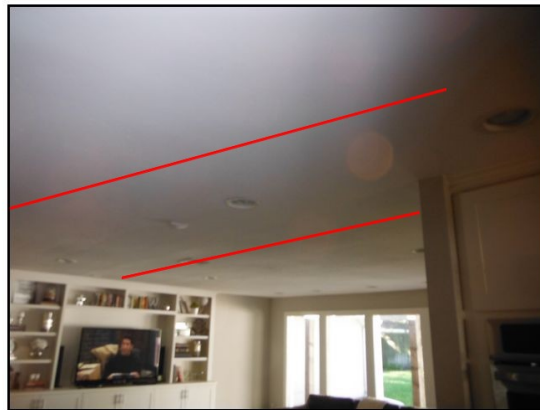
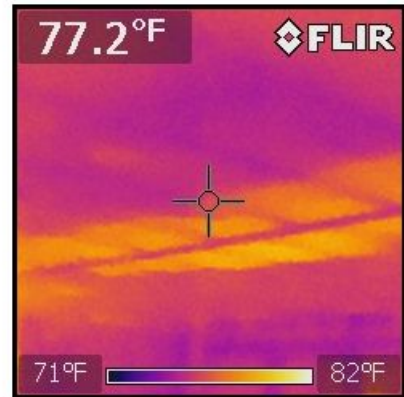
Insulation not properly positioned/missing in areas of attic.

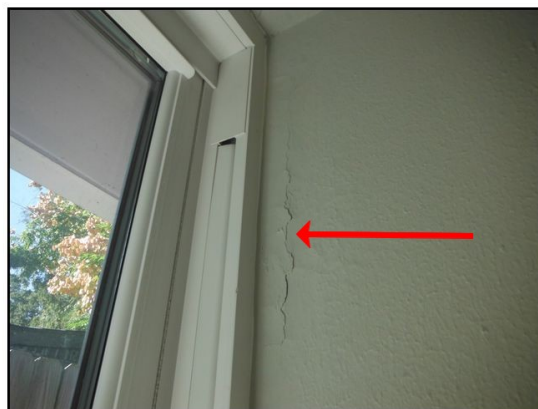
Cosmetic cracks and/or repaired cracks in sheetrock observed over one or more doors, windows, and/or corners.

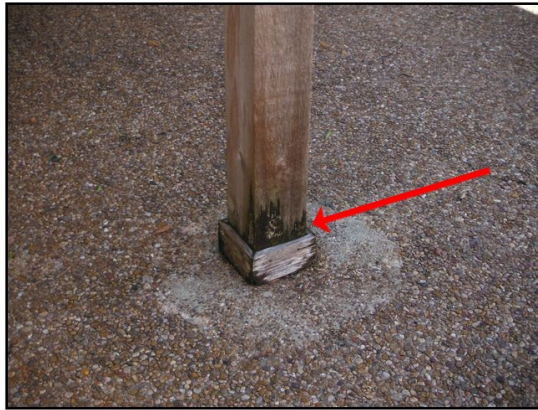
Wood rot / damage observed bottom/base of one or more wood columns.

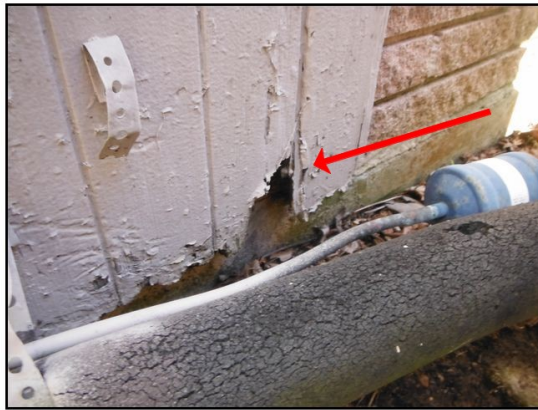
Wood rot observed on areas of house.

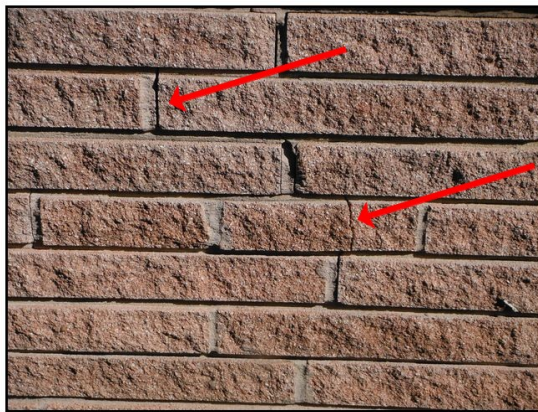
Cracks in brick veneer and/or repairs, one or more locations, Recommend buyer take photographs of cracks, their location, and width [ruler across the crack] with a high resolution camera that has a date stamp for future reference.

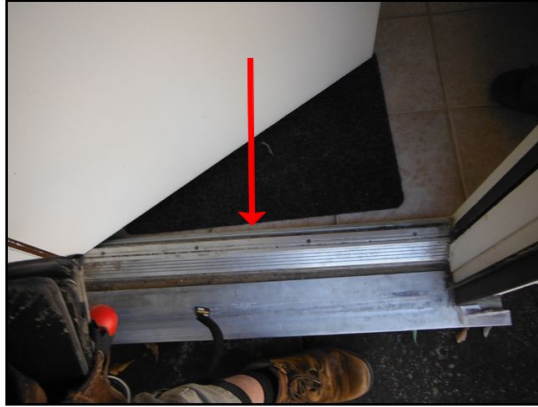
*Could not find / observe indications / proof that proper door pan flashing was installed below one or more exterior doors. I did not see any evidence of water penetration. Recommend monitoring during heavy wind driven rains for water entry.*

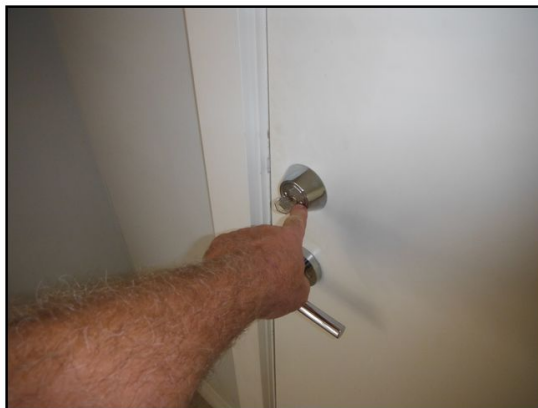
Exterior door does not have thumb latch to unlock door. All egress doors shall be opened from the inside without the use of a key or special knowledge or effort. Ref. IRC code R311.2.

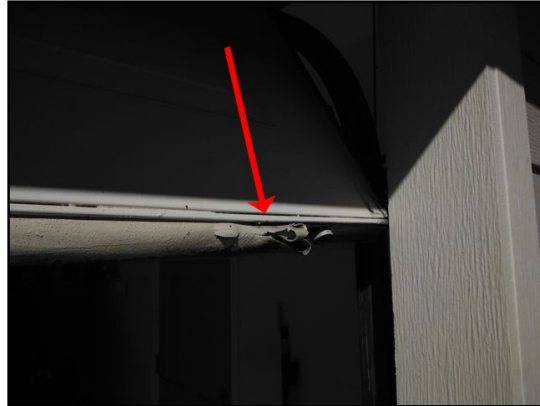
Weather stripping torn/damaged and/or missing on garage door.

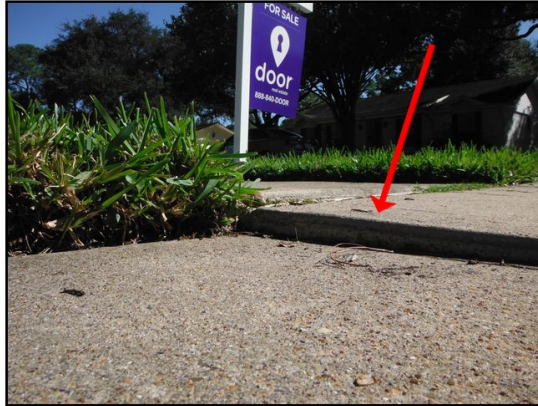
Tripping Hazard(s), walks and/or driveways are uneven.

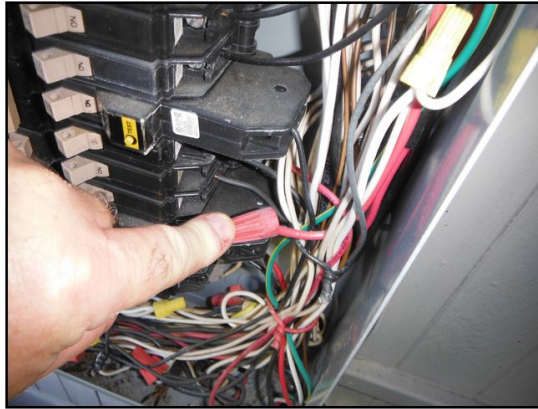
Disconnected wiring observed in panel.

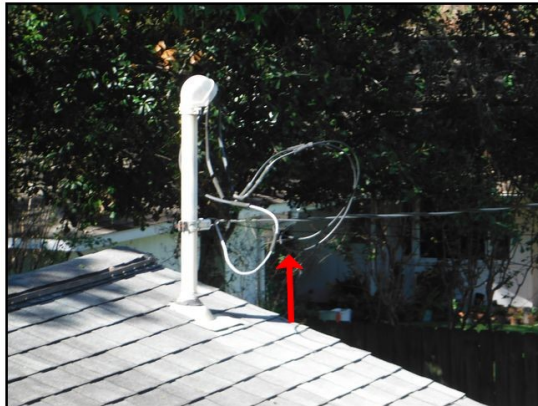
Low elevation of power lines over roof, electrocution hazard. Code requires a minimum clearance of 3 feet over roof.

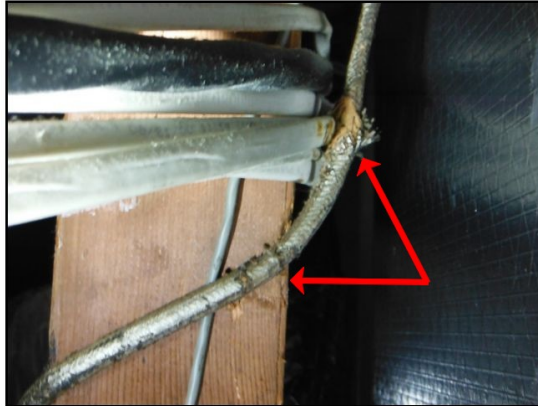
**Damaged Romex wiring observed at following locations; attic near scuttle hole.**

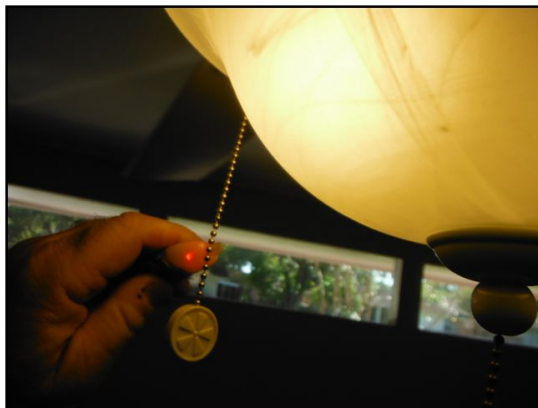
One or more ceiling fan(s) were found to be not grounded.

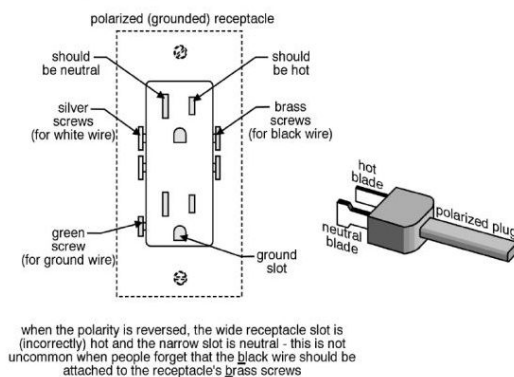
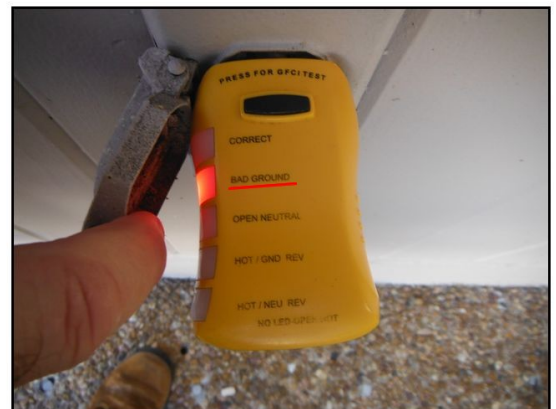
Improperly wired, 3 prong outlet not grounded or polarity reversed, including but not limited to; north exterior wall.

**Reversed polarity**

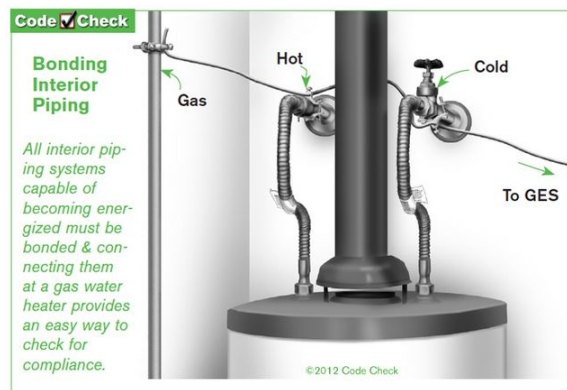
Ground rod / wire missing or damaged at gas meter.

Gas and hot / cold water lines are not properly bonded near water heater. Does not appear to comply with most recent electrical code.

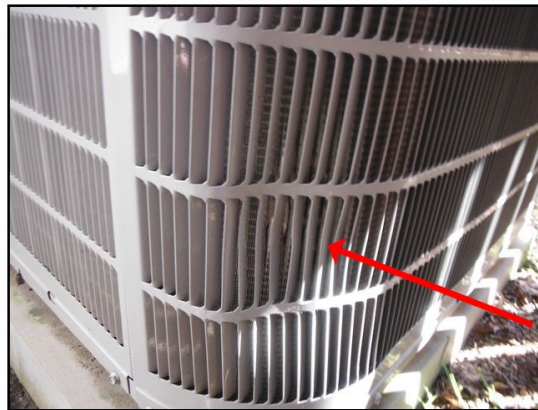
Coil fins damaged/bent, need to be straightened to improve air flow/efficiency.

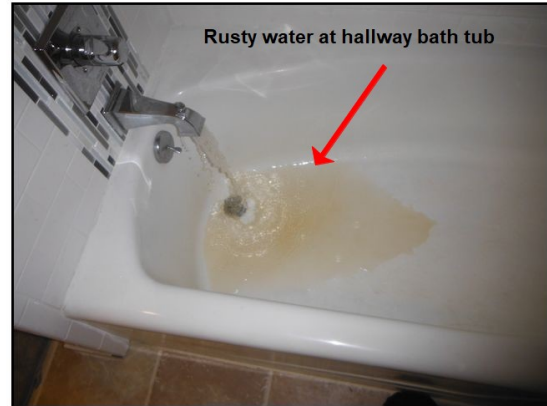
**Observed indications of advanced deterioration of galvanized piping and/or previous repairs. Additional water leaks, repairs, and/or replacement should be expected and budgeted for in the near future. Recommend further evaluation by a licensed plumber.**

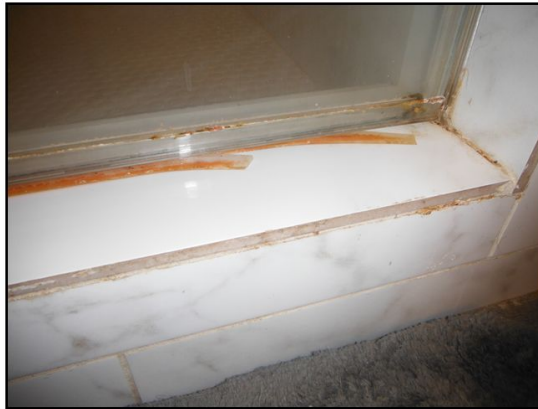
Shower door lower weather stripping loose and / or damaged, results in possible water leaking from base of door, needs repair / replacement.

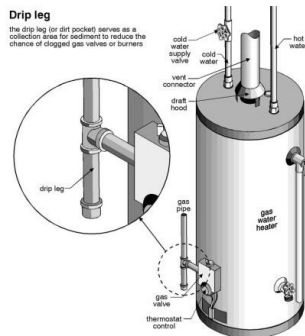
*Did not observe gas line drip leg(s) on gas house heater and/or gas water heaters which is called for in the manufactures installation instructions.*

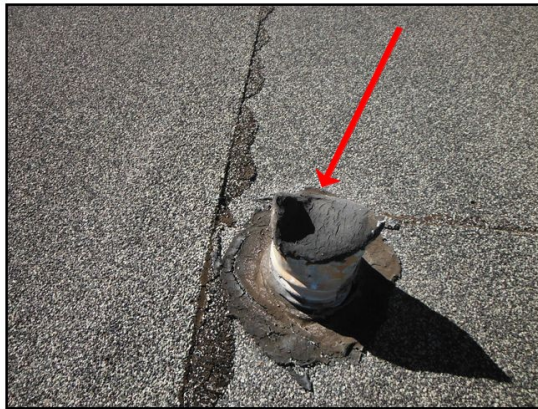
DWV stack has been blocked with tar, recommend removing tar for proper ventilation.

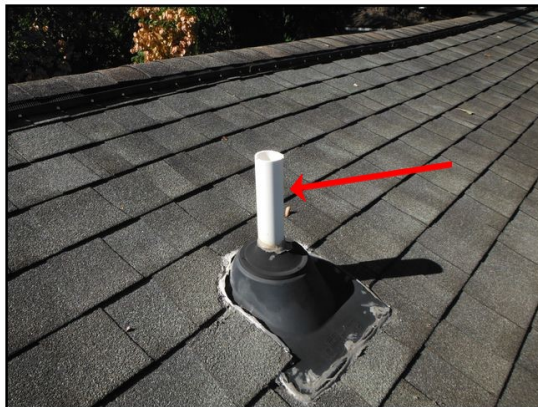
Painting of exterior plastic PVC vents above roof line required to prevent UV damage.

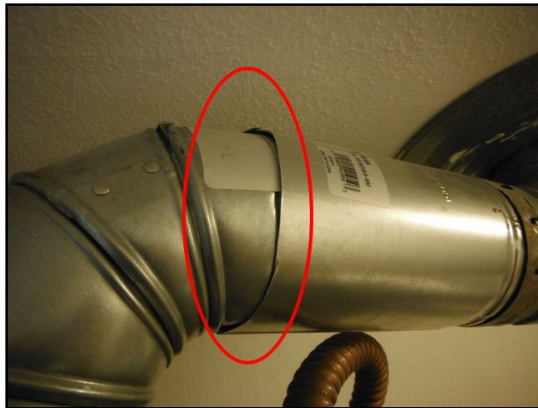
Not all double wall vent pipe connection(s) are properly secured together;

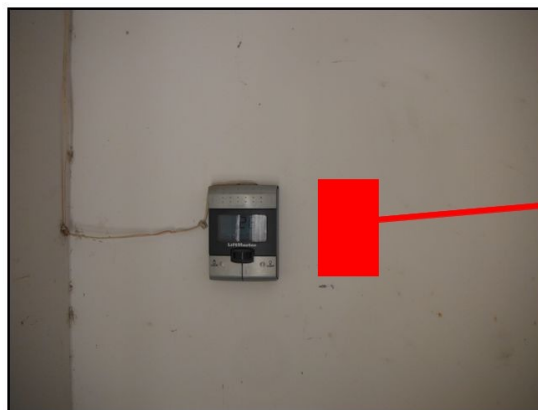
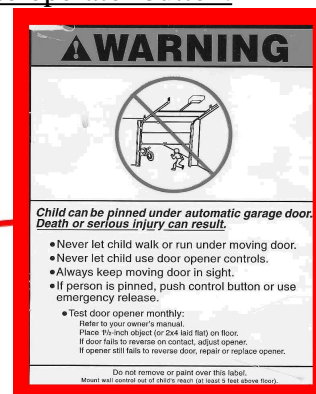
Missing required safety sticker / decal next to operator button.

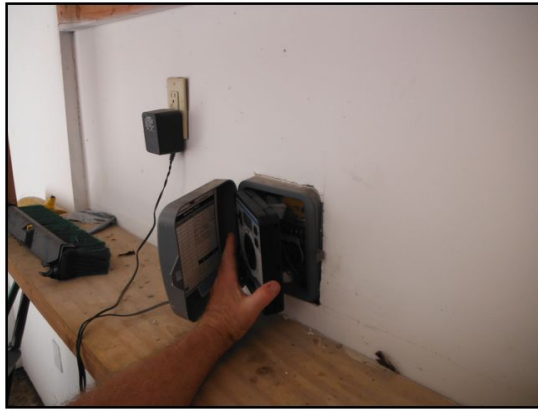
System control unit is not properly secured in housing.
