Invoice # 8790
Erick Calderon
Inspection at 5630 Cheena Dr
Houston, Tx 77096
11/05/2018

Sewer Inspection Report

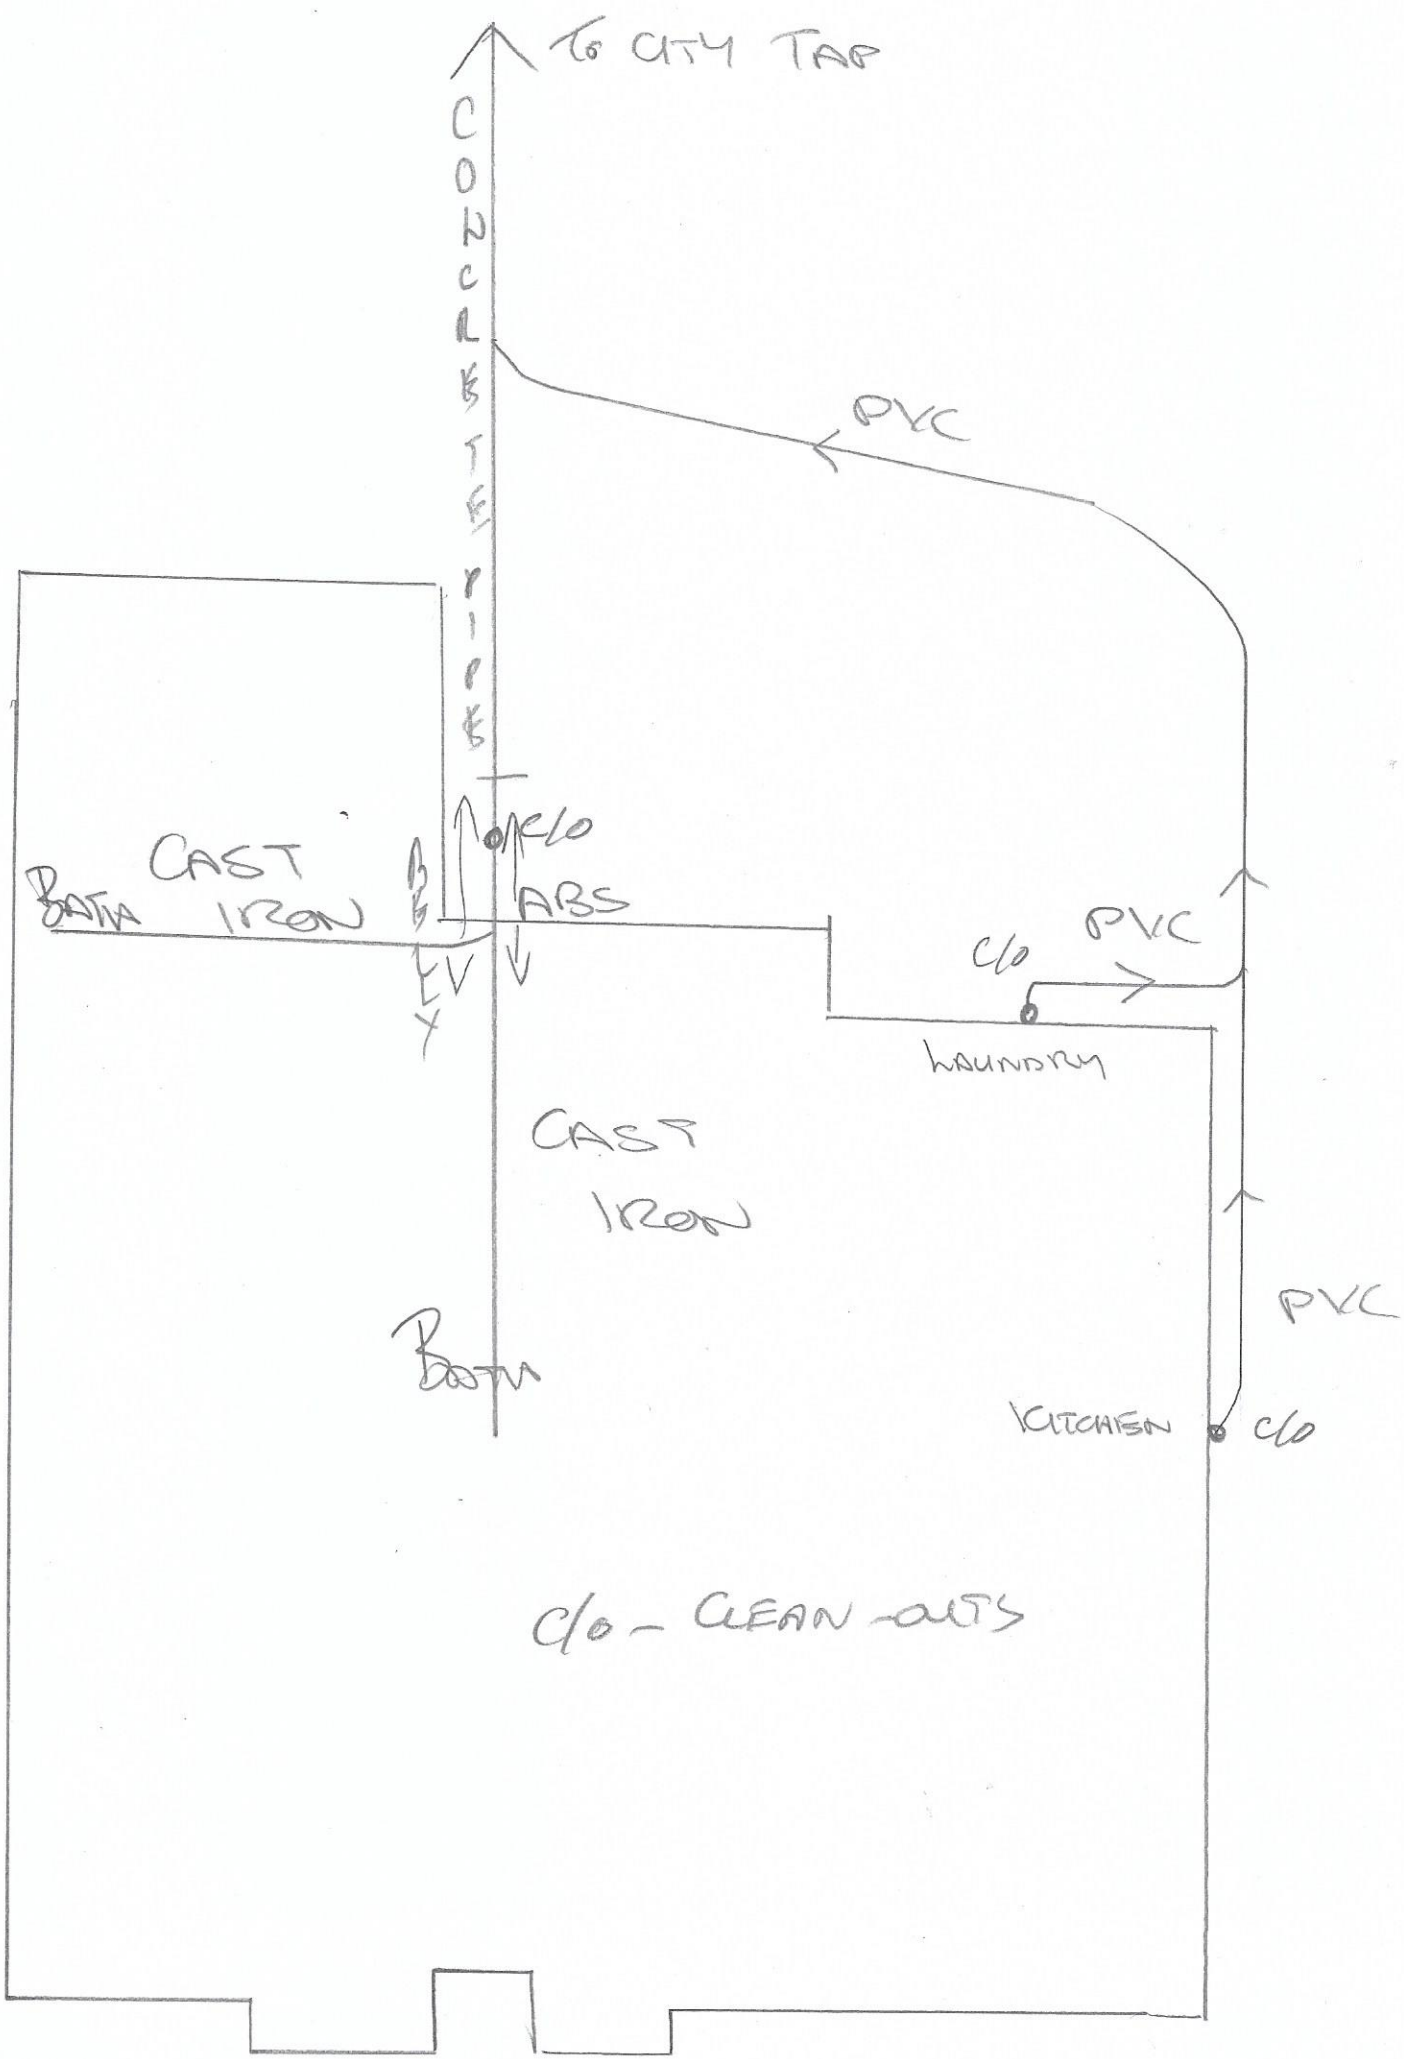
One main and two secondary clean-outs were located (approximate locations indicated on the diagram).
Clean-outs should always be visible and accessible, and thus this main clean-out should be raised.
Clean-outs are access points at ground level to enter into the sewer system for general maintenance, clearing of stoppages, inspections and hydro-static leak testing.

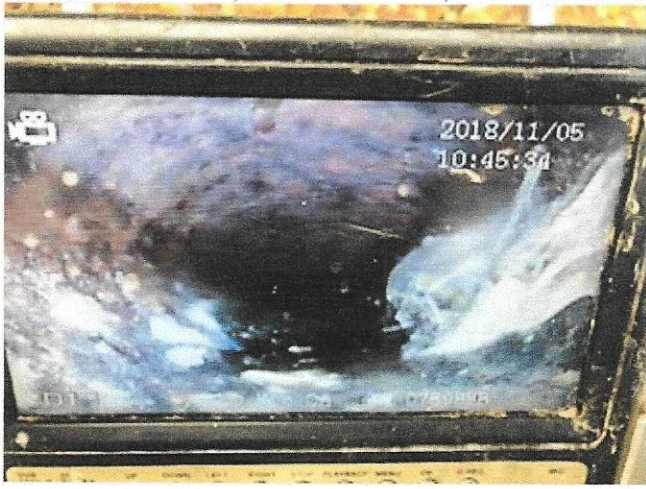
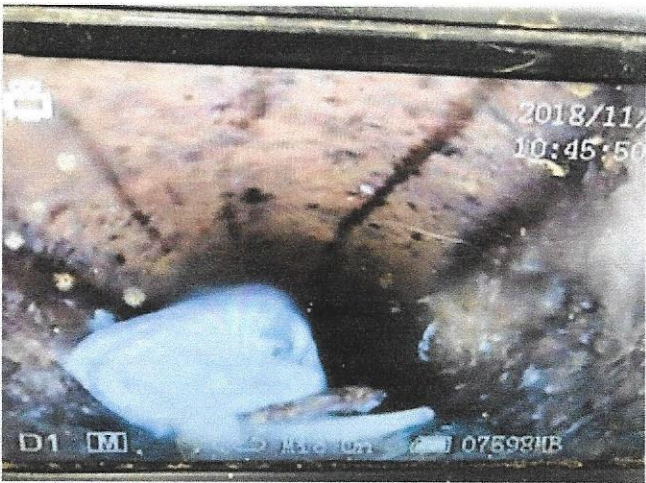
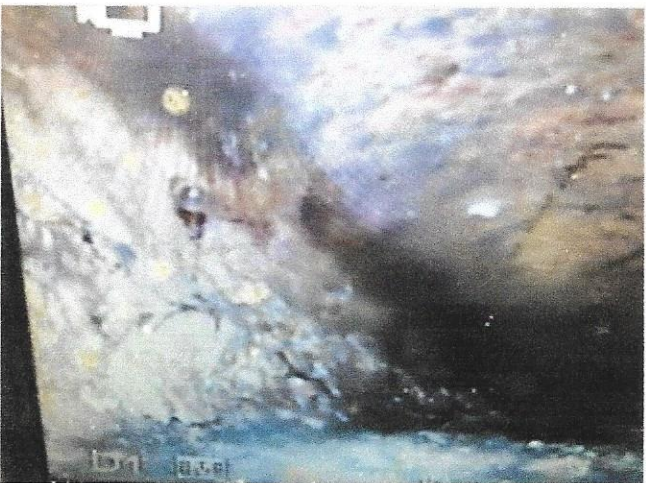
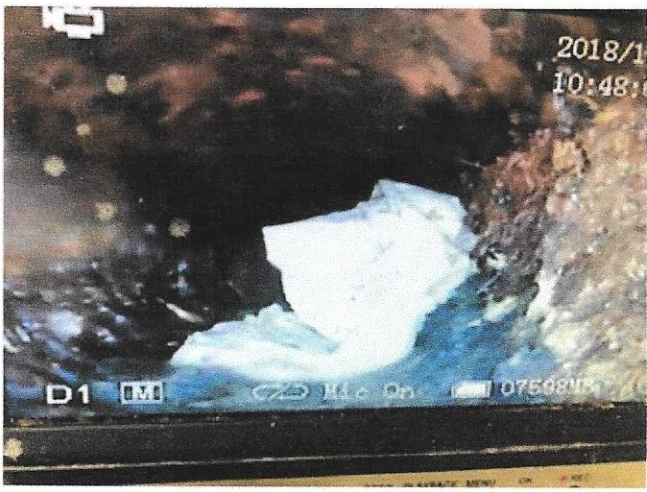
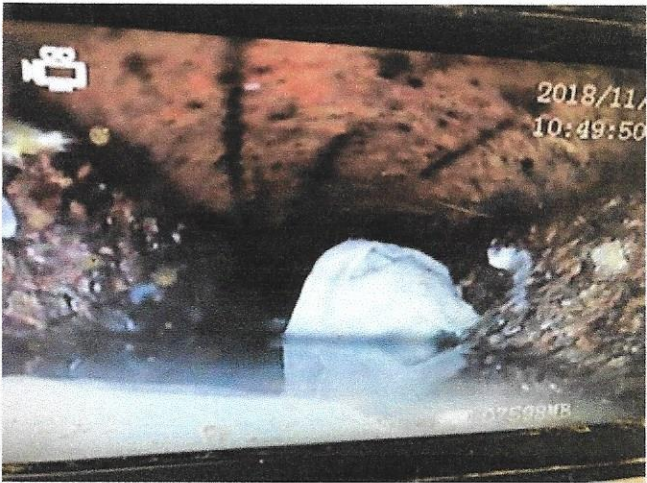
Several cracks, breaks, leaks and bellies (dipping section of pipe, typically holding water) was seen under the slab.
The cast iron showed multiple areas of debris caught in the cast iron pipe.

DEBRIS, CRACKS, BREAKS, LEAKS & BELLIES

Because permission was not granted to perform this test, this inspection at this time, is incomplete, however given the evidence already seen on camera today, and the age of the system (50-60 years is the expected working life of cast iron pipe), it would behoove the owner to begin planning an update to PVC pipe. In that case, no further testing would be needed.
