Property Inspection Report

19227 Mossy Pointe Ln, Tomball, TX 77377 Inspection prepared for: Michael Ortiz Real Estate Agent: Kristen Robinson - REALM Real Estate HWY 6 (Memorial)

> Date of Inspection: 8/28/2019 Time: 1:30 PM Age of Home: 2007 Size: 2507 Order ID: 13282

Inspector: David Philp
License #21284
9630 Cannock Chase, Houston, TX 77064
Phone: 832-567-5791
Email: clientcare@1strateinspections.com
1stRateInspections.com

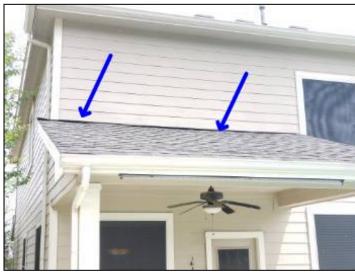
-The roof flashing is lifted. Recommend securing -Due to granular loss on portions of the roof these all loose or lifted flashing and sealing nails to help portions of the roof coverings may age

prevent water penetration. Mainly at - patio cover prematurely. This is often due to normal wear due to the age of the roof. Mainly at- front porch

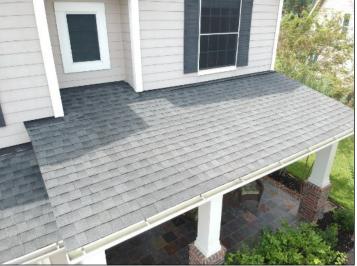
-The roof flashing is lifted. Recommend securing all loose or lifted flashing and sealing nails to help prevent water penetration. Mainly at - patio cover

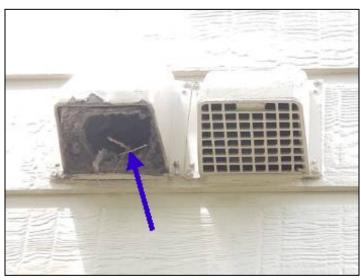
Indications are that there is a bird nest in one of the vents.

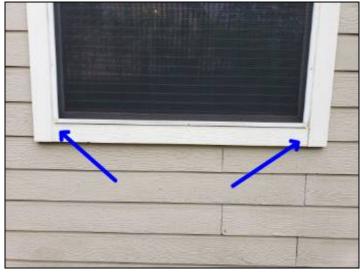
-There is some damage to the exterior siding, recommend repair or replacement to help prevent water penetration. Unable to determine the condition of the underlying materials. Mainly at right

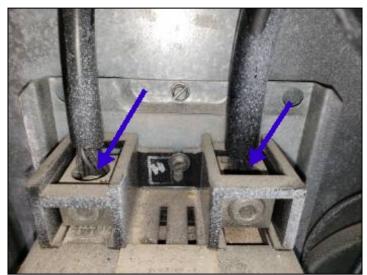
-There is no antioxidant on main aluminum feeds to the panel box. This should be used to help prevent overheating.

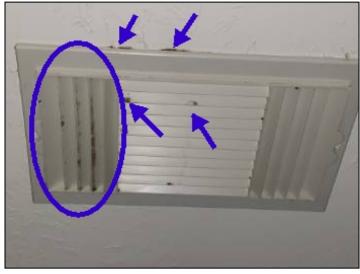
-Registers are showing signs of growth, recommend cleaning vents and ducts as needed. Air sampling will most likely not identify microbial growth, however a swab or tape sample will determine if there is microbial growth.

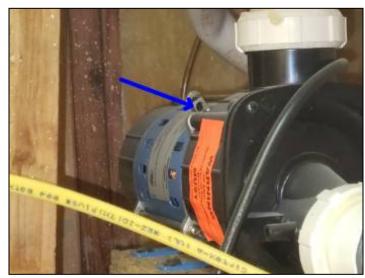
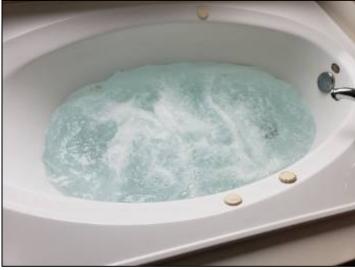
-Bonding was missing on Hydro Massage Therapy The hydro therapy tub is operating as intended. Equipment.

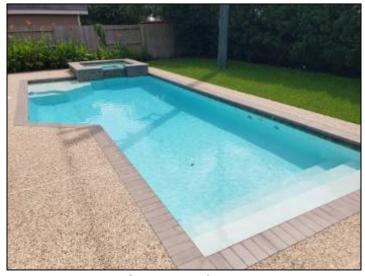
Overview of pool
