PROPERTY INSPECTION REPORT

Concerning: 18710 Duke Lake Drive , Spring, TX 77388
(Address or Other Identification of Inspected Property)

By: Levi Greene Lic.#: TREC #20866 07/17/2019
(Name and License Number of Inspector) (Date)

Home Inspection Report

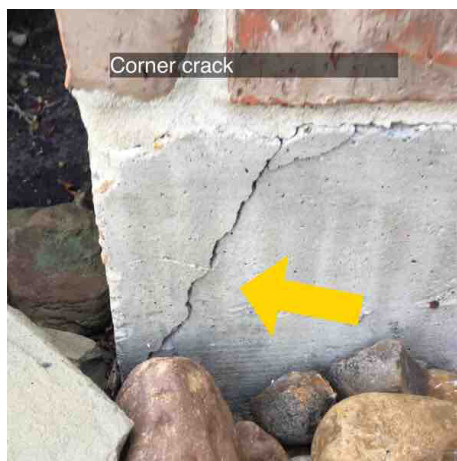
- **Corner cracks observed on most corners, fill in cracks in order to reduce chance of rust damage to post tension cables, cracks appear to be cosmetic and common to many homes.**

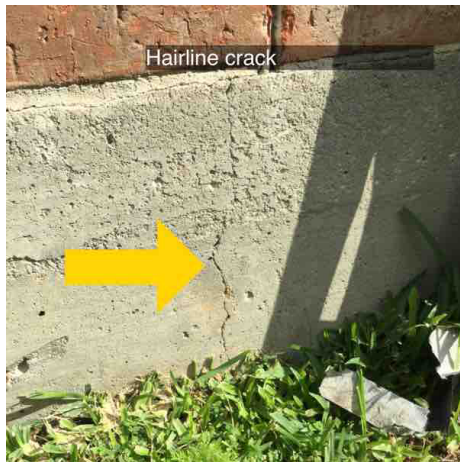
• There is a hairline crack in the foundation on the south side and a crack in the garage floor surface that in the opinion of this home inspector does not appear to be causing serious structural issues at this time, recommend to seal crack and monitor. Sometimes these types of cracks are from concrete shrinkage and others can be from foundation movement. If you have concerns about the garage cracks, you may want to have evaluation by a qualified foundation contractor or structural engineer. All cracks need to be filled in and monitored for any further cracking. If future cracking occurs, a foundation contractor or structural engineer will need to evaluate the foundation further.

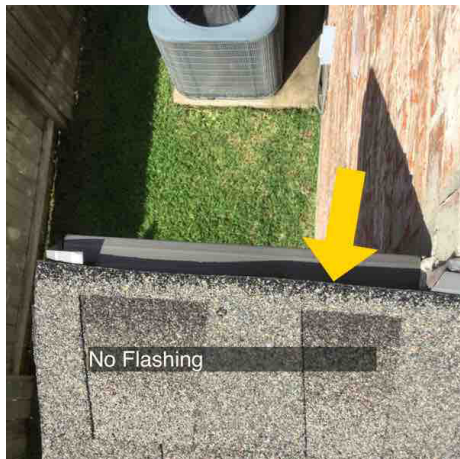
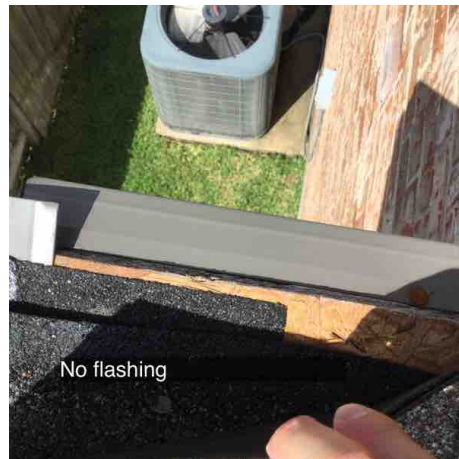
- The south east corner of the rear patio cover is not flashed, needs repair prevent water damage.

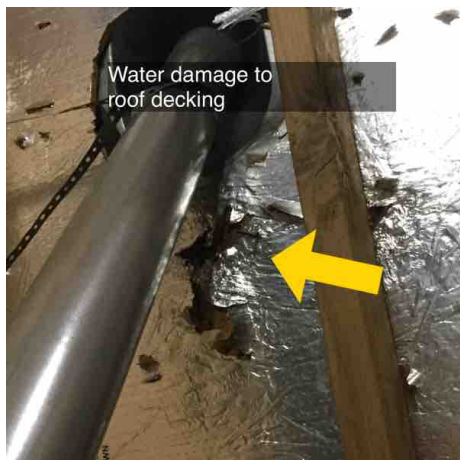
- Due to water damage noted to the roof decking above the right water heater exhaust vent in the attic, it is advised to seek further evaluation of the roof by a qualified roofing contractor to determine if any corrective actions are required at this time.

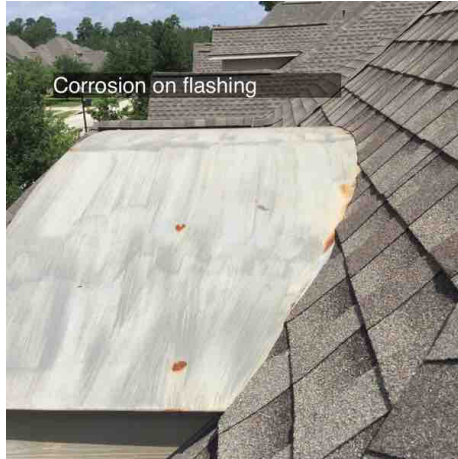
- Rust noted on some areas of the flashing, rust needs to be removed and flashing need to be painted to prevent further damage and possible water intrusion.

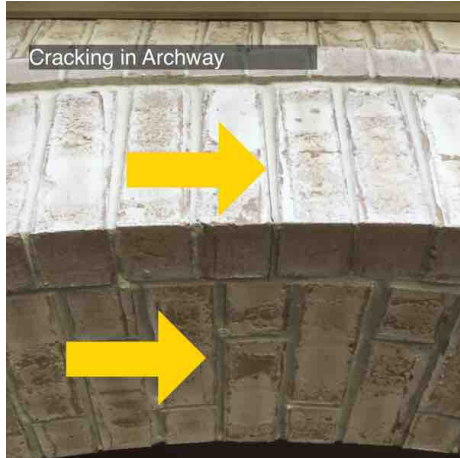
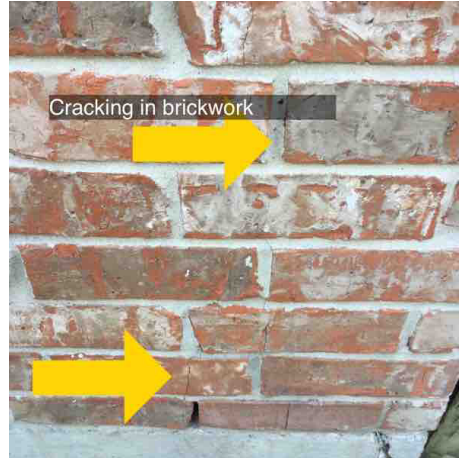
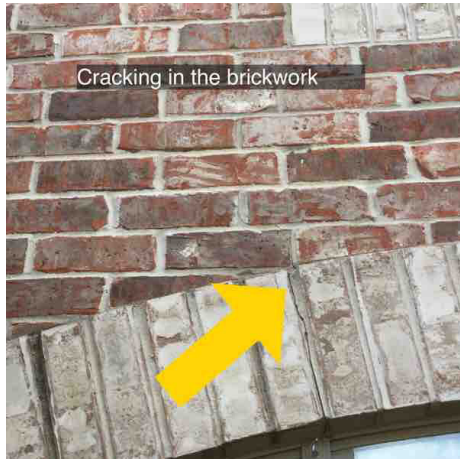
- There are cracks in the brickwork above the front entry archway, the window in the formal dining room and on the northwest corner of the home, cracks appear to have been caused by settlement and movement of the foundation and also could have been from the wall moving some from not being supported properly, needs further evaluation and repair as needed by a qualified contractor.

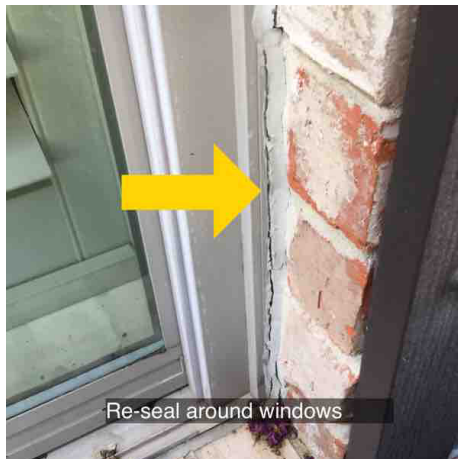
- Open/close/locked all accessible windows.
- Need to caulk and seal around the exterior windows to reduce possibility of water leaking in.

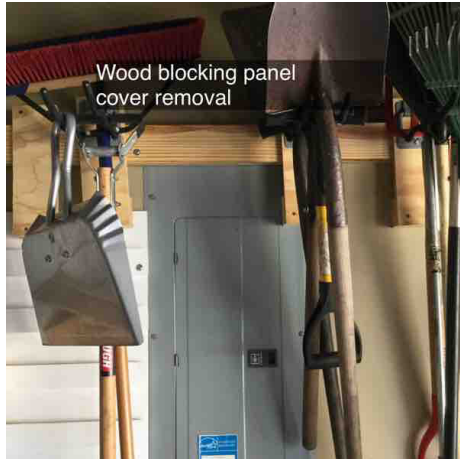
- The dead front could not be removed from the garage panel, wood has been installed over it preventing it from being removed, wood installed onto the walls blocking the panel cover needs to be removed and the panel should be evaluated by a qualified electrical contractor.

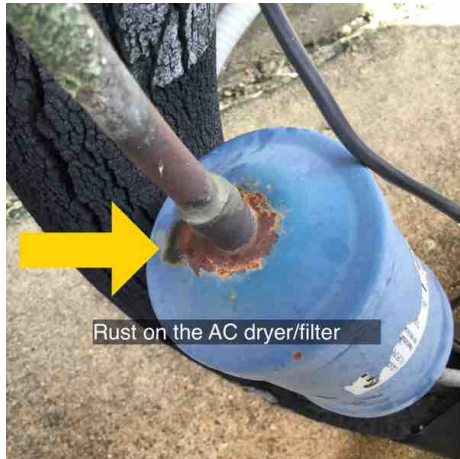
- **Dryer/filter on the exterior unit has rust damage to it, recommend further evaluation by a qualified HVAC contractor for possible leaks.**

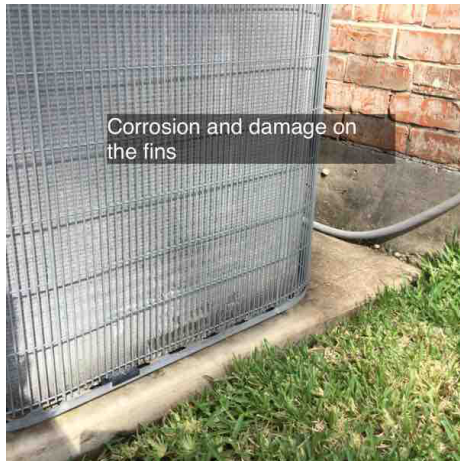
- **There is corrosion on the fins of the exterior units that needs evaluation and repair as needed by a qualified HVAC contractor.**

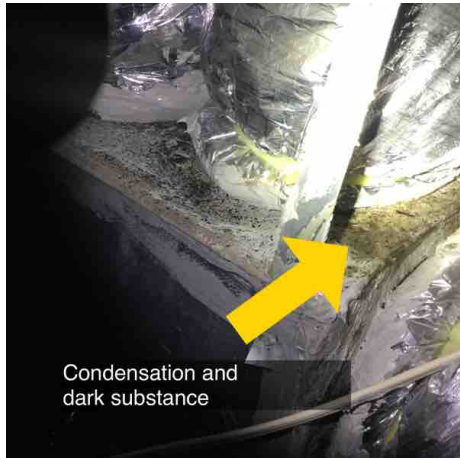
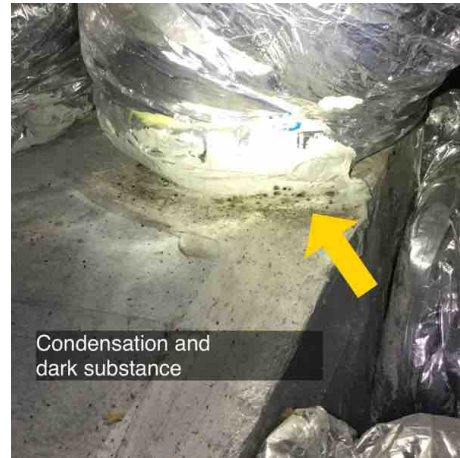
- Condensation noted on both of the air conditioning systems in the attic, the dark substance was also noted on these units appears to be due to the condensation, due to this recommend to have a qualified environmental contractor be contacted to see if air samples and other testing should be done on the house for potential mold type issues and what repairs may be needed.

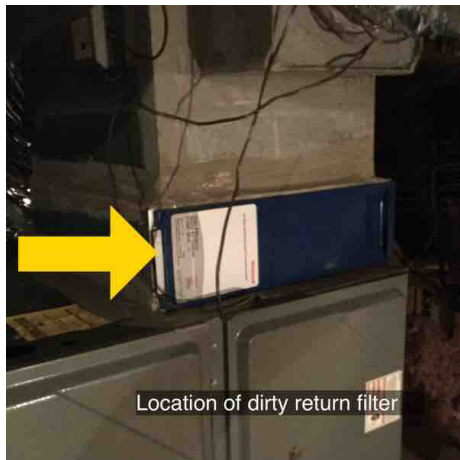
- The return filters located in the attic are dirty, the A/C system/coils need to be evaluated further and cleaned by a qualified HVAC contractor to check for possible damage/rust issues, units need to be cleaned and filters need to be replaced and ducts should be evaluated for cleaning also.

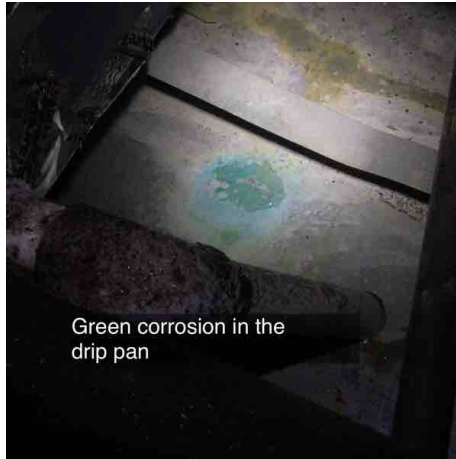
- There is some green corrosion in the secondary drip pans in the attic that could have been caused by a refrigerant leaks on the A/C systems, recommend further evaluation of the system by a qualified HVAC contractor.

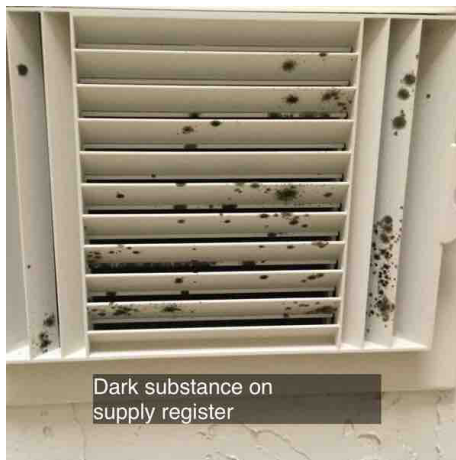
- Supply registers, vents are dirty, dark substance on them, need to be cleaned and evaluated for cause and ducts should be evaluated for cleaning also, recommend further evaluation by a qualified environmental contractor for what the substance is on the registers if there is a potential environmental issue that would need further investigation.

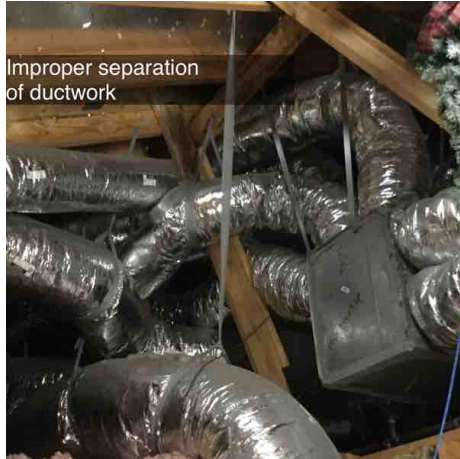
- Some of the ducts in the attic do not appear to be properly strapped because of them touching each other which can cause air flow restrictions and condensation issues, need to be repaired.

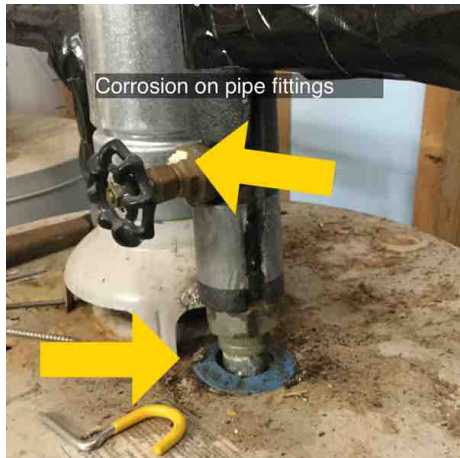
- The temperature and relief drain valves were not tested due to possibility that the valve will stick open causing water to leak out, recommend evaluation of valves. Valves should be tested at least several times a year and sometimes need to be replaced after several years. The drain pipes for the hot water tanks were not tested for potential leak issues with the connection or leaks from the drain pipes.
- **Tanks are making knocking noises which appears to be caused by hard water deposits in the tank and can be a indication that the tank may need to be replaced in the near future, recommend to drain the tank and re-evaluate, may need further repair.**
- **There is corrosion and rust on the pipe connections on top of the tank, pipes/fittings need further evaluation and repair as needed by a qualified plumbing contractor to reduce chance of water leak issues.**

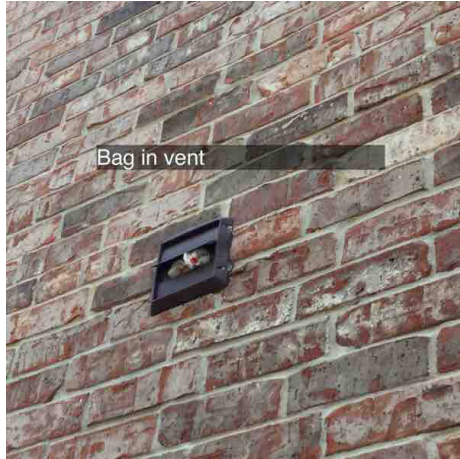
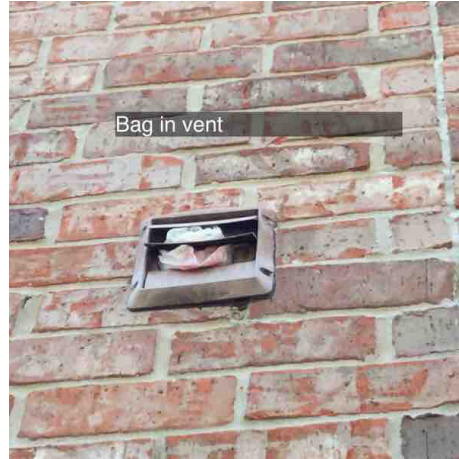
- **Two of exhaust vents on the exterior north wall have bags stuffed into them, the homeowner indicated this was to prevent birds from nesting, bags need to and Vince should be evaluated.**
