## PROPERTY INSPECTION REPORT

10207 Eagle Hollow Dr  
Humble TX 77338

Prepared For: Lance Goble  
(Name of Clients)

Concerning: 10207 Eagle Hollow Dr, Humble TX 77338  
John Rugg - TREC #24498, TPCL FIRM #2017015000  
FIRM #ACO1162, LEAD FIRM #2110697, ASBESTOS  
By: AGENCY #100576, TPCL FIRM #0761253 10/26/2021 9:30 am  
(Name and License Number of Inspector) (Date)

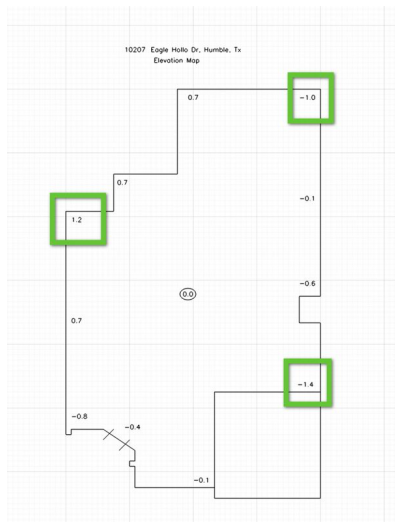
*Foundation levels - Monitor:*

Based on the elevation survey taken at the time of inspection there were areas of the home that had a higher or lower elevation than the rest of the home. These areas should be monitored for continued movement. If you have any concerns about the foundation life expectancy, insurability, or the potential for future problems, a professional engineer should be consulted.

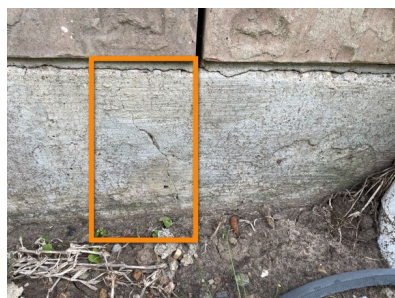
Cracks were observed in the foundation wall.

Recommendation: Recommend monitoring.

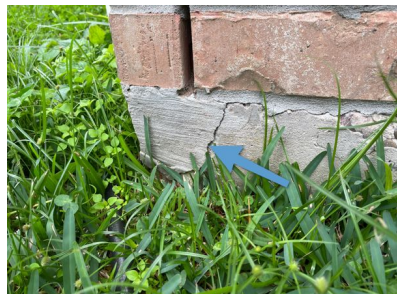
There were corner pops noted on some of the foundation corners. These are caused by the weight of the wall sliding against the foundation and causing the edge to chip or crack. And while you will see these called out on an inspection report, they're typically not a big deal. It's kind of a normal wear-and-tear issue, and rarely indicates a serious problem.

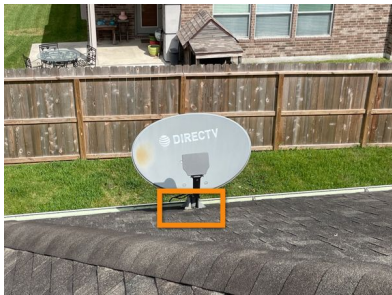
There was a satellite dish installed on the roof. Due to the penetrations in the roof this area is prone to future leaking.

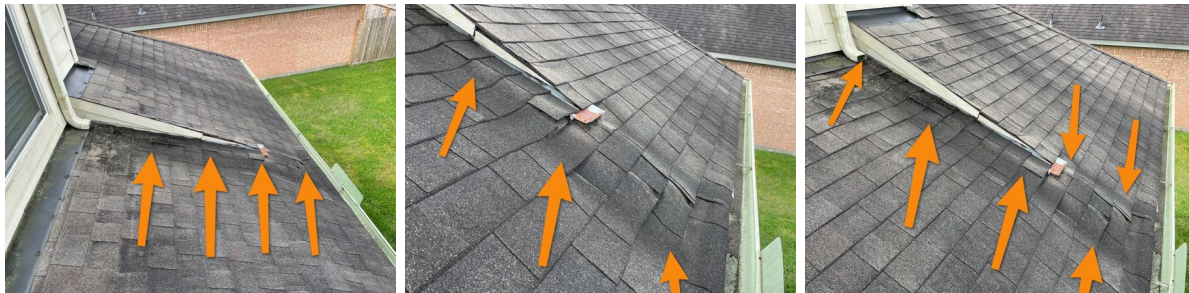
Due to the placement of the gutter downspout and the wall to roof transition, this area has been getting saturated with rain water and has rotted the roof decking underneath the shingles. This area should be assessed by a roofing specialist and repair as needed. It is also recommended that the gutter downspout be extended or relocated to prevent future damage.

Recommendation: Contact a qualified professional.

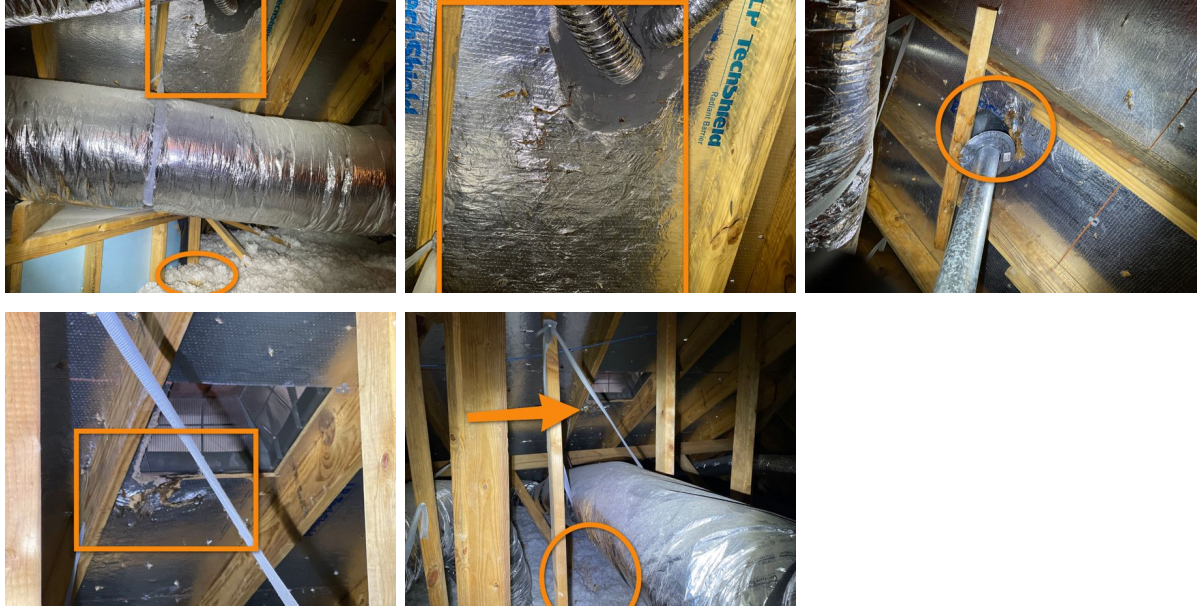
Areas of water damage and staining were noted on the roof decking and structural members in the attic.

Recommendation: Contact a qualified professional.

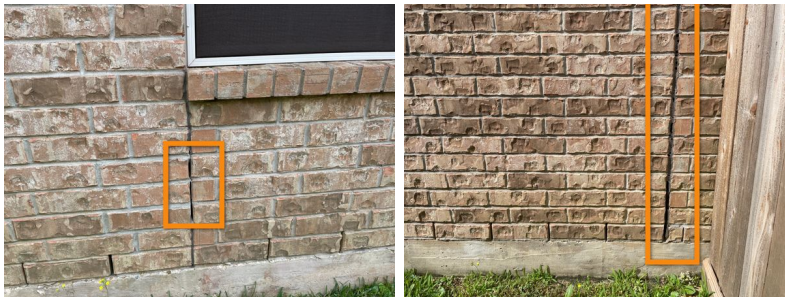
Caulking is needed at the expansion gaps.

Recommendation: Contact a qualified professional.

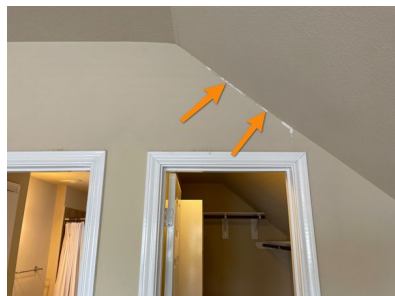
Upstairs Bedroom

There were tape pulls and cracks at ceiling/wall connection points.

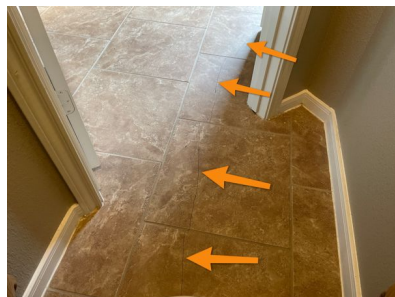
There are cracked floor tiles observed. Repair is recommended.

Recommendation: Contact a qualified flooring contractor

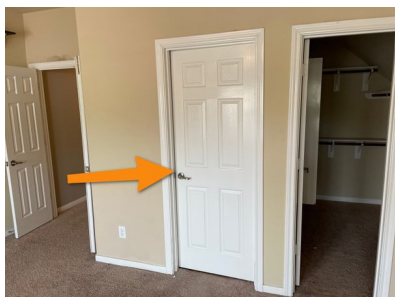
The door binds at the jamb. Adjustments may be needed for proper operation.

Recommendation: Contact a qualified door repair/installation contractor.

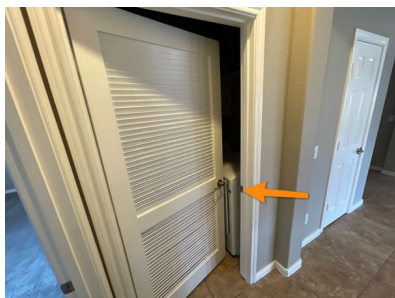
There were doors present that did not latch when shut.

Recommendation: Contact a qualified door repair/installation contractor.

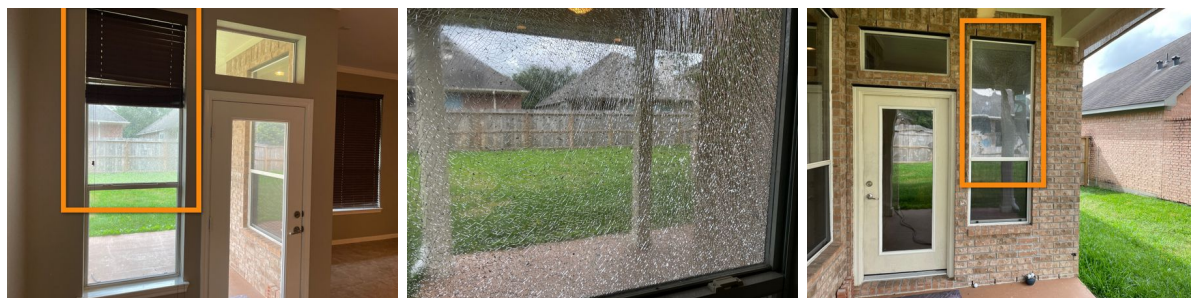
There was a broken window observed. Recommend repair or replacement.

Recommendation: Contact a qualified window repair/installation contractor.

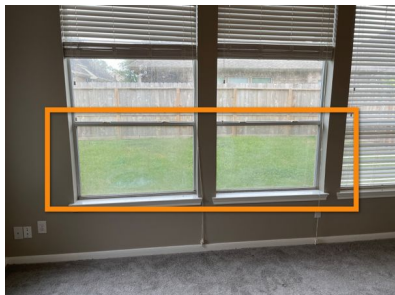
There were windows observed at the time of inspection in which the seals were starting to fail. Replacement is recommended. Refer to "Window" note at miscellaneous section.

Recommendation: Contact a qualified window repair/installation contractor.

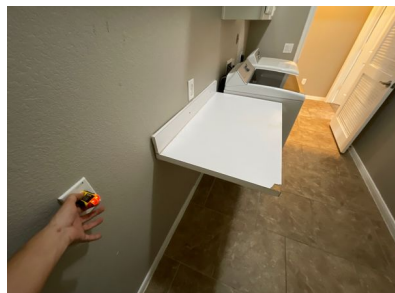
Not all TREC required areas were GFCI protected. Required areas include, but are not limited to the Kitchen, all Bathroom/Restrooms, Garage, Exterior, Crawlspace, Unfinished Basements, Laundry Rooms, and Bar areas.

Recommendation: Contact a qualified electrical contractor.

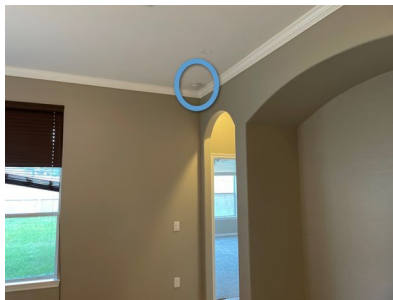
Living Room

Some smoke alarms were chirping at time of inspection. This generally indicates that batteries need to be replaced.

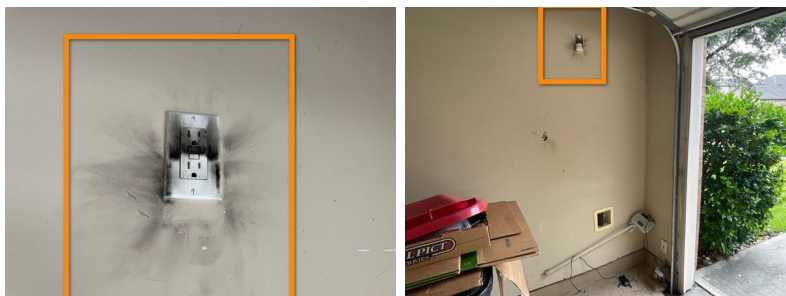
There were scorch marks noted at various outlets.

Recommendation: Contact a qualified professional.

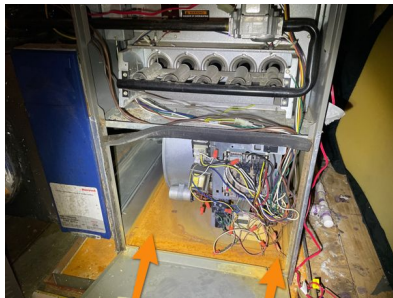
There were areas of rust present at the interior cabinet.

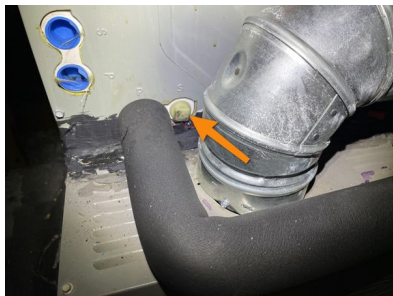
The secondary drain line was missing. Repair is recommended.

Recommendation: Contact a qualified professional.

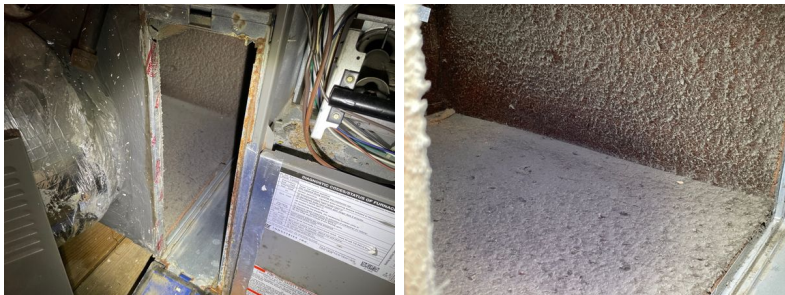
The filter for the unit is missing. The evaporative coils may need cleaning.

Recommendation: Contact a qualified heating and cooling contractor

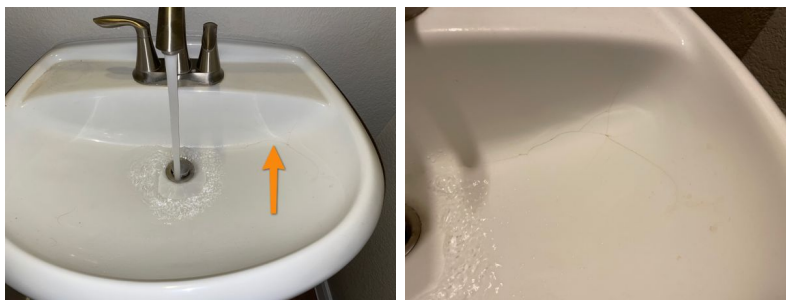
Downstairs Guest Bathroom

There was surface damage present at the sink.

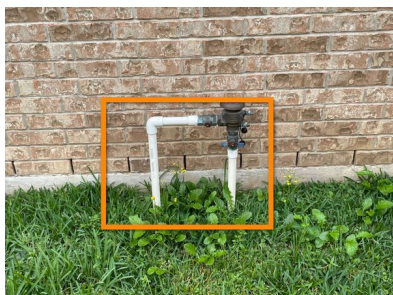
Any water supply lines in the attic or at the exterior should be insulated to protect the pipe from freezing and bursting.

Recommendation: Contact a qualified professional.

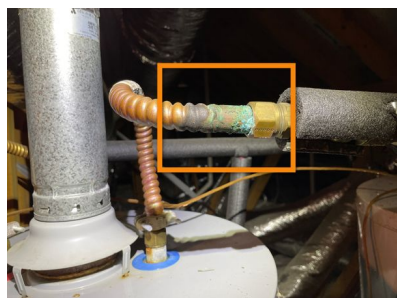
There is corrosion on the valves and fittings at the water heater. Corrosion is prone to water leaking and corroded areas should be replaced as needed.

Recommendation: Contact a qualified plumbing contractor.

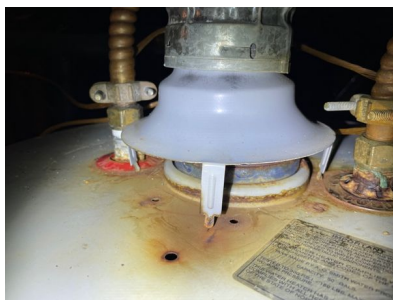
The draft hood to the water heater is not securely centered above the unit.

Recommendation: Contact a qualified plumbing contractor.

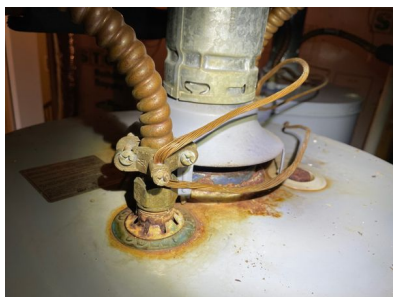
Areas of rust were observed on the unit. Rusting can worsen and lead to water leaks. Repair or replacement is recommended.

Recommendation: Contact a qualified plumbing contractor.

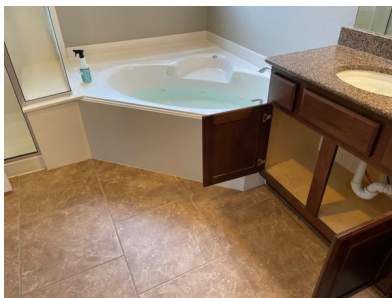
The access panel to inspect the master bathroom whirlpool pump motor was not accessible without destructive means. Unable to inspect motor.

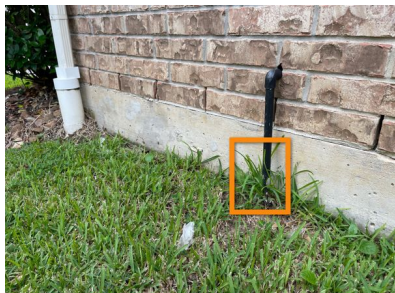
The conduit is damaged at the exterior sprinkler line, exposing the wiring inside.

Recommendation: Contact a qualified professional.

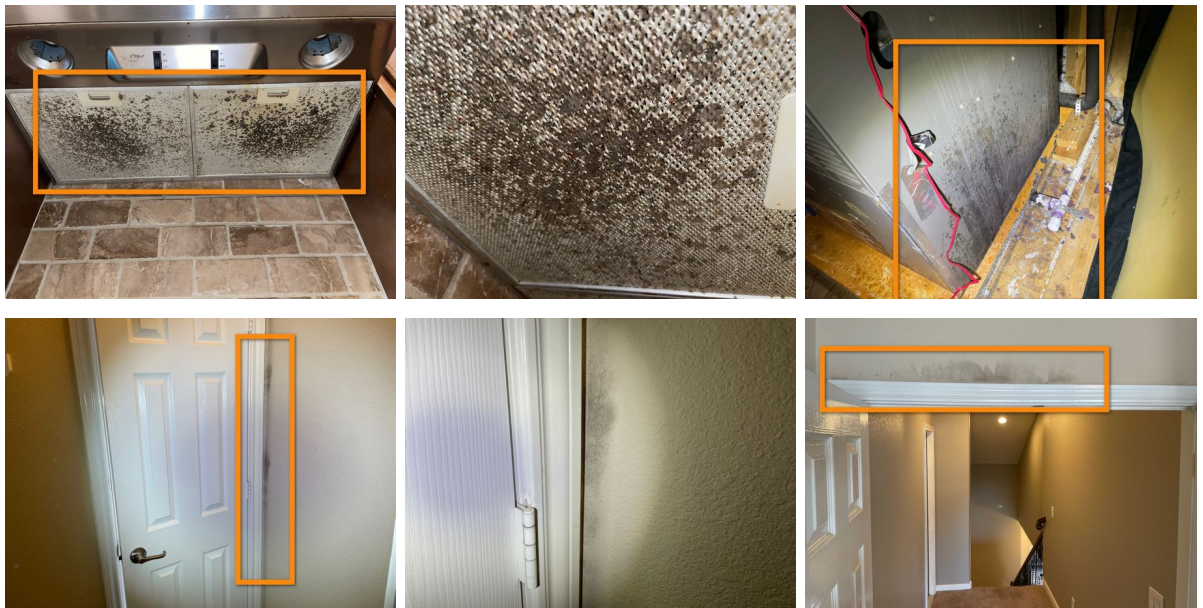
There was assumed mold growth observed within the home. It is recommended that these areas be further sampled and analyzed and remediated as necessary.

Recommendation: Contact a qualified mold inspection professional.
