Insight Property Inspection

PROPERTY INSPECTION REPORT

Prepared For:		
	(Name of Client)	
Concerning:	4611 Knoxville Street B, Houston, Texas 770	51
	(Address or Other Identification of Inspected Prope	erty)
By:	Richard Chandler #6803 / Insight Property Inspections	12/10/2021
	(Name and License Number of Inspector)	(Date)
	(Name, License Number of Sponsoring Inspector)

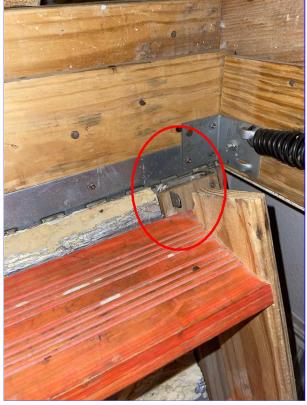
D. Item 1(Picture)

i – inspected	NI – Not inspected NP – Not Present D – Dencient
I NINP D	
	not readily available elsewhere. The website was published specifically to help buyers and others understand the foundation inspections with reference to real estate transactions.
✓ □ □ □ B.	Grading and Drainage Comments:
☑ □ □ □ C.	Roof Covering Materials Types of Roof Covering: 3-Tab fiberglass Viewed roof covering from: Roof Level Comments:
☑ [] [] ☑ D.	 Roof Structures and Attics Roof-Type: Gable Roof Structure Type: Rafters, Joists and Purlins Method used to observe attic: Walked Attic info: Pull Down stairs Approximate Average Depth of Insulation: 10 inches Comments: 1) The pull down stairs have damaged or missing hardware. Injury could result if not repaired. A qualified contractor should inspect and repair as needed

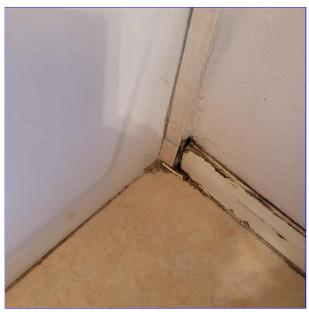
E. Item 1(Picture)

Comments:
(1) Wood rot was observed at the upstairs hall bathroom baseboards.

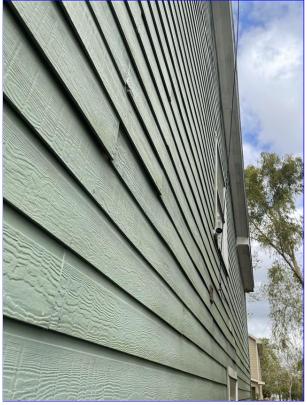
E. Item 2(Picture)

(2) Loose siding boards were observed at the sides and rear of the house is needed.

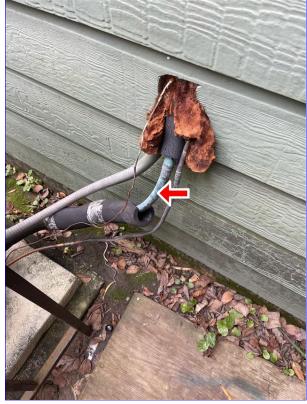
B. Item 1(Picture)

(1) The foam sleeve on suction line is missing in area(s) at outside unit. Missing foam on suction line can cause energy loss and condensation. I recommend service or repair as needed.

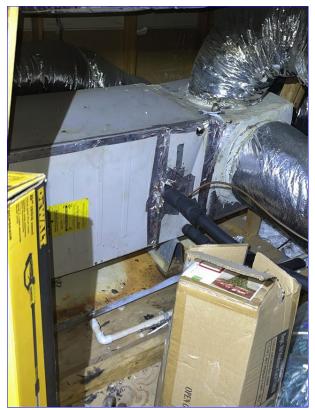
B. Item 2(Picture)

(2) Rust was noted in the safety pan under the evaporator coil in the attic. This should be cleaned professionally by a qualified and licensed HVAC contractor and replaced if the rust has damaged the corrosion resistant coating of the safety pan. After pan has been cleaned and/or replaced, the primary and secondary drain lines should be flow checked and cleaned if necessary plus checked for proper termination..

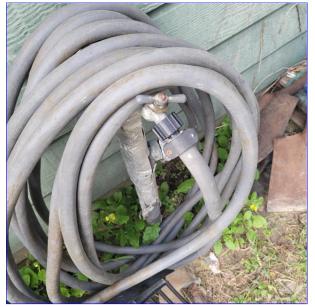
A. Item 2(Picture)

(1) Install anti siphon devices on all exterior faucets. The lack of anti siphon devices can allow nonpotable water or other contaminants to be drawn into the water supply in the event of a drop in water pressure. This is considered a health hazard
